Preliminary Design Report-Consultation

Categories 1, 2 & 3
Scheme Name
Name and Location – BusConnects Route 7 Liffey Valley to City Centre, Dublin
Structure(s)
Name and nature of the Structure(s) – Route 7 Retaining Structures
Structures Options Report
Reference - R07-RW010, R07-RW011
Revision - L02
Date - 23 rd June 2022
Submitted by Signed
Name John McElhinney
Position <u>Structural Discipline Lead</u> (Team Leader)
Organisation Jacobs Engineering
Date <u>23/06/2022</u>
Structures Section confirmation of consultation
Signed
Name
Position

This report outlines the Preliminary Design for the retaining structures on Core Bus Corridor (CBC) 07 Liffey Valley to City Centre. The other routes undertaken by Jacobs shall be covered in separate reports. The scope of this report extends only to structures considered within Dublin County Council (DCC) maintenance boundary.

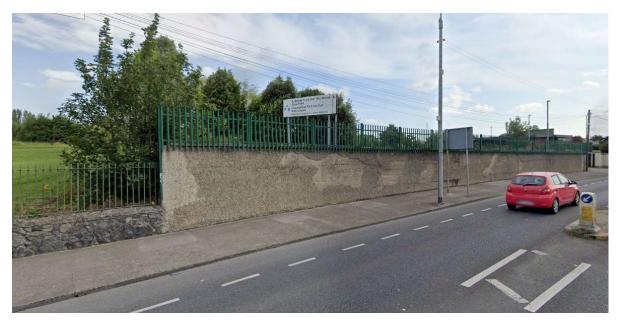
Figure 2.4.3: Photo of wall location R07-RW010

The existing wall appears to consist of a mass gravity wall, with approx. 2.0m retained height. To accommodate the widening required at this location, any new wall would have retained height varying from 2.0m to 3.0m. The length of the affected part of the existing wall is approx. 80m. The alignment of the wall is constrained by a new attenuation pond proposed to the east of the junction with St Laurence's Road required to offset the removal of

permeable surface in the development of this route. Access requirements for maintenance of the wall and access to the pond requires the proposed wall to be offset from the edge of the pond by 2m.

R7-RW010 is located on the north side of the Sarsfield Road R833, along the Longmeadows Park Lands. The proposed widening encroaches on an existing retaining wall which also forms part of the boundary partition separating the highway from the golf course.

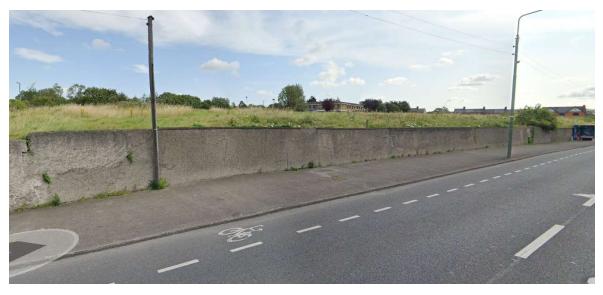
Figure 2.4.4: Photo of wall location R07-RW011

The existing wall comprises of concrete gravity walls with a maximum retained height of 2.5m. Rendered finish shows signs of deterioration with localized debonding of render along the length of the wall. The western end of the wall forms part of the access to the golf course located to the north of the wall. The eastern end of the wall supports a green space that appears unused. Land take at the west end of the proposed wall is therefore unlikely to be a major constraint.

R7-RW011 is located on the north side of the Sarsfield Road R833, along the Longmeadows Park Lands. The proposed widening encroaches on an existing retaining wall which also forms part of the boundary partition separating the highway from the golf course.

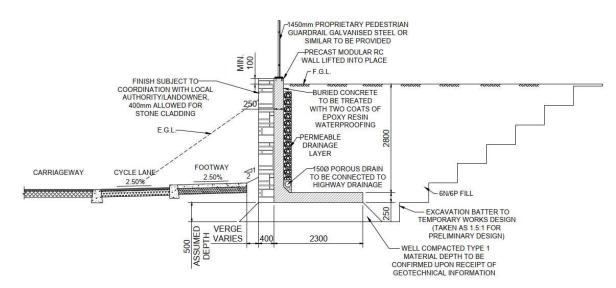
Figure 3.1.2: R07-RW010 & R07-RW011 Typical Cross-Sections

Precast concrete retaining wall is the preferred option at this location as it can best limit disruption to local residents through its comparatively short construction time. Finishes to the wall can also be catered to the wishes of the individual properties, further reducing local disruption. This solution reduces the hazards exposed to the operatives constructing the wall as off-site fabrication reduces the time and complexity of work in the excavation, required section need only be quickly lifted into position and connected.

Shallow foundations are proposed placed directly atop a suitably prepared layer of compacted unbound fill.

In conjunction with the provision of the compacted material for the foundation layer, the wall base was sized to limit the bearing pressures to 150kN/m². Further GI is recommended to determine suitability of the proposed foundation solution.

Nominal 20mm vertical movement joints will be used between sections of wall to allow for natural expansion and contraction of the concrete.

A permeable drainage layer will be provided behind the in-situ concrete retaining walls in accordance with CC-SPW-00500 and will provide positive outfall from one end to the other of the structure and will connect to the mainline road drainage.

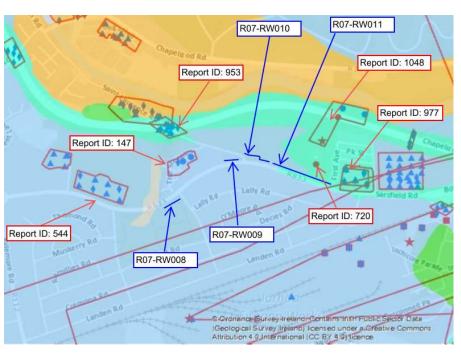
Figure 6-1 Extract from GSI website showing location of available historical GI reports for R07-RW008 – R07-RW011.

Publicly available GI reports (Figure 6-1, GSI External Report Refs: 720, 976, 1048) indicated the natural superficial geology of the area is generally described as firm to very stiff clay with gravel strata also recorded within boreholes to the north of the proposed structure. Significant thickness of made ground, up to 13m in thickness, have been recorded approx. 70m to 250m north – northeast of the proposed structures in historic GI reports (GSI External Report Ref: 720, 1048). Made ground was also recorded at thicknesses of between 1.1m and 1.4m in GSI External Report Ref 976 which is located adjacent to the Sarsfield Road at the eastern end of R07-RW011. No information is provided to indicate the strength or consistency of the made ground material.

The ground conditions at this location are assumed to comprise Till derived from limestones (Dublin Boulder Clay) overlying bedrock geology of dark limestones and shale of the Lucan Formation. The site of R07-RW011 is recorded to have "urban" deposits, which are assumed to be made ground overlying Glacial Till deposits. Total thickness of superficial deposits are unconfirmed, publicly available borehole information indicate a minimum thickness of 20m.

Due to this variability in the thickness and lack of strength data for made ground in this area it is recommended that ground investigation is undertaken at the wall location to confirm the founding strata and suitability of the proposed foundation solution.

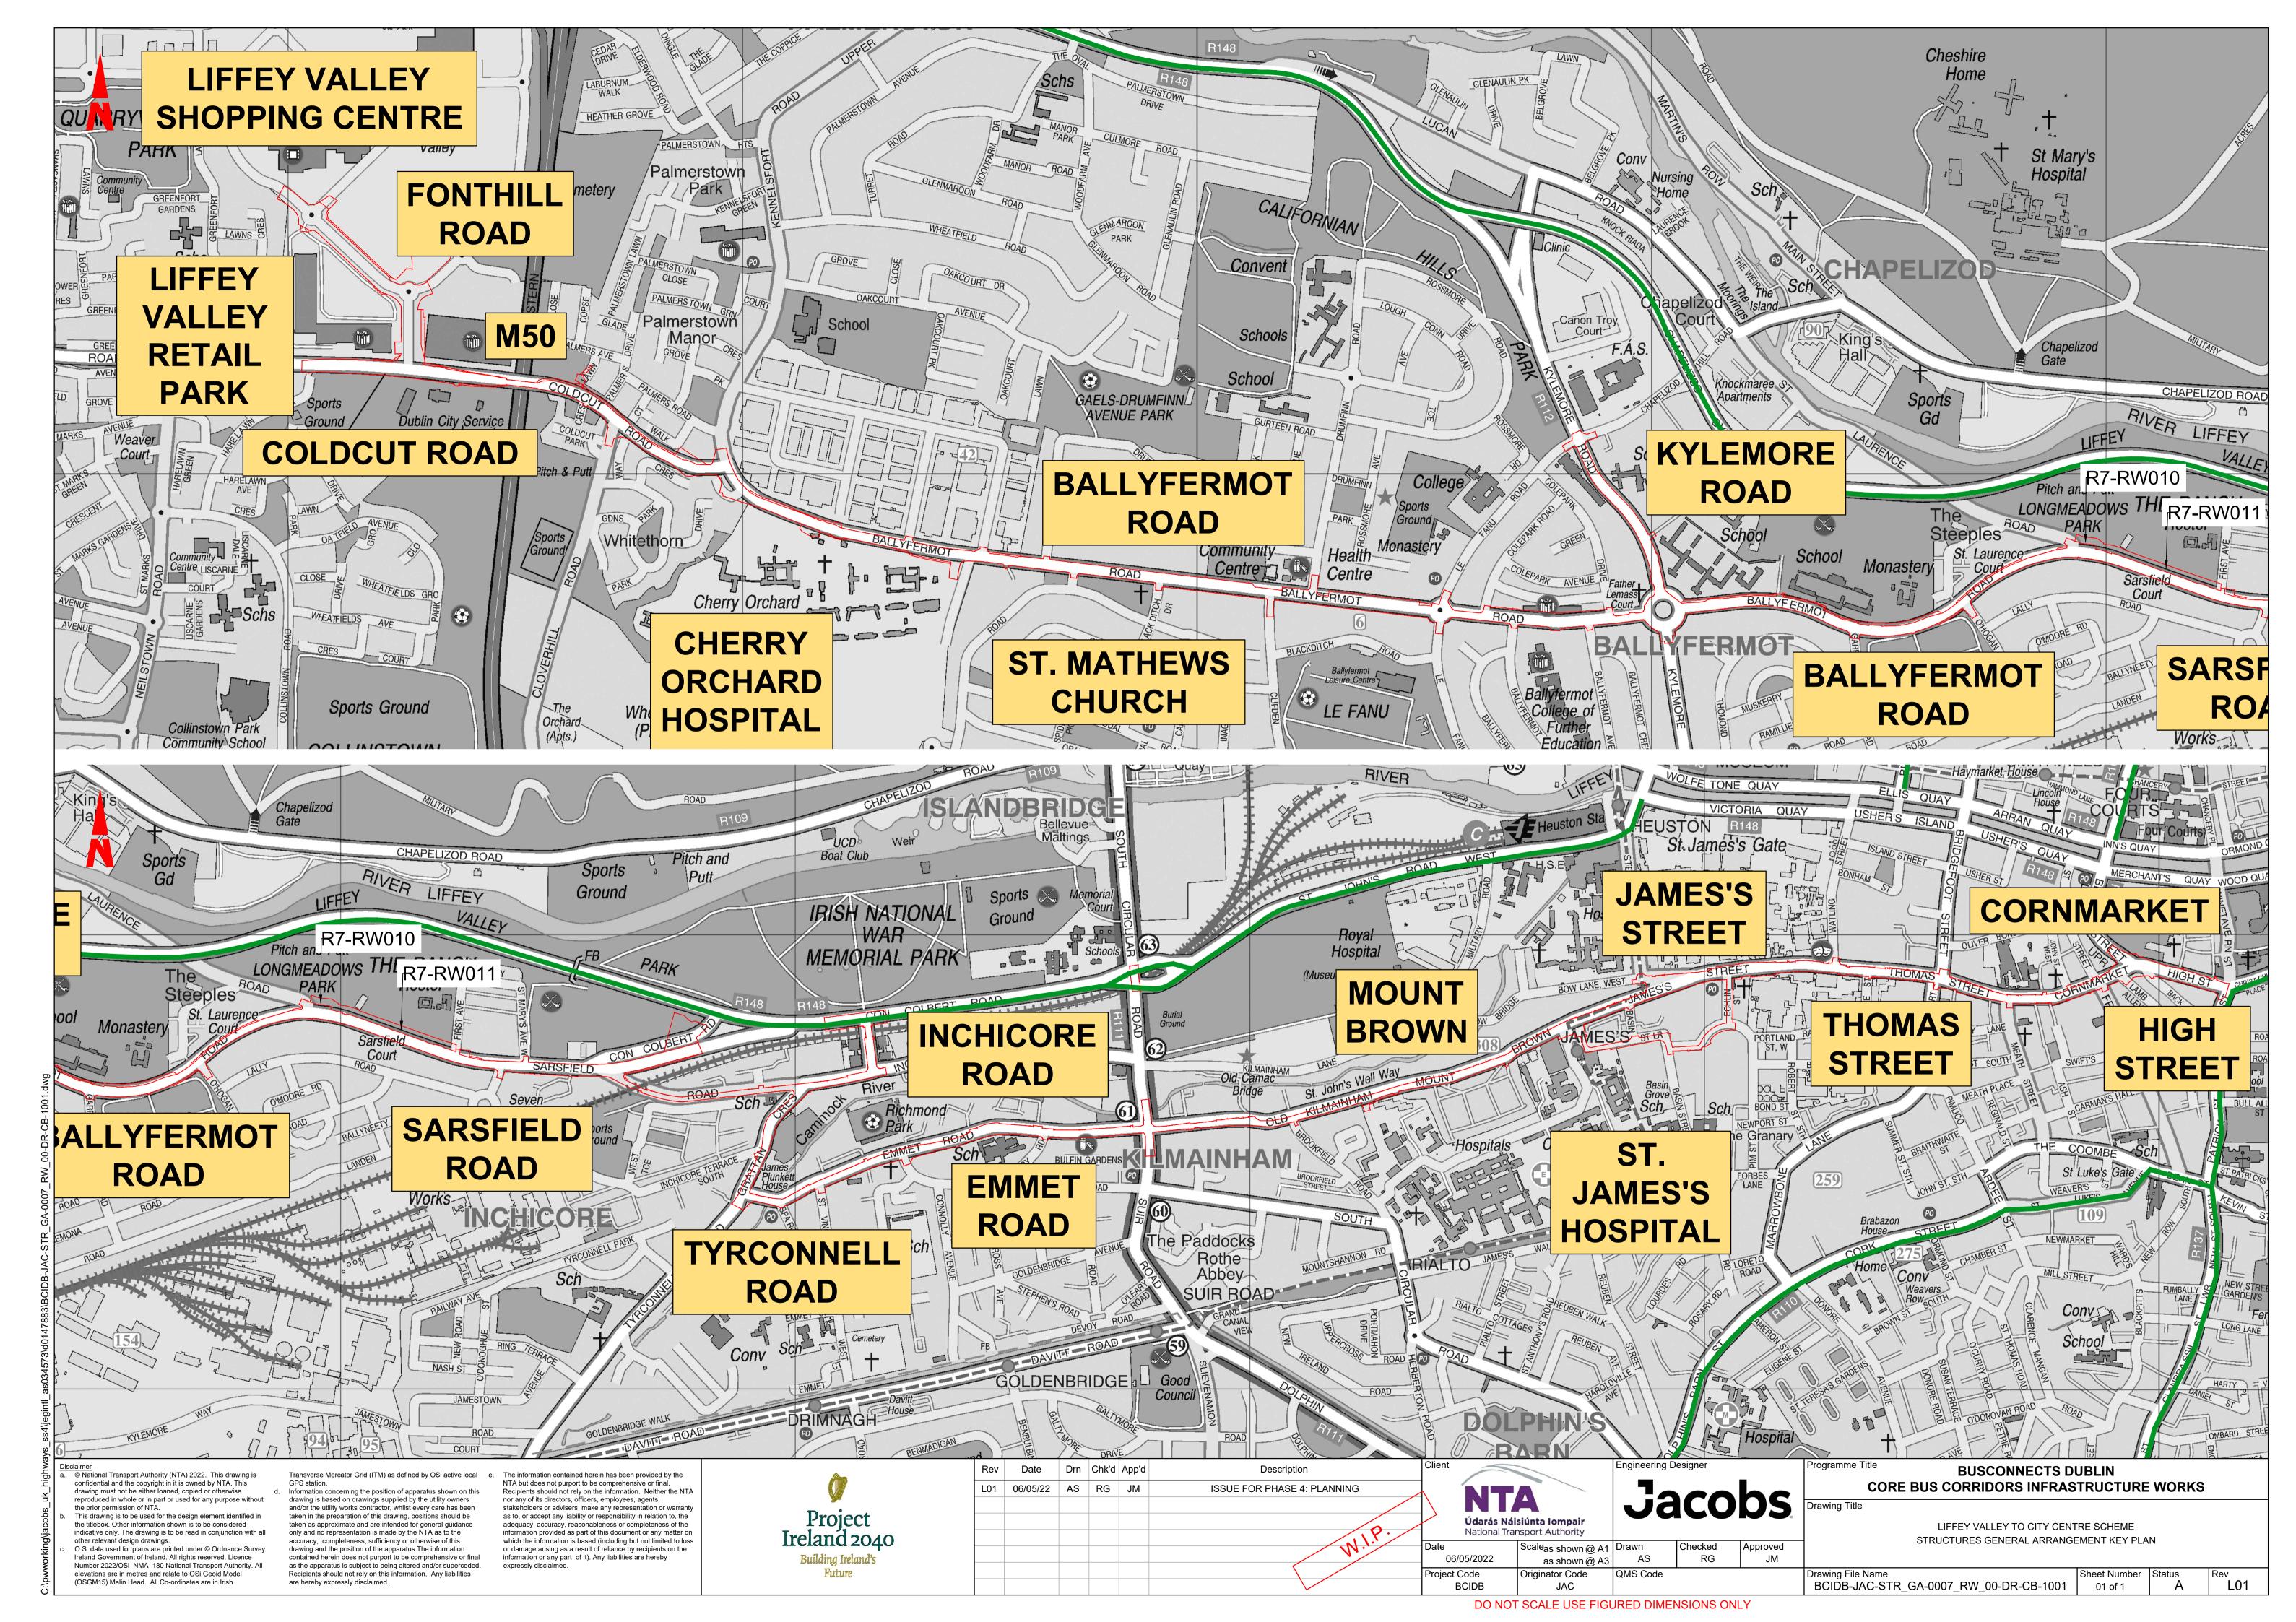
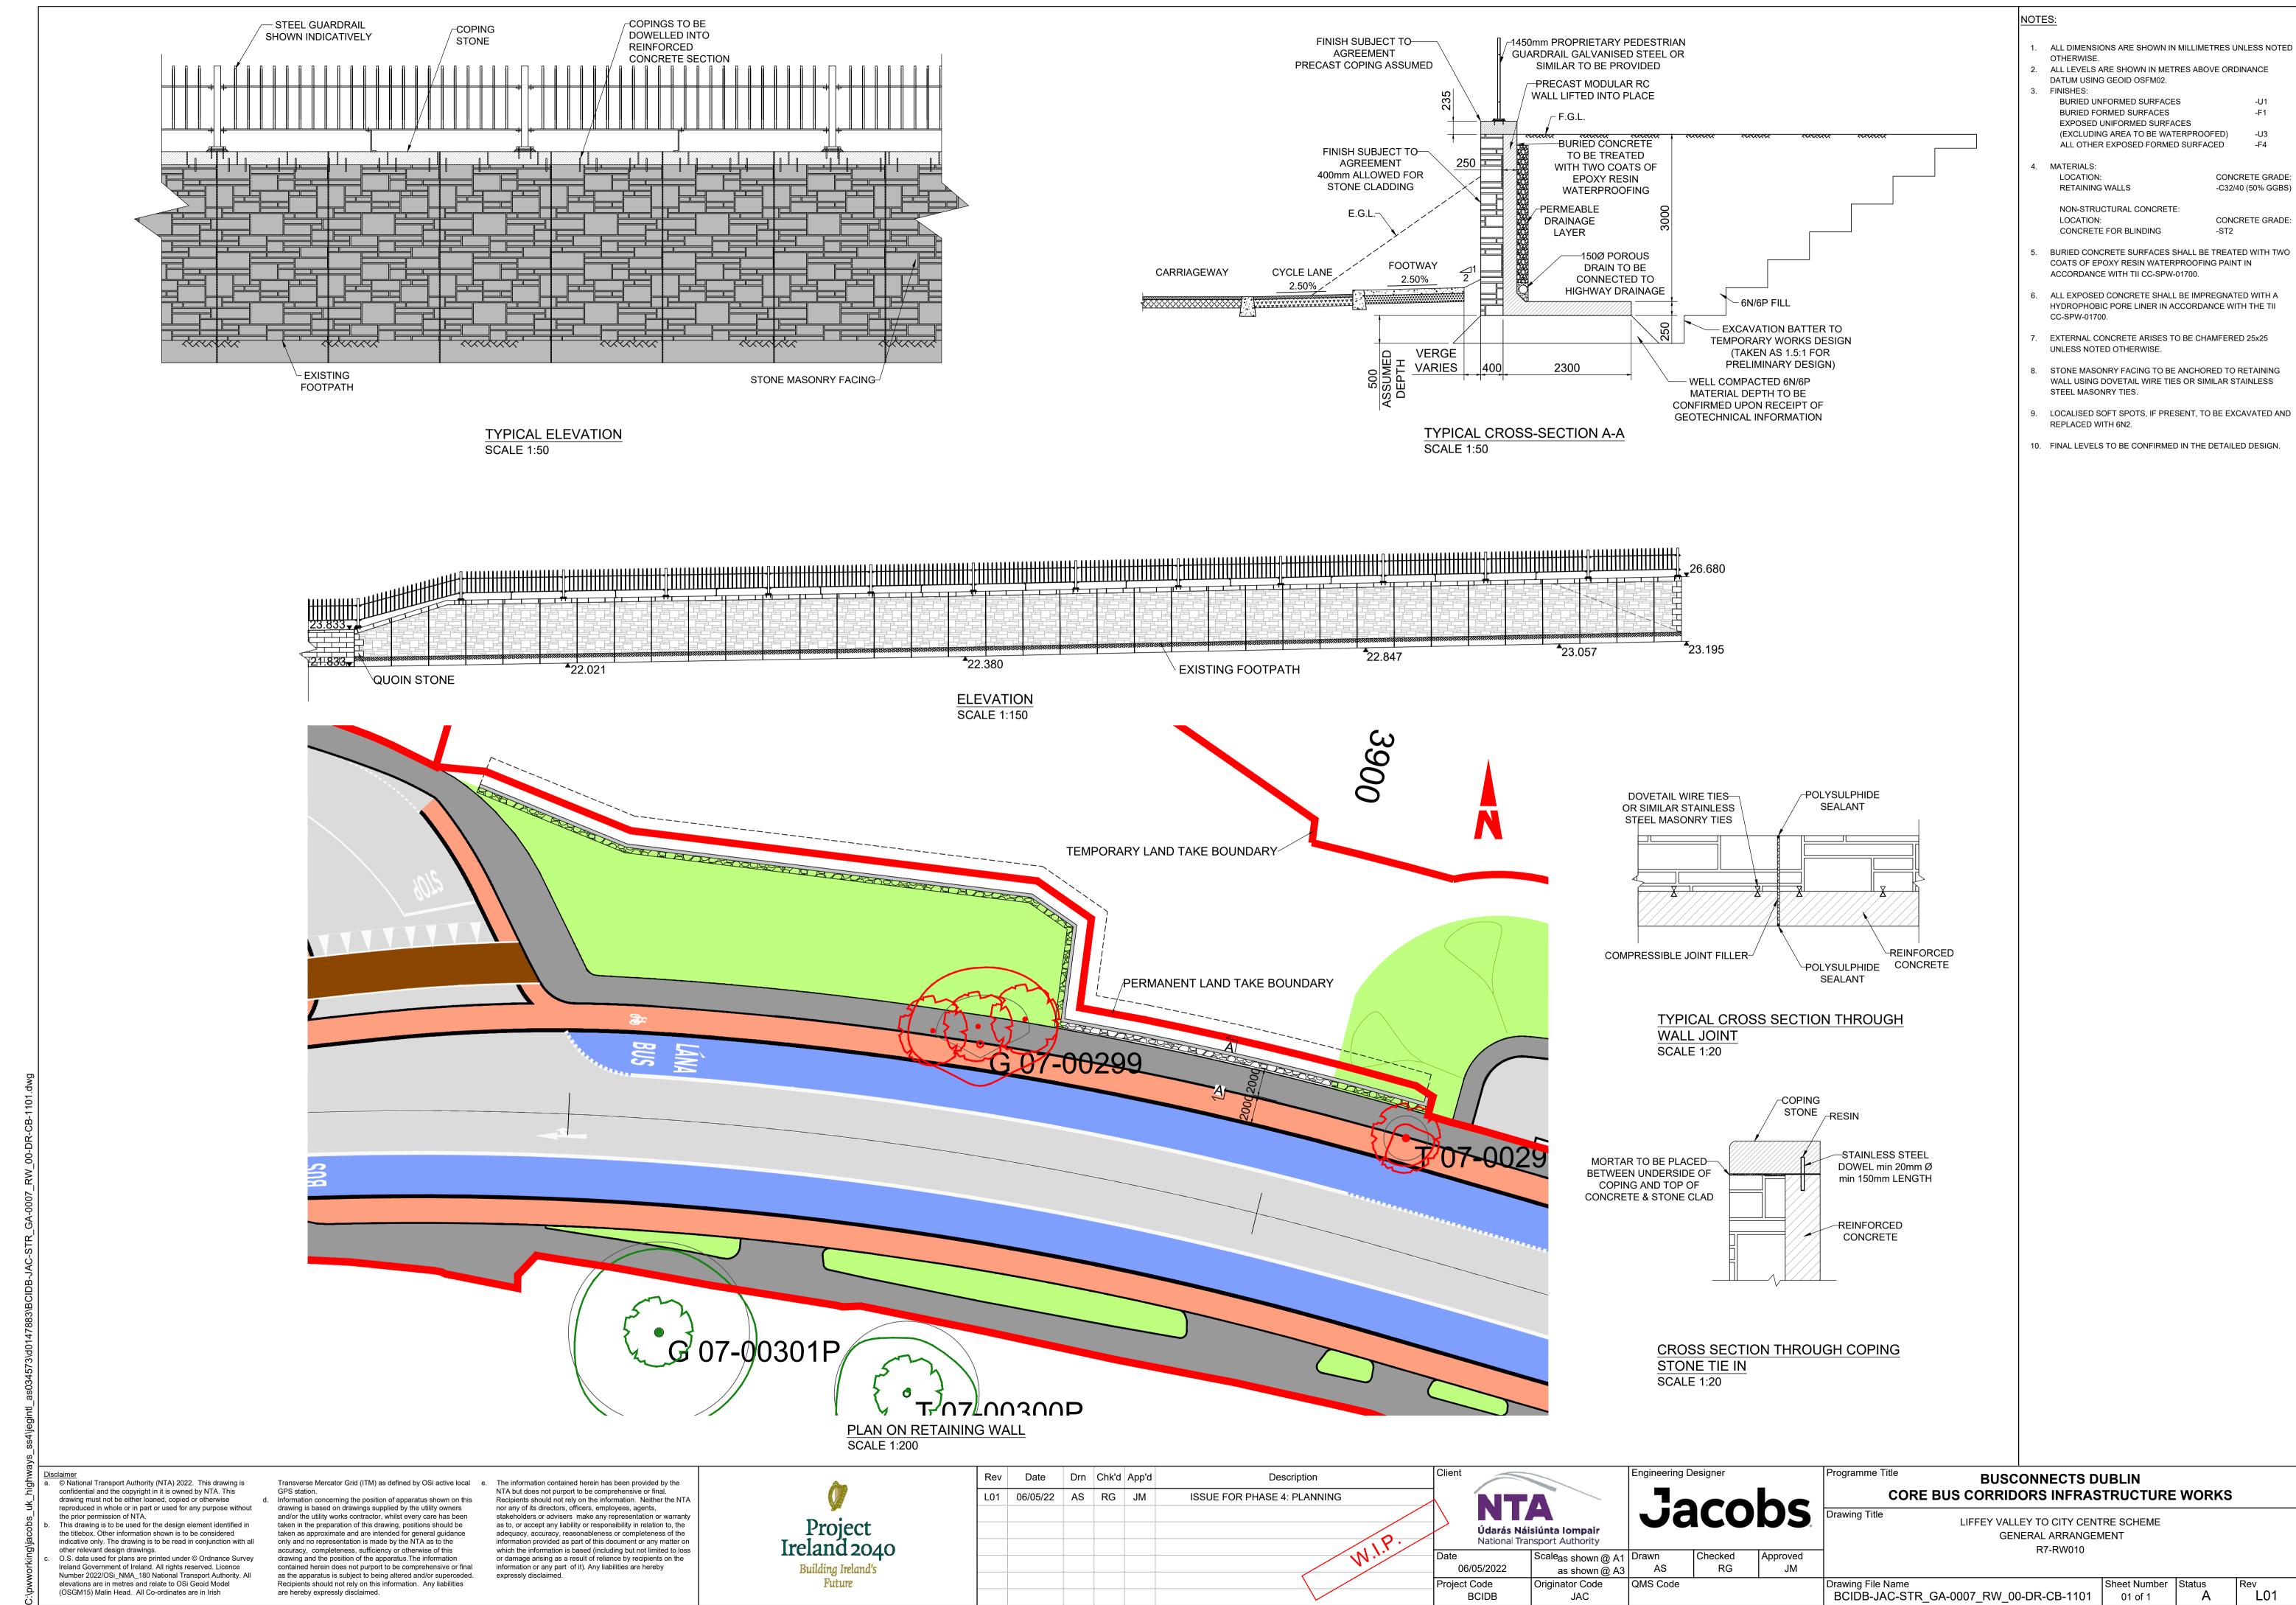
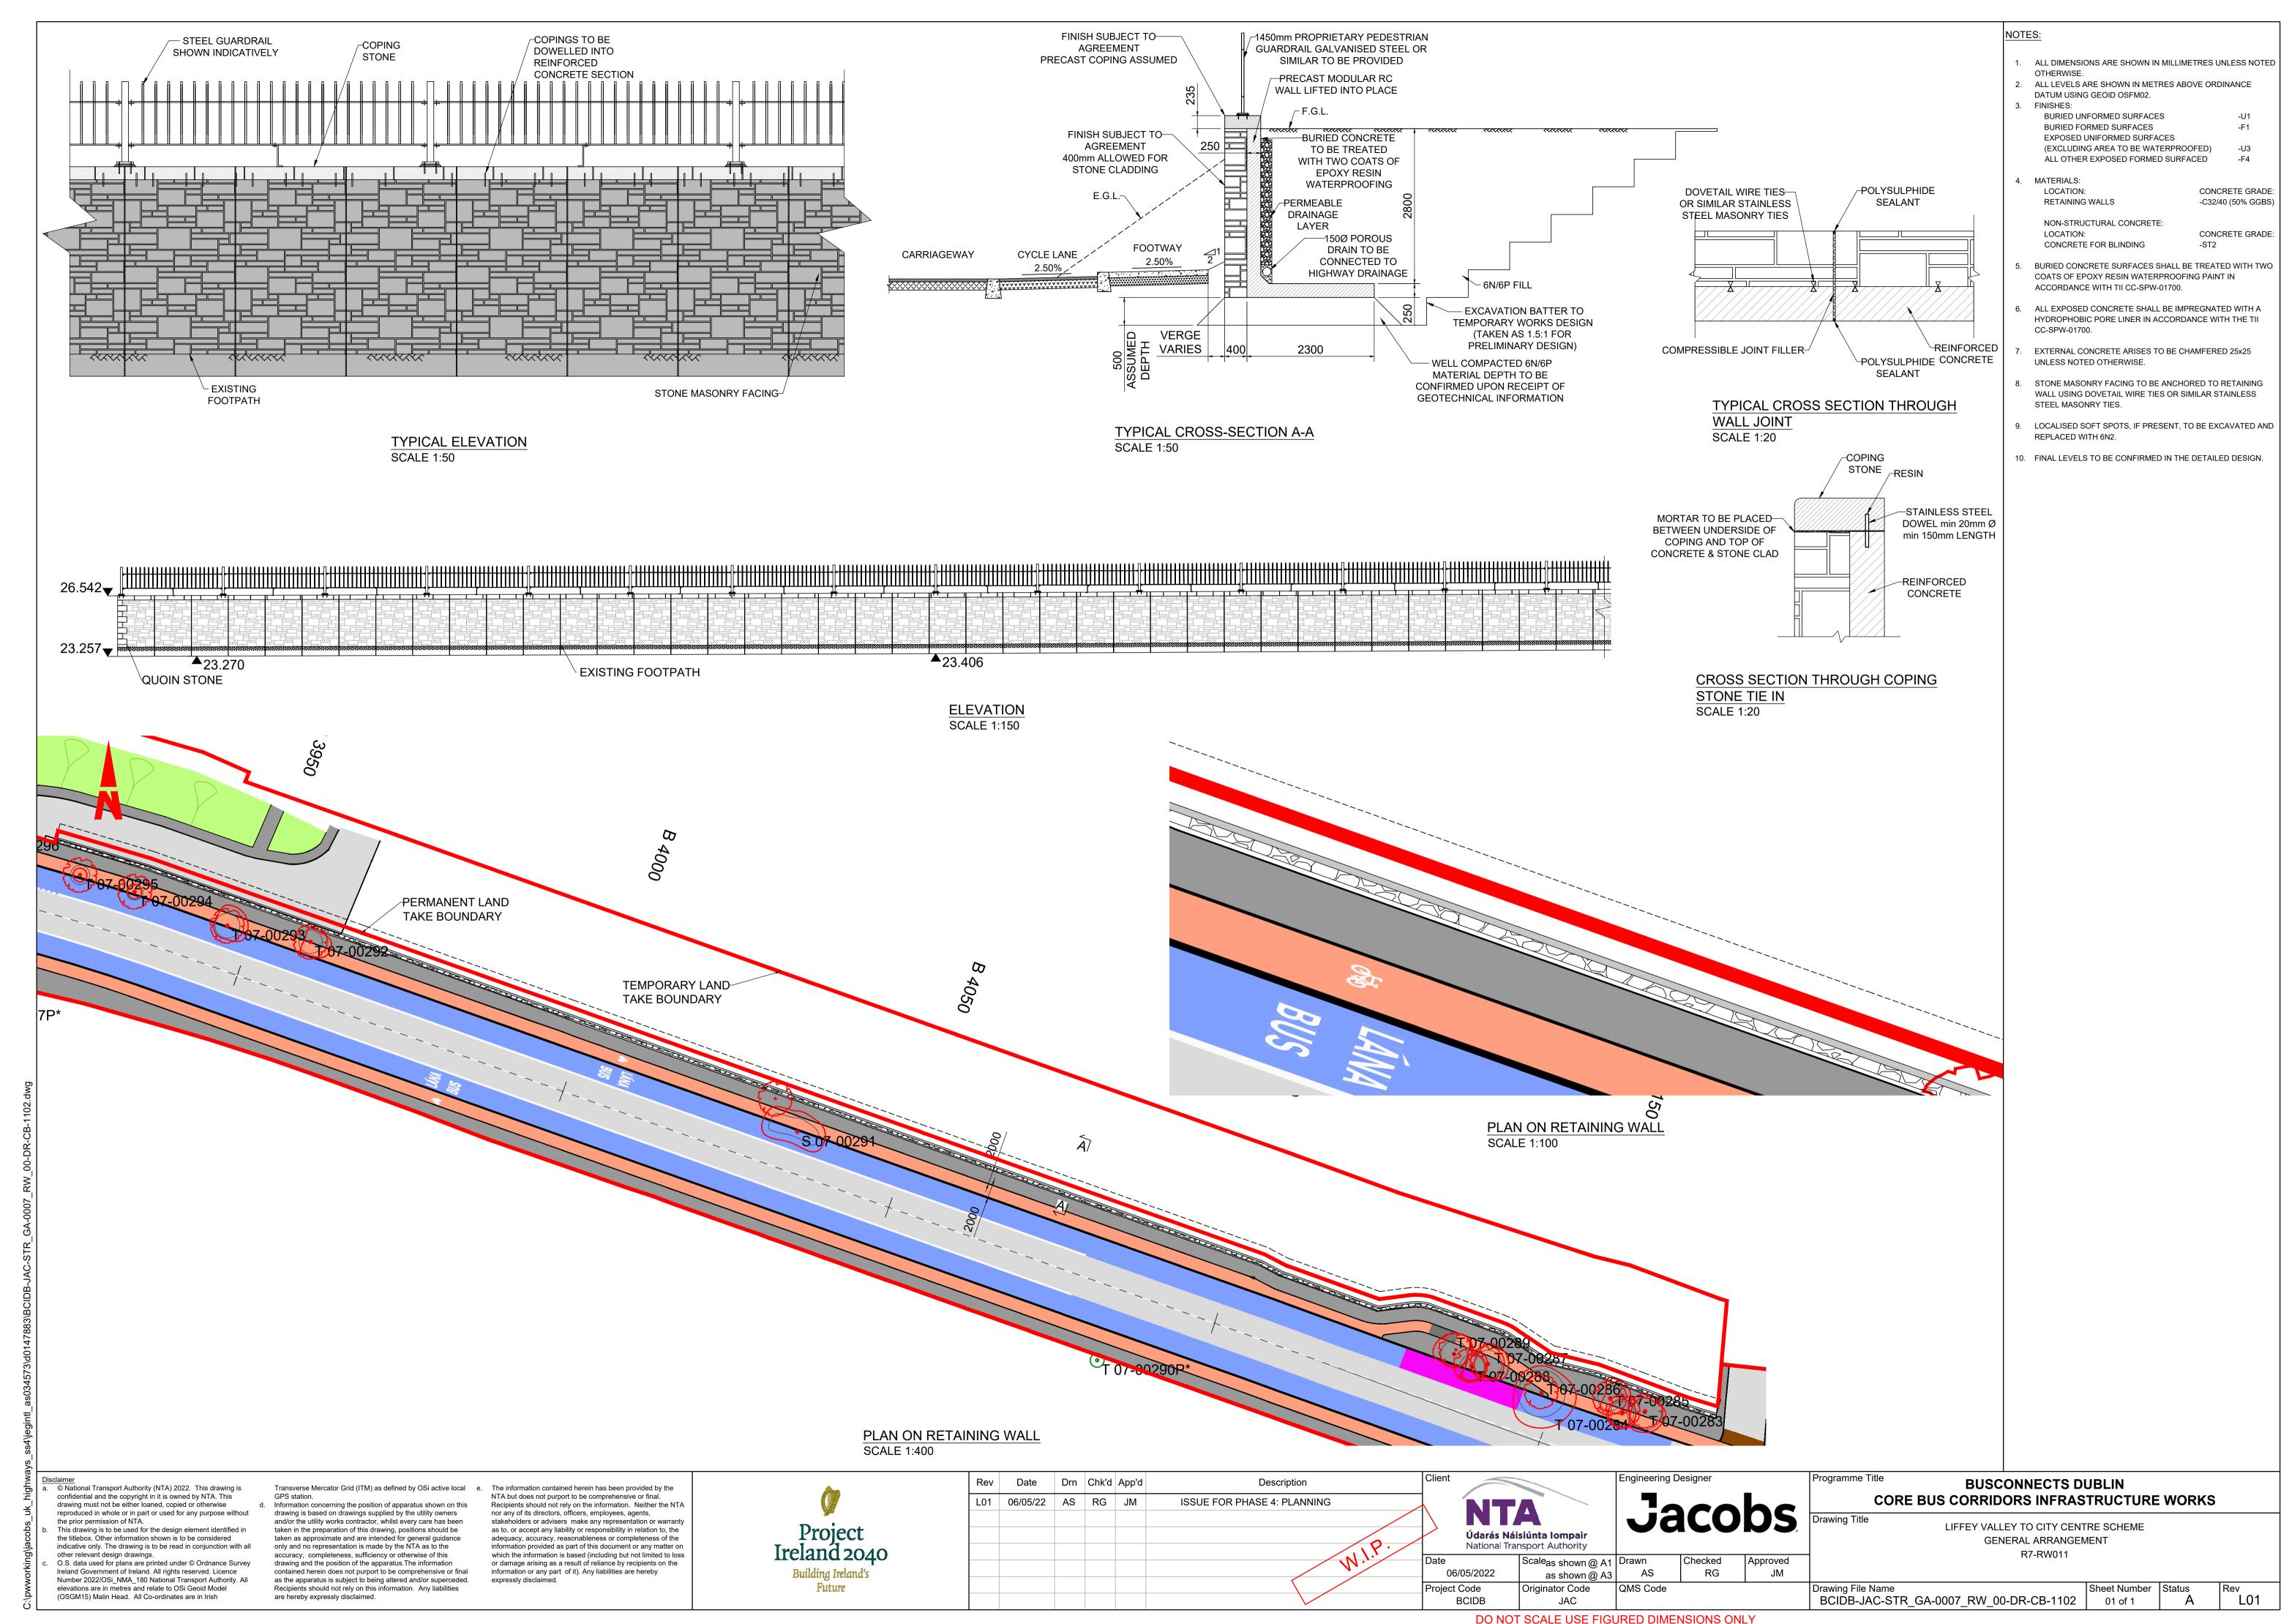
Drawing Reference	Drawing Title	Revision
BCIDB-JAC-STR_GA-0007_RW_00-DR-CB-1001	Site Location Plan	L01
BCIDB-JAC-STR_GA-0007_RW_00-DR-CB-1101	General Arrangement R7-RW010	L01
BCIDB-JAC-STR_GA-0007_RW_00-DR-CB-1102	General Arrangement R7-RW011	L01

Refer to Appendix A - BCIDB-JAC-STR GA-0007 RW 00-DR-CB-1001 for details.
