Section 10: AIR

10 AIR

This section of the remedial Environmental Impact Assessment Report (rEIAR) assesses any potential impact the quarrying and ancillary activities at the site may have had on the surrounding environment, with regards to the receiving air environment.

Dust Monitoring Survey for Tinneys Quarry,
Trentamucklagh, St Johnston, Co. Donegal.

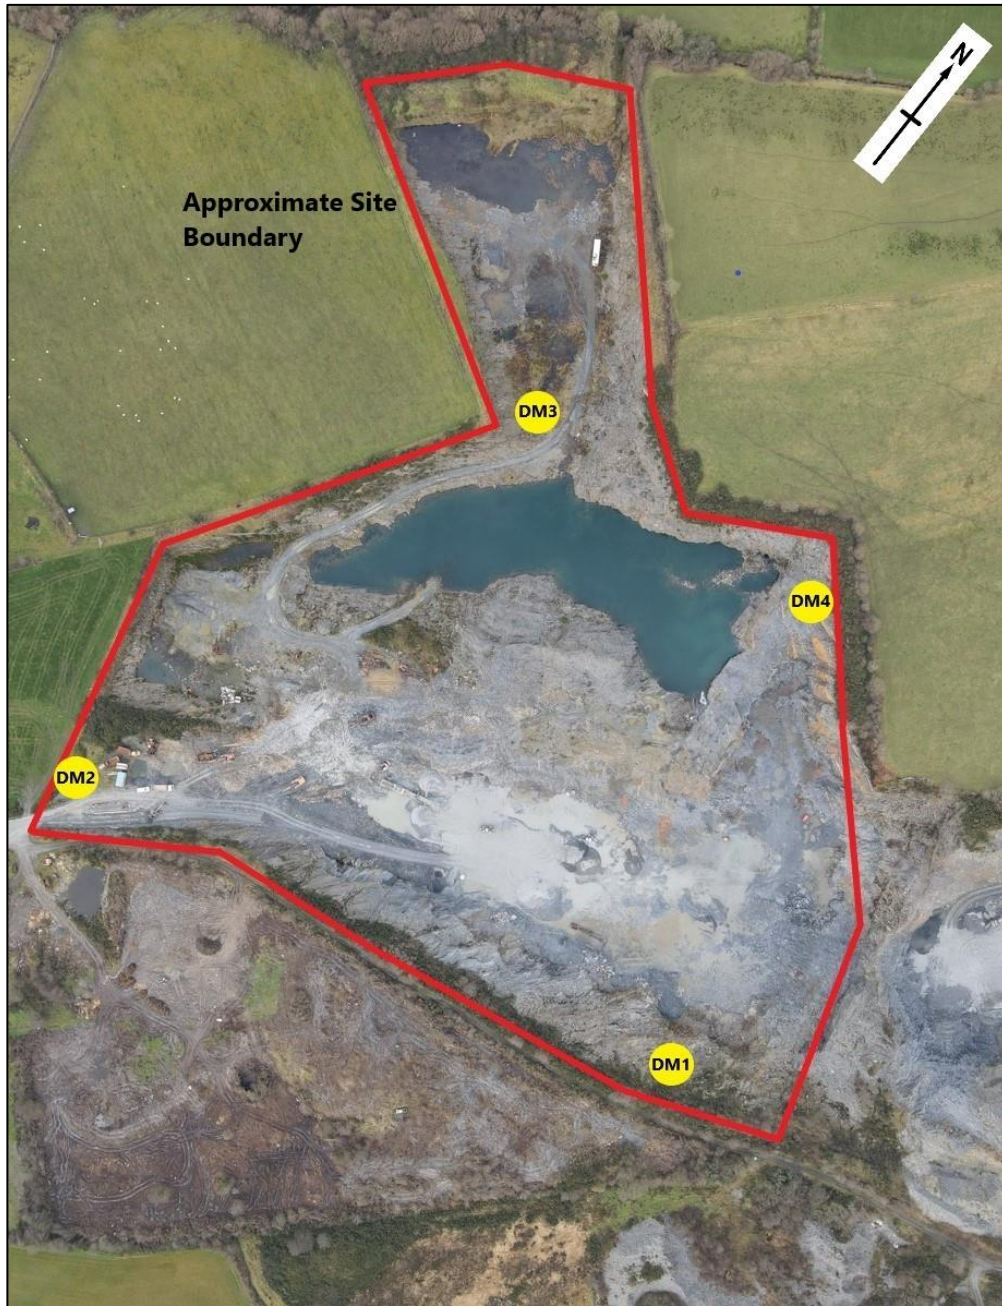
Figure 10.2: Dust Monitoring Locations

To assess the likely dust generation and deposition at the site boundaries, four dust monitors were installed in January 2022. The monitors were placed at the existing extraction area boundaries and were changed monthly over the five-month study period. The dust monitoring report is attached as Appendix 10.1.

The location of the dust monitors is shown below in Figure 10.2 below.

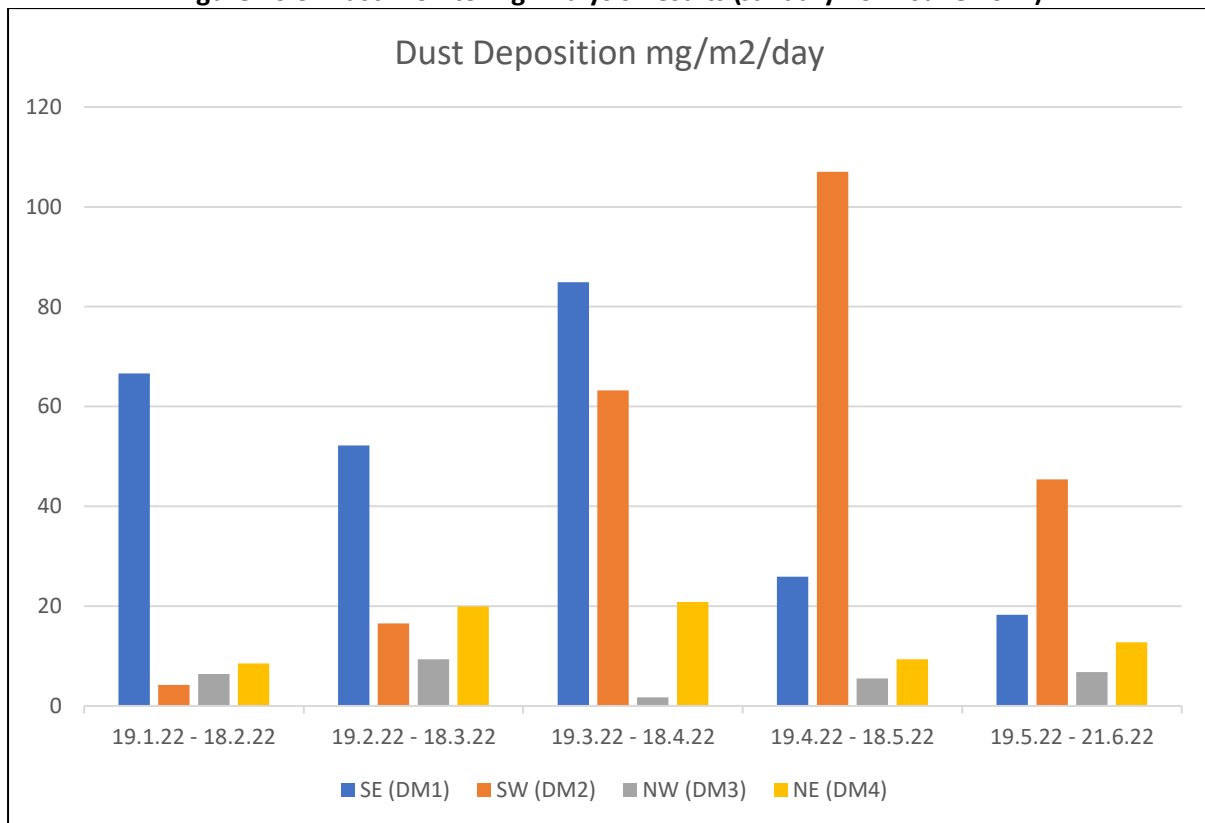
Figure 10.3: Dust Monitoring Analysis Results (January 2022-June 2022)

A summary of the dust deposition results is given in Table 10.2 below and illustrated graphically in Figure 10.3 below.

It can be seen from Table 10.2 and Figure 10.3 that the dust deposition results are well below the guideline threshold of 350 mg/m²/day.

As noted in Section 10.5, Dust Monitoring, dust deposition levels on the site boundary are in compliance with guideline values of 350 mg/m²/day. In fact, most of the monitoring results were considerably below the guideline value.

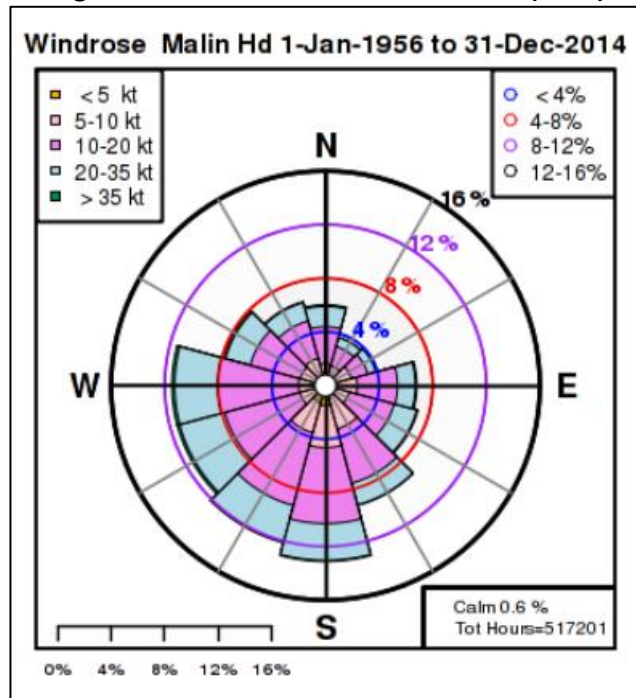
Figure 10.4: Wind Rose for Malin Head (2014)

The predominant wind direction is from the southwest. Figure 10.4 shows the wind rose for Malin Head (50 km north of the application site).

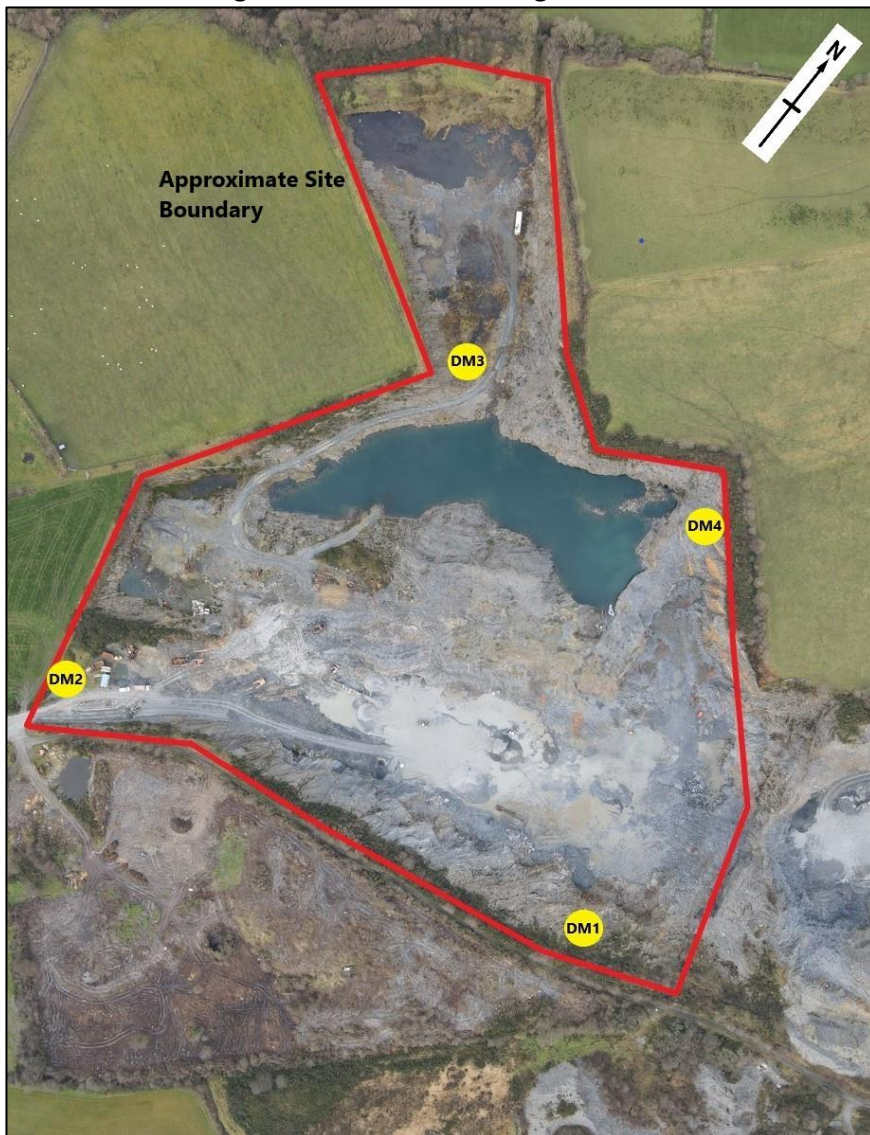
Figure 3.1: Dust Monitoring Locations

- One Dust Monitor (DM 1) was placed along the south-eastern boundary of the site.
- A second Dust Monitor (DM 2) was placed near the entrance to the quarry on top of the berm on the south-west site boundary.
- A third Dust Monitor (DM 3) was placed in the north-western portion of the quarry.
- The fourth Dust Monitor (DM 4) was placed below the remaining quarry face along the north-eastern site boundary.

The positions of these dust monitors are indicated on Figure 3.1.

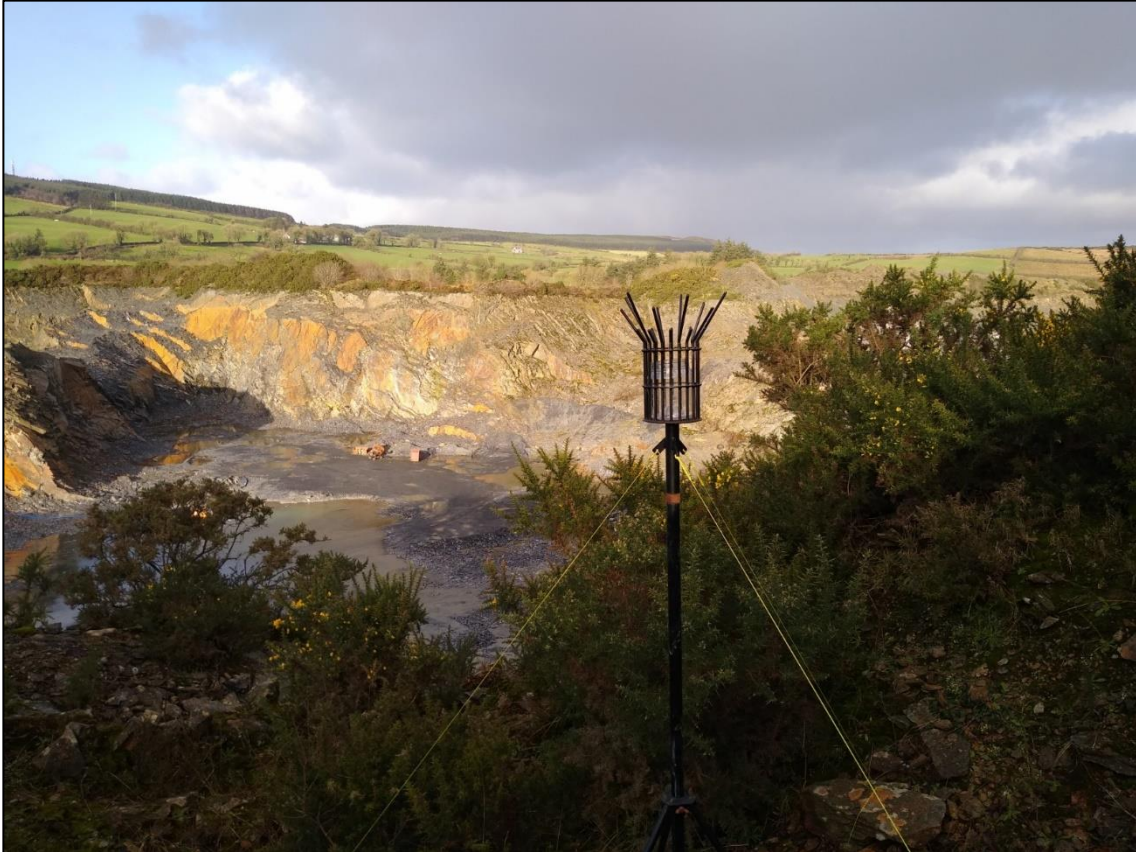
Photograph 3.1: Location of Dust Monitor 1 on the south-eastern boundary of the site

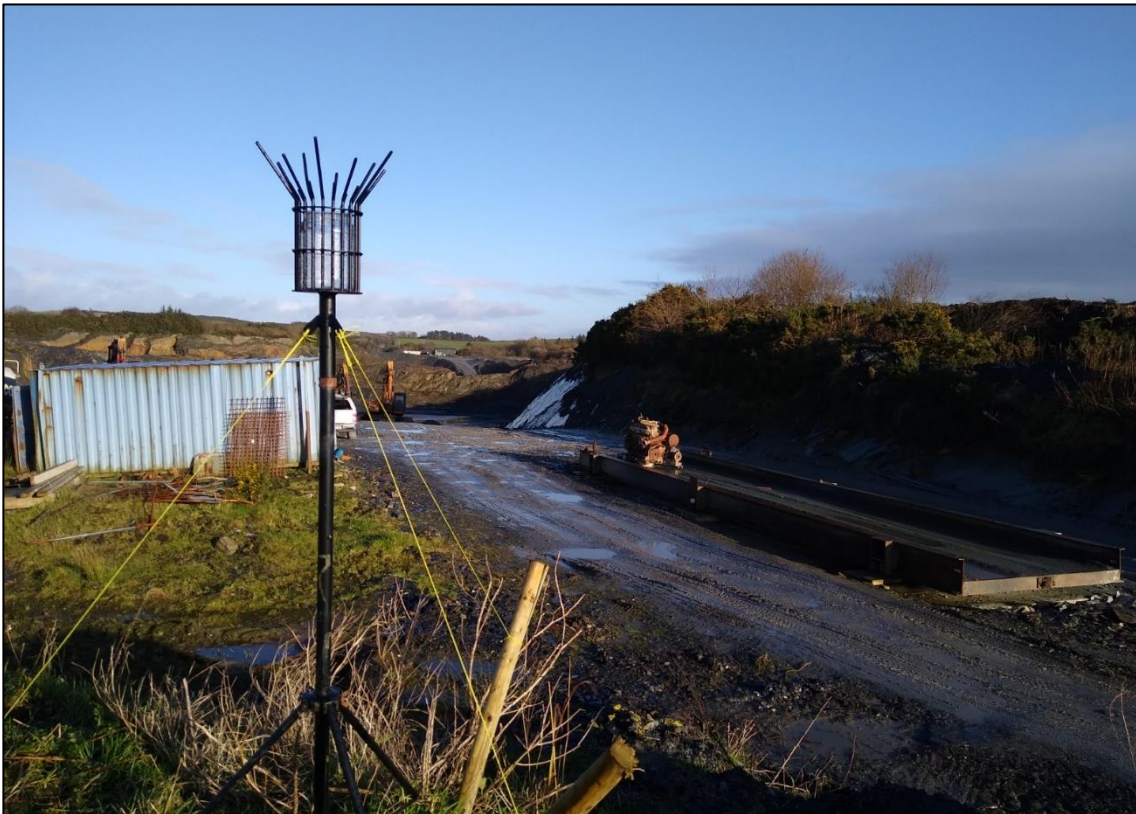
Photograph 3.2: Dust Monitor 2, placed near the entrance of the quarry

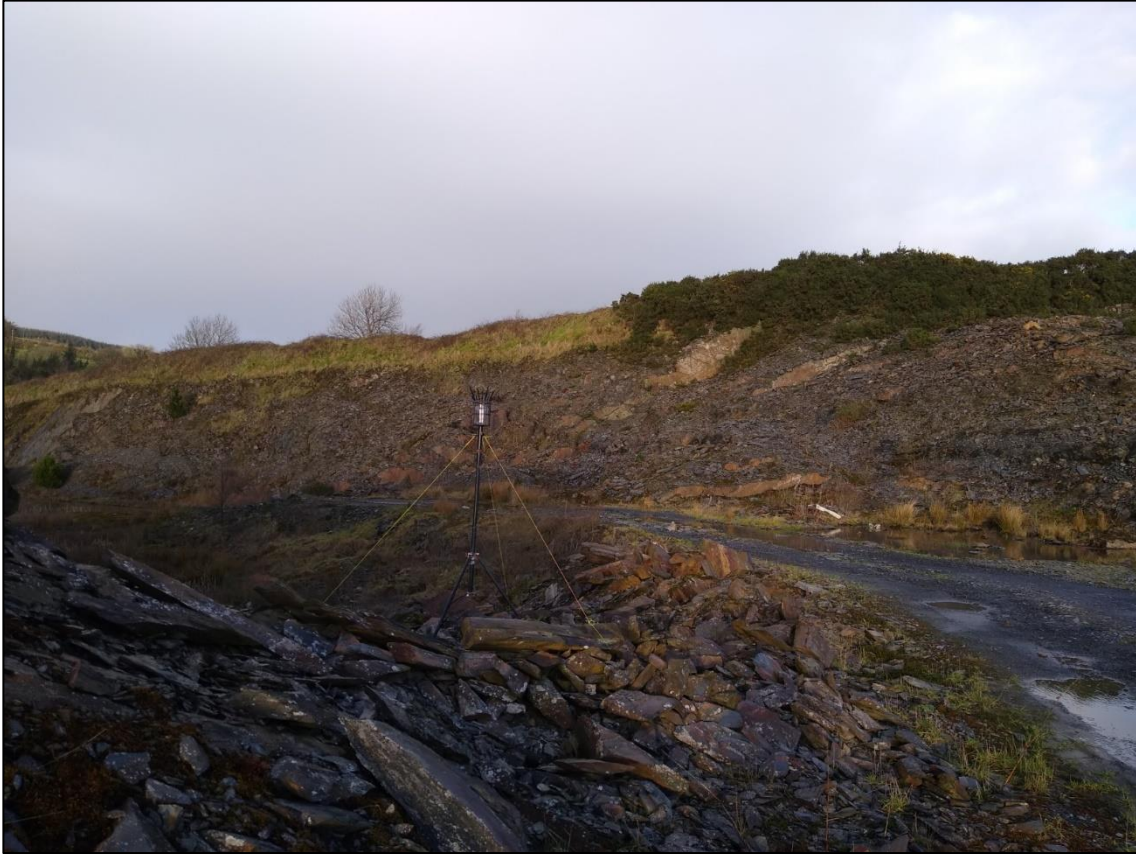
Photograph 3.3: Dust Monitor 3 in the north-western portion of the site

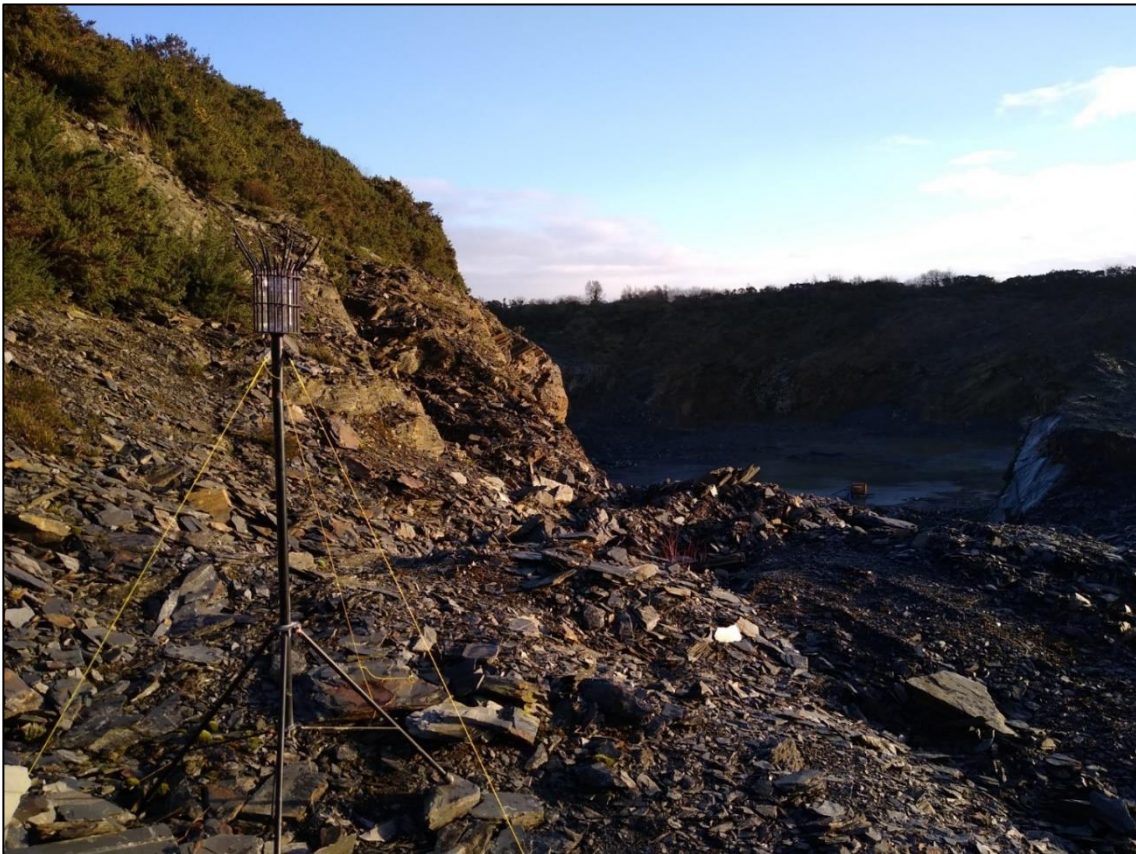
Photograph 3.4: Dust Monitor 4 in place along the north-eastern boundary of the site

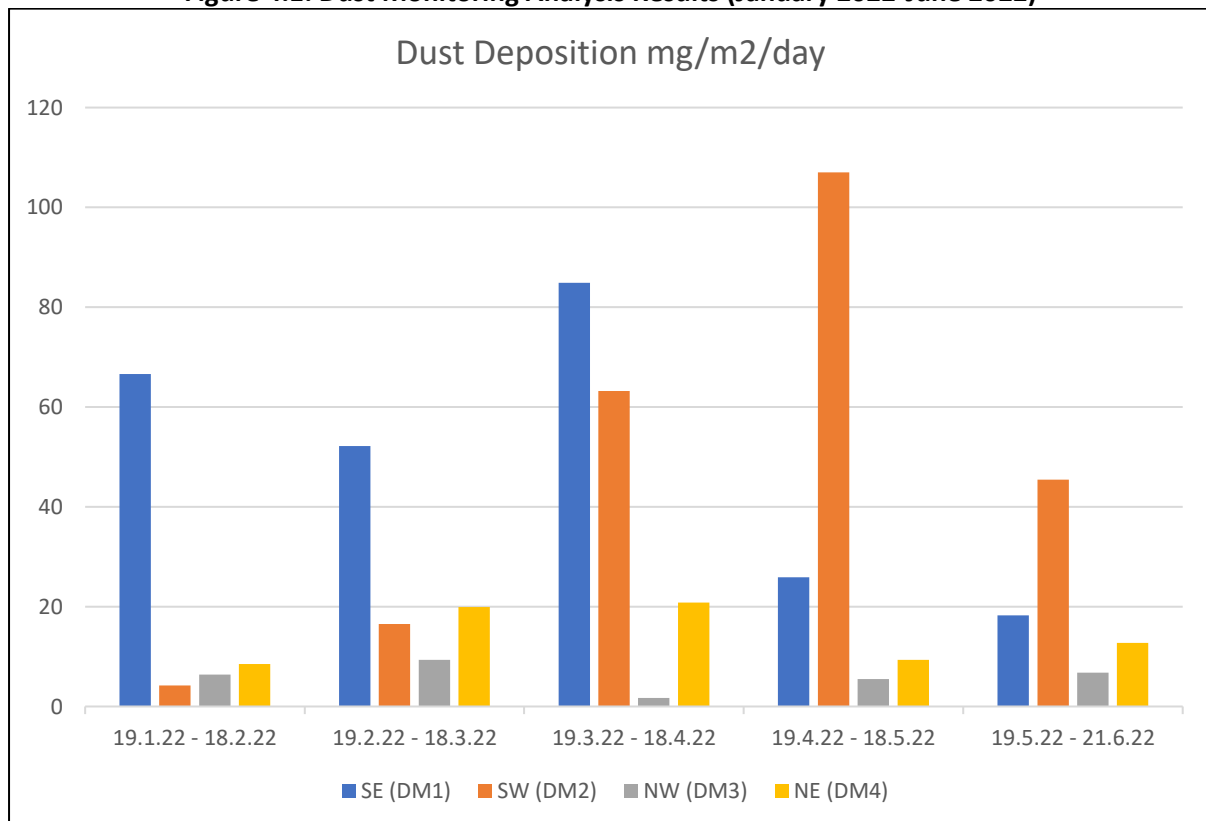
Figure 4.1: Dust Monitoring Analysis Results (January 2022-June 2022)

The dust monitors were left in place for 30 days (+/- 2 days). The dust collected was sent to Aqualab in Killybegs for Bergerhoff dust analysis. This process was repeated until 21st June 2022. The results for the past five months, from January 2022 – June 2022, are presented in Table 4.1 and Figure 4.1 below. The analyses certificates from Aqualab are presented in Appendix 1.

It is noted that the dust deposition monitoring has been in compliance with the 350 mg/m²/day DoEHLG (2004) threshold limits.
