## Section 12.0: MATERIAL ASSETS – TRAFFIC

This section of the remedial Environmental Impact Assessment Report (rEIAR) evaluates the effects that the historical and current quarry traffic has had on the existing road network in its vicinity.

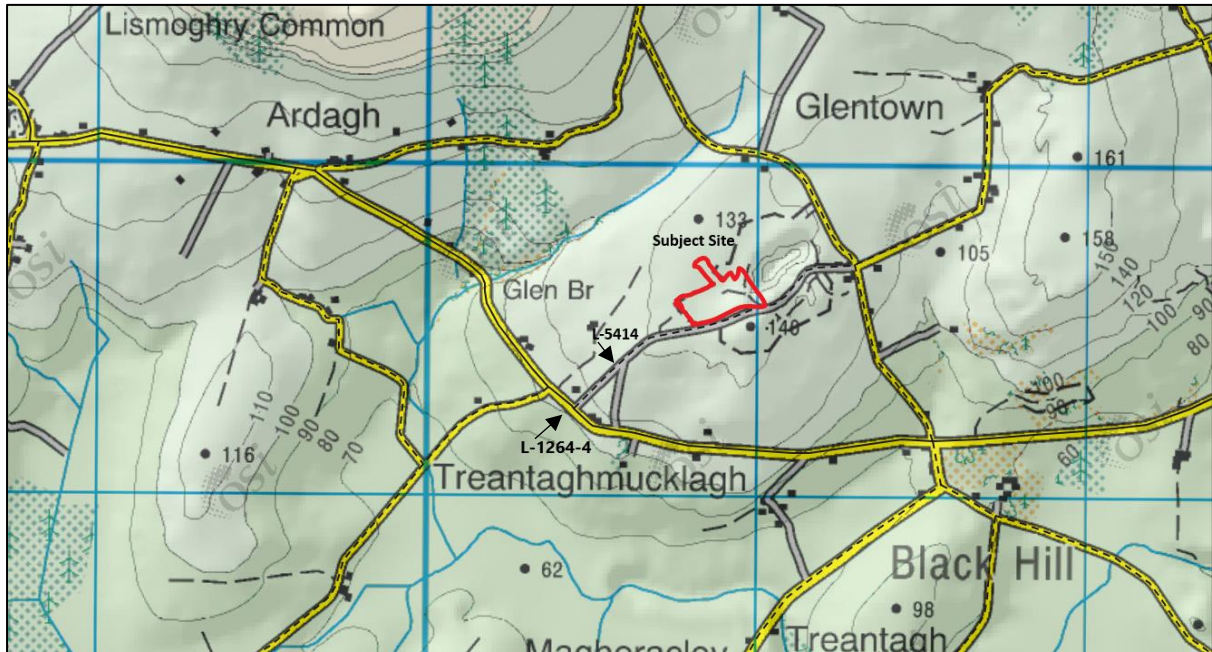
**Map 12.1: Site Location in Relation to Road Network**

The subject site is located within the townland of Trentamucklagh, St. Johnston, County Donegal. The quarry is served by the L-5414 which is a local secondary road and is in good condition. This road leads directly onto the L-1264-4 which is a local primary road. Map 12.1 shows the network of local roads surrounding the quarry and the overall distribution of roads in the general area.

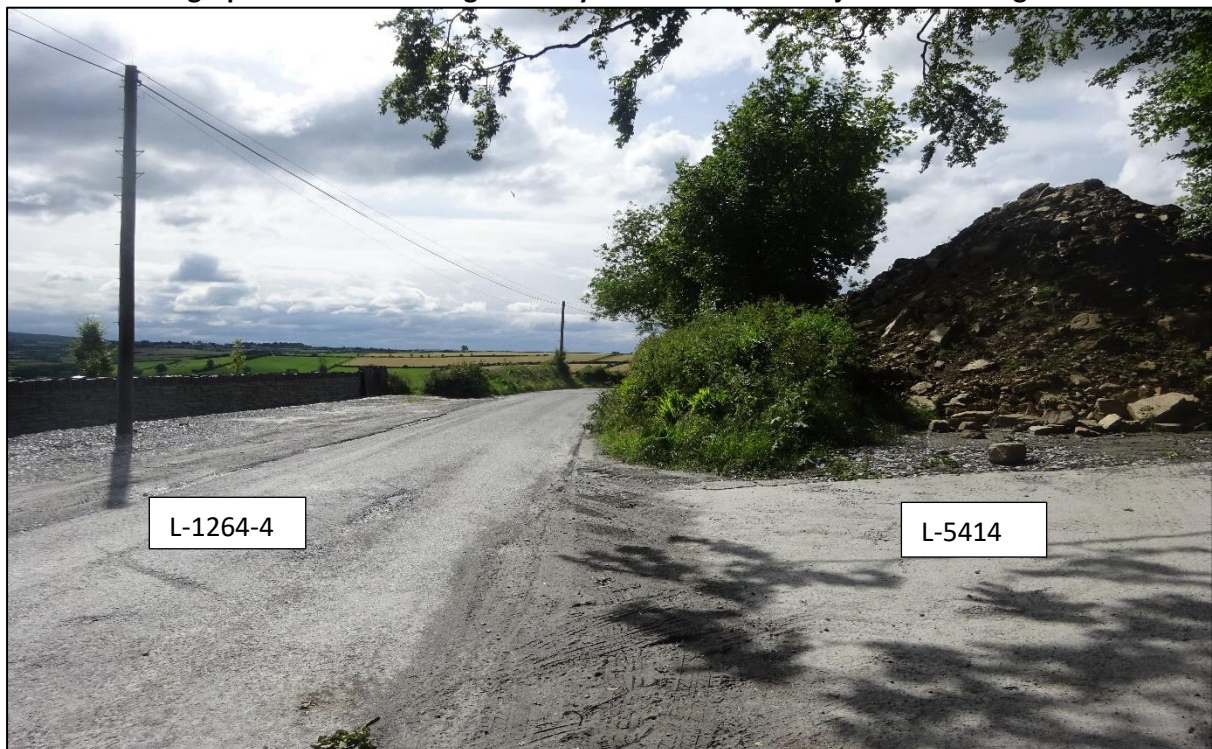
**Photograph 12.1: The existing roadway entrance to the subject site looking West**

Photograph 12.1 below, shows the Local Road L-1264-4 at the main entrance looking West.

Guidelines state that sightlines must be provided for an entrance onto a county road which is 2.5m back from the road and provides clear sightlines of 70m in each direction. These conditions are fulfilled for the main entrance to the site, which was permitted by way of a grant of retention permission issued under planning reg. ref. 04/6411 for 'Retention for quarry entrance and access road and associated site'.

The condition has been achieved with vision lines in excess of 70m in each direction

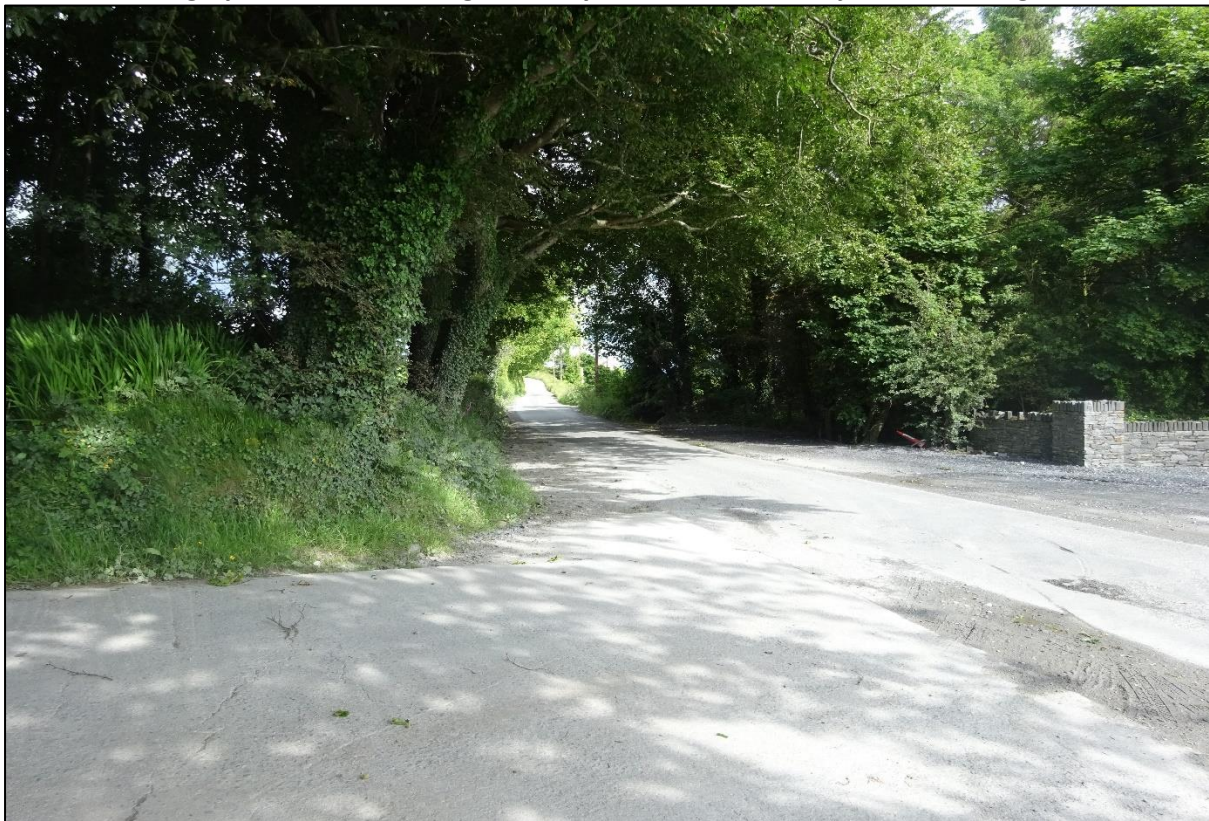
**Photograph 12.2: The Existing Roadway Entrance to the subject site looking East.**

Photograph 12.2, below, shows the Local Road L-1264-4 at the main entrance looking East.

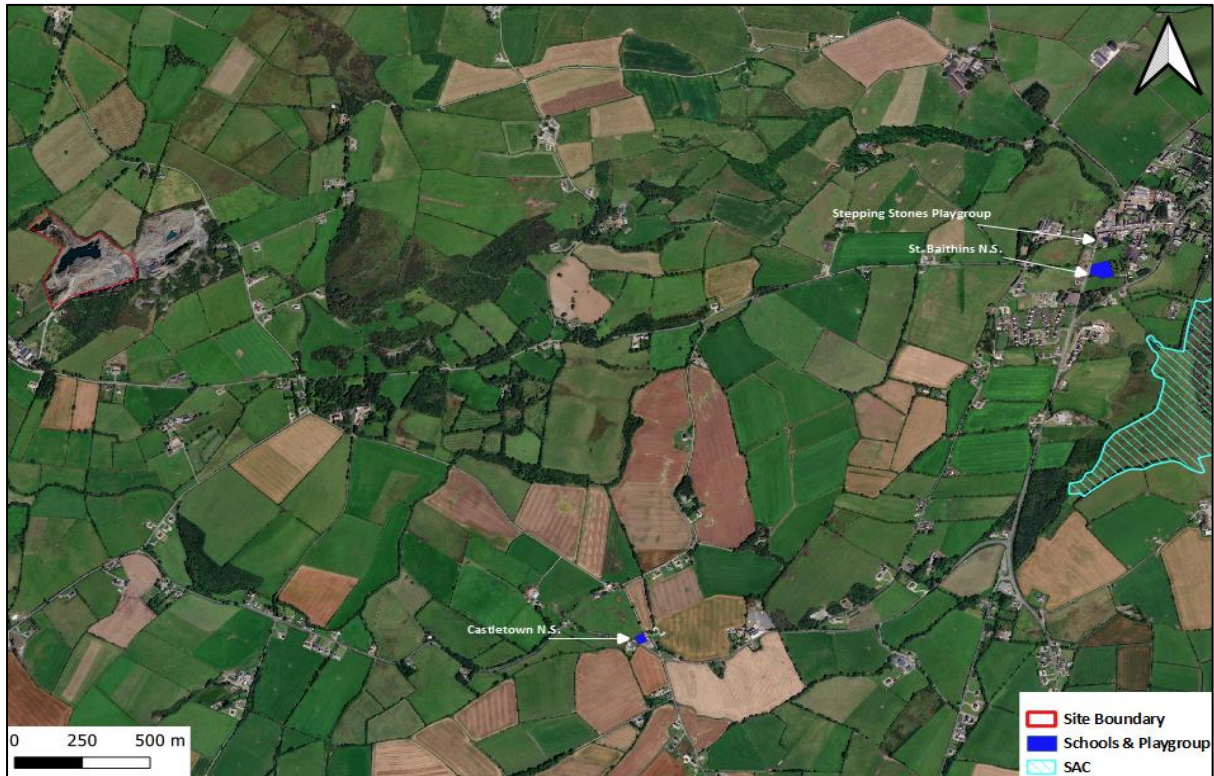
**Figure 12.1: Location of schools and playgroup in relation to the subject site.**

Findings from the traffic survey show that a significant amount of vehicles were travelling West on the L-1264-4 road towards Galdonagh and Manorcunnigham, perhaps this road was being used by vehicles to get to Letterkenny town and to avoid traffic on the Regional road at busier times of the day to. There are two primary schools and a playgroup located in the area which contribute to the road traffic levels in the morning and evening times. St. Baithin's National School is located approx. 3.8km from the subject site, Castletown National School is located 2.5km from subject site and Stepping Stones Playgroup is located 3.8km from the subject site. Figure 12.1 shows the location of the primary schools and playgroup in relation to the subject site.
