15 LANDSCAPING & RESTORATION

15.1 Introduction

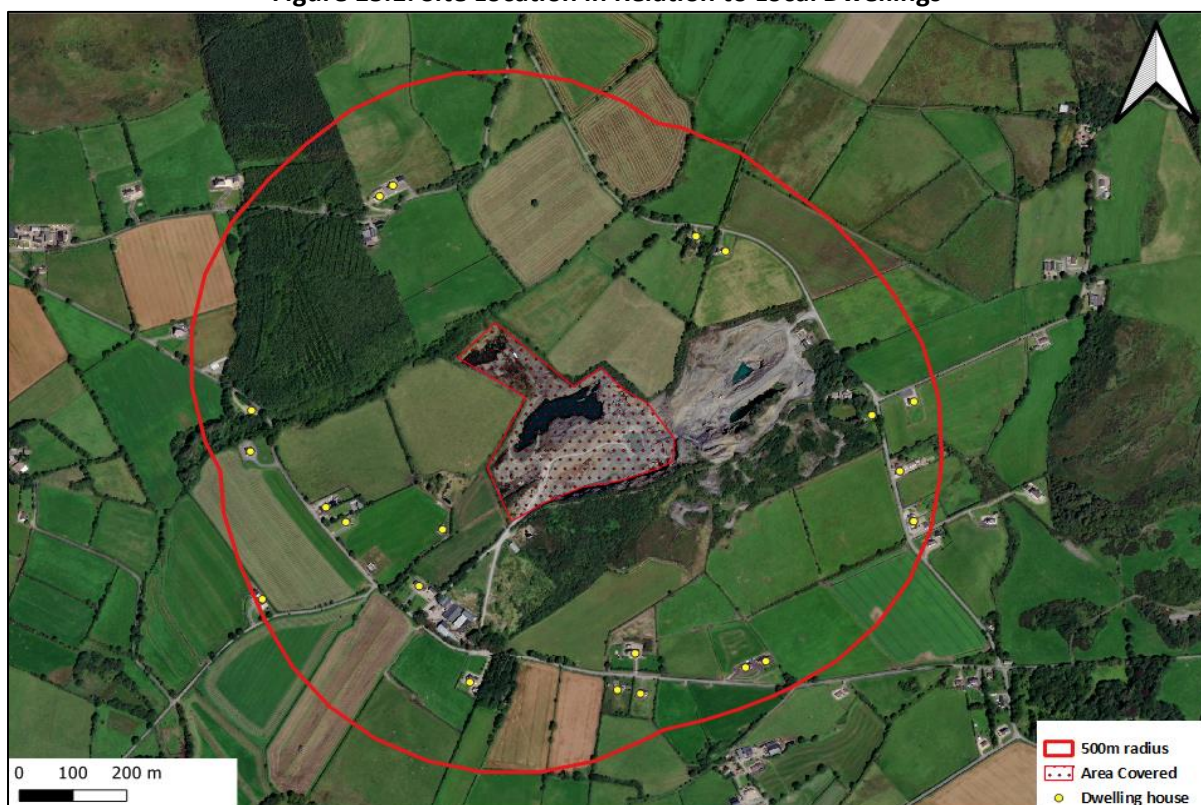
Figure 15.1: Site Location in Relation to Local Dwellings

The quarry is situated in a sparsely populated rural area with sporadic once off housing, the closest occupied dwelling is approximately 120m Southwest of the subject site. There is also a dwelling situated 190m from the subject site on the L-5414-1 local secondary road on the approach to the quarry. Figure 15.1 shows domestic dwellings in relation to the quarry with 500m radius. Map 15.1 illustrates the existing road network.

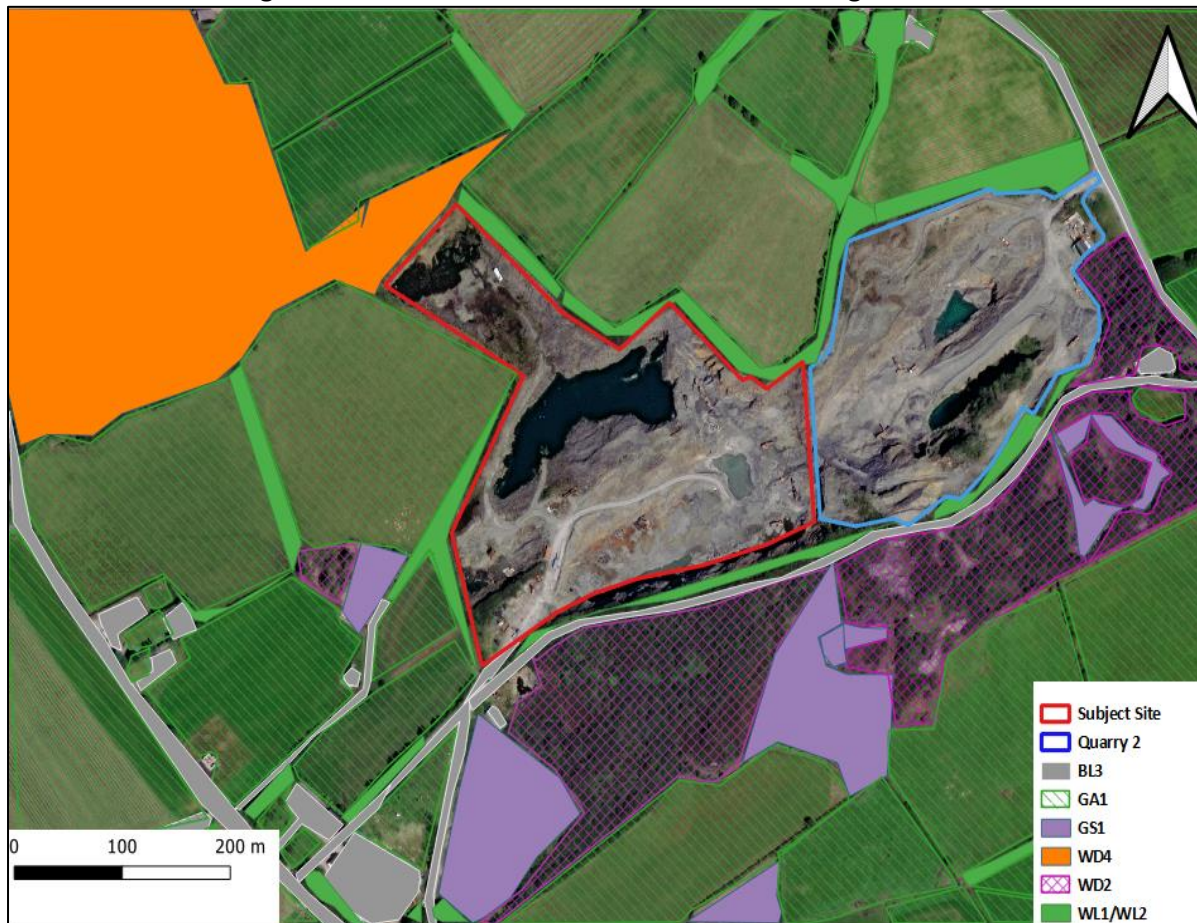
Figure 15.2: Location of habitats in the surrounding environs

The quarry is situated in a rural area with sporadic housing. The site is surrounded by agricultural land on all sides apart from the east where a quarry face separates the subject site from a separate quarry which is operated by a different owner. A detailed habitat assessment of the subject site and surrounding environs was conducted as part of Section 6: *Biodiversity*. Figure 15.2 demonstrates the locations of improved grassland (green lines) which can be used for agricultural purposes and existing areas of conifer plantations (green dots) in relation to the subject site.

This map was created on QGIS software and using data collected during site visits according to Fossitts guide to habitats in Ireland.

Land use immediately surrounding the quarry site is predominantly agricultural with some isolated blocks of commercial forestry (WD4) to the North and Northwest of the site. These are mainly plantations of Sitka Spruce and Lodgepole Pine. Most of these commercial plantations which are privately owned and currently provide limited ecological roles within these areas. Intensive livestock grazing is the dominant agricultural activity surrounding the existing quarry. The field pattern in the general area is regular with fields extending from the local primary road L-1264-4 and surrounding the quarry. The subject site is not visible from the L-1264-4 road passing the entrance as the mature tree line along the road and topography is shielding it from sight. Another quarry owned by a separate operator lies to the east of the subject site with a large ridge separates the two quarries. The subject site borders have become dominated mainly by gorse and bramble and measure approximately 1.4 Km.

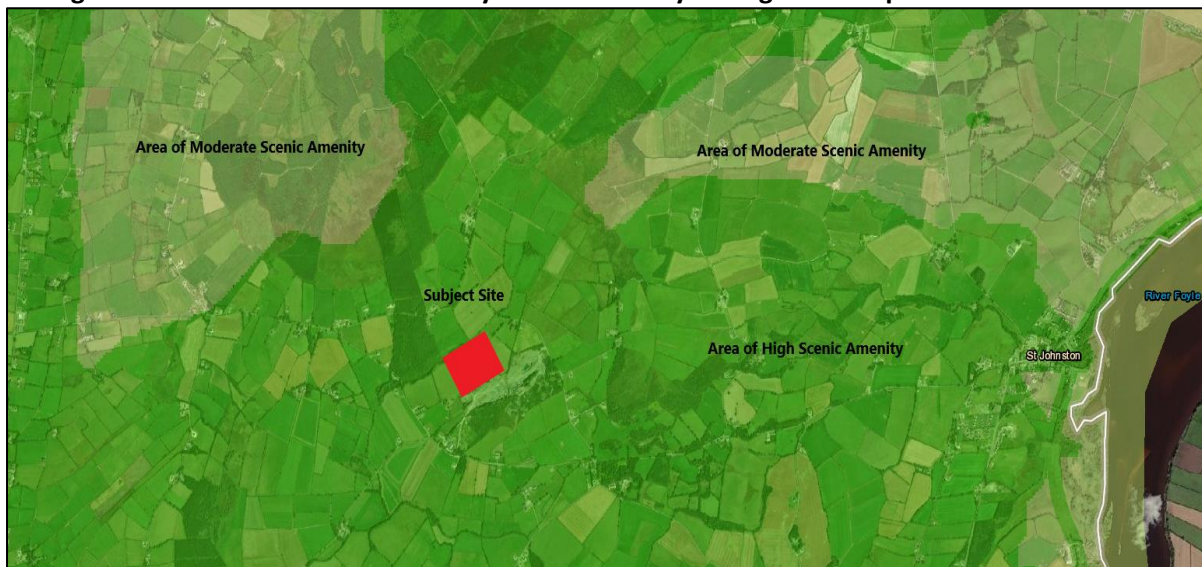
Figure 15.4: Areas of Scenic Amenity as described by Donegal Development Plan 2018-2024

The County Development plan for 2018-2024 highlights areas of Especially High Scenic Amenity (EHSA) as worthy of protection from any deterioration in landscape character. The quarry site is located outside of the EHSA. The quarry site is classified as being located within an Area of High Scenic Amenity shown in Figure 15.4.

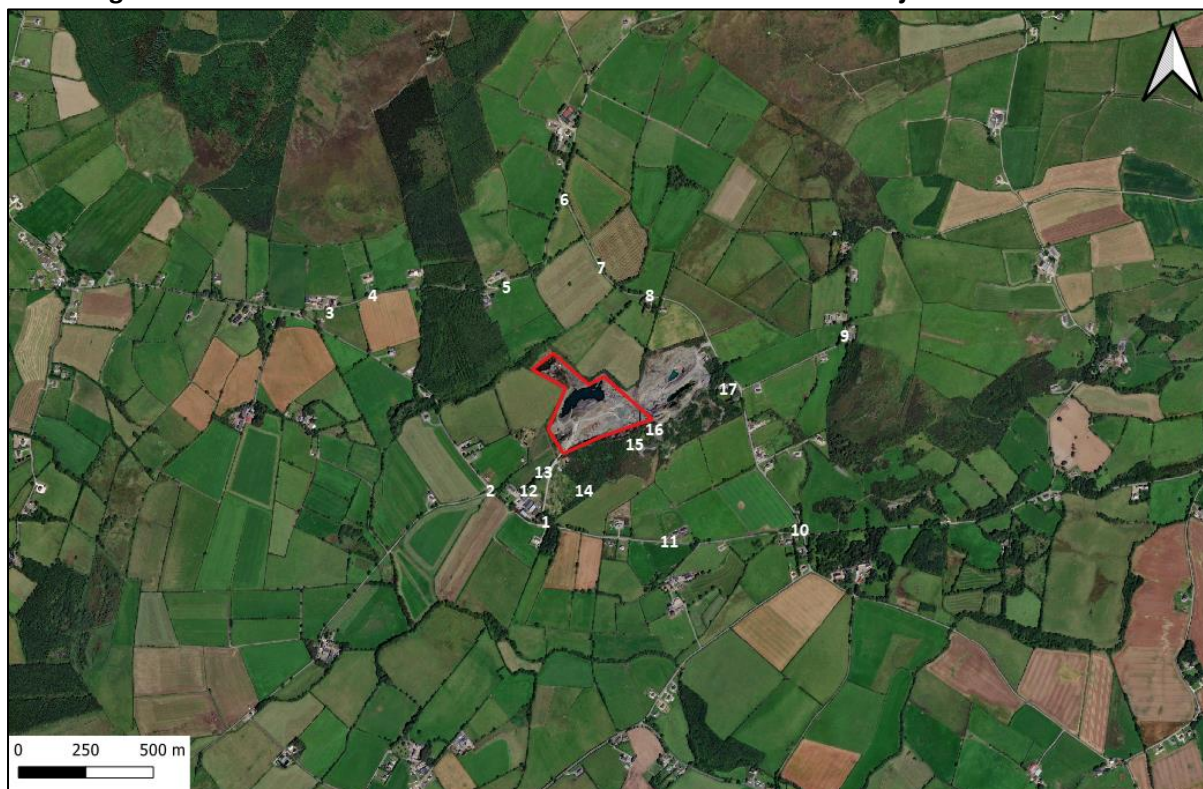
Figure 15.5: Locations from which the visual assessment of the subject site was made

The visibility of the quarry site was initially assessed by a desktop study of OS and street view maps to identify potential viewpoints. This was followed up by a field survey where viewpoints were chosen at locations from which the quarry was visible. The viewpoints were chosen to give a representative sample of views of the quarry development within the landscape to illustrate the impact on local residential properties and on protected views, where relevant. Figure 15.5 identifies locations within the surrounding environs which were investigated regarding the visual impact of the quarry site. Photographs 15.1 to 15.17 shows the view from the various viewpoints in relation to the subject site. Table 15.7 displays the locations of the viewpoints in relation to the subject site and whether the quarry was visible or not.

**Table 15.7: Descriptions of view from viewpoints as shown in figure 15.5**

Viewpoint	Location of Viewpoint	Description of View from Viewpoint
1	View from L-1264-4 244m S from the subject site nearest boundary	No aspect of the development is visible from this site due to the existing tree line which aids in screening the site
2	Beside dwelling 180m SW of the subject site nearest boundary	No aspect of the development is visible from this site due to the existing tree line which aids in screening the site
3	Dwelling 770m NW of the subject site nearest boundary	The development is visible from this site
4	Dwelling 684m NW of the subject sites nearest boundary	The development is visible from this site
5	Dwelling 313m N of the subject sites nearest boundary	The development is visible from this site
6	View from where L-5194-2 meets L-5394-1 road 593m NE from nearest site boundary	The development is visible from this site
7	View from L-5394-1 road 375m NE of the subject site nearest boundary	No aspect of the development is visible from this site due the location of the subject site

8	Dwelling 330m E of the subject sites nearest boundary	The development is visible from this site
9	View from L-5414-1 in front of Agricultural sheds 507m E from subject site nearest boundary	No aspect of the development is visible from this site

Viewpoint	Location of Viewpoint	Description of View from Viewpoint
10	View from L-1264-4 road 671m SE of the subject site nearest boundary	No aspect of the development is visible from this site
11	View from the L-1264-4 road 416m S of the subject site nearest boundary	No aspect of the development is visible from this site due the location of the subject site
12	Dwelling located on access road 185m from the subject site nearest boundary	No aspect of the development is visible from this site due to the existing tree line which aids in screening the site
13	View from access road L-5414-1 29m S of the quarry entrance gates	The development is visible from this site
14	View from agricultural field 182m SW of the quarry	No aspect of the development is visible from this site due the location of the subject site
15	View from 48m SE from quarry boundary	No aspect of the development is visible from this site due to the existing boundary berm being heavily vegetated which aids in screening the site

16	View of berm at SE boundary	The development is visible from this site
17	Dwelling house along the L-5414 road 290m NE of the subject site nearest boundary	No aspect of the development is visible from this site due the location of the subject site

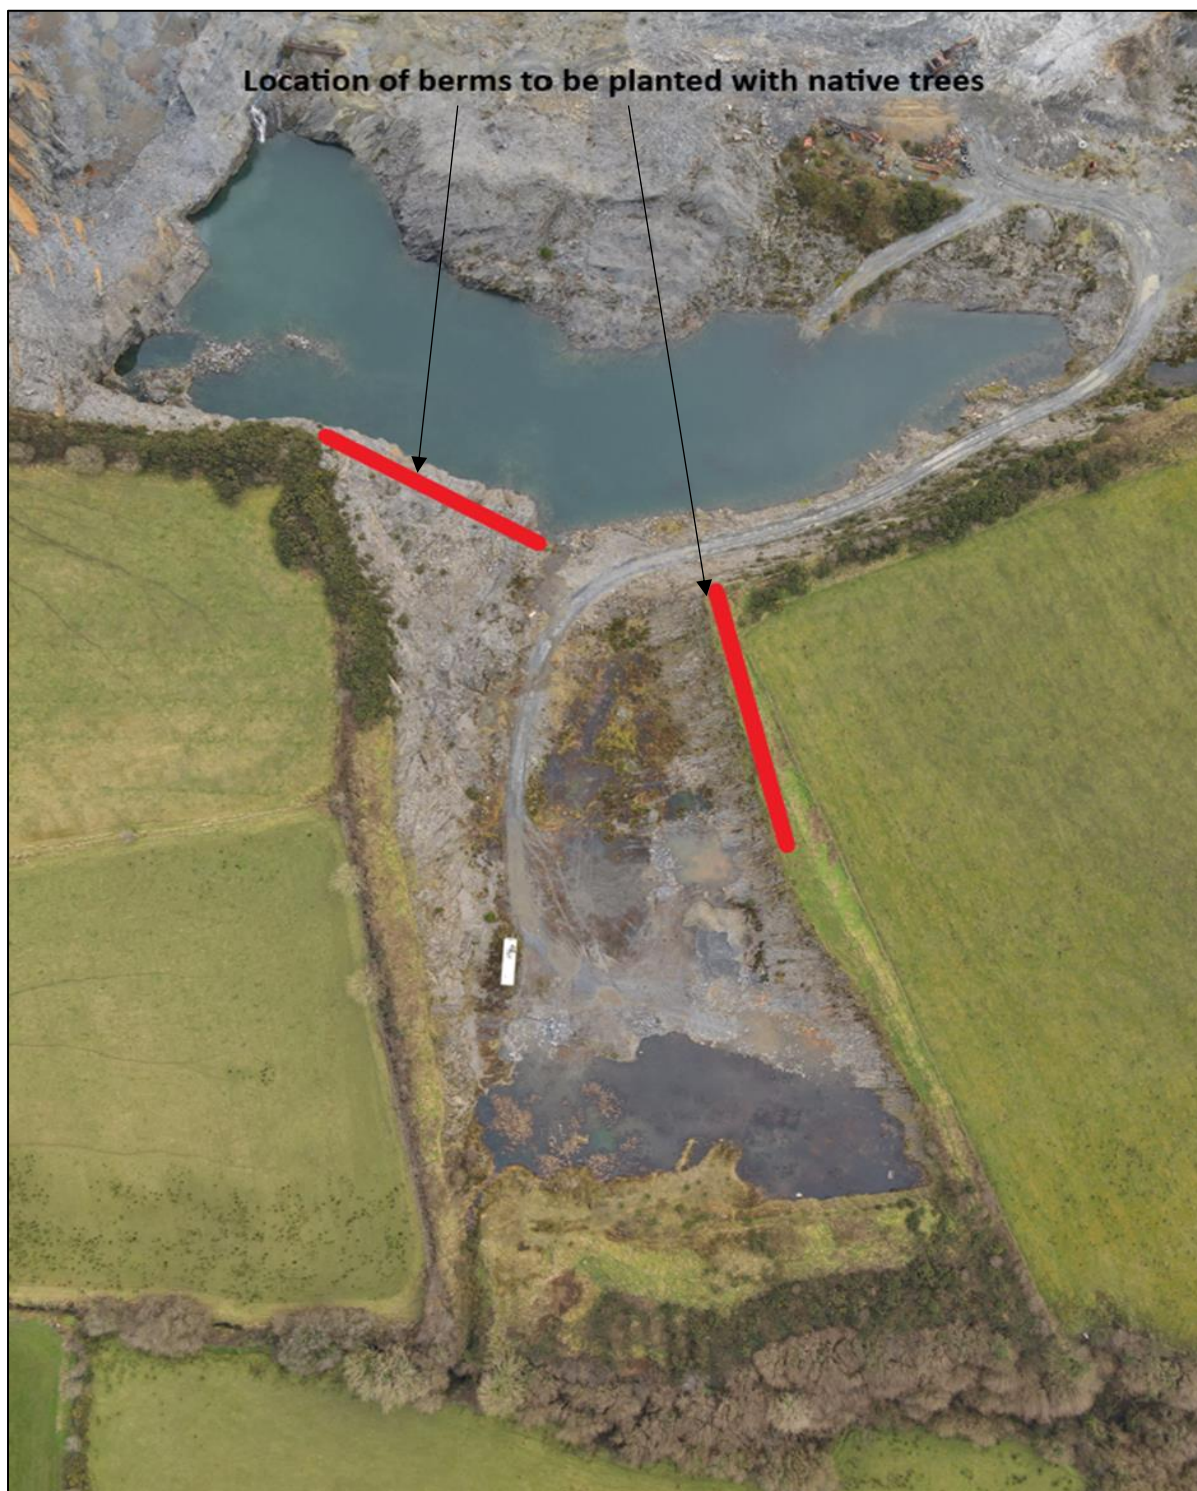
Photograph 15.18 Location of berms that are to be planted

The existing berms are illustrated schematically on the aerial photographs in Figures 15.18 and 15.19.

The existing berms to the North of the quarry site near the settlement ponds will be planted with native trees which will reduce the visual impact of the subject site and add to the biodiversity value of the area. The use of native species will support a wider range of insects and animals and will contribute to the connectivity and biodiversity value of the region. Species to be planted are listed in 15.8.2.

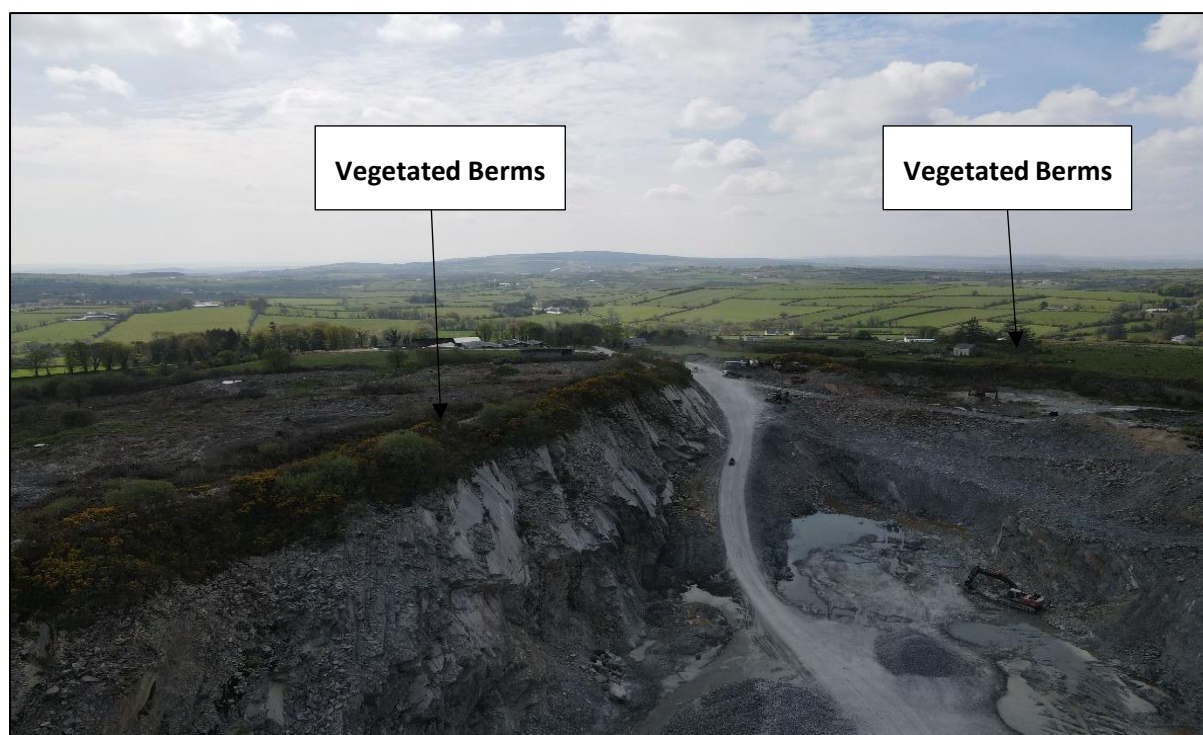
Photograph 15.20: Existing vegetated berms around the quarry

In the past berms have been constructed in and around the quarry site which have been allowed to regenerate with indigenous vegetation over time. No further overburden is going to be stripped from this quarry as it will be solely rock extraction. The location of the vegetated berms are shown on the aerial photograph in Figure 15.20.
