## Section 7: LAND, SOILS &amp; GEOLOGY

## 7 LAND, SOILS AND GEOLOGY

This section of the rEIAR describes the natural characteristics of the site and surrounding area in terms of land, soils and geology. An assessment is made of the potential impacts associated with the proposed development and the activities that will be undertaken. Existing mitigating measures are reviewed, and further measures proposed where required, to remove or reduce any potential impacts identified.

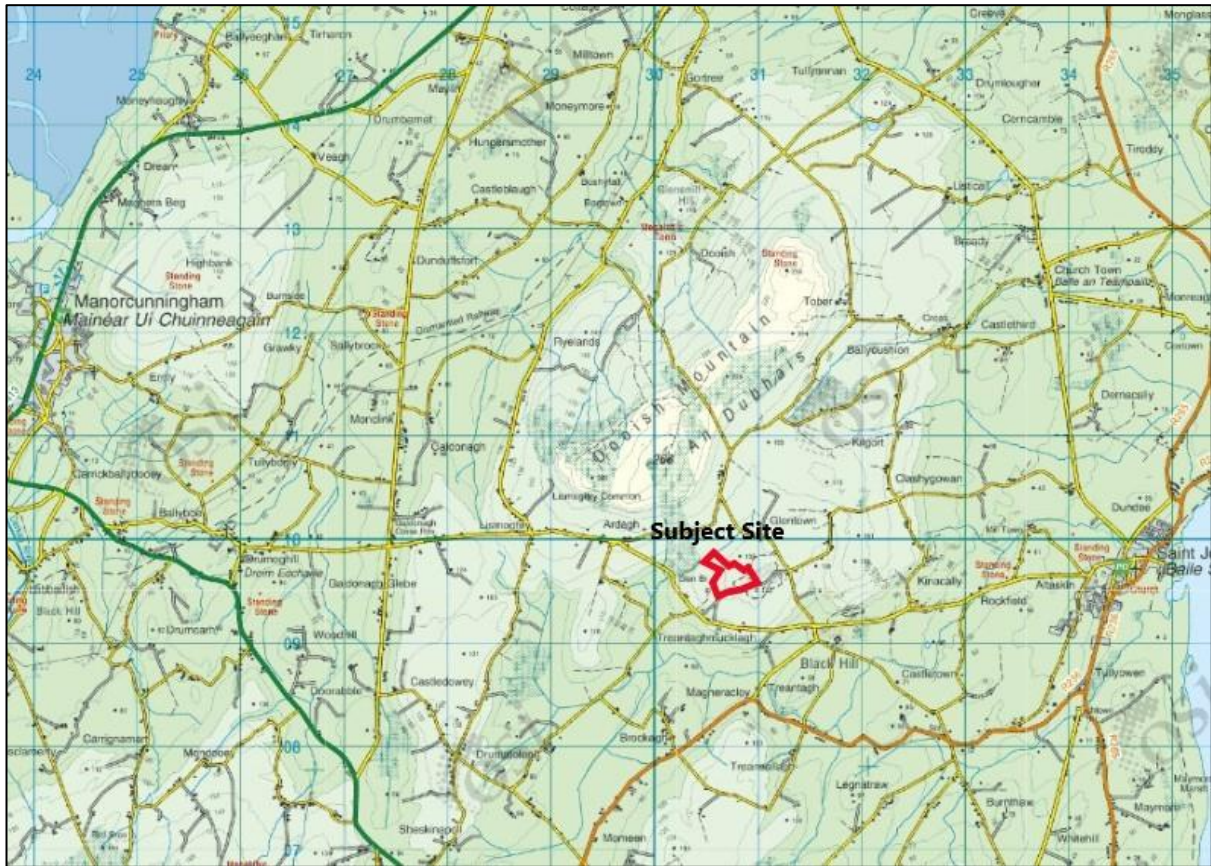
Figure 7.1: Location of Subject site

The site is surrounded by agricultural land on all sides apart from to the east where a quarry face separates the site and a separate quarry operated by a different owner. An extensive area of commercial forestry lies to the north and northwest of the site, flanking the slopes of Dooish Mountain. The application site location is outlined in Figure 7.1 and the site layout is shown in Figure 7.2.

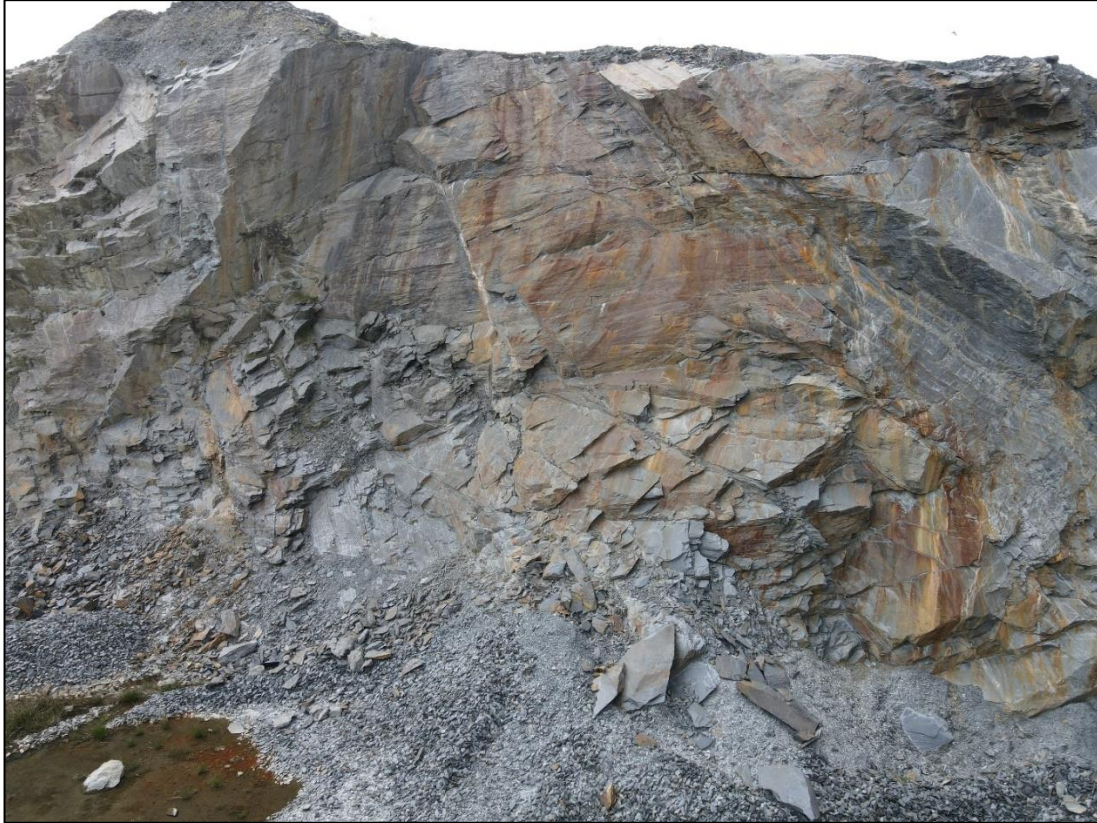
**Photograph 7.1: Typical slate with no obvious bedding**

Much of the quarry is in blue-black slate with no obvious bedding but there are also clearly bedded, fine grained graded units like those shown in Figures 8 and 9 (of Appendix 7.1), where there are 10 to 15cm thick graded beds with a fine sandy base passing upwards into meta-mudstone. There are also laminated grey-green silty slates (Figure 11) and thinly bedded units where the intersection of the bedding with the dominant slaty cleavage results in a strongly banded slate (Figure 12). Some of the thinly bedded slates show very complex folding. Figure 10 shows the face in the north-eastern corner of the active quarry where banded slates are tightly folded.

Photograph 7.1 below shows a typical quarry face with no obvious bedding within the slate. Photograph 7.2 below shows complex folding in banded slates in the northeast part of the quarry.

The area is underlain by meta-sedimentary rocks which are assigned to the Lough Foyle Succession of the Dalradian. Most of the rocks in the Lough Foyle Succession belong to the Argyll Group and the Southern Highland Group of Middle to Upper Dalradian age, and the rocks were originally deposited about 600 to 700 million years ago. The most recent geological map of the area is Geology of North Donegal, 1:100,000 scale, published by the Geological Survey of Ireland, in 1997. The quarry itself is in the upper part of the Lough Foyle Succession and the rocks are of Cambrian age. The stratigraphic sequence in the Lough Foyle succession is poorly understood due to intermittent exposure and structural complexity. The main lithologies present are meta-greywackes/psammities and meta-pelites/slates. All the strata exposed in Tinney's Quarry are slates.
