# SECTION 8.0 WATER

| 8.0 WATER..... | 4 |

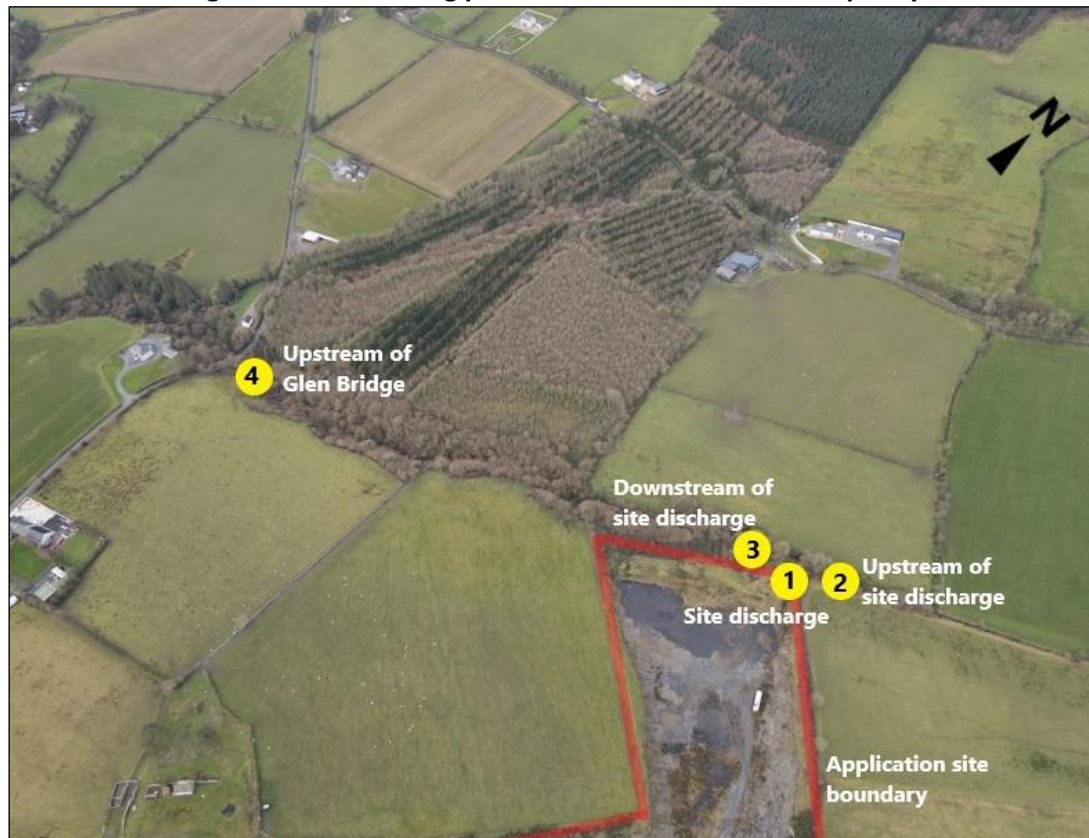
**Figure 8.5: Monitoring points for flow rate and water quality**

Conductivity results confirm the likelihood of a groundwater influence from the site outflow (Section 8.4.15.1).

In addition to ecological assessment, an assessment of the water chemistry of the receiving waters was made. The results of samples analysed as part of this study and those taken as part of the discharge licence conditions are presented in Table 8.6 below. All samples are taken from the tributary of the St Johnston stream. Sample point 1 relates to upstream of the site discharge, sample 2 from downstream of the site discharge and sample 3 upstream of the Glen Bridge. The sample points are indicated on Figure 8.5.

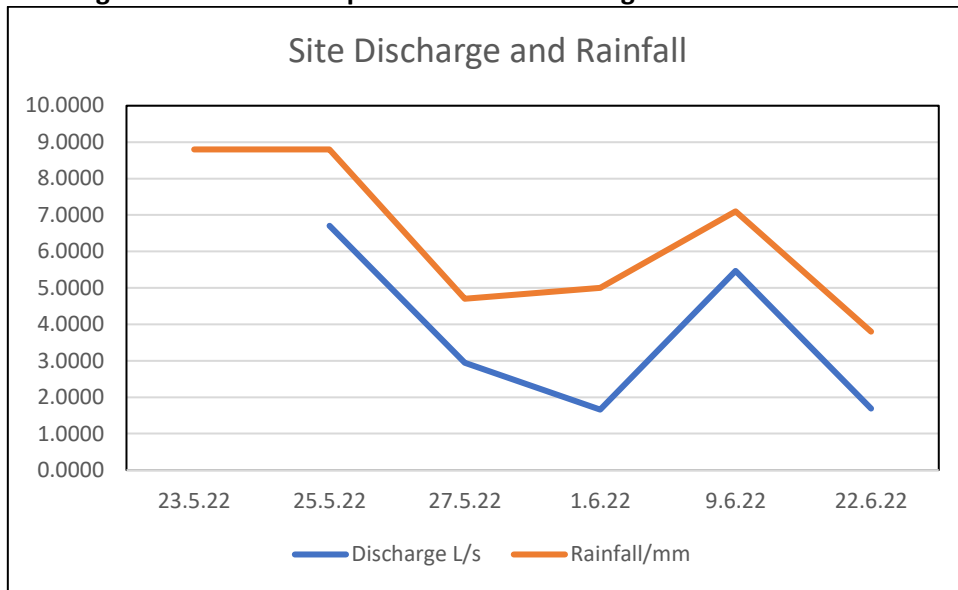
**Figure 8.6: Relationship between site discharge and incident rainfall**

The requirement for activation of the pump is directly related to the amount of incident rainfall. The flow rate of the site discharge can be seen to be related to the amount of incident rainfall. Figure 8.6 below shows the relationship between the site discharge flow rate in L/sec and the amount of incident rainfall in the previous 72 hours in mm.

Average flow rate for the site discharge was 2.03 L/s when the pump was off. Average flow rate observed when the pump was turned on or had been turned off within 4 hours of measurement was 6.44 L/s. A weighted average of site discharge was estimated attempting to account for average weather conditions. Over the course of a year, it is assumed that the pump was active for approximately one hour per day on an average of four days per week throughout the year.

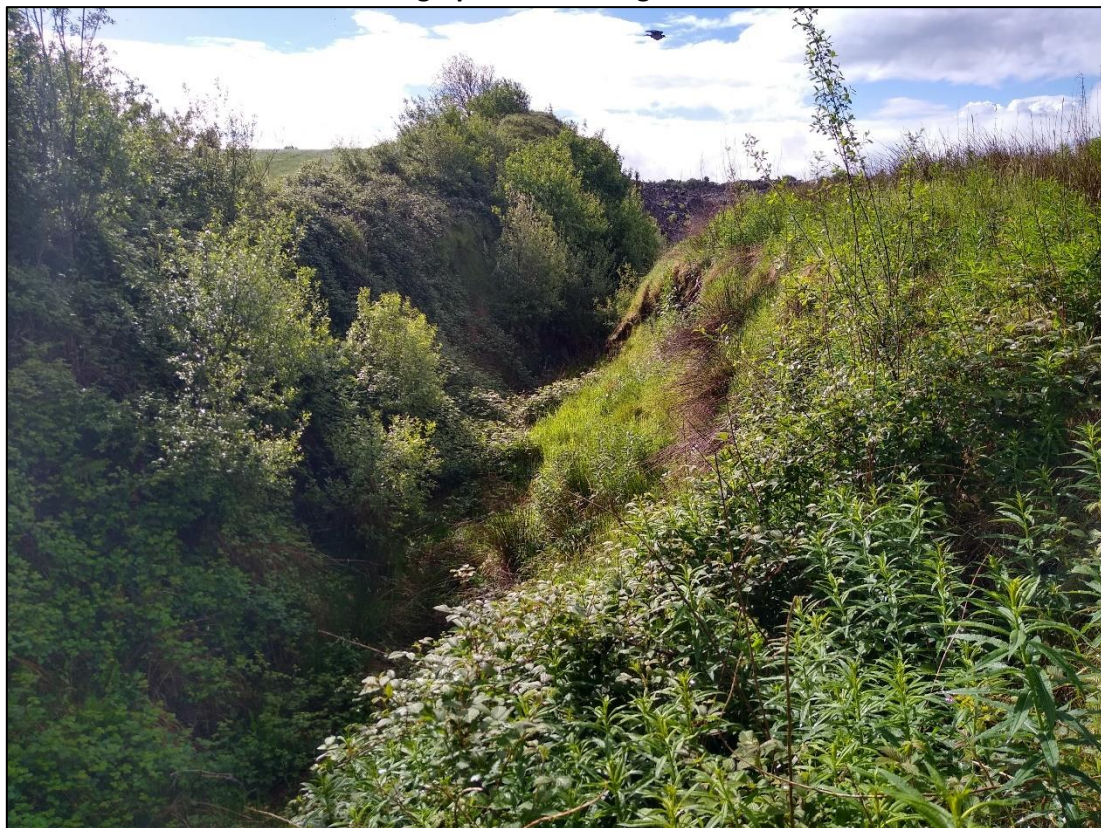
**Photograph 8.1: Discharge channel**

Photograph 8.1 below shows the discharge channel on the site with heavily vegetated steep banks and vegetated channel.

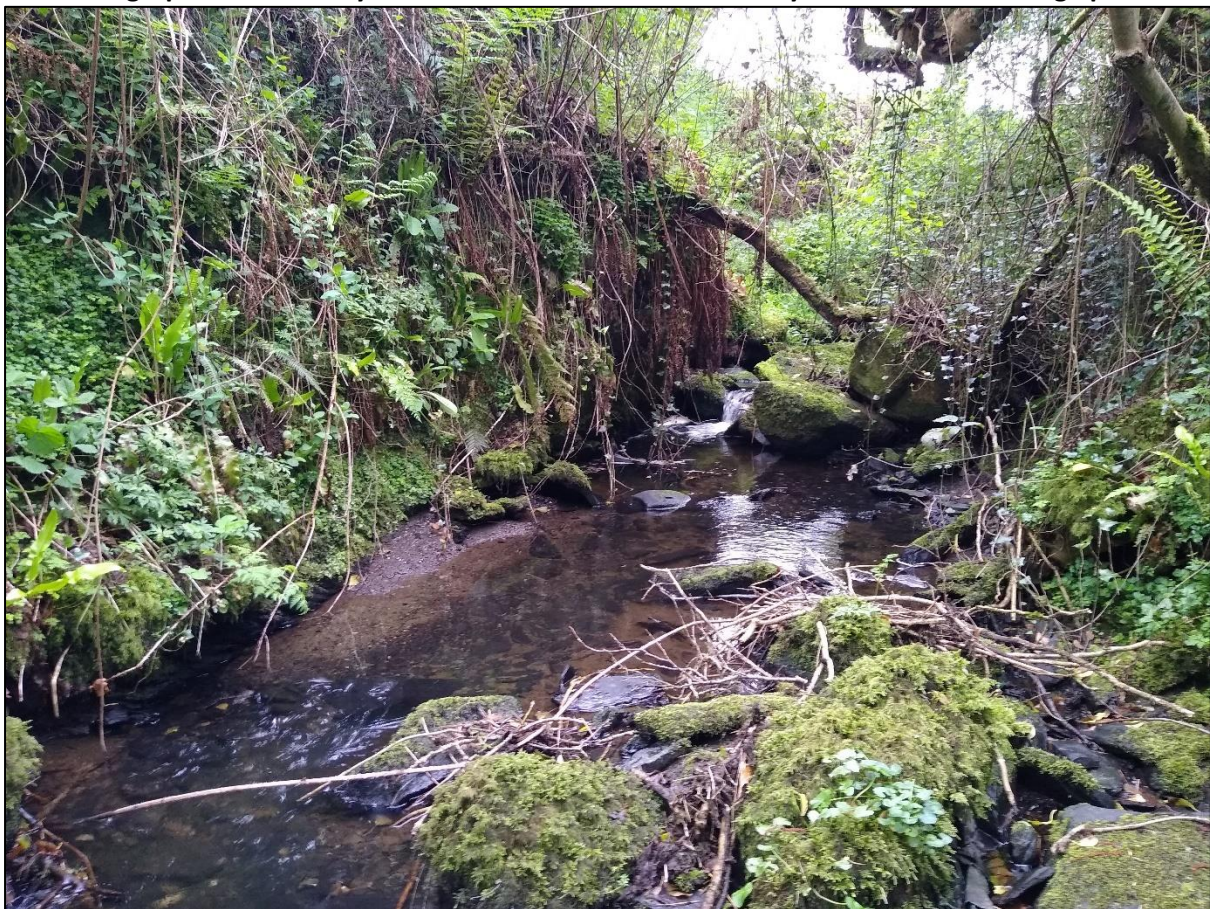
**Photograph 8.2: Tributary of St Johnston Stream immediately south of site discharge point**

It is concluded that there is sufficient hydrological capacity in the tributary to assimilate the flow from the application site. The tributary of the St Johnston Stream forms a small but steep sided valley on its route from Doosh Mountain past the application site and for several kilometres south of the site. Photograph 8.2 below illustrates the typical channel structure of this tributary.

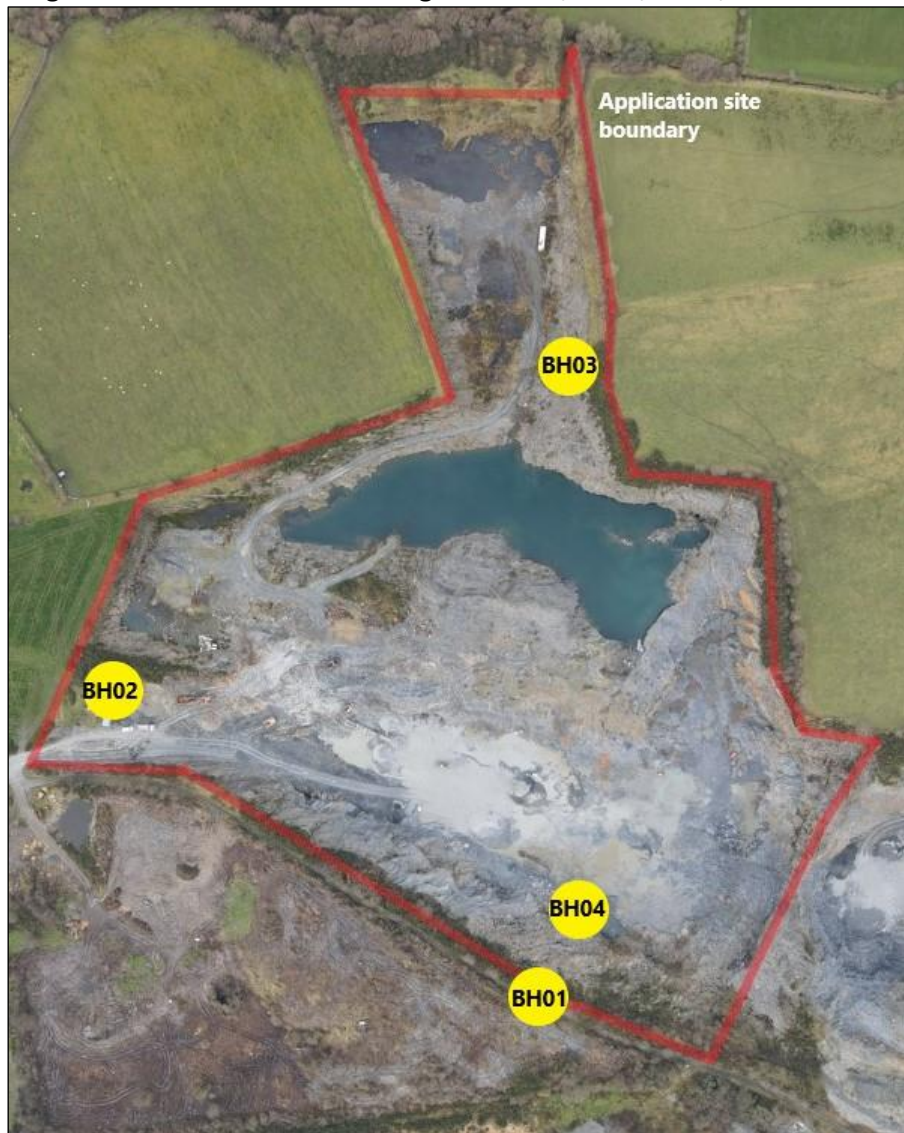
**Figure 8.9: Position of monitoring boreholes, BH01, BH02, BH03 & BH04**

To assess the current hydrogeological regime on site, four monitoring boreholes were drilled and installed in February 2022. The position of the four wells (BH01, BH02, BH03 & BH04) is shown in Figure 8.9 below.

The boreholes were 100 mm in diameter drilled to 25 mbgl, 50 mm diameter standpipe installed, slotted at the bottom 12 m, gravel packed, and bentonite sealed. The drilling crew reported no water strikes encountered in any of the four monitoring boreholes and that drilling dust remained dry throughout the drilling process. No drilling logs were made available.

BH01 is located on the southeast boundary of the application site outside of the berms at approximately 134.43 mOD. BH02 is located in the upper western edge of the site close to the site entrance at 125.38 mOD. BH03 is located in the worked out northern portion of the site at 117.35 mOD. BH04 is situated in the southeast part of the quarry void at 109.421 mOD.

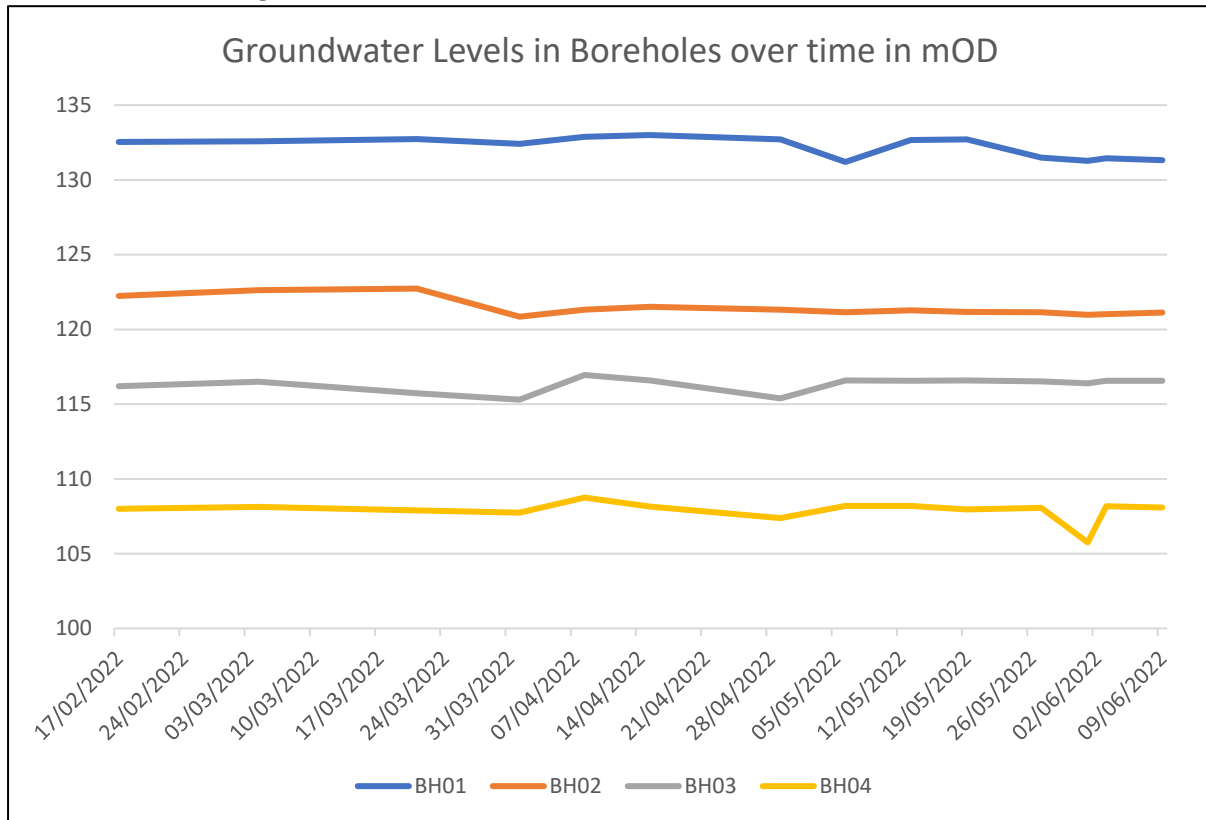
**Figure 8.10: Groundwater levels at BH01, BH02, BH03 & BH04**

Groundwater levels were recorded with an electronic dip meter approximately weekly at each of the boreholes over the course of a 3-month study period of March, April and May 2022. It is noted that at the start of the study period groundwater levels are likely to have been at their highest. Plots of the groundwater level variation over time are given below for the four monitoring boreholes in Figure 8.10 below. The groundwater level readings are presented in Appendix 8.3.

The groundwater levels at BH01 varied between 131 mOD and 133 mOD over the study period. The groundwater levels at BH02 varied between 121 mOD and 123 mOD over the study period. The groundwater levels at BH03 varied between 115 mOD and 117 mOD over the study period. The groundwater levels at BH04 varied between 107.4 mOD and 108.8 mOD over the study period.

Most of the boreholes showed a seasonal variation in level of almost 2 m. BH04 near the quarry deck showed the least variation in groundwater levels. The dip in groundwater level in BH04 observed around 2.6.2022 was related to the slow recovery of levels following an aquifer test on 27.5.2022 where groundwater was removed from the borehole. Sections 8.4.13.5 & 8.4.13.6 contains more details of the aquifer testing.

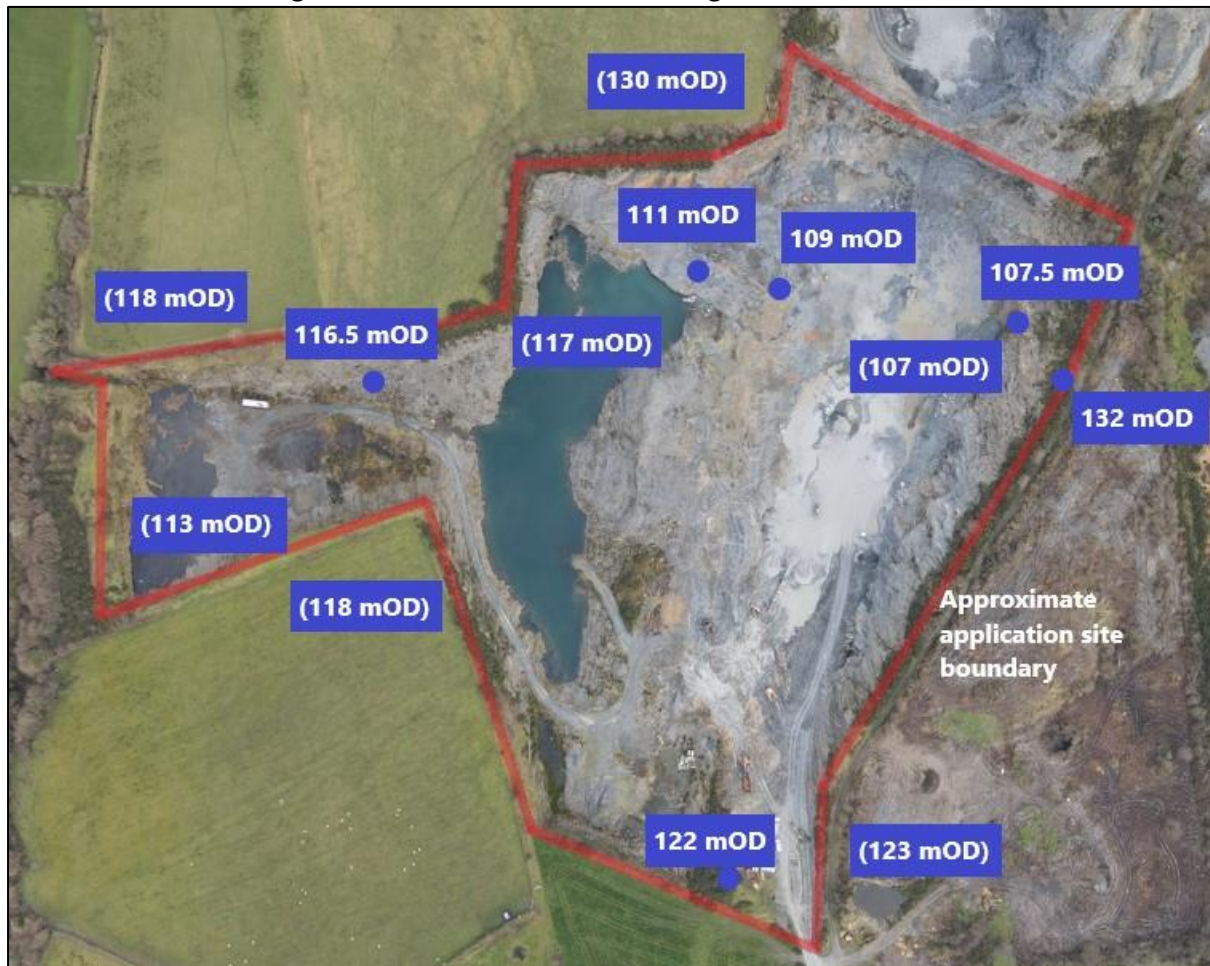
**Figure 8.11: Measured and Inferred groundwater levels**

Groundwater levels throughout the site are noted on the aerial photograph presented as Figure 8.11. Inferred, rather than measured, groundwater levels are presented in brackets. It is noted that there is likely to be a variation in levels of up to 2 m due to seasonal effects.

It can be seen from Figure 8.11 above that groundwater movement will follow the local topography and be to the northwest towards the tributary of the St Johnston stream.

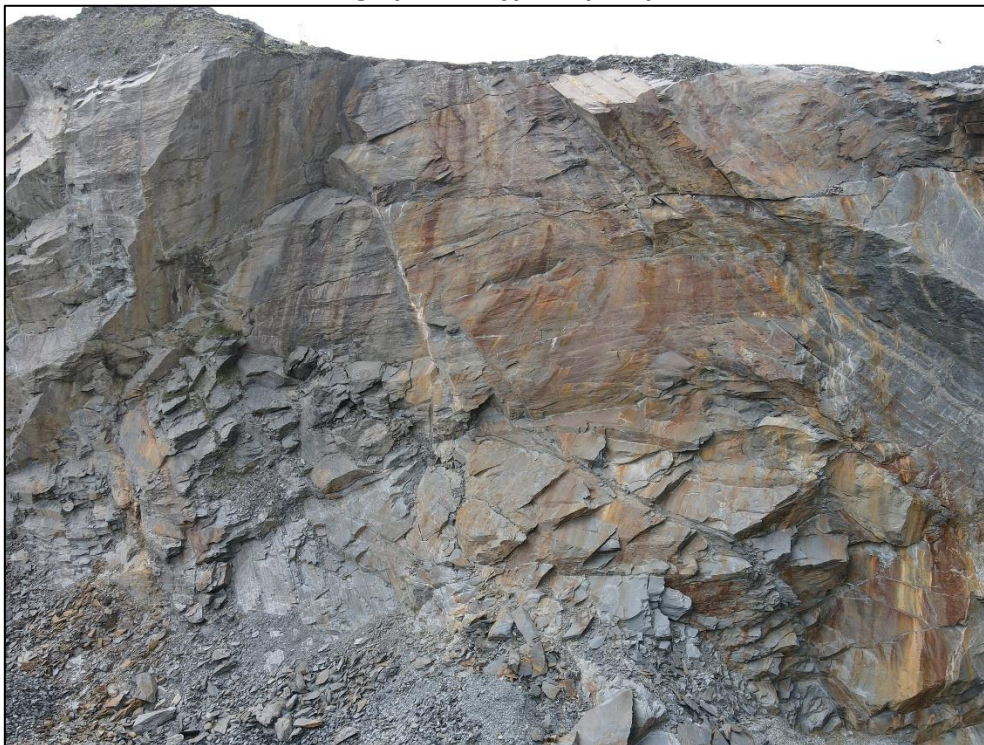
**Photograph 8.3: Typical quarry face**

Measurement of hydraulic conductivity is problematic on site due to the likely transport mechanism within the rock types. Groundwater movement through the slate is likely to be confined to fracture flow within small cracks and joints. There is not expected to be any intergranular flow on site. There is likely to be a high degree of variability through the site with the amount and orientation of the cracks and fractures dictating the flow regime. Complex folding of the lithologies in the eastern part of the quarry will also add to the variability in groundwater flow. Hydraulic conductivity is expected to decrease with increasing depth due to the decreasing number of cracks and fractures at depth.

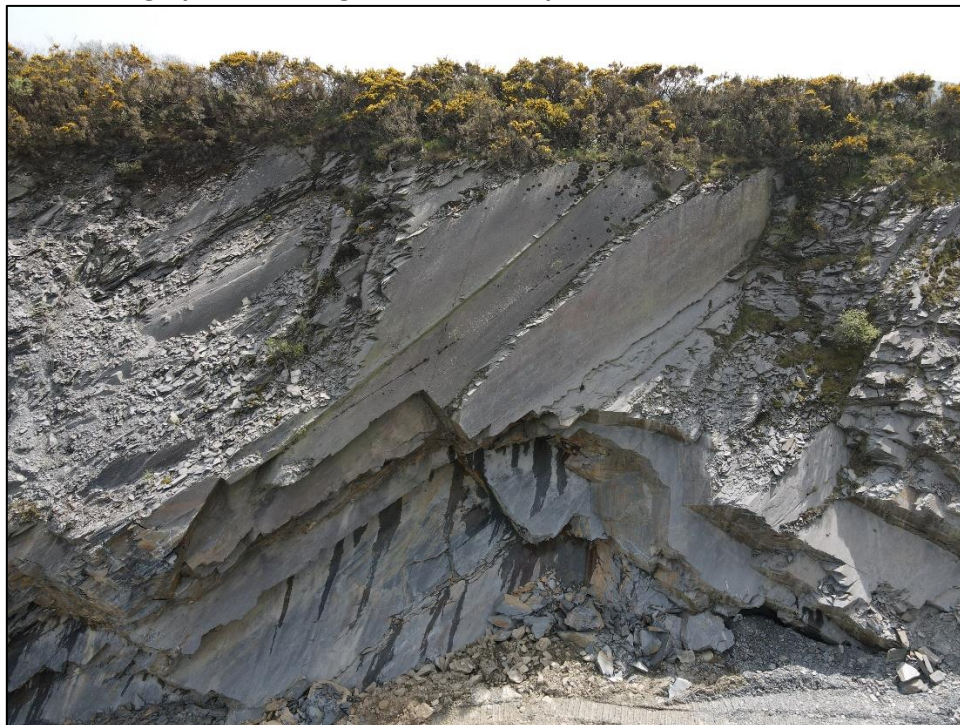
**Photograph 8.4: Slow groundwater seep between bedded slate units**

Photograph 8.4 below shows the maximum observed groundwater flow through the quarry faces. The face pictured is on the southern quarry boundary and the water movement appears to be between bedded units but the quantities of groundwater involved are minimal. It is noted that this is the only water movement through any of the exposed rock faces through the entire application site.

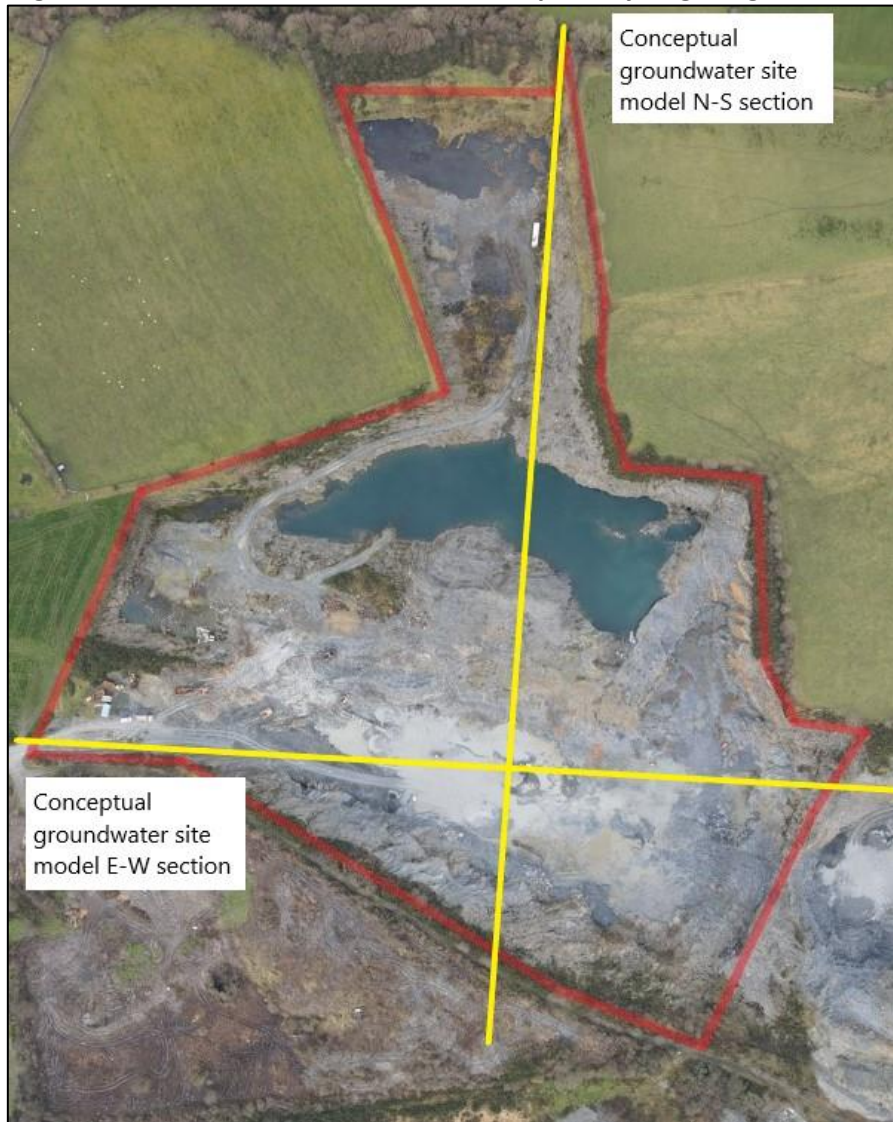
**Figure 8.12: Lines of cross section for conceptual hydrogeological models**

A conceptual site model has also been generated for the hydrogeology of the site and is shown in Figures 8.13 & 8.14. Figure 8.13 is a cross sectional conceptual model showing the site across a north-south axis. Figure 8.14 is a cross sectional conceptual model showing the site across an east-west axis. Neither conceptual model is shown to scale. The cross-section lines are depicted on Figure 8.12 below.

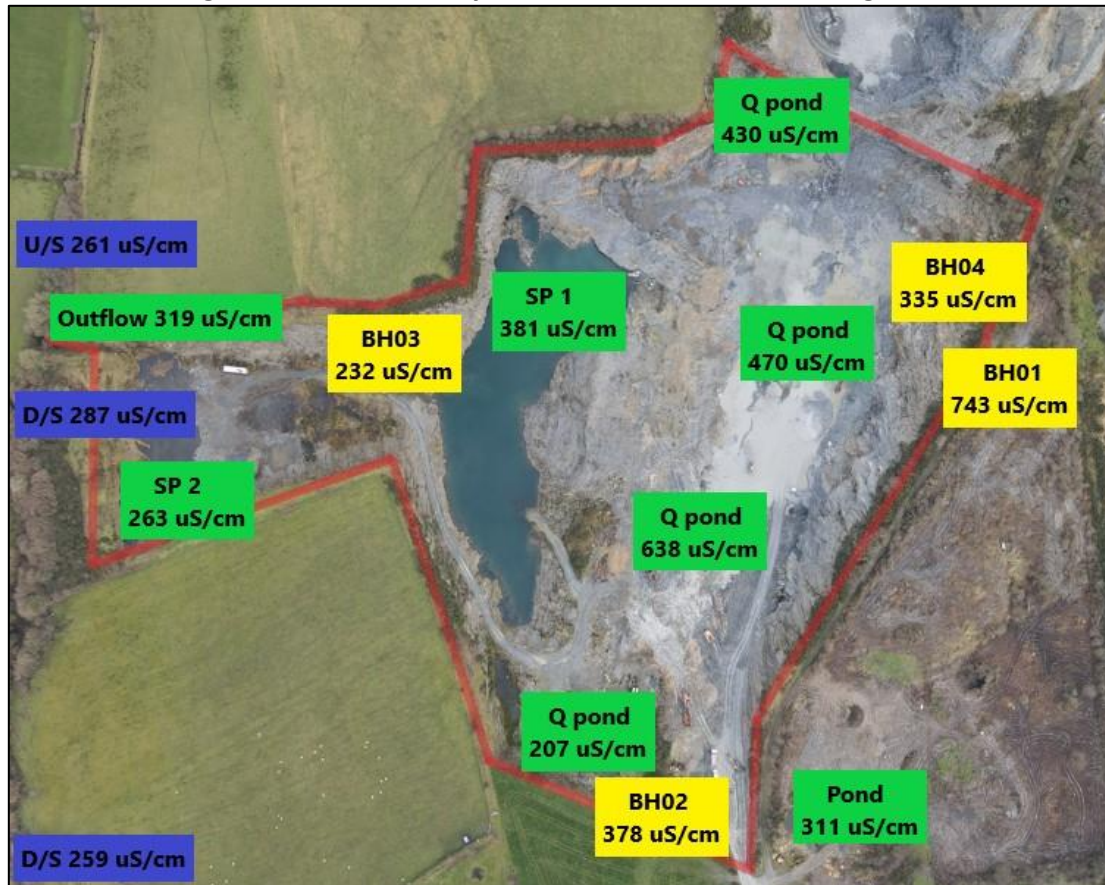
**Figure 8.15: Conductivity values for water sources through site**

Conductivity in the St Johnston stream tributary was around 260  $\mu\text{S}/\text{cm}$  upstream of site discharge and approximately 400 m downstream of the site discharge. Immediately downstream of the discharge point, the stream showed a slightly elevated conductivity readings of an average of 287  $\mu\text{S}/\text{cm}$  which is likely to be due to the groundwater influence within the discharge waters.

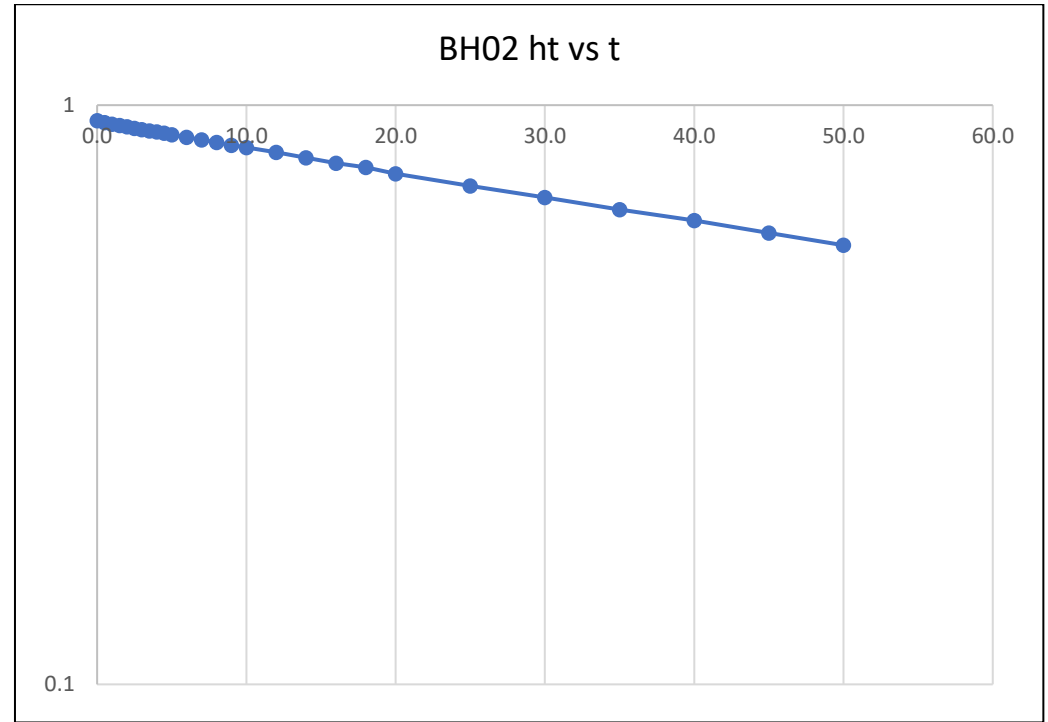
- **BH02:  $K = 6.36 \times 10^{-5} \text{ m/s}$**

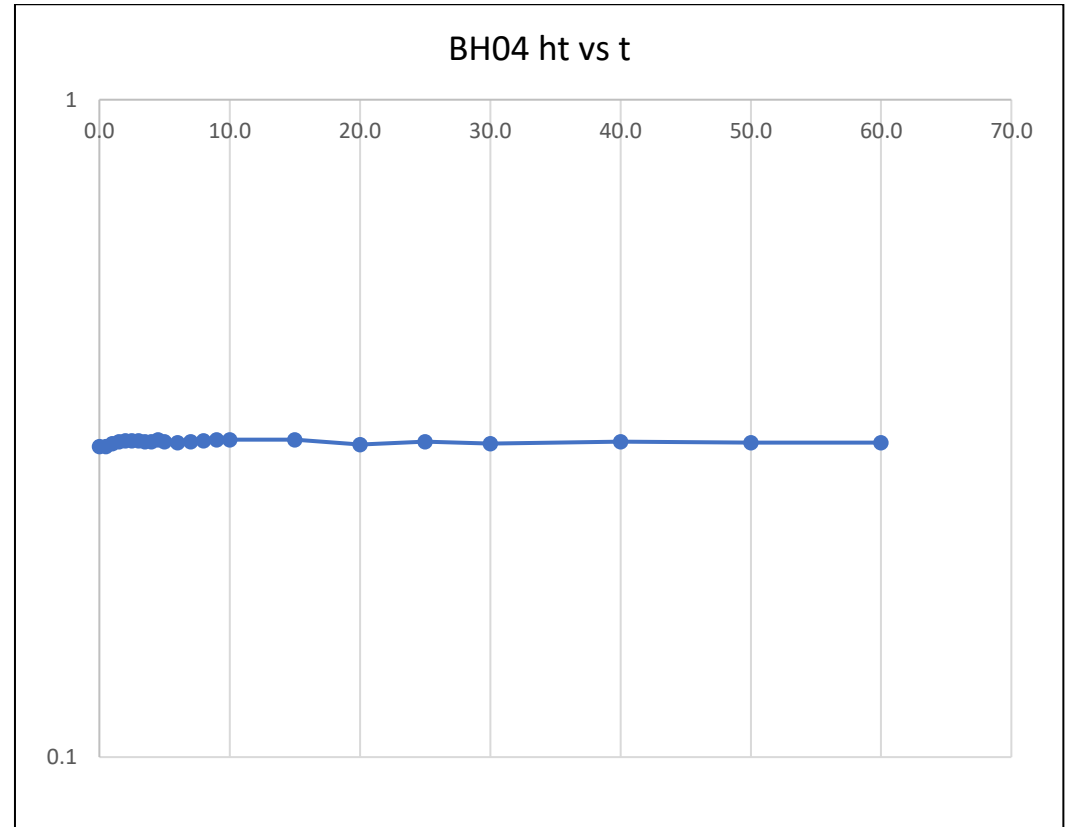
● BH04:K = 1.52 x 10<sup>-7</sup> m/s

Although these tests were limited in nature, a similar recharge response is demonstrated in boreholes 1,2 & 3. The aquifer in BH04 is situated deeper at 109 mOD than the other boreholes which may explain the decrease in hydraulic conductivity observed. The K value for BH04 is two orders of magnitude lower than the other boreholes.
