10.0 LANDSCAPE AND VISUAL

This Remedial Environmental Impact Assessment Report (rEIAR) has been prepared to accompany a substitute consent application for an existing sand and gravel quarry at Ballinabarny North and Bolagh Lower, Redcross, Co. Wicklow. The remedial Landscape and Visual Impact Assessment (LVIA) was prepared by Macro Works Ltd.

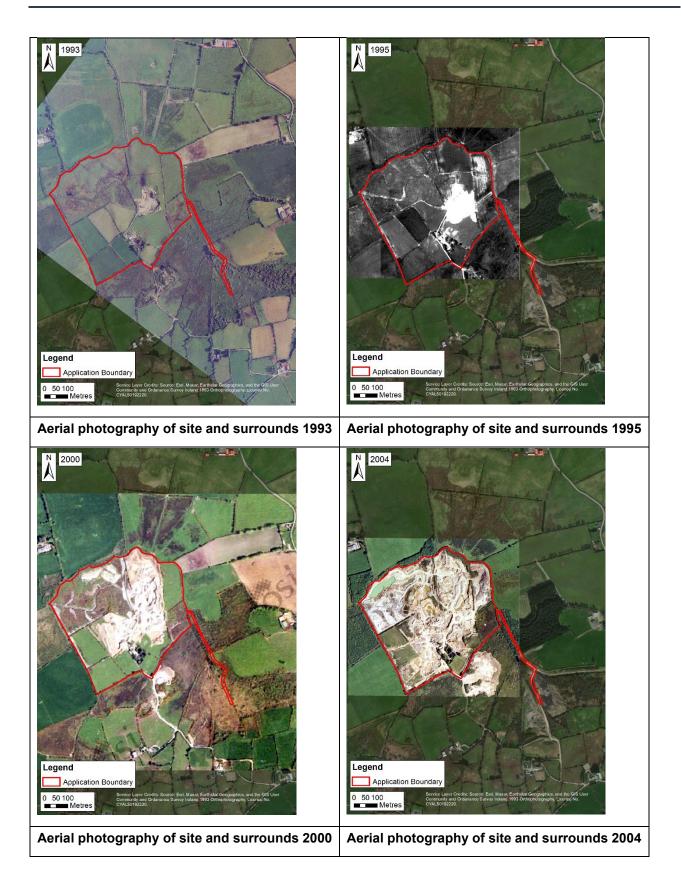
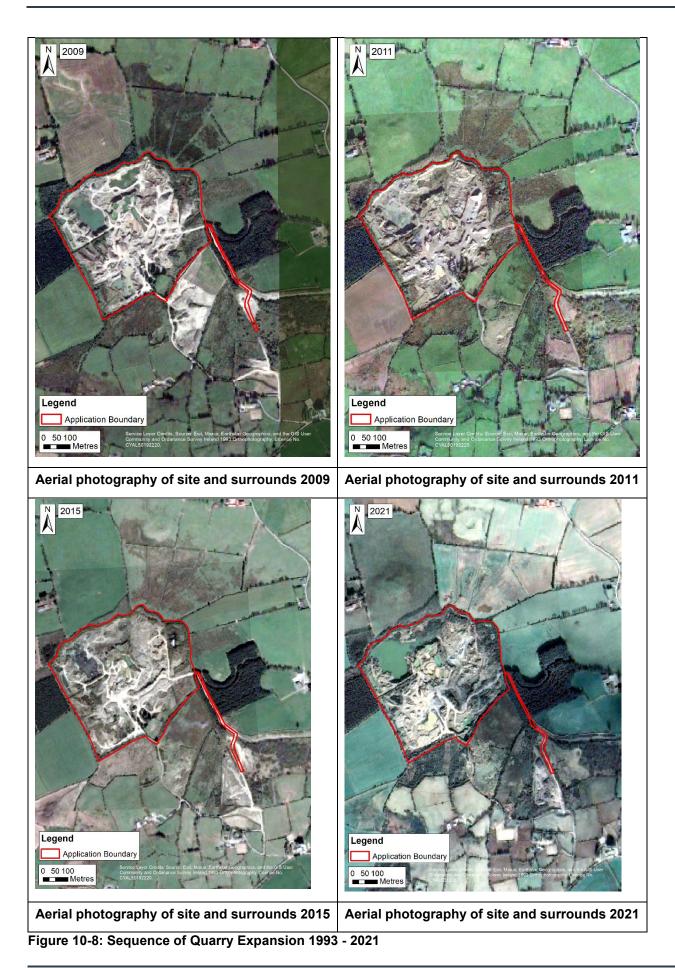
Land cover has changed slightly, but in the manner of an evolving rural area that passes from one familiar land use to another in rotation i.e. there are small patches of commercial conifer plantation to the east west and south, which were still in marginal farmland / scrub in 1990, but have been planted since. Although the granularity of earlier aerial photography can be influential, it would also appear that the farmed areas are generally in higher quality pasture at present than they were through the intervening period whether due to more intensive farming practices. The progressive extension of the quarry since 1990 is presented in the sequence of figures below.

What is most apparent from the sequence of aerial photographs in Figure 10.8 is that the most rapid expansion of the quarry occurred in the early 2000s during the height of the Celtic Tiger years when construction work and therefore the demand for building materials was at a peak. During the subsequent recession years from c.2008 to 2013 quarry expansion was less dramatic. Also apparent is the increase in commercial forest plantations that surround the site to the east and west.

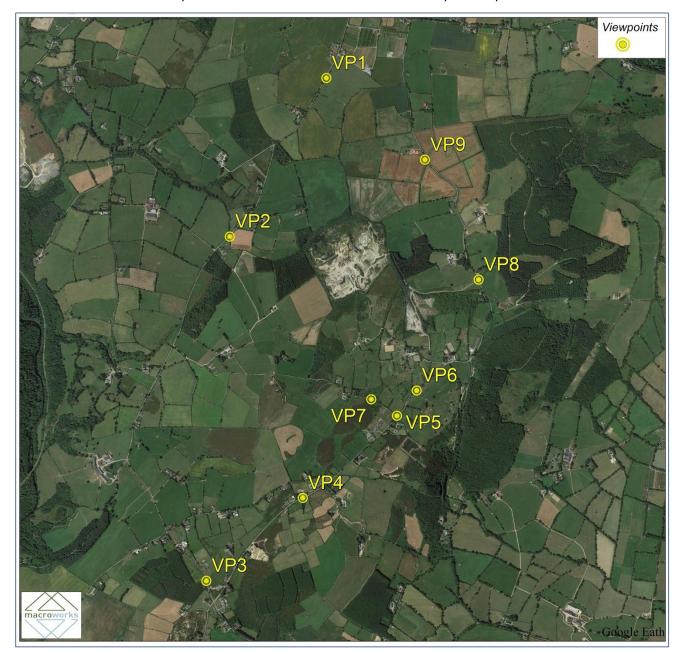
Figure 10-9: VP Location Map

A total of eight viewpoints were captured during fieldwork representing local receptors around the quarry. These will be used for the visual impact assessment and are shown on the viewpoint map below.

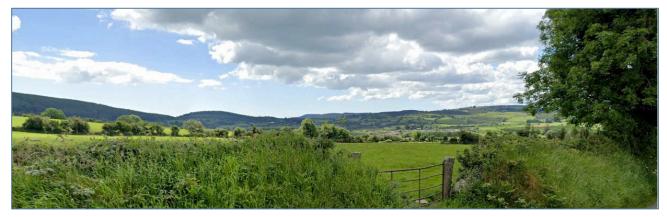
Figure 10-10: Viewpoint 1

The significance of the visual effect is **Slight.** The quality of the effect is considered adverse and of a long term duration.

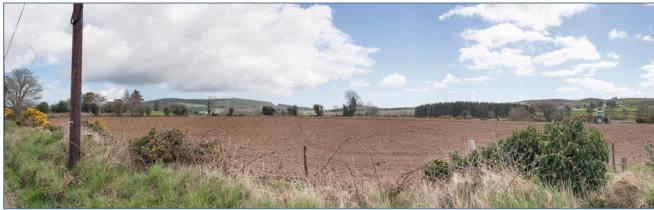
Figure 10-11: Viewpoint 2

The significance of the visual effect is Imperceptible. The quality of the effect is considered Neutral.

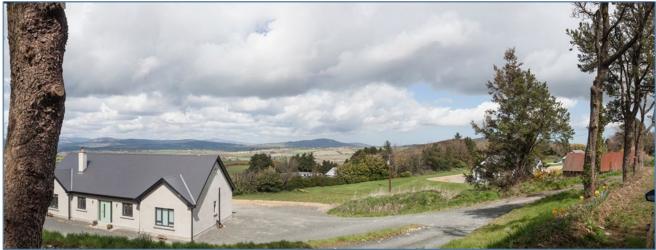
Figure 10-13: Viewpoint 4

The significance of the visual effect is Imperceptible. The quality of the effect is considered Neutral.

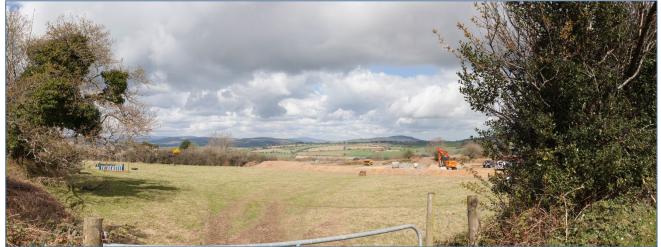
Figure 10-14: Viewpoint 5

This is an elevated and extensive view to the north through a gateway between sections of roadside hedgerow that otherwise contain views from this section of road. The backdrop of the view is similar to that for VP3 and VP4, being rolling farmland and distant mountains, but the foreground field includes the foundations of an imminent dwelling. For the time being, the quarry is partially visible in the lower middle ground as a series of scrub covered hummocks and bare-ground areas.

The significance of the visual effect is **Slight.** The quality of the effect is considered adverse and the duration is long-term.

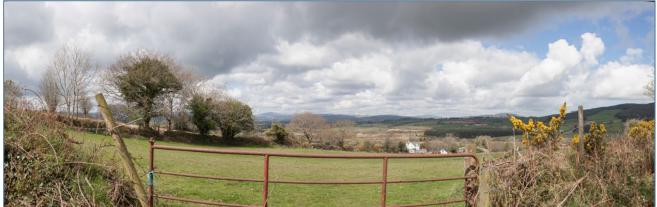
Figure 10-15: Viewpoint 6

The significance of the visual effect is **Moderate-slight.** The quality of the effect is considered Adverse and the duration is long-term.

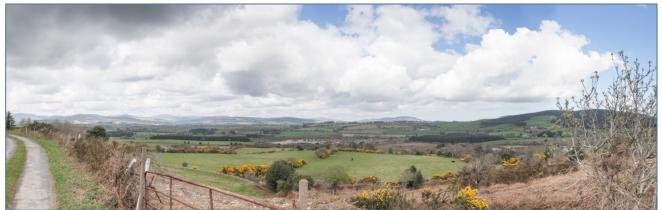
Figure 10-16: Viewpoint 7

The significance of the visual effect is **Moderate-slight.** The quality of the effect is considered adverse and the duration long-term.

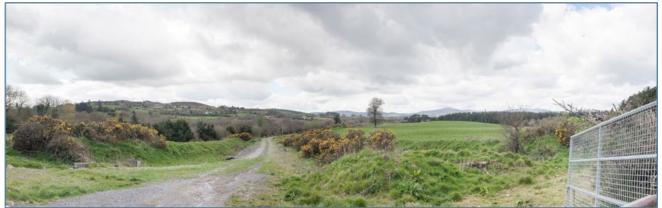
Figure 10-17: Viewpoint 8

The significance of the visual effect is Imperceptible. The quality of the effect is considered Neutral.
