5.0 SOILS, LAND AND GEOLOGY

This rEIAR chapter presents an assessment of potential impacts resulting from quarrying related activities that have been carried out at ECT Sand and Gravel's quarry at , Ballinabarny, Co. Wicklow ('the Site') on the land, soils and geology at the Site and in the wider Study Area.

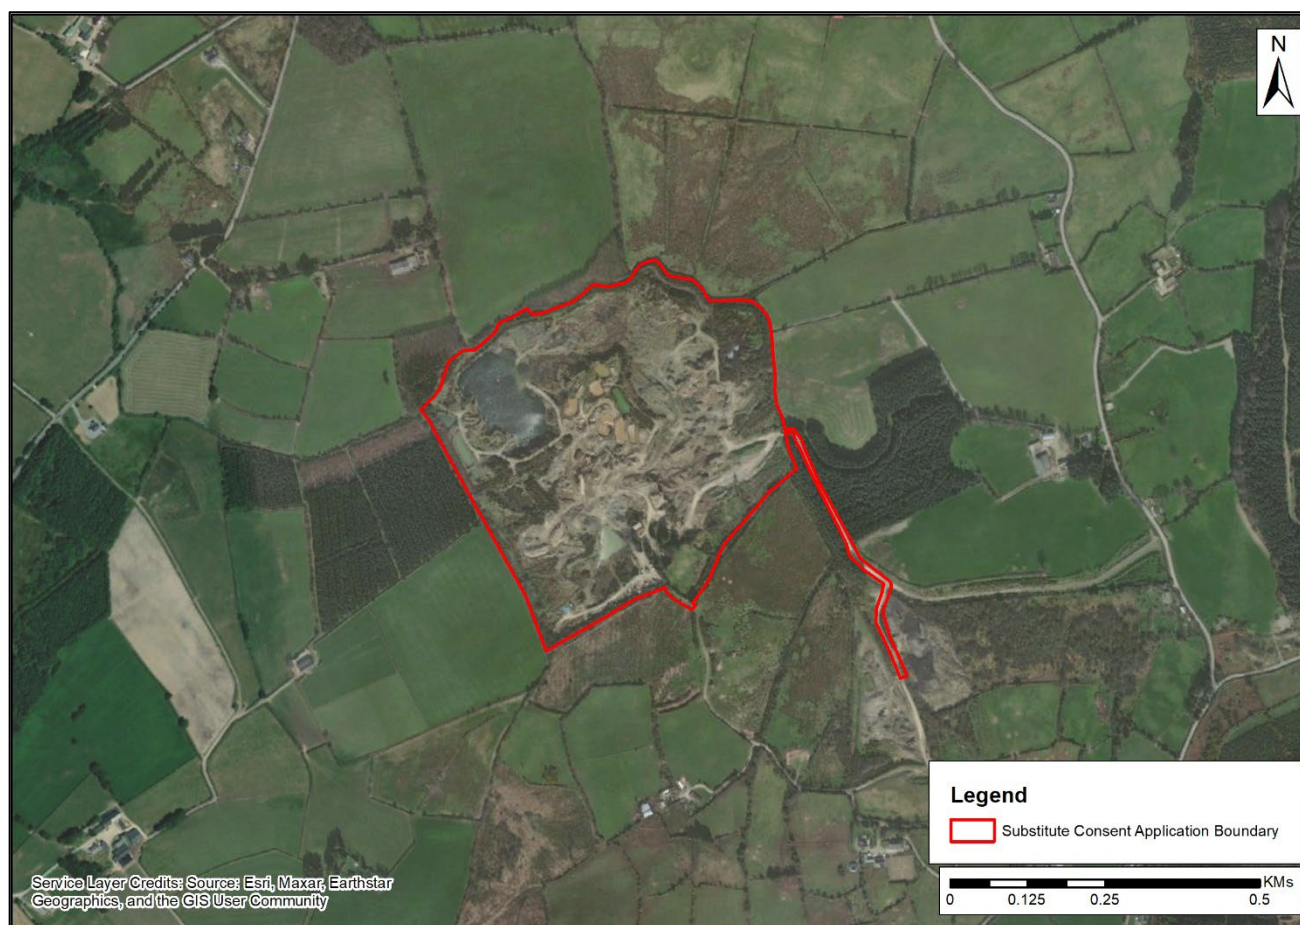
Figure 5.1: Location of the Site (rEIA Site Boundary)

The geographical study area for the assessment covers the rEIA site boundary ('the Site') (identified on Figure 5.1) and a buffer zone of 500 m from the Site boundary, which together are referred to as the 'Study Area'. This Study Area has been selected because most potential effects to geological and soil receptors are anticipated to occur within the Development footprint or immediately adjacent to it.

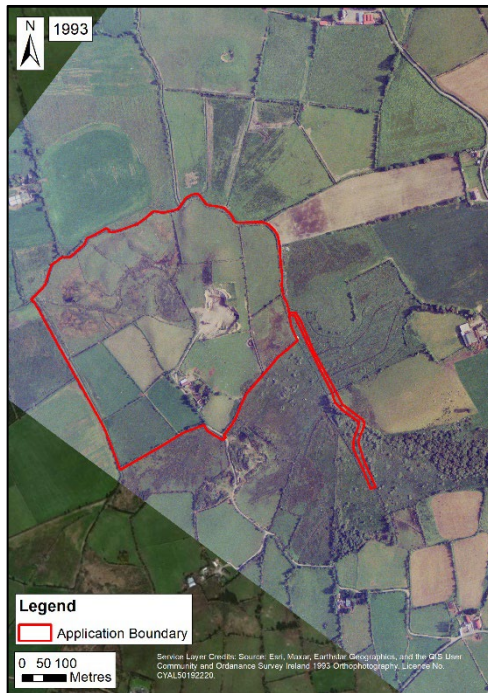
Figure 5.2: Aerial Photo of the Site in 1993

The oldest available aerial imagery closest to the baseline date of 1990 for the area is a 1993 OSI orthophotography survey (Figure 5.2), which has been used to approximate the 1990 baseline footprint of the quarry. The area of the quarry in 1990 is estimated to be 0.75 ha (see Chapter 2 for full details). The surrounding land use is agricultural with some patches of woodland.

The lower basal elevation of the working in 1993 (the proxy year used to develop the baseline – see Chapter 2 for more details) was approximately 124 mAOD.

Quarrying activities have expanded within the Site boundary. Quarrying progression can be seen in Figure 5.2 to Figure 5.6 and an estimation of the tonnage extracted between 1990 and 2021 has been made and is presented in full in Chapter 2 – Project Description.

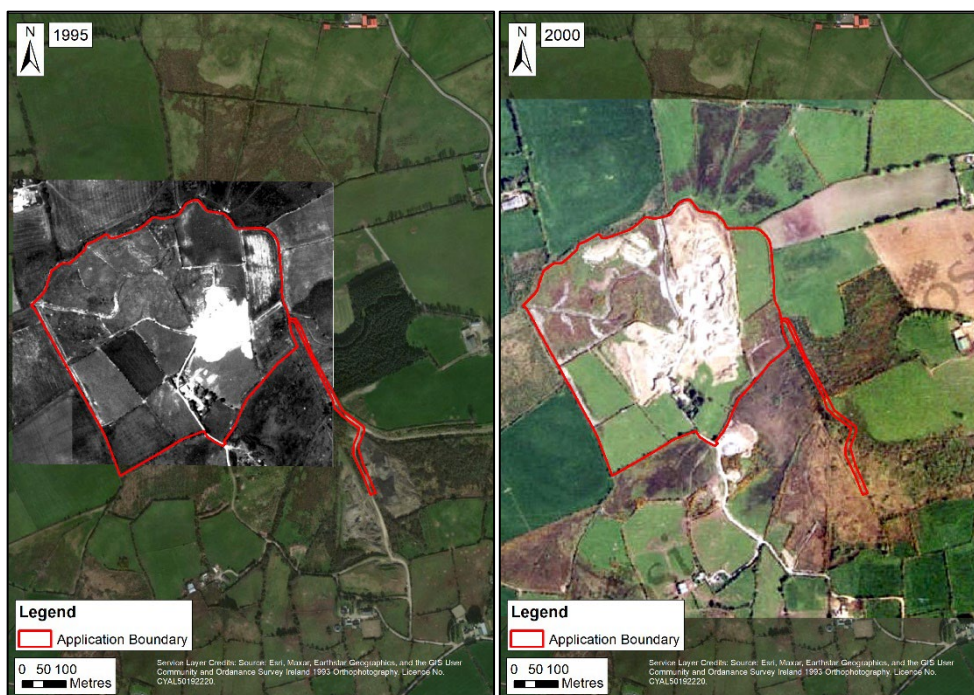
Figure 5.3: Aerial Photos of the Site in 1995 and 2000

Based on available aerial imagery and contour mapping, the extraction area expanded over this period first in a westerly and northerly direction up to 2000, then expansion occurred in all directions between 2000 and 2009. Some agricultural fields/scrubland have been lost within the Site as the quarry expanded over time. Based on the aerial photographs, extraction below the water-table in the northwest of the Site started at some point between 2000 and 2004. This ceased in 2008, resulting in a waterbody being created within the Site footprint to the northwest of the processing plant.

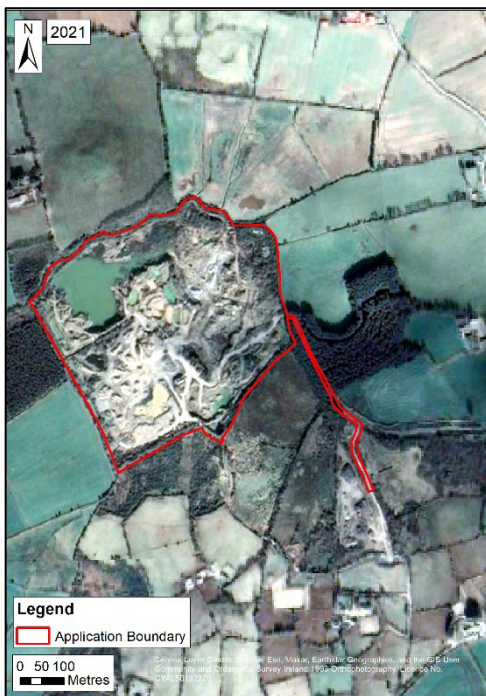
Figure 5.6: Aerial Photo of the Site in 2021

The quarry Site comprises land that is currently used for quarrying activities, which include: excavation areas; haul roads; stockpiles; processing plant; administration, maintenance, storage and welfare facilities; and the lake formed from historical below water-table mineral extraction. The current extent of the quarry (including extraction, plant and ancillary areas) extends to approximately 23.7 ha. The current extracted quarry area is 20.16 ha. Sand and gravel extraction is taking place in the central area of the Site. The typical lower basal elevation of quarrying in 2022 was 114 mAOD, except for in the northwest corner of the Site where below water table excavation has taken place and the basal elevation is c.111 mAOD.
