5.0 LAND, SOILS, GEOLOGY AND HYDROGEOLOGY

5.1 INTRODUCTION

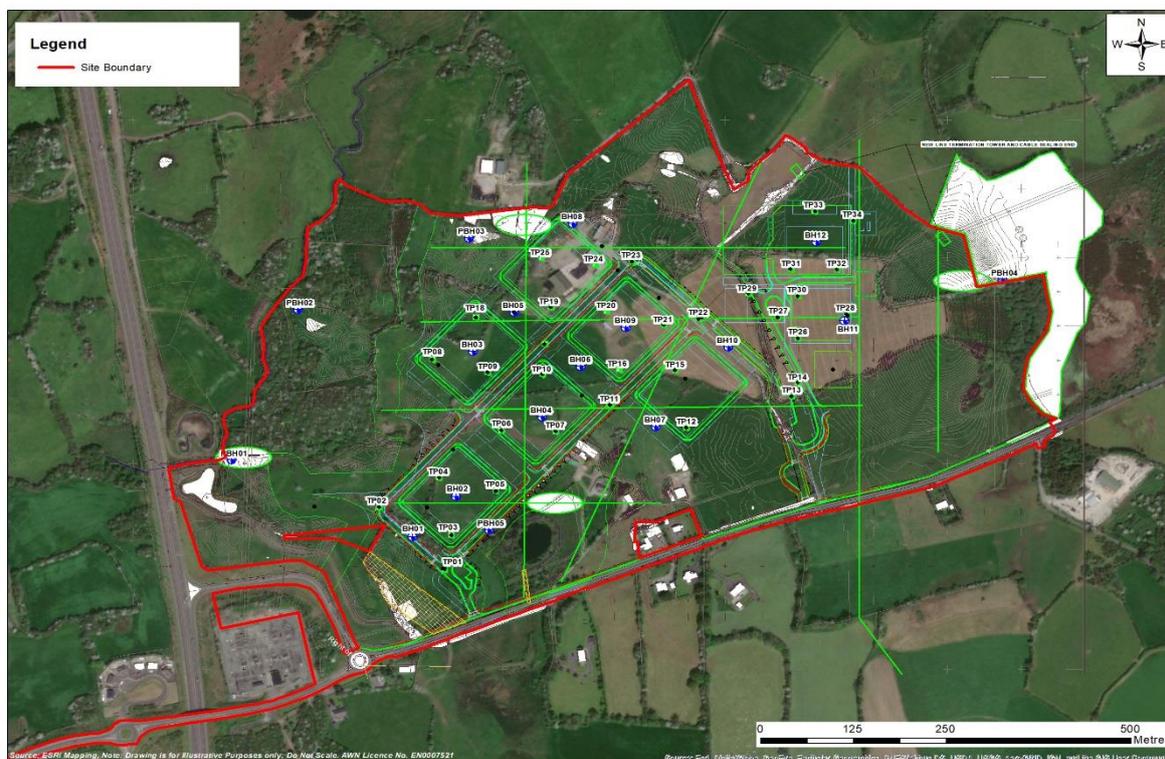
The location of all completed trial pits and boreholes at which representative samples were collected is presented in Figure 5-1 Site Investigation Exploratory Hole Map (GII, 2021) below.

Figure 5-1 Site Investigation Exploratory Hole Map (GII, 2021)

Trial pit and borehole logs are included in the GII site investigation report which include a description of the lithologies observed in each excavation, depth to bedrock, refusals, type of bedrock and rock quality distribution (RQD) to borehole termination depth.

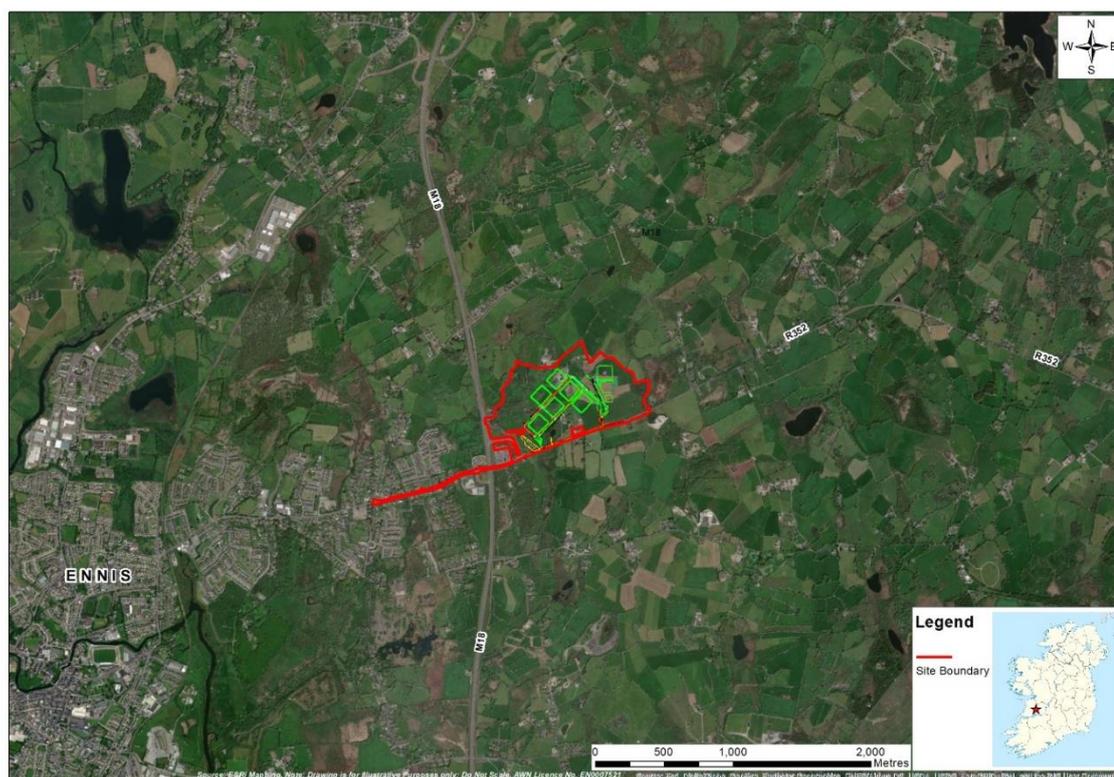
Figure 5-2 Site Location with site layout (AWN, 2021)

The site comprises approx. 58 hectares (ha) and is located to the east of Ennis in the townland of Tooreen and Cahernalough, Co Clare. The lands are bordered to the south by the R352 (Tulla Road) and to the west by the M18 national route. The lands are traversed by a [Gas Networks Ireland, GNI] transmission gas pipeline and overhead powerlines connecting to the existing Ennis 110kv Substation that adjoins the western boundary.

The site location map for the proposed development is presented in Figure 5.2 below.

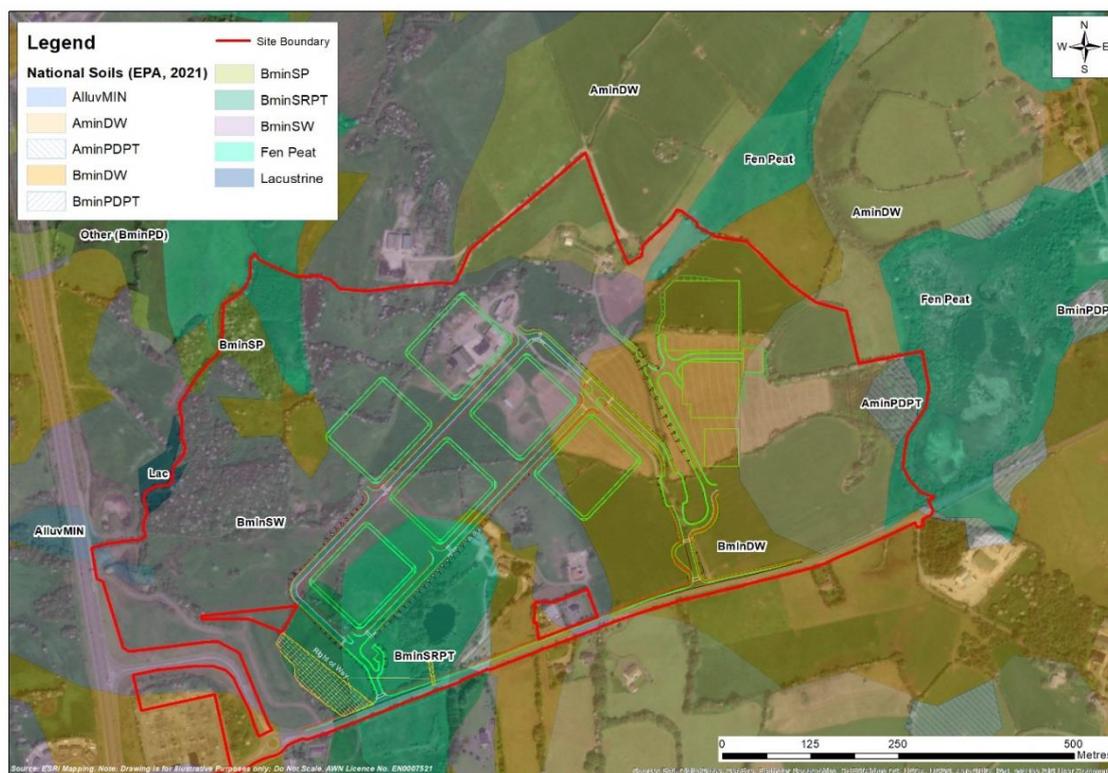
Figure 5-5 below presents the soils map indicating the soil lithologies discussed above.

Figure 5-5 Soils Map with the proposed site layout (Source: EPA/ Teagasc, 2021)

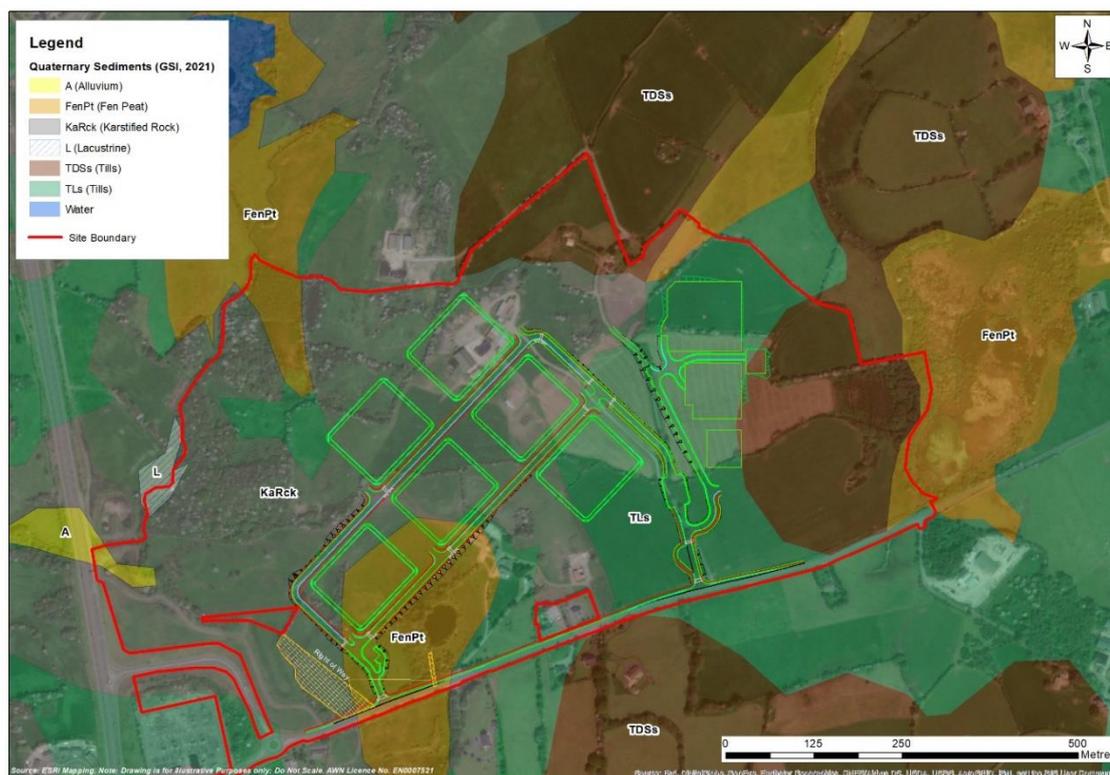
Figure 5-6 Subsoils Map with the proposed site layout (Source: GSI, 2021)

Recent investigations undertaken by GII confirm rockhead close to the surface within the west of the site and at local highs across the site. Generally, recorded depth to bedrock (dtb) increases towards the east. The depth of overburden varies to match this with sandy clayey GRAVELS reported to a depth of 2.00 metres below ground level (mbgl) noted along the western section; similar GRAVEL material is noted to 5.00 mbgl to the eastern section of the site (GII, 2021).

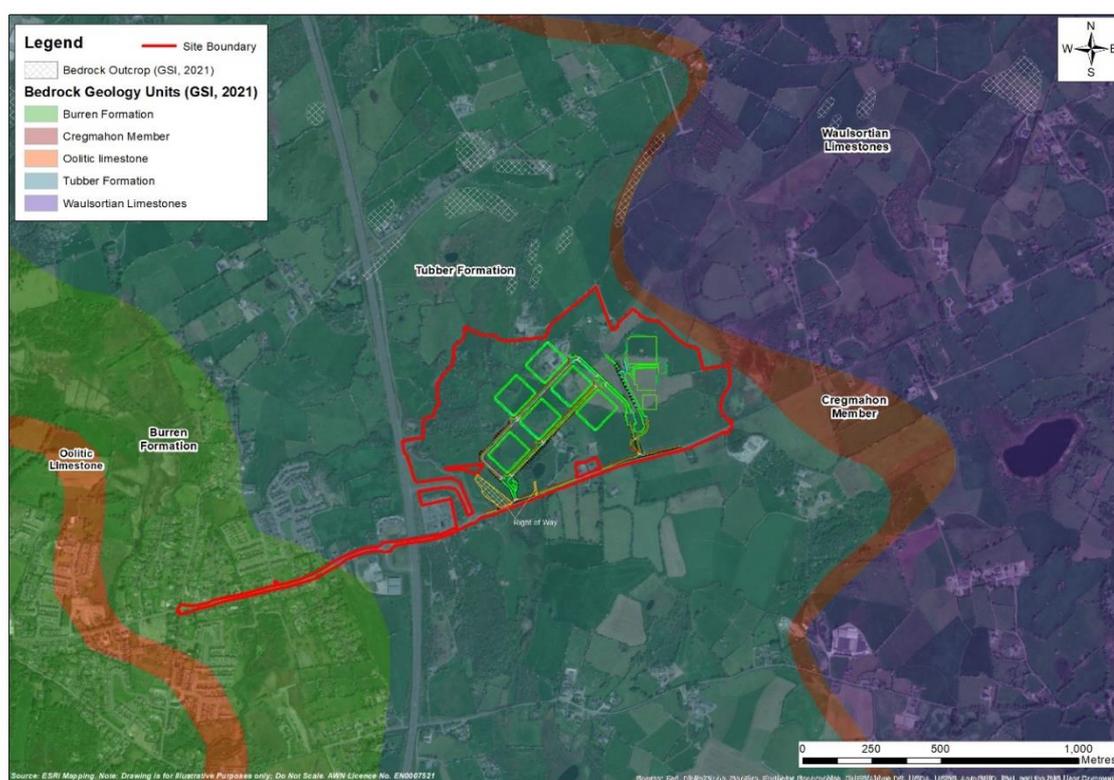
The GSI (2021) bedrock geology map (100K structural database) indicates no structural faults in the study area.

Figure 5-7 Bedrock Geology Map with the proposed site layout (Source: GSI, 2021)

Site investigations (GII, 2021) indicate bedrock depth is highly varied throughout the site with rockhead recorded at 0.60 mbgl at BH06 (western section of the site), 2.30 mbgl at BH08 (centre of the site) and 6.20 mbgl at PBH04 (eastern section of the site). The depth to bedrock is shallow across the site especially in the western and centre sections while bedrock is deeper along the eastern boundary owing to the thicker subsoils present. However, the bedrock surface is observed as undulating across the site and there are localised points with shallow bedrock for example within the eastern section of the site. Section 5.3.18 presents the CSM for the subject site. Bedrock was not encountered at any of the trial pits (with refusal also noted).

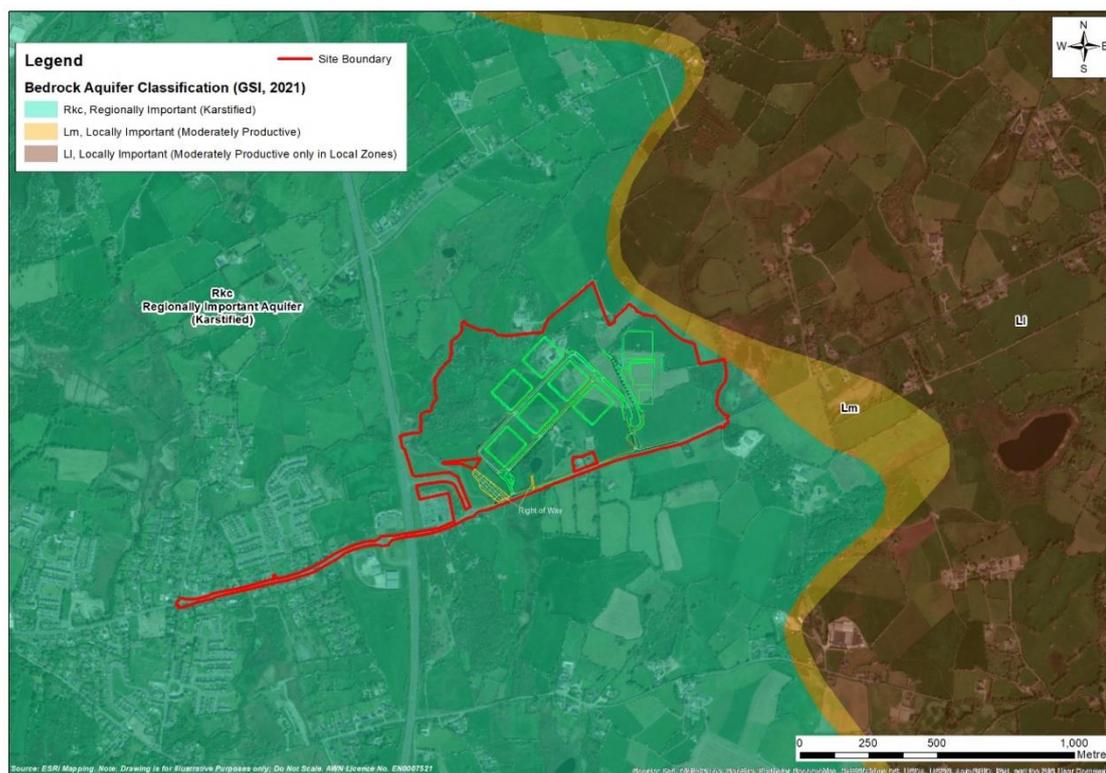
Figure 5-8 Aquifer Classification Map with the proposed site layout (Source: GSI, reviewed 2021)

The GSI has devised a system for classifying the bedrock aquifers in Ireland. The aquifer classification for bedrock depends on a number of parameters including, the area extent of the aquifer (km²), well yield (m³/d), specific capacity (m³/d/m) and groundwater transmissivity (mm³/d). There are three main classifications: regionally important, locally important and poor aquifers. Where an aquifer has been classified as regionally important, it is further subdivided according to the main groundwater flow regime within it. This sub-division includes regionally important fissured aquifers (Rf) and regionally important karstified aquifers (Rk). Locally important aquifers are subdivided into those that are generally moderately productive (Lm) and those that are generally moderately productive only in local zones (LI). Similarly, poor aquifers are classed as either generally unproductive except for local zones (PI) or generally unproductive (Pu).

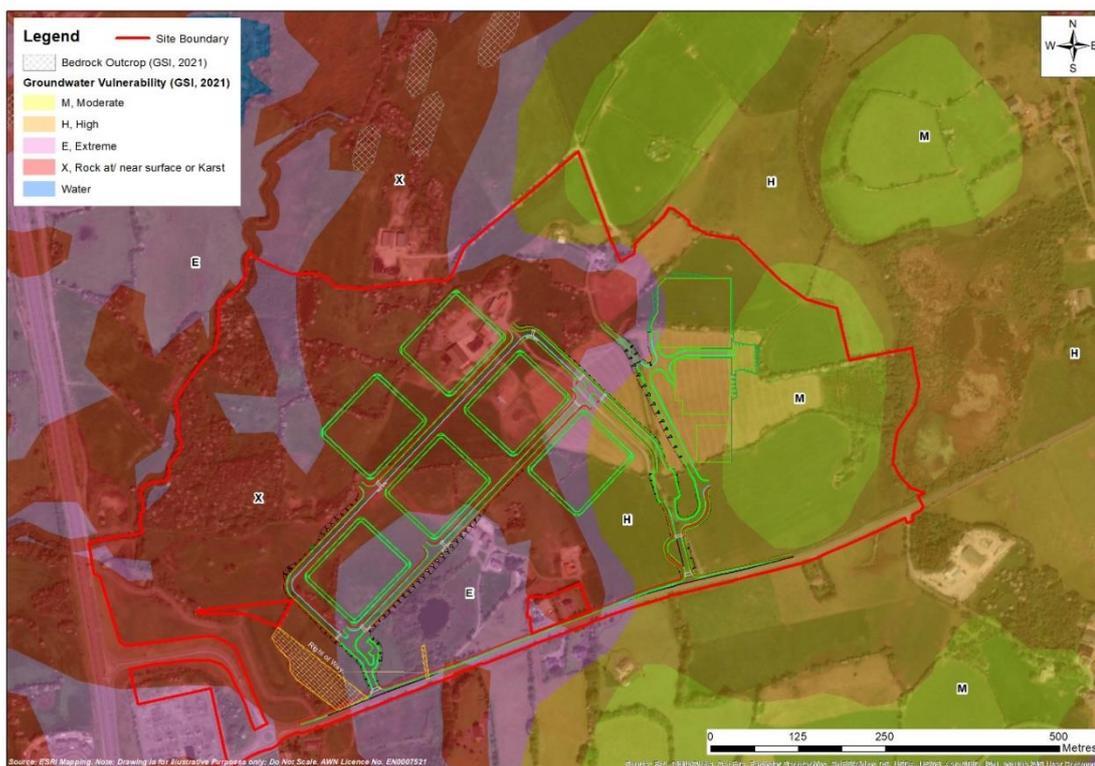
The aquifer vulnerability class in the region of the site is presented below as Figure 5-9.

Figure 5-9 Aquifer Vulnerability Map with the proposed site layout (Source: GSI, 2021)

Aquifer vulnerability is a term used to represent the intrinsic geological and hydrogeological characteristics that determine the ease with which groundwater may be contaminated generally by human activities. Due to the nature of the flow of groundwater through bedrock in Ireland, which is almost completely through fissures, the main feature that protects groundwater from contamination, and therefore the most important feature in protection of groundwater, is the subsoil (which can consist solely or of mixtures of peat, sand, gravel, glacial till, clays or silts).

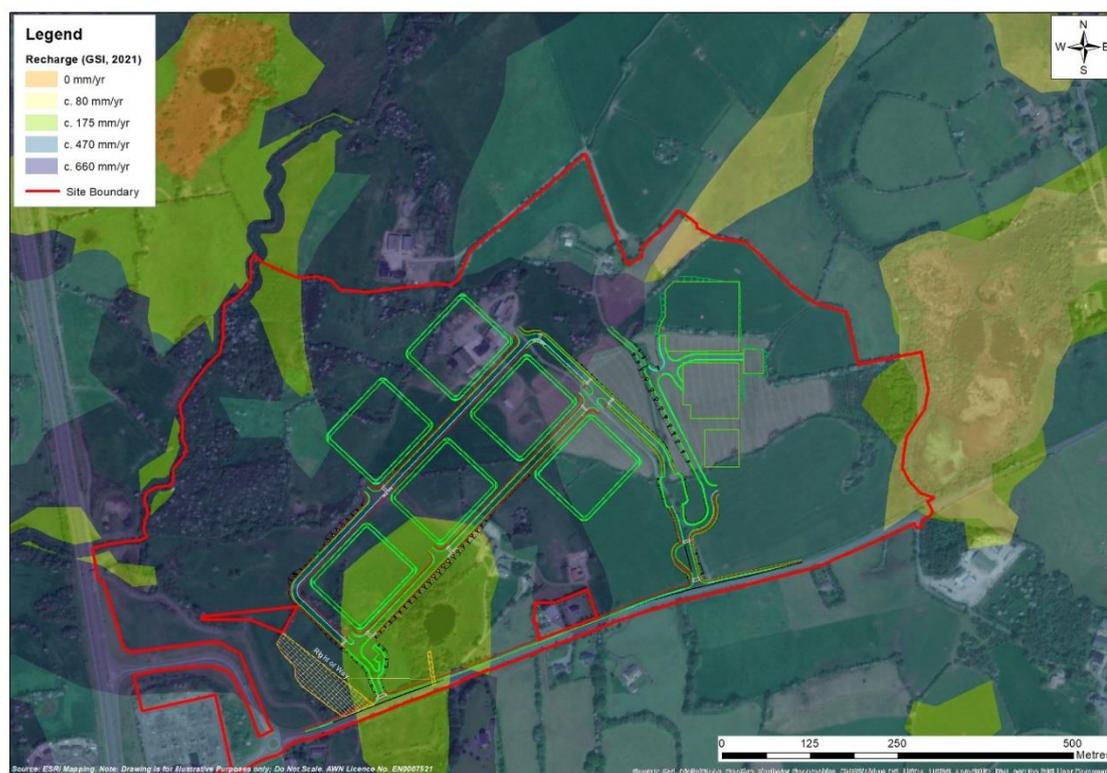
Furthermore, when reviewing recharge map on the GSI web viewer, this confirms that the eastern section of the site is karst environment as there is high volumes of recharge potential located here, refer to Figure 5-10 below. Recharge volumes for the proposed development site and surrounding are range from 175 mm/year to 660 mm/yr.

Figure 5-10 Recharge map with proposed site layout (Source: GSI, 2021)

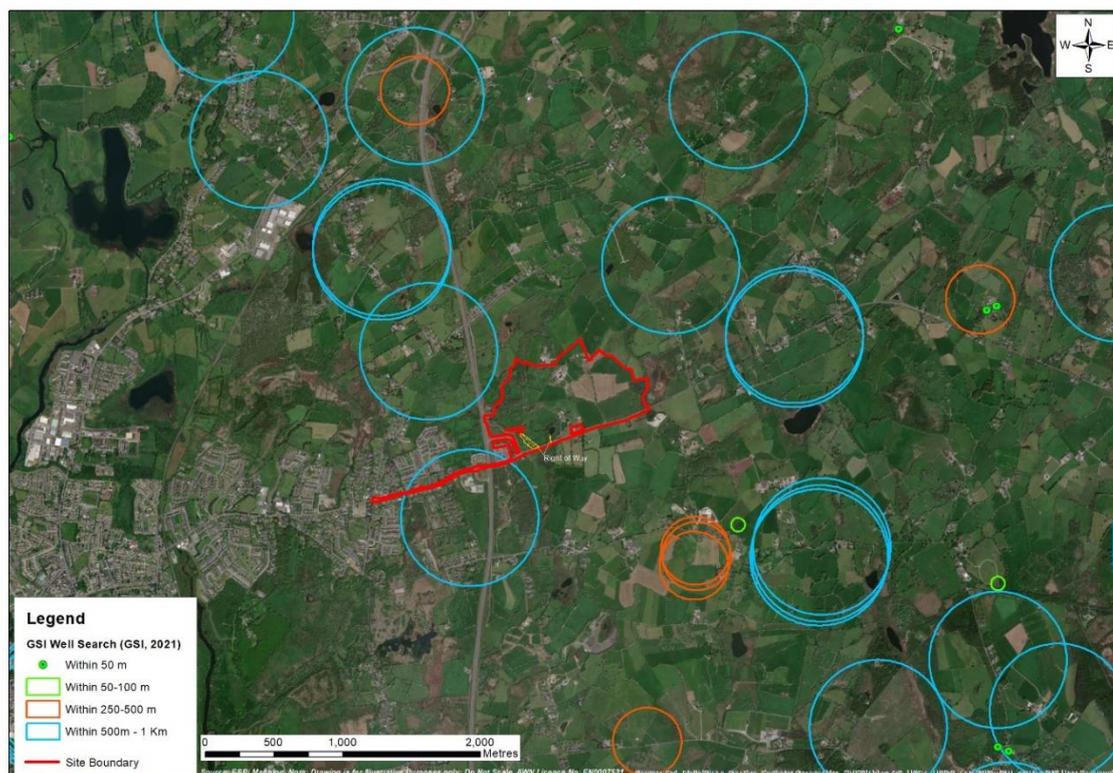
Figure 5-11 GSI Well Search Map (Source: GSI, 2021)**Table 5.2** GSI Well Card Index (Source: GSI, 2021)

The GSI Well Card Index is a record of wells drilled in Ireland, water supply and site investigation boreholes. It is noted that this record is not comprehensive as licensing of wells is not currently a requirement in the Republic of Ireland. This current index does not show any wells drilled or springs at the site or surrounding area with the nearest recorded wells located 0.5 km to the east of the site (associated with the Baleskin Reception Centre). None of the wells listed are categorised as domestic use. The site is not located near any public groundwater supplies or group schemes. There are no groundwater source protection zones in the immediate vicinity of the site.

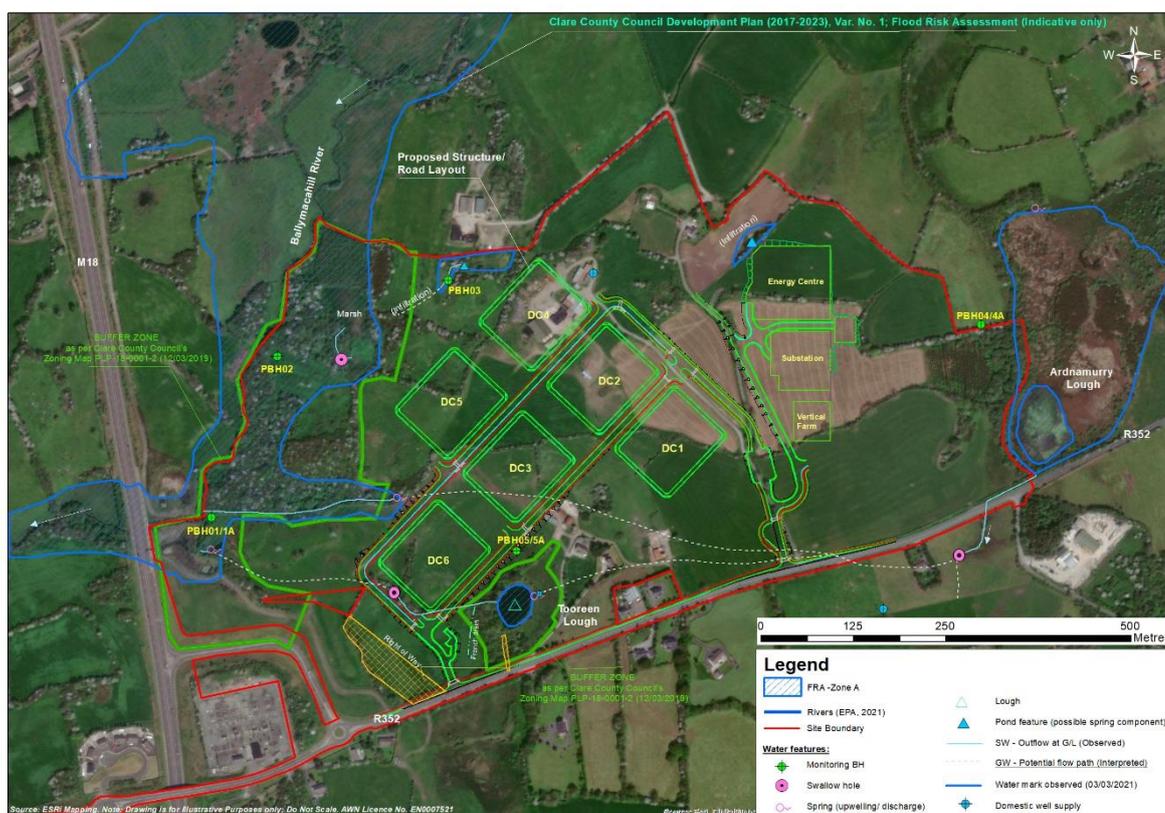
Figure 5-13 Internal and local karst features across the site with the proposed Site Layout.

4. There is one (1) no. sinkhole located west from Toureen Lough. There is a small overland stream from Toureen Lough to this sinkhole. It is believed that this sinkhole discharges through a spring located along the Ballymacahill (also referred to Spancelhill) River.

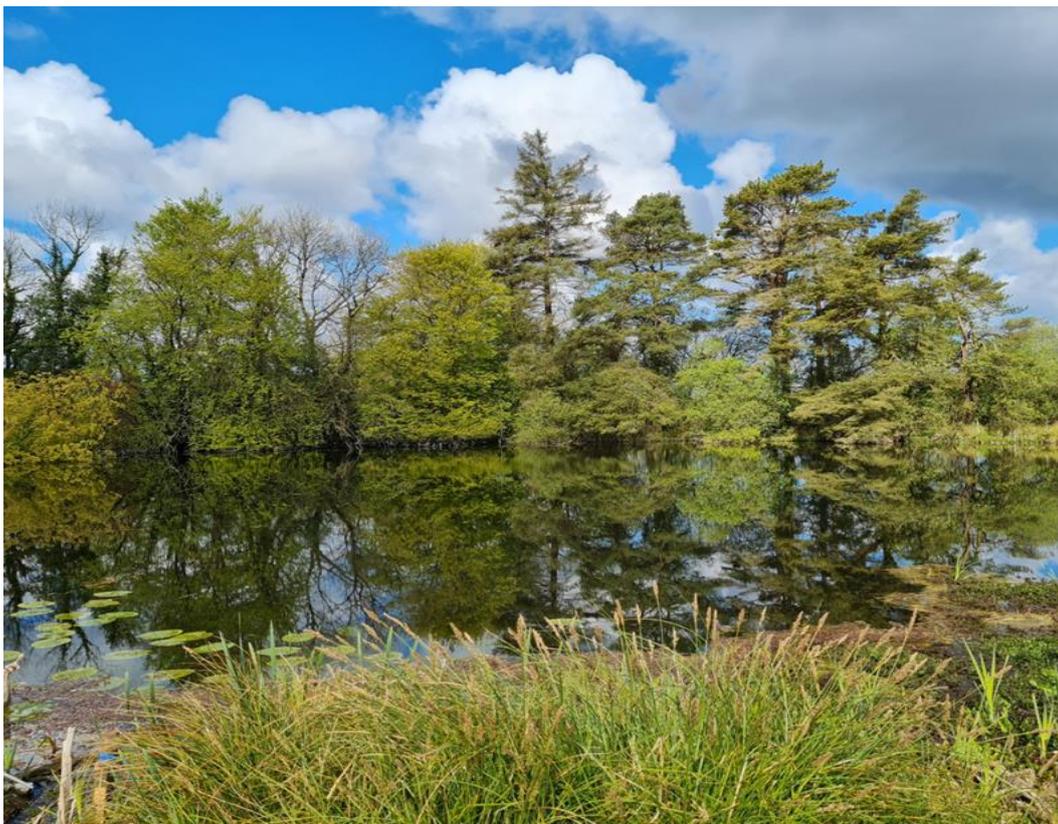
Insert 5.1 *Toureen Lough – view is N-W*

There are four water features of significance either within the site boundary or along the site boundary where flooding historically occurs (see Figure 5-13, below). These are; Tooreen Lough to the south (within the proposed development area), Ardnamurry Lough farther to the east (outside of the site boundary line), and two pond features located to the north and north-east -both within the proposed development. These features discharge to ground at nearby sink holes also identified on Figure 5-13, below. All four areas are likely to be a combination of groundwater contribution and ponding rainfall. The latter two (i.e. ponds to the north/ northeast) are seen to continue to discharge during dry spells as observed on site (April/ May 2021). All four features are located in [locally] low lying depressions within the landscape.

All of these water features have been observed to expand in terms of lateral extent seasonally with autumn/ winter flooding and this footprint is generally followed by recession during drier conditions in summertime. This filling and emptying/ lowering of water levels is likely based on exceedance of storage capacity of the karst conduit system in wetter months in addition to pluvial components.

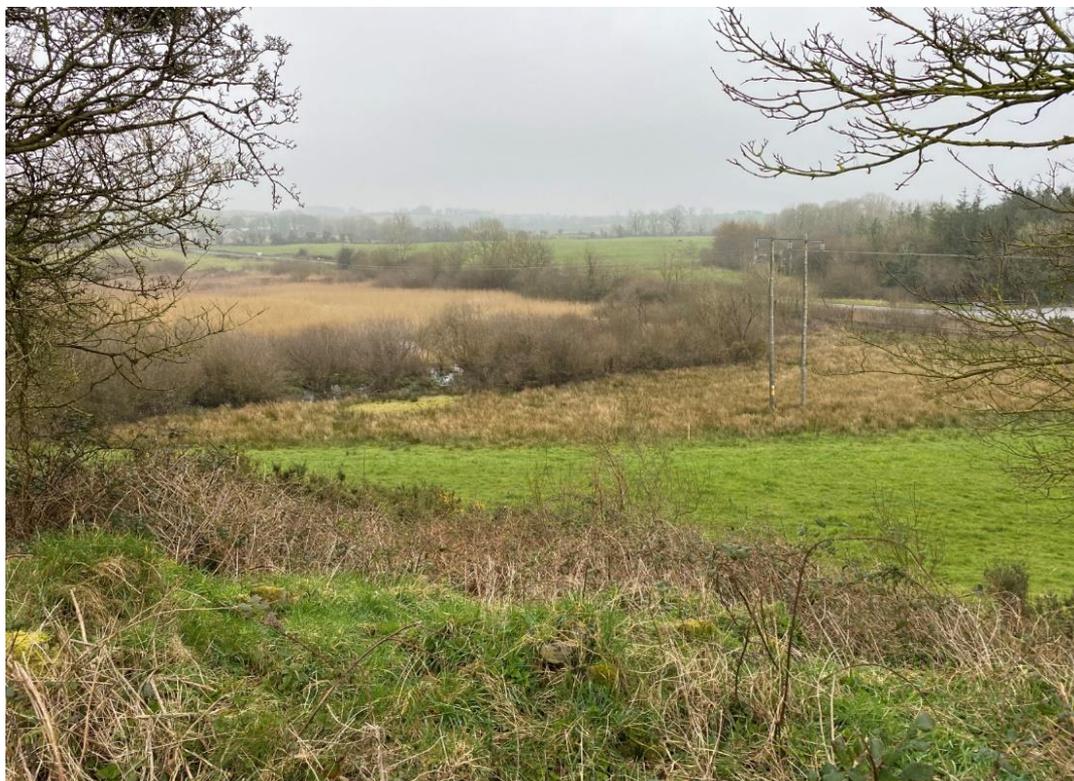
Insert 5.2 *Ardnamurry Lough -View is to E (discharge is to south crossing beneath the R352 road to Right Hand Side)*

The swallow hole located farther east and south of the R352 road (this water is sourced from the wetlands at Ardnamurry Lough) is interpreted as possibly discharging in two directions at the point the water reaches the end of the [CCTV recorded] culvert, namely (a) to the immediate south and away from the R352 road, and (b) to the west crossing the R352 at a point where 'possible karstified Limestone' is reported by APEX (2021) as Feature 8.1 through which the transmission gas main also runs. This feature is interpreted as 5-6m in depth and discussion with the landowner indicated significant groundwater in the area during the excavation for the gas main installation. Where (b) represents a potential [groundwater] flow path then this water is interpreted to flow westwards beneath the proposed development and ultimately discharging to either Tooreen Lough spring or the main spring located to the northwest of Tooreen Lough, or both. Discharge to the spring at Tooreen Lough will follow the drainage network described above. Where the discharge [or part thereof] is to the main spring to the northwest of the lough, then this water will feed into the stream flow that ultimately discharges to the Ballymacahill River (refer also Figure 6-2 above). The geophysical survey (APEX, 2021) did not identify these conduits but identified a significant karstic and dolomitised zone which coincides with the swallow holes on the west of the proposed development site. The ecological assessment (Chapter 7) has not identified any specific groundwater dependent species present.

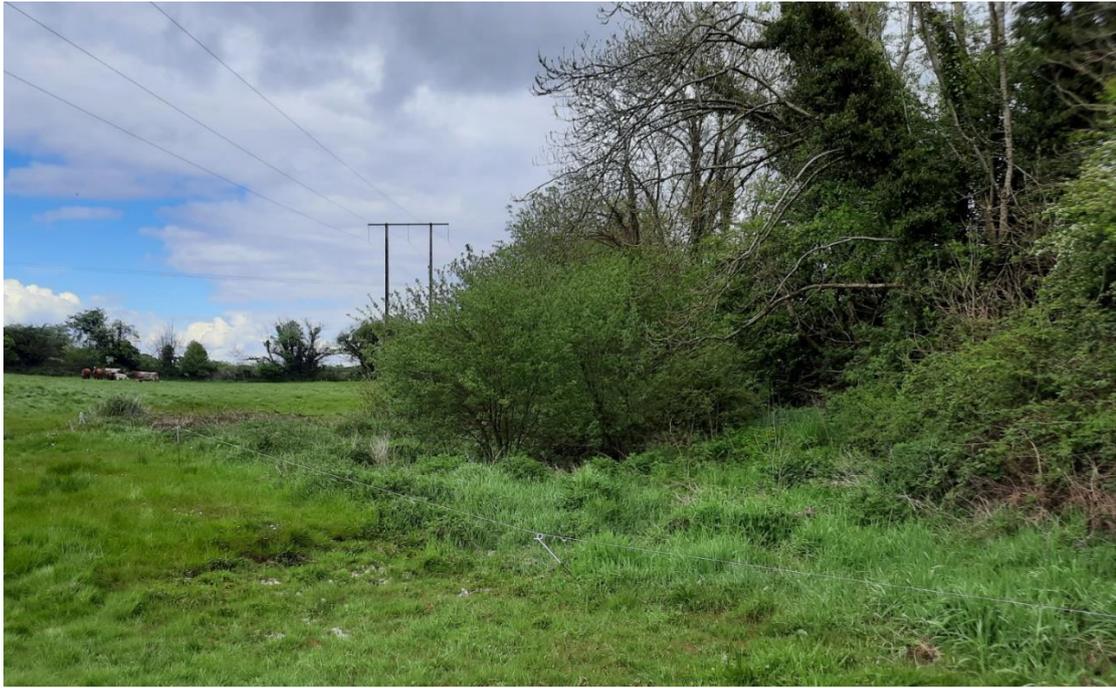
Insert 5.3 Pond to north-east (view is W-E) with existing wall to the Right Hand Side

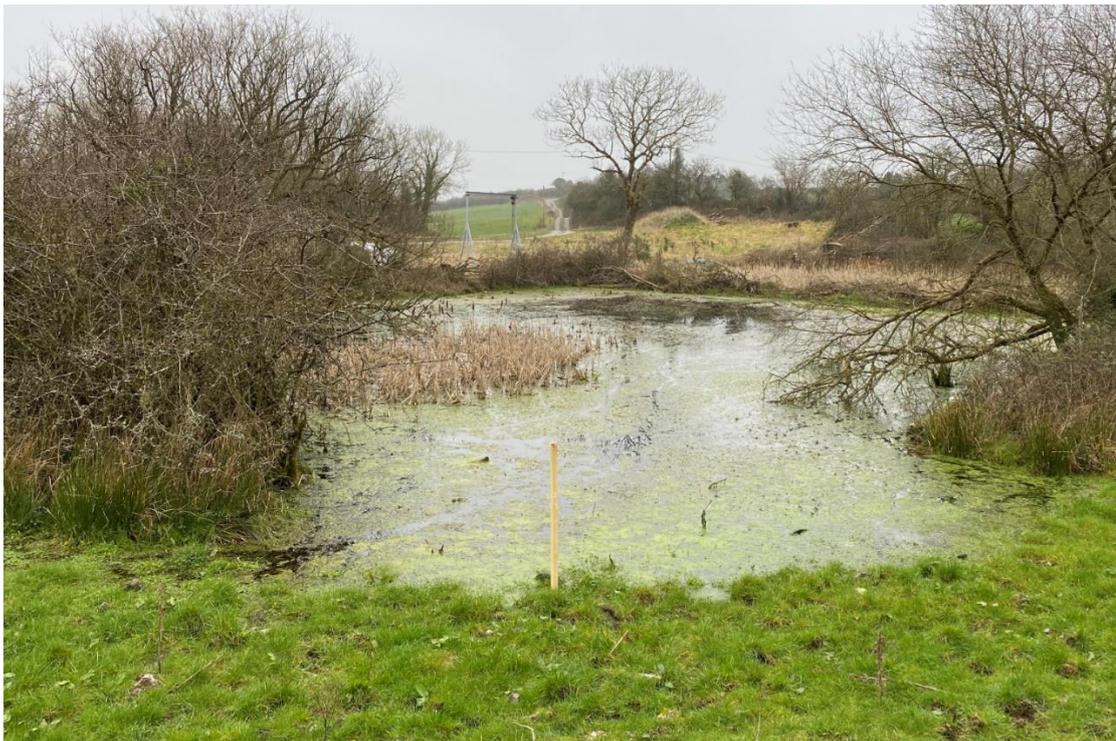
Insert 5.4 Ponds to the north -saturated (03/03/2021) -view is to North.

Local drainage within the development boundary is less defined. Surface water features within the site boundary comprise a series of ponds to the north with variable seepage to ground, and Toureen Lough to the south near the R352. As mentioned in Section 5.3.17, there are a number of karst features within and adjacent to the proposed development site. Spring discharges have been identified mainly to the west of the site and include a spring to the immediate east of Toureen Lough discharging to this feature, and a spring to the NW of the lough which may potentially receive groundwater from a swallow hole located farther east and south of the R352 road (this water is discharged from the Ardnamurry Lough wetlands located adjacent to the eastern site boundary line -refer to Figure 5-13 above). It is likely, under increased local water levels [head] at the lake, that Toureen Lough ultimately discharges into the Ballymacahill River under gradient flow observed in the field as both at surface and possibly through gravelly subsoils located between the lough and the river. Local drainage would also typically follow the topographical decline in gradient recorded from east to west/ southwest (refer also to Figure 5-13 above).

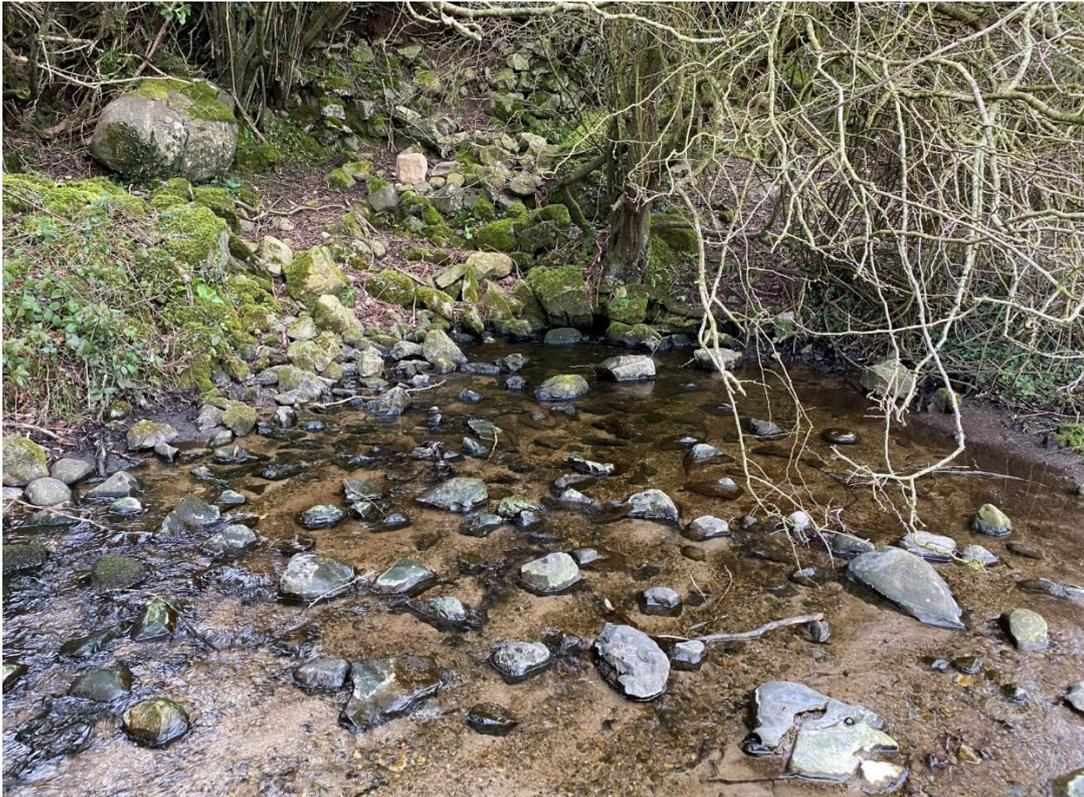
Insert 5.5 Spring discharge (main) which flows directly to Ballymacahill River.

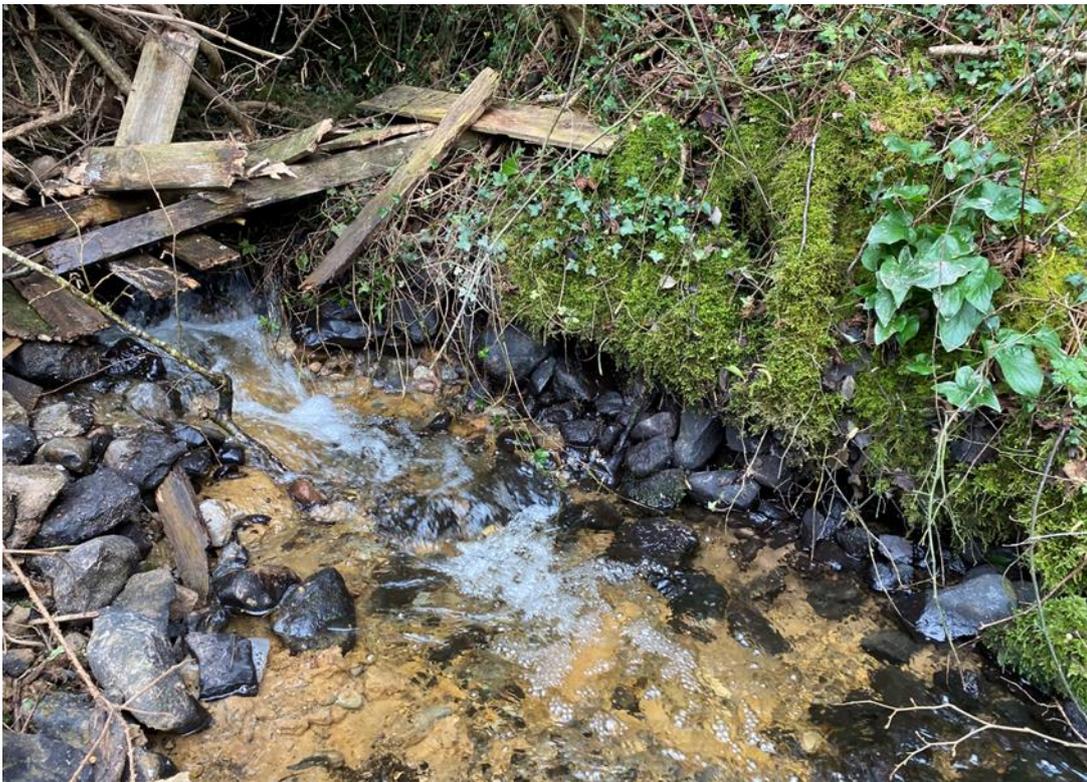
Insert 5.6 Spring discharge (main, second view) and flows directly to Ballymacahill River.

3. There are two (2) no. springs located across the proposed development site – one is located to the north-western section of the site and the second is located in the western section of the site (southwest of the proposed DC 6 building). Refer to Figure 5-13 below. These springs are dependent on water levels across the site and seasonal changes.

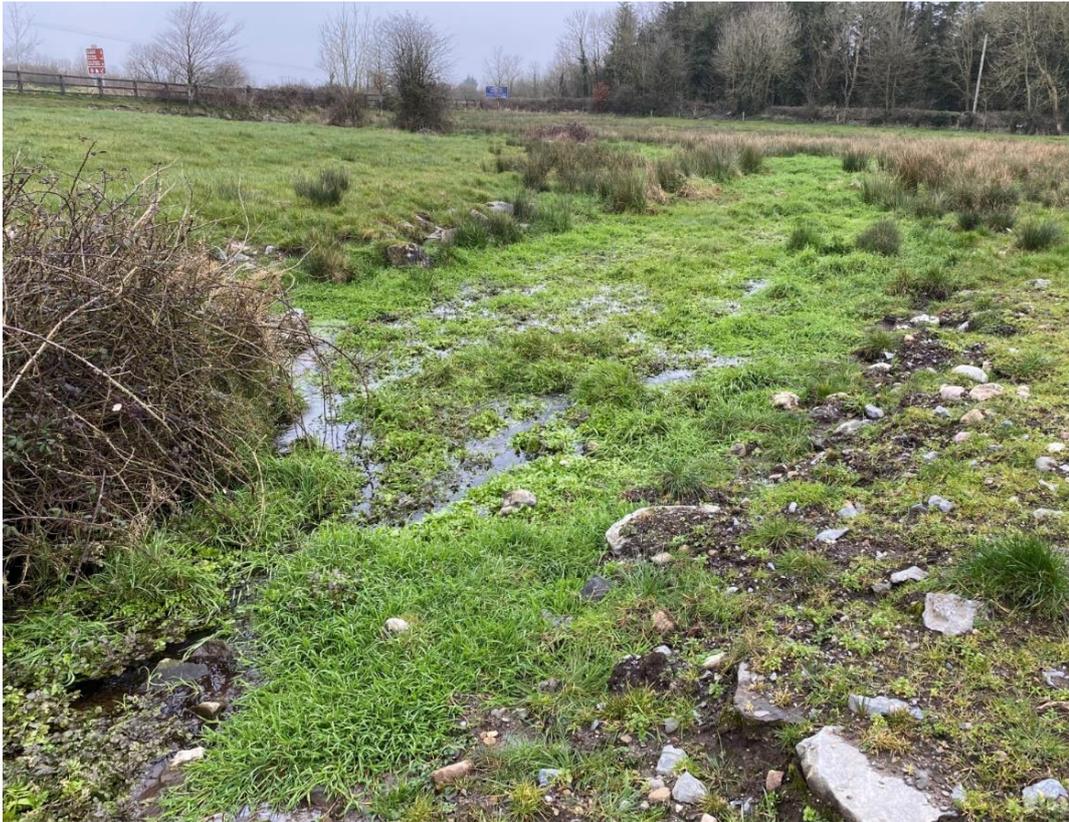
Insert 5.7 Swallow hole located to south of R352 (i.e discharge from Ardnamurry Lough)

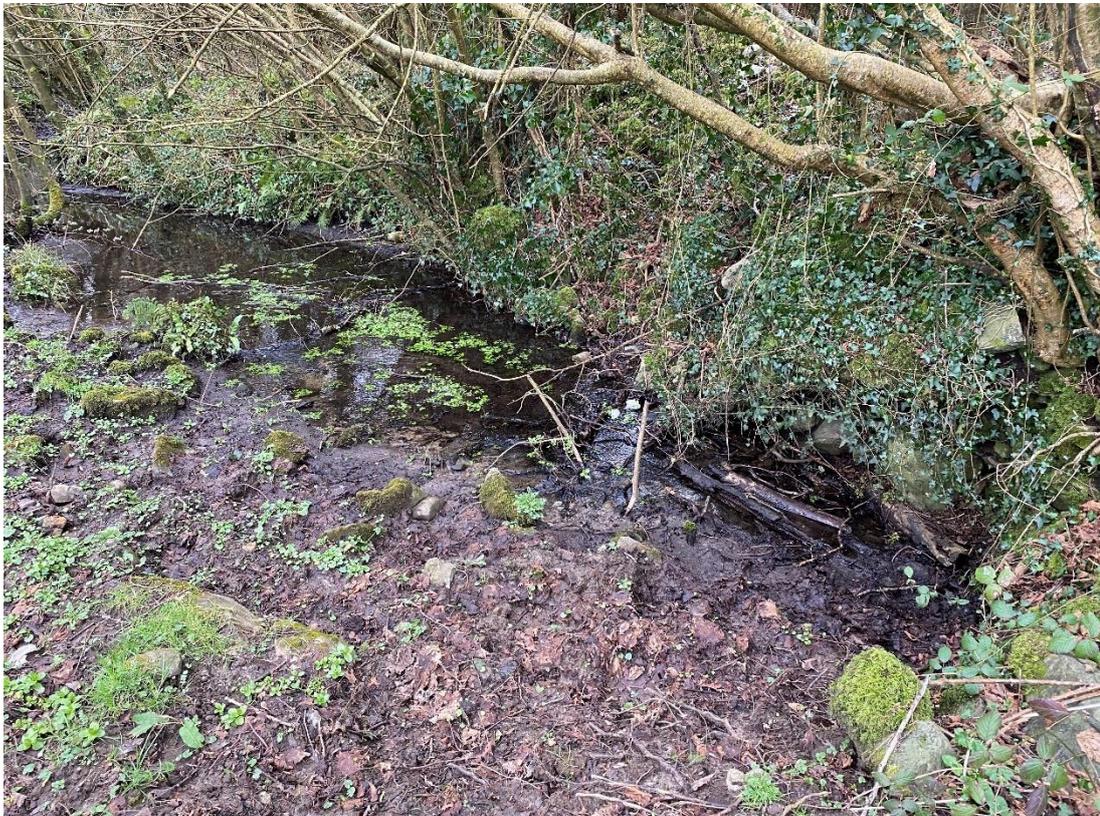
Insert 5.8 Swallow hole located to south of proposed DC6 building and connected to Toureen Lough stream flow.

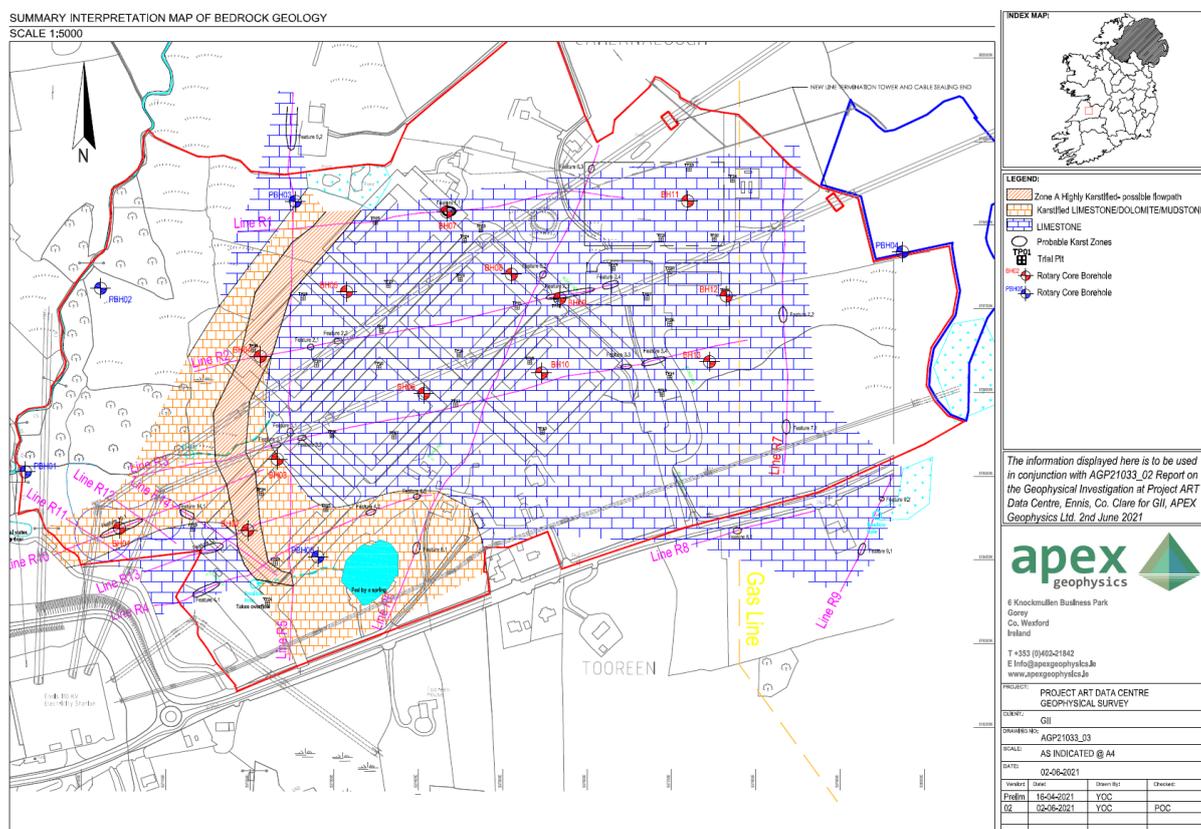
Figure 5-15 Geophysical survey – interpretation map of the bedrock geology (Apex, 2021).

APEX Geophysics Limited (AGL) carried out a geophysical survey in May-June 2021 as part of the ground investigation for the proposed development. The underlying objectives of the geophysical survey were to identify any potential underground karst conduits/ water-bearing strata within the overall study area including features which could potentially be discharging to Tooreen Lough and/ or to pond features located to the north, south and east of the site. In addition, the aims of the survey were to provide information on the subsurface conditions across the site. A summary of the geophysical interpretation is presented in Figure 5.15 below.

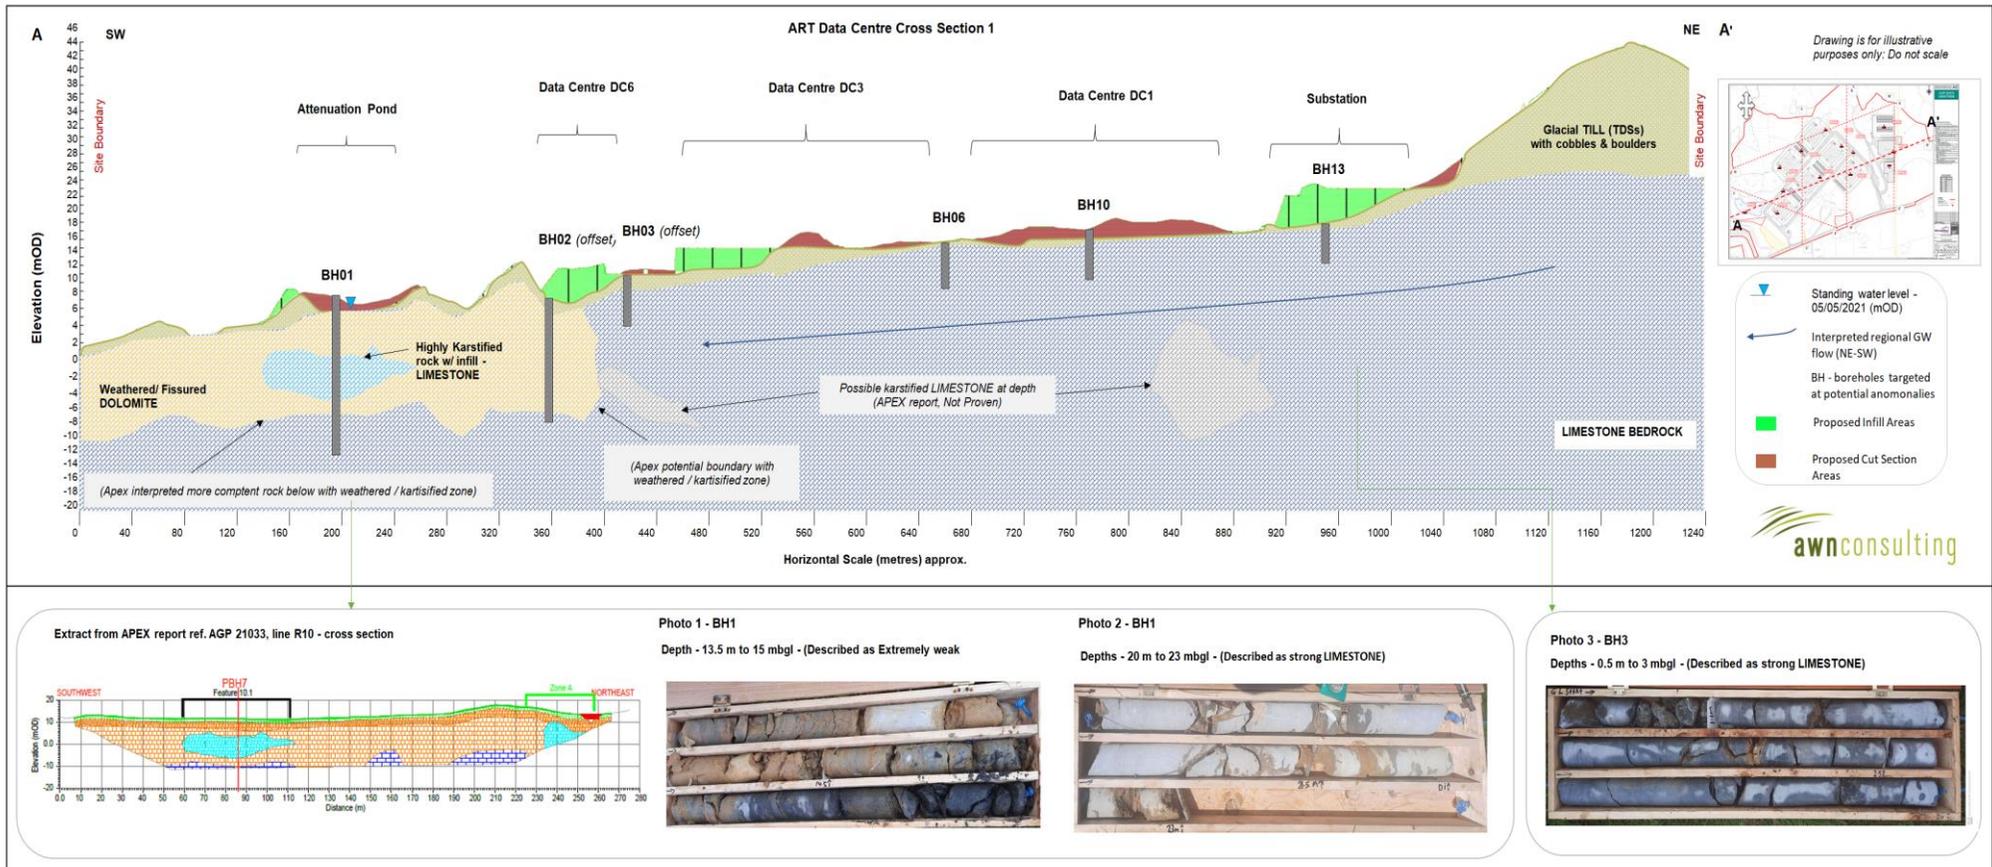
Figure 5-16 Local Cross Section A-A' with view from SW to NE.

- The underlying geology of this section is made up of weathered / fissured DOLOMITE underlain by competent LIMESTONE at greater depth (generally greater than 7 metres below ground level). Refer to Figure 5-16, below. This is based on the available data, geophysical data and site investigations carried out across the site.
- This DOLOMITE bedrock is highly weathered and fissured with some silt and clay infilled voids.
- Within this unit, there are areas where there is highly karstified LIMESTONE rock. These features are usually located approx. 7 to 10 metres below ground level (m bgl).
- Competent LIMESTONE rock unit is underlying this dolomitised rock which is presented in Figure 5-16, Figure 5-17 and Figure 5-18.

Six (6) no. local geological cross sections can be seen in Figure 5-16 to Figure 5-21 below based on the available data such as geophysical survey report, site investigations borehole logs and supplementary site walkovers. The relevant borehole logs were used to construct the Conceptual Site Model (CSM) for the proposed development. These are presented in the cross-sections below in Figure 5-16 to Figure 5-21.
