5.0 LAND, SOILS, GEOLOGY AND HYDROGEOLOGY

5.1 INTRODUCTION

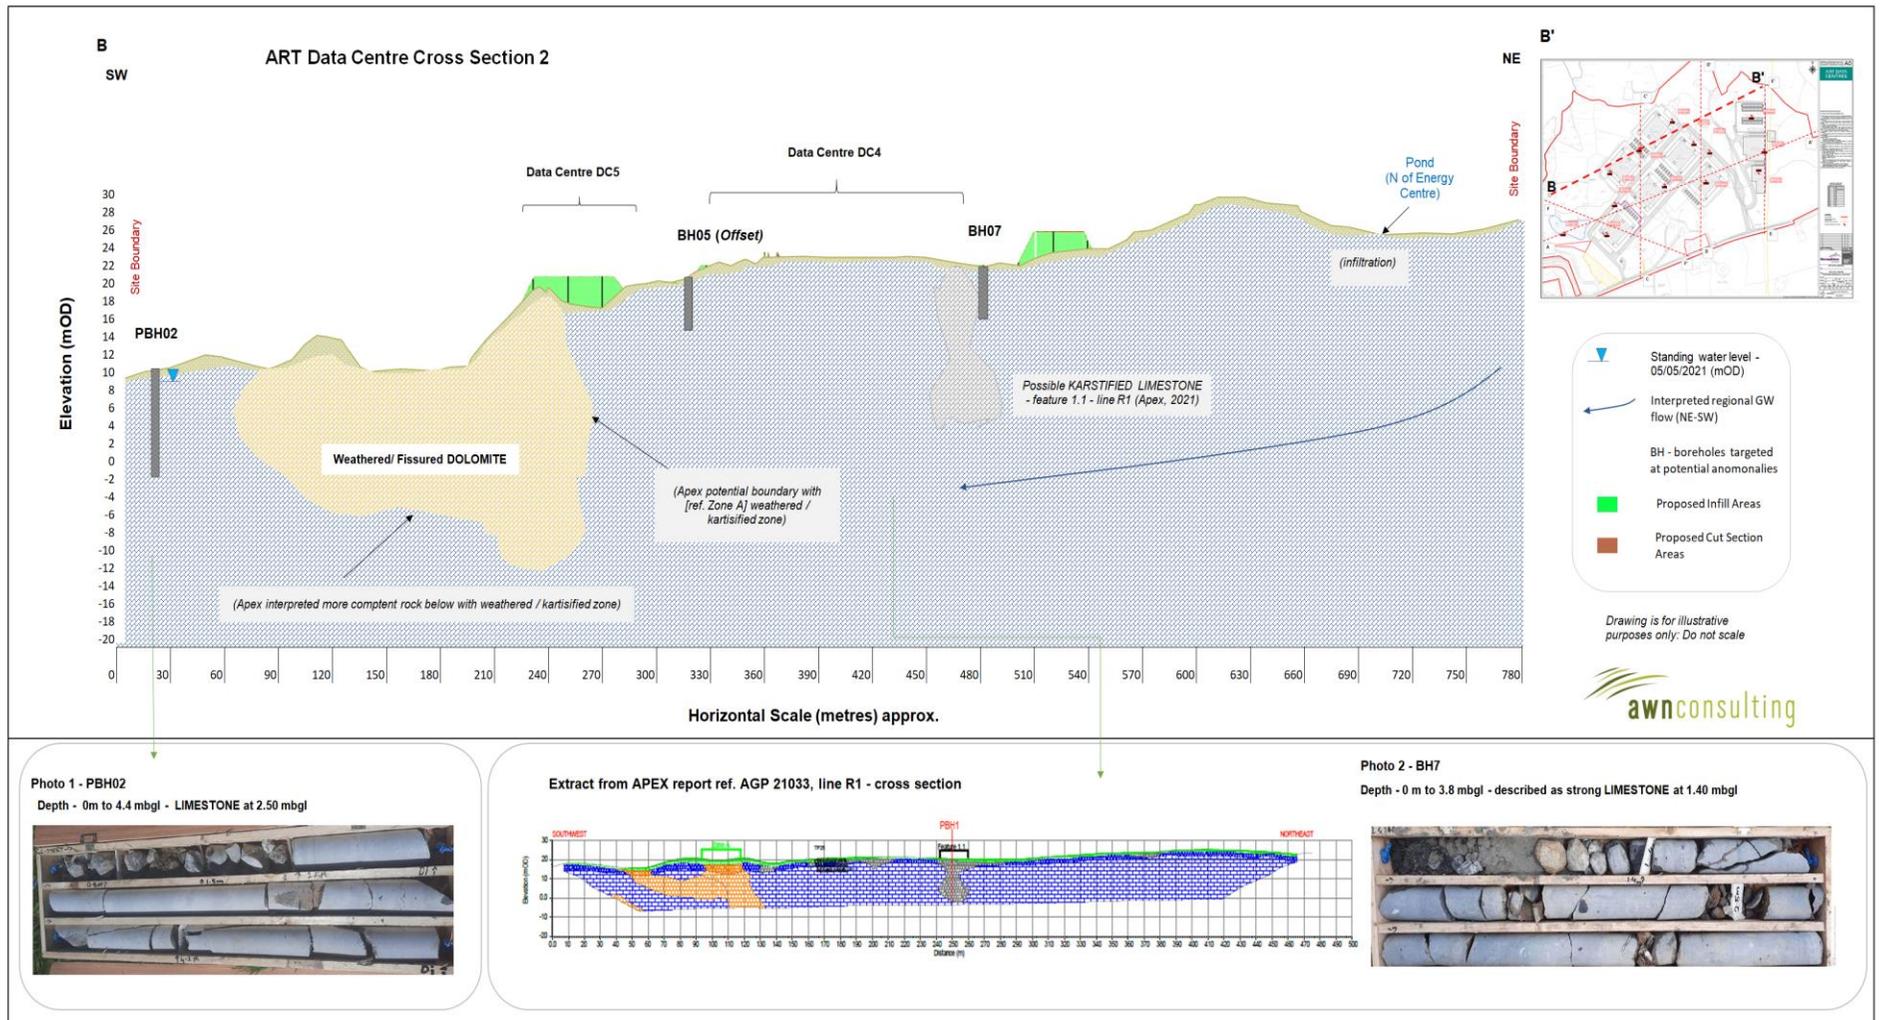
Figure 5-17 Local Cross Section B-B' with view from SW to NE.

- The underlying geology of this section is made up of weathered / fissured DOLOMITE underlain by competent LIMESTONE at greater depth (generally greater than 7 metres below ground level). Refer to Figure 5-16, below. This is based on the available data, geophysical data and site investigations carried out across the site.
- This DOLOMITE bedrock is highly weathered and fissured with some silt and clay infilled voids.
- Within this unit, there are areas where there is highly karstified LIMESTONE rock. These features are usually located approx. 7 to 10 metres below ground level (m bgl).
- Competent LIMESTONE rock unit is underlying this dolomitised rock which is presented in Figure 5-16, Figure 5-17 and Figure 5-18.

Six (6) no. local geological cross sections can be seen in Figure 5-16 to Figure 5-21 below based on the available data such as geophysical survey report, site investigations borehole logs and supplementary site walkovers. The relevant borehole logs were used to construct the Conceptual Site Model (CSM) for the proposed development. These are presented in the cross-sections below in Figure 5-16 to Figure 5-21.

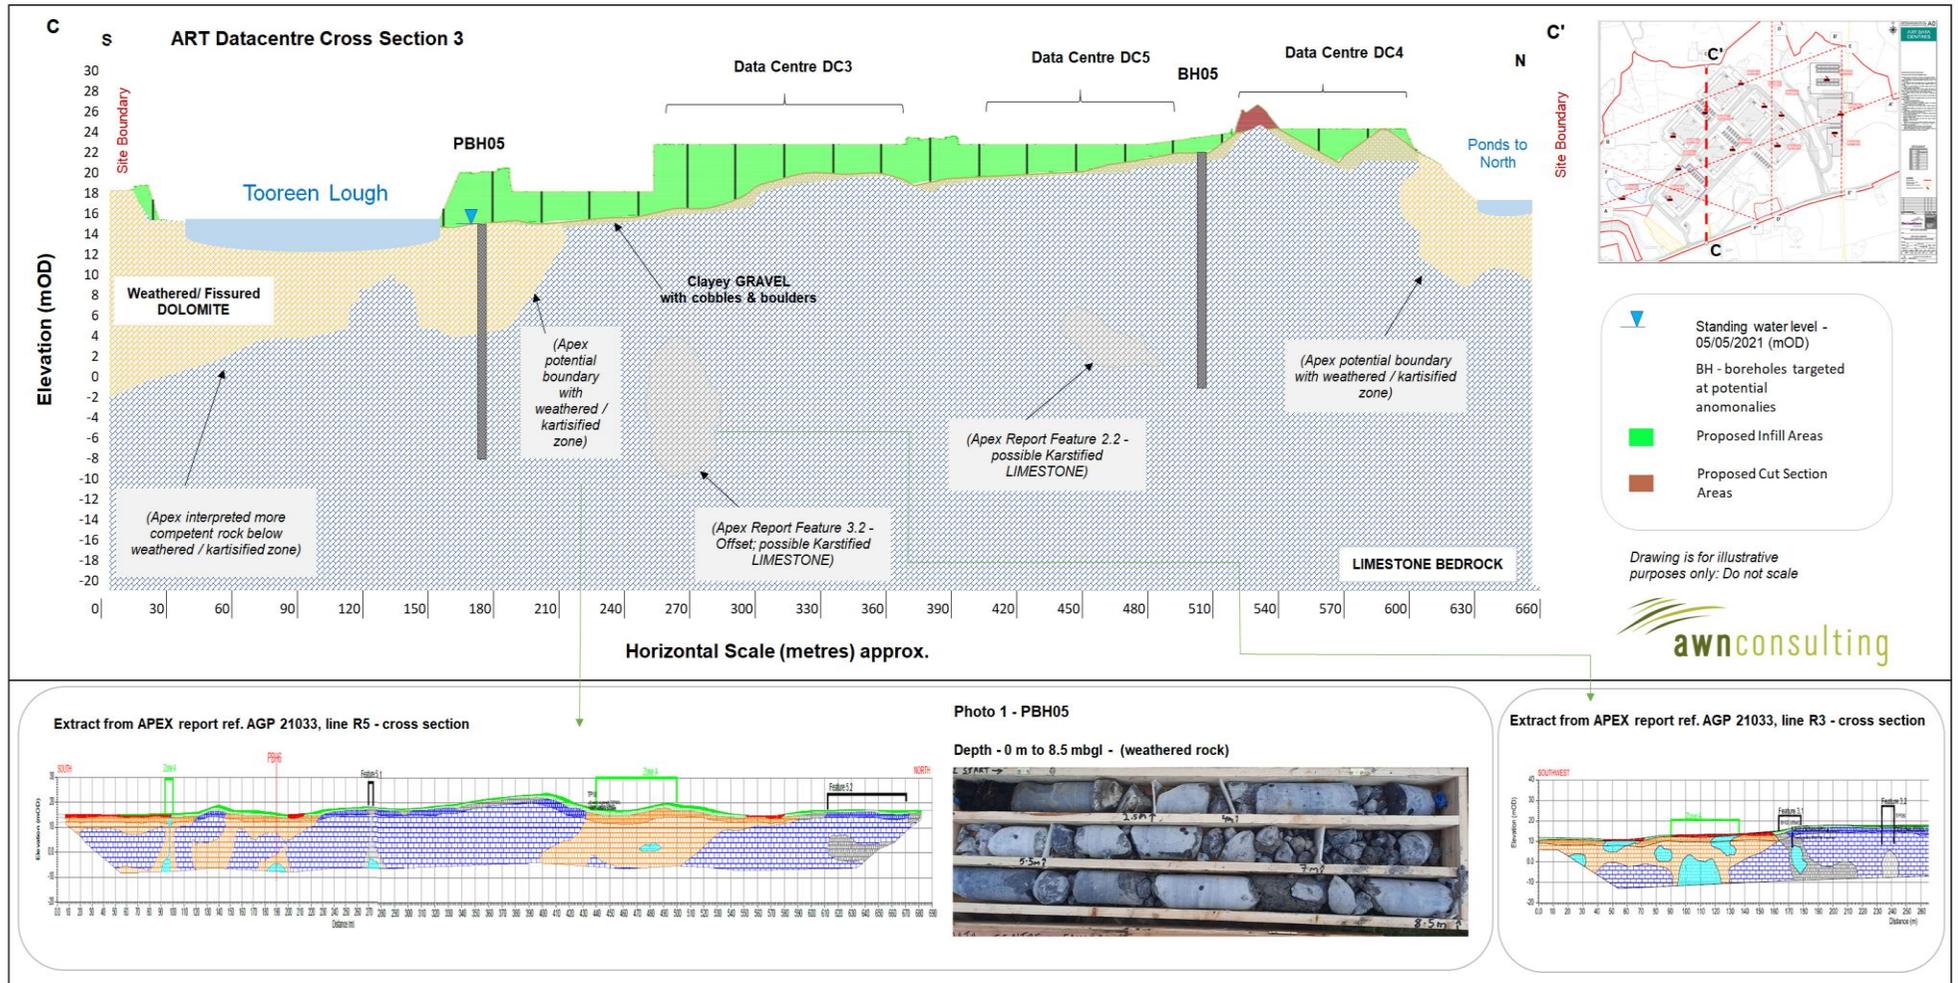
Figure 5-18 Local Cross Section C-C' with view from S to N.

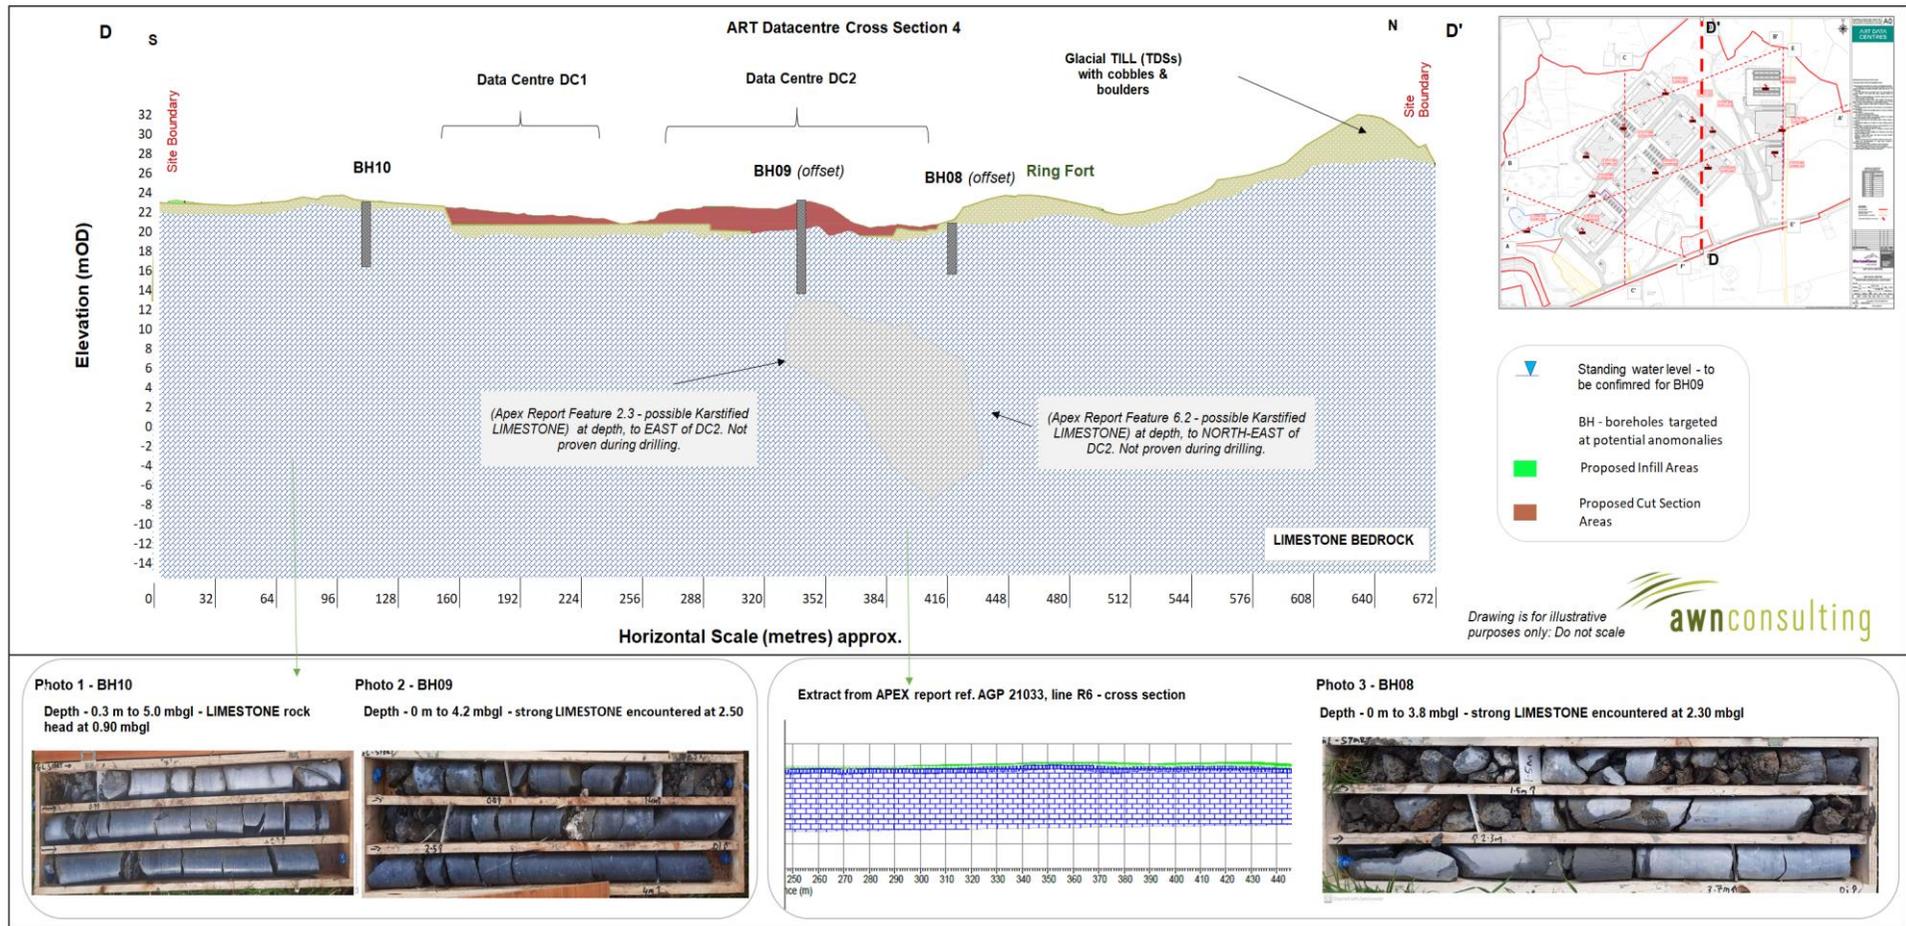
Figure 5-19 Local Cross Section D-D' with view from S to N.

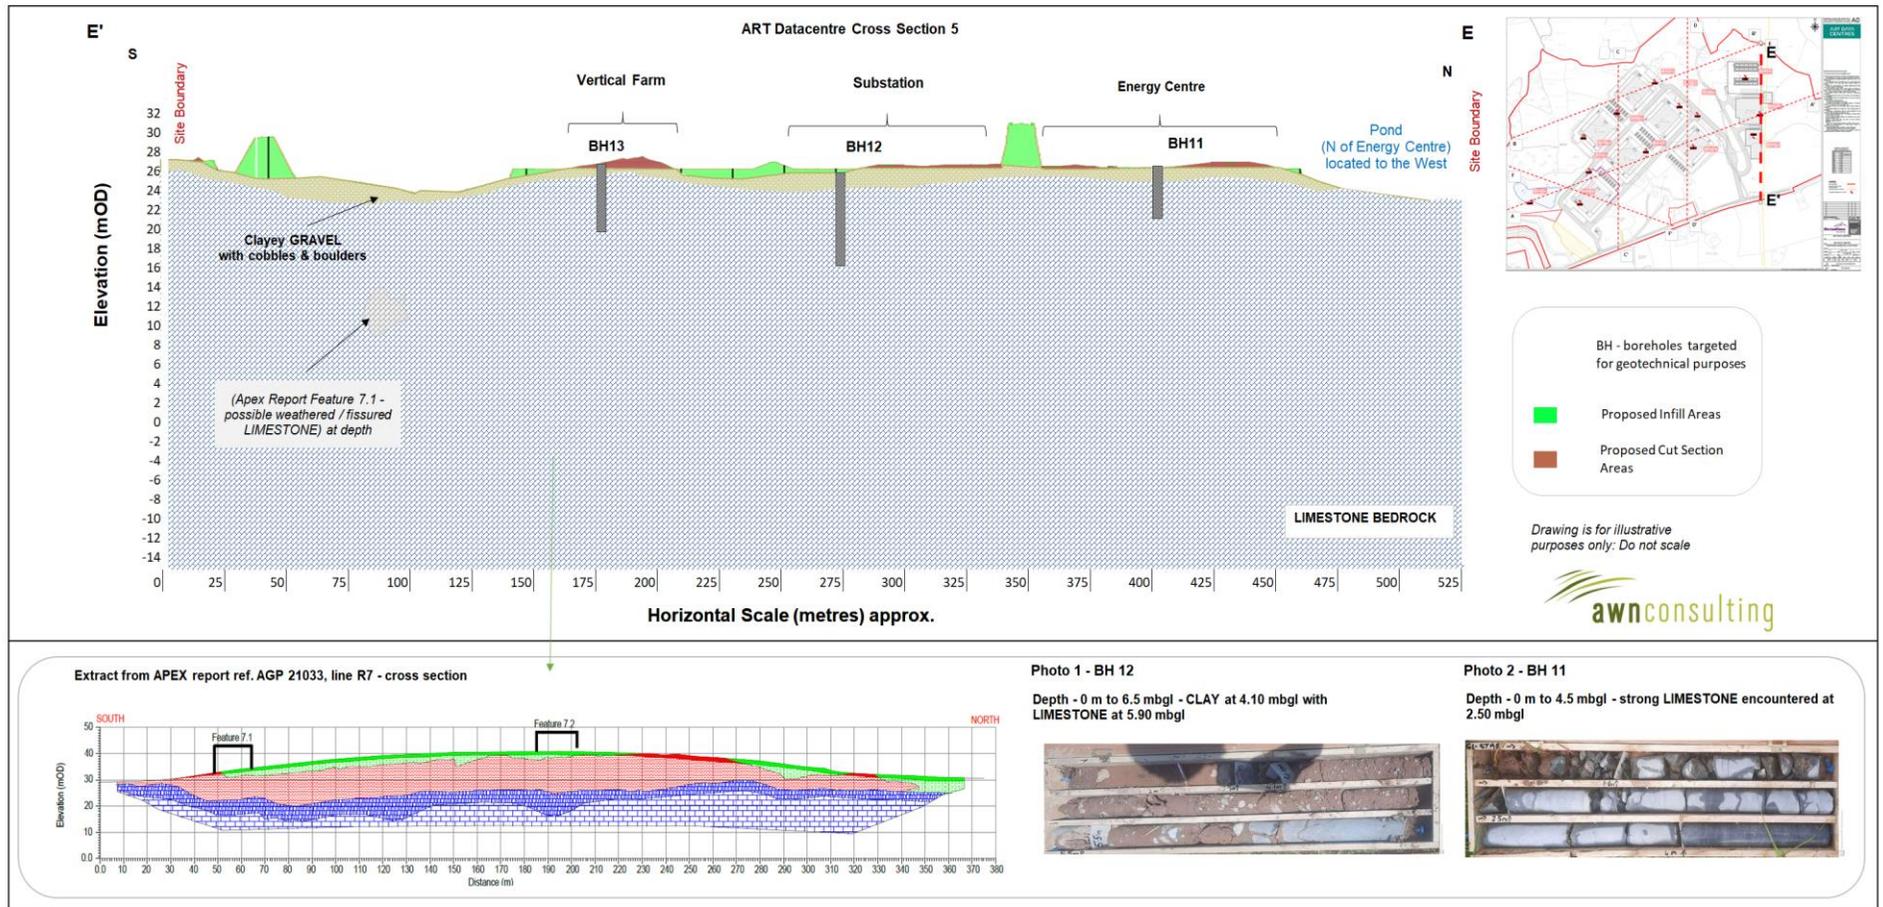
Figure 5-20 Local Cross Section E-E' with view from S to N.

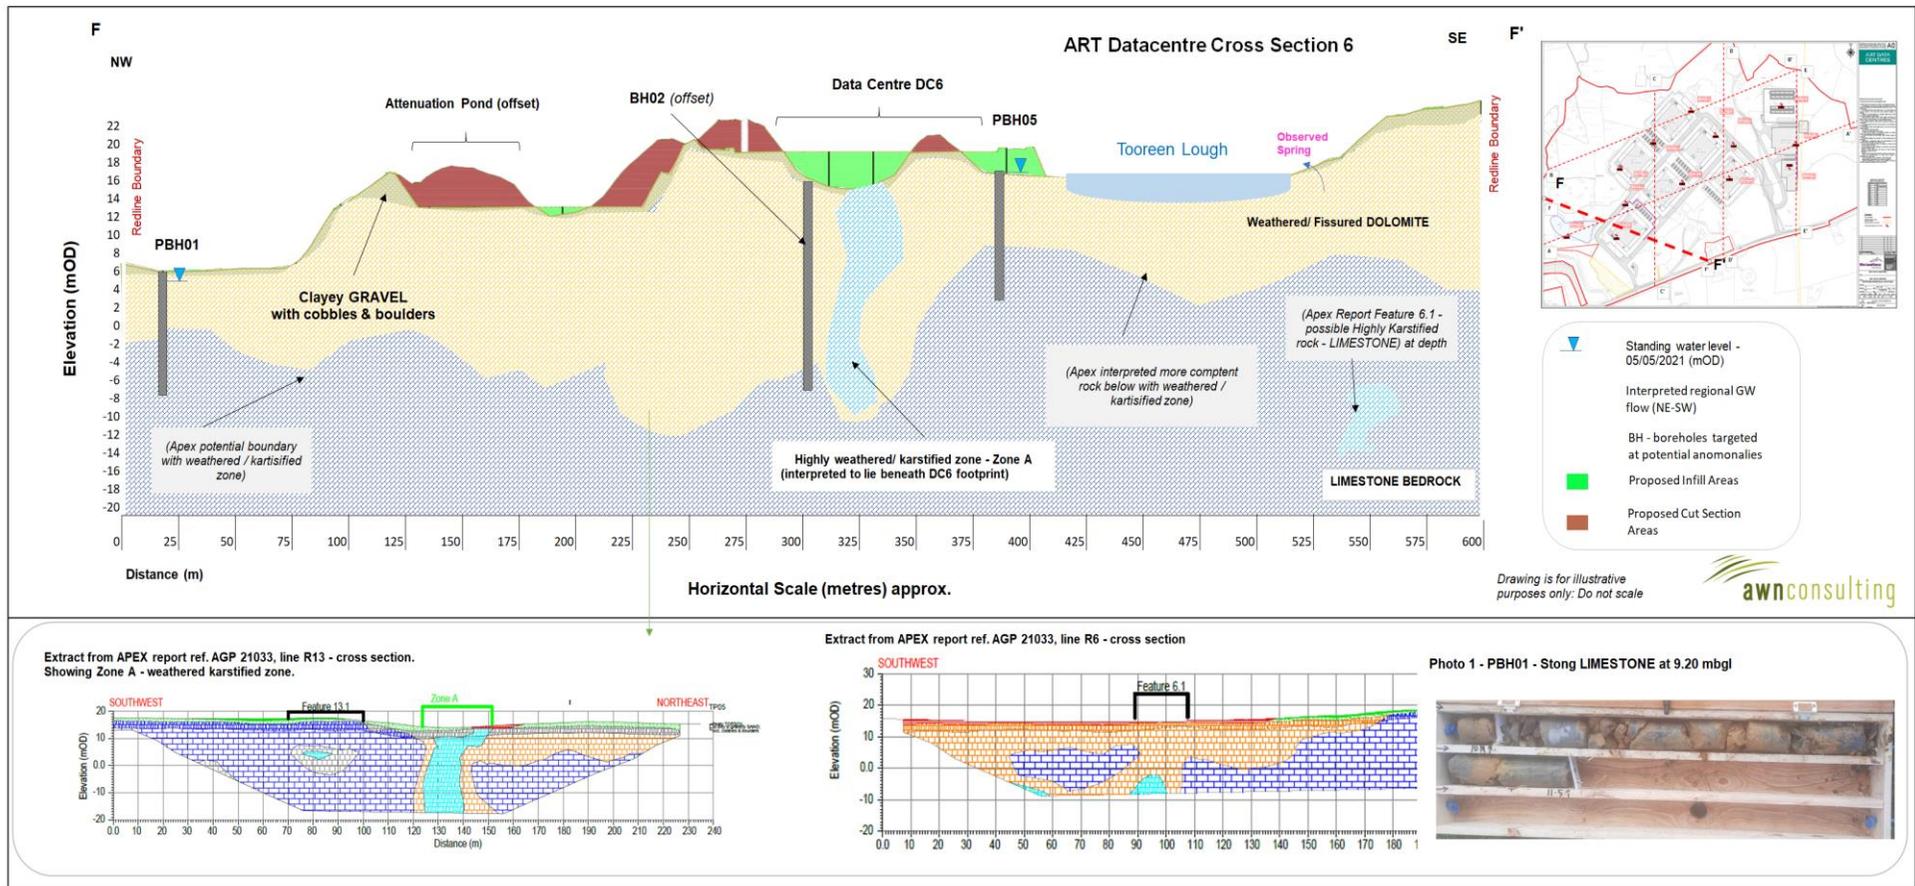
Figure 5-21 Local Cross Section F-F' with view from NW to SE.

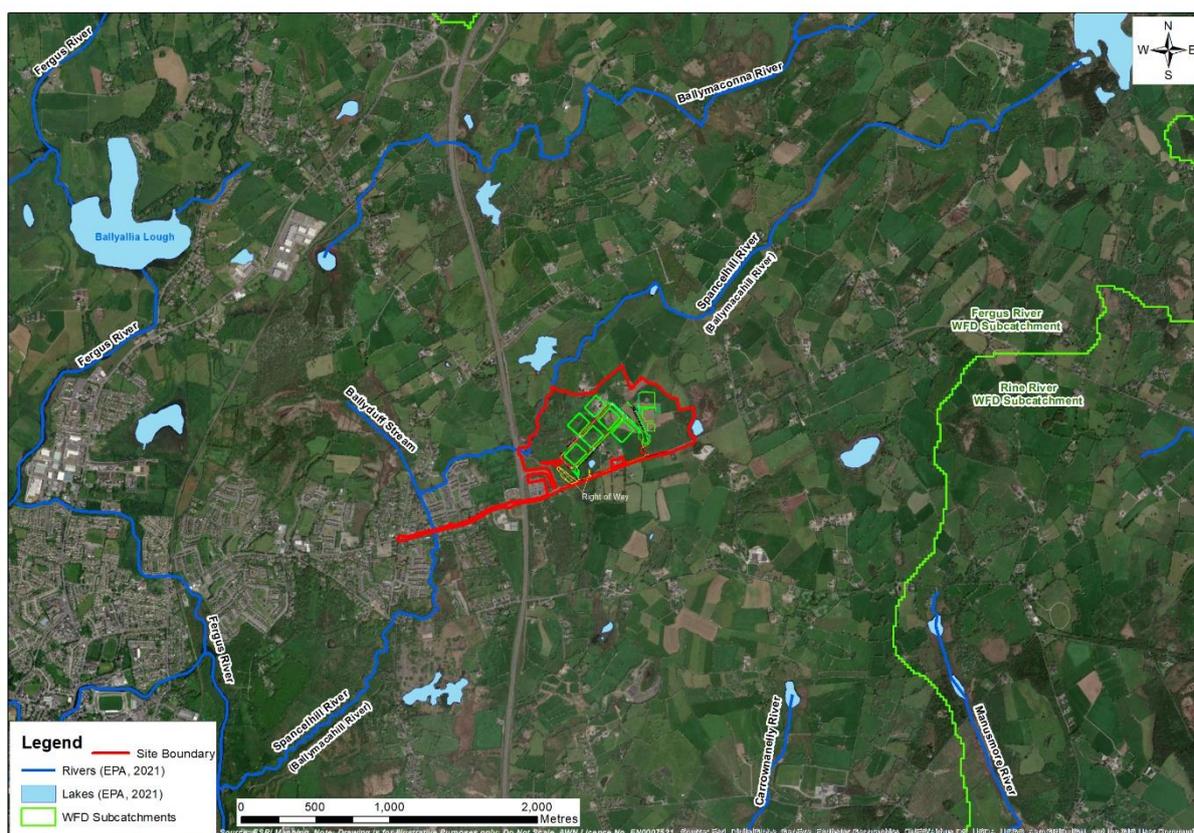
In terms of regional drainage, generally all identified water courses tend to drain in a northeast to southwest orientation (refer Figure 6-1 below). This would also indicate a general interpreted NE-SW groundwater flow orientation (refer Chapter 6 Land, Soil, Geology & Hydrogeology).

Figure 6-1 Hydrological Setting and Site Boundary (Source: EPA, 2021)

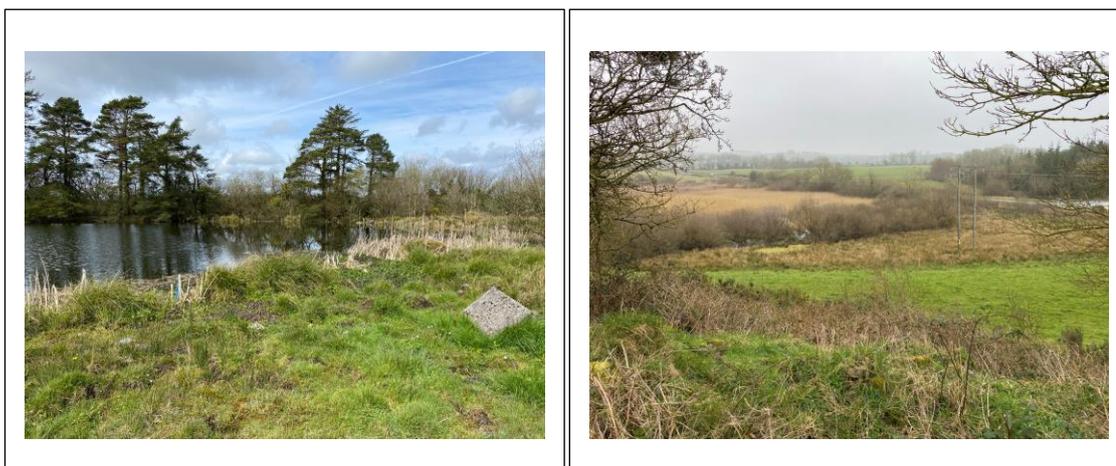
Insert 6. 1 Tooreen Lough (LHS, April 2021) and Ardnamurry Lough (RHS, March 2021)

The swallow hole located farther east and south of the R352 road (this water is sourced from the wetlands at Ardnamurry Lough) is interpreted as possibly discharging in two directions at the point the water reaches the end of the [CCTV recorded] culvert, namely (a) to the immediate south and away from the R352 road, and (b) to the west crossing the R352 at a point where 'possible karstified Limestone' is reported by APEX (2021) as Feature 8.1 through which the transmission gas main also runs. This feature is interpreted as 5-6m in depth and discussion with the landowner indicated significant groundwater in the area during the excavation for the gas main installation. Where (b) represents a potential [groundwater] flow path then this water is interpreted to flow westwards beneath the proposed development and ultimately discharging to either Tooreen Lough spring or the main spring located to the northwest of Tooreen Lough, or both. Discharge to the spring at Tooreen Lough will follow the drainage network described above. Where the discharge [or part thereof] is to the main spring to the northwest of the lough, then this water will feed into the stream flow that ultimately discharges to the Ballymacahill River (refer also Figure 6-2 above). The geophysical survey (APEX, 2021) did not identify these conduits but identified a significant karstic and dolomitised zone which coincides with the swallow holes on the west of the proposed development site. The ecological assessment (Chapter 7) has not identified any specific groundwater dependent species present.

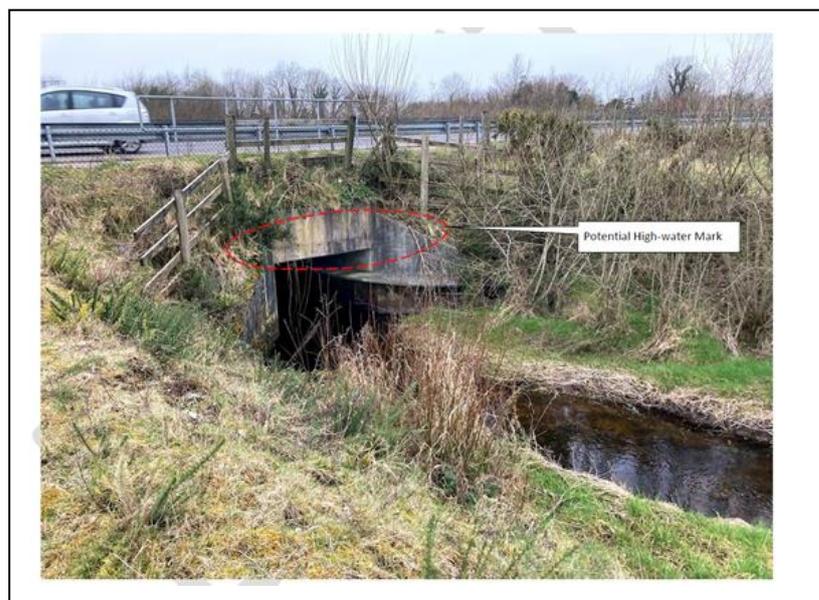
Insert 6.2 Culvert under M81 motorway.

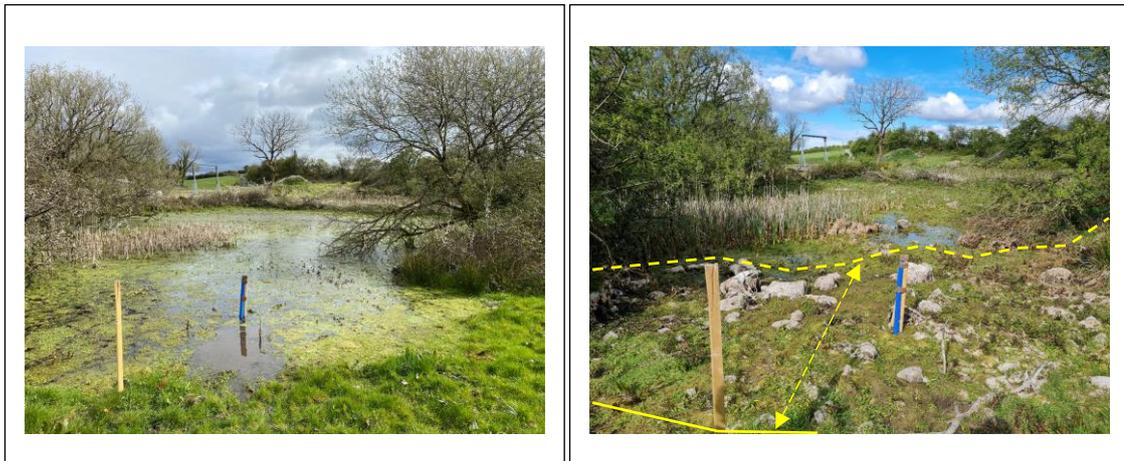
Insert 6.3 presents [recent] imagery of the recession in water levels at the (2 no.) ponds to the north.

Insert 6.3 Ponds to the north -Observed recession in water levels April to May 2021

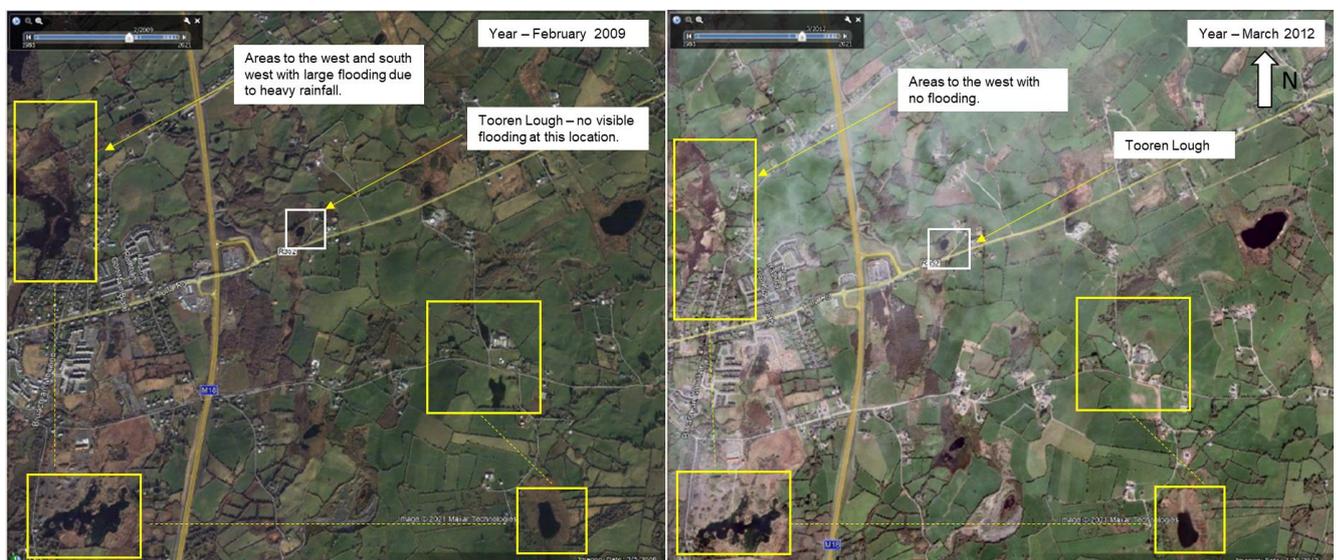
Based on available historical aerial imagery, the water level in Tooreen Lough appears to not dramatically fluctuate. The aerial image from February 2009 (significant flood in Ennis Town), flooding is noted in the west and south-west of the site due to the antecedental weather conditions. This is confirmed in the March 2012 aerial photograph where the features to the west and south-west almost recede completely and again, Tooreen Lough does not change, see Insert 6.4 below.

Insert 6.4 The fluctuation of Tooreen Lough based on high flood and rainfall events.

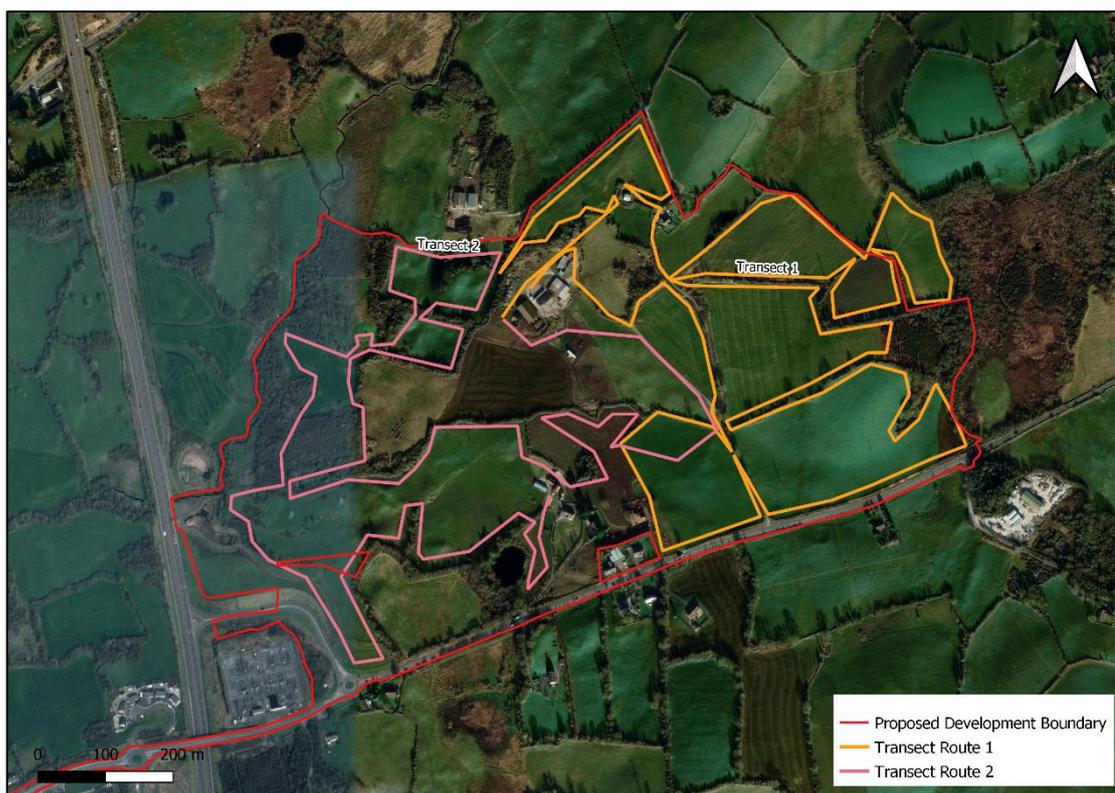
Figure 7.2 Indicative transect routes walked within the site

Full details of these 2020 surveys are provided in Appendix 7.8 and the locations of the transect routes are presented in Figure 7.2. A summary for each species is provided below.

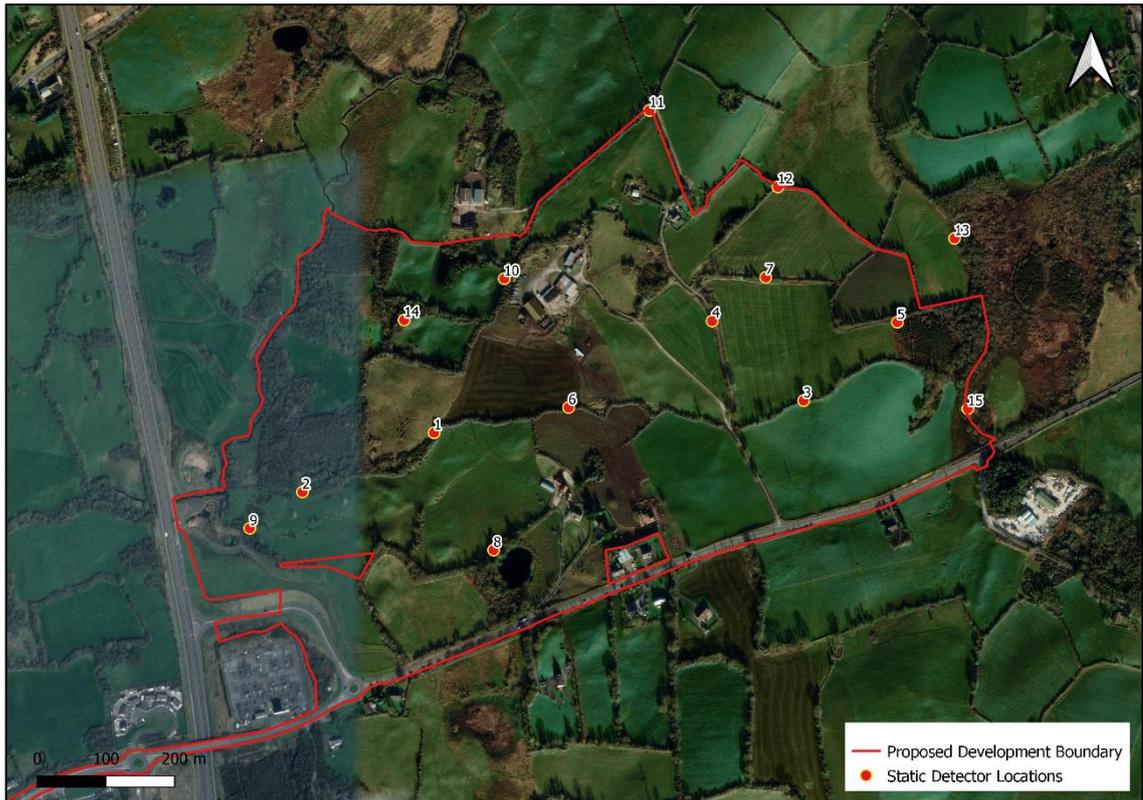
The walked transect surveys were supplemented by automated static bat detectors (*i.e.* Song Meter SM2). This use of static bat detectors at a fixed location for an extended period of time increases the likelihood of recording lesser horseshoe bats present on site compared to walked transects only. Detectors were deployed for a minimum period of 8 nights at 15 different locations within the subject lands between the 6th July and 20th October 2020. Locations of these deployments were chosen with an emphasis on areas identified as being potentially suitable for commuting and/or foraging bats, whilst also ensuring the site was covered as best as possible. Locations of the deployed static detectors can be found in Figure 7.3. Once the detectors had been deployed for a minimum of 7 nights, they were collected and the data was analysed using Kaleidoscope bat analysis software. This software identifies each individual bat call recorded by the detectors, which can then be used to identify the calls by species.

Figure 7.3 Locations of deployed static bat detectors
