Project: P19188 Howth

HOWTH HARBOUR AND SURROUNDING ENVIRONMENT

Underwater Archaeological Impact Assessment
Howth Fishery Harbour Centre dredging project
20D0018, 20R0076

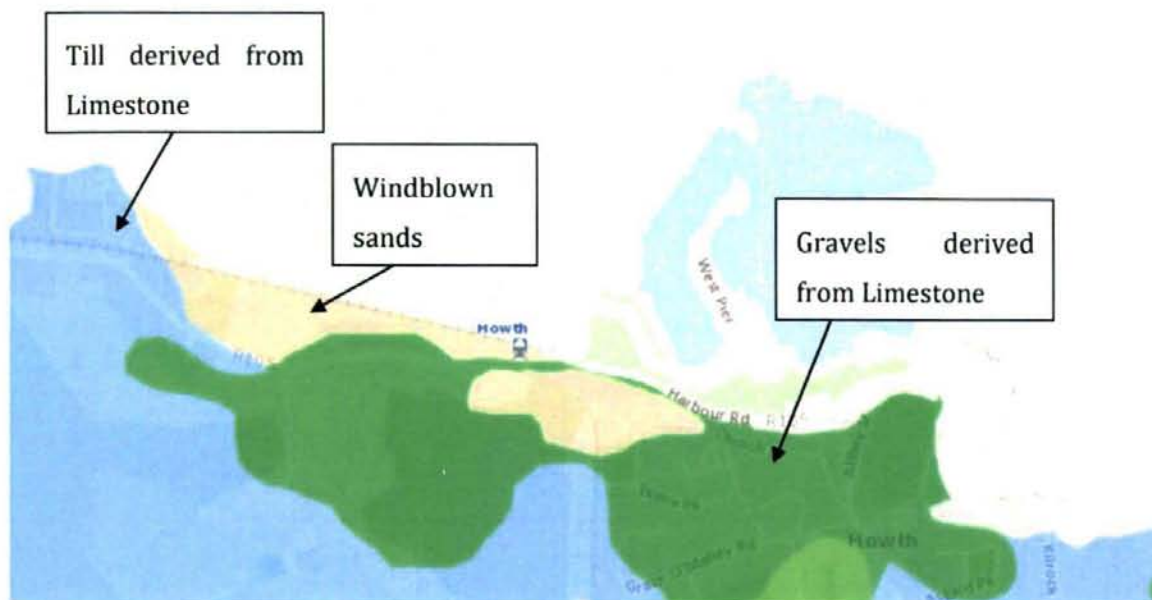
According to the GSI Quaternary Geology map, see Figure 1-3, the surrounding land areas are underlain by a combination of windblown sands (shown in grey), gravels derived from Limestones (shown in green) and till derived from limestones (shown in blue).

Figure 1-3: GSI Quaternary Geology Map

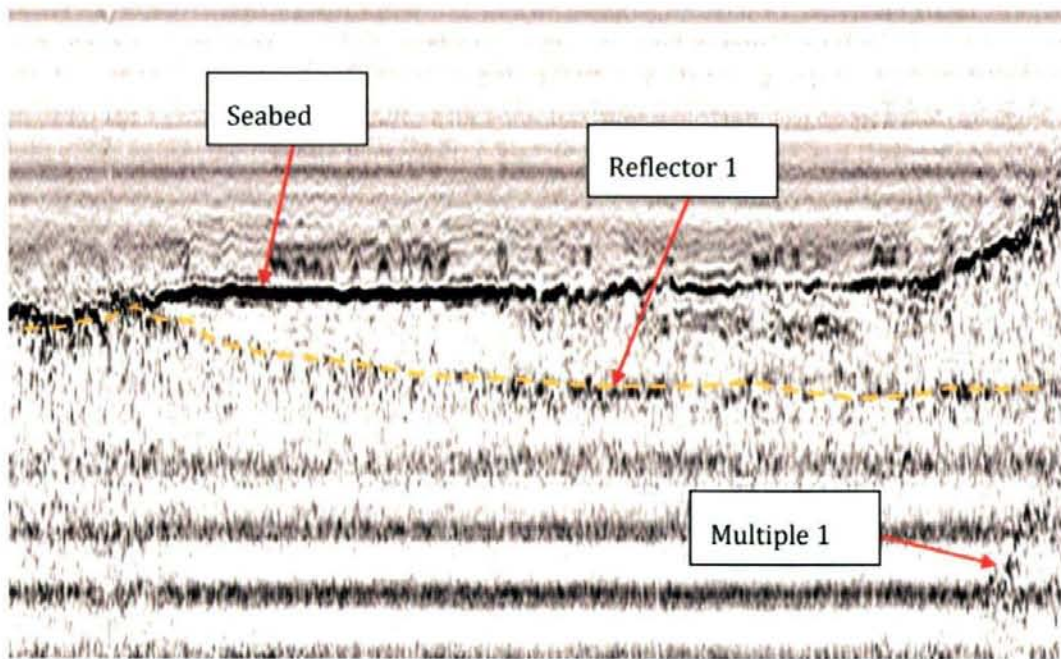
Figure 3-2: Data example from sub bottom profiler survey showing picked reflectors.

Direct investigation undertaken as part of this overall project was examined as part of the geophysical investigation. The reflector as interpreted as part of this survey appears shallower than the depths reported by RC201 and RC202, where rock is reported c. 4.3m and 4.4m below seabed, respectively. However, on both logs a boulder clay is noted at depths consistent with the reflector picked from the sub bottom profiler data.
