## Appendix 11

### Architectural Heritage Impact Assessment

# Howth Fishery Harbour Dredge & Reclamation Project

IMPACT ASSESSMENT

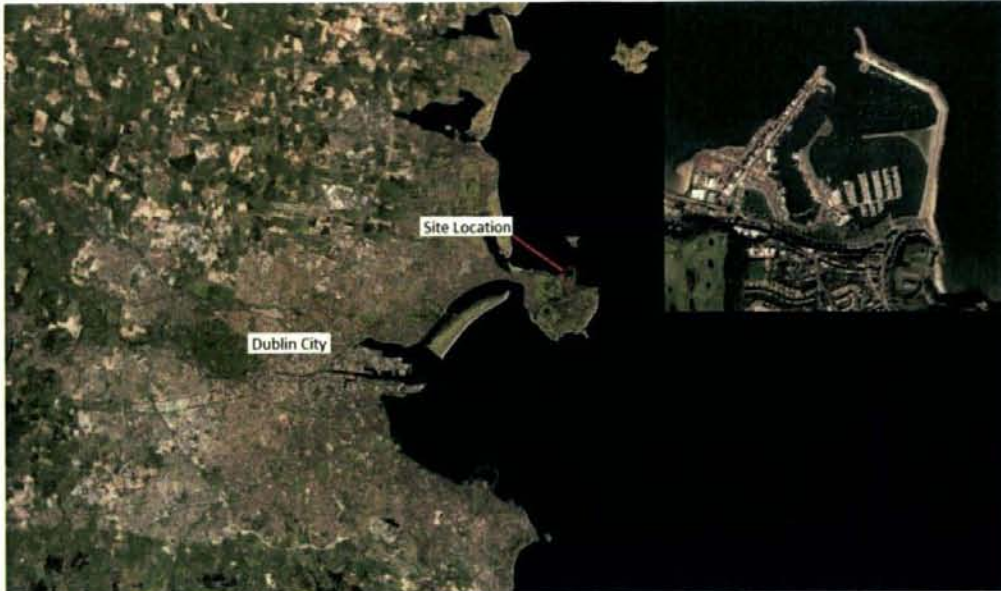
Figure 1: Aerial View of site (Malachy Walsh & Partners)

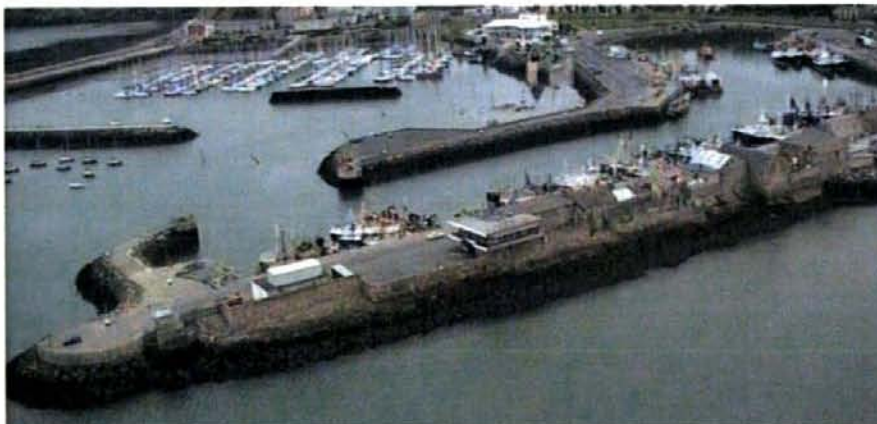
Figure 2: Western elevation of pier (MWP)

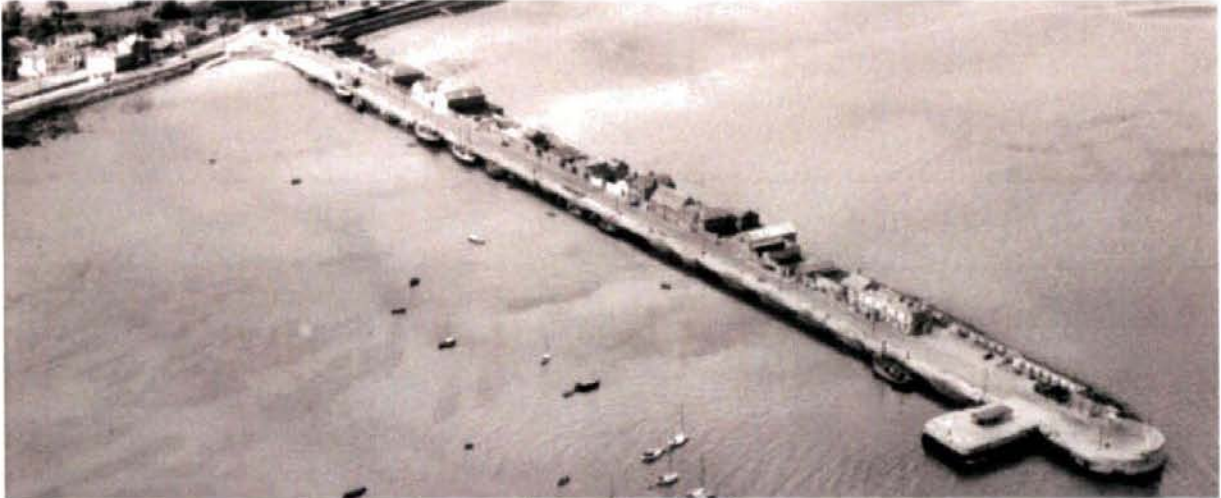
**Figure 12: Aerial photograph of West Pier, 1952 (Britain from Above)**

The proposed works will have no direct physical impact on the original historic fabric of the West Pier or on any of its Protected structures or NIAH buildings. However it is proposed to remove an area of wall to the north of the former Harbour Master's House in order to provide access from this end of the original pier to the proposed new public realm to the west. The wall is approximately 2-2.5m high, of rubble masonry construction with concrete buttresses to the eastern side. The Harbour Master's House originally adjoined a coast guard station (see Figs. 8 & 9) located on the site of this area of boundary wall. The coast guard station was still in place on the 1907 OS map (Fig. 10) but had been removed by the 1950's (see aerial photograph Fig. 12).

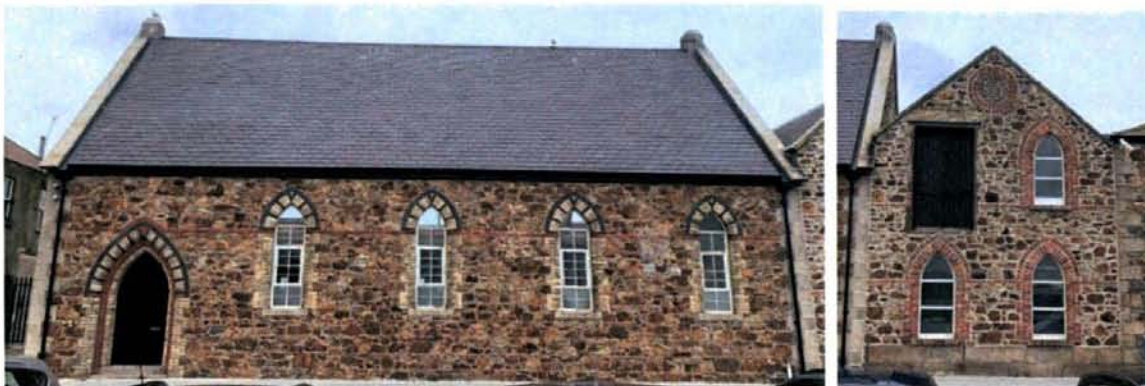
Figure 16: Mariner's Hall and adjoining gable-fronted warehouse

The former Mariner's Hall is a detached five-bay roughly dressed stone built former church, built 1864, with exposed rubble stone façade and polychromatic brick dressings to openings. There is a two-bay, two-storey gable fronted warehouse attached to the north-east gable. The building is presently in use as offices.

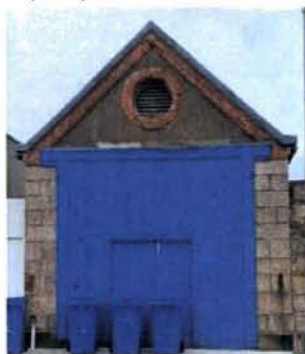
Figure 17: Former Lifeboat House

Single-bay, single-storey gable-fronted former coastguard boathouse, built c. 1870, with a granite slipway to the rear.

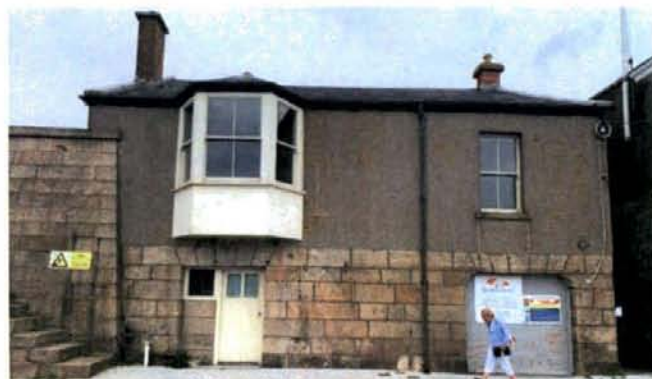
Figure 18: Harbour Building

Two-bay, two-storey harbour building with ashlar granite to ground floor and render finish to first floor. Built c. 1870. Distinctive canted bay window to first floor.

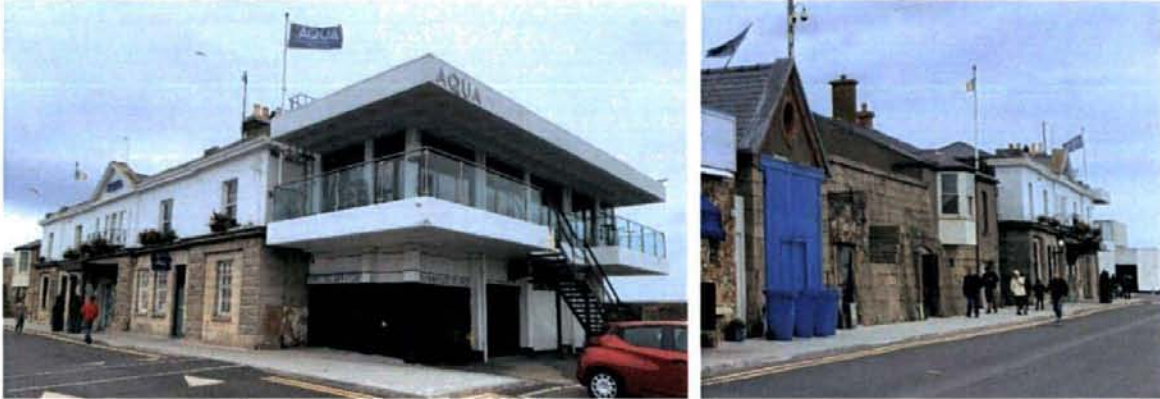
Figure 19: Former Harbour Master's House

Detached (originally terraced) five-bay, two-storey former Harbour Master's house, built c. 1880. With breakfront end bays and pediment over central breakfront entrance bay. Single-bay, two-storey extension, c. 1970, to north-east. Now in use as a restaurant.

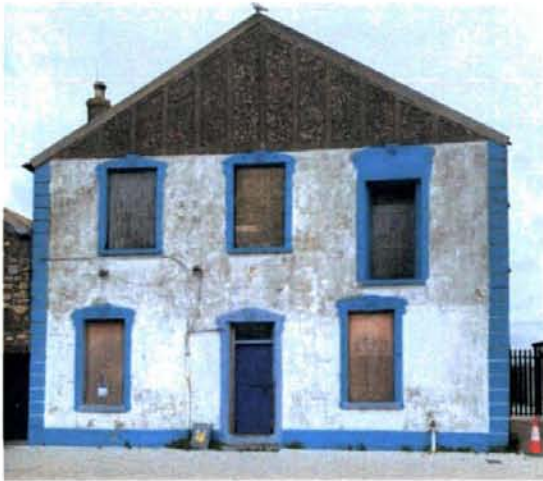
Figure 20: Former House

Detached, gable-fronted three bay two-storey former house, built c. 1870

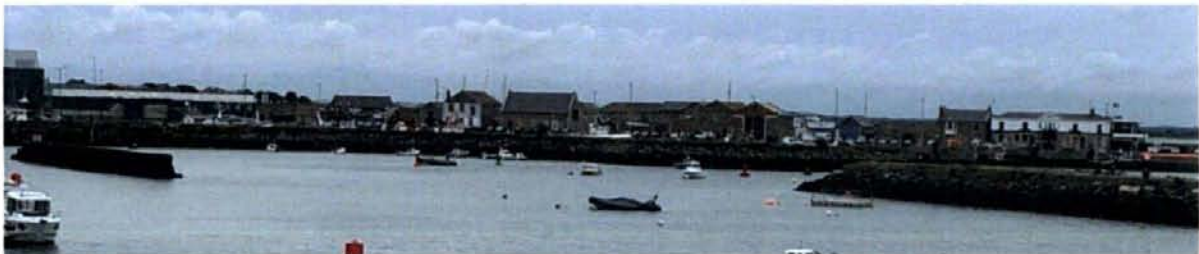
Harbour, built 1807-13, comprising East and West Piers, constructed of ashlar granite and rubble stone, with ashlar granite sea walls.

Figure 21: Howth Harbour - View towards West Pier from East Pier

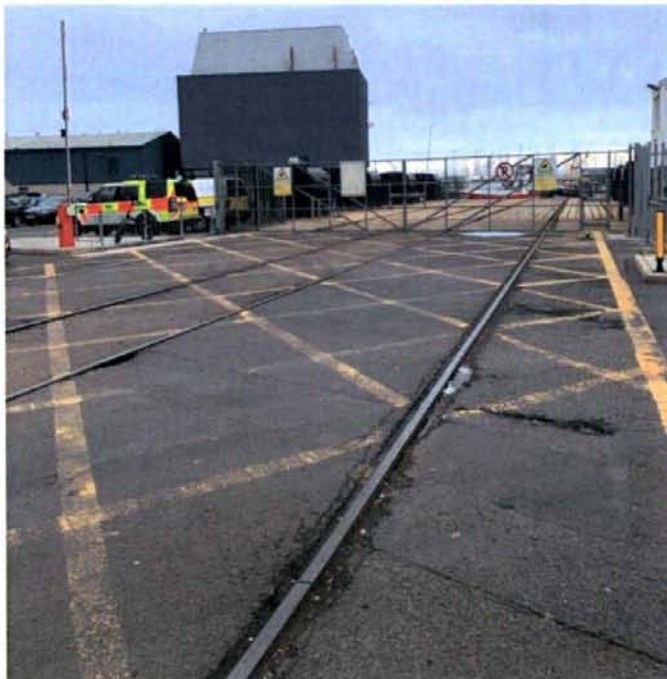
Boat turning station with cast-iron tracks, c. 1910,

Figure 23: Boat turning station

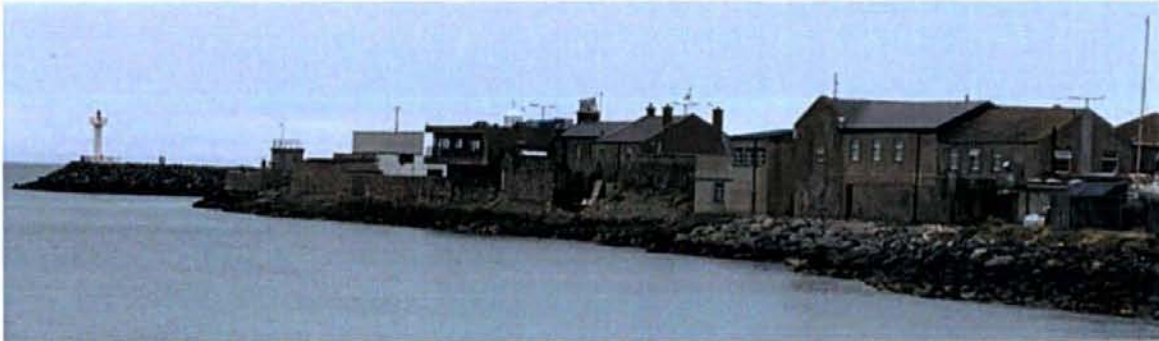
**Figure 24: Rear elevations of buildings on West Pier, viewed from south west**

The existing sloped semi-dressed revetment probably still resides below the rock armour to the upper section of infill.

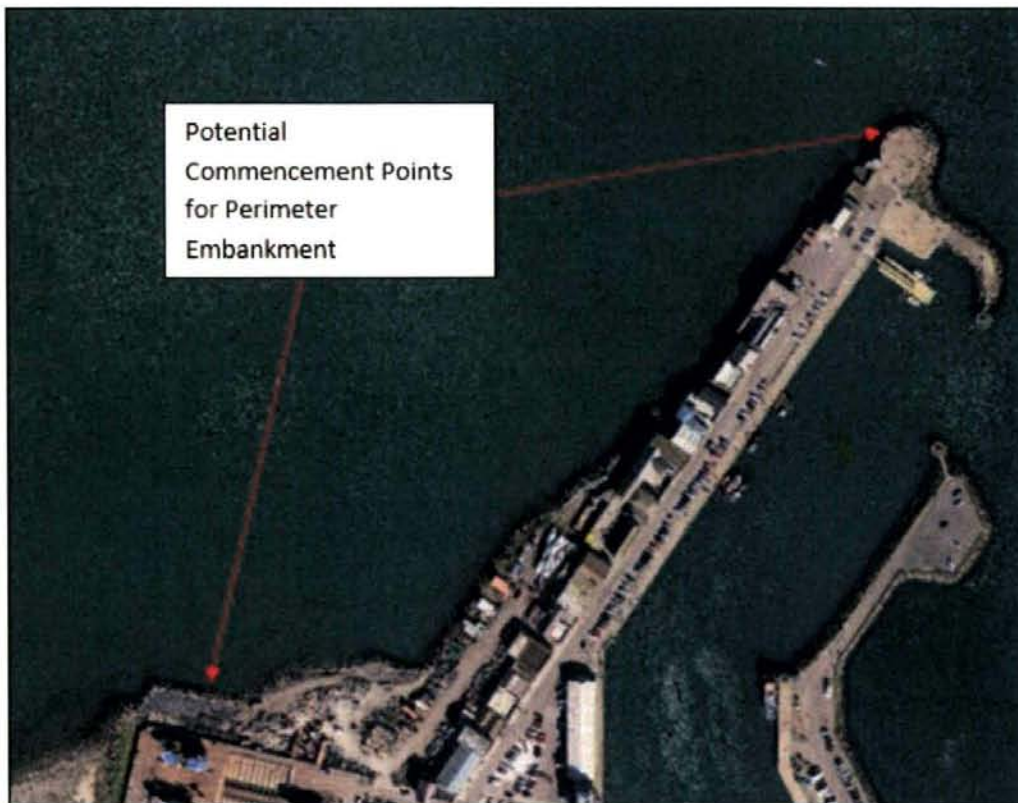
Figure 26: Serial photograph showing potential commencement/finishing points for the perimeter embankment (MWP)

Material will be placed on top of the existing West Pier revetment and there will be no removal or demolition required to the existing West Pier.

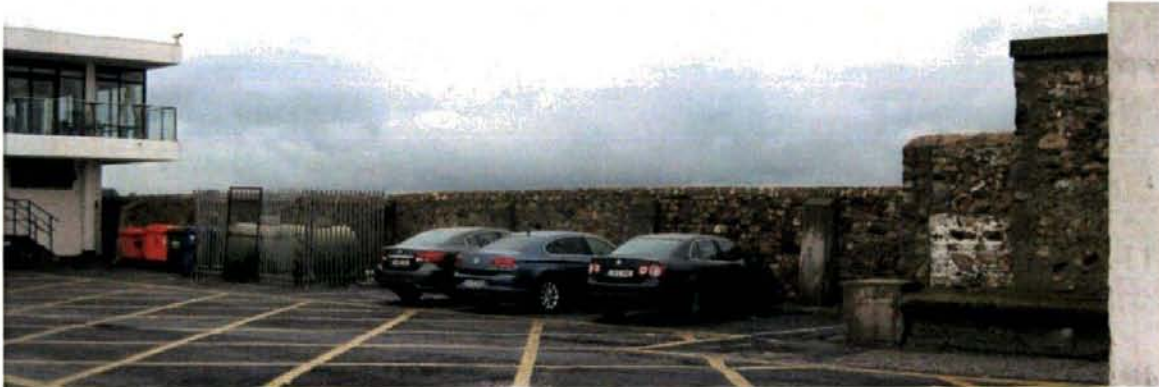
**Figure 27: Area of wall to be removed to north of the former Harbour Master's House**

The date of construction of the existing wall is uncertain, but it appears very unlikely that it formed part of the structure of the coast guard station, and was probably originally constructed after that building was demolished in the early 20<sup>th</sup> century. It also bears signs of having undergone a number of phases of repairs and possible modifications, generally using cementitious mortars, with the concrete buttresses also likely to be a later addition.

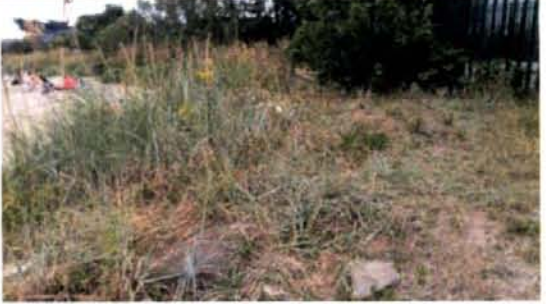
<b>Plate: 33 – Disturbed dune formation and scrub</b>	<b>Plate: 34 – Sea Defences placed on Dune Formation</b>

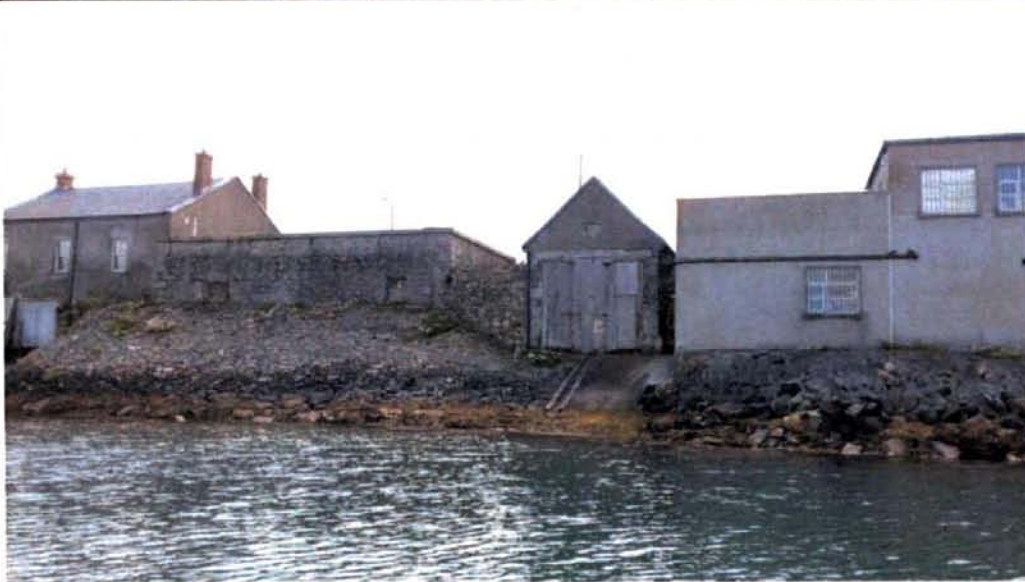
The time that Leisler's bats were recorded on both static bat detectors does not indicate that a Leisler's bat roost exists in close proximity to the Application Site. However, suitable features for roosting bats do exist within buildings along West Pier (see Figures 37 to 38 below).

**Plate: 37 – Old buildings along West Pier during day time assessments**
