Ballymun / Finglas to City Centre Core Bus

Corridor Scheme

Bus Stop Review

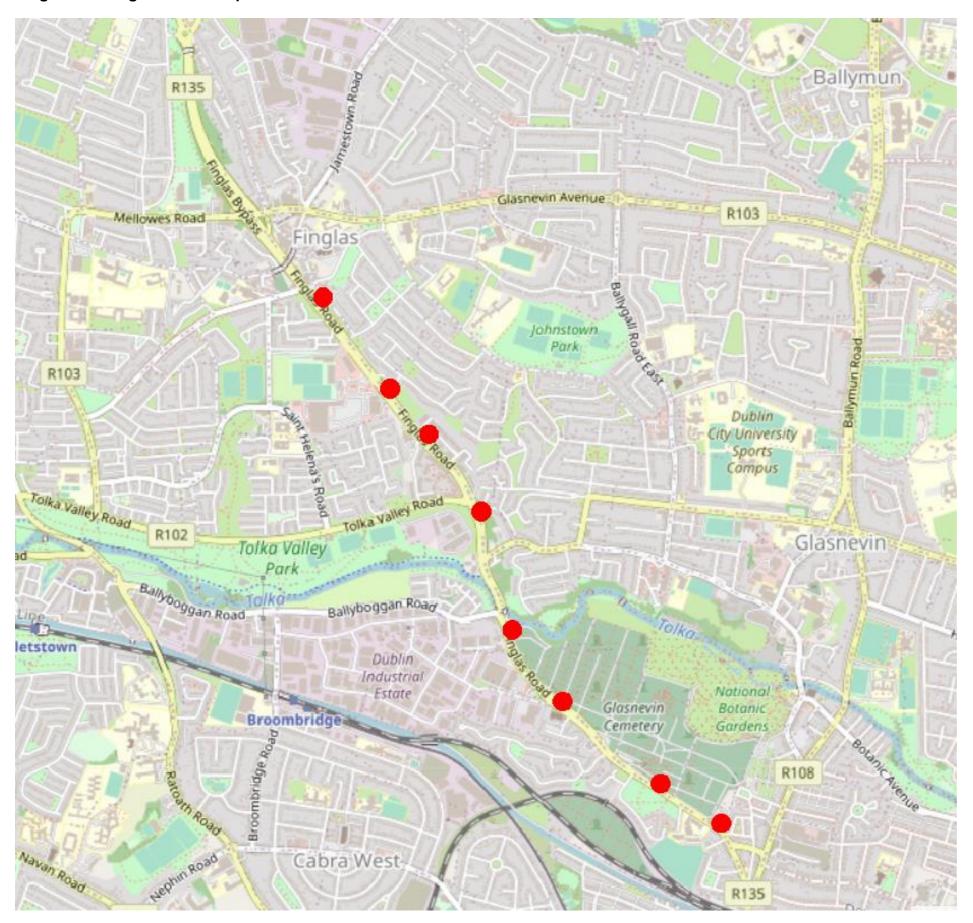
Finglas Proposed Inbound Stops

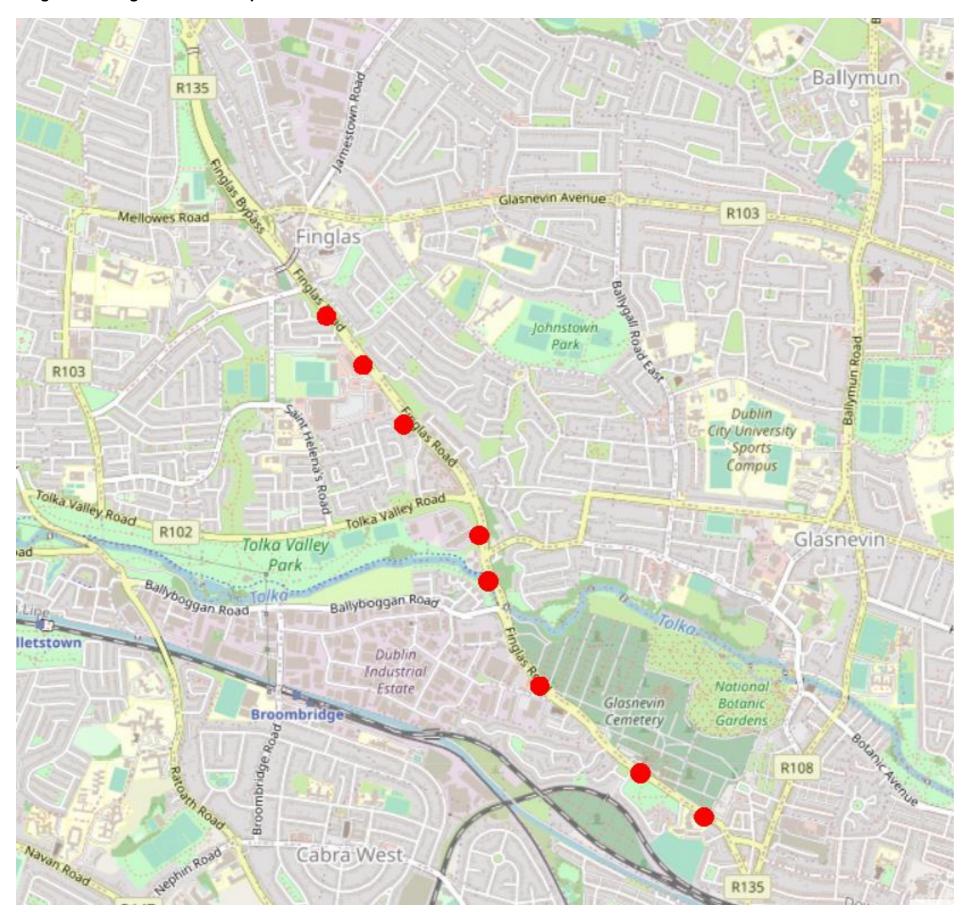
Finglas Proposed Outbound Stops

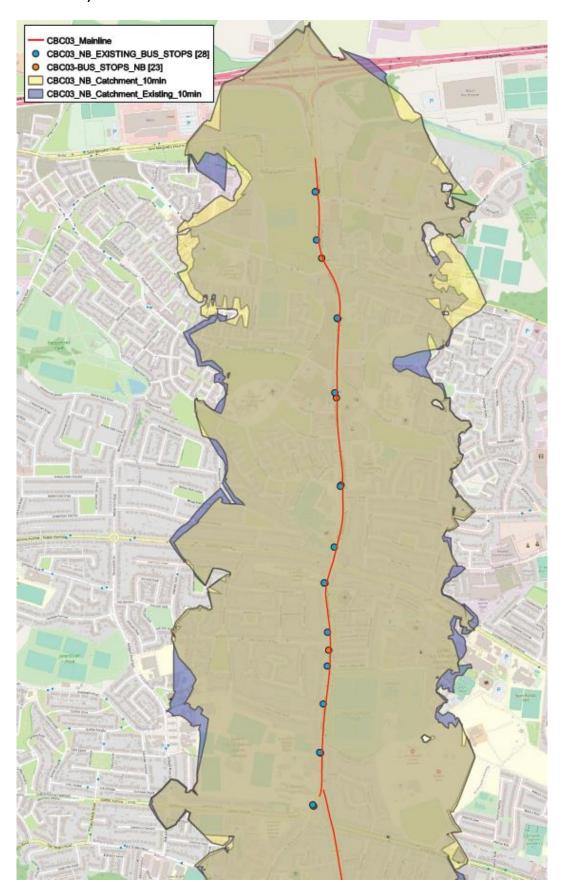
Ballymun 10-minute walking Catchment Outbound (Between Griffith Avenue and Chancery Street)

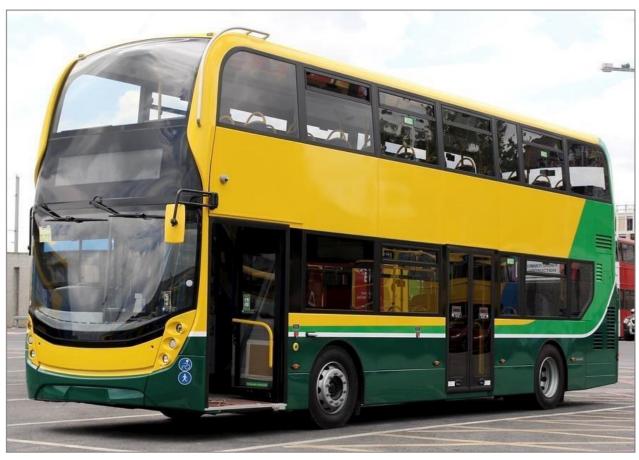
For avoidance of doubt this manual assumes the standard bus is a twin axle double decker bus (10 to 11m in length) with a front and middle doors. Other vehicles, such as 3-axle double decker, are in use by Dublin Bus and should be considered when undertaking the Geometric Design.

Figure 1.2 Standard Bus being used on the CBC's.

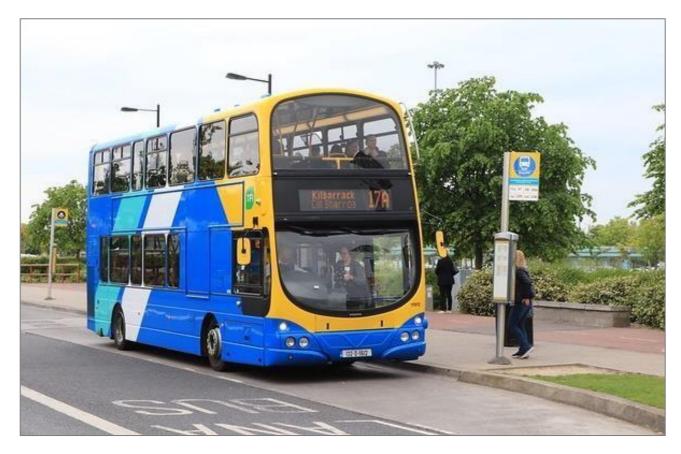
Figure 1.6 A typical bus lay-by adjacent to a bus lane; note concrete surface for additional durability.

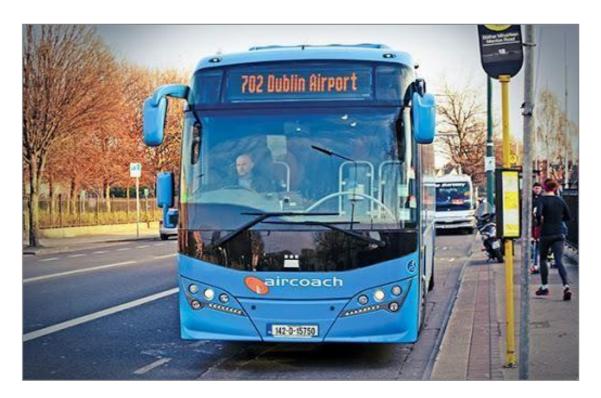
Figure 1.8 Multiple bus operators may be using bus stops along the Corridors.

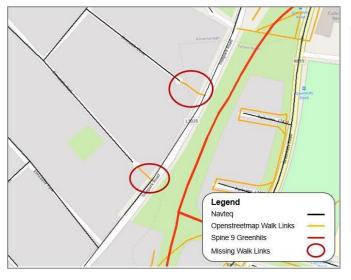
To do this you will add walk links extracted from OpenStreetMap's data clearly coding these into the Navteq supplied by the NTA. Google Streetview should be used as a check to ensure any link added to the Navteq exist on the ground and are accessible to all. Informal walk links should not be added at this stage.

Figure 4.2 Example of permeability link missing from Navteq mapping on Tallaght/Clondalkin Cor Bus Corridor.

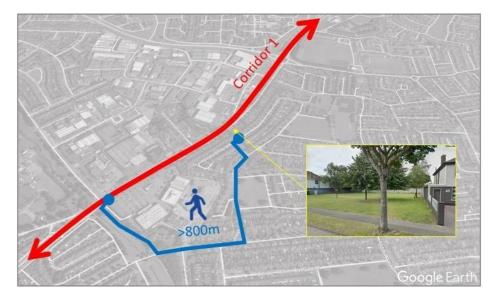
An example from the Clongriffin to City Centre CBC can be seen in Figure 4.4 where a very large housing estate which is located immediately adjacent to the proposed bus corridor has a continuous boundary wall that runs for over 800m preventing easy access to the bus routes and requiring a walk of almost

1km to access the bus routes. Opening a pedestrian access on the boundary wall could create a much shorter route to the buses and substantially increase the bus passenger catchment area.

Figure 4.4 Permeability option on the Malahide Road (Source: Google Maps).

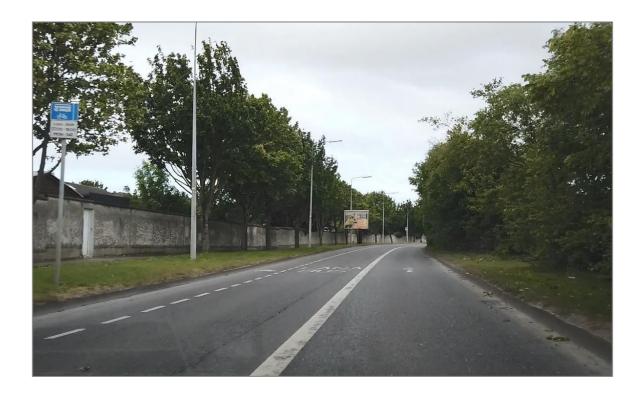
Figure 4.5 Boundary wall along Malahide Road (Corridor 1) where local residents have opened up individual doors to access the existing QBC route.

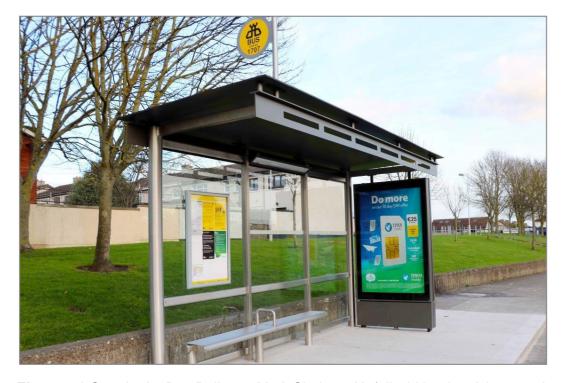
Figure 5.2 Standard 3 Bay Reliance Mark Shelter with full width advertising panel.

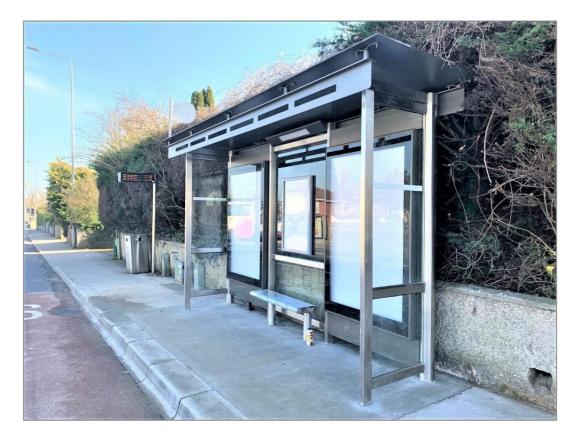
Figure 5.5 Cantilever narrow roof Bus Shelter

It is important that ED's do not immediately choose the minimum sized shelter as this will impact on the weather protection provided to bus passengers and potentially advertising revenue share received by the NTA. Where there are a substantial number of bus stops using the nonstandard bus shelter it is recommended that the NTA IPO are consulted prior to finalising the proposals.

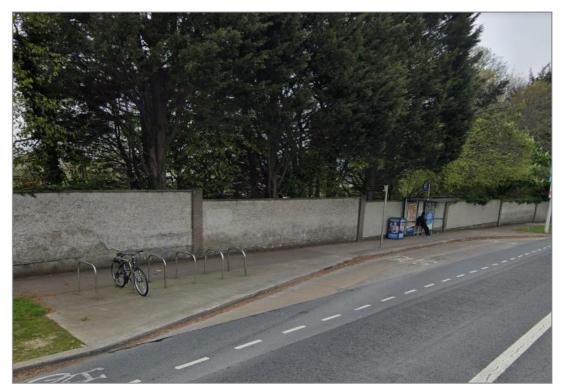
Figure 5.6 Sheffield Bicycle Stands provided at a Bus Stop on the N11.

Providing cycle parking at bus stops has the potential to increase the catchment area of a bus corridor by providing a safe place for cyclists to secure their bike for the duration of their trip. ED's should look to provide cycle parking at all bus stops along the BusConnects Corridors where space permits. The **minimum provision is 3 Sheffield Stands** (accommodating 6 bicycles) in the vicinity of a bus stop. Where larger numbers of cyclists can be expected consideration should be given to providing a larger covered area of approximately 10 Sheffield Stands (accommodating 20 bicycles).

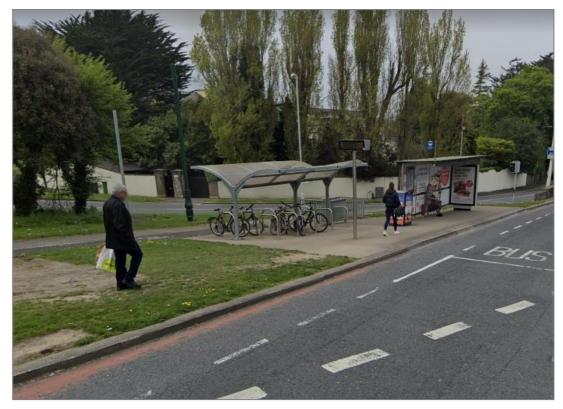
Figure 5.7 Covered Sheffield Bicycle Stands provided at a Bus Stop on the N11.

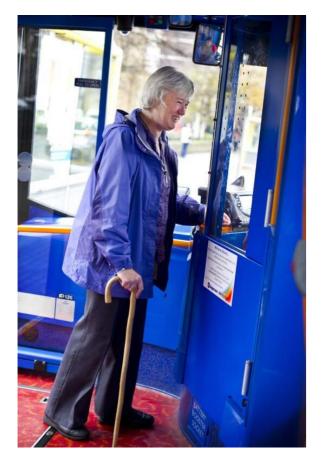
The DfT document Inclusive Mobility (2005) suggests recommended distance limits without rest for various Mobility Impaired Groups that ranges from 50 to 150m, which limits the distance between interchanging bus stops significantly. It is therefore recommended that the distance between the key interchange bus stops is limited to approximately **100m walking distance** where possible to enable all impaired groups to be able to interchange, consideration must be given to providing a rest spots at approximately 50m between the bus stops to cater for those that will not make this distance without a rest.

Figure 5.9 Pedestrians using sticks have a limited range of 50m before needing a rest.

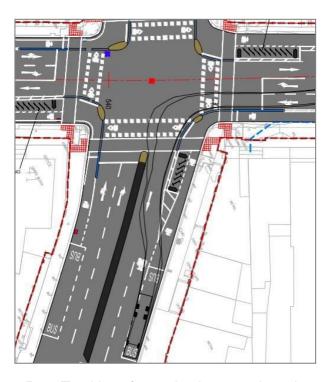
- Where a bus is joining a Spine from a side road it is important that the bus stops are fully accessible by the turning vehicle and sufficient space is provided to allow the bus to pull in flush with the bus stop so as the gap between the kerb and the bus is minimised (both doors). It is also important to ensure that the manoeuvring bus does not require the bus to sweep over the kerb line.

Figure 5.11 Tracking of a turning bus entering a bus stop.

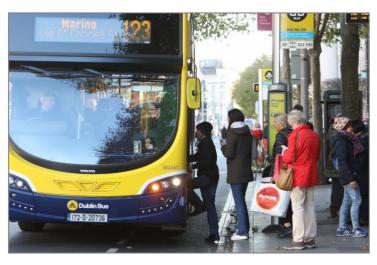
Figure 5.12 Having buses flush with the bus stop is important to allow the ramp to lower correctly, but also to speed up the boarding and alighting of all passengers as gaps slow this down.

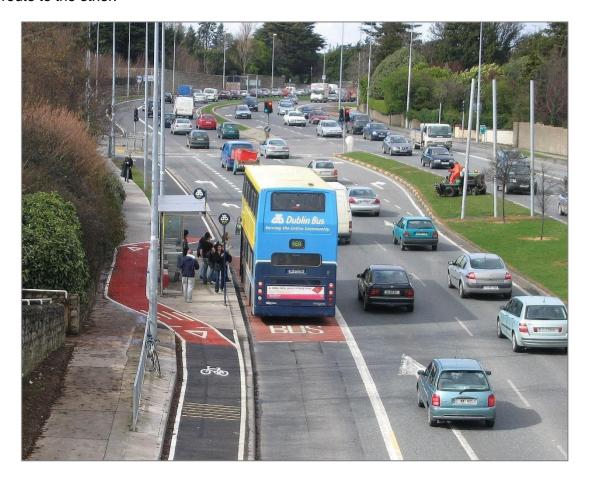
For buses entering and exiting the Spine, consideration should be given to how passengers may switch from one branch to another branch route. While this can happen anywhere along the Spine it will most regularly occur at the last stop before the branch route peels off the Spine. An existing example of this can be seen at Foxrock Church where two high frequency routes (46A/145) deviate at this point. At the last stop before the 46A deviates to Kill Avenue significant numbers switch from one route to the other.

Figure 6.2 Foxrock Church Bus Stop on the N11 QBC

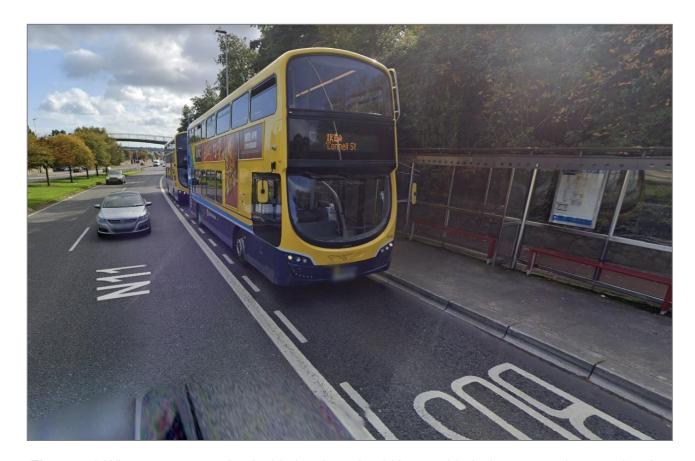
Number of Bays at Where a Corridor is carrying approximately **25 to 30 buses** or more per hour, consideration be given to lengthened the bus stop cage and kerbing to provide space for 2 buses stopping simultaneously. Independent arrival and departure is not required.

Figure 7.2 Where space permits double bus bay should be provided where more than one bus is expected to arrive at a bus stop simultaneously (source: Google)

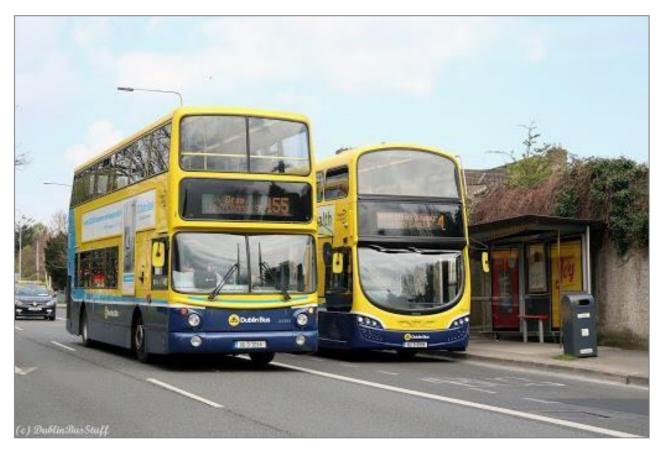
Requirements	for	Where a section of corridor is carrying approximately 40 to 50 buses or more
passing Lanes		an hour, consideration should be given to providing passing lanes at bus
		stops.

Figure 7.3 In-line bus stops on a heavily used bus corridor can lead to express, or non-stopping buses, being delayed or making overtaking manoeuvres. (source: Dublin Bus Stuff).
