Appendix 9.2 – *‘Remediation Option Appraisal, Historic Landfill at Bray Harbour, Co. Dublin’*, Fehily Timoney & Co., 2017.

## REMEDIATION OPTION APPRAISAL

## HISTORIC LANDFILL AT BRAY HARBOUR, CO. DUBLIN

MARCH 2017

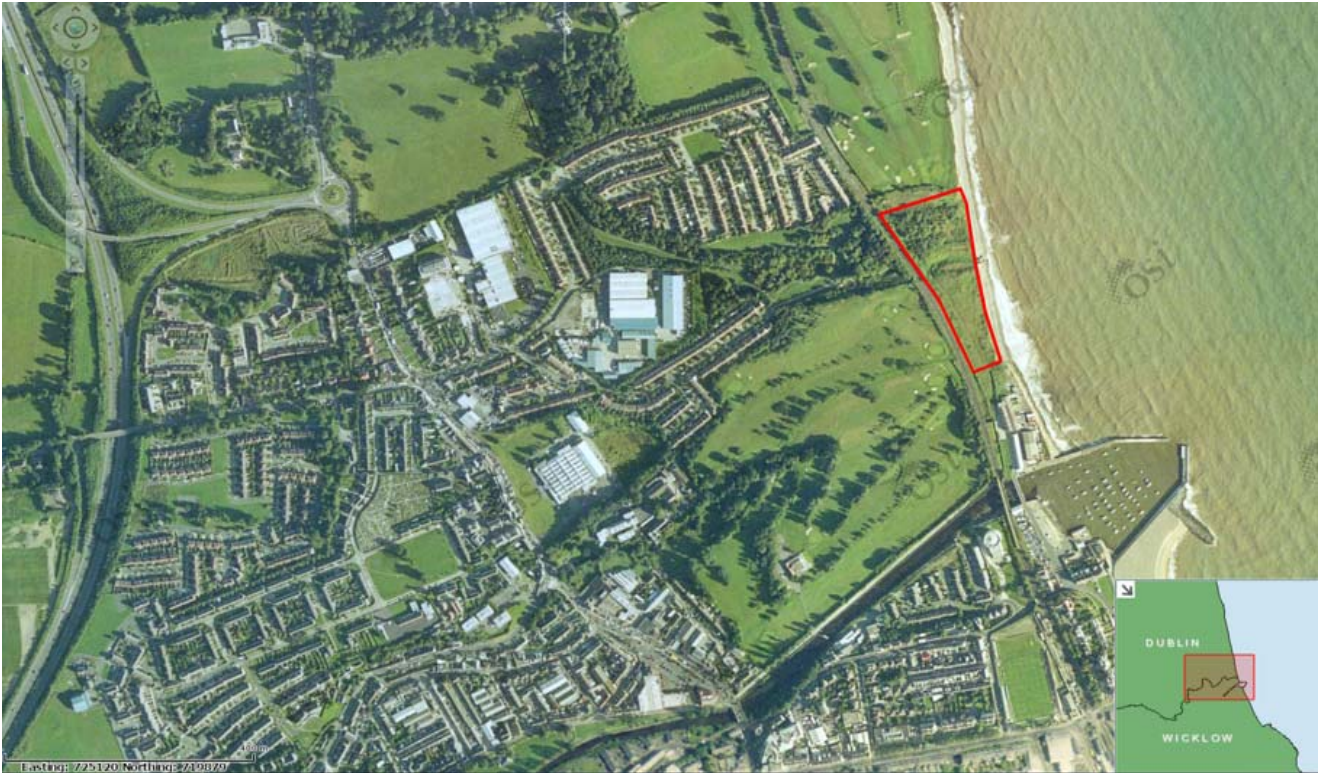
**Figure 2.1: Aerial Photograph of Site**

Source: GSI Maps, Site boundary outlined in red

The location of the site is presented in on Figure 2.1.
