METROLINK

A5.20

**Blasting
Strategy**

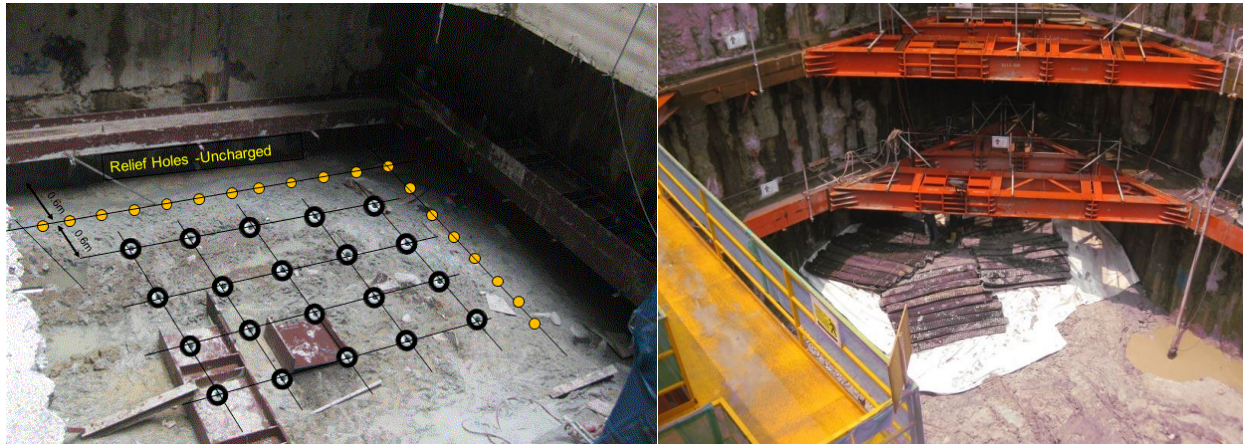
Figure 5-2 (left) shows a schematic view of the blasting design with relief holes close to the diaphragm wall.

Figure 5-2 (right) illustrates the blasting area after the charging stage and before blasting.

Figure 5-2: Schematic View of Blasting Design (left) and Blasting Area After Charging Stage (right)

On this project the actual vibration values recorded were smaller than the values estimated using the theoretical calculations, showing a successful use of blasting.
