METROLINK

A15.1

**MetroLink Invasive
Species Technical
Report – Glasnevin**

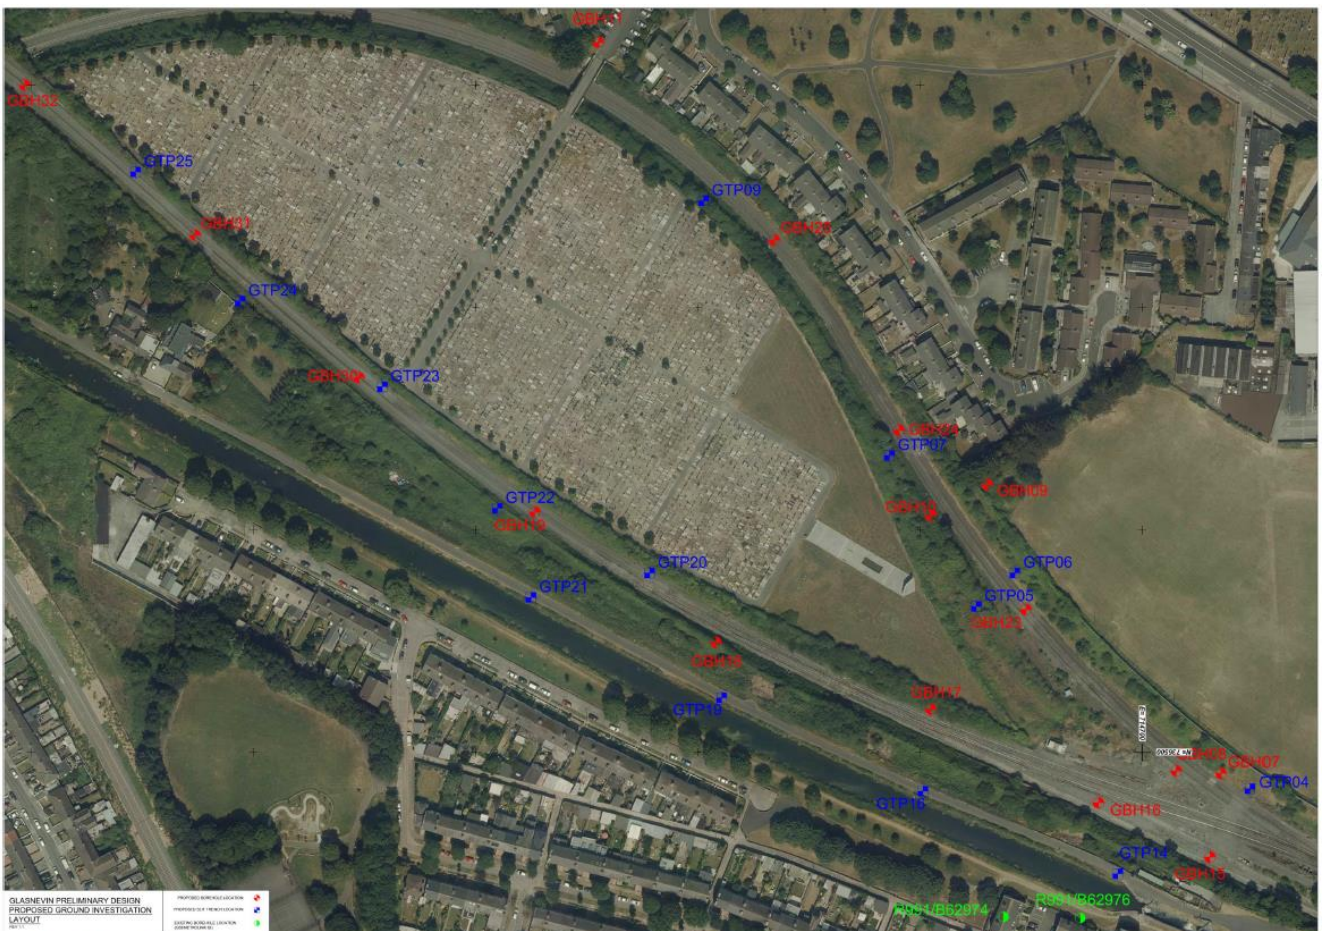
Figure 1: Proposed G.I locations at Glasnevin identified in blue and red.

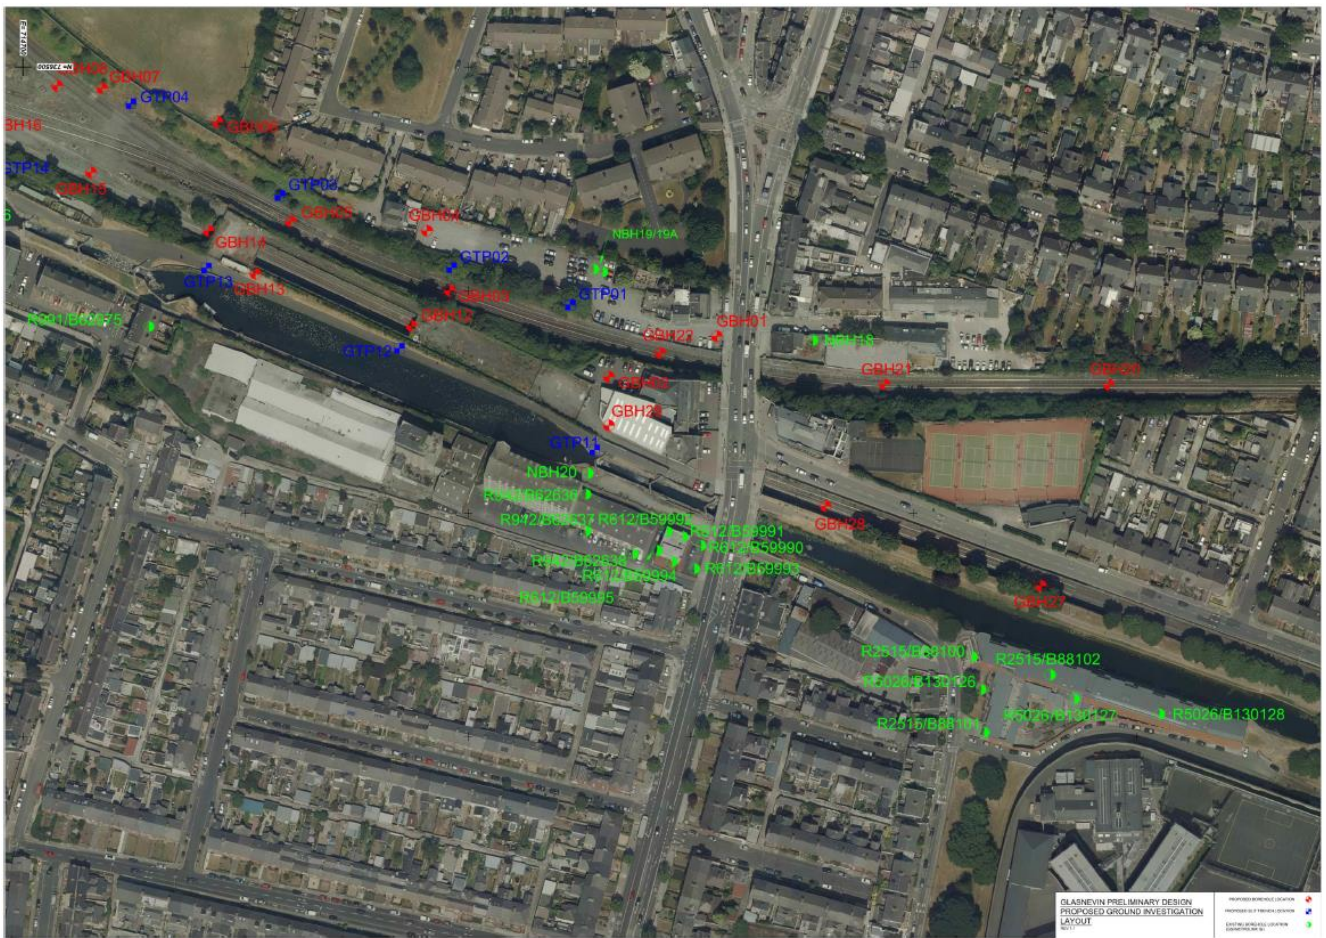
Figure 2: Proposed G.I locations at Glasnevin identified in blue and red.

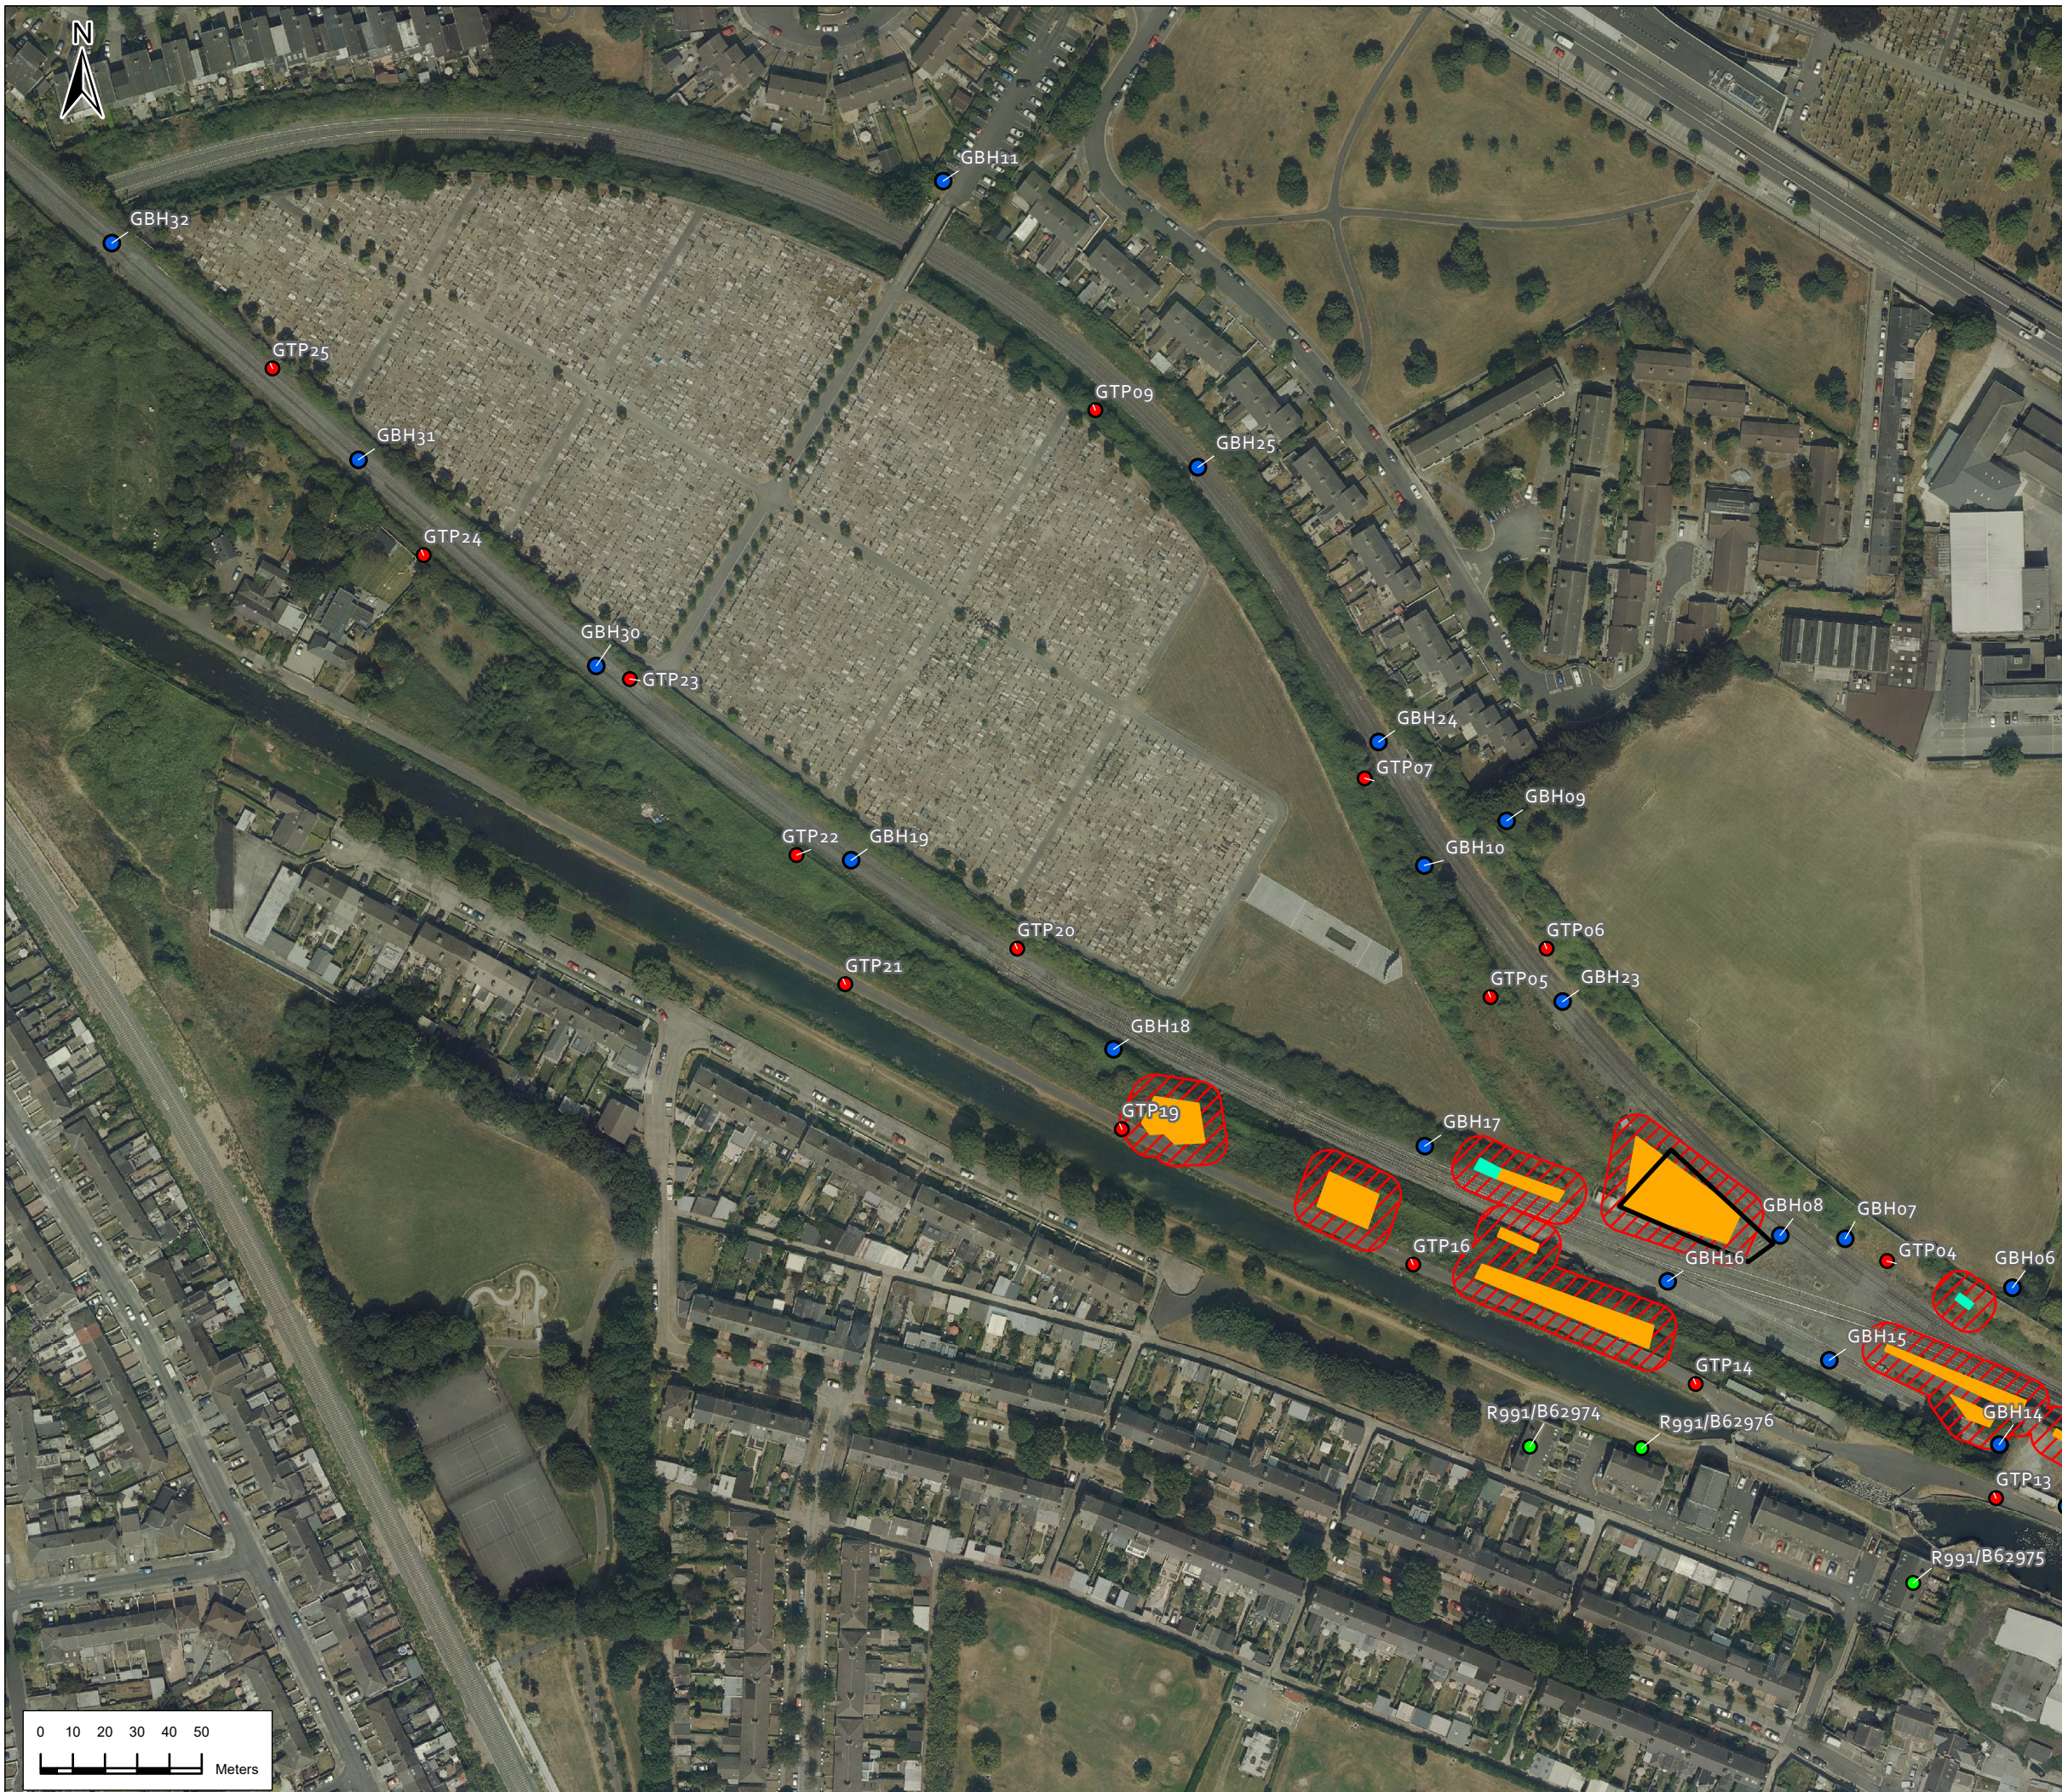
Drawing Title
**Invasive Species Survey Results
Sheet 1 of 2**

Japanese knotweed was recorded within 7m from two proposed G.I locations (GBH 14 and GTP19). An area proposed for the site compound was also heavily infested with Japanese knotweed and had been partially covered with stockpiled ballast stone. No other invasive species listed on the Third Schedule of the European Communities (Birds and Natural Habitats) Regulations (S.I. 477 of 2011) were recorded within or adjacent to any proposed G.I locations.

All locations where Japanese knotweed was recorded are shown on **Figure 1, Appendix A**. Further information on the infested areas are provided in **Table 3.1** and **3.2** below.

It is recommended to microsite GBH14 and GTP19 to locations outside the 7m exclusion zone. The proposed site compound is partially within an area heavily infested with Japanese knotweed. If the site is not relocated there is a high risk of potential contamination of vehicles and plant, and spread of this invasive species. **Section 4.1** provides recommendations for site hygiene and measures to prevent the spread of Japanese knotweed during GI works.

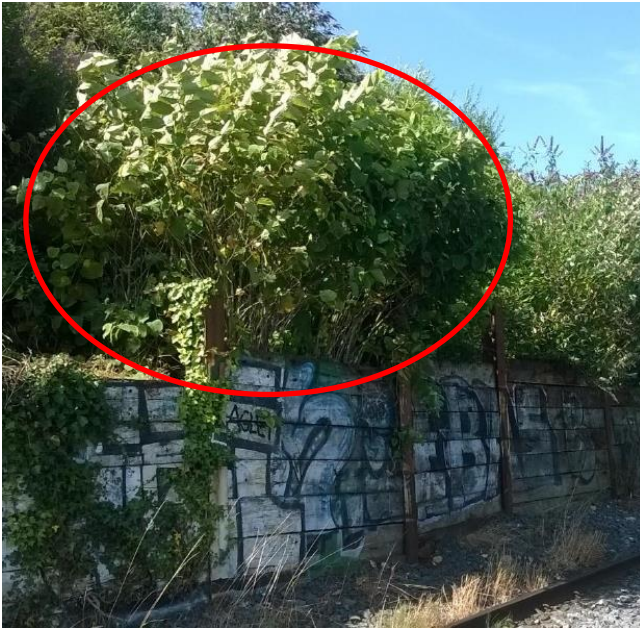
Photograph A1: Japanese knotweed recorded behind retaining wall south of the railway track during previous Irish Rail surveys

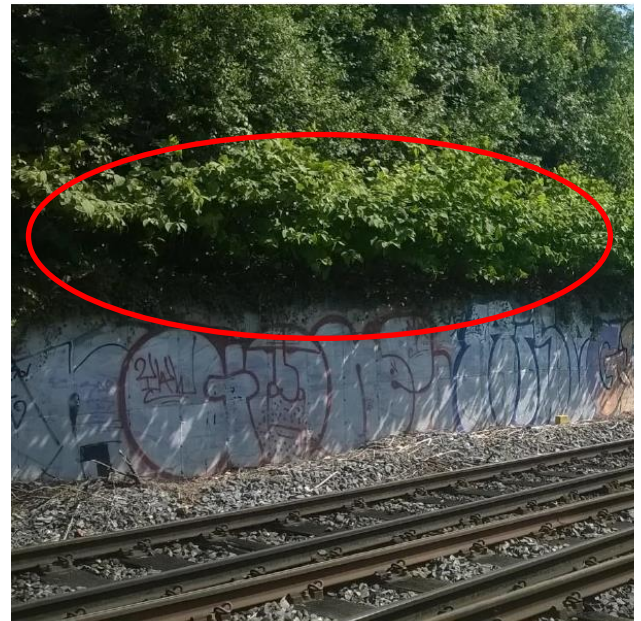
Photograph A2: Japanese knotweed recorded behind retaining wall at the boundary with Glasnevin cemetery during previous Irish Rail surveys

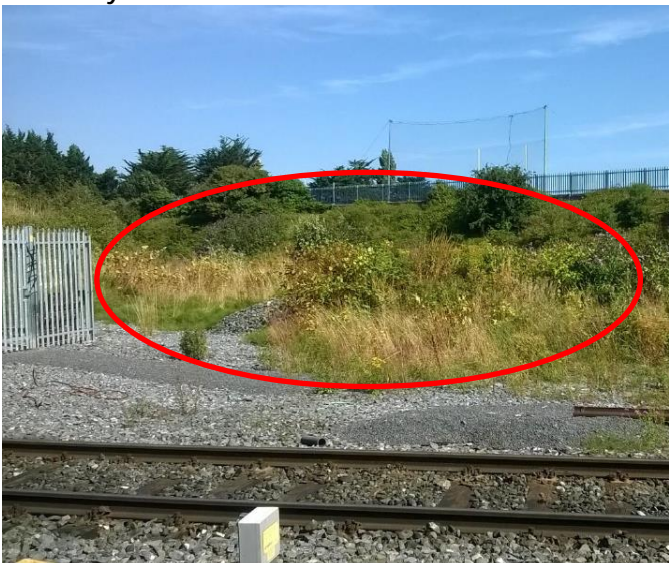
Photograph A3: Japanese knotweed recorded at the V in Glasnevin rail junction during previous Irish Rail surveys (proposed compound location)

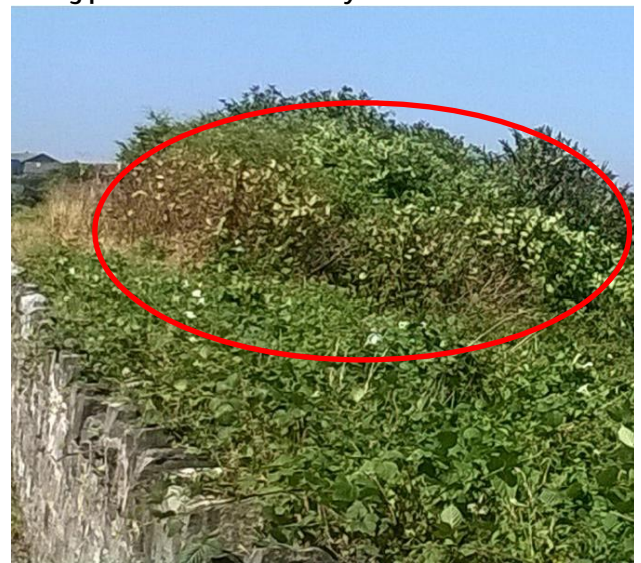
Photograph A4: Japanese knotweed recorded along the canal tow path during previous Irish Rail surveys

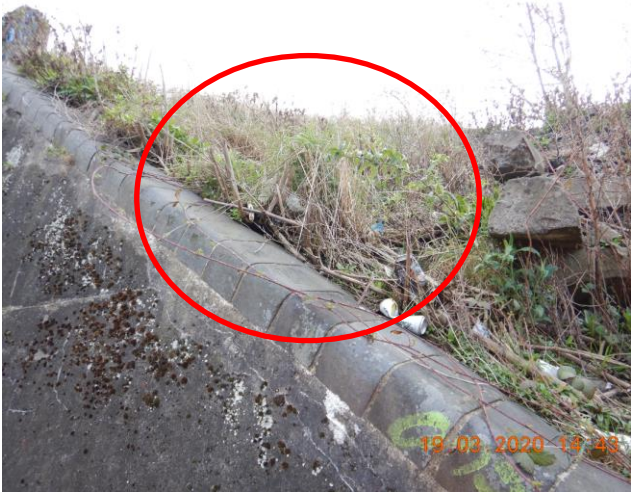
Photograph A5: Japanese knotweed recorded along the access ramp at Glasnevin rail junction during Jacobs invasive species surveys

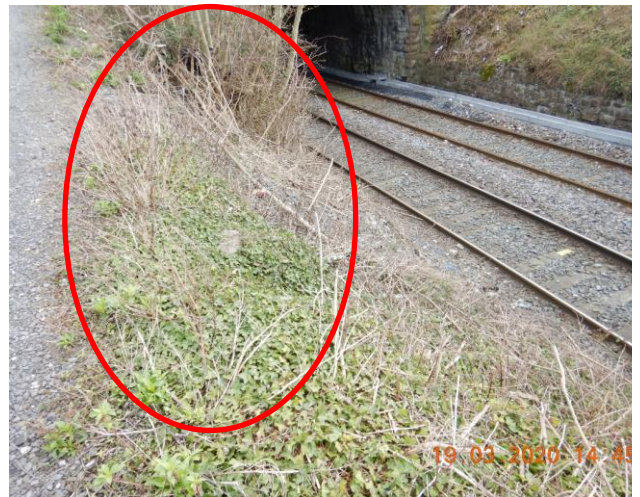
Photograph A5: Japanese knotweed recorded south of the access ramp during Jacobs invasive species surveys
