**Archaeological
Geophysical Survey
Report – St Stephen's
Green to Lissenhall**

**St. Stephen's Green to Lissenhall,
MetroLink,
Dublin**

Archaeological Geophysical Survey

EAG 372

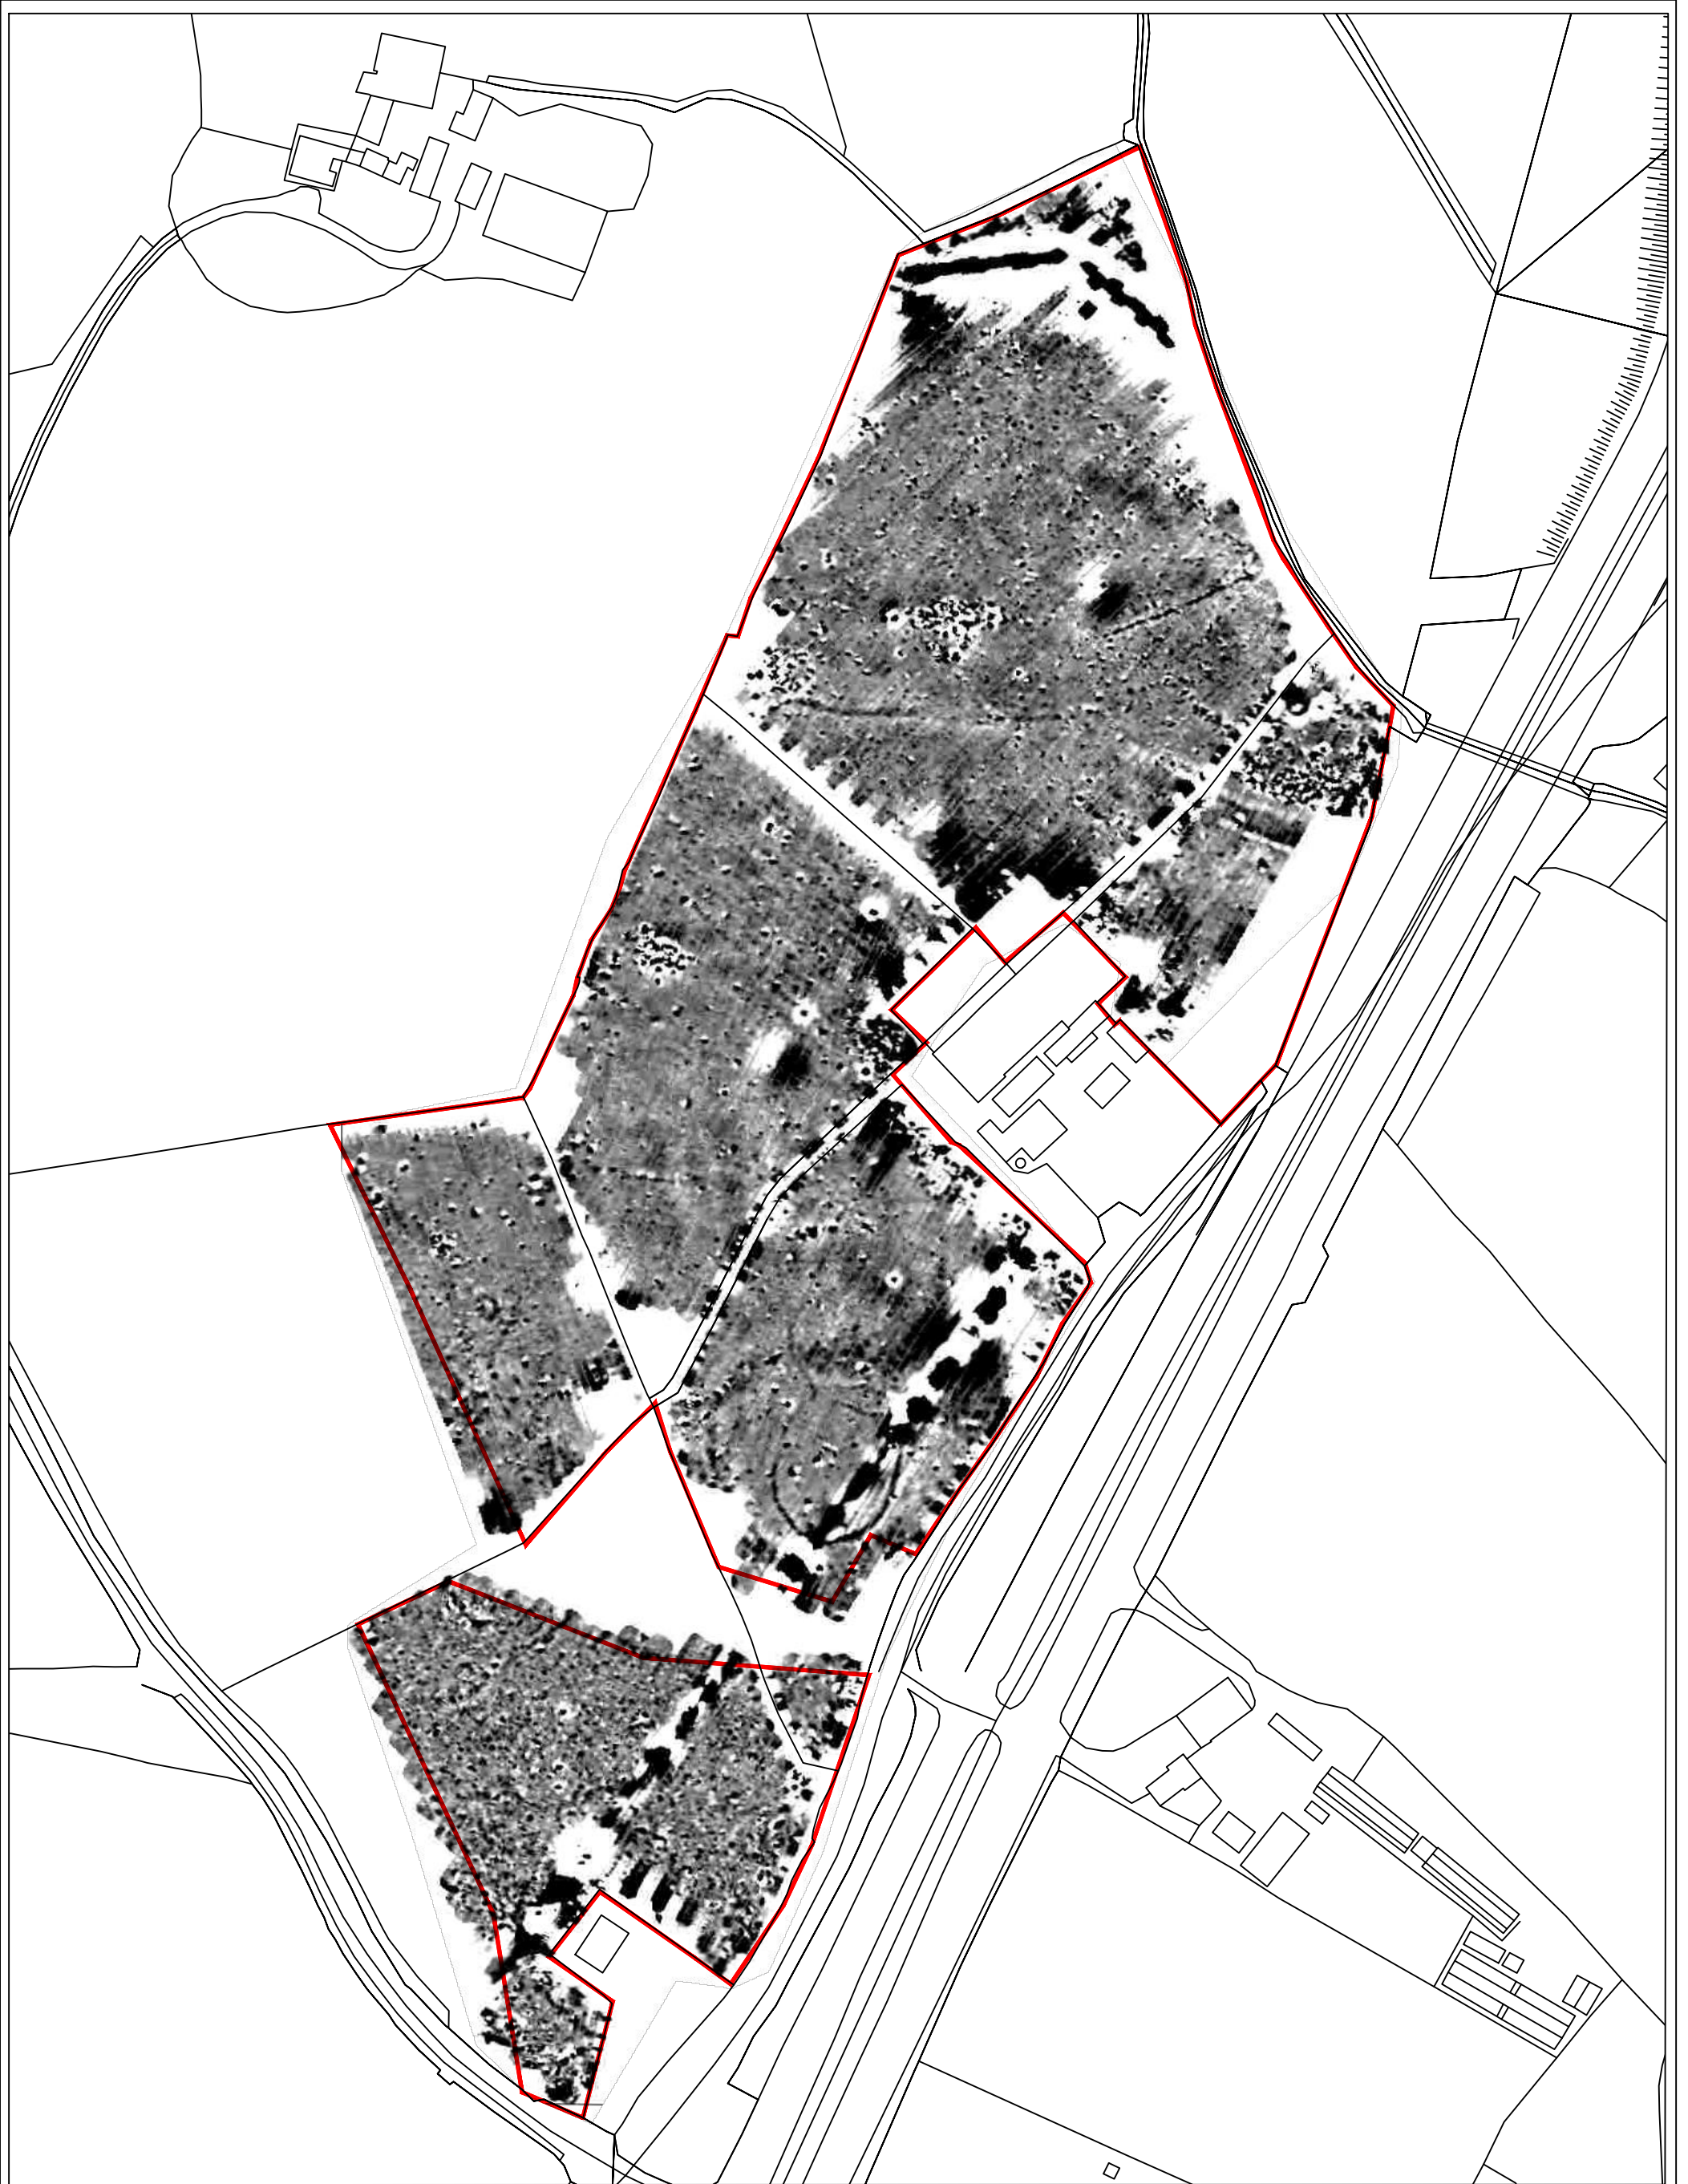
Method of Assessment:		Magnetometer					Site:	Lissenhall			
Site Description:		Pasture field containing short grass, tree stumps, fallen trees and nettles.									
Figure No.:		7 & 8									
No.	Form of Anomaly	ITM (E,N)	Possible Source(s) of Anomaly					Comment	Recommendation		
			Ditch	Archaeology	? Archaeology	Ferrous	Geology / Soils		Interference / Modern	Test Excavation	Geophysical Survey
M1	Four sub-oval areas of magnetic enhancement	718861.445,748907.138 Multiple locations					✓		Four roughly oval areas of magnetic enhancement, measuring up to 29m in diameter and located near the northeastern field boundary. May be associated with magnetically enhanced soils caused by agricultural, archaeological or geological activities.	✓	
M2	Highly magnetic linear	718896.770,748833.706	✓		✓			✓	Possible ditch or cut feature, measuring c. 44m SW-NE. This feature roughly coincides with a topographical depression (visible in LiDAR data) and may be archaeological or agricultural in origin.	✓

Method of Assessment:		Magnetometer						Site:	Lissenhall		
Site Description:		Pasture field containing short grass, tree stumps, fallen trees and nettles.									
Figure No.:		7 & 8									
No.	Form of Anomaly	ITM (E,N)	Possible Source(s) of Anomaly					Comment	Recommendation		
			Ditch	Archaeology	? Archaeology	Ferrous	Geology / Soils		Interference / Modern	Test Excavation	Geophysical Survey
M7	L-shaped highly magnetic anomaly	718891.650,748811.702	✓		✓				Possible ditch or cut feature, measuring c. 21.5m E-W and 24m NW-SE. May be related to M5.	✓	
M8	Positively magnetic linear and parallel negatively magnetic linear	718883.459,748794.559	✓		✓				Possible ditch (c. 25.7m NW-SE) and bank (c. 18.6m NW-SE) which appear to be connecting M5 and M9. This anomaly also coincides with the topographical expression mentioned above (and is visible in LiDAR data). Possible archaeology or agricultural in origin.	✓

M9	Two parallel negatively magnetic linears	718920.320,748774.858			✓				Two possible banks, walls or stone features, measuring c. 27.7m NW-SE and spaced roughly 6m apart. The northern linear appears to continue as M8 in the field to the east. M9 may be associated with a topographic expression and may be a trackway or possible archaeological feature.	✓	
M10	Two areas of magnetic enhancement	718920.320,748774.858					✓		Two areas of enhanced soil measuring up to c. 22m in diameter and located in the northeastern field. May be soil changes caused by agricultural, archaeological or geological activities.	✓	
M11	Positively magnetic curvilinear	718748.518,748704.232	✓		✓				Possible archaeological ditch or cut feature, c.18m NW-SE.	✓	
M12	Positively magnetic linear	718747.238,748666.364	✓		✓				Possible ditch or field drain, c. 107.5m E-W (cut by modern farm track). May be archaeology or agricultural in origin.	✓

Method of Assessment:		Magnetometer						Site:	Lissenhall		
Site Description:		Pasture field containing short grass, tree stumps, fallen trees and nettles.									
Figure No.:		7 & 8									
No.	Form of Anomaly	ITM (E,N)	Possible Source(s) of Anomaly					Comment	Recommendation		
			Ditch	Archaeology	? Archaeology	Ferrous	Geology / Soils		Interference / Modern	Test Excavation	Geophysical Survey
M17	Positively magnetic curvilinear	718770.020,748625.938			✓		✓		Possible ditch or cut feature, c. 6.6m NW-SE, may be archaeology or agricultural in origin.	✓	
M18	Positively magnetic linear	718766.180,748617.751	✓		✓				Possible ditch or cut feature, c. 15.6m NW-SE which runs from the field boundary into M21. Possible archaeology or of agricultural origin.	✓	
M19	Interconnecting sub-oval and curvilinear highly magnetic anomalies	718788.194,748602.399	✓	✓	✓				A sub-oval enclosure ditch, 38m NE-SW and 35m NW-SE, which may be connected to or is dissected by a curving ditch at the northern extent. The sub-oval enclosure sits on top of a topographical rise in the field with a gentle slope down all sides. It appears to be enclosed by M21 around the northwestern half and contains M20. A modern services pipe cuts through the enclosure in SW-NE direction. The highly magnetic nature of the anomaly M19 suggests it might contain burnt or fired remains.	✓

M24	Highly magnetic curvilinear	718698.602,748620.309	✓		✓				Possible ditch, c. 39m N-S. May be of archaeological or agricultural origin. The highly magnetic signature indicates the presence of burnt or fired deposits.	✓

Method of Assessment:		Magnetometer						Site:	Lissenhall		
Site Description:		Pasture field containing short grass, tree stumps, fallen trees and nettles.									
Figure No.:		7 & 8									
No.	Form of Anomaly	ITM (E,N)	Possible Source(s) of Anomaly					Comment	Recommendation		
			Ditch	Archaeology	? Archaeology	Ferrous	Geology / Soils		Interference / Modern	Test Excavation	Geophysical Survey
M25	Highly magnetic curvilinear	718686.828,748598.049	✓		✓				Possible dug features, c. 7.8m E-W and 10.6m N-S. May be of archaeological or agricultural origin and is likely to contain burnt or fired remains.	✓	
M26	Weakly magnetic curvilinear	718711.145,748602.911	✓		✓		✓		Possible ditch or cut feature, c. 14.8m SW-NE. May be of archaeological or agricultural origin and M26 may extend from M24.	✓	
M27	Weakly magnetic curvilinear	718707.050,748582.698	✓		✓		✓		Possible dug feature, c. 10m E-W. May be of archaeological or agricultural origin.	✓

M28	Highly magnetic linear	718717.710,748422.262	✓		✓				Possible ditch, c. 23.4m NW-SE which contains burnt or fired remains. May be of archaeological or agricultural origin.	✓	
	L-shaped highly magnetic anomaly	718865.959,748939.735						✓	A modern services pipe running across the northern corner of the northernmost field.		
	Linear highly magnetic anomaly	718816.906,748601.377						✓	A modern services pipe running in NE-SW direction through the two southeastern fields. Cuts through archaeological site M19/20/21.		
	Multiple linear and curvilinear magnetic trends	Multiple locations			✓		✓		Possible archaeological, agricultural or geological features.	✓	
	Multiple parallel positively magnetic linears	Multiple locations					✓		Cultivation furrows running mostly in NW-SE direction throughout the central and southern fields.		
	Areas of strongly magnetic responses	Multiple locations				✓		✓	Modern disturbance such as fencing materials, dumping against field boundaries, buried metal objects, electricity pole foundations.

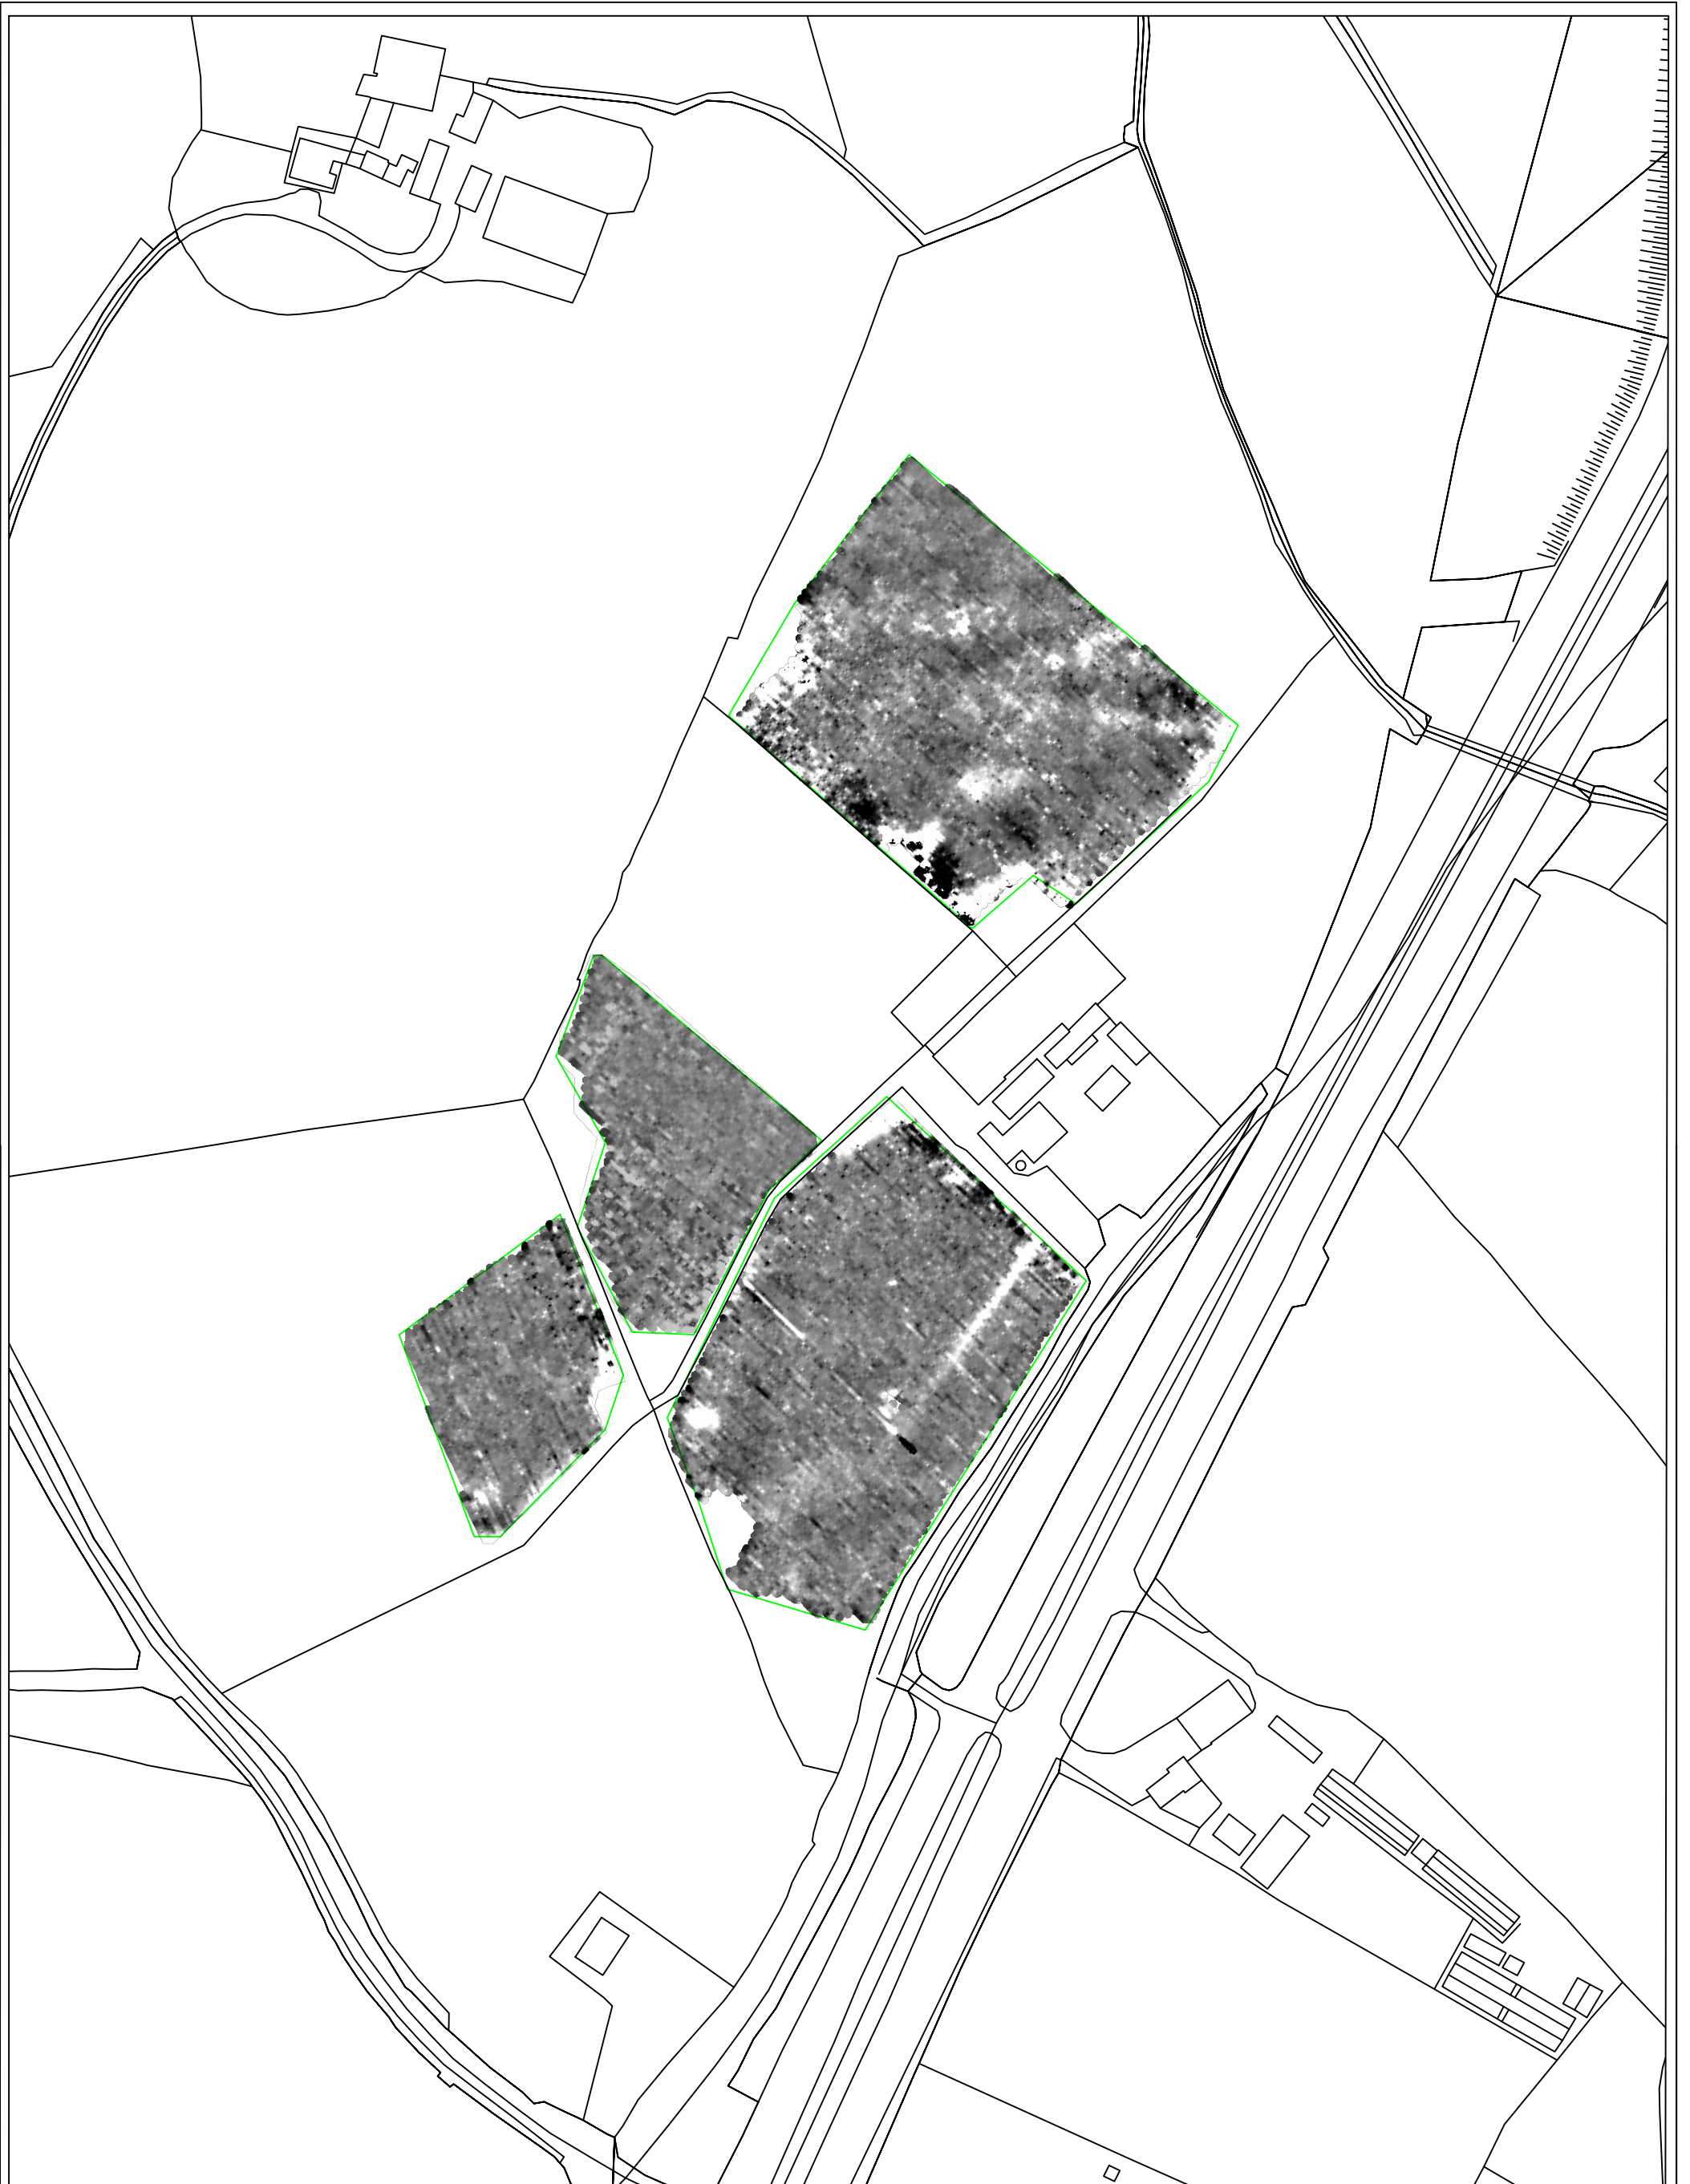
Method of Assessment:		Resistivity						Site:	Lissenhall		
Site Description:		Pasture field containing short grass, tree stumps, fallen trees and nettles.									
Figure No.:		9 & 10									
No.	Form of Anomaly	ITM (E,N)	Possible Source(s) of Anomaly					Comment	Recommendation		
			Ditch	Archaeology	? Archaeology	Ferrous	Geology / Soils		Interference / Modern	Test Excavation	Geophysical Survey
R29	Low resistivity linear	718821.271,748855.979	✓		✓		✓		Possible ditch or cut feature (c. 40.8m E-W).	✓	
R30	Two angular areas of raised resistivity	718836.335,748844.687			✓		✓		Possible compacted earth or stone areas, the larger measures c. 14.5m N-S and 17.5m E-W. The smaller area measuring c. 8m N-S and 7m E-W. Both features could be archaeological or geological in origin.	✓	
R31	Amorphous area of low resistivity	718811.746,748832.510			✓		✓		An area of disturbed ground or containing higher moisture content than the surrounding soil. This area measures c. 55m E-W and up to 12m N-S. The eastern section, which contains an irregular pit of very low resistivity, corresponds to an area of modern disturbance in the magnetometer data which cuts ditched anomaly M3.	✓

Method of Assessment:		Resistivity						Site:	Lissenhall		
Site Description:		Pasture field containing short grass, tree stumps, fallen trees and nettles.									
Figure No.:		9 & 10									
No.	Form of Anomaly	ITM (E,N)	Possible Source(s) of Anomaly					Comment	Recommendation		
			Ditch	Archaeology	? Archaeology	Ferrous	Geology / Soils		Interference / Modern	Test Excavation	Geophysical Survey
R38	Crescent shaped raised resistivity anomaly	718866.018,748810.369			✓		✓		Possible compacted earth or stone feature (c. 10.8m SE-NW and 4m NE-SW) which could be archaeological, agricultural or geological.	✓	
R39	Multiple high resistivity anomalies	718894.816,748810.148			✓				A crescent shaped compacted earth or stone feature (c. 9.8m diameter) and three irregular possible stone features (measuring between 2.5m and 6m in diameter). These features appear to coincide with magnetometer anomaly M7 and may relate to archaeology or geology.	✓

Method of Assessment:		Resistivity						Site:	Lissenhall		
Site Description:		Pasture field containing short grass, tree stumps, fallen trees and nettles.									
Figure No.:		9 & 10									
No.	Form of Anomaly	ITM (E,N)	Possible Source(s) of Anomaly					Comment	Recommendation		
			Ditch	Archaeology	? Archaeology	Ferrous	Geology / Soils		Interference / Modern	Test Excavation	Geophysical Survey
R47	High resistivity linear	718782.190,748808.868			✓			✓	Possible compacted earth or stone feature (c. 31.5m SW-NE) which runs through an area of possible modern disturbance and may be related to modern agricultural activities.	✓	
R48	Irregular high resistivity anomalies	718804.657,748775.608			✓		✓	Possible curvilinear compacted earth or stone feature (c. 11m diameter) connecting two irregular possible stone features (up to 6m and 9.5m in diameter). This feature could be geological or archaeological.	✓

Method of Assessment:		Resistivity						Site:	Lissenhall	
Site Description:		Pasture field containing short grass, tree stumps, fallen trees and nettles.								
Figure No.:		9 & 10								
No.	Form of Anomaly	ITM (E,N)	Possible Source(s) of Anomaly					Comment	Recommendation	
			Ditch	Archaeology	? Archaeology	Ferrous	Geology / Soils		Interference / Modern	Test Excavation
R58	Raised resistivity curvilinear	718824.286,748625.664			✓			Possible compacted earth or stone feature (c. 25m SW-NE) of archaeological, agricultural or geological origin.	✓	
R59	Low resistivity linear	718806.472,748618.579	✓		✓			Possible ditch or cut feature (c. 36.5m E-W). May be related to R56 and magnetometer anomaly M21.	✓	
R60	Low resistivity linear	718784.296,748613.128	✓	✓	✓			Possible ditch or cut feature (c. 22.5m NW-SE). Coincides with section of magnetometer anomaly M19 and is likely to be part of an archaeological enclosure ditch.	✓

Method of Assessment:		Resistivity					Site:	Lissenhall			
Site Description:		Pasture field containing short grass, tree stumps, fallen trees and nettles.									
Figure No.:		9 & 10									
No.	Form of Anomaly	ITM (E,N)	Possible Source(s) of Anomaly					Comment	Recommendation		
			Ditch	Archaeology	? Archaeology	Ferrous	Geology / Soils		Interference / Modern	Test Excavation	Geophysical Survey
R68	Raised resistivity curvilinear	718691.929,748589.530			✓		✓		Possible compacted earth or stone feature (c. 29m E-W). May be related to R67/69/72.	✓	
R69	Two raised resistivity curvilinears	718693.828,748608.991			✓		✓		Two segments of a possible sub-circular compacted earth or stone feature (c. 11m E-W and 10m N-S). May be related to R67/69/72 and could be archaeological in origin.	✓	
R70	Low resistivity curvilinear	718720.422,748621.015	✓		✓		✓		Possible ditch or cut feature (c. 45m N-S).	✓	
R71	Low resistivity curvilinear	718712.507,748608.832	✓		✓		✓		Possible sub-circular ditched feature with opening at north (c. 7m diameter) which may be archaeological or agricultural in origin.	✓

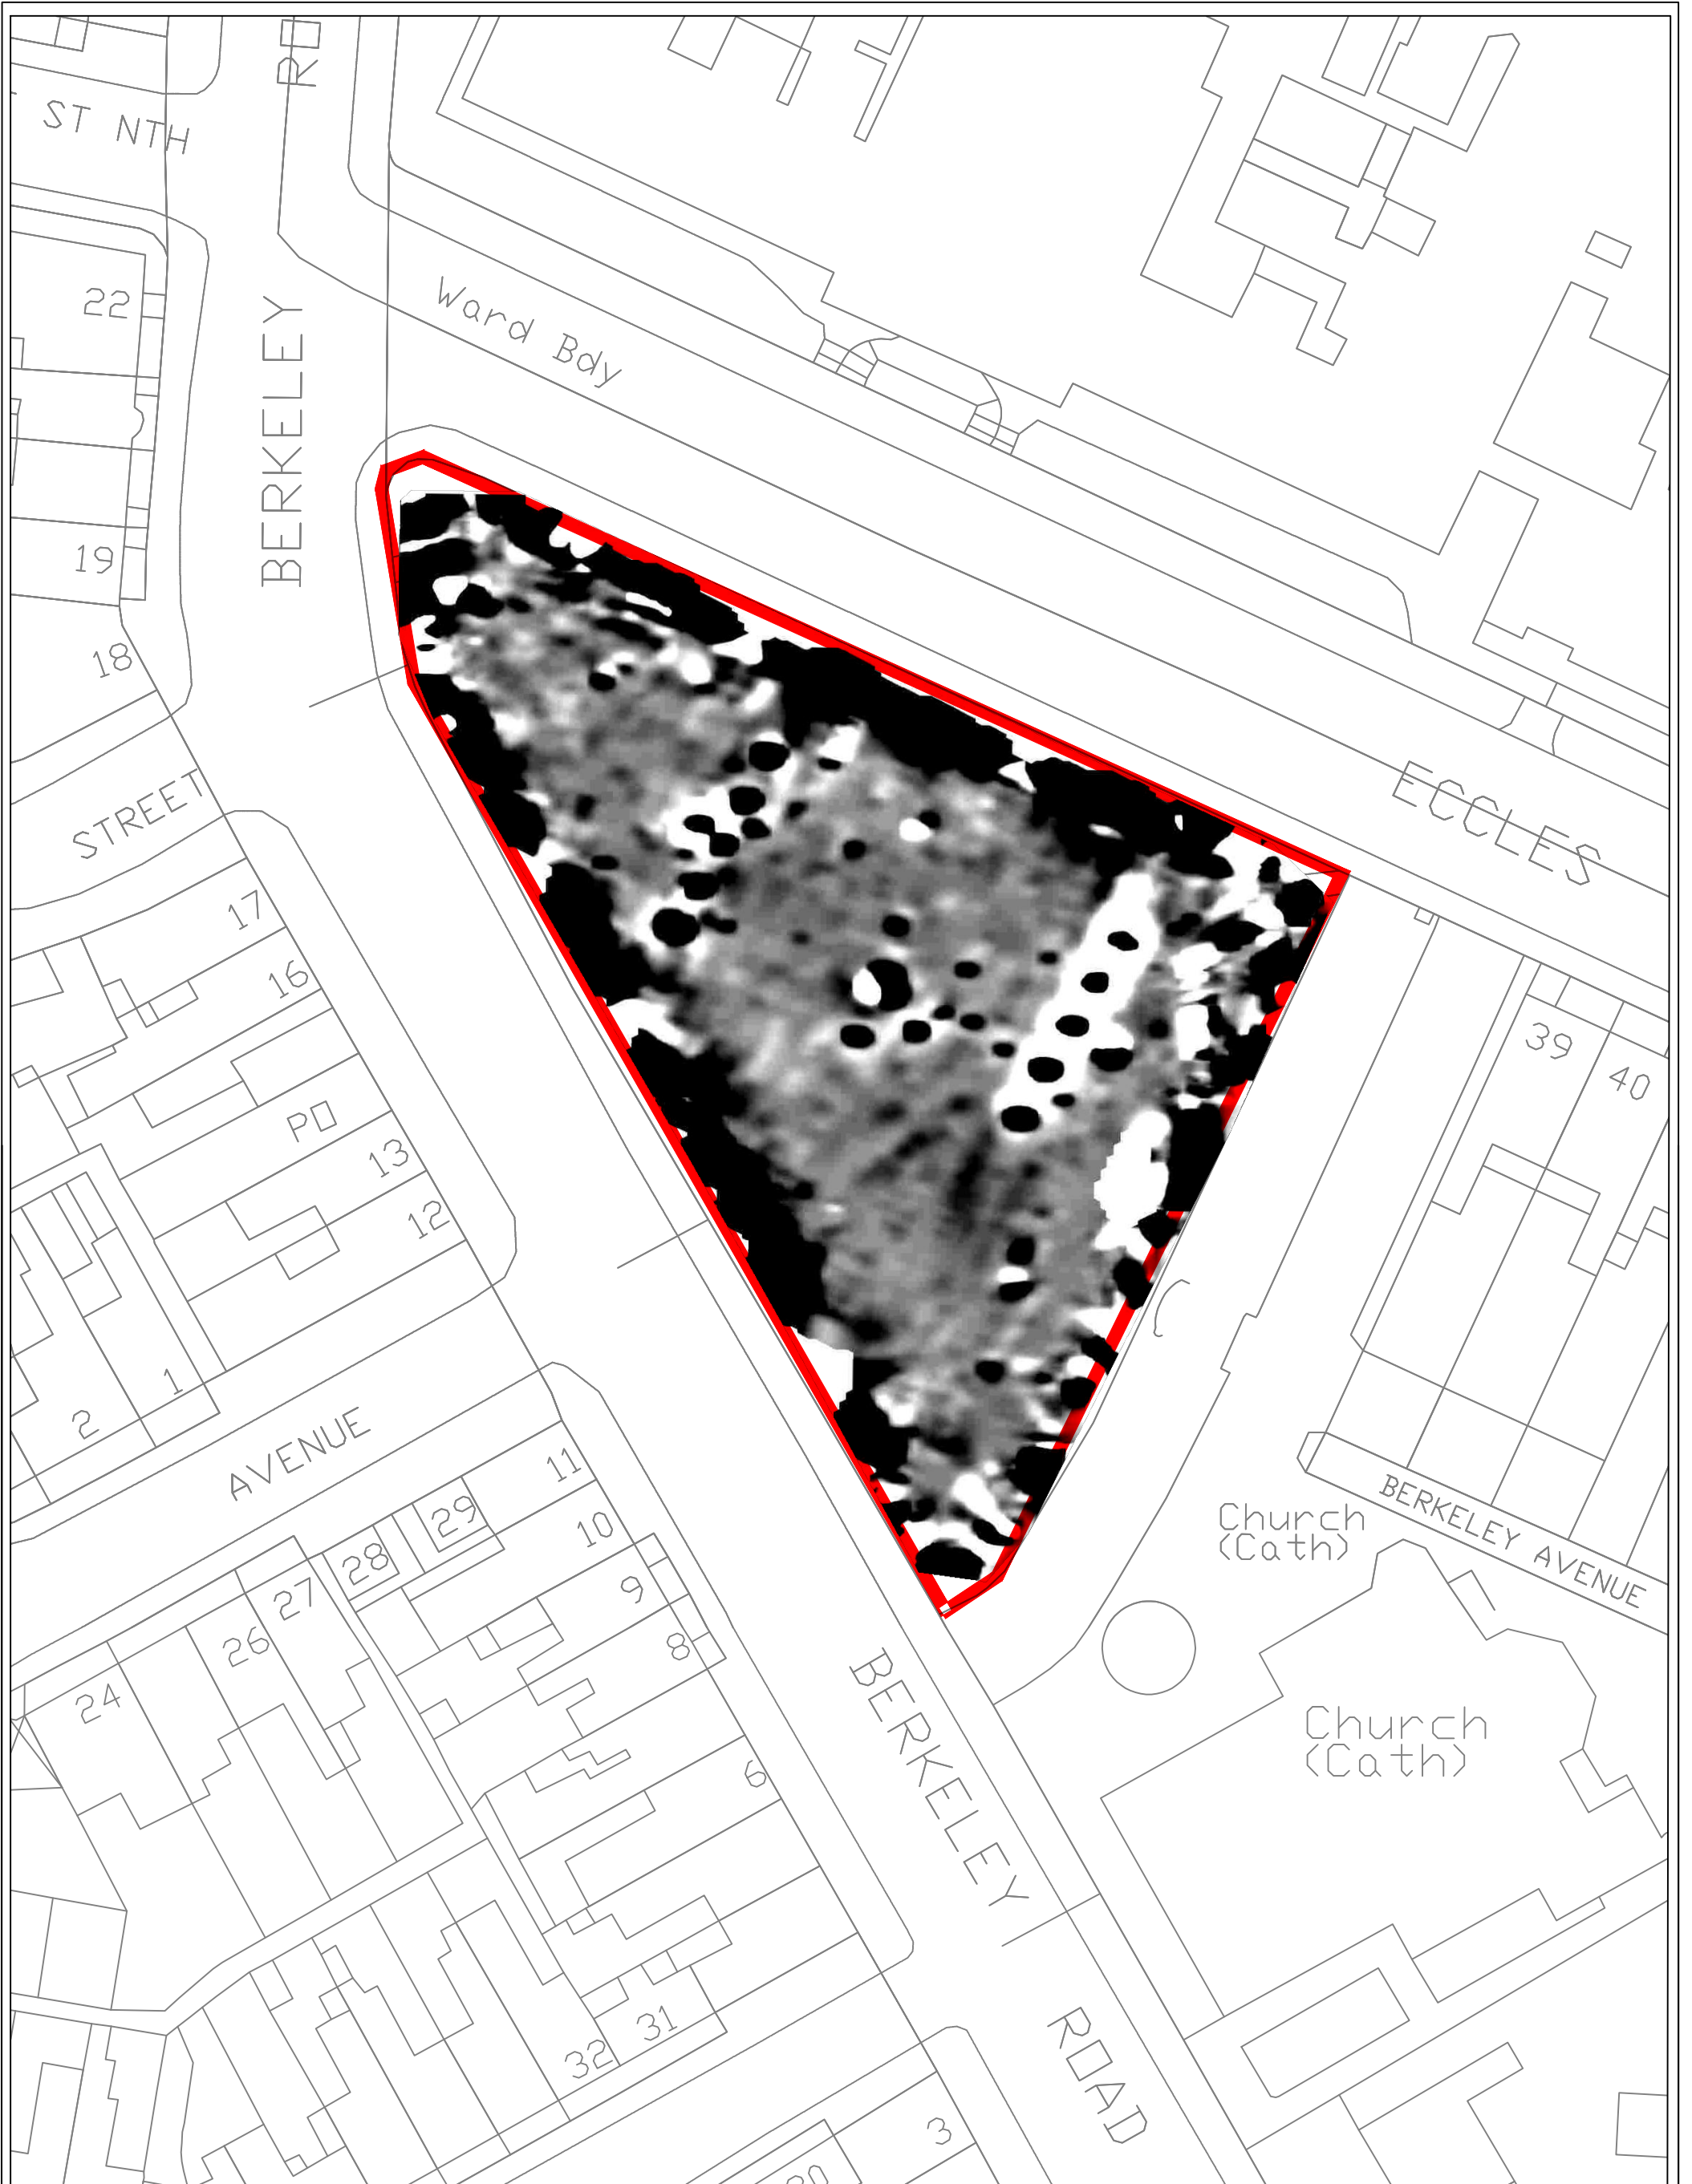
Method of Assessment:		Magnetometer					Site:	Mater			
Site Description:		Flat landscaped park containing short grass, trees, vegetation, metallic sculptures and gravel paths									
Figure No.:		21 & 22									
No.	Form of Anomaly	ITM (E,N)	Possible Source(s) of Anomaly					Comment	Recommendation		
			Ditch	Archaeology	? Archaeology	Ferrous	Geology / Soils	Interference / Modern		Test Excavation	Geophysical Survey
	Areas of very strong magnetic responses	Throughout the survey area						✓	<p>The highly magnetic responses along the edges of the survey area were caused mainly by the iron fence surrounding the park; however, there are also electricity cables and lights beside the trees along the fence. There is a metal sculpture connected to an underground gas pipe which shows up as highly magnetic disturbance in the northwest portion of the survey area.</p> <p>Further metallic remains and possible electric cables have been detected in the form of highly magnetic disturbance. Other isolated dipoles anomalies located in the centre of the survey area are likely caused by buried metal objects of modern origin.</p> <p>Overall the high level of magnetic disturbance may have masked any potential archaeology present.</p>

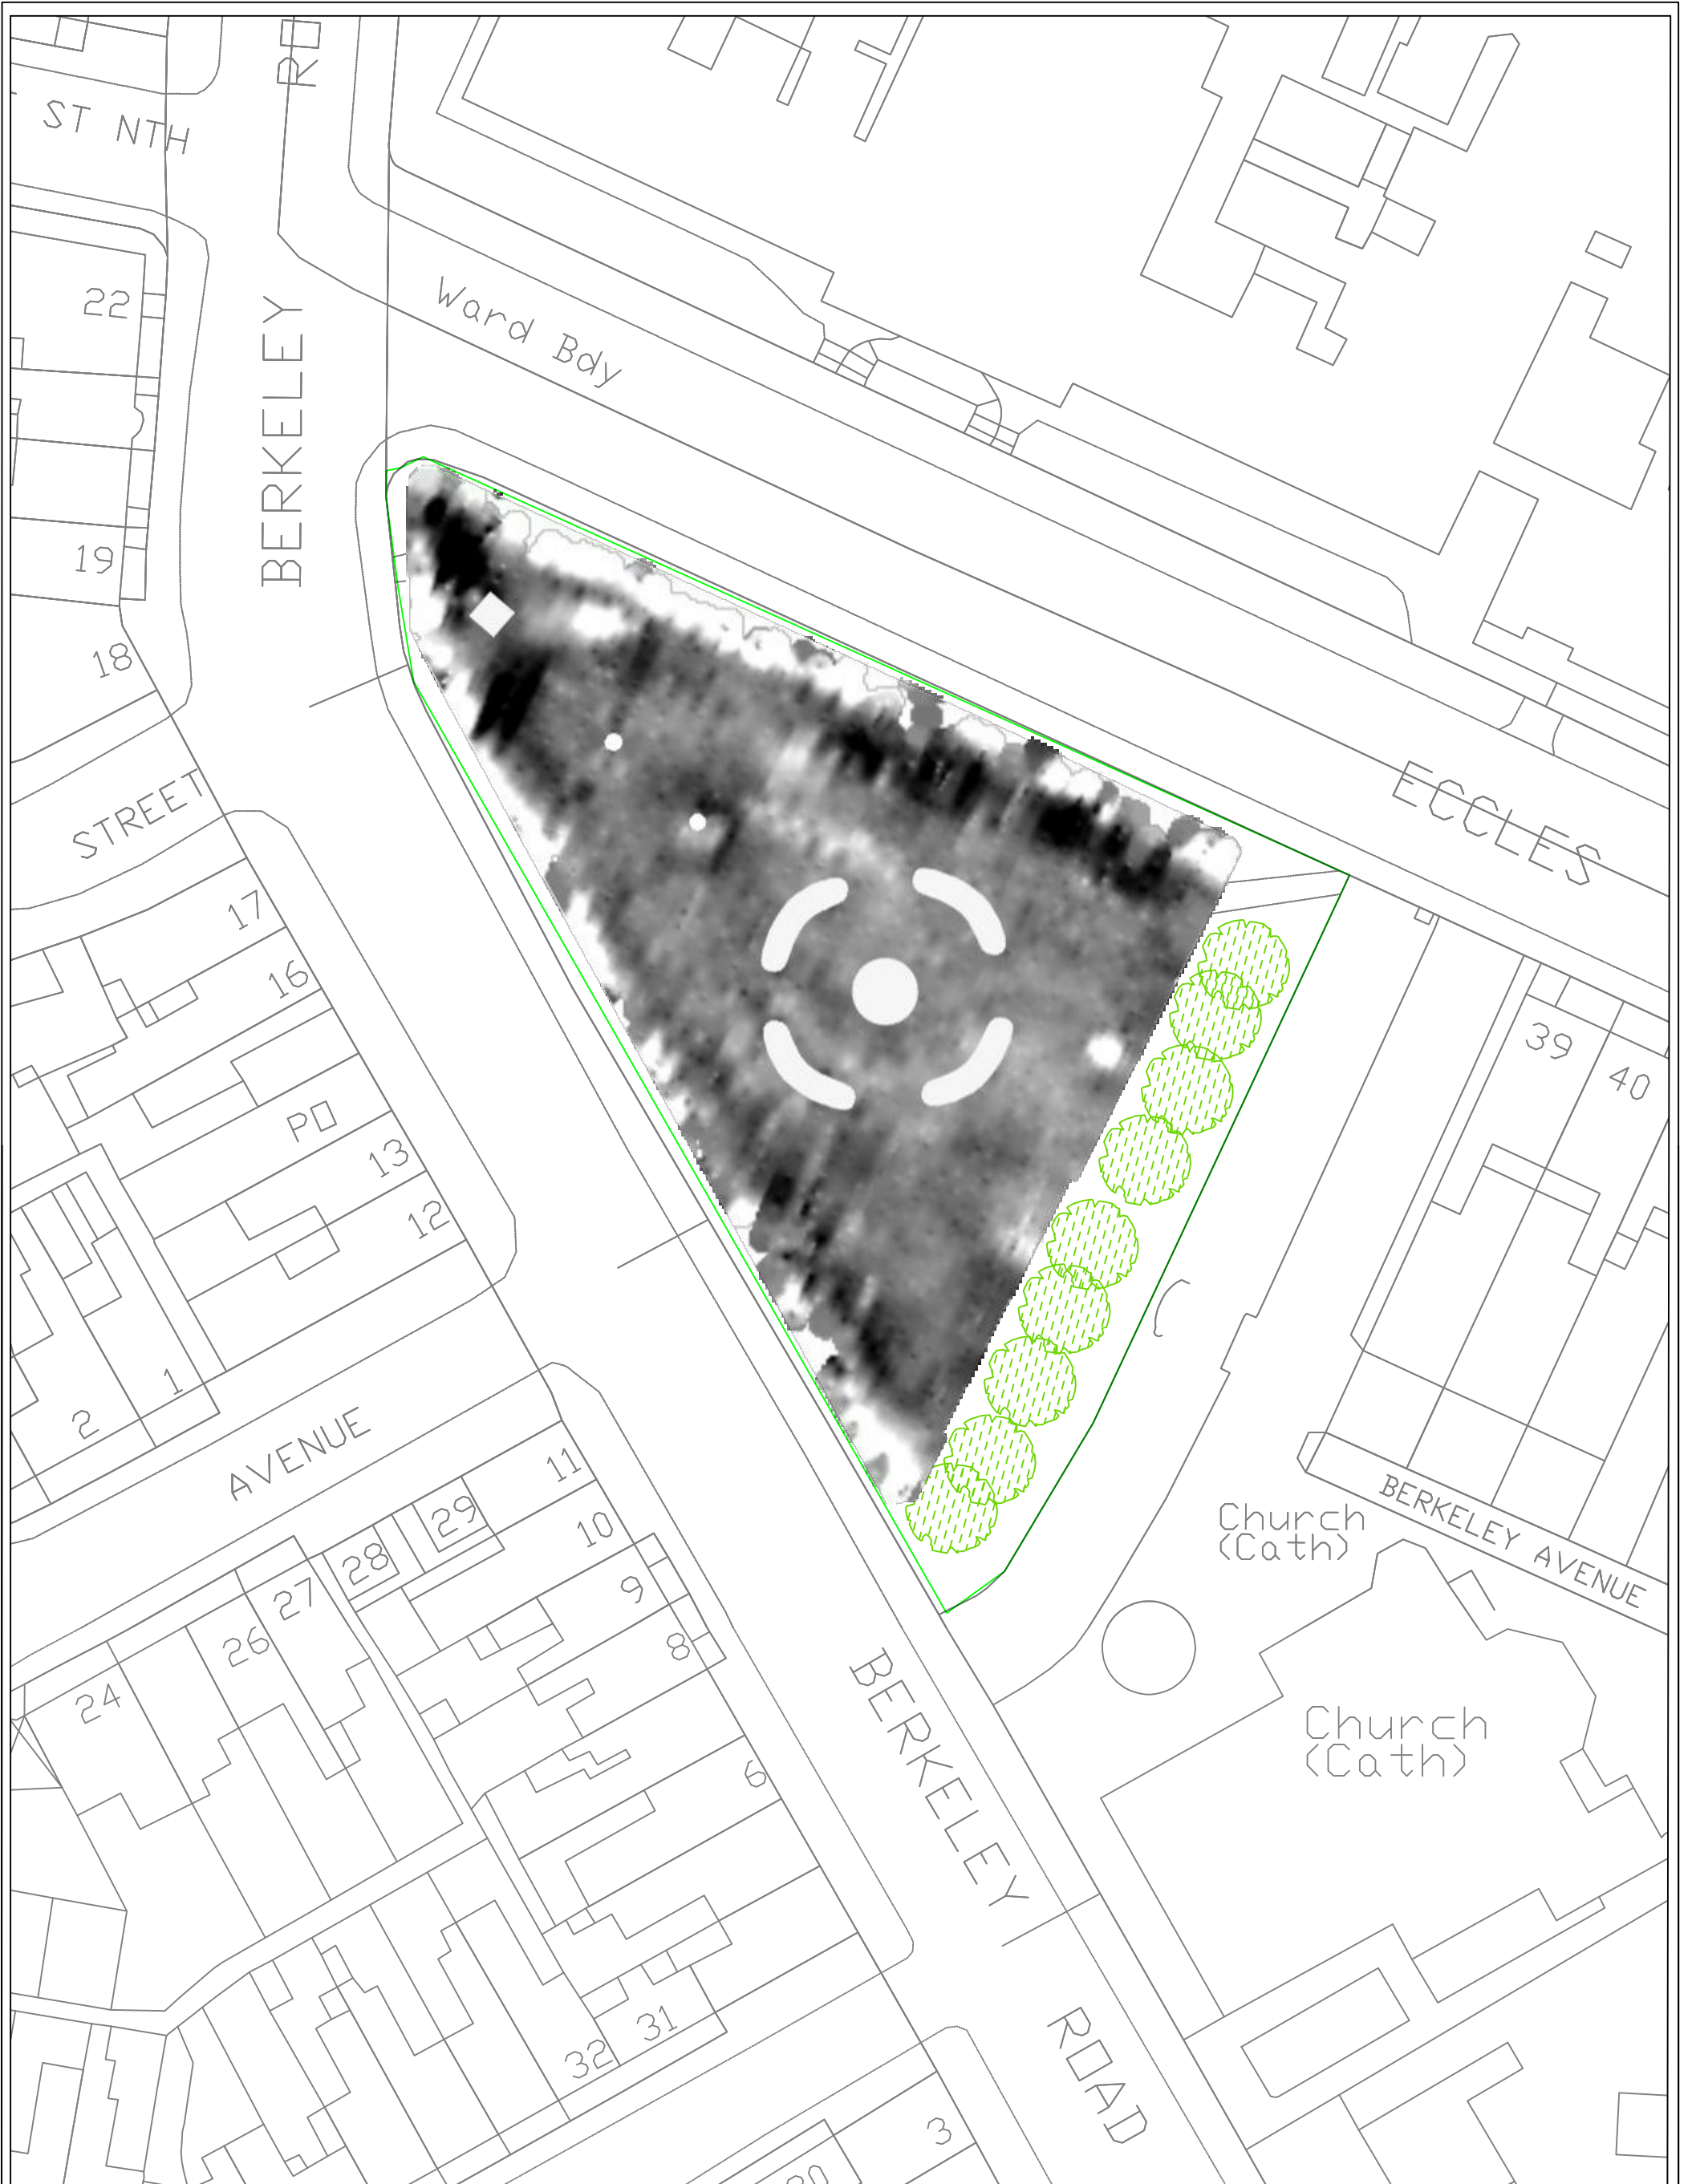
Method of Assessment:		Resistivity						Site:	Mater		
Site Description:		Flat landscaped park containing short grass, trees, vegetation, metallic sculptures and gravel paths									
Figure No.:		23 & 24									
No.	Form of Anomaly	ITM (E,N)	Possible Source(s) of Anomaly					Comment	Recommendation		
			Ditch	Archaeology	? Archaeology	Ferrous	Geology / Soils		Interference / Modern	Test Excavation	Geophysical Survey
R1	Three isolated high resistivity anomalies	715182.131,735711.312 715182.040,735706.722 715186.393,735700.849			✓			✓	Three areas of compacted earth or stone located around the upstanding cross monument in the northern corner of the survey area. Two large area measuring c. 10.2m x 4.3m and 8.7m x 4.2m and one small area c. 1.6m in diameter. It is likely that these anomalies are associated with the monument or park construction.	✓	
R2	Two isolated low resistivity anomalies	715193.200,735706.490 715198.450,735705.685			✓			✓	Two possible dug features in the northern section of the survey area. One measuring c. 6.6m x 2.5m and the other is c. 2m in diameter. These are located adjacent or under the present pathway within the park. They could be archaeological in origin or associated with the construction of the park.	✓

R3	Three isolated raised resistivity anomalies	715202.043,735694.216 715198.865,735702.922 715192.163,735692.627			✓			✓	Two large (11.7m x 3.9m and 9.7m x 3m) and one small (c. 1.2m diameter) area of compacted earth or stone which may be archaeological in origin or associated with the construction of the park.	✓	
R4	Raised resistivity linear	715198.761,735675.033						✓	Linear compacted earth or stone feature measuring c. 62m in length which coincides with the location of the path along the southwestern edge of the park. It is likely that this anomaly has been caused by the path or its foundations.		
R5	Raised resistivity linear	715224.738,735692.210						✓	Linear compacted earth or stone feature measuring c. 32.5m in length and coinciding with the location of the path along the northern edge of the park. It is likely that this anomaly has been caused by the path or its foundations.		
R6	Two interconnecting low resistivity linears	715198.932,735680.084	✓					✓	Possible shallow ditches measuring c. 62m NW-SE and 15m NE-SW. They run along the side of the present day paths and although they could be archaeological in origin it is more likely to be associated with the park construction or park services.	✓

Method of Assessment:		Resistivity						Site:	Mater		
Site Description:		Flat landscaped park containing short grass, trees, vegetation, metallic sculptures and gravel paths									
Figure No.:		23 & 24									
No.	Form of Anomaly	ITM (E,N)	Possible Source(s) of Anomaly					Comment	Recommendation		
			Ditch	Archaeology	? Archaeology	Ferrous	Geology / Soils		Interference / Modern	Test Excavation	Geophysical Survey
R7	Low resistivity linear	715221.318,735690.655							Possible shallow ditch measuring c. 26m in length and running along the path along the northern edge of the park. This feature is similar in origin to R6.	✓	
R8	Three linear and curvilinear raised resistivity anomalies	715229.558,735680.239 715221.007,735687.701 715198.932,735686.613			✓		✓	✓	Three compacted earth or stone features up to 29m in length. These may be associated with a former park layout or archaeological features.	✓

Areas of very high resistivity disturbance	Along the edges of the survey area and around sculpture						✓	Modern interference around the edges of the survey area is caused by a combination of fencing materials and foundations, underground cables or services along the edges of the. Interference within the centre of the pathways is caused by a central gas-sculpture.
