**MetroLink  
Archaeological Trial  
Testing Report  
- Lissenhall Area 1**

## **MetroLink – Estuary Park & Ride, Lissenhall Little/Balheary Demesne, Swords, Dublin**

### **Targeted Archaeological Test Excavations**

Licence No.: 19E0757

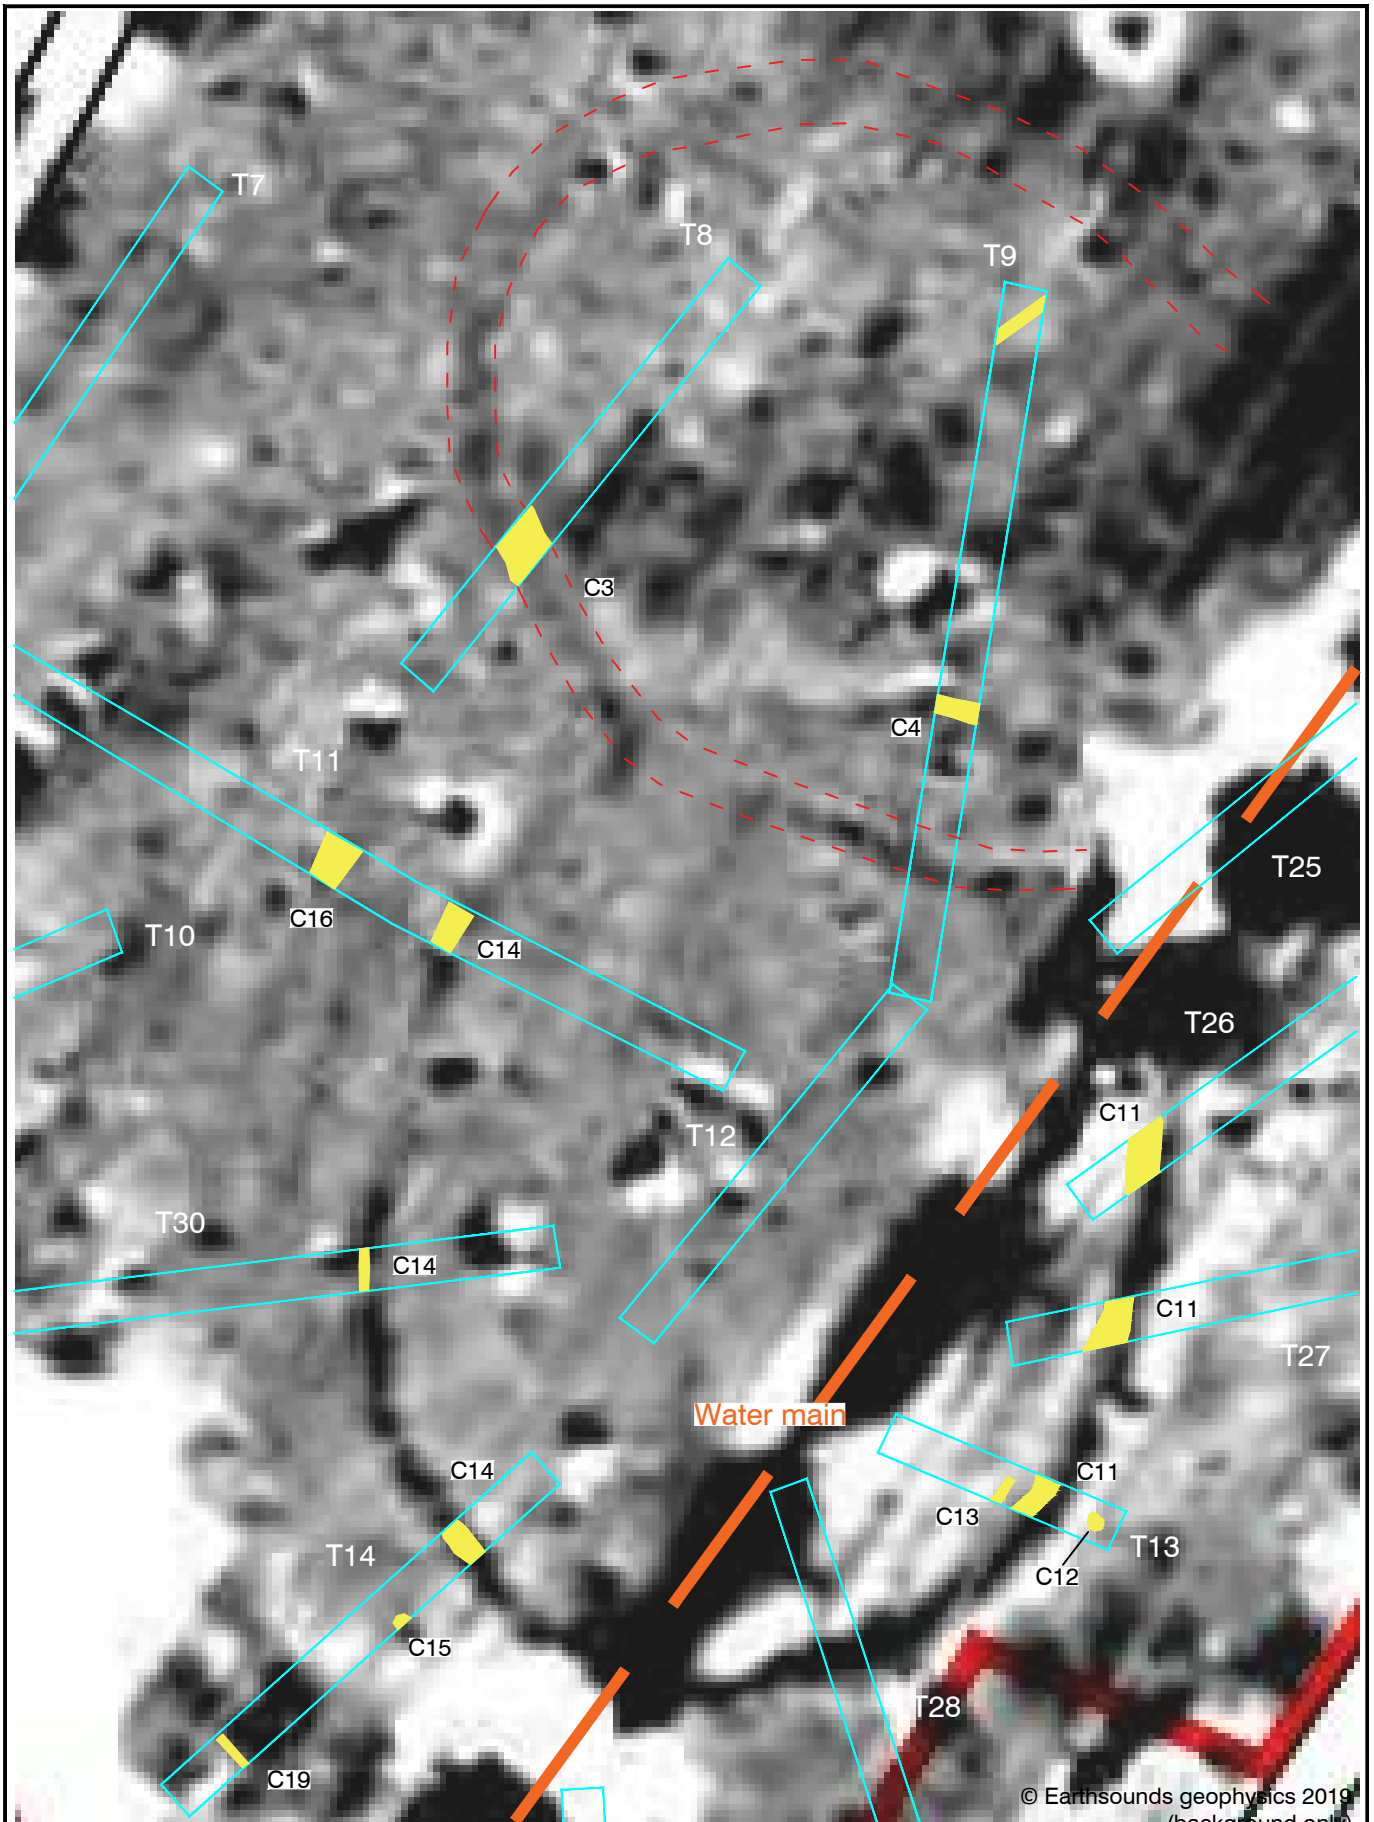
Figure 11: Area 1A – Detail of Test Trenches containing Archaeological Features, overlain on geophysical survey results grey scale image; Gimson & Garner 2019)

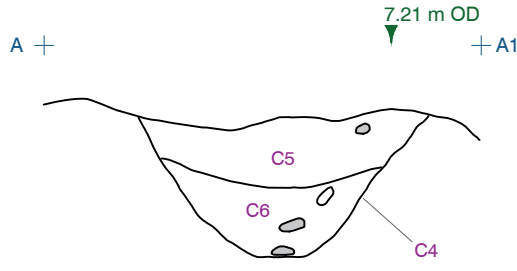
Area 1A - Section of trench 9 (east-facing)

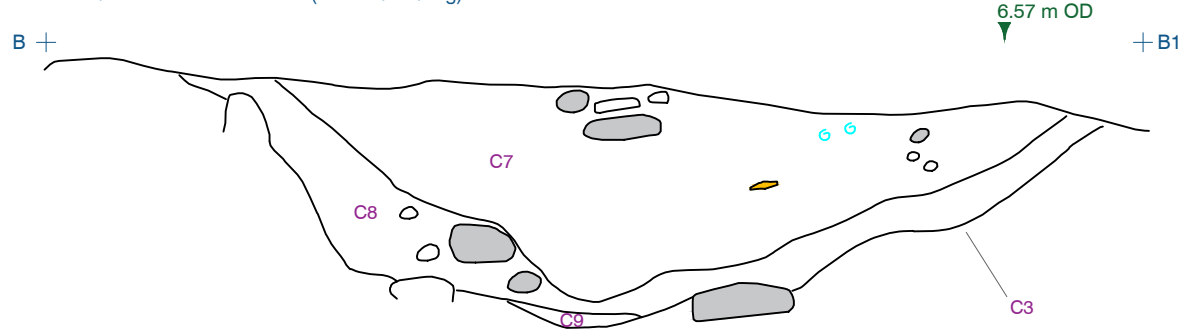
Area 1A - Section of trench 8 (southeast-facing)

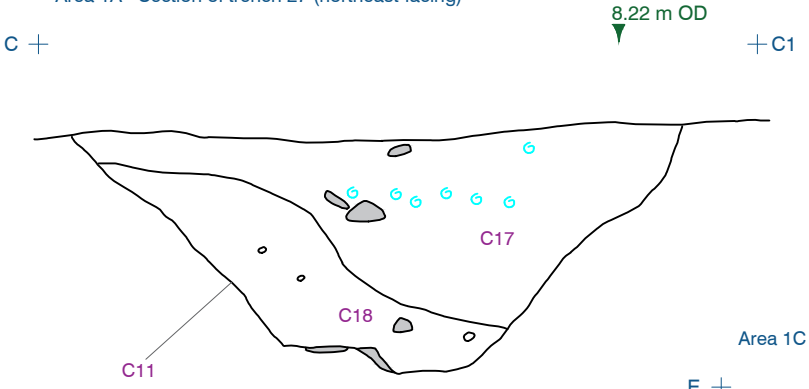
Area 1A - Section of trench 27 (northeast-facing)

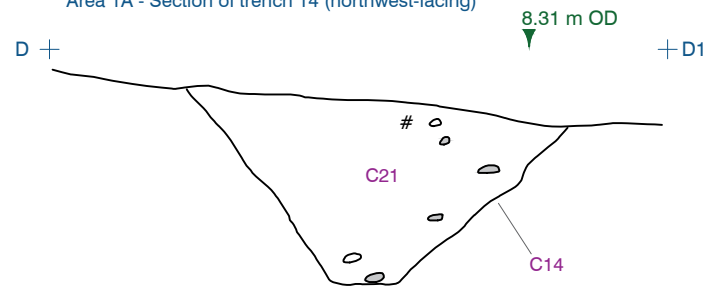
Area 1A - Section of trench 14 (northwest-facing)

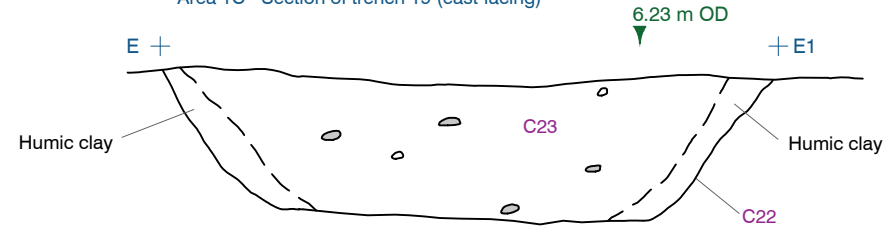
Area 1C - Section of trench 19 (east-facing)

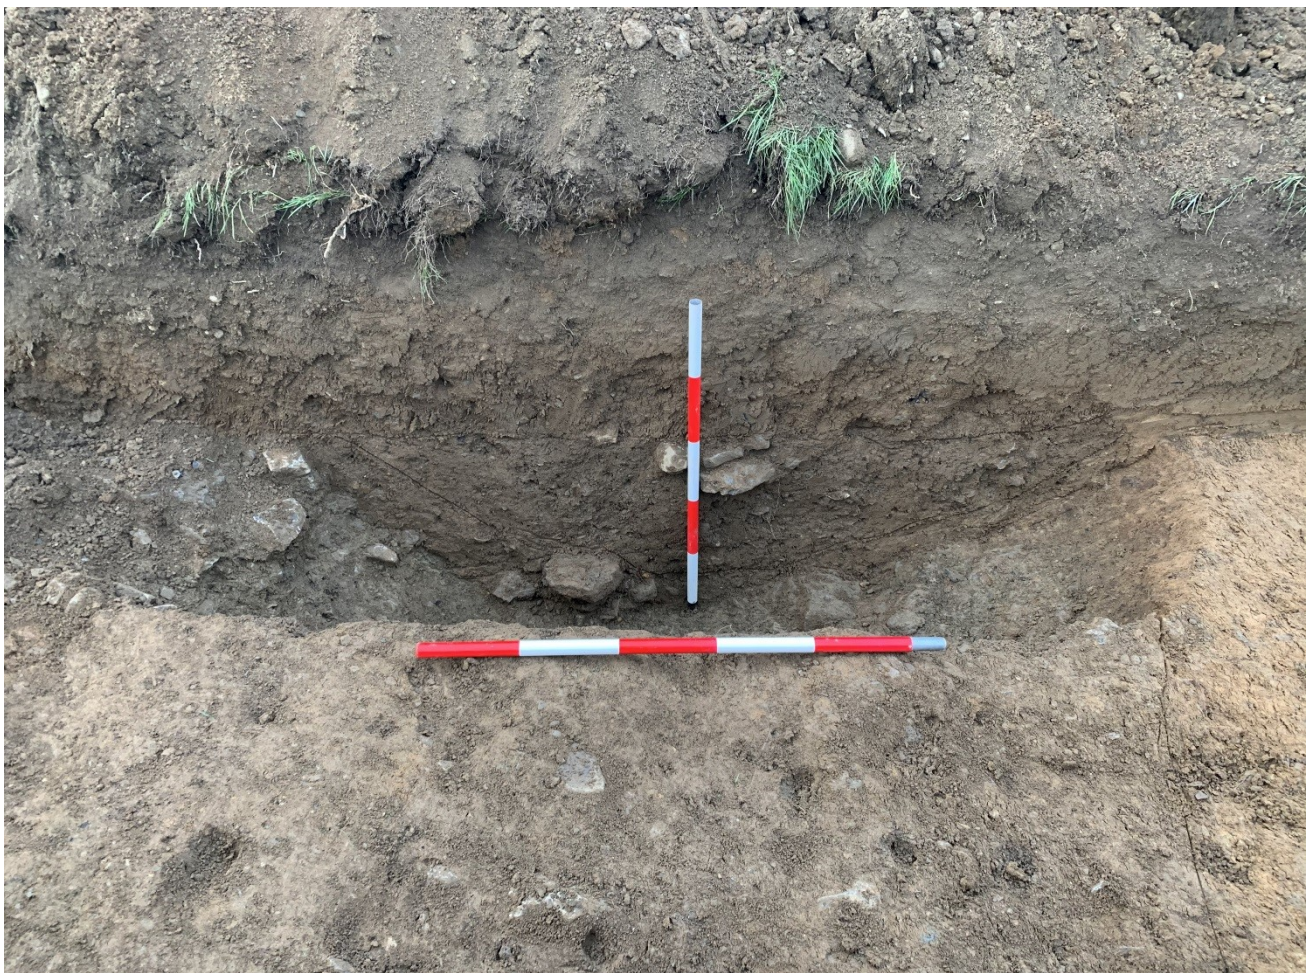
Plate 8: Area 1A: Test Trench 8, section through Ditch C3 facing west

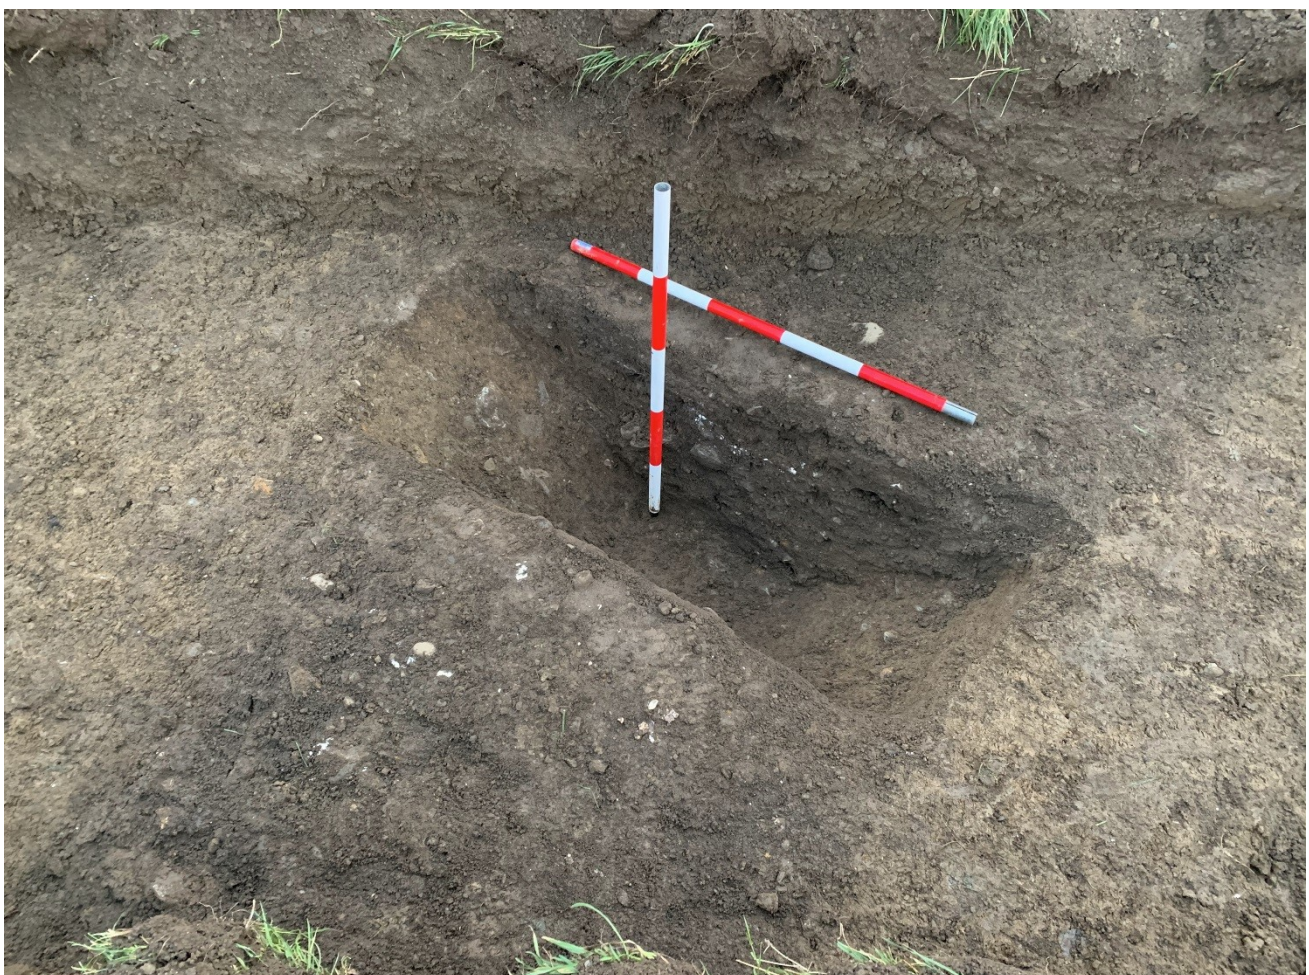
Plate 30: Area 1A: Test Trench 27, section through C11 facing south

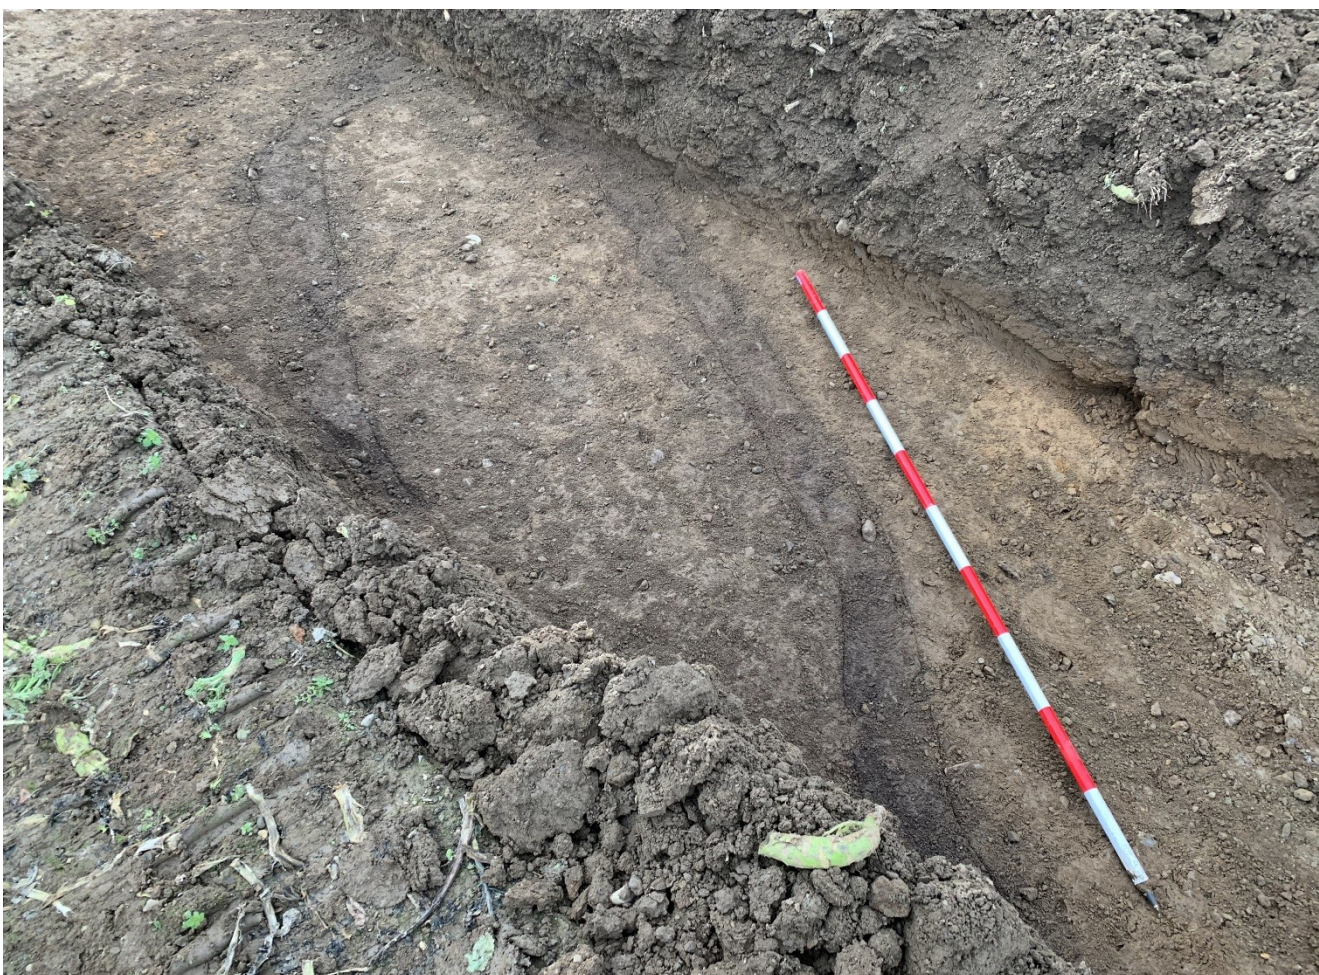
Plate 38: Area 1C: Test Trench 21, Ditch C22 facing southwest

| Context | Type | Description | Measurements | Associated Cut / Fill | Finds | Samples | Drawings | Plates |
|---|---|---|--|---|---|--|---|---|
| C22 | Cut | Cut of ditch or hedgerow in Test Trench 19, 20 & 21 in Area 1C aligned NE-SW. Ditch measures 1.6m in width and consists of loose brown clay defined by two narrow bands (one either side) of humic clay full of roots. Feature is on same alignment as a tree belt shown on the first edition 6 inch map and later 25 inch map (Figure 12). | 1.6m in width | C23 | Modern finds recovered from fill C23 | - | Figures 9 & 12 | Plate 38 |

| Context | Type | Description | Measurements | Associated Cut / Fill | Finds | Samples | Drawings | Plates |
|---|---|--|---|---|---|---|---|---|
| C23 | Deposit | Fill of hedgerow C22 in Test Trenches 19-21. Consists of loose brown clay defined by two bands (one either side) of humic clay full of roots. Modern finds recovered from fill. Feature is on same alignment as a tree belt shown on the first edition 6 inch map and later 25 inch map (Figure 12). | 1.6m in width | C22 | 5 Body sherds of glazed white earthenware – 19 <sup>th</sup> /20 <sup>th</sup> century in date. | - | Figures 9 & 12 | Plate 38 |

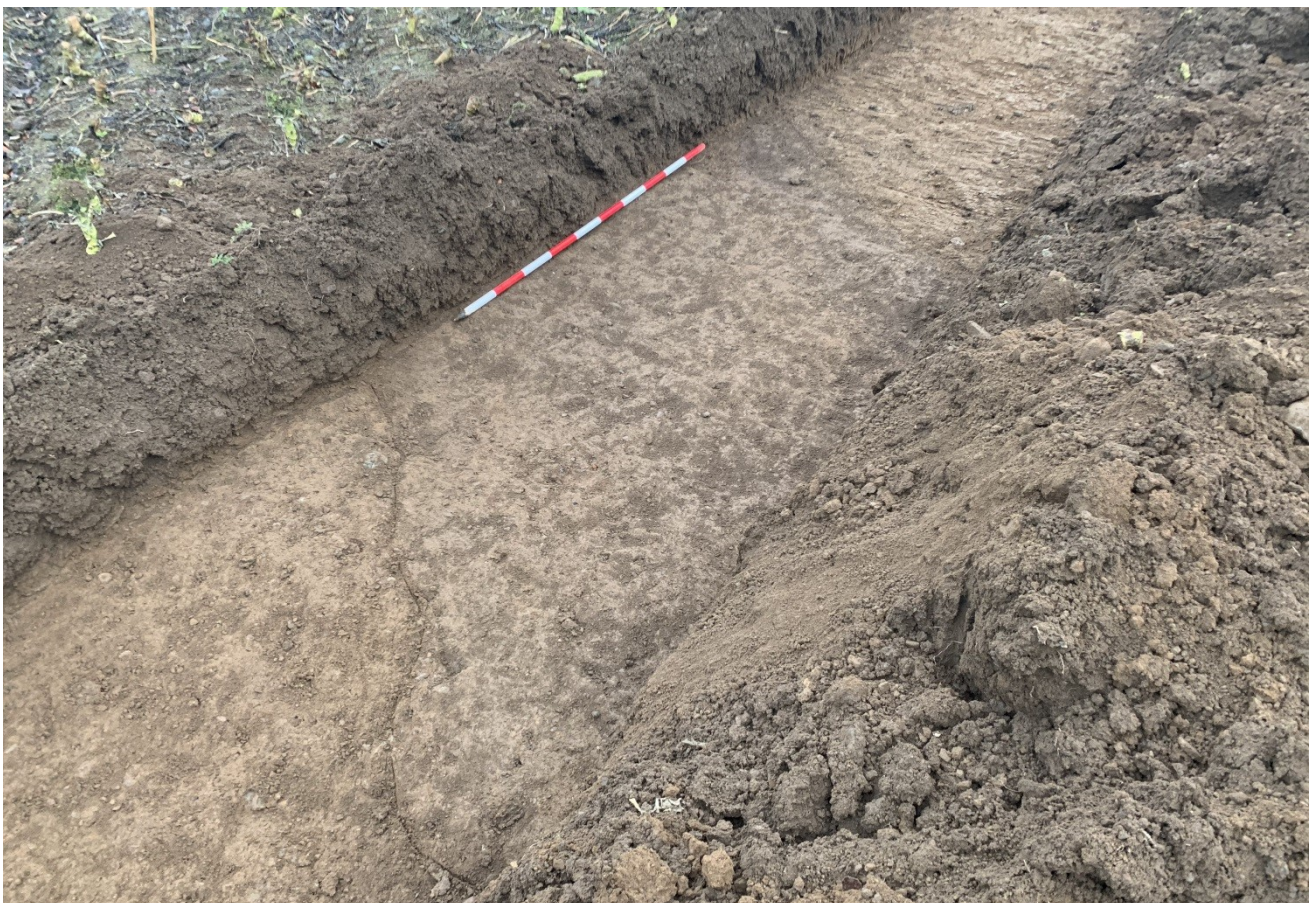
Plate 44: Area 1C: Test Trench 35, Ditch C24 facing north

| Context | Type | Description | Measurements | Associated Cut / Fill | Finds | Samples | Drawings | Plates |
|---|---|--|---|---|---|---|---|---|
| C25 | Fill | Fill of C24. Consists of loose brown clay, humic in nature and containing roots and modern pottery. Feature is on same alignment as a tree belt shown on the first edition 6 inch map and later 25 inch map (Figure 12). | 1.7m in width | C24 | 3 Body sherds of glazed white earthenware – 19 <sup>th</sup> /20 <sup>th</sup> century in date. | - | Figures 9 & 12 | Plate 44 |
