**Flux Valves and
Electromagnetic
Fields from
MetroLink**

Client: Transport Infrastructure Ireland	Title: Simulated Magnetic Field Testing of Flux Valve Compass on ATR Aircraft
Attention: Multiple Recipients

REPORT REF: 20E9047-2

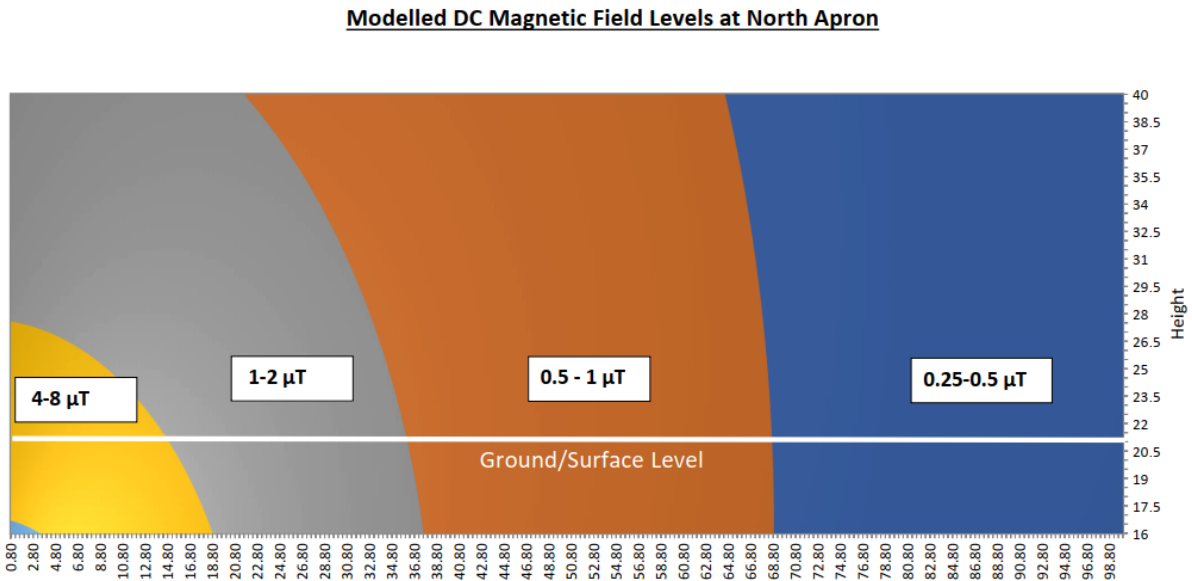
The proposed tunnel at Dublin Airport is at a depth of 18 m. The modelled DC magnetic field fluctuations based on full current loading of the traction supply from a single substation is indicated below:

Figure 1: Modelled DC Magnetic Field variations above tunnel

As discussed, there were no concerns in relation to planes in flight. The issue of concern for Stobart was in relation to the surface level magnetic fields and their potential effect on the flux valves mounted on the wings of their ATR aircraft. Expanding the modelling of Figure 1:

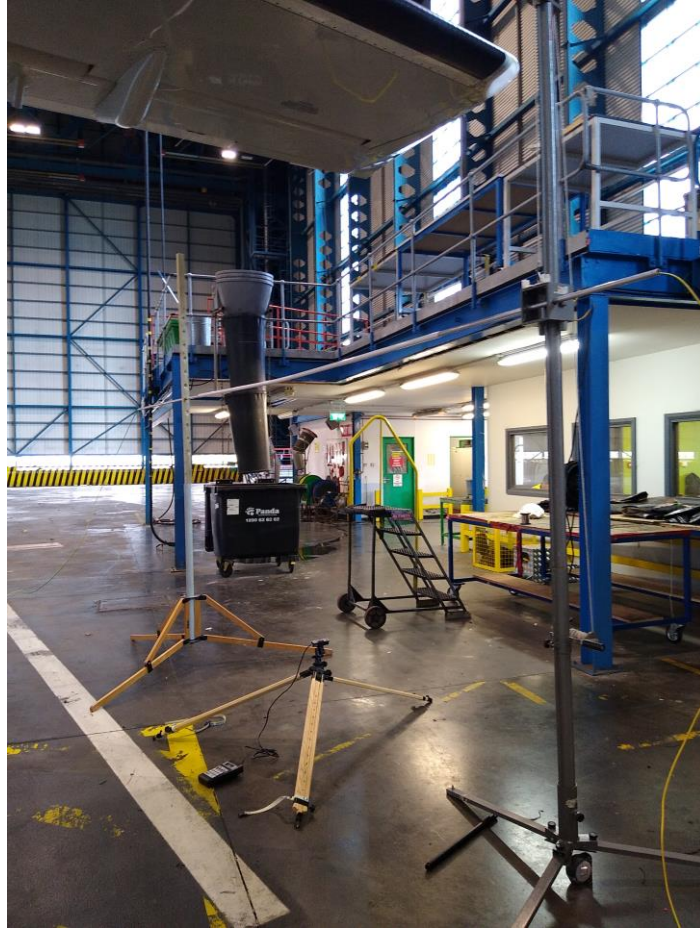
The DC magnetic field was generated using a cable and current source. The current of the coil was controlled by a high DC current source actuator. The transducers of the equipment under investigation were placed within its magnetic field region which was calibrated for the correct distance use a 3-axis magnetometer.

Figure 3: Magnetic Field source installed below wing

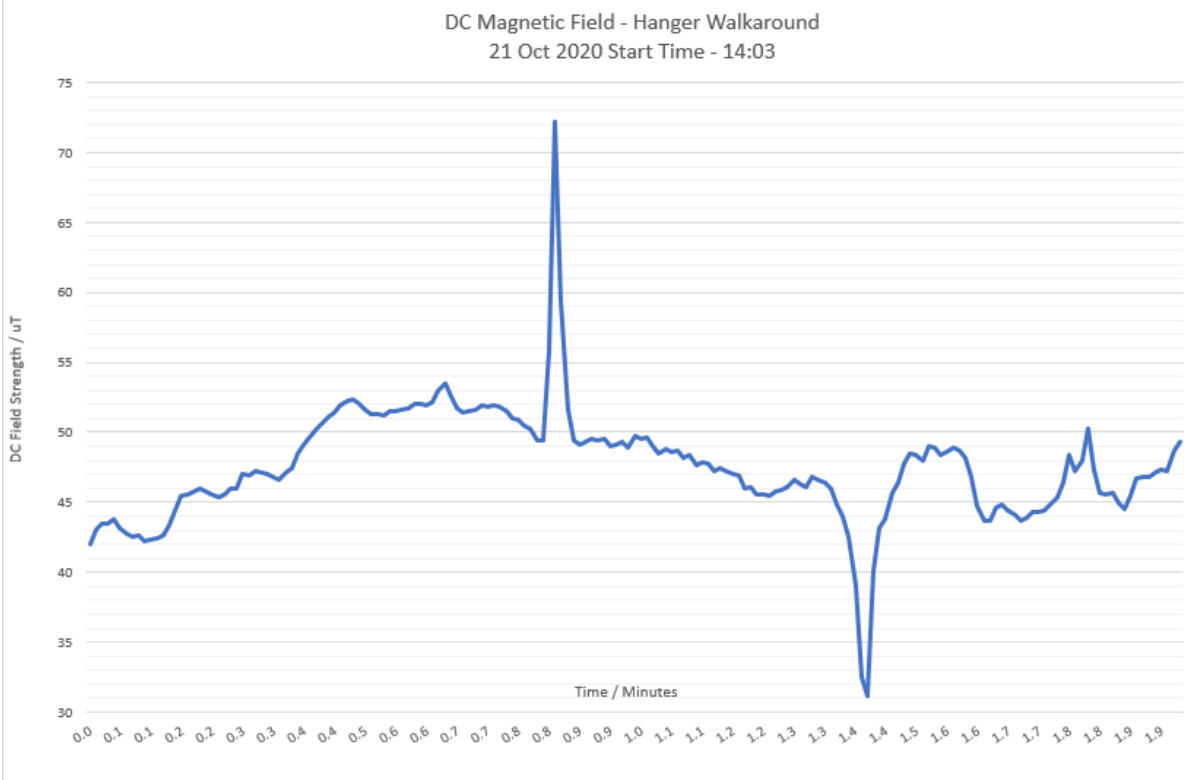
Fluxgate compass readings are ignored when inside the hanger due to local metallic structures causing localised disturbances to the lines of flux. This was evident in the differences between the pilot's and FO's displays while the ATR aircraft was parked inside the hanger before the commencement of the test (166 Vs 171 = 5 degrees of a difference). A brief walkaround of the hanger was conducted to prove out the concept that nearby structures can cause these deflections. Figure 4 shows large fluctuations experienced when approaching gantries and metallic stairs, while the building structure and planes would also account for fluctuations. Fluctuations of up to 15 μT were noted with average values being between 1 and 2 μT .

Figure 4: DC magnetic field measured during hanger walkaround

As stated in Section 1.04.3 fluctuations of up to 15 μT were noted inside the hanger with average values being between 1 and 2 μT . The expected fluctuations airside would be in the 1-2 μT range when passing buildings and other aircraft at a distance with higher levels at times attributable to fuel trucks and stairs passing close to the flux valves. These levels from nearby structures and fuel trucks would be as high and higher than those that could potentially be experienced directly above the MetroLink alignment. However, in these instances the pilot or first officer can visually see the source of the disturbance and therefore can carry on their flight preparation. This clearly would not be the case with an underground electrified rail-line and this is the reason an official document outlining a buffer zone along the MetroLink alignment is recommended.

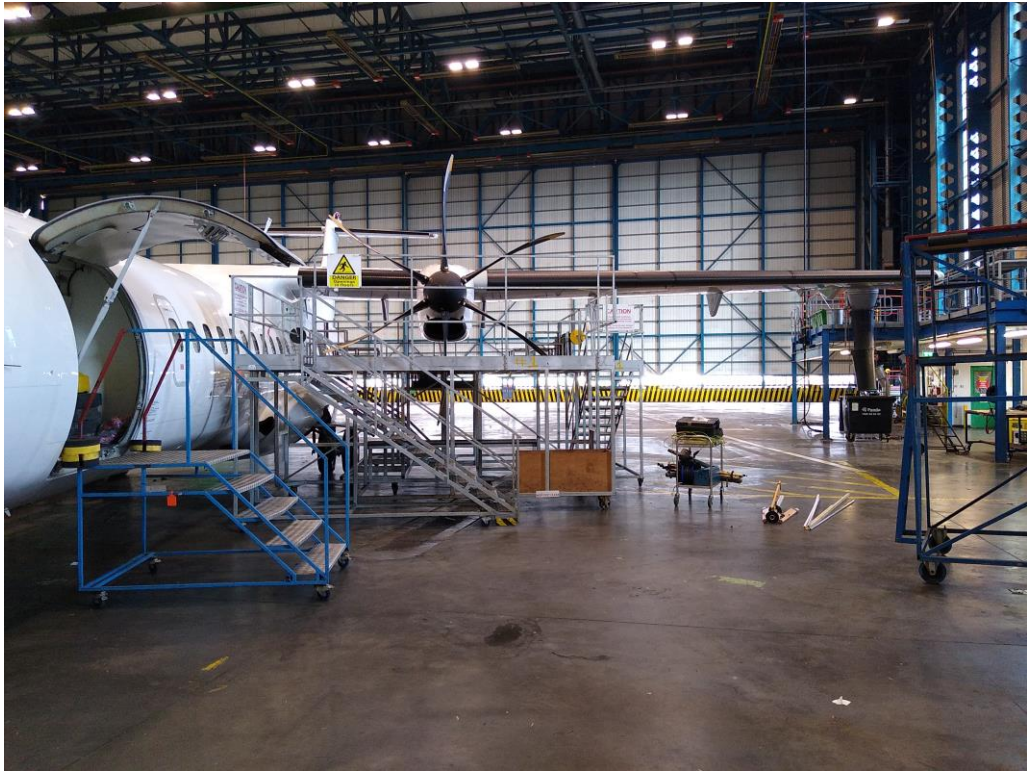
Figure 5: Mobile stairways and gantries surrounding aircraft
