Ground Investigation Report

Lucan to City Centre CBC06
BCIDA-ACM-ERW_GI-0006_XX_00-RP-CE-0001

Client - National Transport Authority

22 December 2020

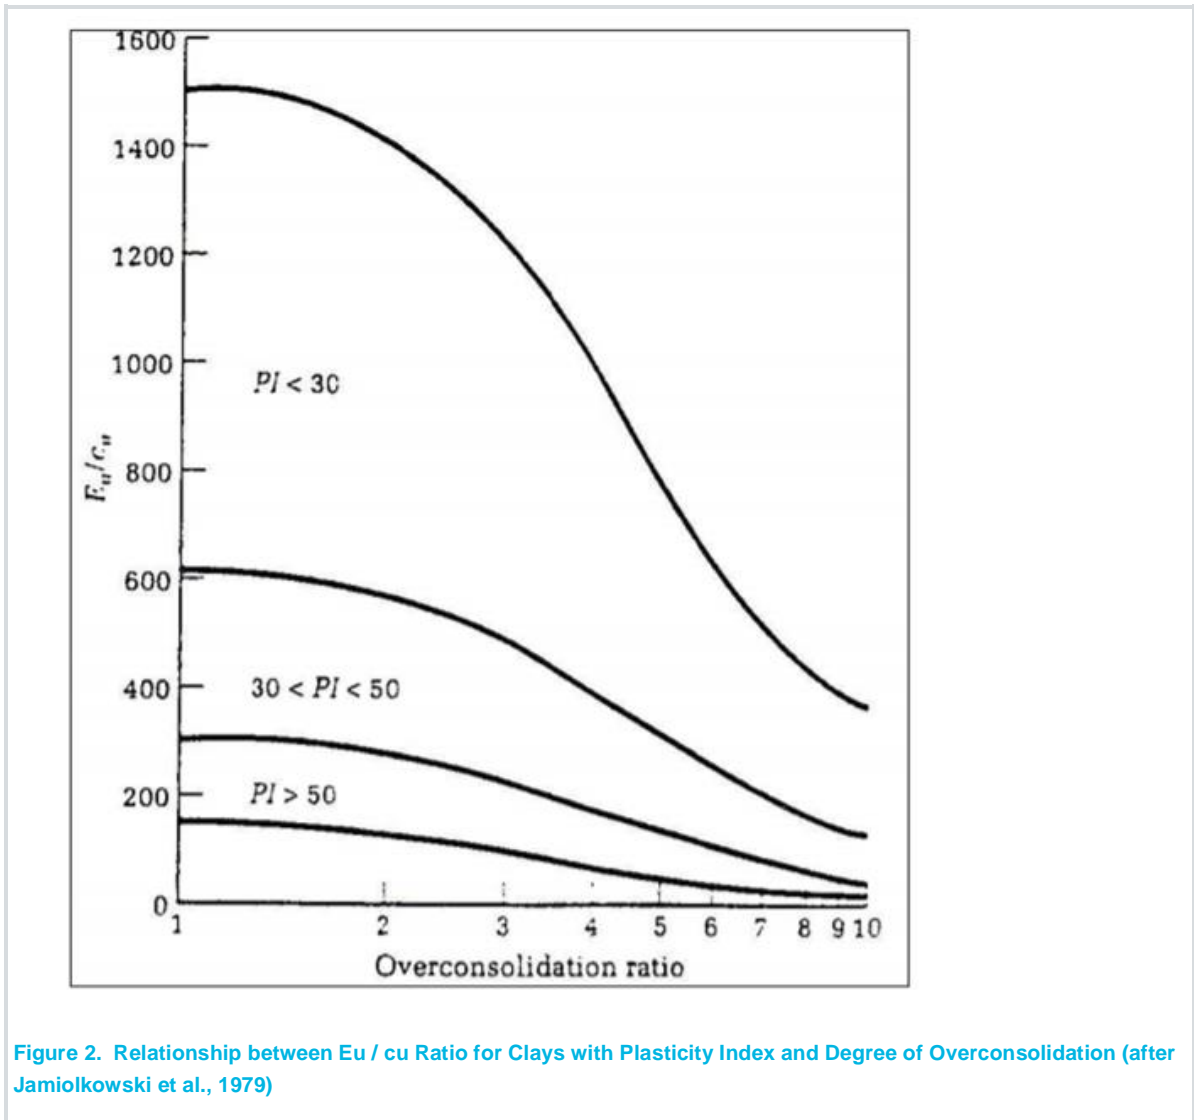
For routine foundation design, which is generally carried out assuming a linear elastic E' soil, a value of 80 MPa is generally considered appropriate for the Dublin Boulder Clay for very high compressive stresses.

The stiffness also depends on the loading situation and $E' \approx 150$ MPa more closely models the behaviour of a driven pile (Farrell et al. 1995b)

Figure 1.	Stroud & Butler (1975).....	21
Figure 2.	Relationship between e_u / c_u Ratio for Clays with Plasticity Index and Degree of Overconsolidation (after Jamiolkowski et al., 1979)	22
