**Appendix E.3**  
Geotechnical Report –  
Ground Investigation

## **Bus Connects Route 6 Lucan to City Centre – Ground Investigation**

**Report No.:** 20-0399B

**Date:** December 2020

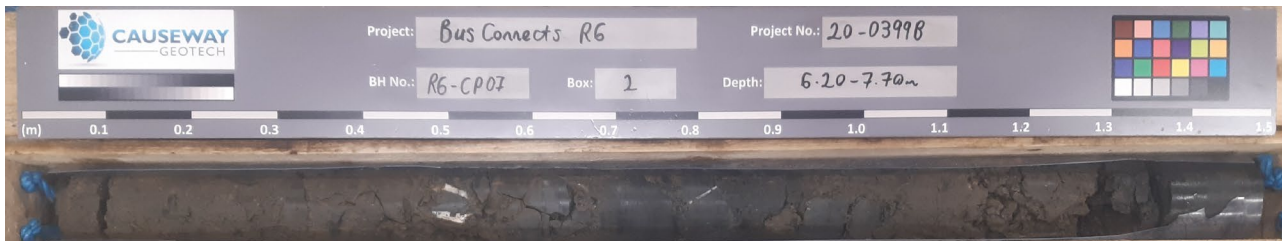
R6-CP07 Box 2 (6.20-7.70m)

6.20										
6.85	C	100	23	7	49.20	6.85 (0.25)		Medium strong (locally weak) dark grey LIMESTONE. Partially weathered: slightly reduced strength, closer fracture spacing with silty gravelly sand deposits.

7.60	C			NI	48.95	7.10 (0.50)		Discontinuities: 1. 0 to 10 degree bedding fractures, closely spaced (50/80/110), undulating, rough with brown silty gravelly sand up to 28mm between fracture surfaces.

7.70	C				48.45	7.60 (1.45)		Brown silty gravelly fine to coarse SAND. Gravel is subangular of limestone.		
7.80								Medium strong thinly bedded dark grey LIMESTONE. Largely unweathered: closer fracture spacing.

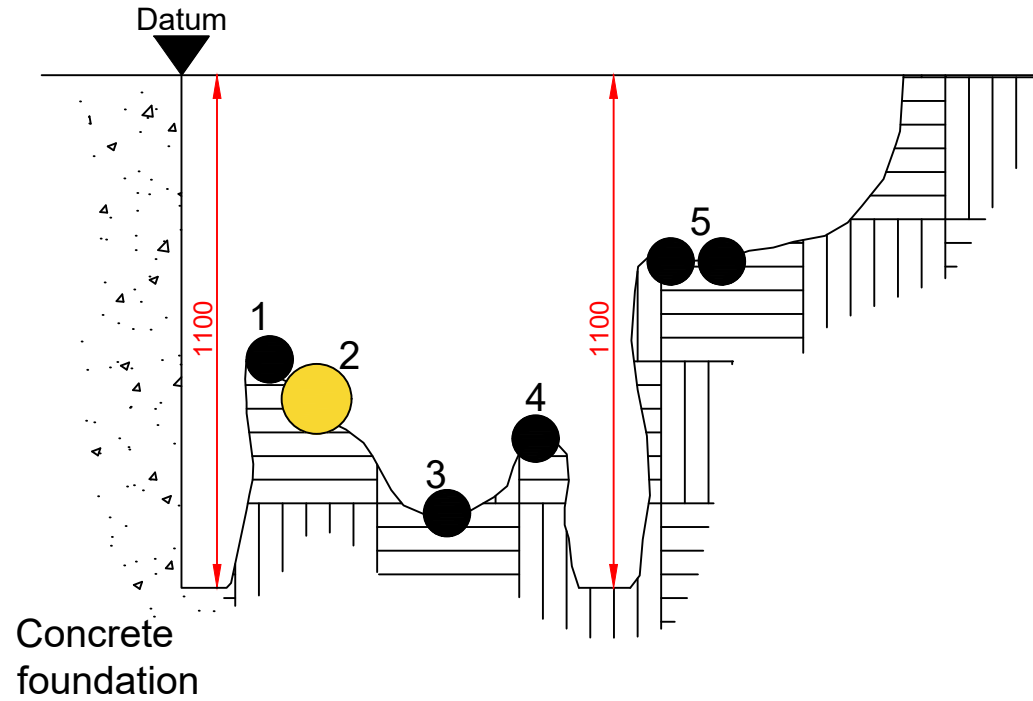
TRENCH: (SECTION & PLAN)

<b>Water Strikes</b>		<b>Depth:</b> 1.10 <b>Width:</b> 0.60 <b>Length:</b> 1.55	<b>Remarks:</b> Base of foundation unable to be determined to presences of services.
<b>Struck at (m)</b> 0.65	<b>Remarks</b> Slow seepage at 0.65m.		
<b>Stability:</b> Stable		<b>Termination Reason:</b> Terminated at scheduled depth.	<b>Last Updated</b> 16/12/2020

Concrete foundation

One slit trench (R6-TP01) was excavated by a combination of hand digging and mechanical excavation using a compact 3t tracked excavator fitted with a 600mm wide toothless bucket, to locate and identify buried services at the site. An attempt was also made to investigate foundations of existing bridge abutments at this location. A concrete projection was identified at 1.10mbgl however it was not possible to establish or confirm foundation makeup.
