## **Castlepollard Quarry**

# **Environmental Impact Assessment Report**

## **Westmeath - County Geological Site Report**

### **Deerpark Quarry (Meehan et al. 2019)**

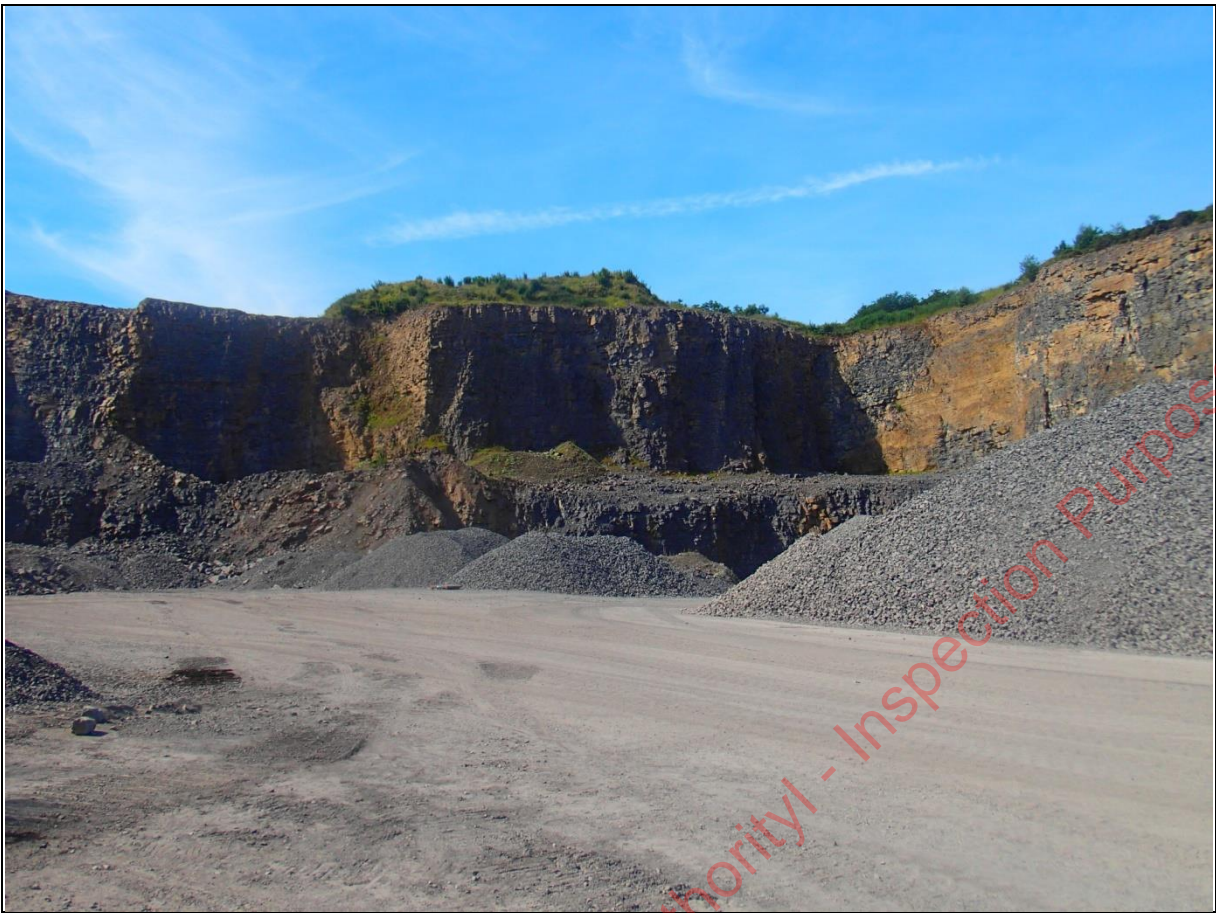
A view of Deerpark Quarry, from the entrance at the north.

Deerpark Quarry is a deep, impressive, working quarry, set into a high crag-and-tail ridge, just 2 kilometres southeast of Castlepollard.

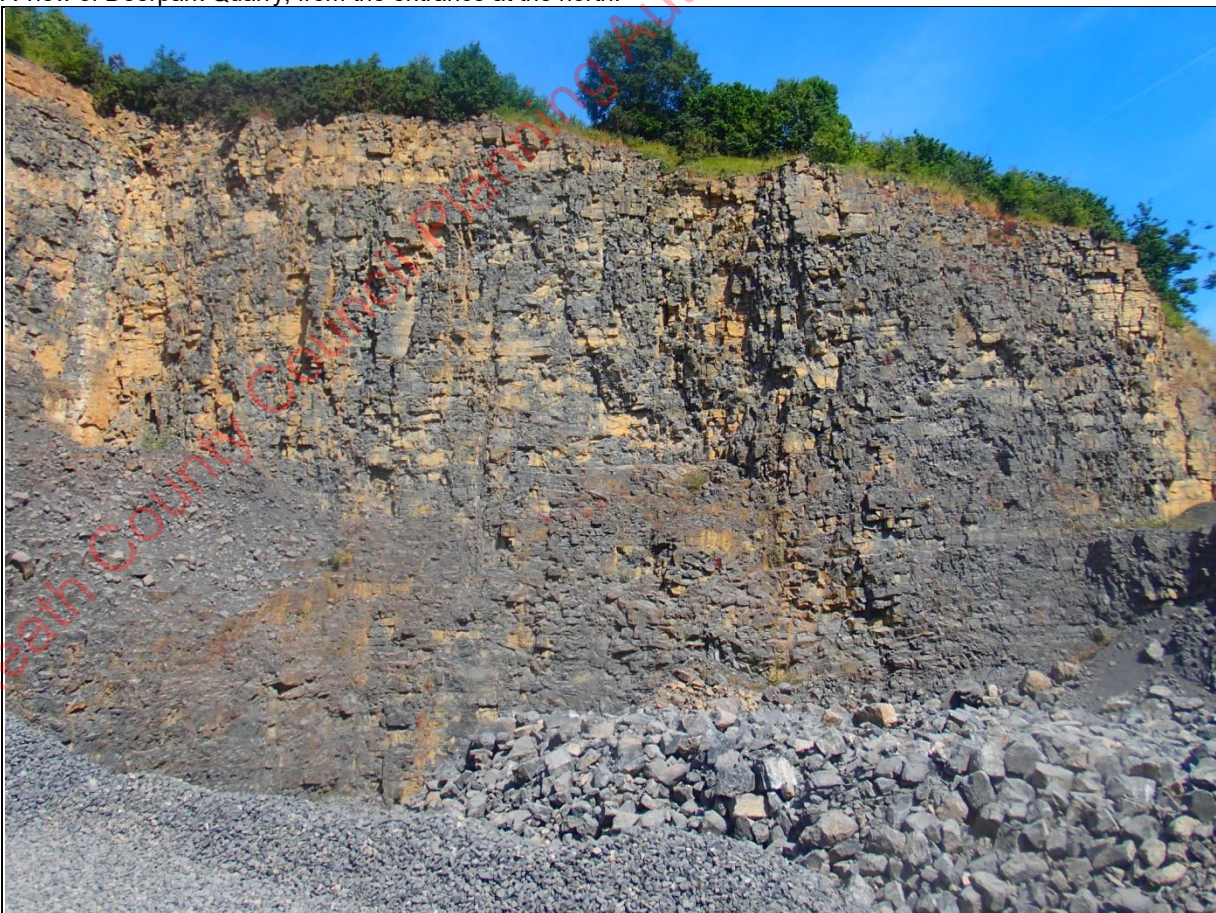
Weakly bedded / laminated units within the massive Derravaragh Chert exposure at Deerpark Quarry.

The bedrock in the sections is highly silicified (chert) in places, and the chert can be seen both as nodules as well as in thin seams and bands. Pyrite is common, locally, within the quarry. Sedimentary structures show occasional evidence of slumping and weak lamination and bedding, set within the bedrock faces, but there are few other structures readily visible.
