# FRESHWATER ECOLOGY SURVEY OF THE NANIKEN STREAM

FOR  
A MIXED USE DEVELOPMENT  
AT  
LANDS EAST OF ST PAUL'S COLLEGE, SYBIL HILL  
ROAD, RAHENY, DUBLIN 5

<b>Client</b>	Raheny 3 Limited Partnership
<b>Project Title</b>	Mixed use Development at lands east of St Paul's College, Sybil Hill Road, Raheny, Dublin 5.
<b>Document Title</b>	Freshwater Ecology Survey Report

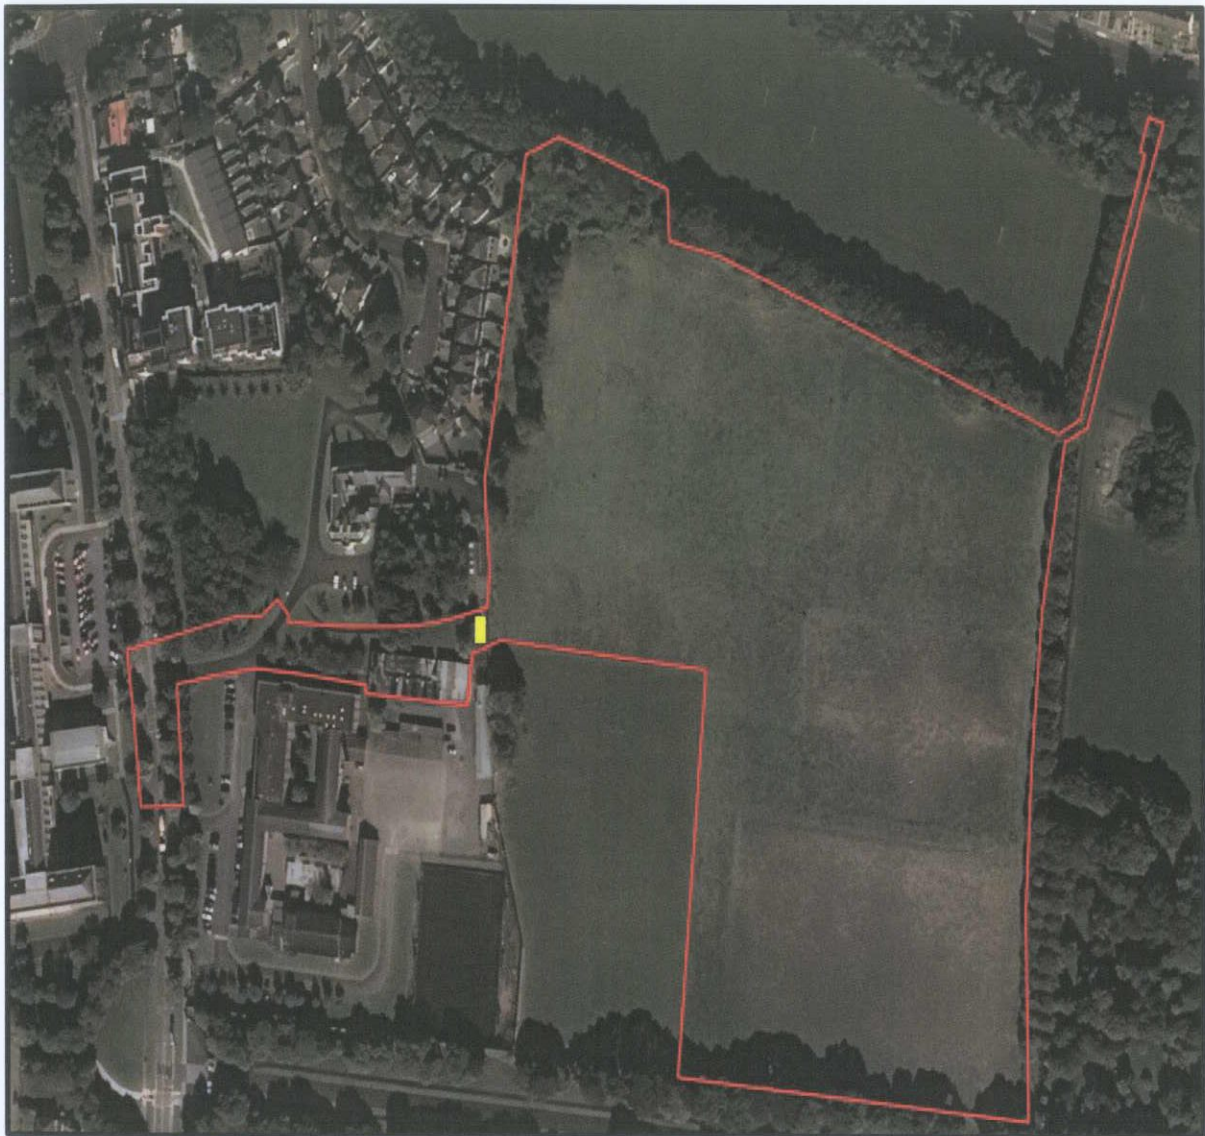
**Fig. 1** Boundary map of the proposed “Foxlands” development site at St. Anne’s Park, Raheny, Dublin 5 exhibiting the extensive amenity grasslands that dominate the site. The yellow bar shows the division of the “main section” from the “access corridor section” for the purposes of this report.

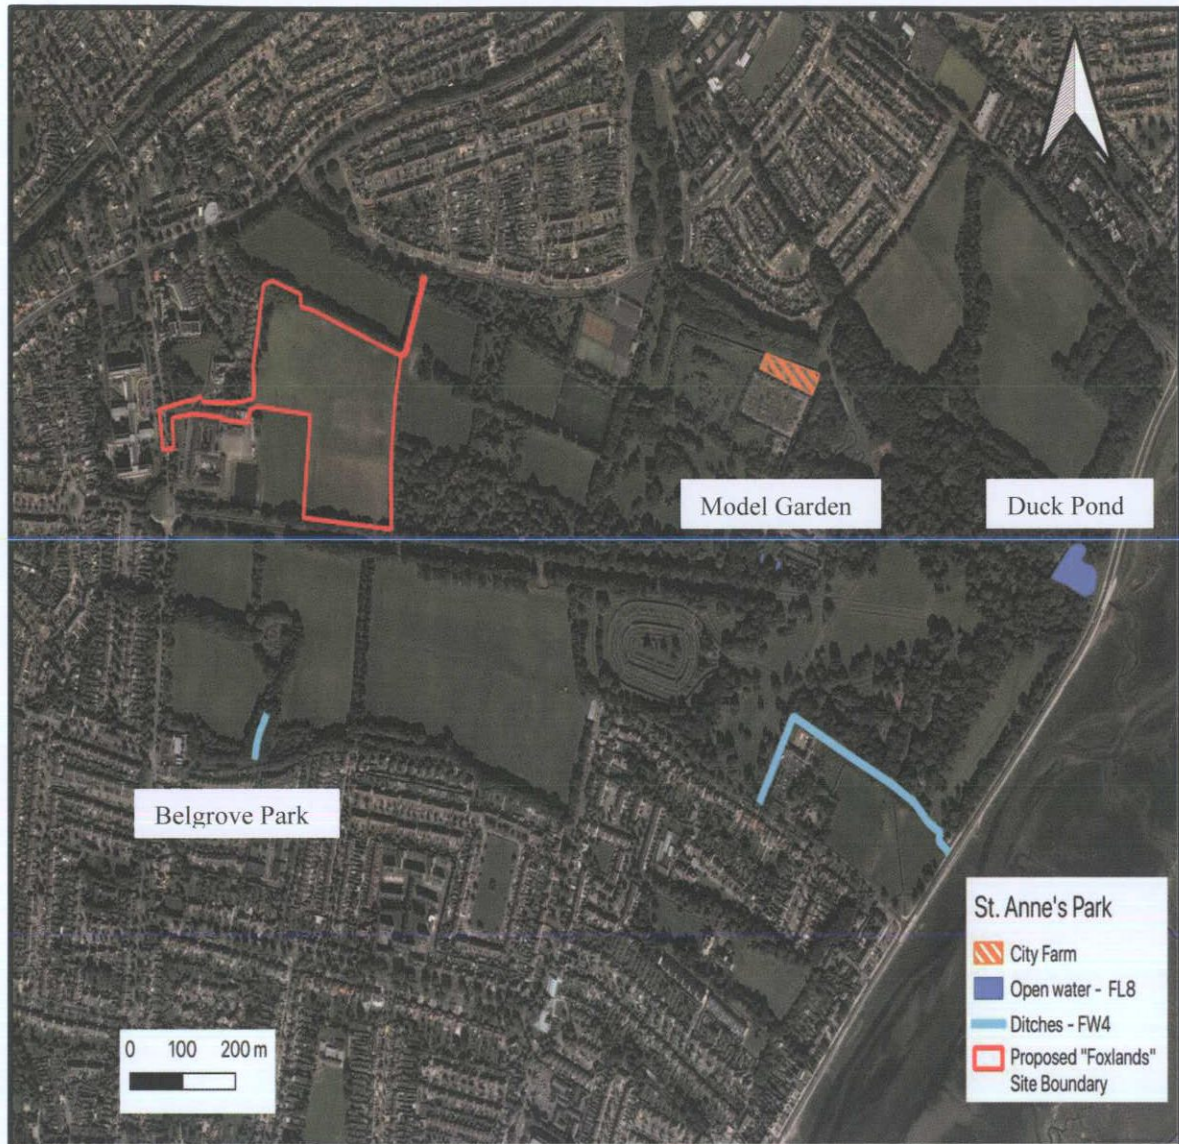
Fig. 2. A map indicating surveyed wetland areas with potential suitability for amphibians and the location of the proposed “Foxlands” development (outlined in red).

agricultural grassland (GA1) and some linear treelines (WL2) to the west and south. The habitats surveyed within the wider St. Anne's Park comprised of man-made open water features in the Model Garden, Duck Pond, and City Farm (not visible on the map) (FL8) and drainage ditches (FW4) – one of which drains into a tributary of the Naniken River within a copse of mixed broadleaf woodland (WD1), and the other drains the lands from Mount Prospect Avenue, north to the Red Stables and eastwards through the lower park to the south lagoon at North Bull Island (Fig. 2).

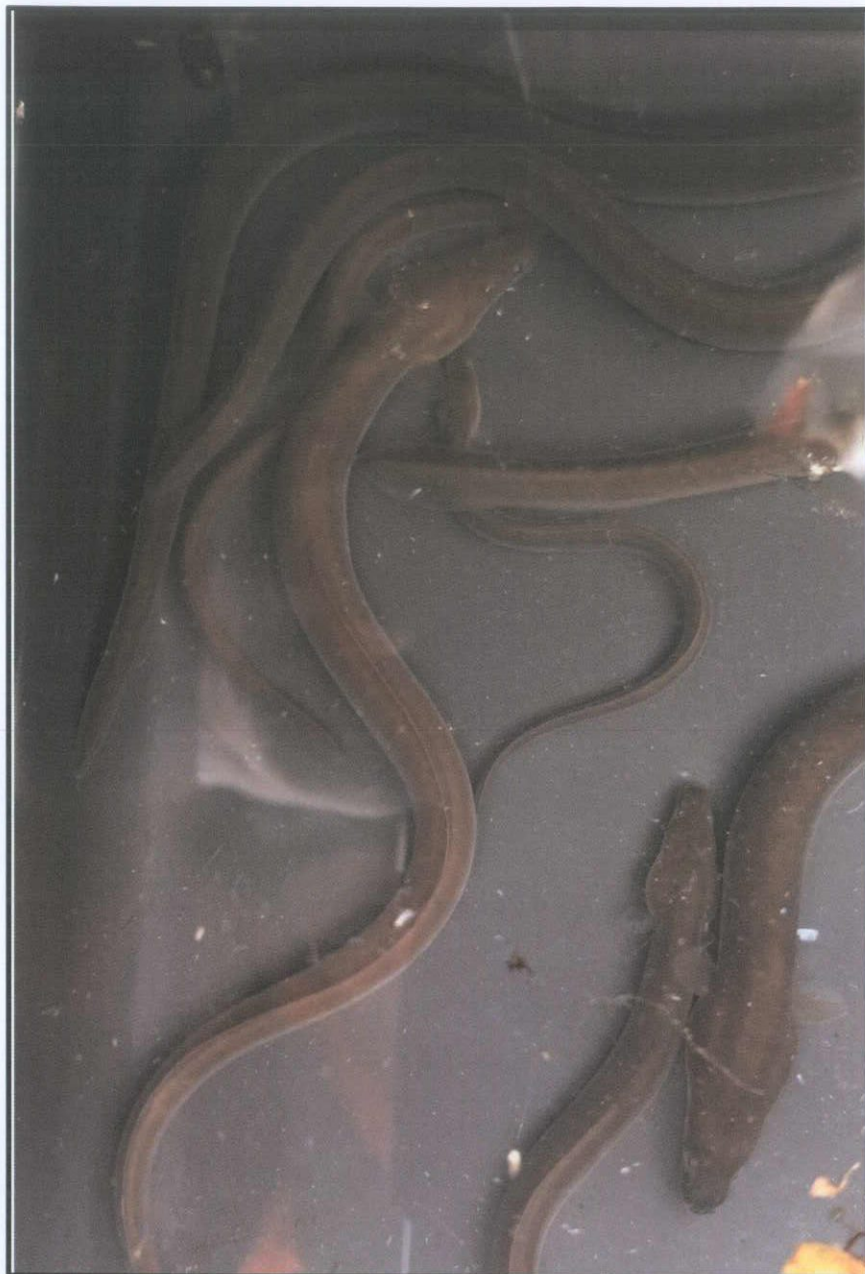
A1.1 Video still of critically endangered European eels of multiple size classes and ages dip netted from the Duck Pond at St. Anne's Park, Raheny, Dublin 5.

Torching resulted in the detection of no fewer than 14 individuals of the critically endangered European eel (*Anguilla anguilla*) of multiple size and age classes (e.g., elvers, yellow eels, and silver eels; see Appendix 1) on the 08/07/2022 and 19 individuals on 13/07/2022. Two individuals of the three-spined stickleback (*Gasterosteus aculeatus*) were also captured by netting with many more individuals seen by torchlight.

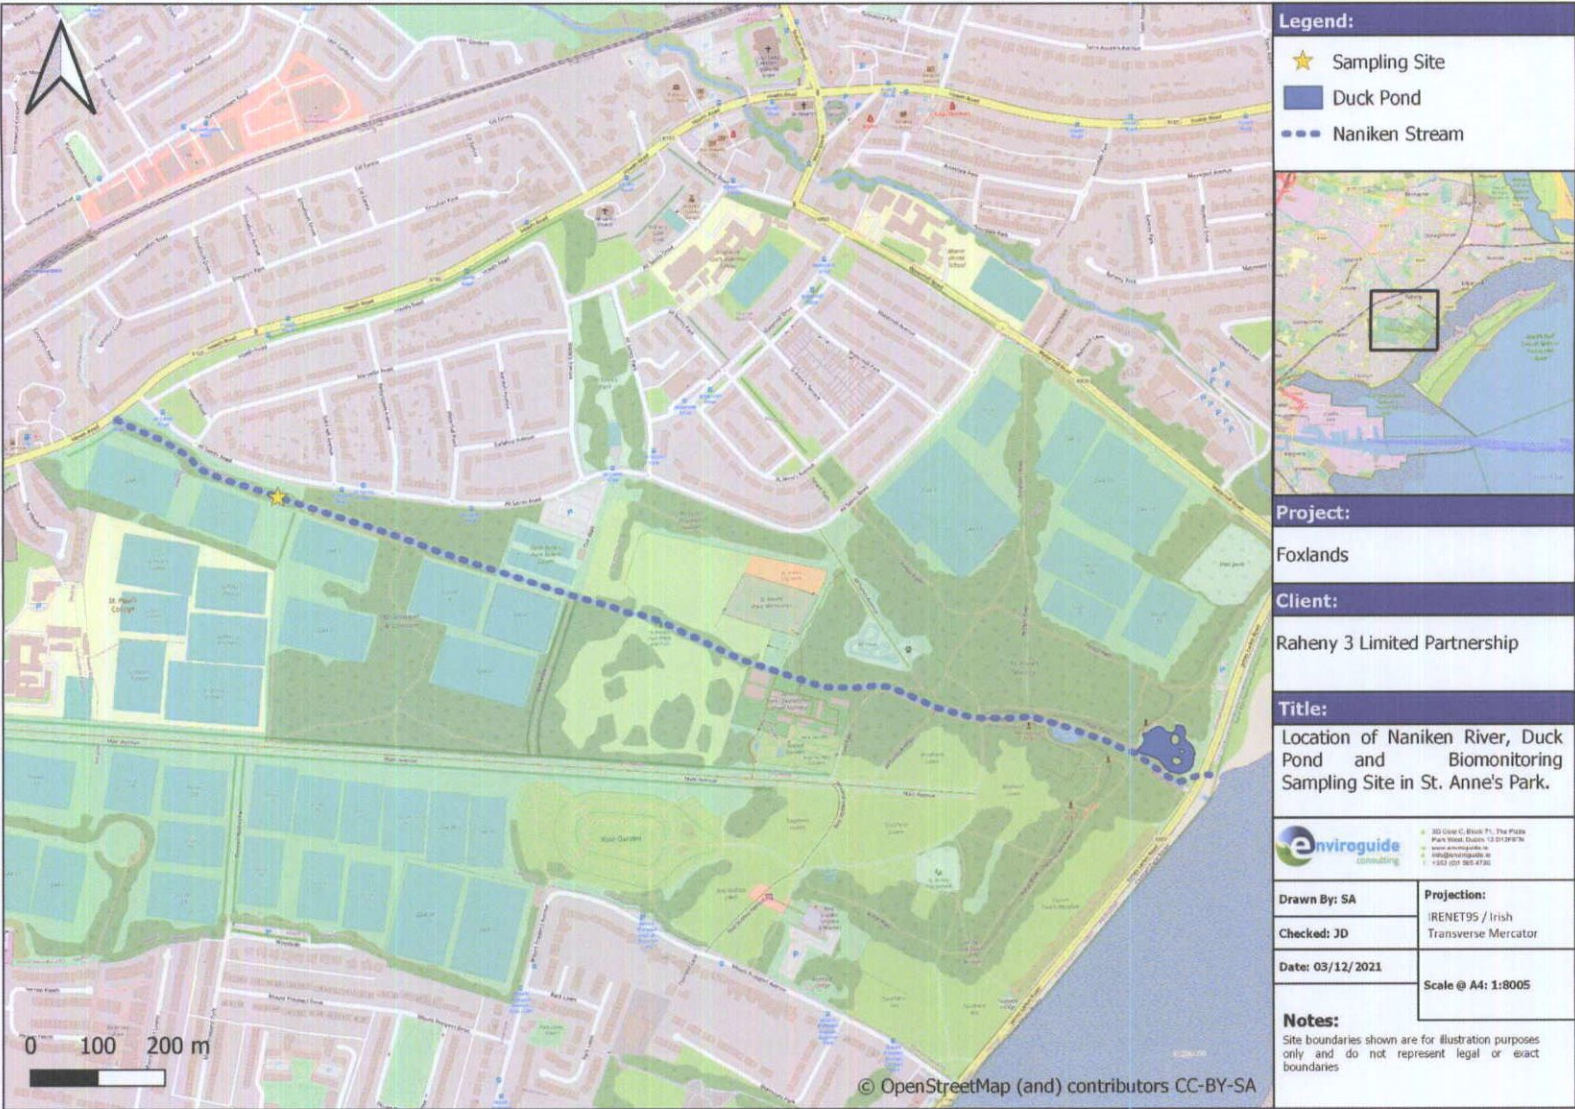
FIGURE 1. LOCATION OF NANIKEN RIVER, DUCK POND AND BIOMONITORING SAMPLING SITE.

The sampling method adopted was that applied by the Irish EPA in the national river monitoring programme (Feeley et al., 2020). The ideal timeframe for carrying out biomonitoring is between June to September when flows are likely to be relatively low and water temperatures highest. Surveys during this period are likely to coincide with the worst conditions to be expected in those reaches affected by waste inputs. River macroinvertebrates were collected on the 24<sup>th</sup> of September 2021 for this assessment. The sampling site location is indicated in Figure 1.

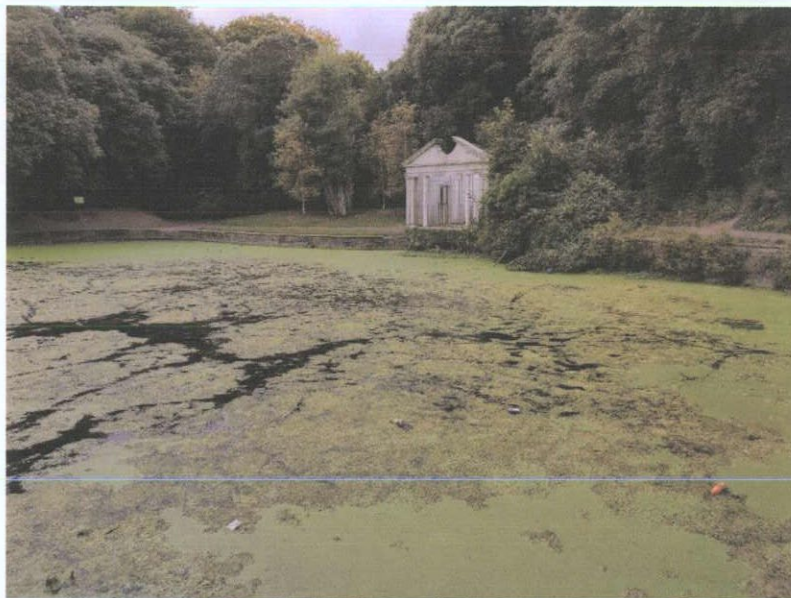
The Duck Pond is an artificial pond (FL8). It was heavily silted on the day of survey, with patches of emergent vegetation noted along the margins of the pond and islands within it. An

extensive duckweed *Lemna* sp. 'carpet' covered large areas of the pond, and filamentous algae was noted within it (Figure 2).

FIGURE 2. DUCKWEED 'CARPET' WITHIN THE DUCK POND.

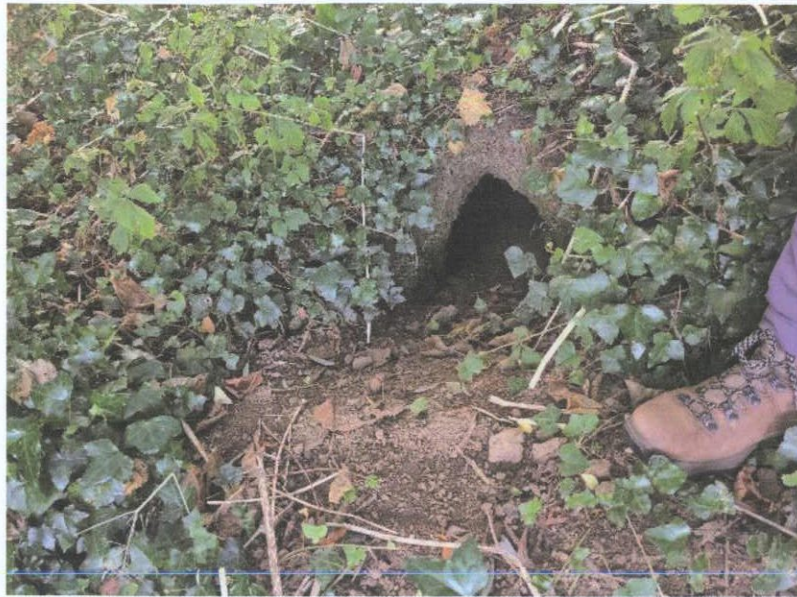
No Otter signs were recorded within or adjacent to the stream during the walk over survey carried out. This finding is in-keeping with the Dublin City Otter survey, which also did not detect any Otter signs along the Naniken (Macklin et al., 2019). An active mammal burrow was recorded on the river bank within the upper reaches of the Naniken river in St. Annes Park. Given the absence of Otter signs along the river, and the size and shape of the burrow, it is likely that it is a Fox *Vulpes vulpes* den Figure 3.

**FIGURE 3. MAMMAL BURROW ON THE BANKS OF THE NANIKEN IN ST. ANNES PARK.**

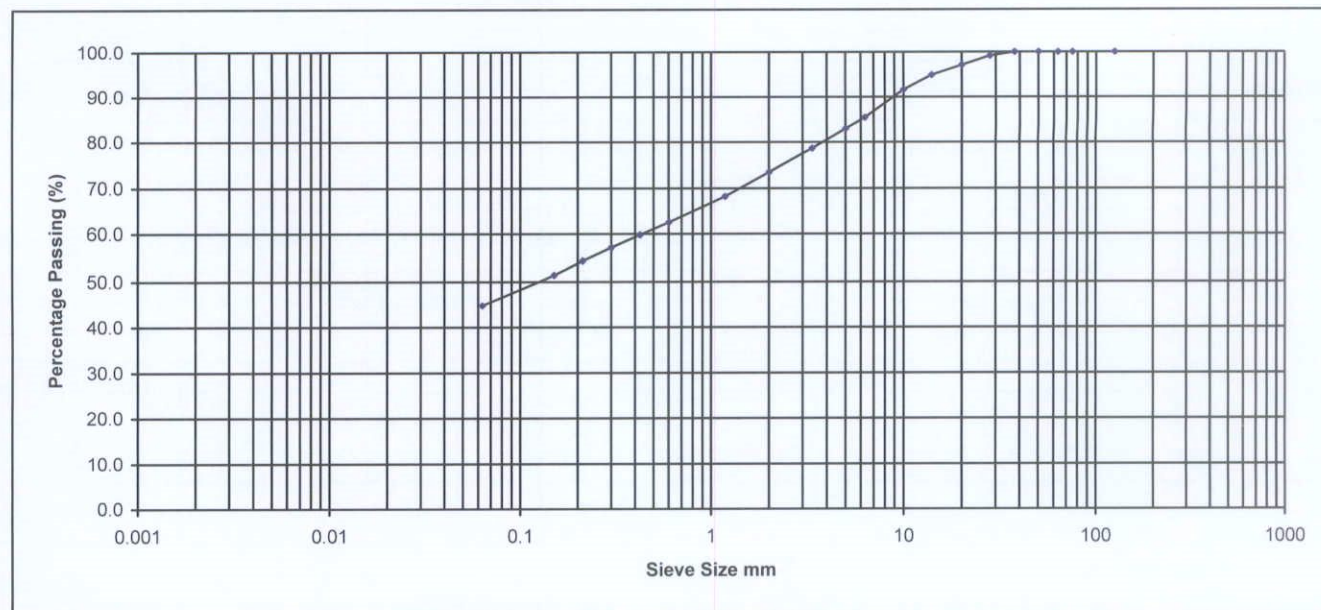
BS 1377 : 1990 : Part 2 : Clauses 9.2 & 9.5

Clay	Fine	Medium	Coarse	Fine	Medium	Coarse	Fine	Medium	Coarse	Cobbles	Boulder
	Silt			Sand			Gravel				
0.0	44.8			28.6			26.6			0.0	0.0

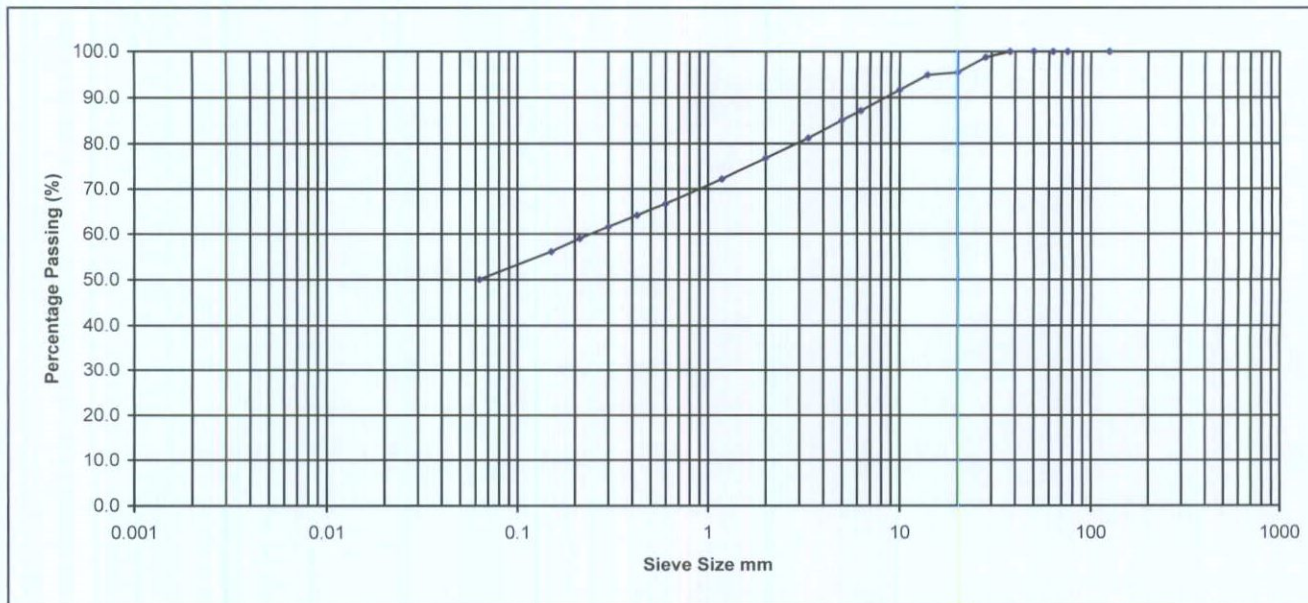
BS 1377 : 1990 : Part 2 : Clauses 9.2 & 9.5

Clay	Fine	Medium	Coarse	Fine	Medium	Coarse	Fine	Medium	Coarse	Cobbles	Boulder
	Silt			Sand			Gravel				
0.0	50.1			26.7			23.2			0.0	0.0

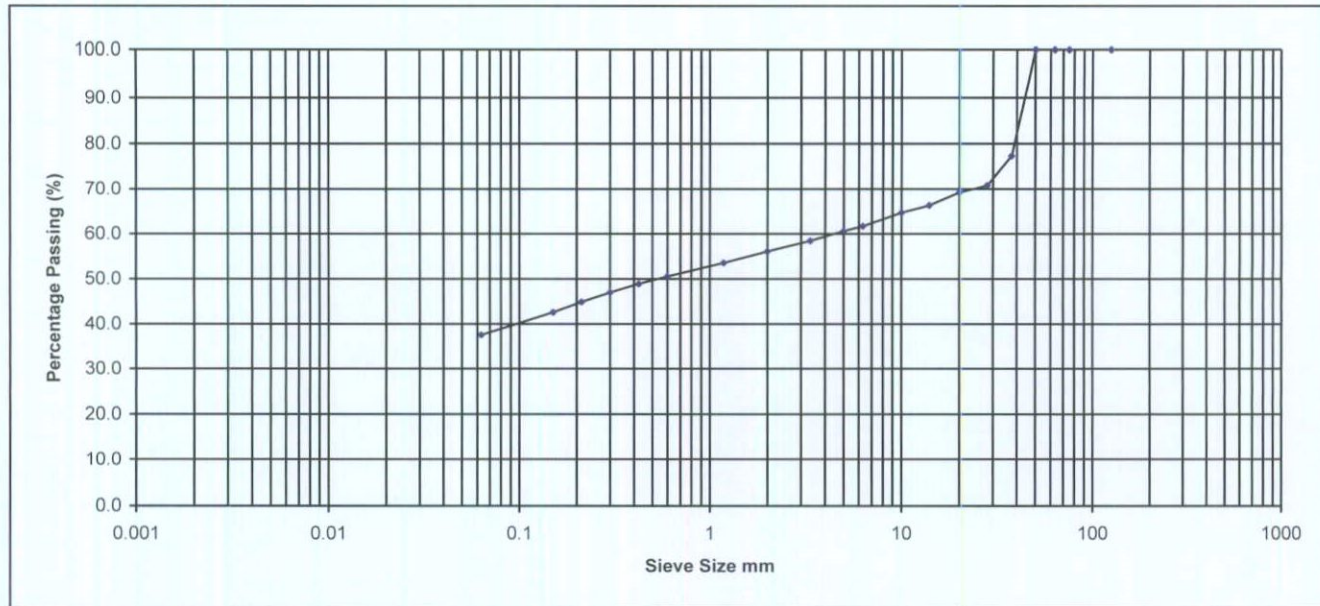
BS 1377 : 1990 : Part 2 : Clauses 9.2 & 9.5

Clay	Fine	Medium	Coarse	Fine	Medium	Coarse	Fine	Medium	Coarse	Cobbles	Boulder
	Silt			Sand			Gravel				
0.0	37.6			18.5			43.9			0.0	0.0
