White Hill Wind Farm

Annex 6.1: Geotechnical & Peat Stability Report

GEOTECHNICAL & PEAT STABILITY REPORT

WHITE HILL WIND FARM

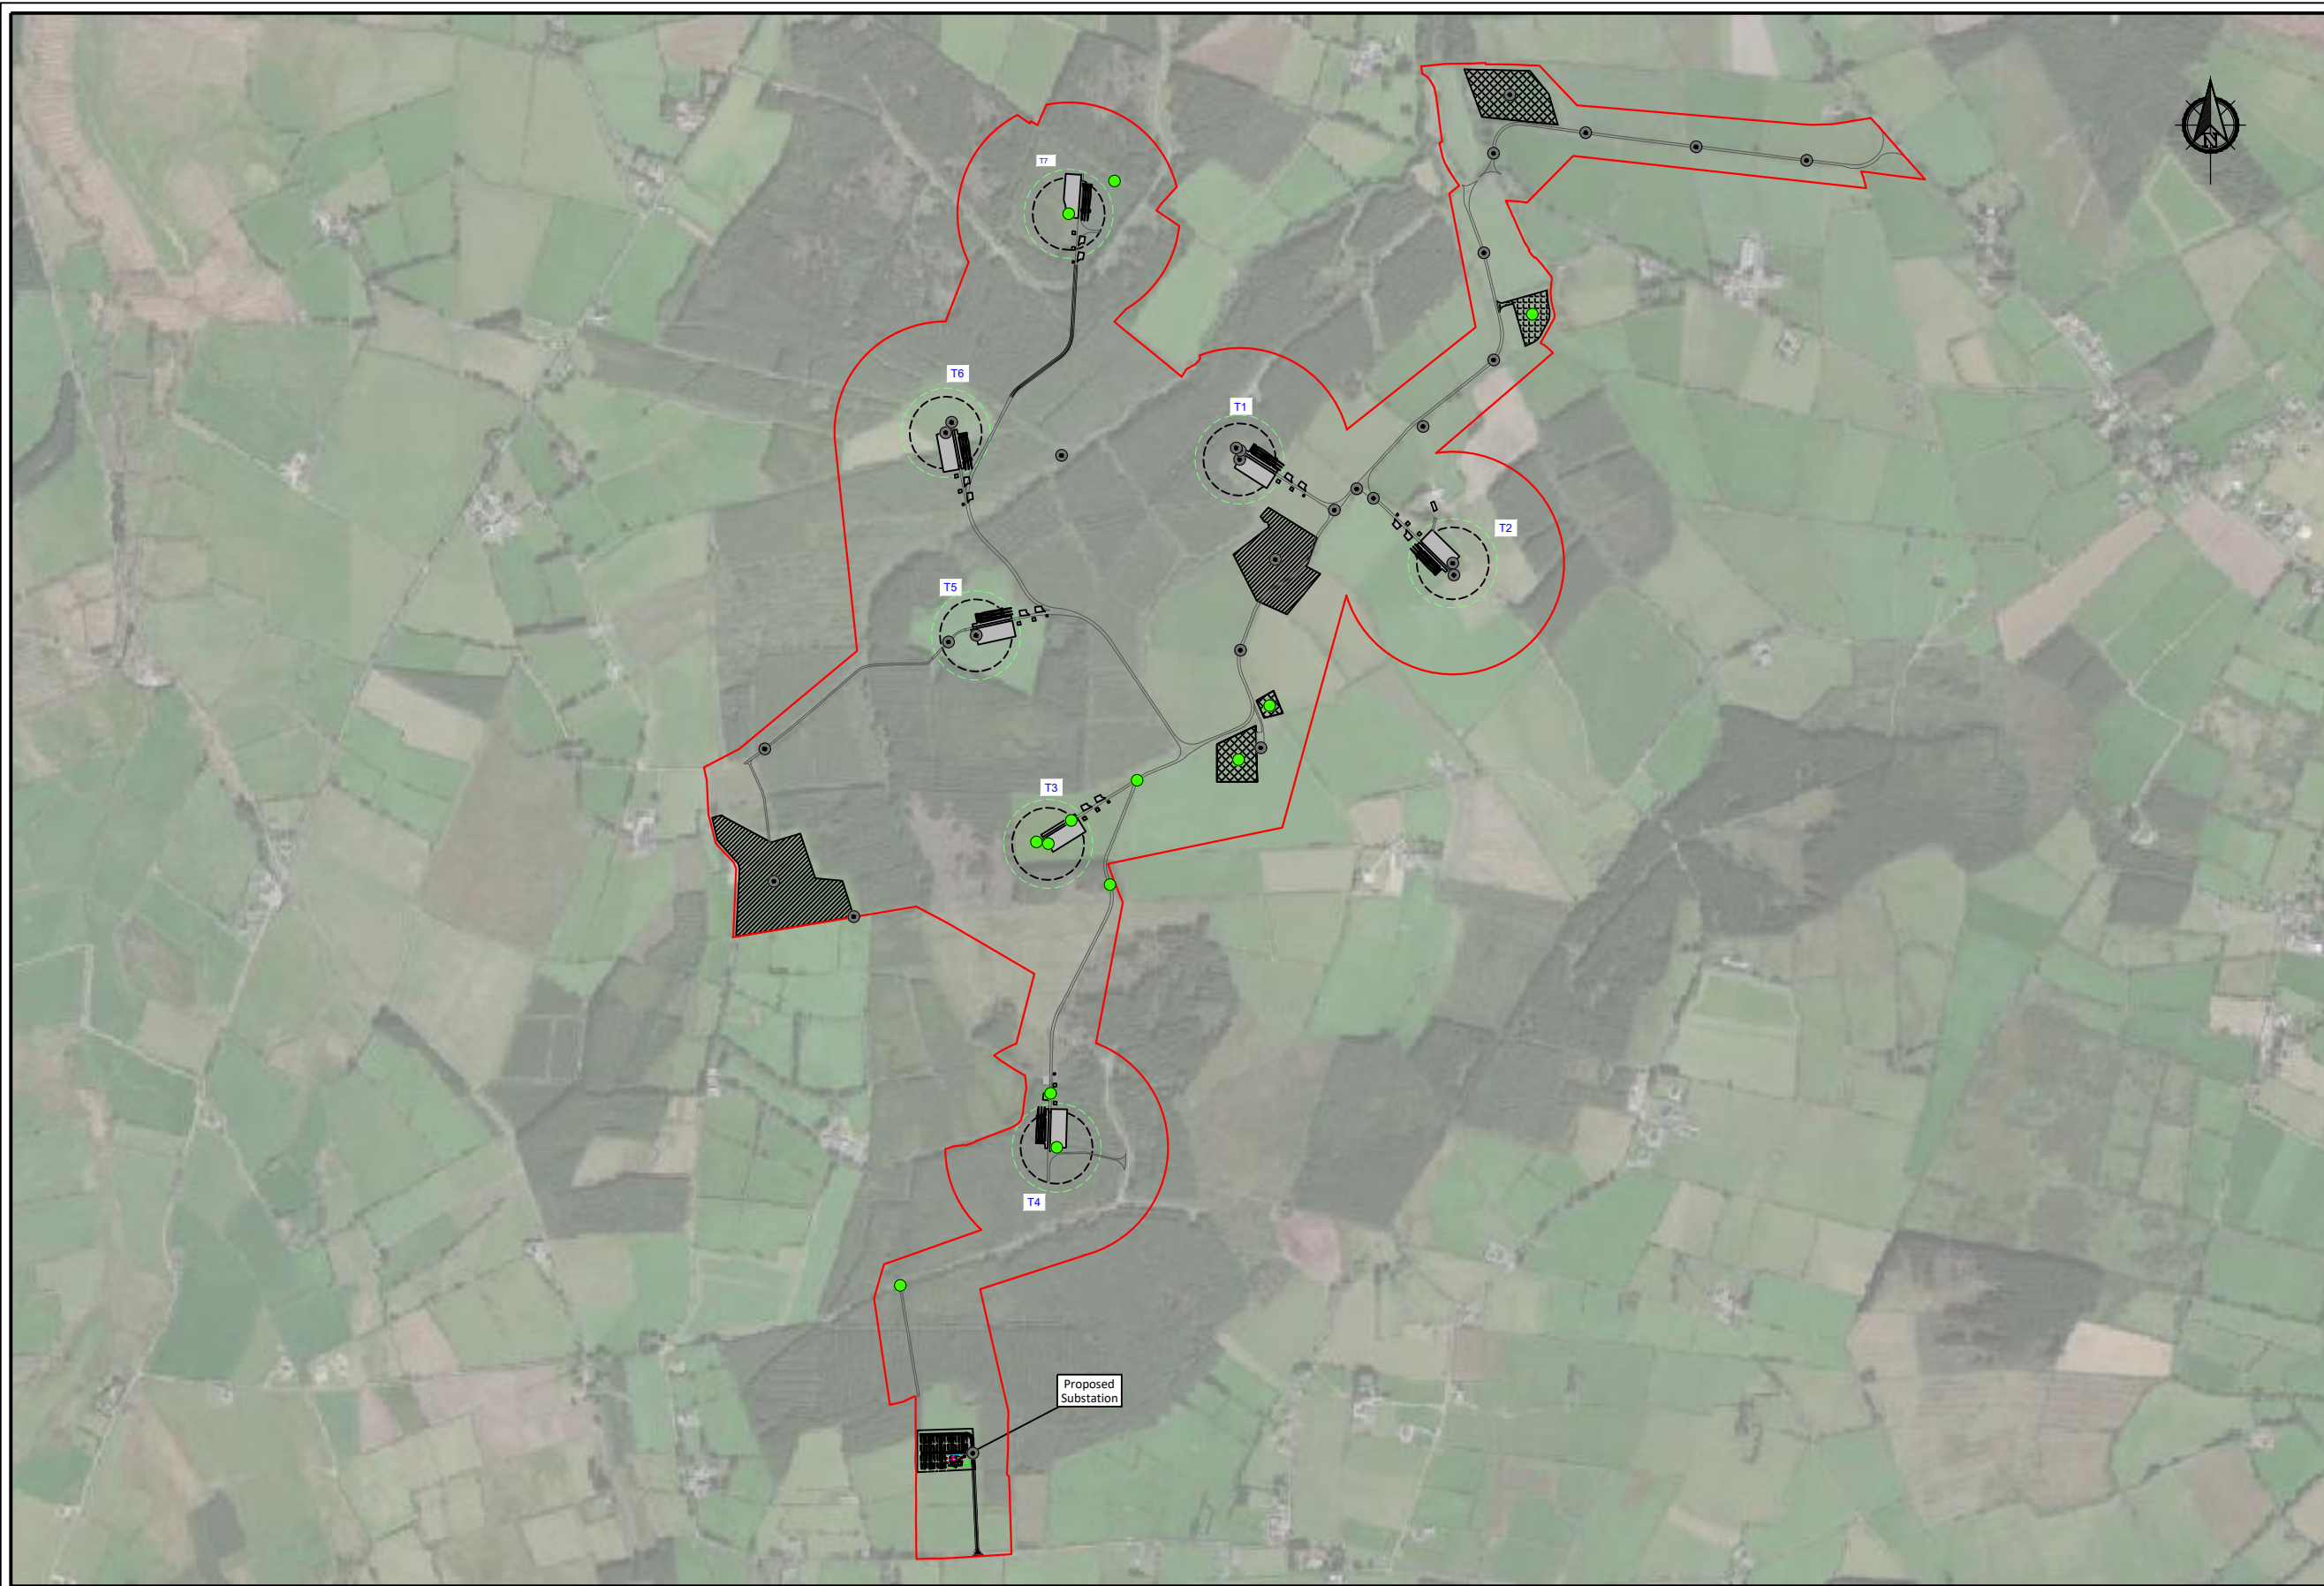
The results of the undrained analysis for the natural peat slopes are presented in Appendix C and the results of the undrained analysis for the most critical load case (load condition 2) are shown on Figure 7.1. The undrained analysis for load condition 2 is considered the most critical load case as most peat failures occur in the short term upon loading of the peat surface. The results from the main infrastructure locations are summarised in Table 7.3. The remainder of the locations where an analysis has been undertaken are along access tracks, and these results are included in Appendix C. The range of FoS results at all locations across the site is summarised below.

- Factor of Safety Legend:**
- 0 < 1.0
 - ≥ 1.0 < 1.3
 - ≥ 1.3
 - No Peat Recorded At This Location
- ↑ Increasing Burden
 ↓ Increasing Stability

The calculated FoS for load condition 1 is in excess of 1.30 for each of the locations (13 no. locations in total where peat was recorded across the site) analysed with a range of FoS of 11.52 to 114.68, indicating a low risk of peat instability.

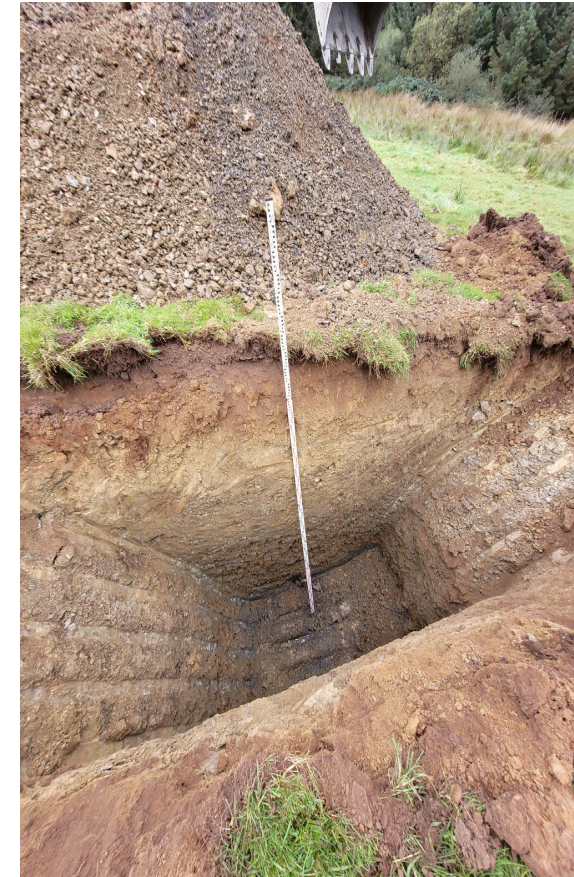
SUBSURFACE PROFILE

Depth	Symbol	Depth/Elev.	Description	Water Strikes	Sample Type	Comments
0.00		0.00	Ground Surface			
		0.00	Slightly peaty topsoil			
			Firm, organgy brown SILT			
1.00		-1.00				
		1.00	Very firm, organgy brown, gravelly SILT/CLAY			
2.00		-1.90				
		1.90	Soft, grey, weathered SHALE			
3.00		-3.30				
		3.30

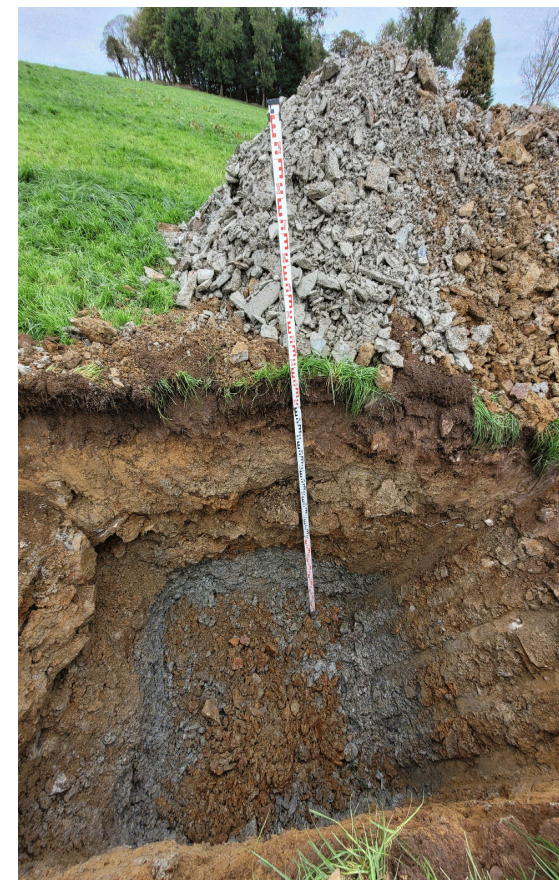
SUBSURFACE PROFILE

Depth	Symbol	Depth/Elev.	Description	Water Strikes	Sample Type	Comments
0.00		0.00	Ground Surface			
		0.00	Topsoil			
		-0.15				
		0.15	Firm, reddish brown, slightly gravelly SILT with angular cobbles			
1.00		-1.00				
		1.00	Soft, loose and weathered bedrock			
2.00						
		-2.30				
		2.30

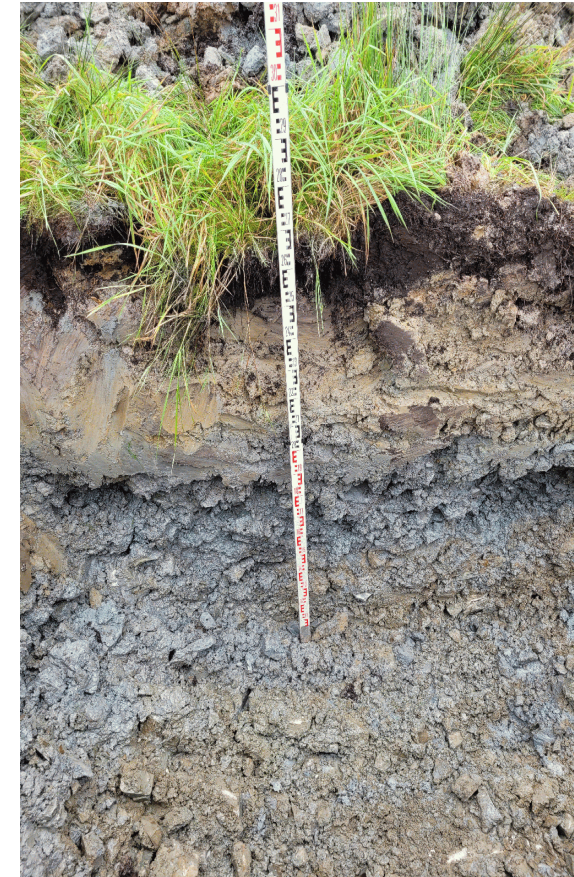
SUBSURFACE PROFILE

Depth	Symbol	Depth/Elev.	Description	Water Strikes	Sample Type	Comments
0.00	Ground Surface	0.00	Ground Surface			
	Dark brown, peaty Topsoil	0.00 -0.15	Dark brown, peaty Topsoil			
	Soft, browish grey CLAY	-0.15 0.15	Soft, browish grey CLAY			
	Firm grey CLAY with abundant angular cobbles	-0.60 0.60	Firm grey CLAY with abundant angular cobbles			
1.00	Refusal on weathered/broken (blocky) bedrock	-1.70 1.70

Refusal on weathered/broken (blocky) bedrock

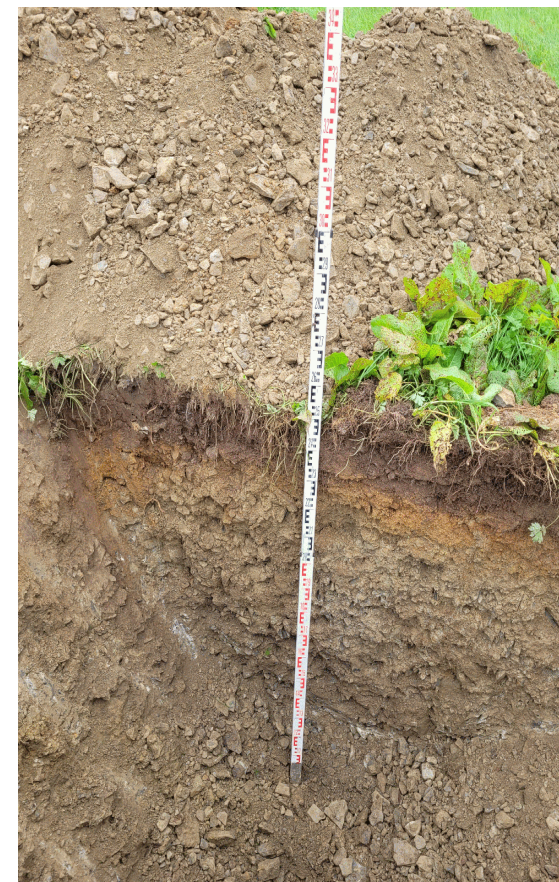
SUBSURFACE PROFILE

Depth	Symbol	Depth/Elev.	Description	Water Strikes	Sample Type	Comments
0.00		0.00	Ground Surface			
		0.00	Topsoil			
		-0.10				
		0.10	Very firm, brown, gravelly SILT			
1.00						
		-1.40				
		1.40	Soft, weathered SHALE			
		-1.50				
		1.50

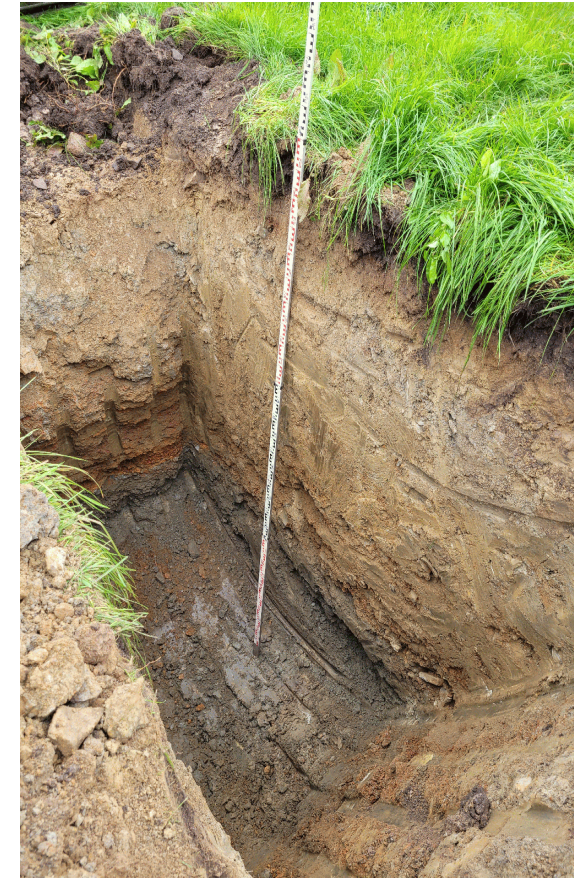
SUBSURFACE PROFILE

Depth	Symbol	Depth/Elev.	Description	Water Strikes	Sample Type	Comments
0.00		0.00	Ground Surface			
		0.00	Peaty Topsoil			
			Very firm to stiff grey SILT with occasional cobbles			
1.00						
		-1.90				
2.00		1.90	Very firm, sandy, gravelly SILT			
		-2.90				
3.00		2.90

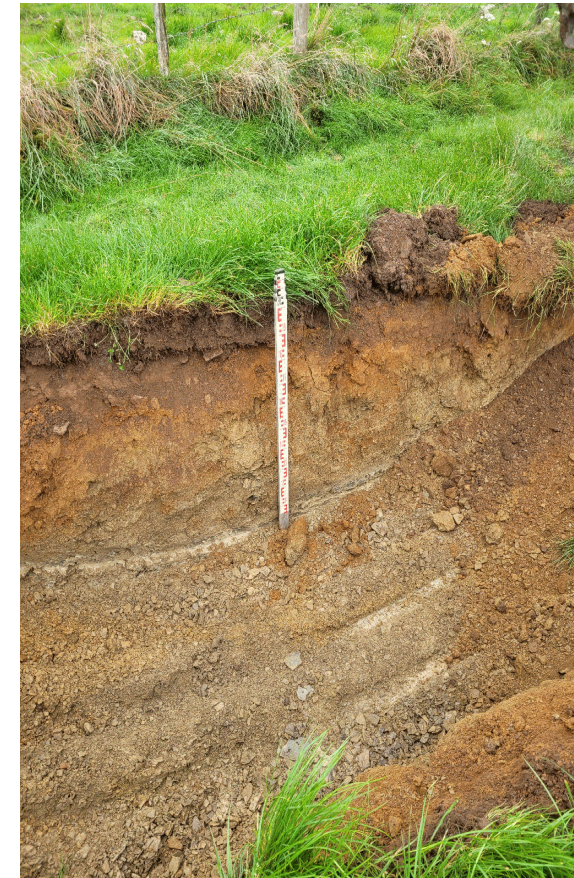
SUBSURFACE PROFILE

Depth	Symbol	Depth/Elev.	Description	Water Strikes	Sample Type	Comments
0.00		0.00	Ground Surface			
		0.00	Topsoil			
		-0.10				
		0.10	Firm, orangy grey SILT			
		-0.70				
		0.70	Soft, grey, weathered SHALE			
1.00		-1.00				
		1.00

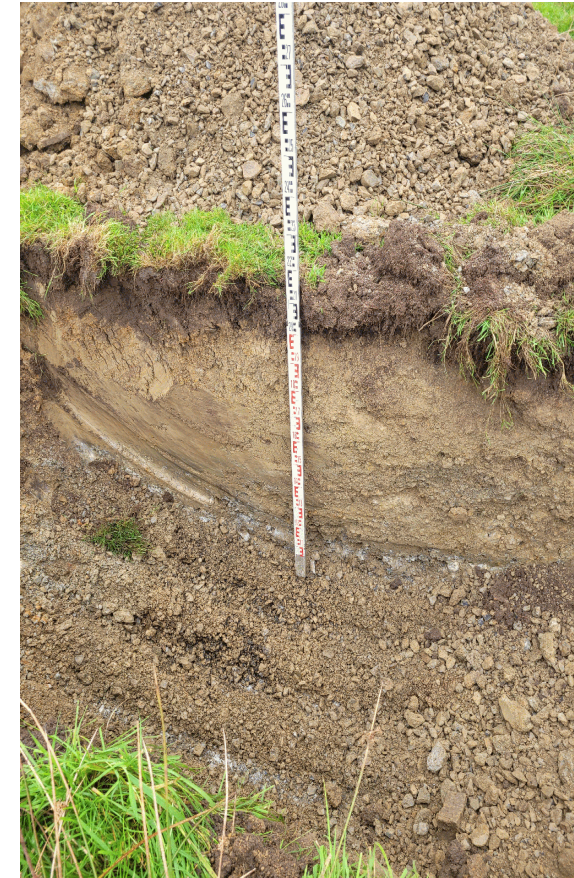
SUBSURFACE PROFILE

Depth	Symbol	Depth/Elev.	Description	Water Strikes	Sample Type	Comments
0.00		0.00	Ground Surface			
		0.00	Peaty Topsoil			
		-0.15 0.15	Firm, organy grey SILT getting more gravelly with depth			
1.00		-1.00 1.00	Soft, weathered SHALE			
		-1.10 1.10

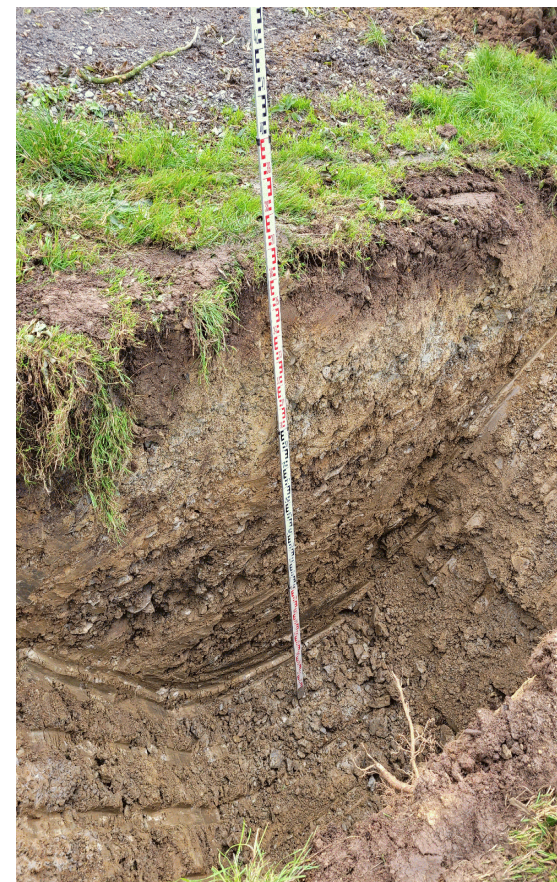
SUBSURFACE PROFILE

Depth	Symbol	Depth/Elev.	Description	Water Strikes	Sample Type	Comments
0.00		0.00	Ground Surface			
		0.00	Topsoil			
			Firm, grey slightly sandy SILT			
1.00		-0.90				
		0.90	Brown, very firm SILT/CLAY with numerous angular clasts and frequent cobbles (Boulder Clay)			
2.00						
		-2.60				
		2.60

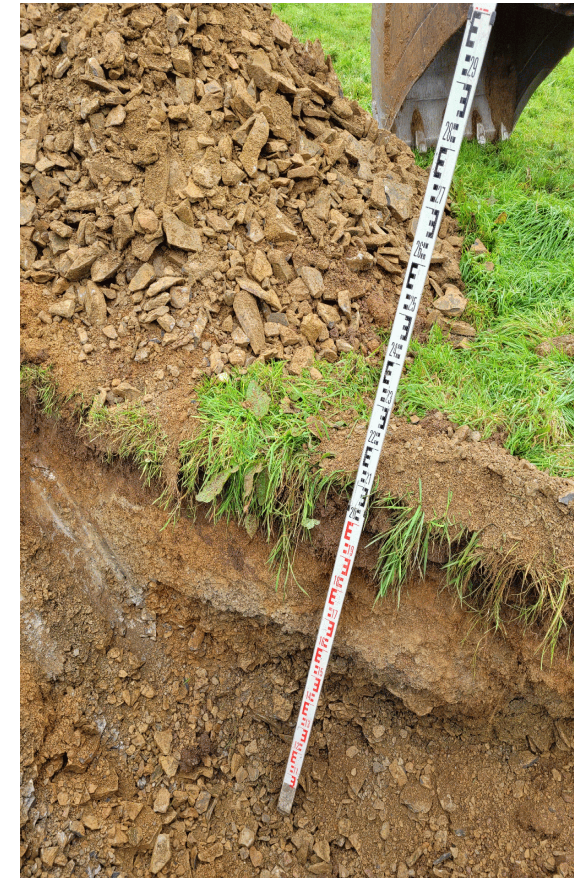
SUBSURFACE PROFILE

Depth	Symbol	Depth/Elev.	Description	Water Strikes	Sample Type	Comments
0.00		0.00	Ground Surface			
		0.00	Peaty topsoil			
		-0.15 0.15	Firm, organgy grey SILT getting more gravelly with depth			
		-0.50 0.50	Soft, weathered SHALE			
1.00		-1.10 1.10
