## APPENDIX 8-1

### PEAT STABILITY RISK ASSESSMENT

# Peat Stability Risk Assessment (PSRA) for Curraglass Renewable Energy Development

<b>Project Title:</b>	Curraglass Renewable Energy Development
<b>Report Title:</b>	PSRA for Curraglass Renewable Energy Development
<b>Document reference:</b>	19162-001-04

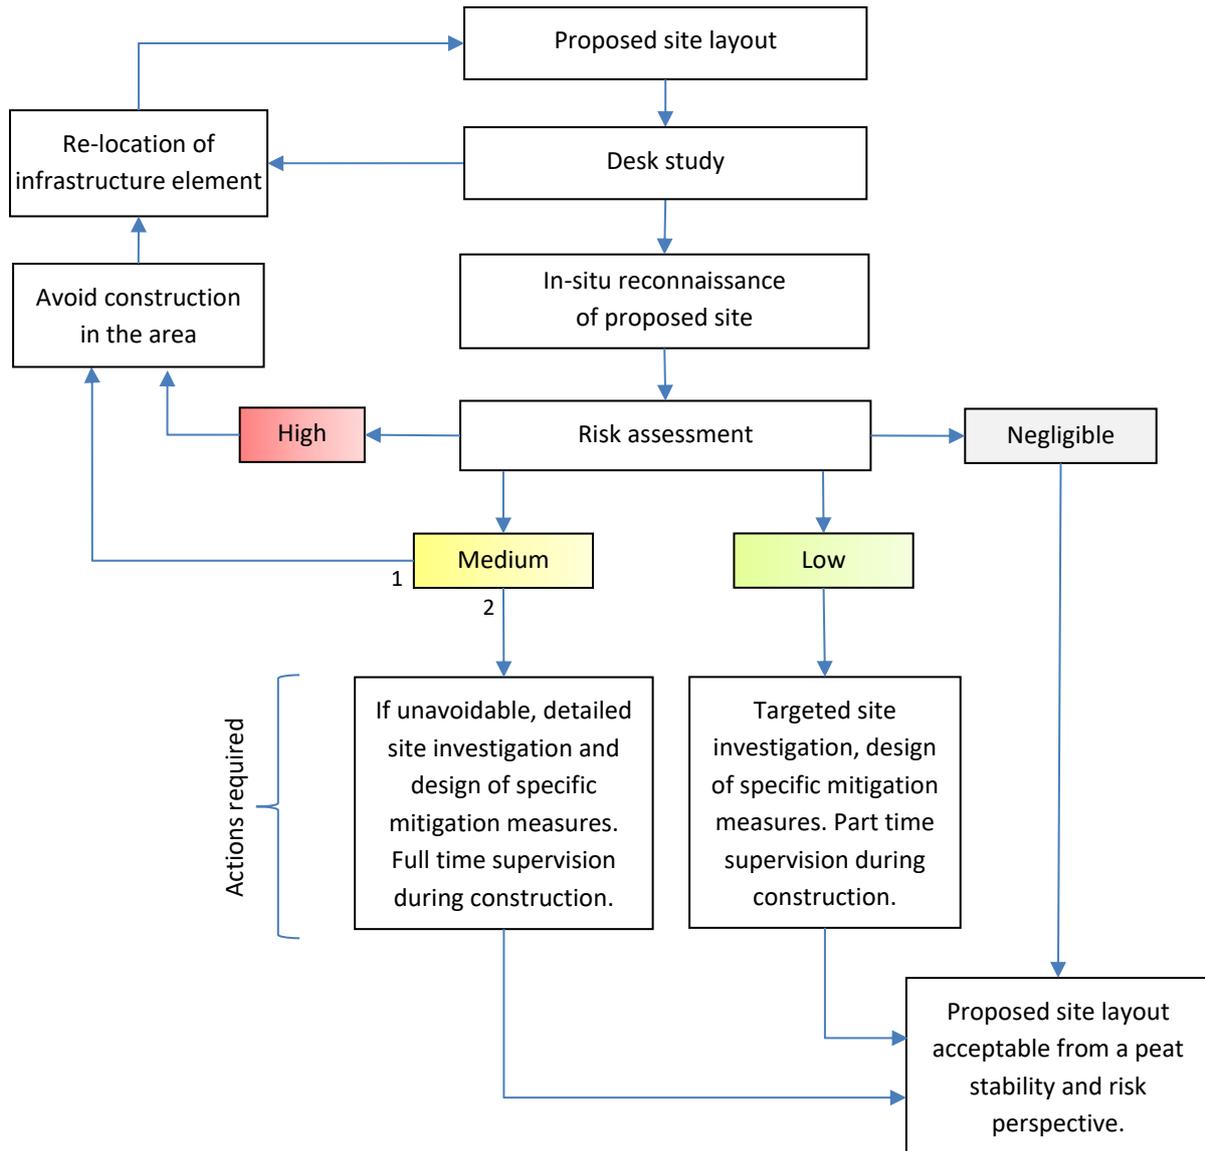
Figure 1-2: Workflow of the PSRA methodology for the acceptability of the proposed site layout.

3. Risk assessment, including:
  - Interpolation of the peat probe values and generation of the peat depth map;
  - Creation of the Factor of Safety (FoS) maps using a deterministic approach (Bromhead, 1986) for drained and undrained conditions;

- Qualitative hazard assessment by combining the FoS with observations of the peat condition identified both on aerial imagery and during fieldwork.
  - Qualitative consequences assessment;

- Calculation of the peat landslide risk by multiplying hazard and consequences;
  - Reclassification of the risk values in four classes:
    - Negligible;

- Low;
    - Medium; and
    - Serious.
4. Proposal of actions required for each infrastructure element.

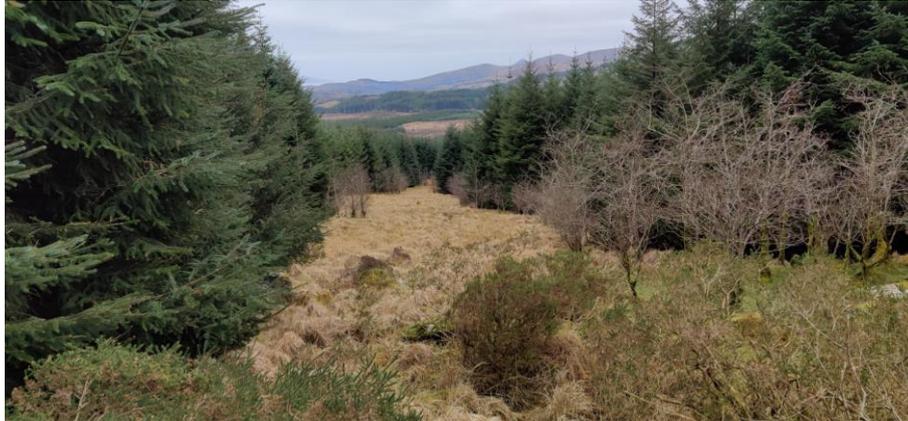
**Figure 3-1: Forestry on site.**

As part of the assessment, the project team carried out a site reconnaissance. This comprised two site visits (21<sup>st</sup> of January and 6<sup>th</sup> of February, 2020) to record geomorphological features concerning the Proposed Development, peat depths and peat strength. An indication of the site conditions (forested and recently felled areas) and undulating topography are shown in Figure 3-1 and Figure 3-2.

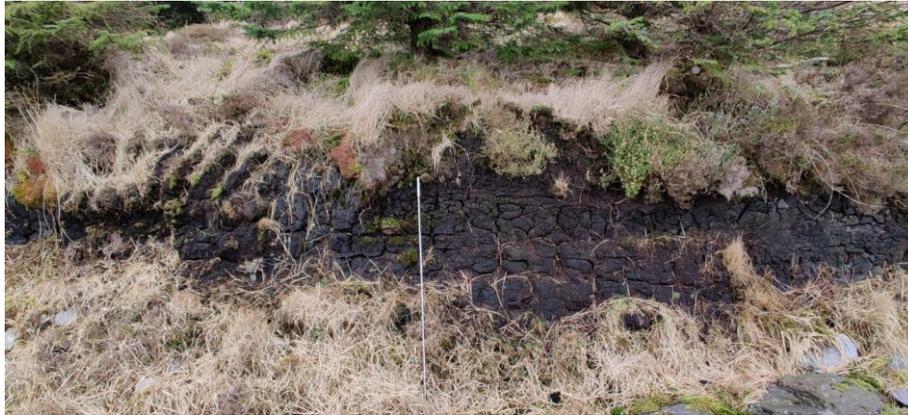
**Figure 3-3: Compact peat side-cast along a track during previous construction works.**

It is noted that the peat in certain sections could not be penetrated to required depth due to either peat compaction (Figure 3-3) or due to the presence of loose rock within the peat itself (where peat was side-cast to construct existing tracks).

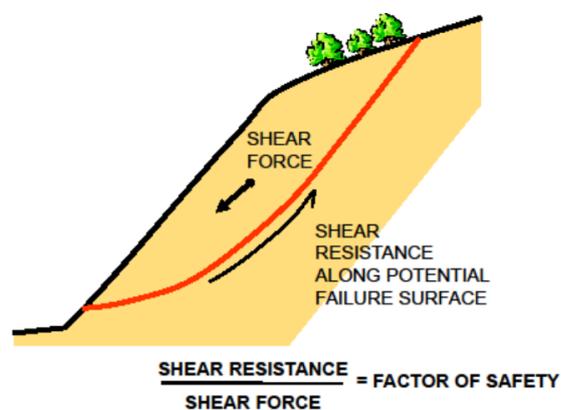
Figure 4-1: Balance of forces in a slope (Scottish Executive, 2017).

The factor of safety is a measure of the stability of a slope. For any slope, the degree of stability depends on the balance between the landslide driving forces (weight of the slope) and its inherent shear strength (Figure 4-1).

Therefore, the factor of safety provides a direct measure of the degree of stability of a slope by the ratio of the shear resistance along a potential surface of failure and the landslide driving forces acting on such surface. Multiple potential surfaces of failure are possible, but the FoS assigned to a slope is that of the surface of failure with the lowest value of FoS.

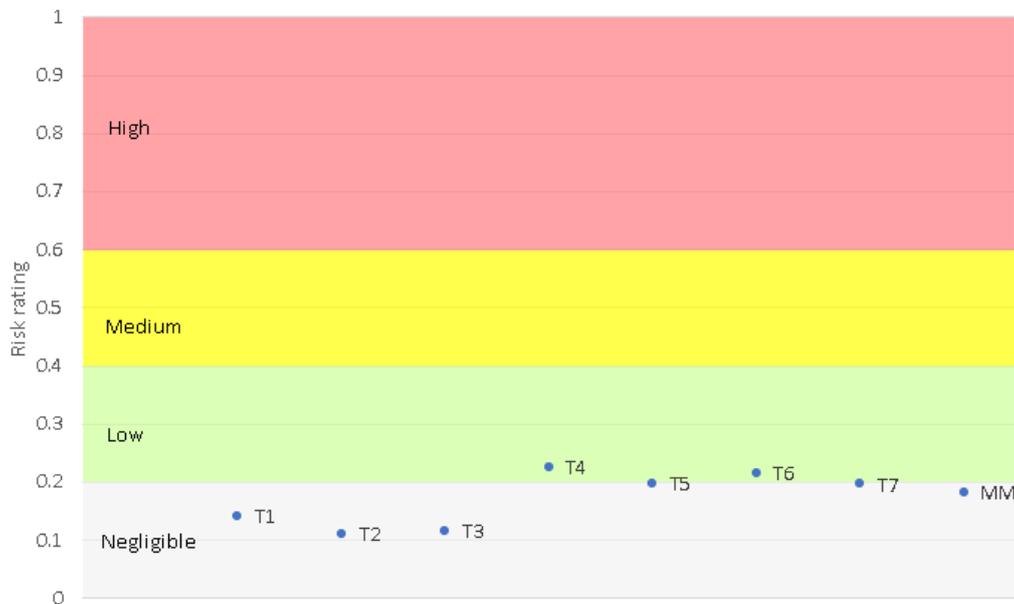
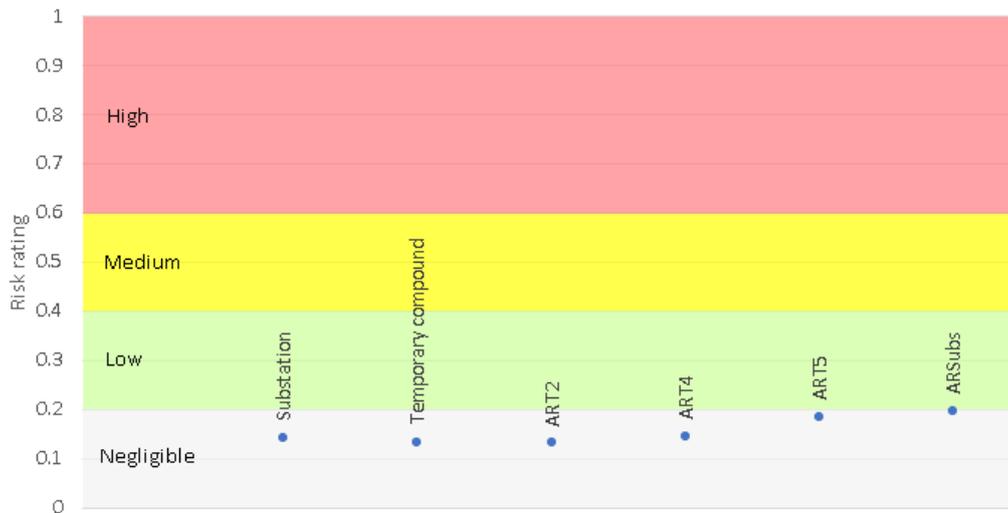
**Figure 5-1: Risk ratings at the proposed infrastructure element sites.**

Risk in each wind farm infrastructure element is calculated with Equation 5-1, i.e. multiplying the scores of the hazard and the scores of the consequences. The risk rating ranges between 0 and 1 and the following levels of risk rating have been distinguished (Figure 5-1):

- **High (0.6 to 1):** Avoid project development at these locations. Mitigation is generally not feasible.
- **Medium (0.4 to 0.6):** Project should not proceed unless risk can be avoided or mitigated at these locations, without significant environmental impact, to reduce risk ranking to low or negligible.
- **Low (0.2 to 0.4):** Project may proceed pending further investigation to refine assessment and mitigate hazard through relocation or re-design at these locations.
- **Negligible (0 to 0.2):** Project should proceed with monitoring and mitigation of peat landslide hazards at these locations as appropriate.

Note: MM = Met mast; ART2 = Access road to T2; ARSubs = Access road to substation.

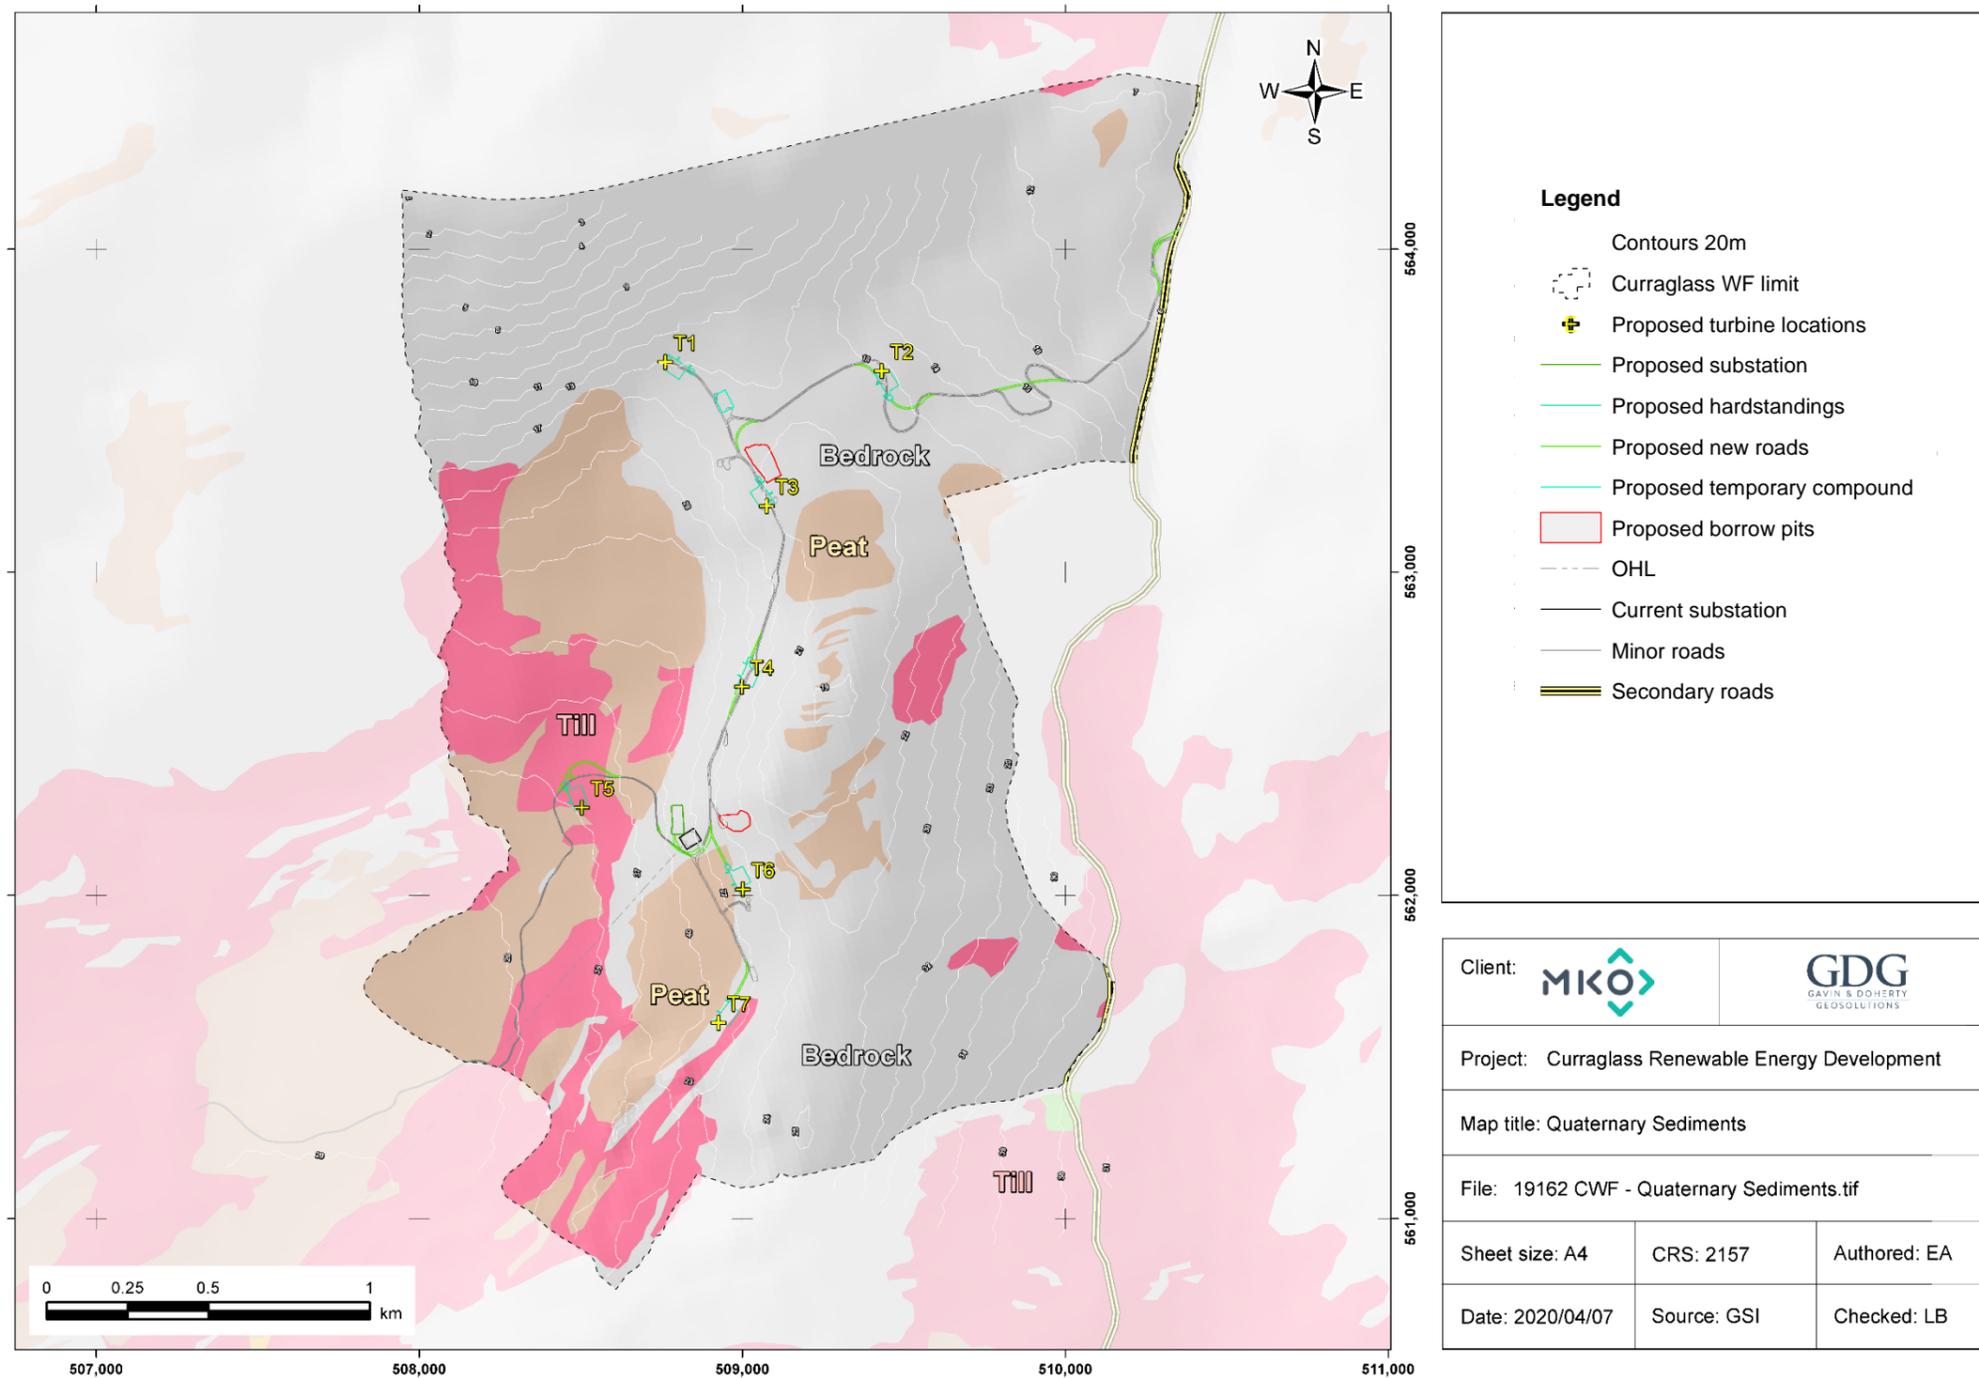
Figure B-2: Quaternary sediments (GSI).

Note: The quaternary sediments in the proposed site have been labelled in the map. This is a regional scale map that does not represent the local details of the peat spatial distribution, which was enhanced for this project through fieldwork peat probes.

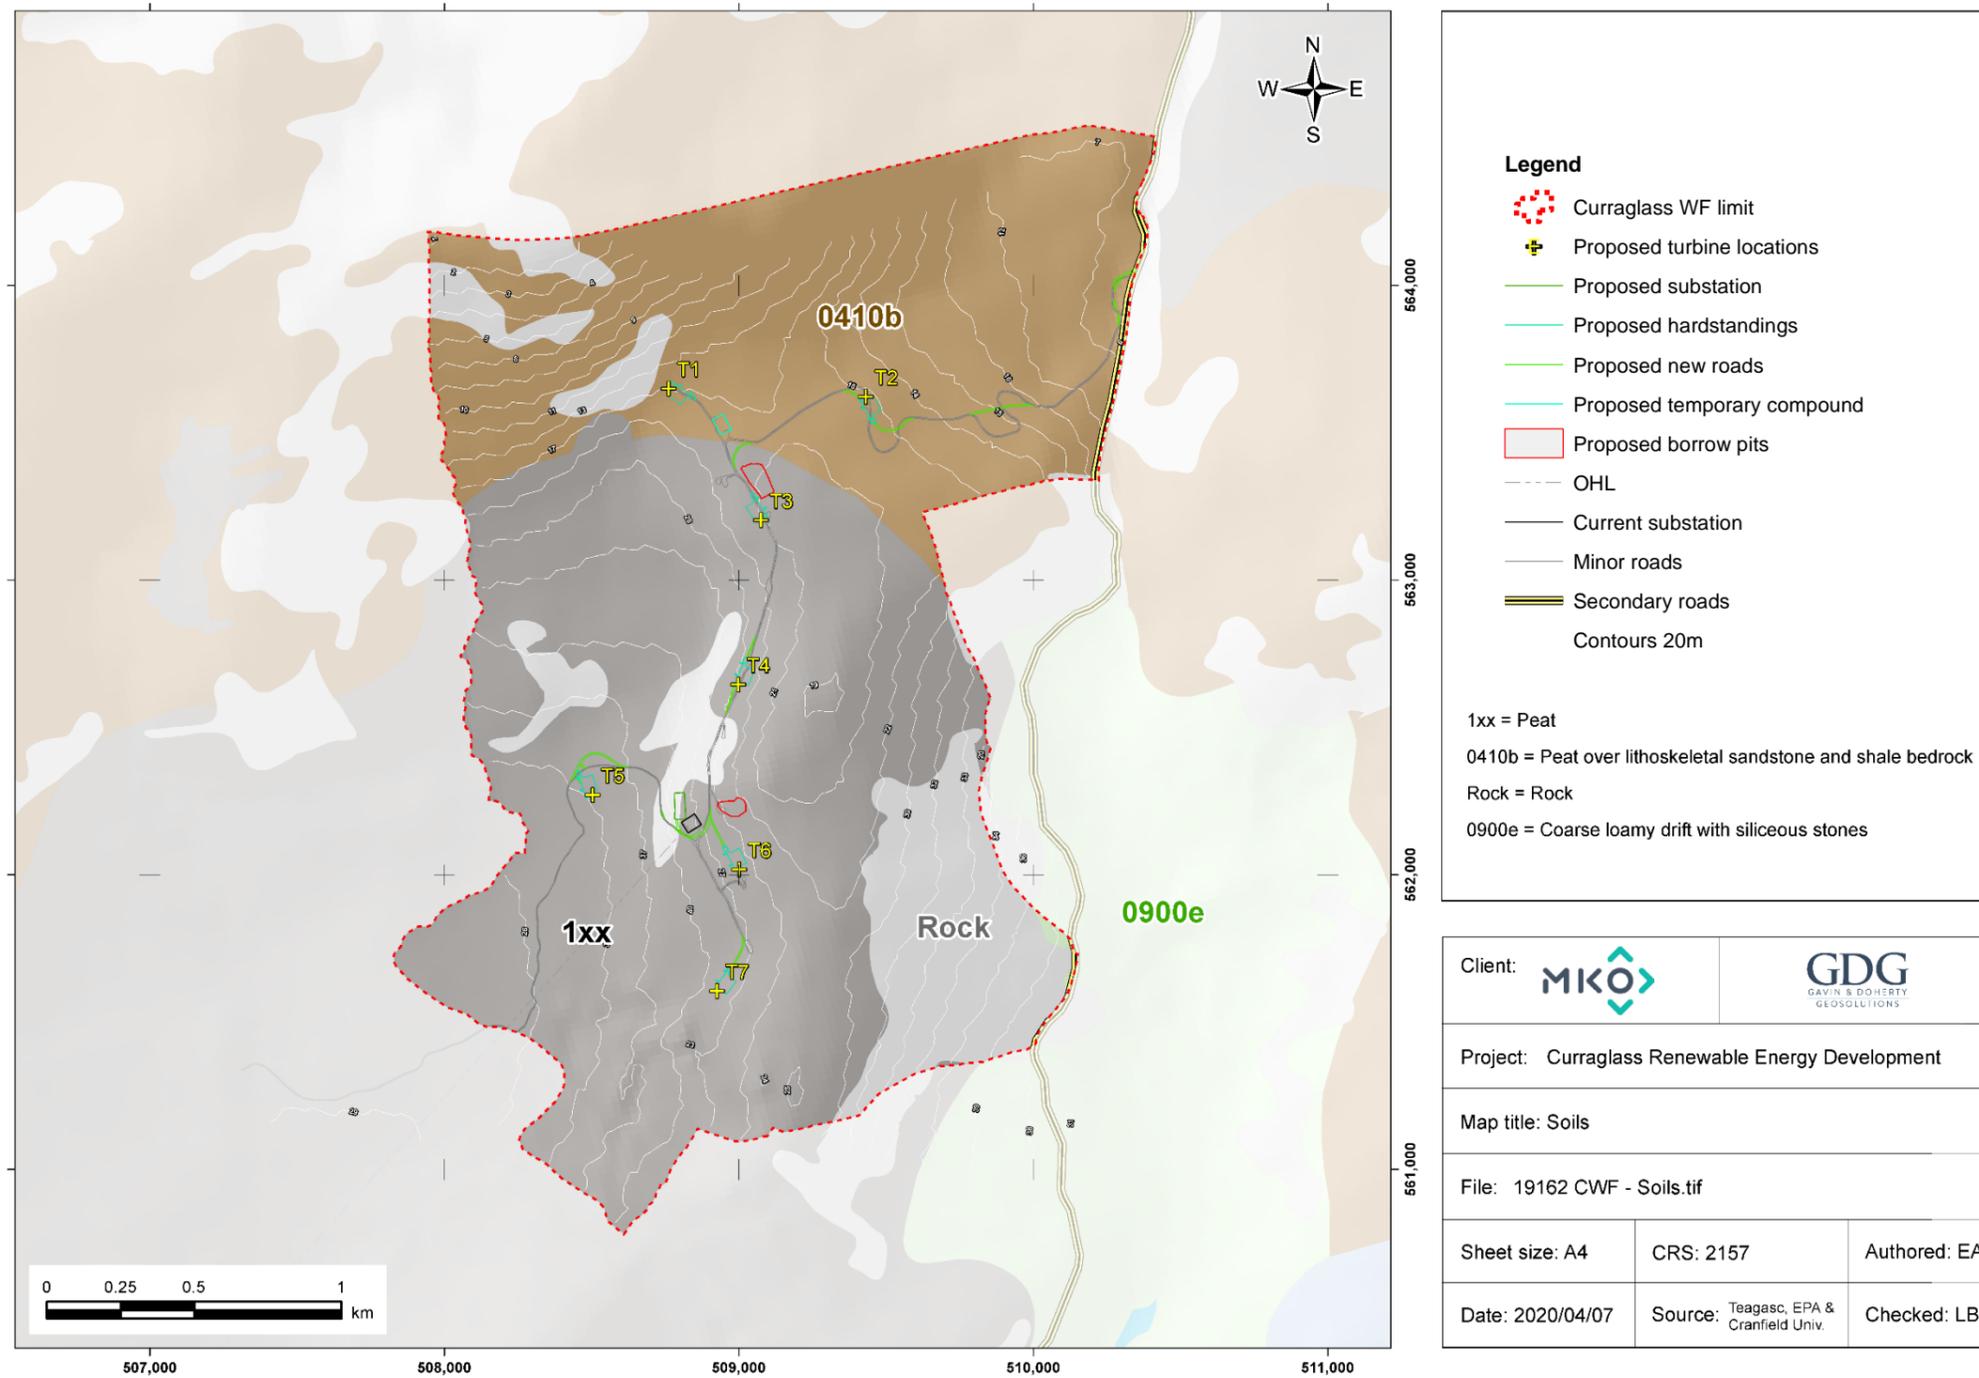
Figure C-1: Soils.

The Irish soil map at 1:250,000 scale (Figure C-1) (EPA, Teagasc, & Cranfield University, n.d.) shows that most of the proposed site is covered by peat. It is noted that the presence or absence of peat cover in the regional scale maps (Figure B-2 and Figure C-1) must not be taken as exact. The depth and extent of peat deposits may vary over short distances as a function of local underlying geology, past and ongoing geomorphological activity and management history. Therefore, these maps have been complemented by peat probes and field observations which are described in Section 3.

Note: The soils in the proposed site have been labelled in the map. This is a regional scale map that does not represent the local details of the peat spatial distribution, which was enhanced for this project through fieldwork and peat probes.

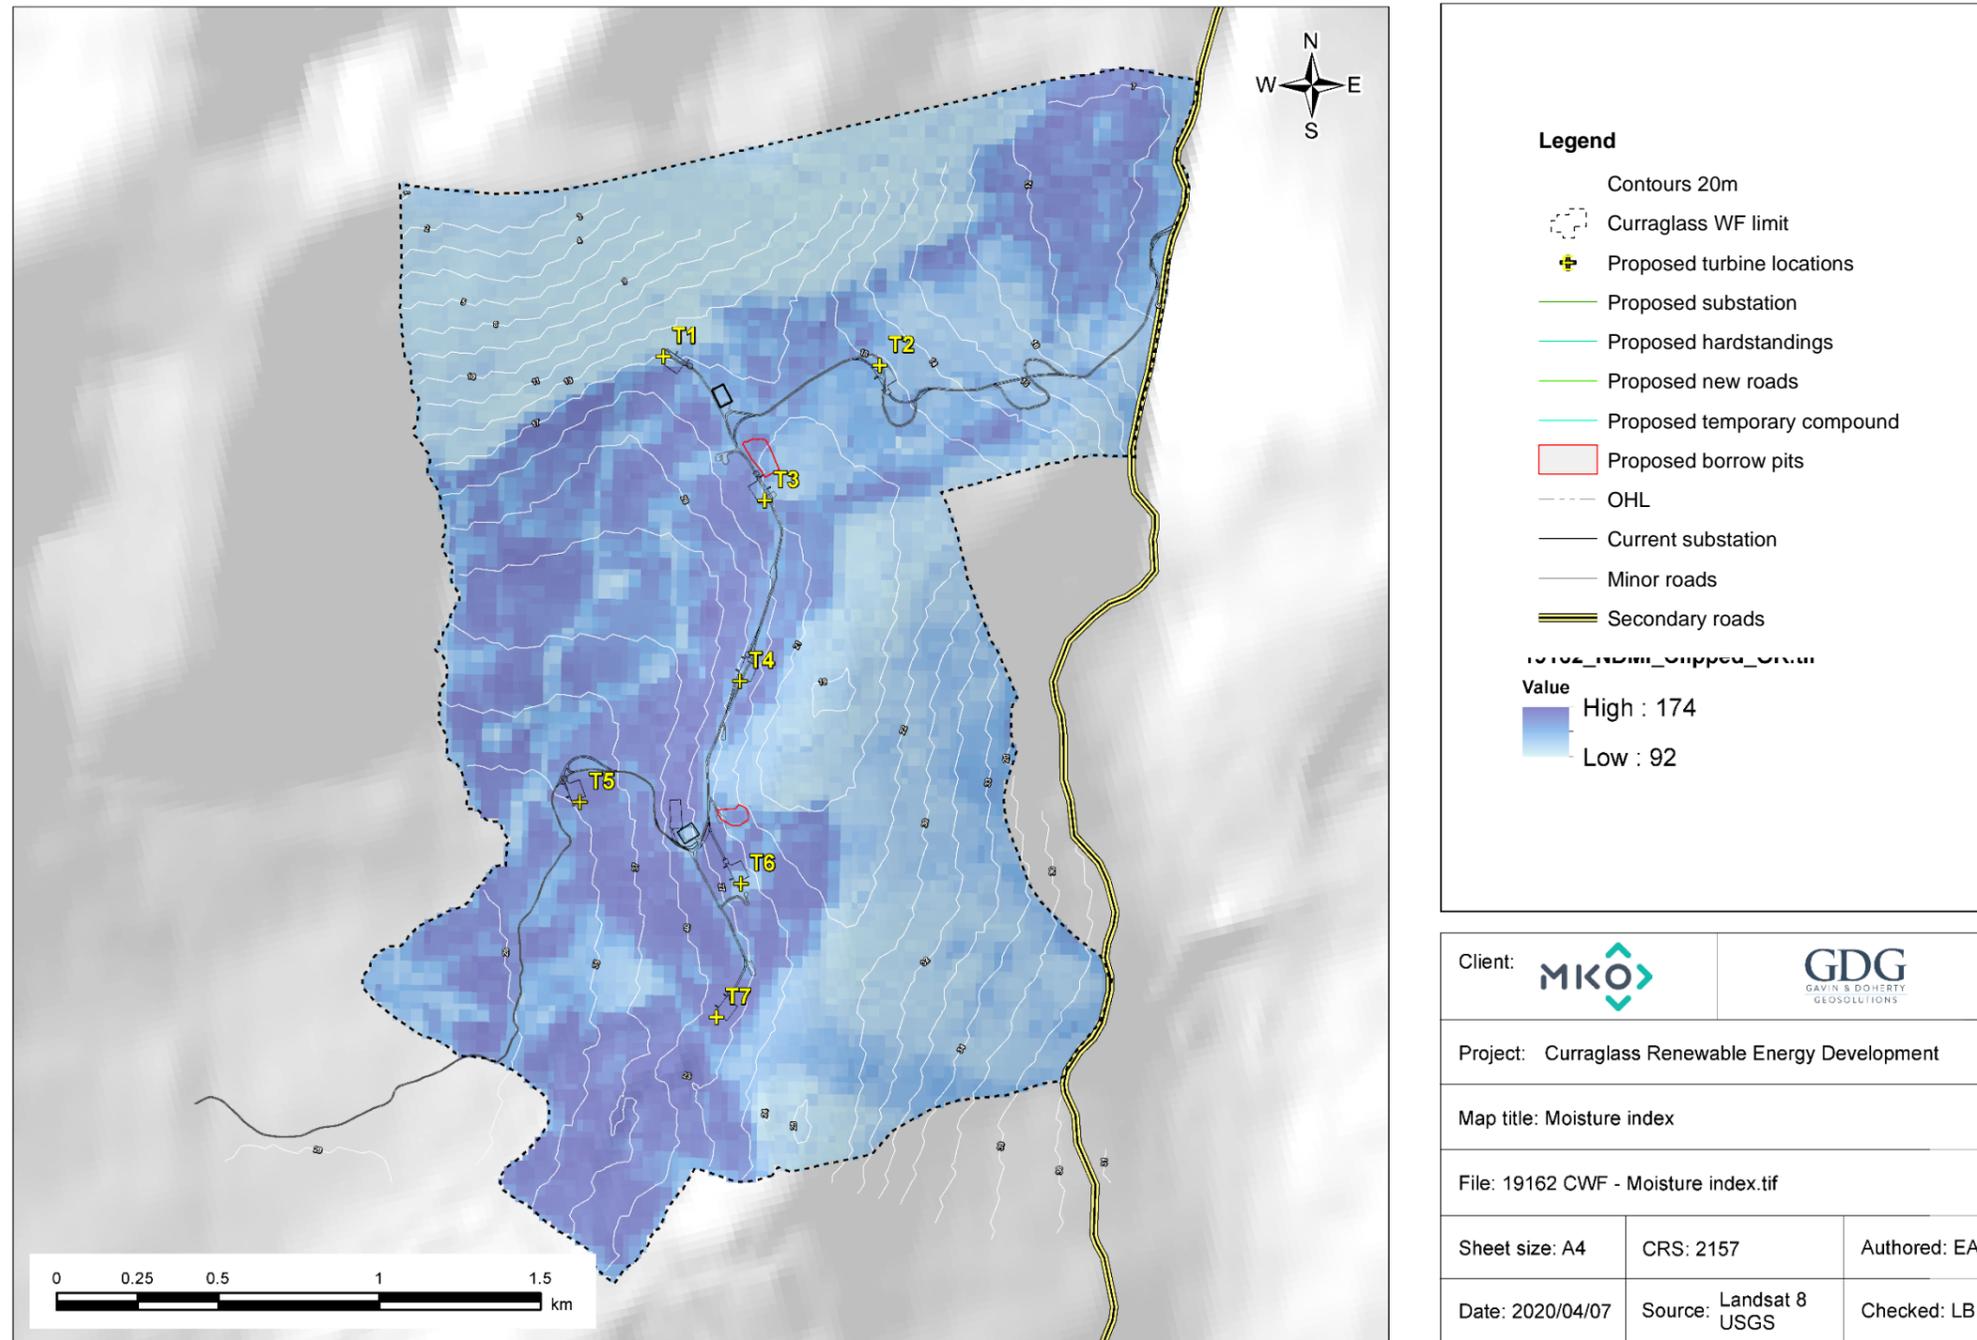
Figure D-1: Moisture Index developed from Landsat 8 and the USGS.

Figure D-1 in Appendix D illustrates the levels of estimated soil moisture across the Proposed Development site. Wetlands and other vegetated areas with high levels of moisture appear as dark blue (e.g. along the SW-NE valley). Regions of high elevation (e.g. north sector) and slopes which face east exhibit lower values of moisture and are represented as light blue and green.

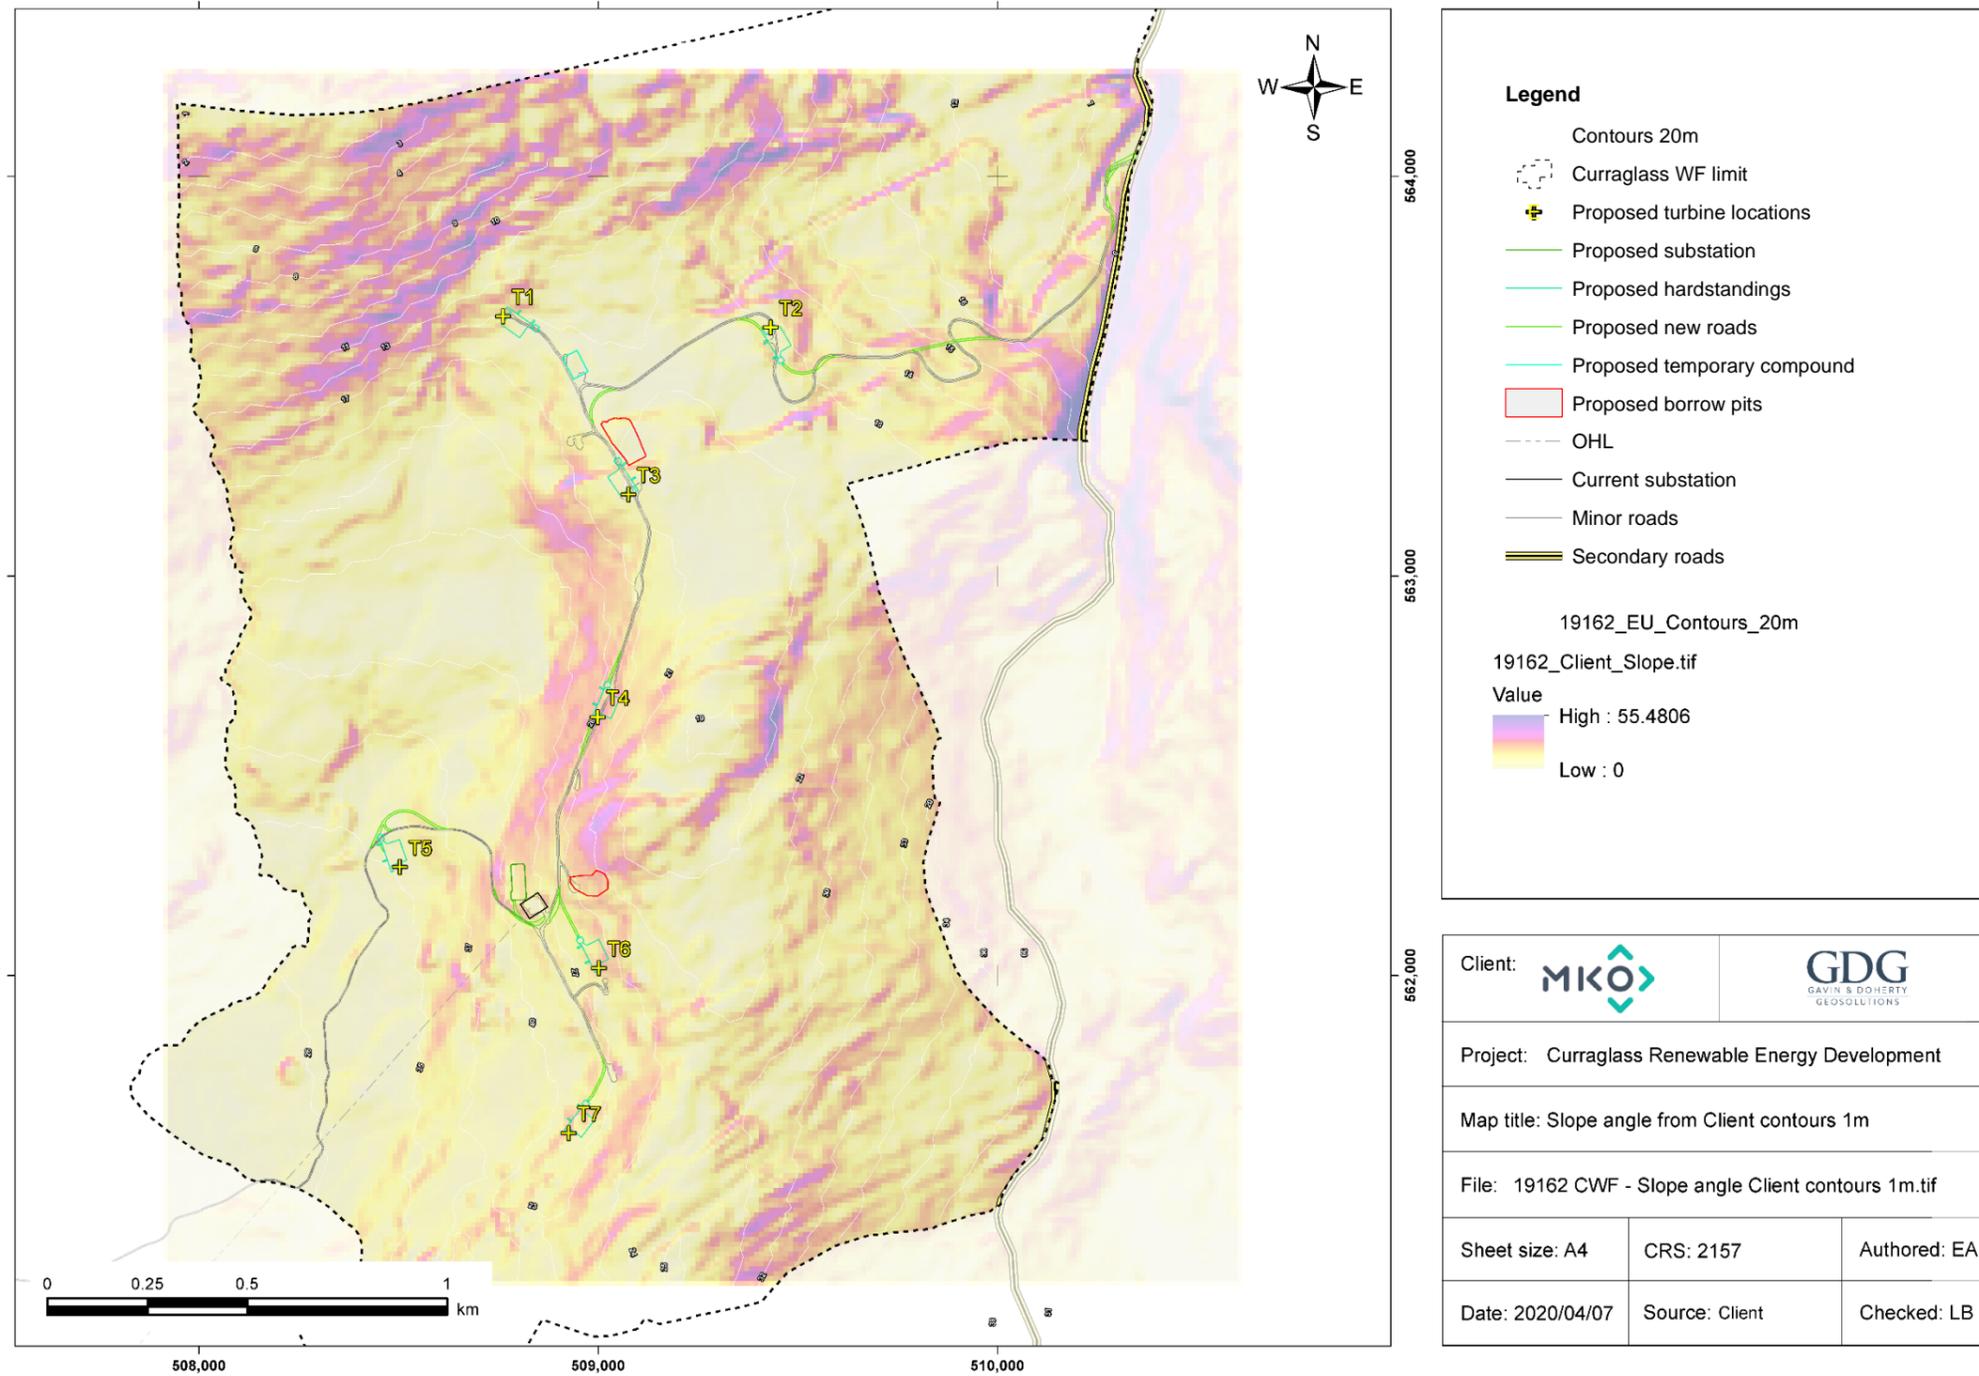
Figure F-1: Slope angle in degrees derived from the 1-meter contours sourced from Bluesky.

Note: The spatial resolution of this raster is 12 m and it has been used as an input for the calculation of the peat Factor of Safety (FoS).

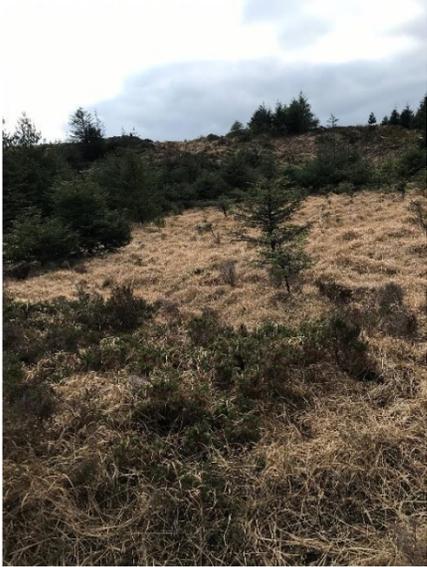
Ground-based photo	Proposed substation	Proposed borrow pits	<b>Peat depth (m)</b> 0 - 0.5 0.6 - 1 1.1 - 2 2.1 - 3.5 3.6 - 5.5	Contours 1m	Proposed hardstandings	Proposed met mast location	Executed peat probes	Proposed new roads	Existing road	Proposed turbine locations	Proposed temporary compound	Rivers			
Ground-based photo	Proposed substation	Proposed borrow pits	<b>Peat depth (m)</b> 0 - 0.5 0.6 - 1 1.1 - 2 2.1 - 3.5 3.6 - 5.5																
Contours 1m	Proposed hardstandings	Proposed met mast location																	
Executed peat probes	Proposed new roads	Existing road																	
Proposed turbine locations	Proposed temporary compound	Rivers																	
<p style="text-align: center;"><b>Description</b></p> <p><b>Date of the satellite images:</b> April 2020. [Centre National d'Études Spaciales (CNES) / Airbus].</p> <p><b>Date of the ground-based pictures:</b> February 2020 [GDG].</p> <p><b>Geomorphology:</b> The topography is convex in the northern half and horizontal in the south.</p> <p><b>Peat:</b> In the northern half the peat depth is almost 0. In the southern half, peat depths of up to 0.45 m can be found.</p> <p><b>Instability evidences:</b> No.</p>		<p style="text-align: center;">0550.JPG</p>

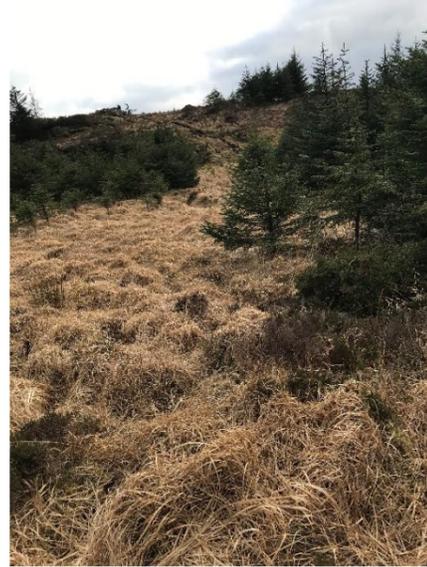
<p style="text-align: center;">0554.JPG</p>

Table J-12: Site reconnaissance of the Borrow Pit 2 site.

<p style="text-align: center;"><b>Imagery</b></p>	<p style="text-align: center;"><b>Peat geo-investigation</b></p>					
<p style="text-align: center;"><b>Shared legend</b></p> <table border="0" style="width: 100%;"> <tr> <td style="vertical-align: top;"> <ul style="list-style-type: none"> <li> Ground-based photo</li> <li>Contours 1m</li> <li> Executed peat probes</li> <li> Proposed turbine locations</li> </ul> </td> <td style="vertical-align: top;"> <ul style="list-style-type: none"> <li> Proposed substation</li> <li> Proposed hardstandings</li> <li> Proposed new roads</li> <li> Proposed temporary compound</li> </ul> </td> <td style="vertical-align: top;"> <ul style="list-style-type: none"> <li> Proposed borrow pits</li> <li> Proposed met mast location</li> <li> Existing road</li> <li> Rivers</li> </ul> </td> <td style="vertical-align: top;"> <p><b>Peat depth (m)</b></p> <ul style="list-style-type: none"> <li> 0 - 0.5</li> <li> 0.6 - 1</li> <li> 1.1 - 2</li> <li> 2.1 - 3.5</li> <li> 3.6 - 5.5</li> </ul> </td> </tr> </table>			<ul style="list-style-type: none"> <li> Ground-based photo</li> <li>Contours 1m</li> <li> Executed peat probes</li> <li> Proposed turbine locations</li> </ul>	<ul style="list-style-type: none"> <li> Proposed substation</li> <li> Proposed hardstandings</li> <li> Proposed new roads</li> <li> Proposed temporary compound</li> </ul>	<ul style="list-style-type: none"> <li> Proposed borrow pits</li> <li> Proposed met mast location</li> <li> Existing road</li> <li> Rivers</li> </ul>	<p><b>Peat depth (m)</b></p> <ul style="list-style-type: none"> <li> 0 - 0.5</li> <li> 0.6 - 1</li> <li> 1.1 - 2</li> <li> 2.1 - 3.5</li> <li> 3.6 - 5.5</li> </ul>
<ul style="list-style-type: none"> <li> Ground-based photo</li> <li>Contours 1m</li> <li> Executed peat probes</li> <li> Proposed turbine locations</li> </ul>	<ul style="list-style-type: none"> <li> Proposed substation</li> <li> Proposed hardstandings</li> <li> Proposed new roads</li> <li> Proposed temporary compound</li> </ul>	<ul style="list-style-type: none"> <li> Proposed borrow pits</li> <li> Proposed met mast location</li> <li> Existing road</li> <li> Rivers</li> </ul>	<p><b>Peat depth (m)</b></p> <ul style="list-style-type: none"> <li> 0 - 0.5</li> <li> 0.6 - 1</li> <li> 1.1 - 2</li> <li> 2.1 - 3.5</li> <li> 3.6 - 5.5</li> </ul>			
<p style="text-align: center;"><b>Description</b></p> <p><b>Date of the satellite images:</b> April 2020. [Centre National d'Études Spaciales (CNES) / Airbus].</p> <p><b>Date of the ground-based pictures:</b> February 2020 [GDG].</p> <p><b>Geomorphology:</b> The topography is slightly concave with a minor gully funnelling the runoff in this sector.</p> <p><b>Peat:</b> Based on nearby peat probes and geomorphic criteria, an average peat depth of 0.2 m is assumed for this borrow pit.</p> <p><b>Instability evidences:</b> No.</p>

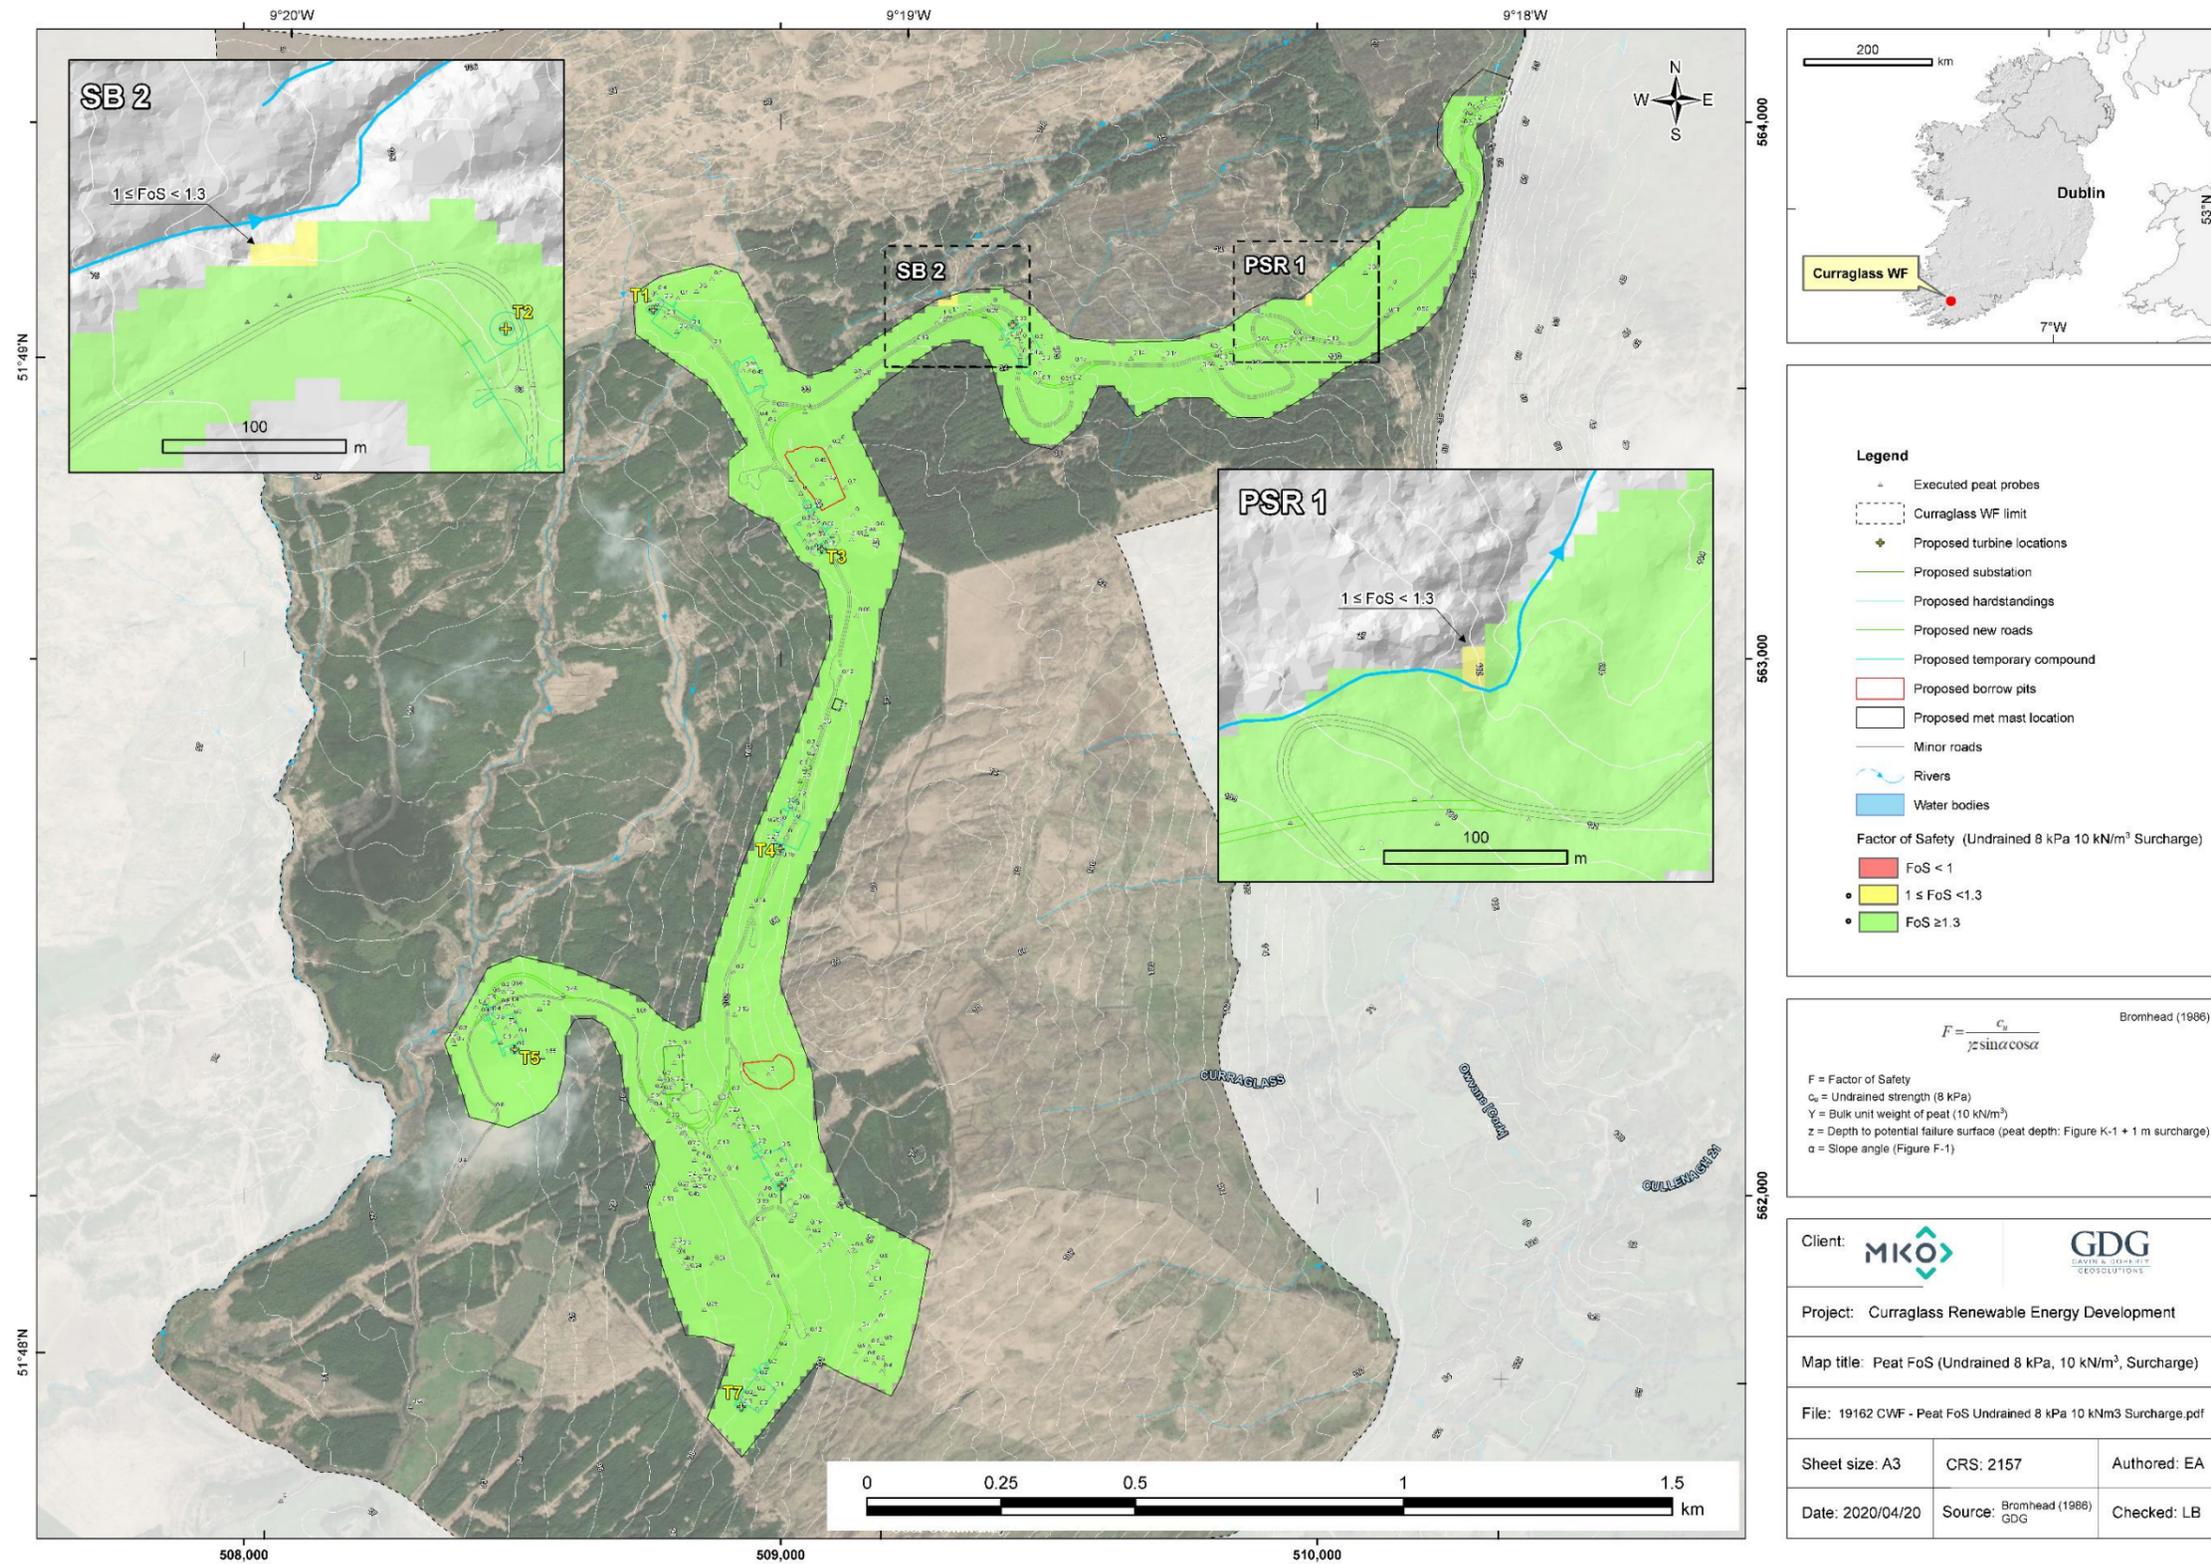
Figure K-2: FoS for undrained conditions and surcharge of 1 m (i.e. 10 kPa).

Note: Safety buffers (SB) and peat stockpile restriction (PSR) areas as identified through the FoS analysis are presented.

The site was found to have both acceptable factors of safety and levels of risk against peat instability. Two areas, referred to as *safety buffers* (see Appendix L), have been highlighted and will have restricted construction activities and should not be used for the storage of peat or soils. The proposed layout avoids these areas. In addition to this, two smaller areas have been highlighted as not suitable for side casting or stockpiling of peat or soils (Appendix K). These areas are indicated on Figures K-2 to K-4 and Figure L-1.
