## APPENDIX 8-1

### PEAT STABILITY RISK ASSESSMENT

# Peat Stability Risk Assessment (PSRA) for Curraglass Renewable Energy Development

<b>Project Title:</b>	Curraglass Renewable Energy Development
<b>Report Title:</b>	PSRA for Curraglass Renewable Energy Development
<b>Document reference:</b>	19162-001-04

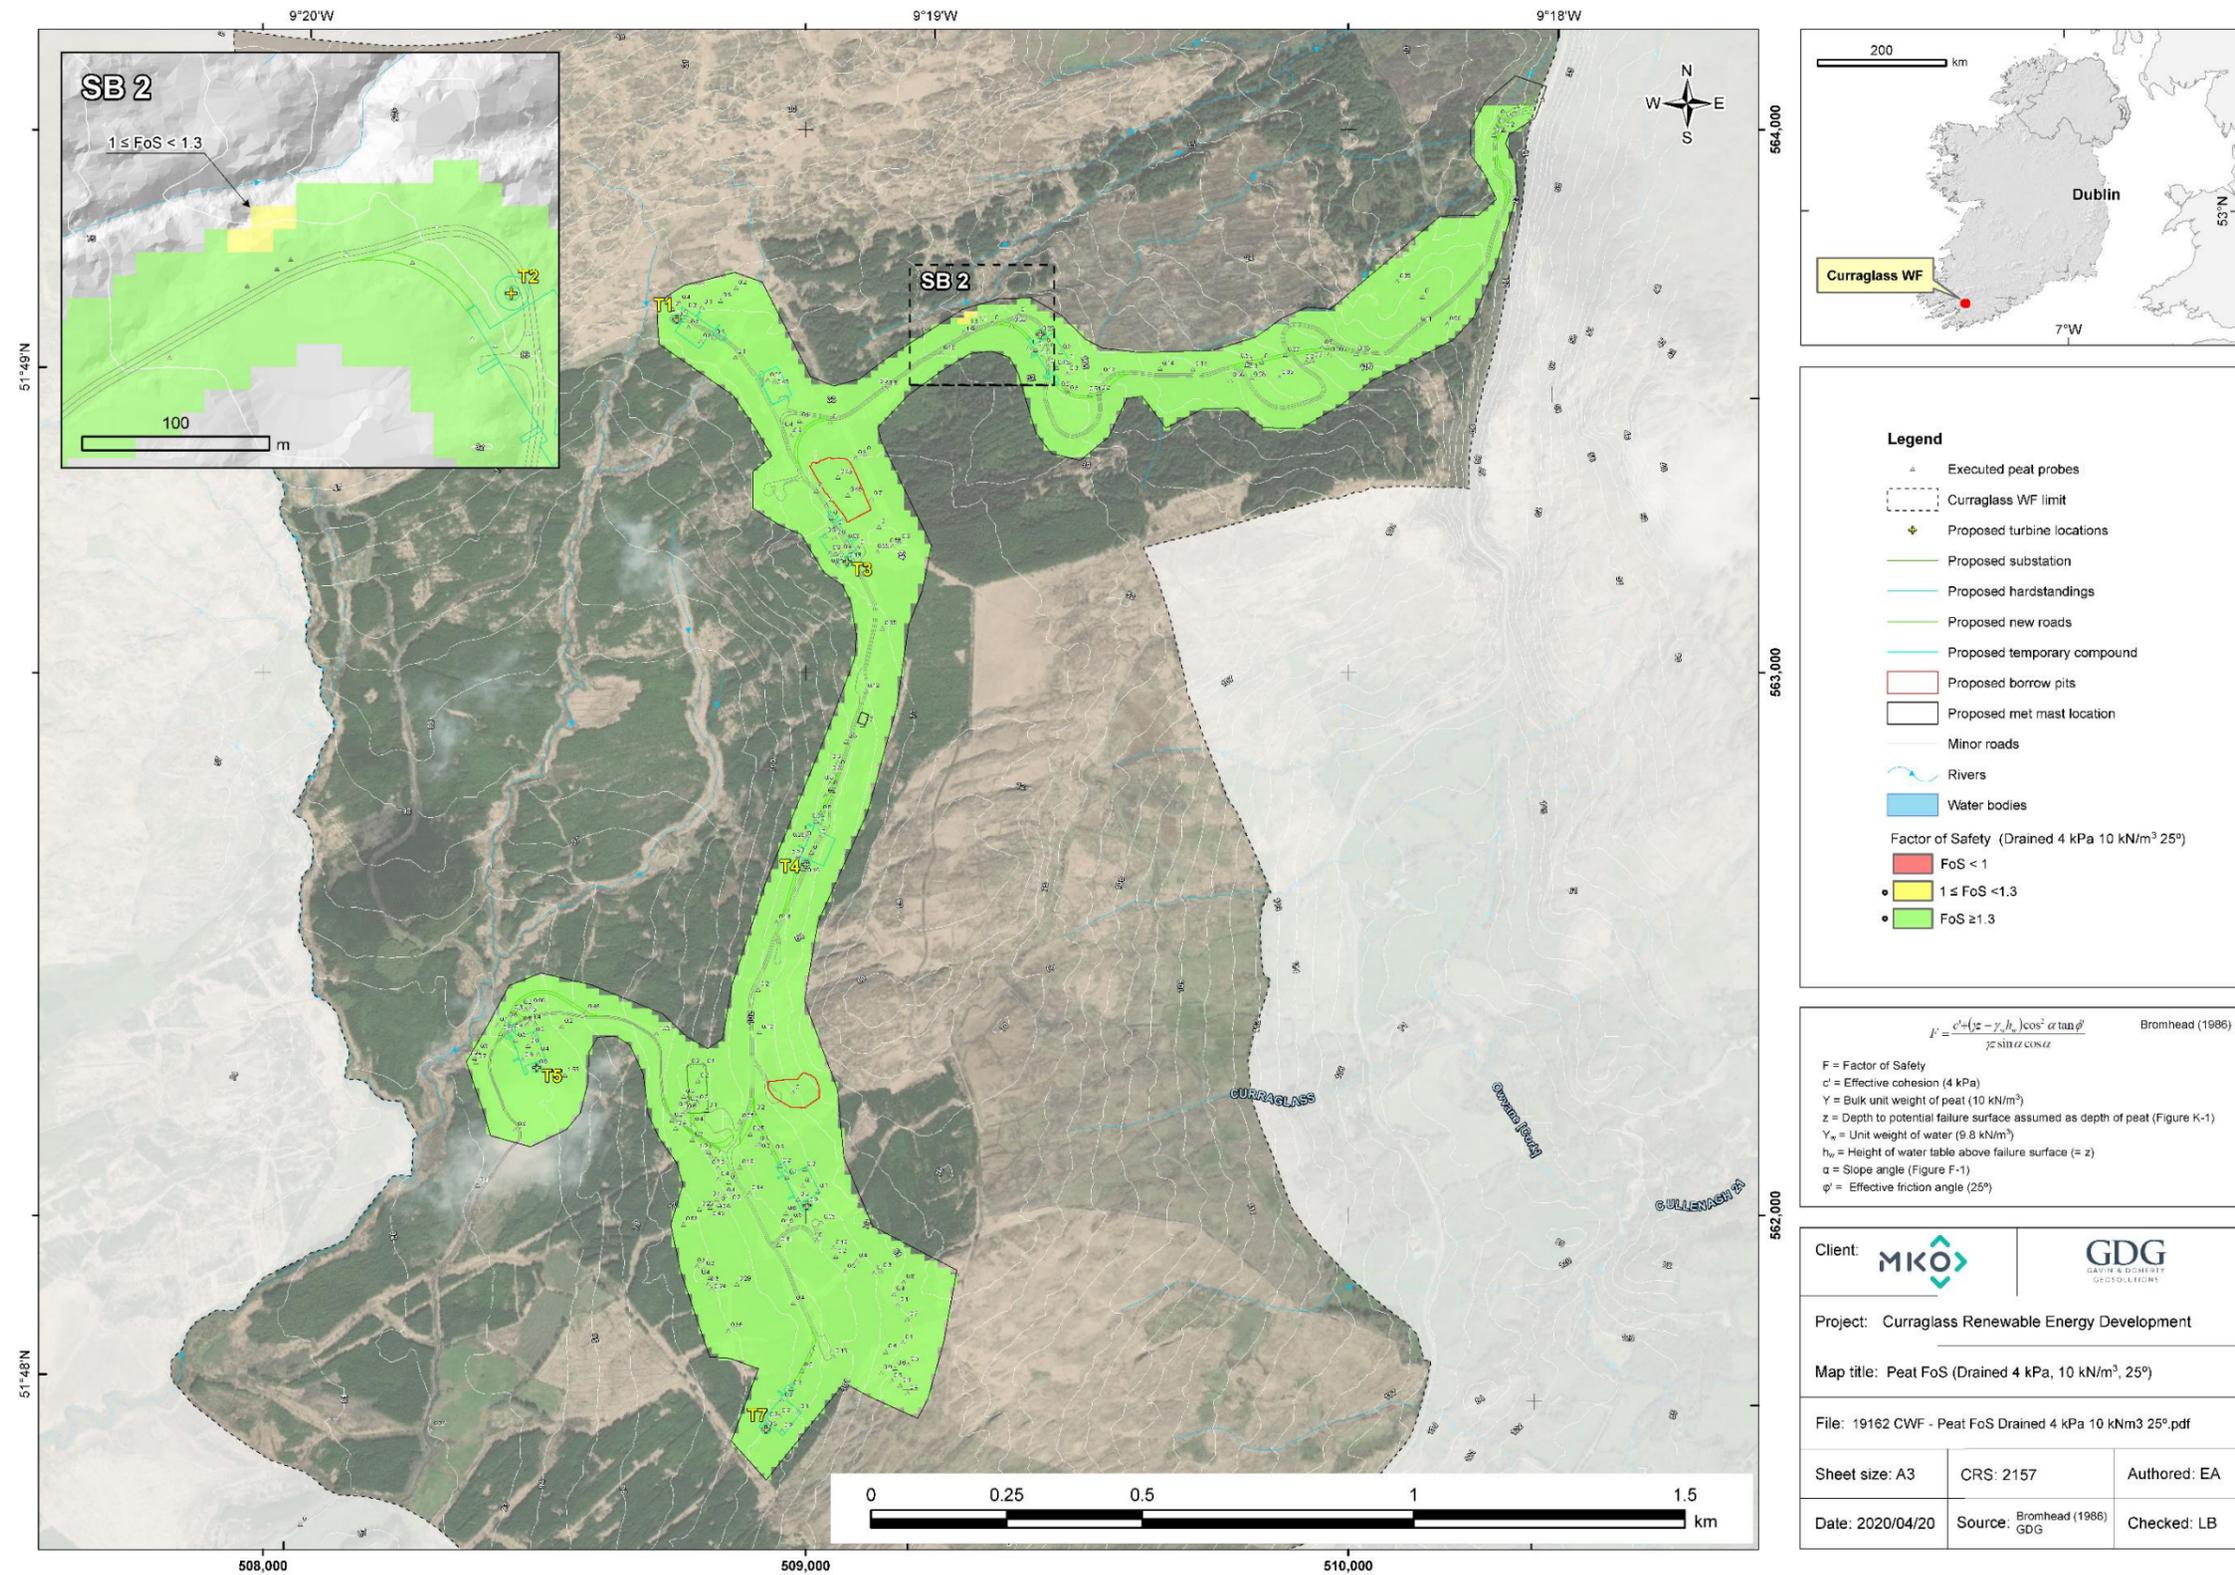
Figure K-3: FoS for drained conditions.

Note: Safety buffers (SB) as identified through the FoS analysis are presented.

The site was found to have both acceptable factors of safety and levels of risk against peat instability. Two areas, referred to as *safety buffers* (see Appendix L), have been highlighted and will have restricted construction activities and should not be used for the storage of peat or soils. The proposed layout avoids these areas. In addition to this, two smaller areas have been highlighted as not suitable for side casting or stockpiling of peat or soils (Appendix K). These areas are indicated on Figures K-2 to K-4 and Figure L-1.

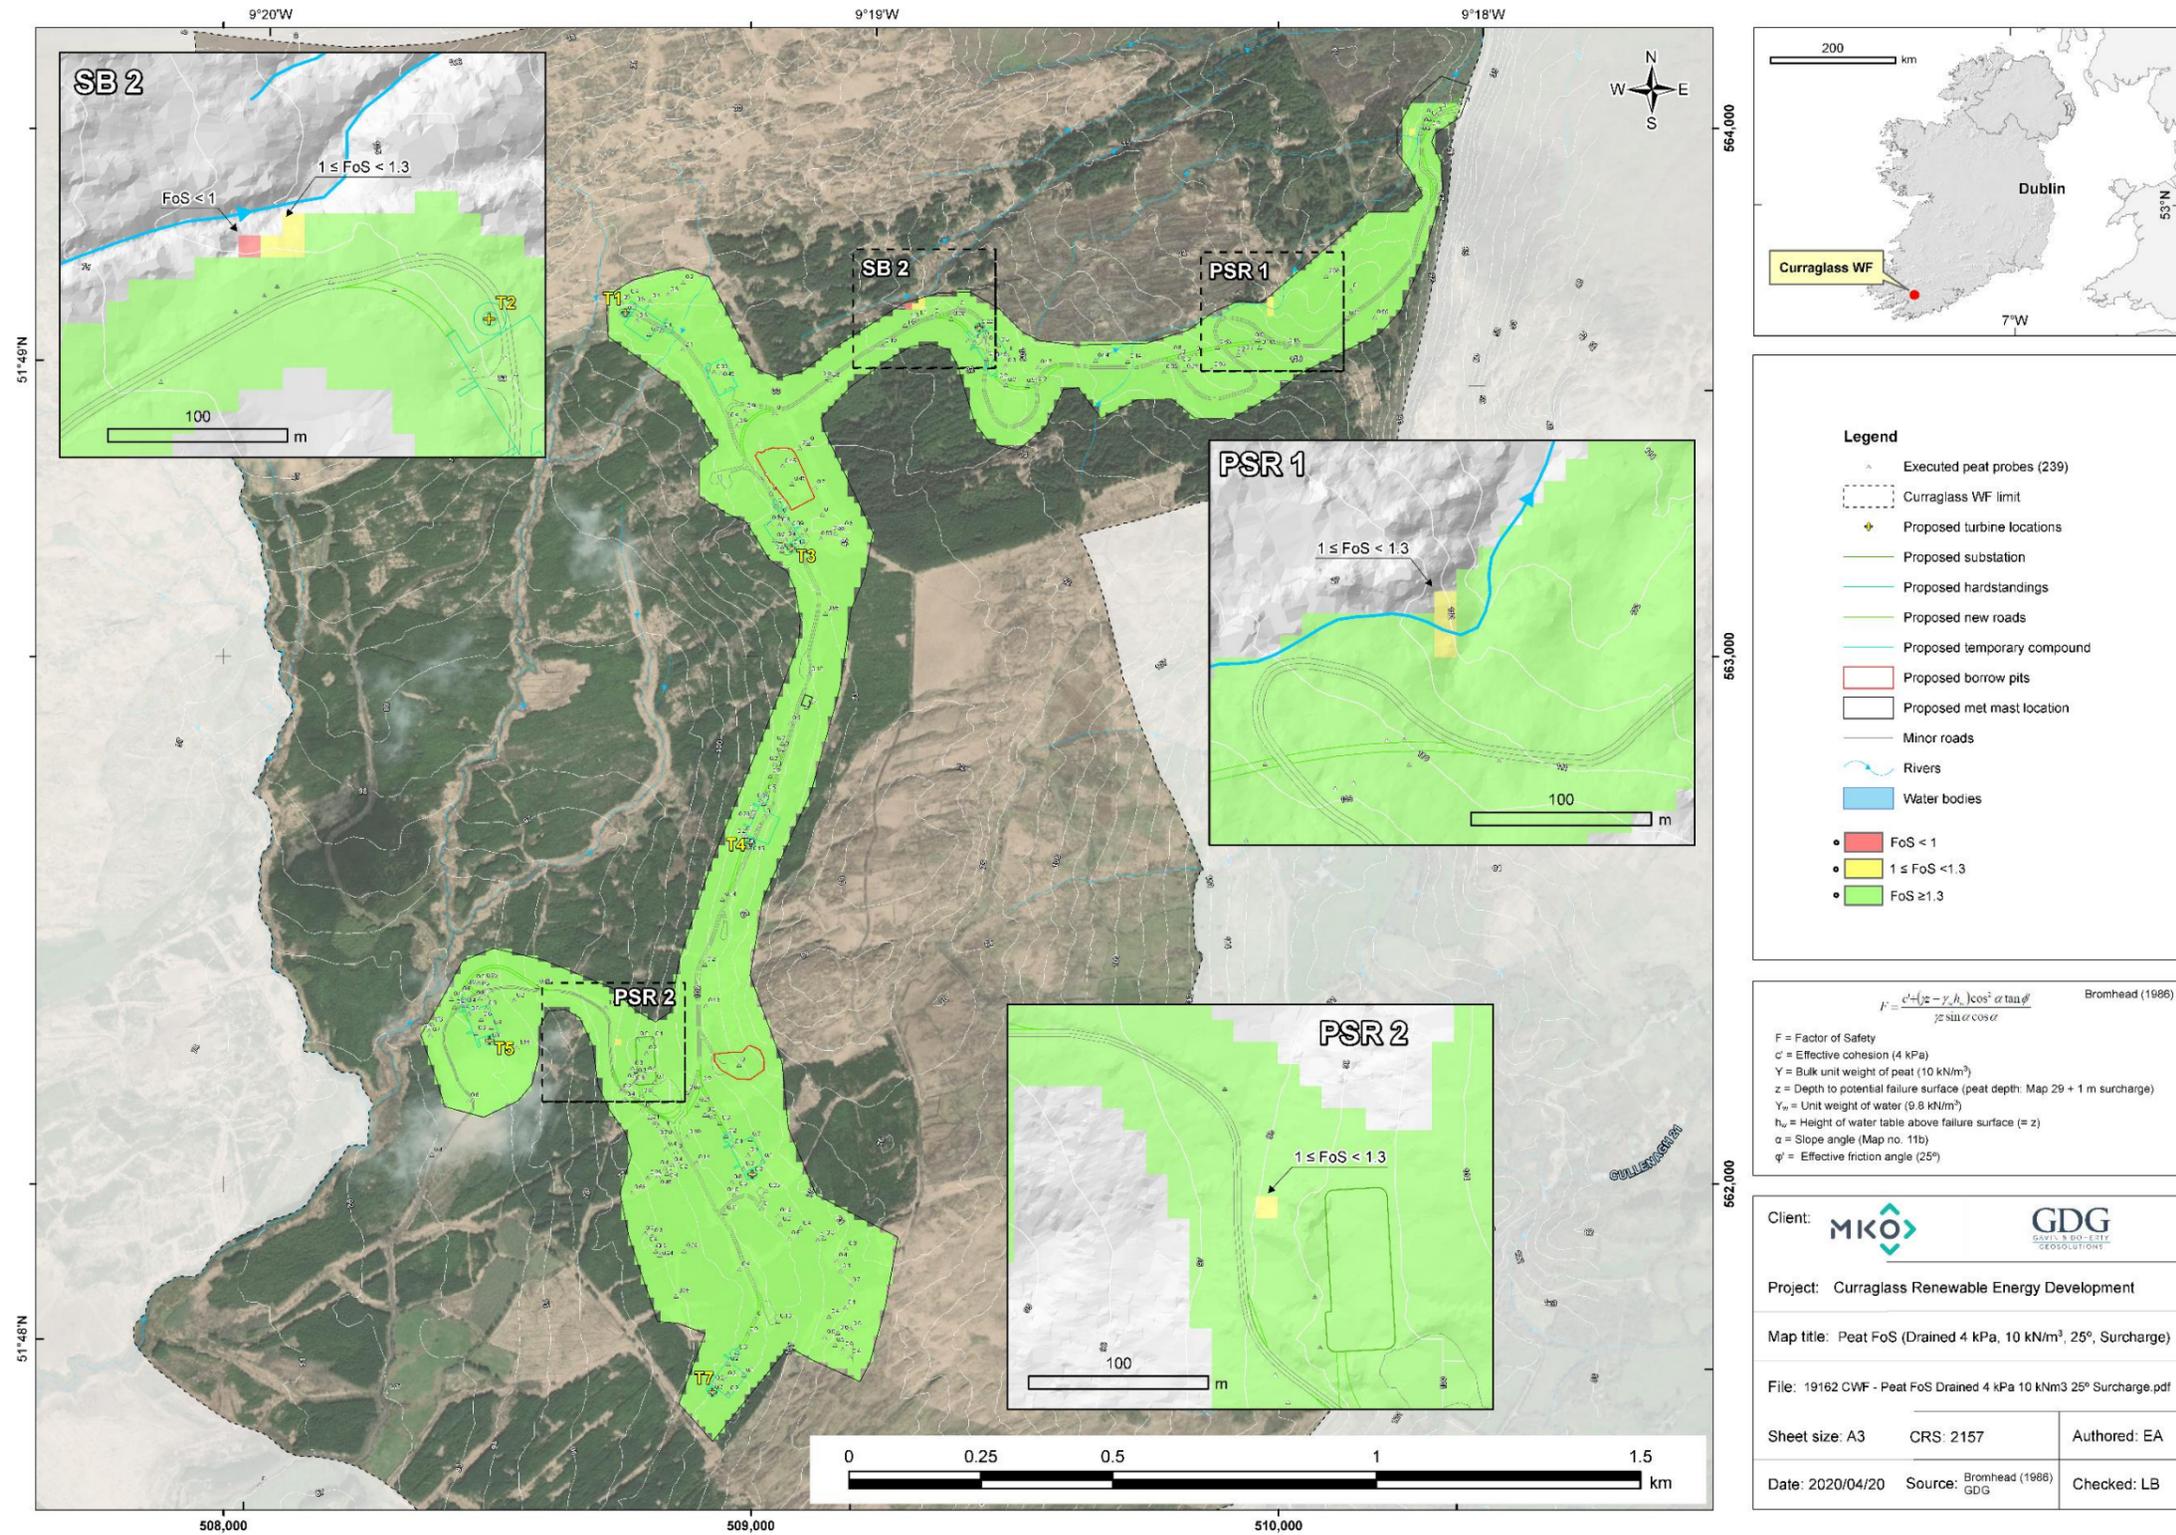
Figure K-4: FoS for drained conditions and surcharge of 1 m (i.e. 10 kPa).

Note: Safety buffers (SB) and peat stockpile restriction (PSR) areas as identified through the FoS analysis are presented.

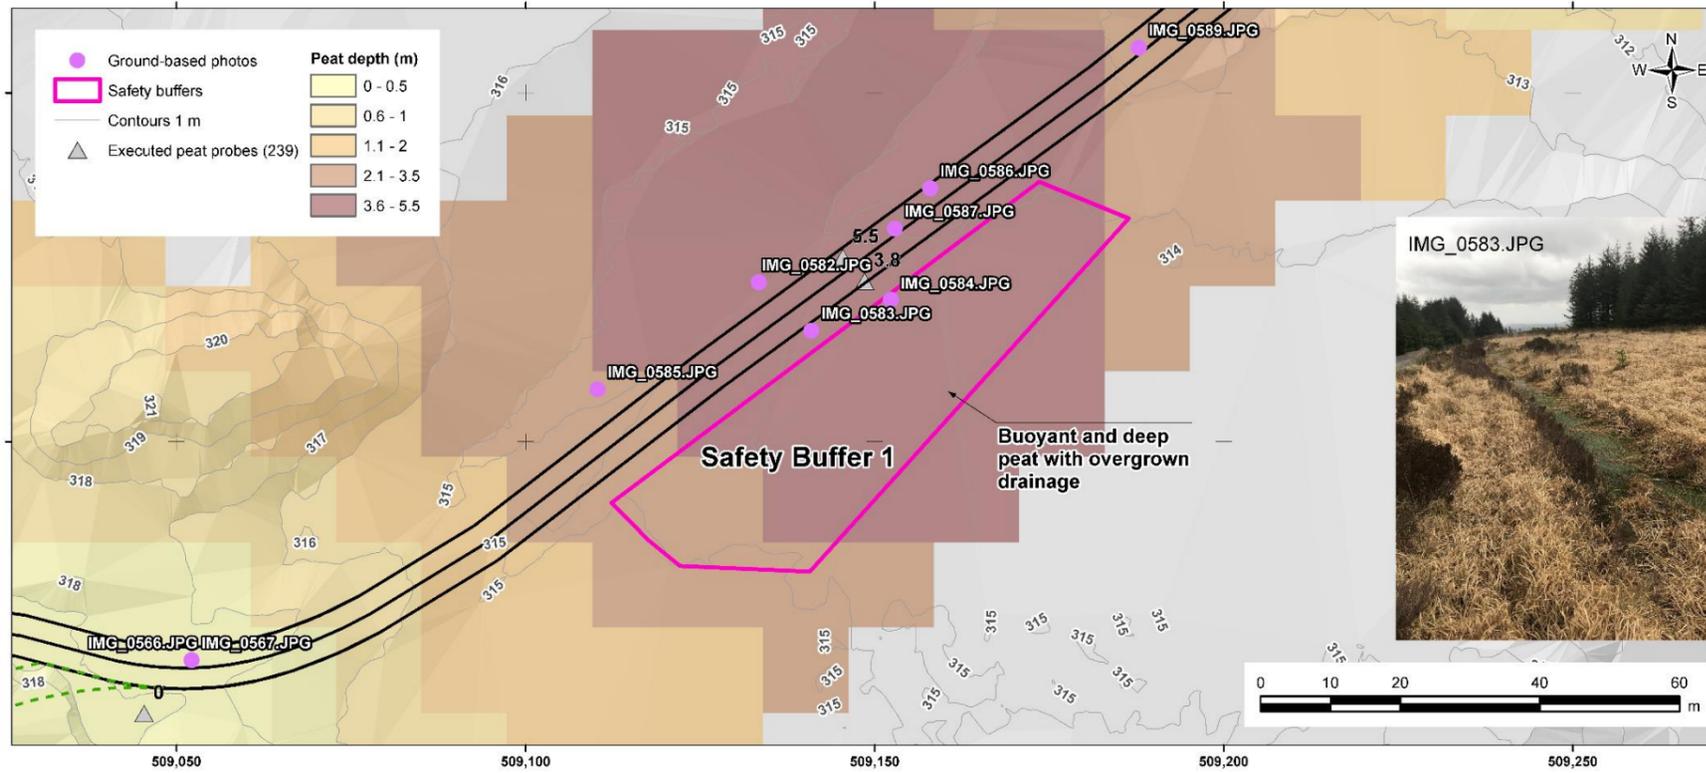
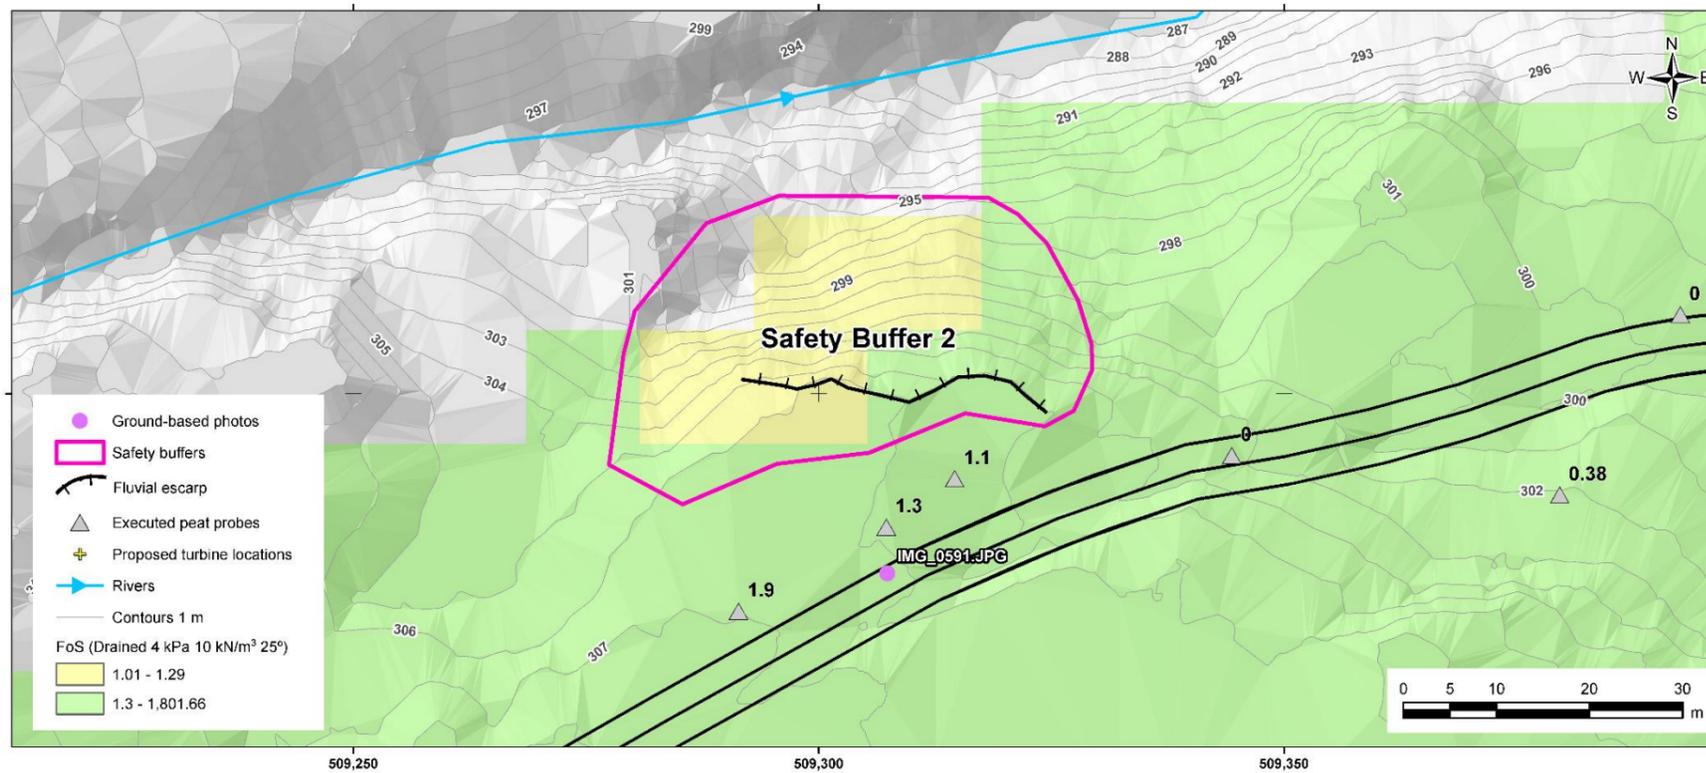
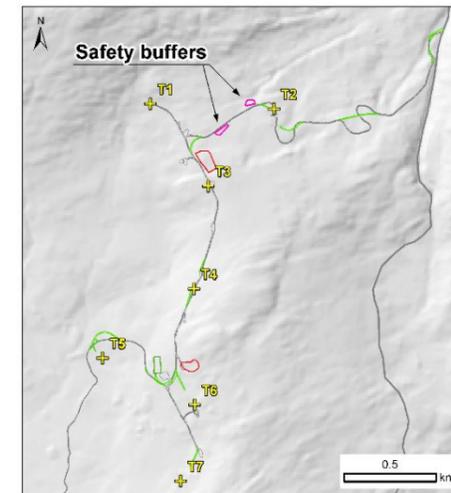
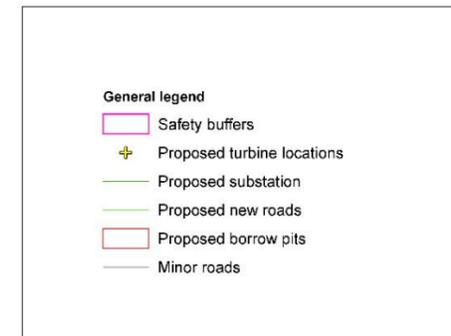
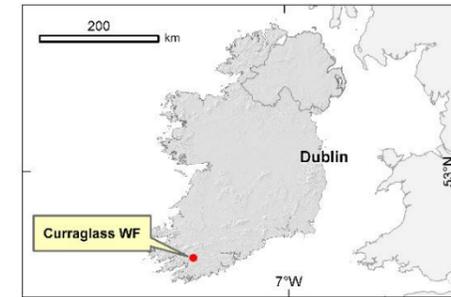
Figure L-1: Safety buffers.

Client:		
Project:	Curraglass Renewable Energy Development	
Map title:	Safety buffers no. 01 & 02	
File:	19162 CWF - Safety buffers 01 & 02.tif	
Sheet size:	A3	CRS: 2157
		Authored: EA
Date:	2020/04/20	Source: GDG
		Checked: LB
