Non - Technical Summary (NTS)

Remedial Environmental Impact Assessment Report

Substitute Consent Application,
Scotshouse Quarry Ltd

Aghnaskew, Scotshouse,
Co.Monaghan

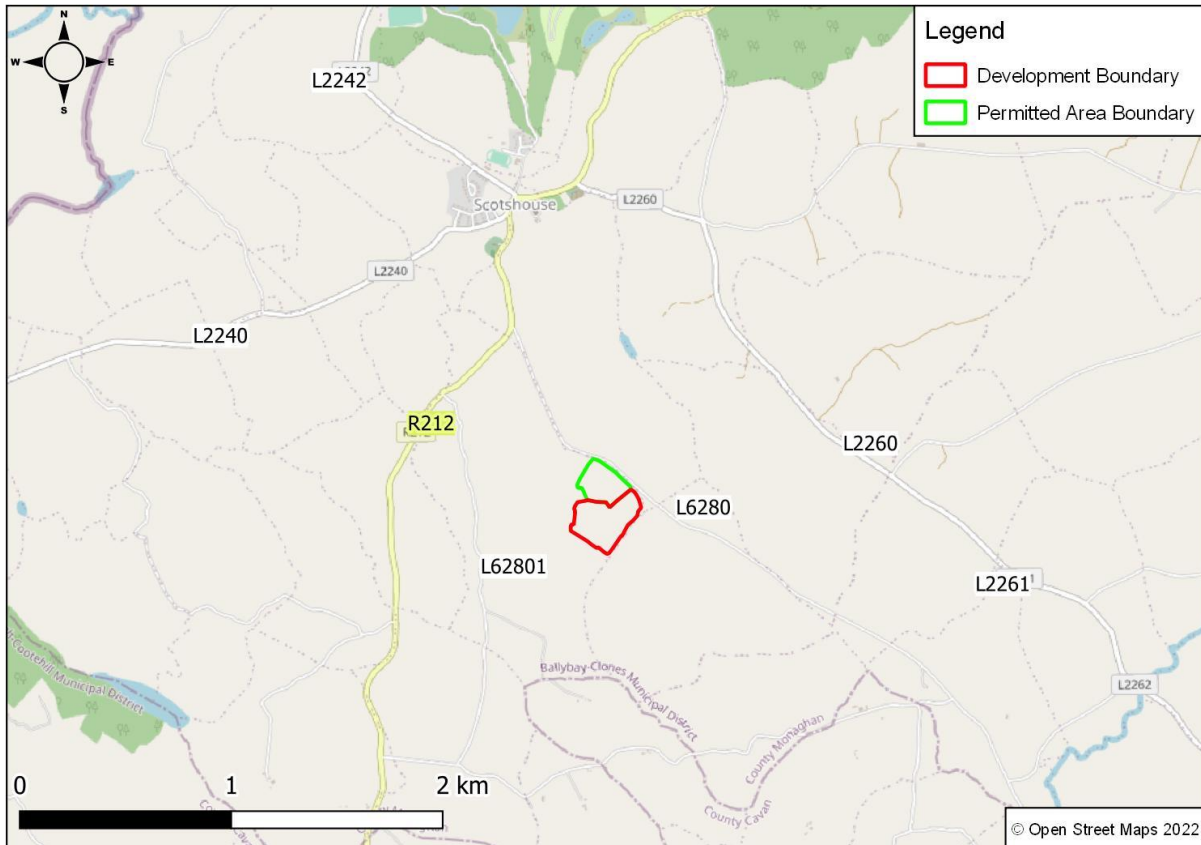
Figure 1-1: Site Location

Malone O'Regan Environmental (MOR) have been commissioned by Scotshouse Quarries Ltd ('the Applicant') to prepare a remedial Environmental Impact Assessment Report (rEIAR) as part of the application to An Bord Pleanála (ABP) for Substitute Consent for part of their quarry ('the Site') in the townland of Aghnaskew, in the Barony of Dartree (Dartree By), Scotshouse, County Monaghan (ITM 649474 818324). See Figure 1-1 below.

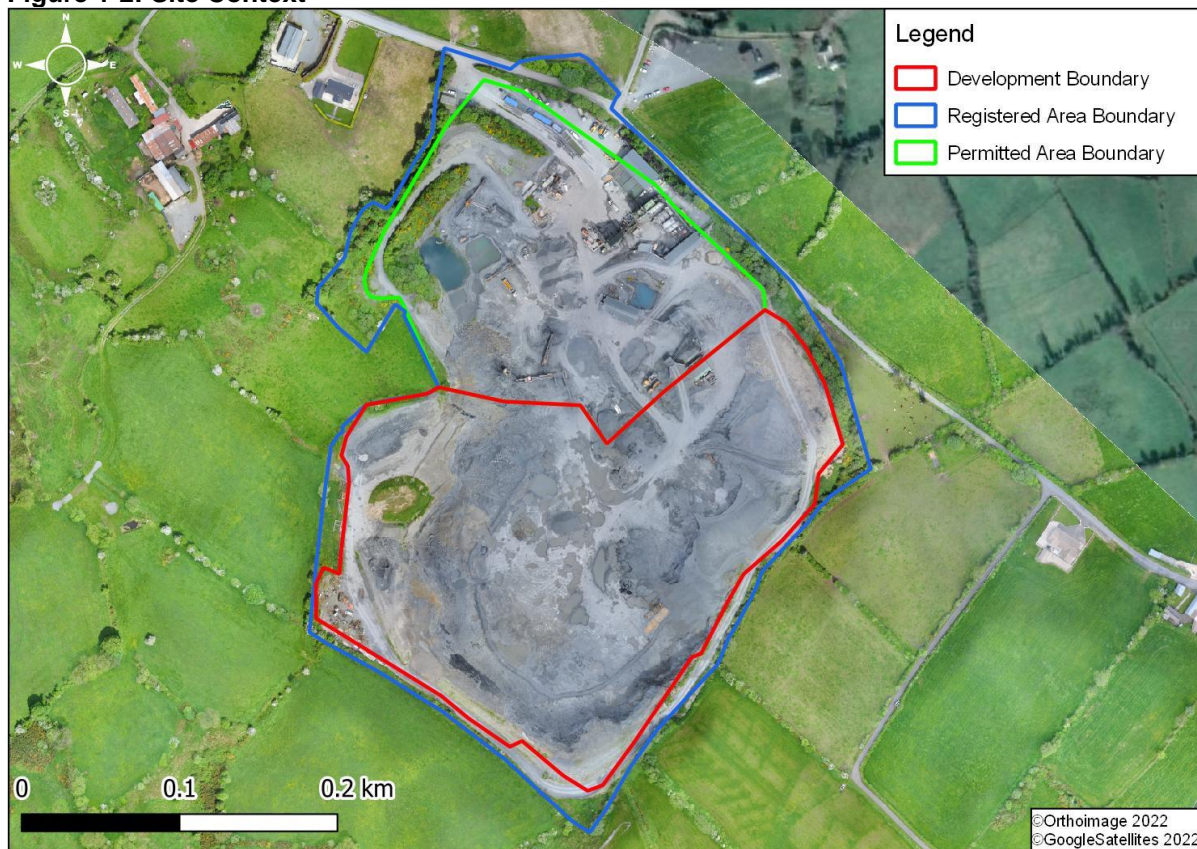
Figure 1-2: Site Context

The Development is immediately south of the Permitted Area, refer to Figure 1-2 and Figure 1-3 below.

The Development relates only to the works that occurred within the Registered Area, but outside the Permitted Area, as shown by the redline in Figure 1-2 above. Activities within the Permitted Area, see section 3.2 below, are authorised under planning. Where relevant, this remedial EIAR considers activities with the Permitted Area as a cumulative impact with the Development under direct assessment.

The Permitted Area is outlined in green in Figure 1-2 above and includes the site entrance and the main processing and services plant within the site.

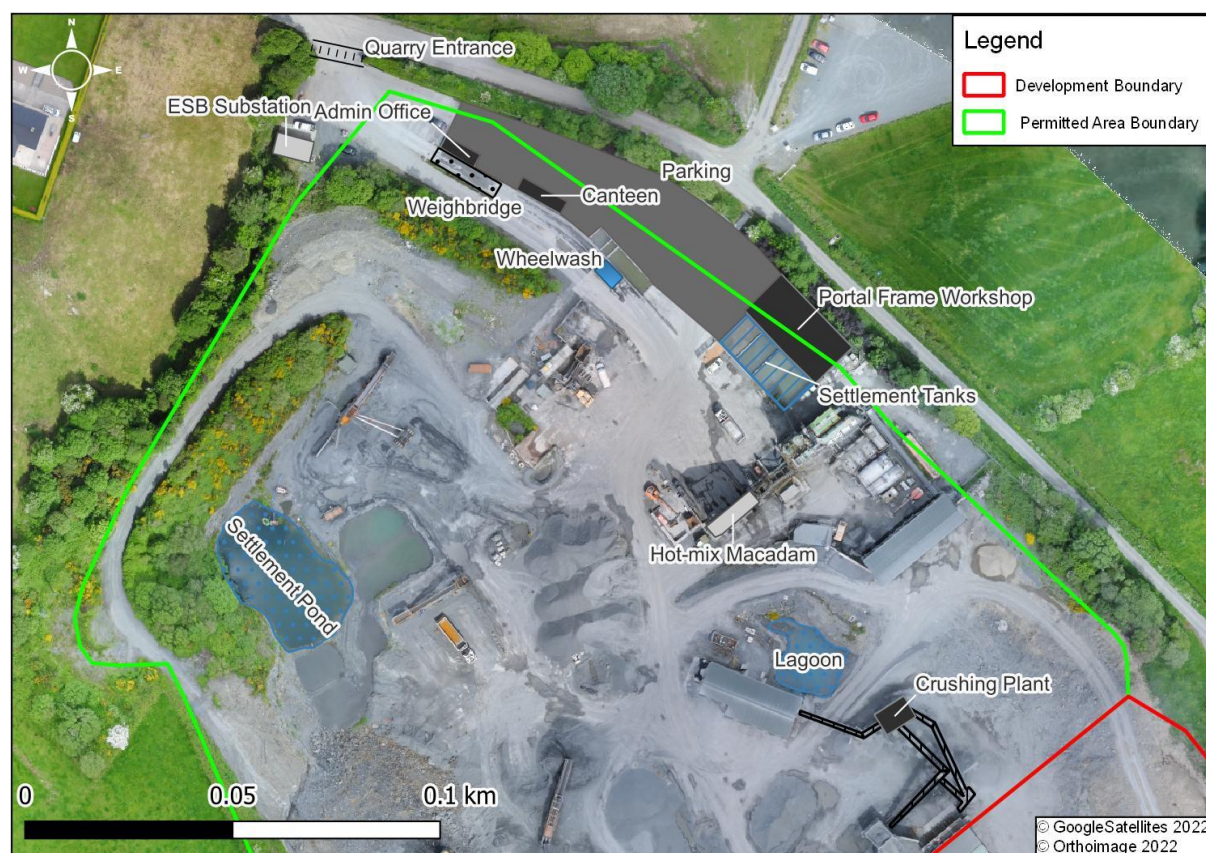
Figure 3-1: Site Infrastructure

The Permitted Area consists of the exposed rock faces and the quarry floor. The following elements are present on the quarry floor (see Figure 3-1 below):

- Entrance gate onto L6280,
- ESB Substation,
- Staff canteen and hygiene facilities,
- Office,
- Weighbridge,

- Wheel wash,
- Workshop,
- Hot-mix macadam plant consisting of
 - Bag house filter
 - Hot stone dryer
 - Cold feed aggregate bins
 - Hot mix storage facility
 - Screen and mixing tower
 - Bitumen tanks
 - Control cabin
 - Fan
 - Chimney and
 - Dust reclamation system
- Crushing plant, consisting of:
 - Two (2No) crushers
 - Screening plant
 - Conveyors
 - Feeding chute
 - Mobile stacker
 - Supporting structure
 - Mobile concrete batching plant and
 - Storage facility
- Settlement tanks,
- Settlement pond and
- Settlement lagoon.

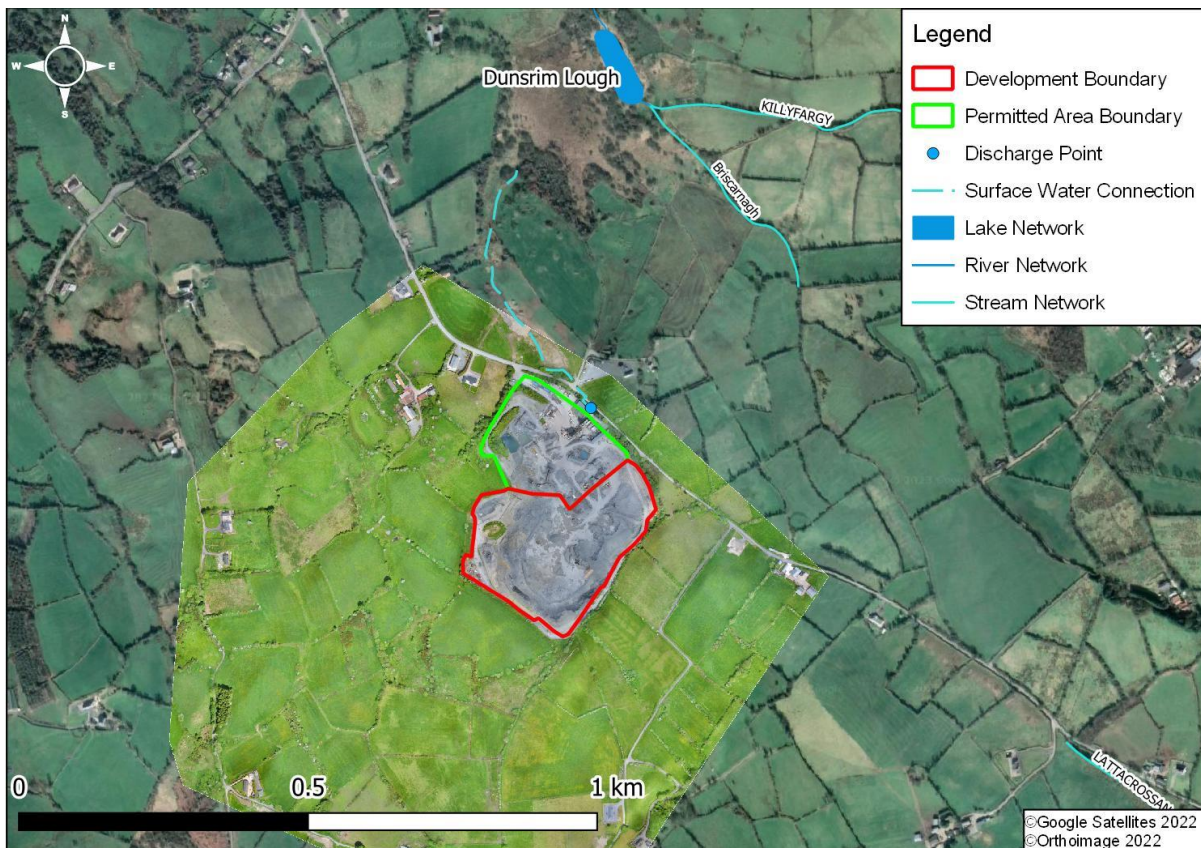
Figure 8-1: Hydrological Connection and Discharge Points

The Site is within the Erne hydrometric area and the Subcatchment Finn. A subcatchment divide is located ca. 134m to the south of the Site. The River Gortnana is located ca. 453m north-east of the Site. Dunsrim Lough is downstream of the licensed discharge point for the Registered Area.
