Environmental Impact Assessment Report,  
Vol 3 Appendices  
Silver Hill Foods  
*November 2022*

## **Appendix 1.1 EIAR Scoping Report**

## Environmental Impact Assessment Report Scoping Report

## Drip Irrigation Pilot Project – Updated Hydrogeological Assessment Report

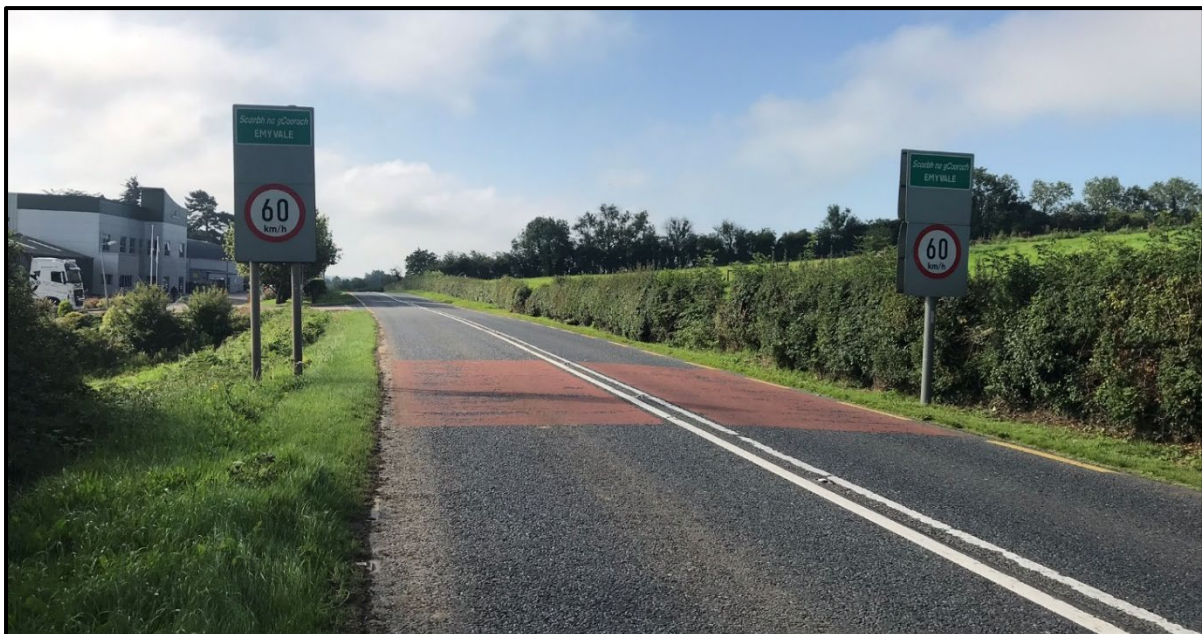
**Figure 3.1 – View along N2 travelling south towards Emyvale**

The National Road N2 carriageway is approximately 7m wide near the T-junction at Silverhill entrance and caters for two-way traffic and connects Monaghan town to the south and to the border with Northern Ireland to the north. The speed limit near the junction is 60km/h, as shown in Figure 3.1 below.

ORS visited the site on August 12<sup>th</sup>, 2020, to assess the general Road condition and traffic flows in the vicinity of the site access junction. For visual detail of the Roadway in the vicinity, please refer to **Figures 3.1 to 3.4** below.

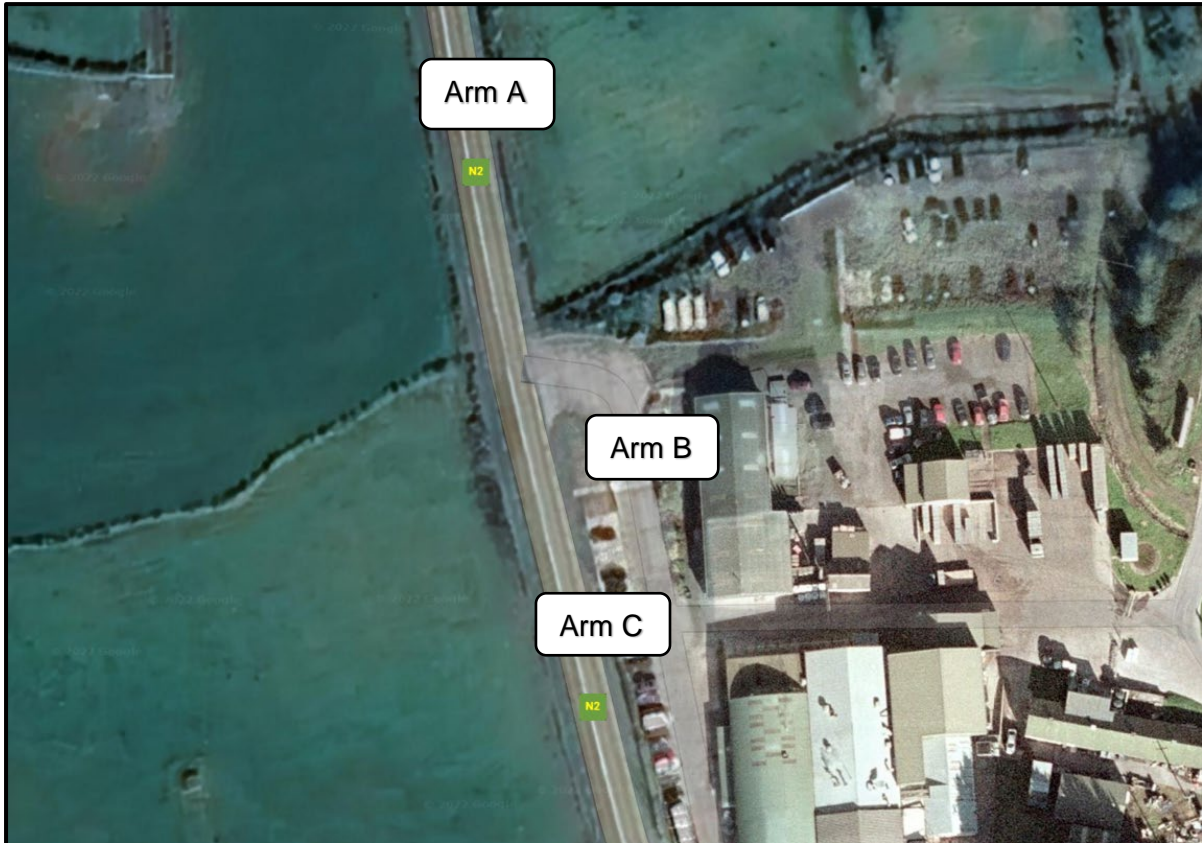
**Figure 5.2 – Silverhill Foods Access T-junction (Source: Google Earth)**

- Arm A: N2 National Road to the north
- Arm B: Silverhill Foods Access Junction
- Arm C: N2 National Road to the south

As described in previous sections, the existing priority T-junction was assessed for a worst-case scenario whereby counted traffic is assumed to comprise 80% HGVs along N2 and 100% HGVs in and out of the facility. In addition, growth factors for HGV's are applied to all traffic flows for future design years in order to obtain a conservative, robust analysis.

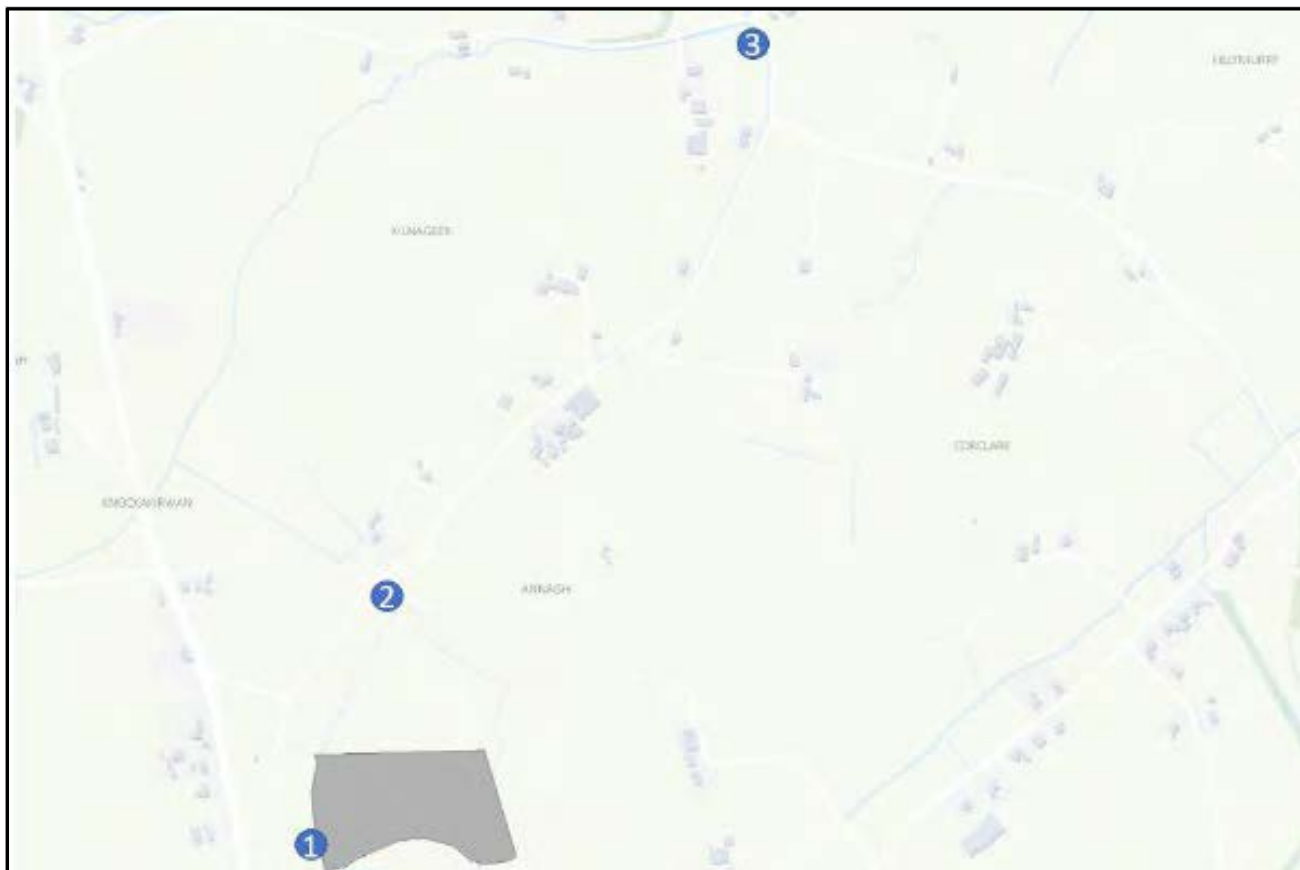
**Figure 2-7: Biological Sample points from water quality tests in 2017.**

The sample points are shown in the **Figure 2-7** below.

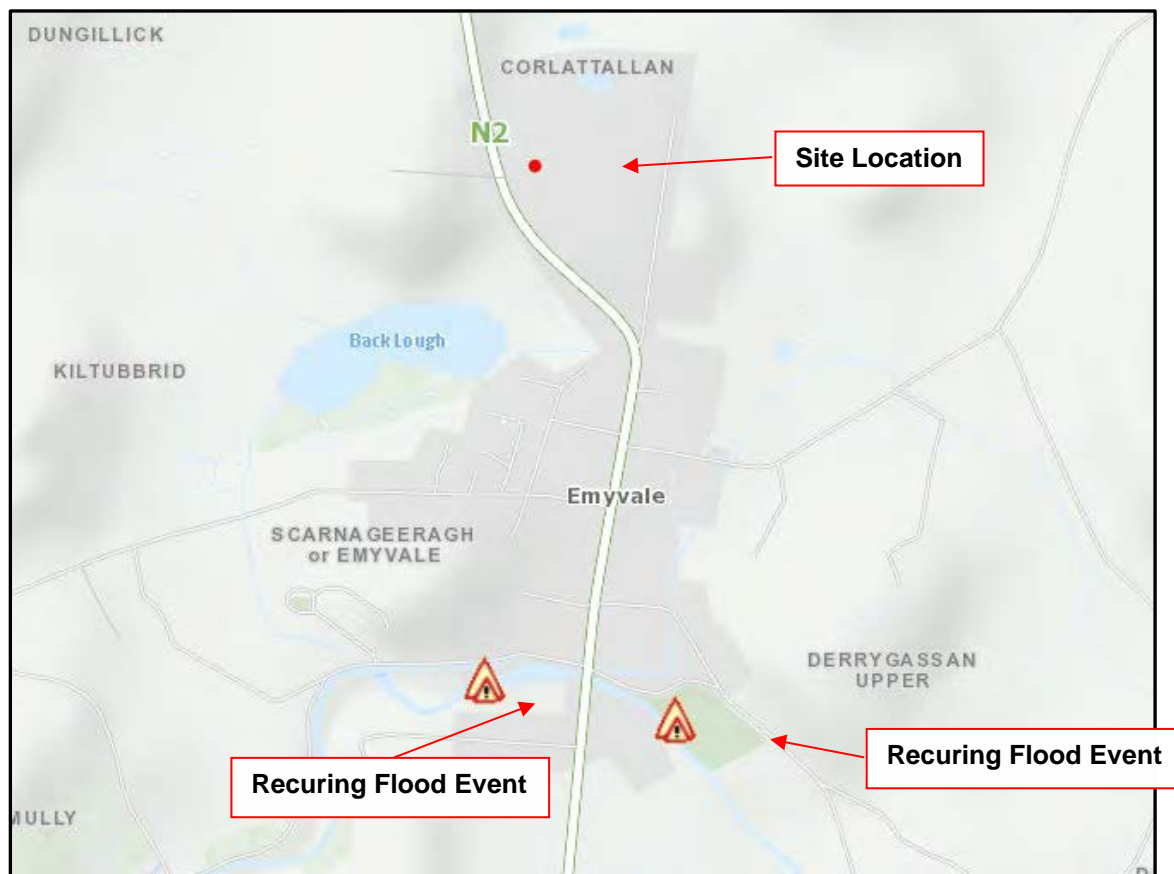
**Figure 2-8: Summary of historic flood events in the vicinity of the subject site (OPW Flood Maps)**

Name	Details	Distance from Subject Site
Mountain Emyvale 1 Recurring	Recurring Flood the source is the Mountain Water River.	c.971.4m south
Mountain Emyvale 2 Recurring	Recurring Flood the source is the Mountain Water River.	c.876.8m south

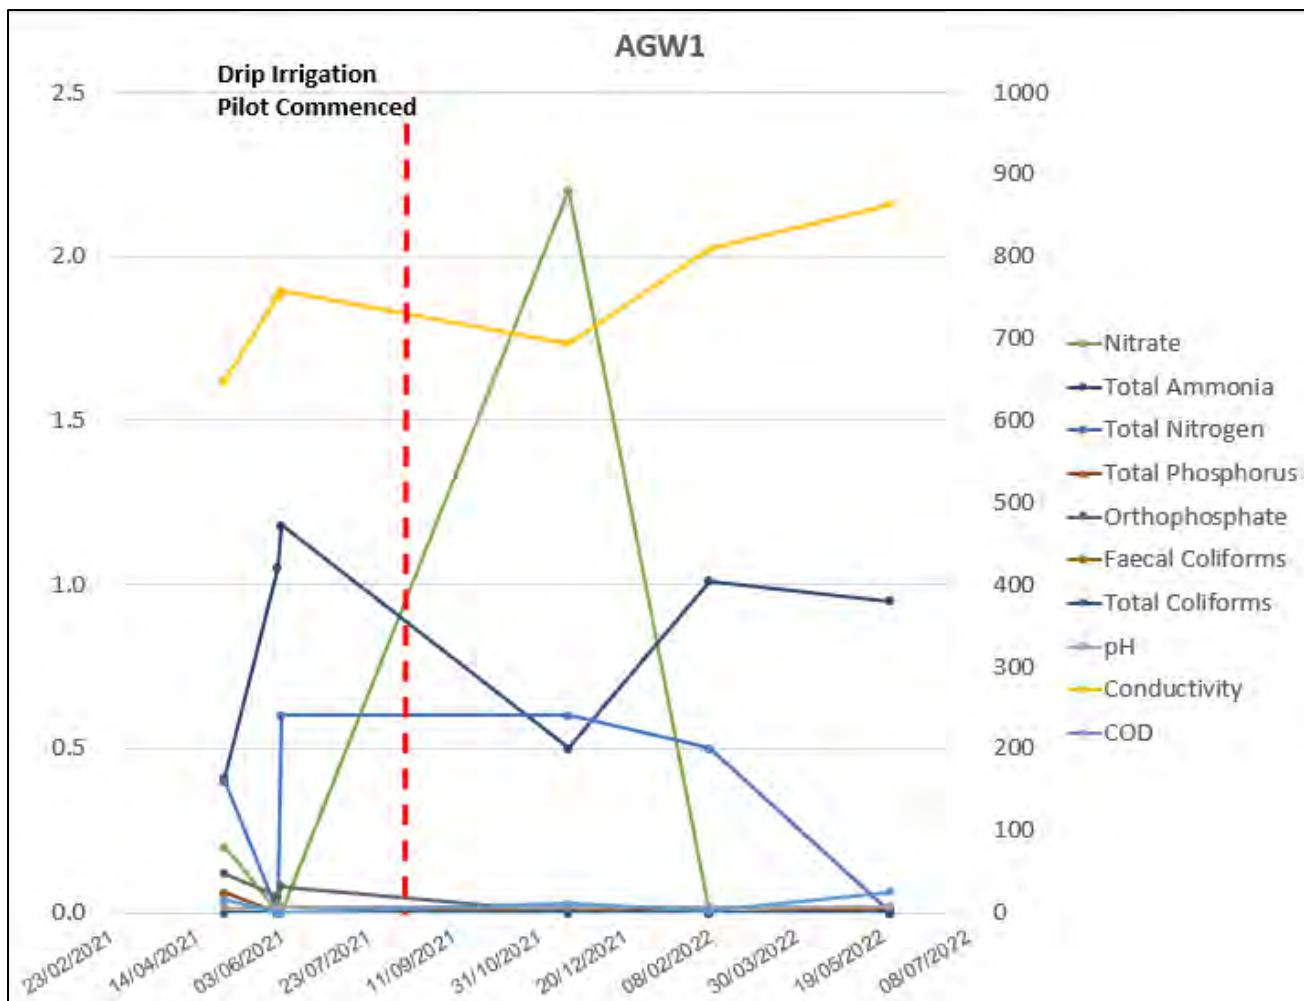
Figure 7-9: Groundwater Results AGW1

The results have also been graphed as presented in **Figure 7-9** and **Figure 7-10** below.

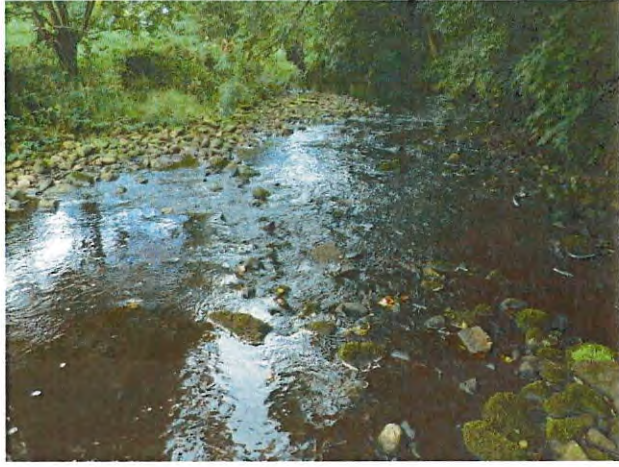
Site Code	MW-1
Grid Reference	H 67086 43351
Site Location	d/s Bridge and Weir
Site Photograph

Channel Width (m)	10-15
Depth (cm)	10-20
Substrate (in order of dominance)	Large rocks, Cobble, Gravel, Sand, Mud (Heavy siltation)
Flow Type	Riffle 40% Glide 60%
Instream Vegetation	Filamentous algae 5% Bryophytes 5%
Dominant Bankside Vegetation	Ash, Alder
Summer Shade of Stream by Bankside Vegetation	20%
Trout Adult Habitat	Good
Trout Nursery Habitat	Good
Trout Spawning Habitat	Fair-Poor

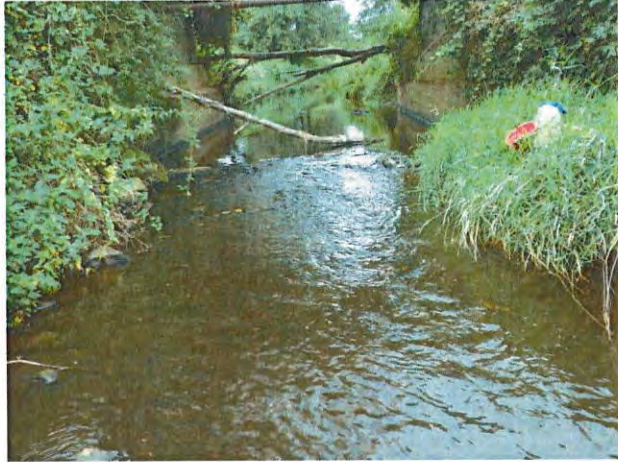
Site Code	MW-2
Grid Reference	H 68464 43140
Site Location	d/s Bridge
Site Photograph

Channel Width (m)	4-6
Depth (cm)	10-15
Substrate (in order of dominance)	Cobble, Gravel, Sand, Mud (Heavy siltation)
Flow Type	Riffle 15% Glide 85%
Instream Vegetation	Filamentous algae 20%
Dominant Bankside Vegetation	Hawthorn, Alder, Nettle, Bramble
Summer Shade of Stream by Bankside Vegetation	<5%
Trout Adult Habitat	Fair
Trout Nursery Habitat	Fair
Trout Spawning Habitat	Poor

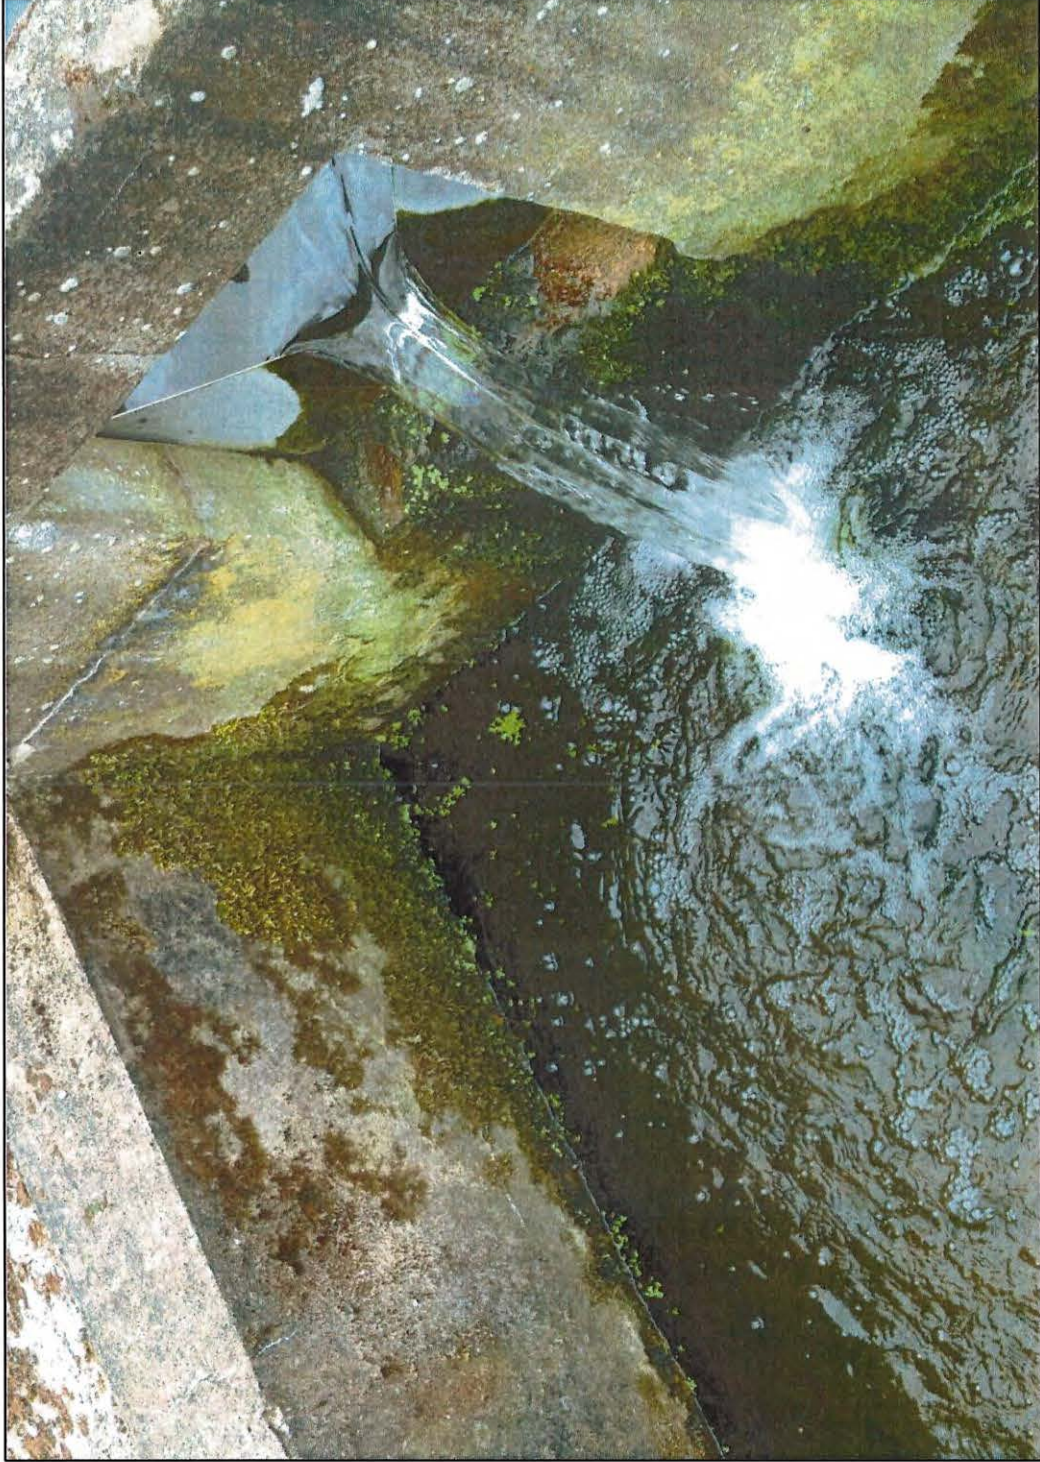
Photo of current final discharge point SW1 (V-notch)

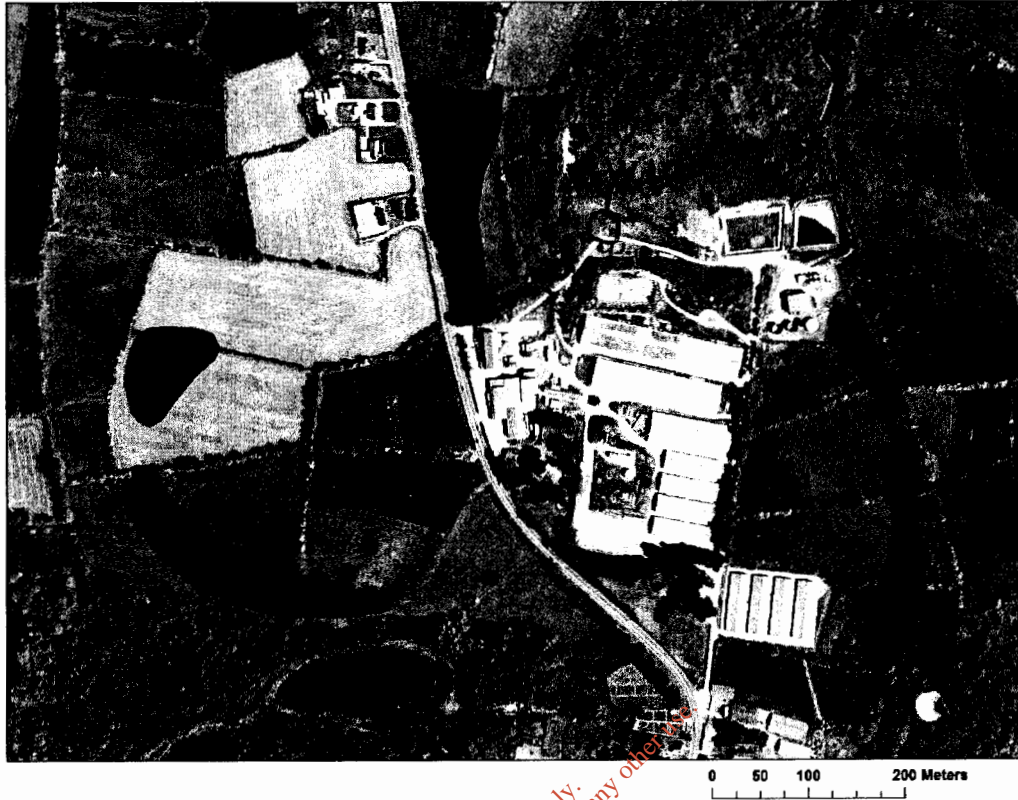
Fig. 1: Aerial photograph of site with surrounding grounds (Area 4 has been selected to carry out this pilot project)

The location we have selected to carry out this pilot project can be seen in both Fig. 1 and Fig. 2 below. In Fig.1 the area of ground is highlighted as Area 4 just slightly north of the processing facility. It is also in quite close proximity to our current discharge point which I have marked in Fig. 1 as SW1.
