Appendix A12.2
Aquatic Baseline
Report

Aquatic baseline report for the BusConnects project, Dublin City

Prepared by Triturus Environmental Ltd. for Scott Cawley

December 2020

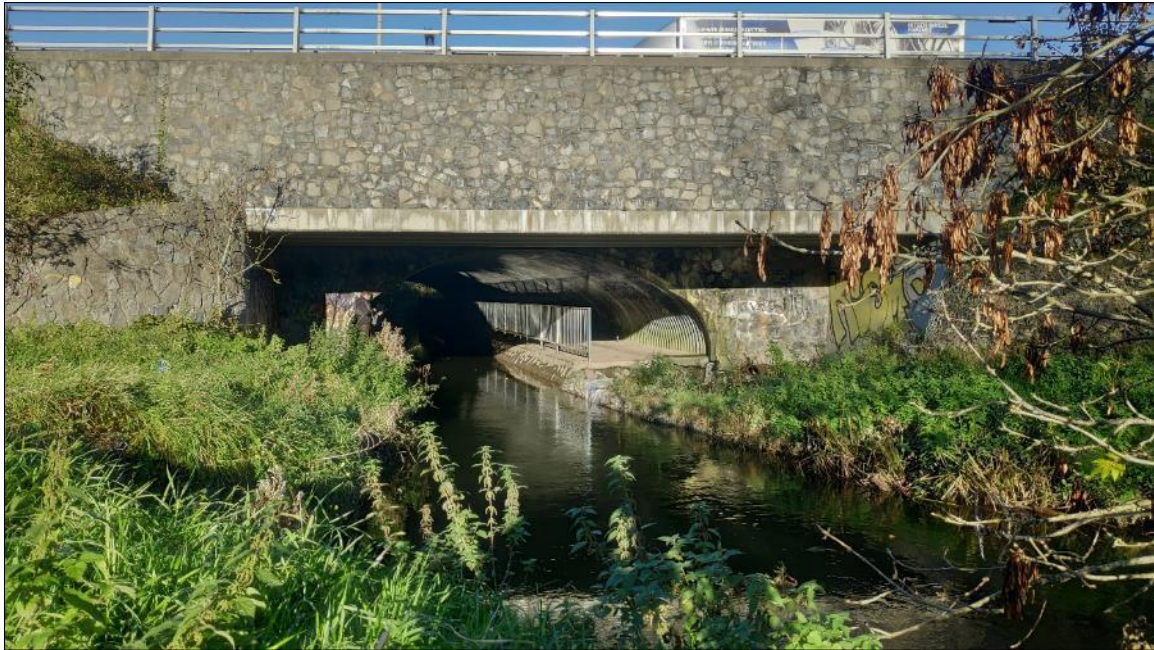
The River Tolka at site T1 was a semi-natural lowland depositing watercourse (FW2) with evident historical deepening and bank modification works. These included gabion basket scour protections and a concrete culverted bed at the N3 road crossing. The river profile mainly comprised of deep glide (60% area) and pool (30%) with more localised riffle (10%). The channel averaged 5-8m wide, with a variable depth of 0.3-1.5m deep. The channel bed comprised rendered concrete under the road crossing. However, downstream of the culvert, the substrata were dominated by boulder and cobble with pockets of very localised medium and fine gravels. The substrata were heavily bedded with 30% cover of filamentous green algae, indicating enrichment. The bed suffered from heavily siltation, albeit swift flows reduced the visible deposition levels on instream substrata. The macrophyte community was limited to small patches of emergent branched-bur reed (*Sparganium erectum*) and watercress (*Rorripa nasturtium-aquaticum* agg.). The coarse substrata on the bed also supported the aquatic moss species *Cinclidotus fontinaloides* and *Platyhypnidium riparoides* locally. The riparian habitats supported mainly scrub habitat (WS1) and rank grassy areas (GS2) with frequent nettle (*Urtica dioica*), butterbur (*Petasites hybridus*), thistles (*Cirsium* spp.) and red osier dog wood (*Cornus cericea*). Riparian trees were scattered along the banks with crack willow (*Salix fragilis*) and sycamore (*Acer pseudoplatanus*) being the most frequent species.

The river was considered a moderate quality brown trout nursery, with some localised deeper pools (including immediately downstream of the culvert) providing good holding habitat. Spawning habitat for both salmonids and lamprey was locally good (c.110m downstream of the culvert in the tailing of a pool where mobile gravel was identified, ITM 707825, 738930). The site offered poor lamprey ammocoete habitat given the high flow rates and predominance of hard substrata. European eel habitat was moderate overall. The deeper pool areas locally would support European eel (*Anguilla anguilla*). White-clawed crayfish are not present in the River Tolka (no known records) and were not recorded during the survey. Otter spraint (1 site (3 spraints)) was recorded under the culvert in a muddy area of the west bank (ITM 707817, 739019).

In summary, the salmonid habitat of this site T1 was considered to be of moderate quality. Equally the European eel habitat present was of moderate value. Additionally it is of value to Q1 species otter, which regularly uses the site .

Plate 3.1 Representative image of site T1 on the River Tolka (facing upstream towards culvert)

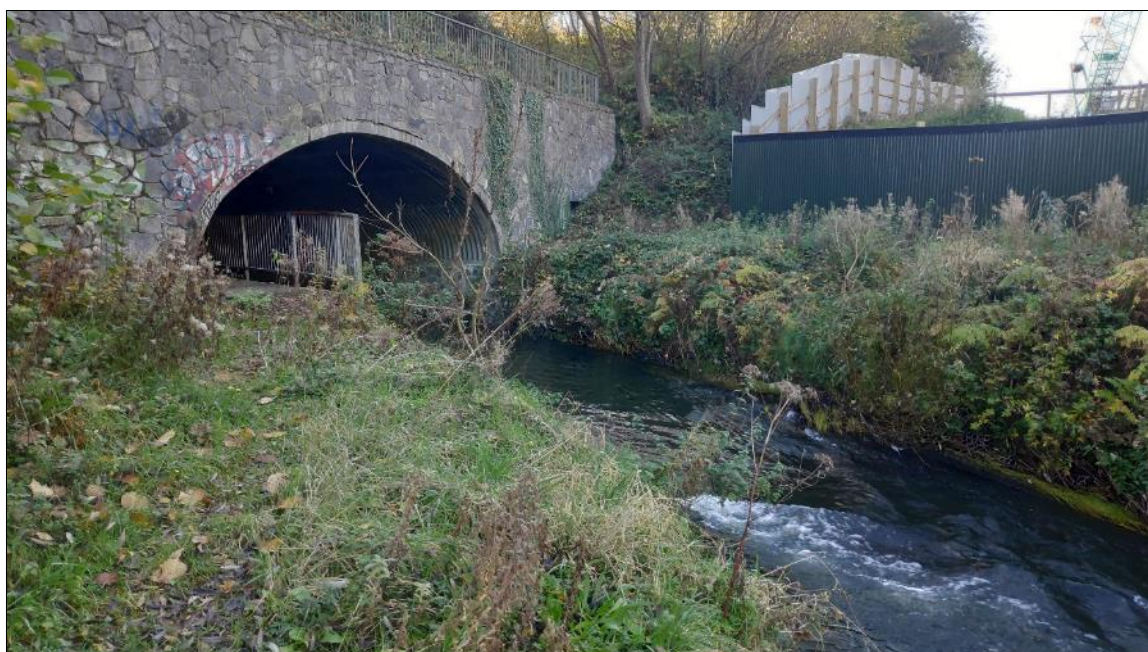
The River Tolka at site T2 was a semi-natural lowland depositing watercourse (FW2) with a swift flow and a well-defined thalweg downstream of the bridge crossing and associated culvert. Located approx. 0.5km downstream of site T1, the river profile was dominated by glide (50%) and riffle (40% area) with more localised pool 10%. The channel width was variable between 6m and 14m wide. The depth was also variable and recorded between 0.4m and 1.0m deep. The good semi-natural character for an urban river, however, was diminished by riverine substrata that were in poor condition due to siltation pressures. Furthermore, hydro-morphologically the river had been altered at the N3 crossing with the channel bed comprising of rendered concrete with little gravel or cobble deposition under the road crossing. Downstream of the culvert, the bed comprised bedrock, boulder and cobble with very localised pockets of medium and fine gravels. The substrata were very however, heavily bedded and covered by filamentous green algae (205 surface area cover, indicating enrichment). While the bed suffered from heavily siltation, the swift flows reduced the visible deposition levels on the visible instream substrata (as with other areas on the River Tolka). The macrophyte community comprised locally frequent watercress (*Rorripa nasturtium-aquaticum* agg.) and lesser water parsnip (*Berula erecta*) in the margins. The coarse substrata on the bed also supported *Cinclidotus fontinaloides* and *Platyhipnidium riparoides* locally. The riparian habitats supported mainly scrub habitat and rank grassy areas with frequent winter heliotrope, nettle, bramble (*Rubus fruticosus* agg.), bracken (*Pteridium aquilinum*), buddleja (*Buddleja davidii*), hemp agrimony (*Eupatorium cannabinum*), spear thistle (*Cirsium vulgare*) and hogweed (*Heracleum sphondylium*). The banks supported a few scattered mature crack willow (*Salix fragilis*), with a more mature treeline downstream of the survey area. The river upstream of the culvert was narrower, very fast flowing and heavily overgrown with scrub. Historical bank works were evident with gabion baskets present.

The river was considered a moderate brown trout nursery, with some localised deeper pools providing good holding habitat. Spawning habitat for both salmonids and lamprey was poor given substrata compaction and bedding. Swift flows largely precluded sediment deposition but some superficial silts were present marginally which provided some limited suitability for *Lampetra* sp. ammocoetes. European eel habitat was moderate overall albeit compaction of the bed and swift flows provided for less optimal refugia. White-clawed crayfish are not present in the River Tolka (no known records) and were not recorded during the survey. Regular otter spraint sites were recorded on the concrete path on the downstream side (ITM 708122, 738814) and upstream side of the culvert (ITM 708095, 738790).

The site T2 was found to be of moderate salmonid and European eel quality, with observable utilisation by otter.

Plate 3.2 Representative image of site T2 on the River Tolka (facing upstream towards culvert)

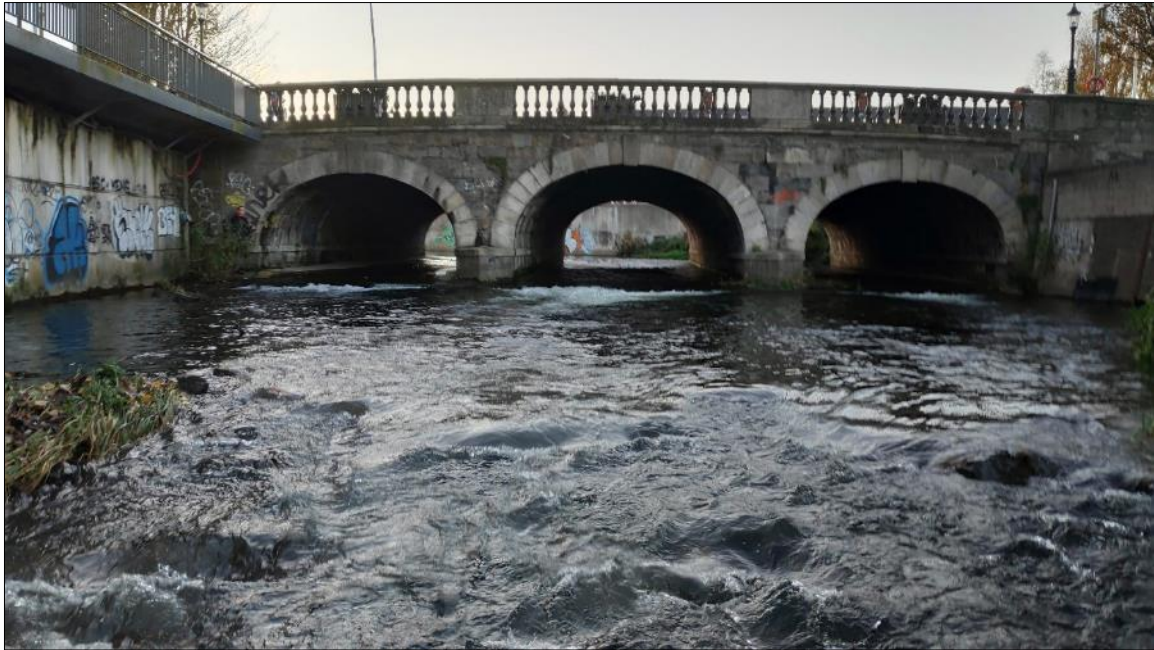
The River Tolka at site T3 was a semi-natural lowland depositing watercourse (FW2) with a swift flow. Despite being located in a heavily urbanised area with high retaining walls, the river profile was surprisingly natural downstream of the bridge (upstream being glide dominated, held between retaining walls and with less natural character). The river profile was dominated by glide (30%) and riffle (50%) with more localised pool 20% (the largest of which was located immediately downstream of the bridge apron/weir). The channel width was variable between 15m and 20m wide, being narrower downstream where marginal riparian stands of osier (*Salix viminalis*), grey

Downstream of the bridge, the river was considered a good brown trout nursery and good holding area for adult fish. Spawning for both salmonids and lamprey was considered locally good, despite siltation pressures. Upstream of the bridge the river was mainly a holding area for salmonids with deeper glide habitat held between retaining walls. Lamprey ammocoete habitat was sparse given the high energy nature of the site. European eel habitat was good downstream of the bridge owing to ample boulder refugia and deeper pool areas. White-clawed crayfish are not present in the River Tolka as previously described for other survey areas and none were recorded during the survey. A regular otter spraint site (1(6), mixed age) was recorded on the bridge apron downstream of the bridge (south bank) (ITM 716124, 736756).

In summary, habitat of good salmonid and European eel quality, and regular utilisation by otter, was observed at this site.

Plate 3.3 Representative image of site T3 on the River Tolka at Frank Flood Bridge (facing upstream)

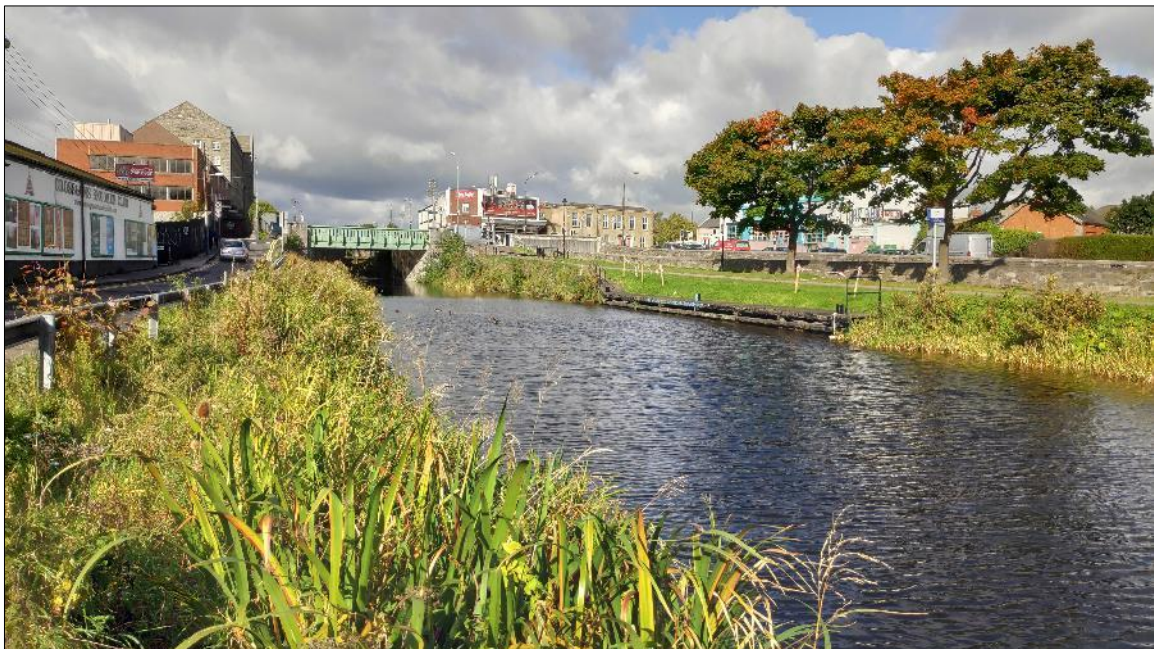
The Royal Canal between the 4th and 5th lock (level 4, Phibsborough) was a uniform 10-12m wide and 1.5-2.5m deep, with a centrally deeper navigation channel in most areas. The substrata were dominated by silt with high clay fractions (often >0.3m in depth), with scattered boulder and localised marginal cobble/gravel areas (e.g. along boat gangway). The 300m section of canal (between the 4th and 5th locks) was typified by narrow riparian fringes bordered by urban areas and built land (BL3). The riparian zones supported a range of common species such as great willowherb (*Epilobium hirsutum*), nettle, meadowsweet, yarrow (*Achillea millefolium*), marsh ragwort (*Jacobaea aquatica*), hedge bindweed (*Calystegia sepium*), creeping thistle, hogweed and occasional teasel (*Dipsacus fullonum*). Non-native Canadian fleabane (*Conyza canadensis*) and buddleja were both occasional. Intermittent planted treelines of sycamore and cherry (*Prunus* sp.) were present in maintained grassland strips (WD5 parkland habitat). The canal margins were lined by narrow linear strips dominated by reed sweet grass (*Glyceria maxima*) with frequent stands of iris (*Iris pseudacorus*) and occasional reed canary grass. Instream, the macrophyte community was dominated by yellow lily (*Nuphar lutea*) (both submerged and emergent forms), with common duckweed (*Lemna minor*) and ivy-leaved duckweed (*Lemna trisulca*) being frequent. Also frequent was Canadian pondweed (*Elodea canadensis*), Nuttall's pondweed (*Elodea nuttallii*), whorled-water milfoil (*Myriophyllum verticillatum*) and stonewort species *Chara* sp. Amphibious bistort (*Persicaria amphibia*) was occasional on bank and in margins. The rare and protected opposite-leaved pondweed (*Groenlandia densa*) is known from this area of the Royal Canal (BEC, 2011; NPWS data) but no stands were observed during the survey (October 2020). It is considered likely that the species is still present but given it is a dark green, submerged pondweed that often sprawls along the bottom, its detection can be difficult.

Overall, site RC1 offered excellent coarse fish habitat for a range of common species including roach (*Rutilus rutilus*), bream (*Abramis brama*), perch (*Perca fluviatilis*) and pike (*Esox lucius*). Well-vegetated canal sections such as this provide valuable nursery habitat for numerous fish species, in addition to good spawning substrata in the spring/early summer months. European eel are known from this section of canal and habitat was considered good. No white-clawed crayfish are known from the eastern extent of the Royal Canal in Dublin City (NBDC, NPWS data, pers. obs.), despite some good physical habitat and physiochemical suitability. No otter signs were recorded during the site visit although suitable marking areas were largely absent.

In summary, this site on the Canal and situated within the Royal Canal pNHA (002103), exhibited high coarse fish habitat, high European eel habitat, and of high quality for otter as a foraging area.

Plate 3.4 Representative image of site RC1 on the Royal Canal at Phibsborough (5th lock)

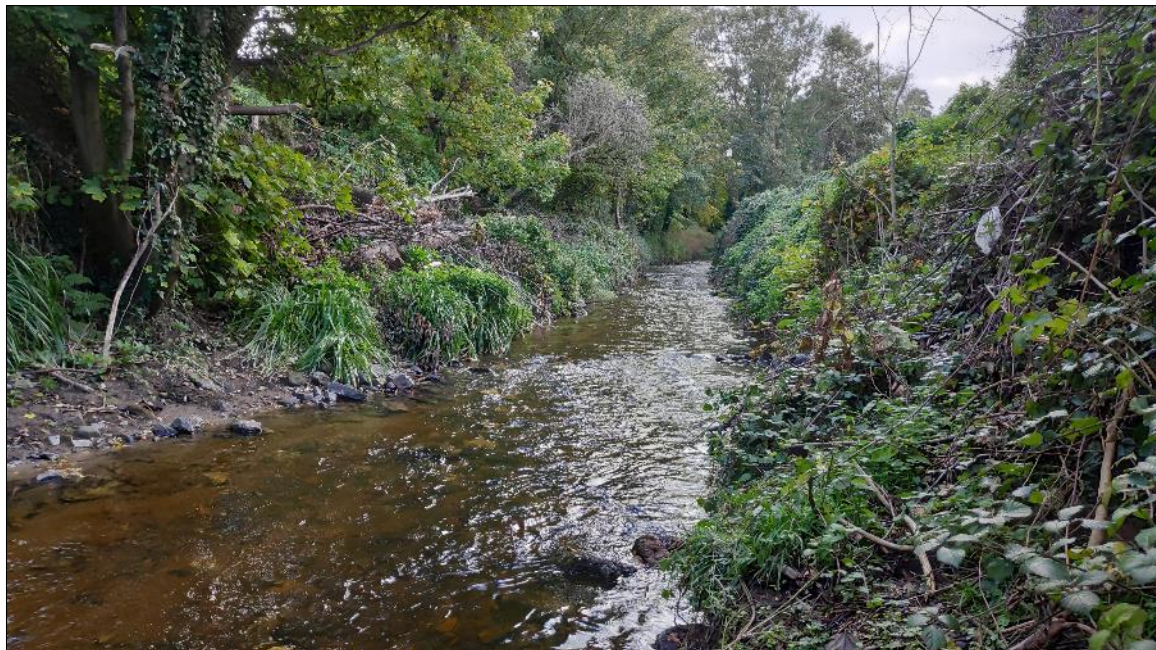
The Owendoher River at site O1 was located approx. 100m upstream of the R114 road bridge (site O2). The upland eroding watercourse (FW1) was swift flowing and averaged 6-7m wide and 0.2-0.5m deep, with localised deeper pool and glide areas to 1m. The river flowed through a semi-natural V-shaped incised valley with bankfull heights of 7-8m (steep sided). The site was characterised by shallow glide (30%) and riffle (60%) with occasional pool areas, usually associated with large instream boulders. The substrata were dominated by partially bedded cobble (40%) with clean sand and fine to medium gravels atop (40% overall). Large boulder was frequent (20%). Siltation was very low with any accumulations of finer substrata dominated by sand. Erosion from floods and human access was evident along both banks. Although adjoined by urban areas (BL3, GA2 etc.), the river was isolated from human activity with poor access via steep

Overall, site O1 offered excellent salmonid habitat, with particularly good spawning opportunities given abundant clean substrata. Whilst limited in extent (site was typically shallow riffle), some very good holding habitat was present in localised small pools (with brown trout evidently plentiful). The site was also a good salmonid nursery. Whilst the site offered some good physical suitability for lamprey spawning, the swift flows and general eroding/spate nature precluded fine sediment deposition and larval habitat was largely absent. European eel habitat was moderate. White-clawed crayfish are not known in the Owendoher, despite some good physical suitability. Otter suitability was very high given low disturbance and good prey resources (but no signs were recorded at this site).

In summary, habitat of excellent salmonid quality, and moderate lamprey and European eel habitat was observed at this site.

Plate 3.5 Representative image of site O1 on the Owendoher River (facing upstream)

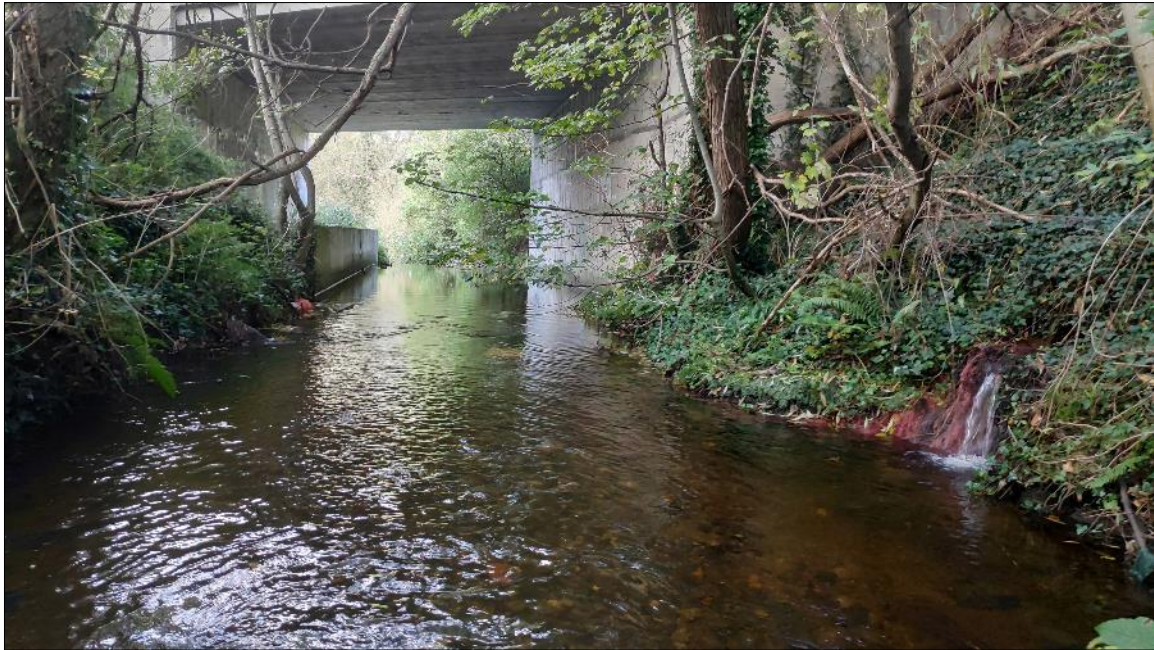
The Owendoher at site O2 was located at the R114 road bridge/culvert, approx. 100m downstream from site O1. Here, the river averaged 6-7m wide and 0.3-0.6m deep, with localised deeper pool and glide areas to 1.2m. The river flowed through a semi-natural V-shaped valley with bankfull heights of 7-8m (steep sided) and was bound by masonry retaining walls under the bridge. In contrast to site O1 upstream, the site was characterised by slower, deeper glide and pool. Downstream of the weir, riffle predominated. The substrata were dominated by partially bedded cobble (30%) with clean sand (30%) and well-sorted gravels (20% overall). There were extensive beds of coarse sand locally. Large boulder was frequent (20%). Siltation was low with any accumulations of finer substrata dominated by sand. Erosion from floods and human interference was evident along both banks. As per site O1, the river was isolated from human activity with poor access via steep banks. The banks supported mature treelines dominated by sycamore, crack willow, ash and elder (*Alnus glutinosa*), with occasional cherry laurel. Buddleja was present downstream of the bridge. The scrubby escarpments supported bramble and ivy with angelica and hedge bindweed. Japanese knotweed and winter heliotrope was scattered throughout the site (but more prevalent upstream). Riparian shading was relatively high and macrophytes were absent. The aquatic moss layer was poorly developed with only localised *Platyhypnidium riparoides* present, with *Hygroamblystegium tenax* on the weir face. The bridge retaining walls did not support vegetation.

Site O2 offered excellent salmonid habitat, with particularly good spawning opportunities given abundant clean substrata. Holding habitat was also excellent (particularly underneath the bridge) although the weir was a significant barrier to fish migration (no fish pass present). Brown trout were plentiful. The site was also a good salmonid nursery (likely brown trout only given known migration barriers downstream). Whilst the site offered some good physical suitability for lamprey spawning, the swift flows and general eroding/spate nature precluded fine sediment deposition and larval habitat was largely absent. European eel habitat was moderate. White-clawed crayfish are not known in the Owendoher. Old otter spraint (1(2)) was recorded under the bridge structure on the west bank (ITM 714179, 728878).

In summary, site O2 showed some excellent salmonid habitat with good spawning gravels. The presence of otter was also noted within the boundaries of the site.

Plate 3.6 Representative image of site O2 on the Owendoher River (facing downstream towards road bridge with point source evident in right foreground)

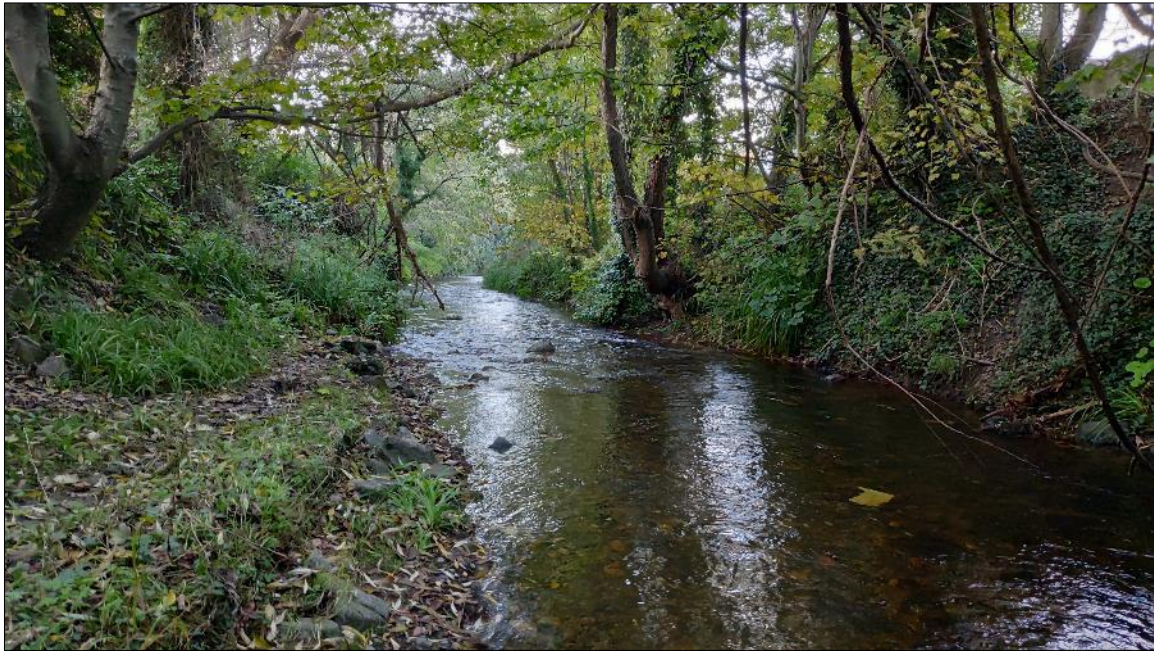
Biological water quality, based on Q-sampling, was calculated as **Q3-4 (moderate status)** (**Appendix A**). The site (station RS09O011700) achieved Q3-4 (moderate status) in 2019 (EPA data).

In summary, site O3 showed excellent salmonid habitat with good habitat in particular. Additionally, habitat with high otter potential (including a possible breeding area) was also noted.

Plate 3.7 Representative image of site O3 on the Owendoher River (facing downstream)

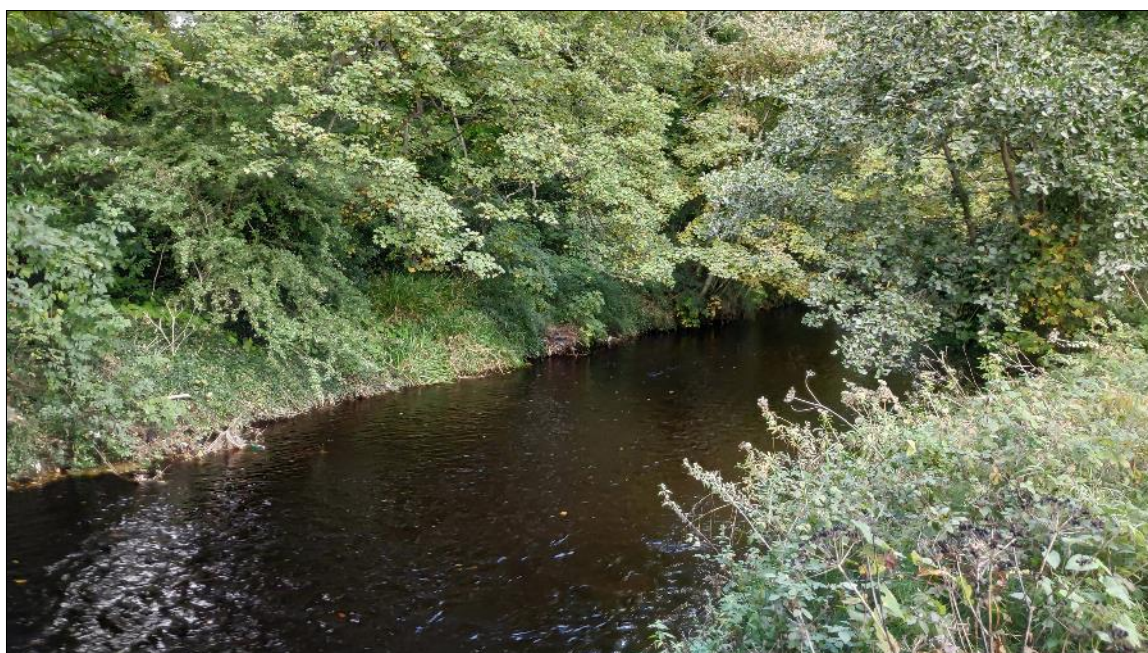
abundant ivy with bramble scrub, pendulous sedge, nettle, hogweed, angelica, hemp agrimony and frequent winter heliotrope. Given the loose substrata and mature tree canopy, macrophyte growth was not present at the survey site. However, some localised *Platyhypnidium riparoides* and *Cinclidotus fontinaloides* was present locally on larger boulder. *Conocephalum conicum* and *Pellia* sp. liverworts were abundant on exposed muddy banks.

In summary, given the excellent salmonid habitat - in particular spawning gravel, with other areas of good quality nursery and holding habitat observed at this site. Otter activity was not seen at this site during survey, but it is thought that habitat potential at this site was high for this species.

Plate 3.8 Representative image of site D1 on the River Dodder at Rathdown Park

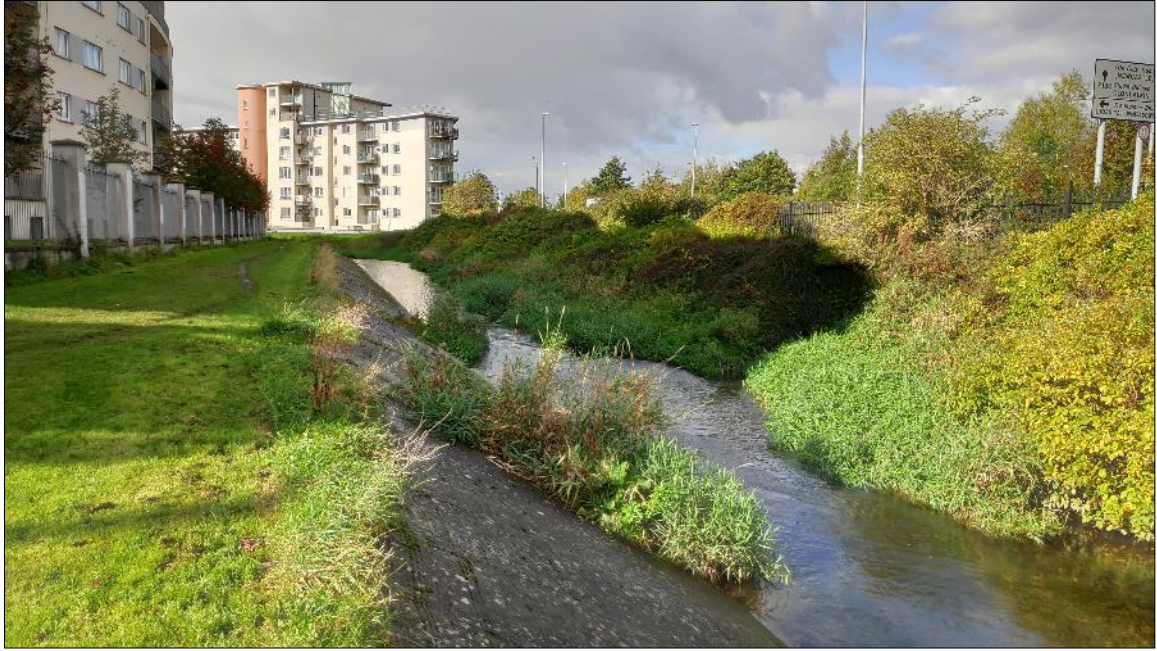
Biological water quality, based on Q-sampling, was calculated as **Q3 (poor status) (Appendix A)**. The nearest EPA biological monitoring station RS09C020310 (c.0.8km upstream) and RS09C020500 (5.4km downstream) both achieved Q3 (poor status) in 2019 (EPA data).

In summary, salmonid habitat was found to be of moderate quality, with moderate quality lamprey habitat and low densities of Annex II white-clawed crayfish at this site.

Plate 3.9 Representative image of site C1 on the River Camac (facing upstream)

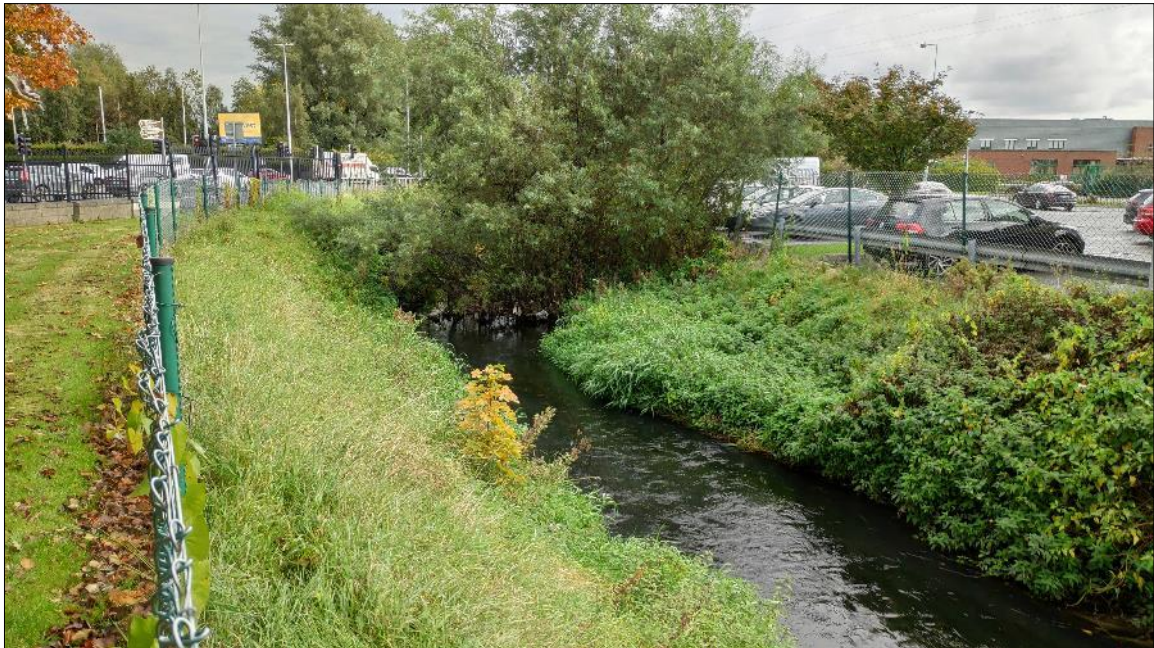
Site C2 offered some very good salmonid habitat (brown trout only). Upstream of the culvert provided excellent quality spawning and nursery habitat (among the best on the entire river) with very good holding habitat for abundant adult trout in undercut banks/under overhanging reed canary grass. A single mature crack willow immediately upstream of the culvert also provided an excellent deep holding pool for adult salmonids. Downstream, whilst spawning and nursery value was somewhat reduced, adult holding habitat was very good given undercut banks and prominent submerged tree roots (willow and sycamore). These also offered excellent refugia for white-clawed crayfish, which were recorded at 'moderate' densities (≥ 1 to < 3 per 10 refugia; Peay, 2003). A total of $n=8$ crayfish were recorded via sweep netting, with males, females and juveniles present, ranging from 19-41mm carapace length. Lamprey ammocoete habitat was present both upstream and downstream of the culvert, usually in association with instream macrophyte beds. European eel habitat was good throughout but better upstream. Despite known utilisation of the river and abundant prey resource, no otter signs were recorded during the site visit (few suitable marking sites present).

Plate 3.10 Representative image of site C2 on the River Camac (upstream of the culvert)

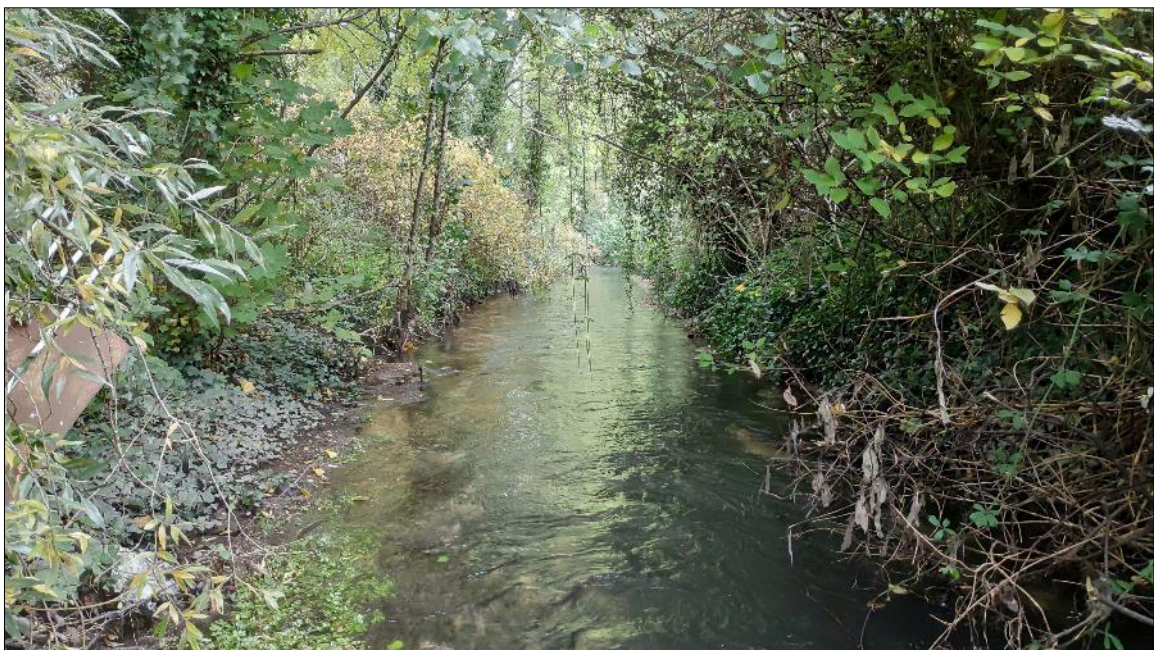
The presence of a healthy Annex II white-clawed crayfish population, in addition to excellent brown trout habitat and good lamprey habitat summarizes the key habitats found at this site.

Plate 3.11 Representative image of site C2 on the River Camac (downstream of the culvert)

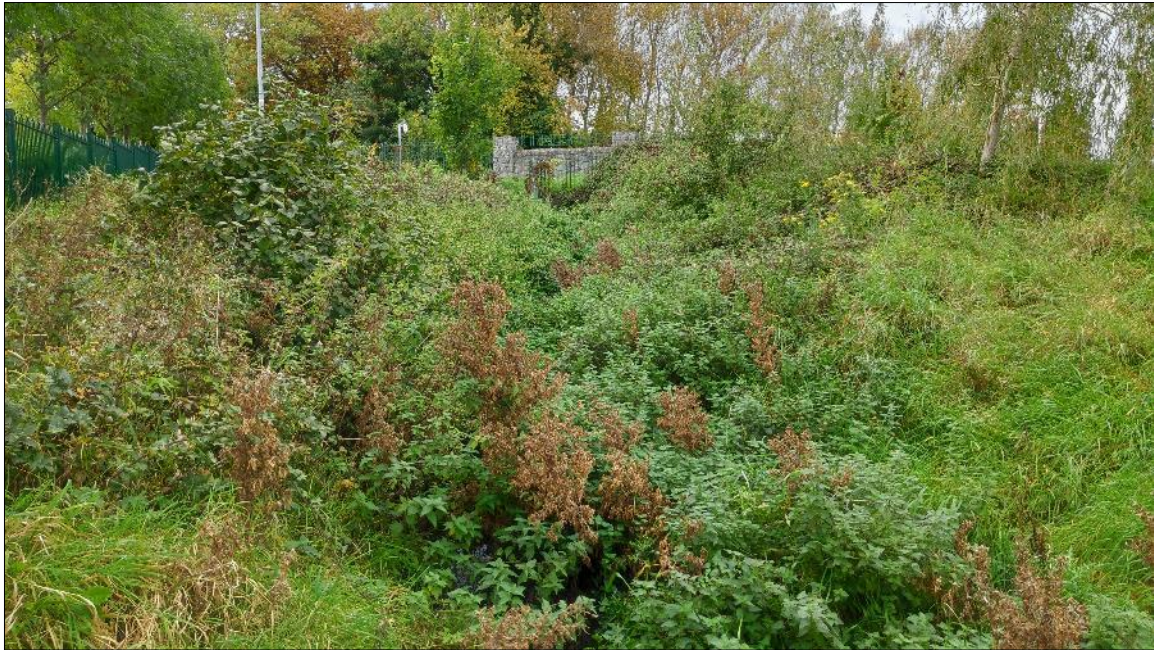
Biological water quality, based on Q-sampling, was calculated as **Q2-3 (poor status) (Appendix A)**. There was no contemporary EPA biological water quality monitoring data available for the River Poddle (Q3, (poor status) recorded at station RS09P030400 in 2007 only).

Site P1 was found to have low fisheries value and poor water quality, and of low overall aquatic ecological value.

Plate 3.12 Representative image of site P1 on the upper reaches of the River Poddle (heavily scrubbed-over, facing upstream to road crossing)
