Appendix D
Arboricultural Impact
Assessment Report

National Transport Authority

**Templeogue / Rathfarnham to City
Centre Core Bus Corridor Scheme**

Arboricultural Impact Assessment
Report

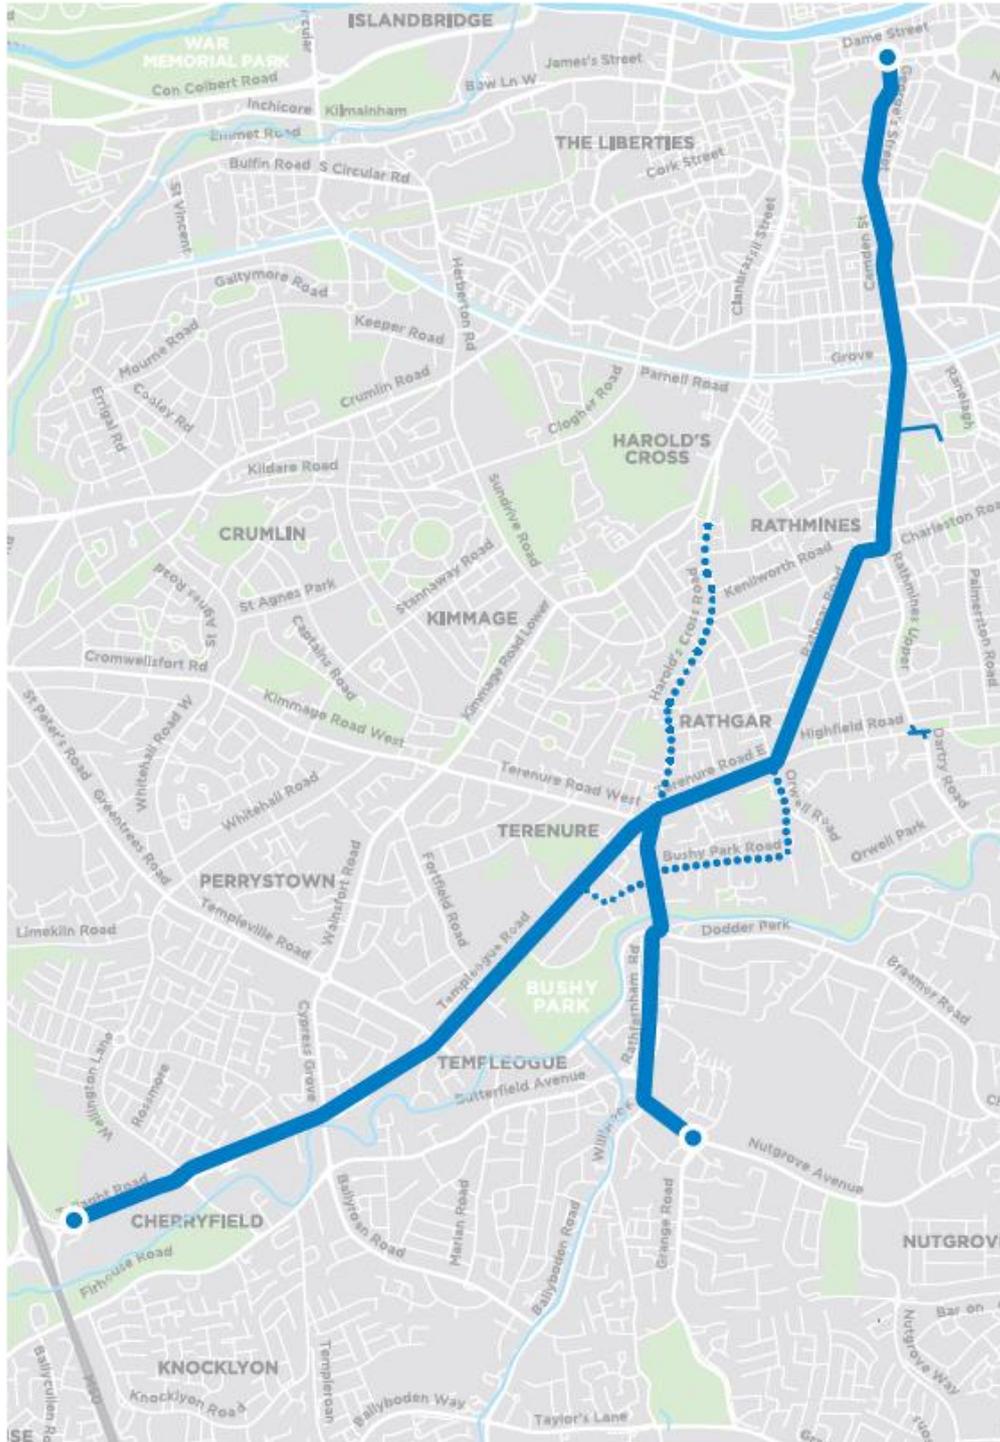
Figure 1: Proposed Route Corridor

The Rathfarnham to City Centre section commences on the R821 Grange Road at the junction with Nutgrove Avenue. The CBC is routed along Grange Road, Rathfarnham Road, Terenure Road East, Rathgar Road, Rathmines Road Lower, Richmond Street South, Camden Street Upper and Lower, and Wexford Street to its junction with Kevin Street Lower and Cuffe Street where priority bus lanes end. From Cuffe Street to Dame Street along Redmond's Hill, Aungier Street and South Great George's Street, the route will involve a traffic lane and a cycle track in both directions where it will join the existing traffic management regime in the city centre. Alternative cycle facilities are also proposed on Terenure Road North and Harold's Cross Road and on Wasdale Park, Wasdale Grove, Victoria Road, Zion Road and Orwell Road.

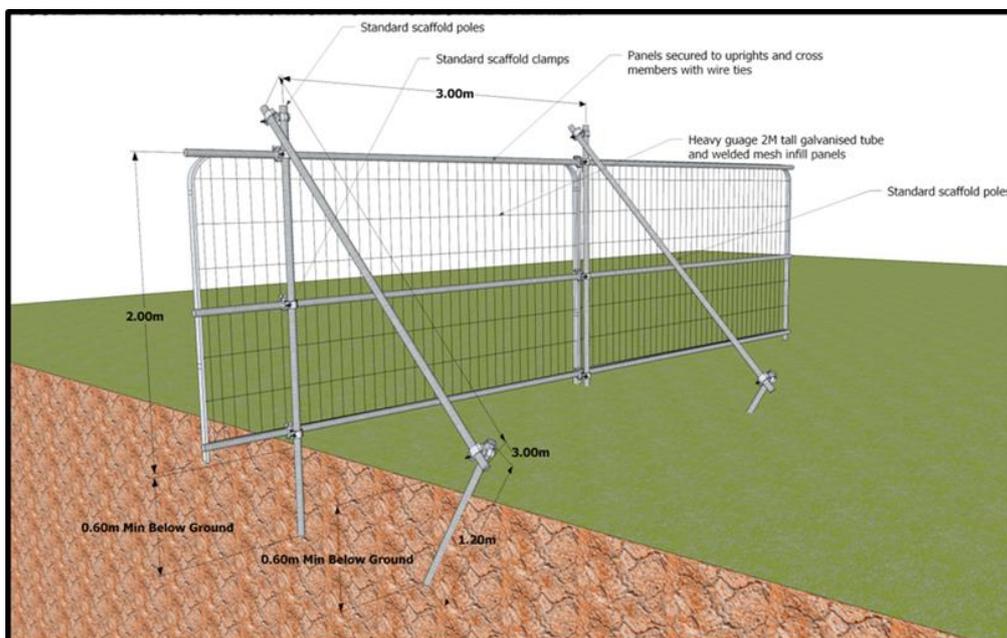
Fencing shall be constructed with robust vertical and horizontal scaffold framework with weldmesh panels firmly attached in accordance with BS 5837:2012 Figure 2. Vertical support poles and bracing poles must be located with care to avoid underground utility services and will be sited to avoid the structural roots of retained trees. Where driven supports are not practicable due to the presence of roots or underground utilities block trays, counterweights or equivalent can be utilised.

Figure 3: Default specification for tree protection barrier in accordance with BS5837:2012 figure 2

Alternative equivalent robust and immovable fencing specification including site hoarding will also be appropriate.

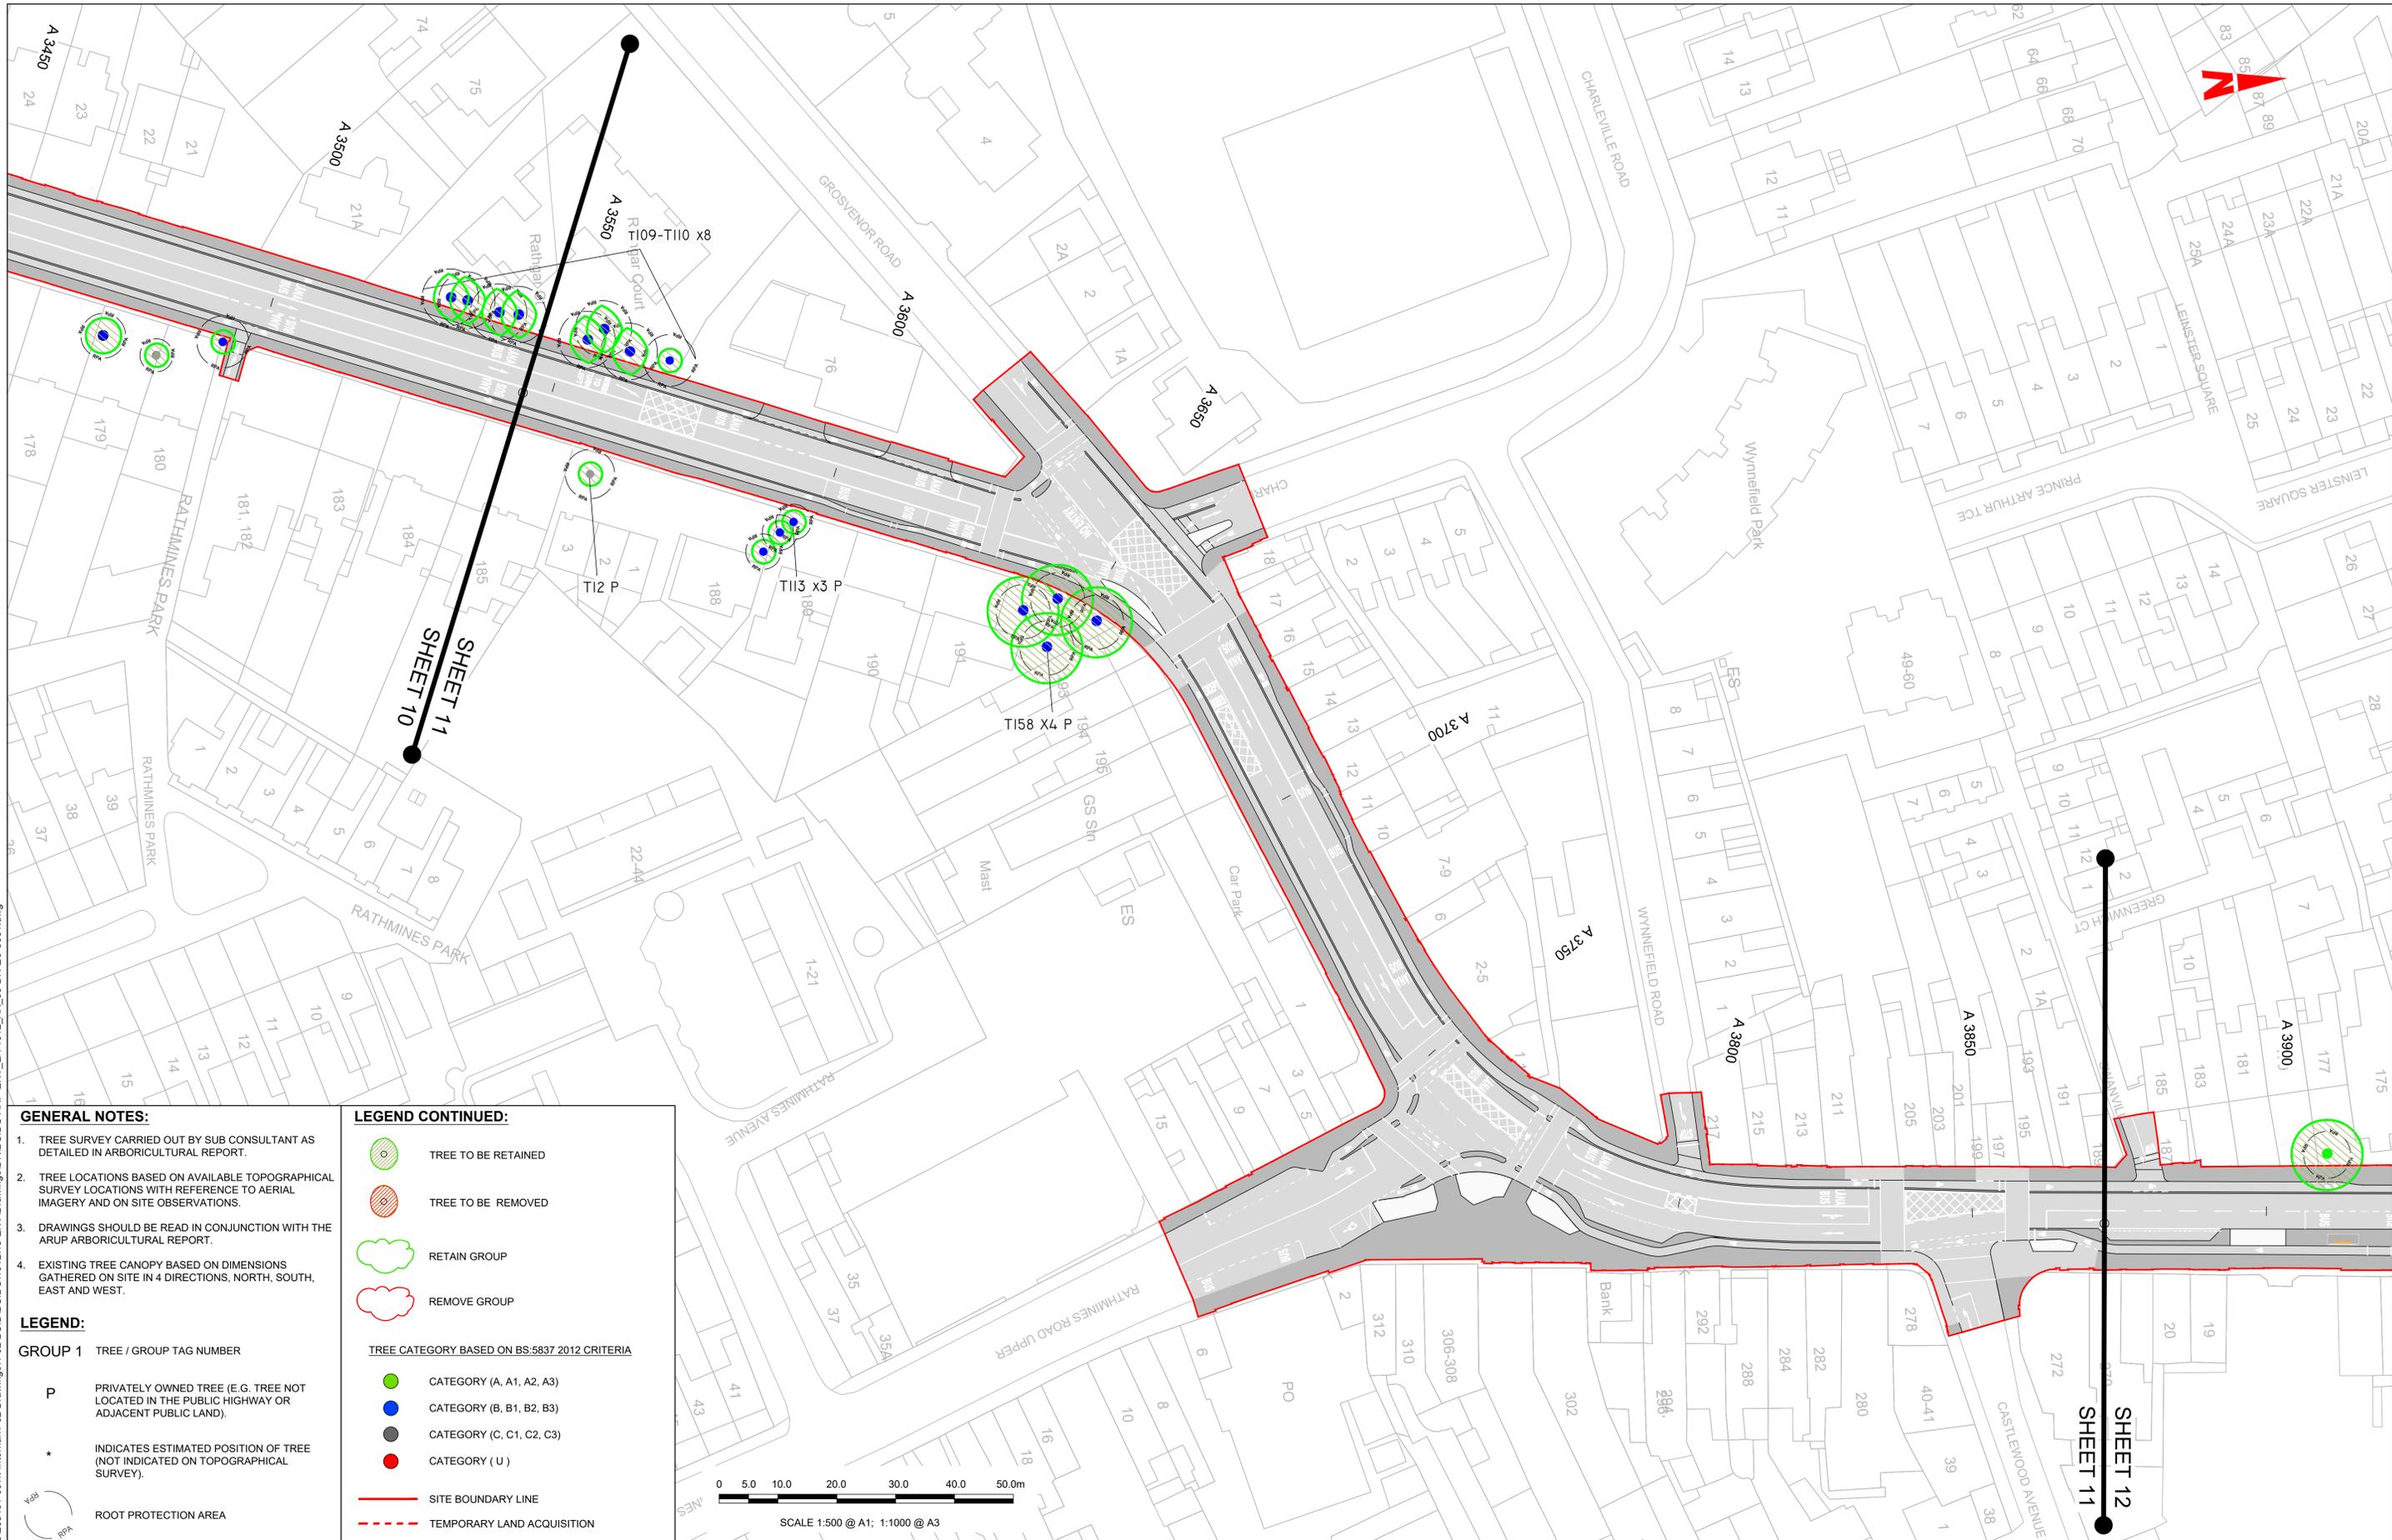
Programme Title BUSCONNECTS DUBLIN CORE BUS CORRIDORS INFRASTRUCTURE WORKS	
Drawing Title TEMPLEOGUE / RATHFARNHAM TO CITY CENTRE SCHEME TREE PROTECTION PLAN	
Drawing File Name BCIDC-ARP-ENV_LA-1012_XX_00-DR-ES-0011	Sheet Number 11 of 37
Status A	Rev M01
