PEAT STABILITY RISK ASSESSMENT
For
Tullaghmore Windfarm, Co. Galway

Consultants:
Jennings O'Donovan & Partners Ltd

Revision 3

Issued: 21st December 2022

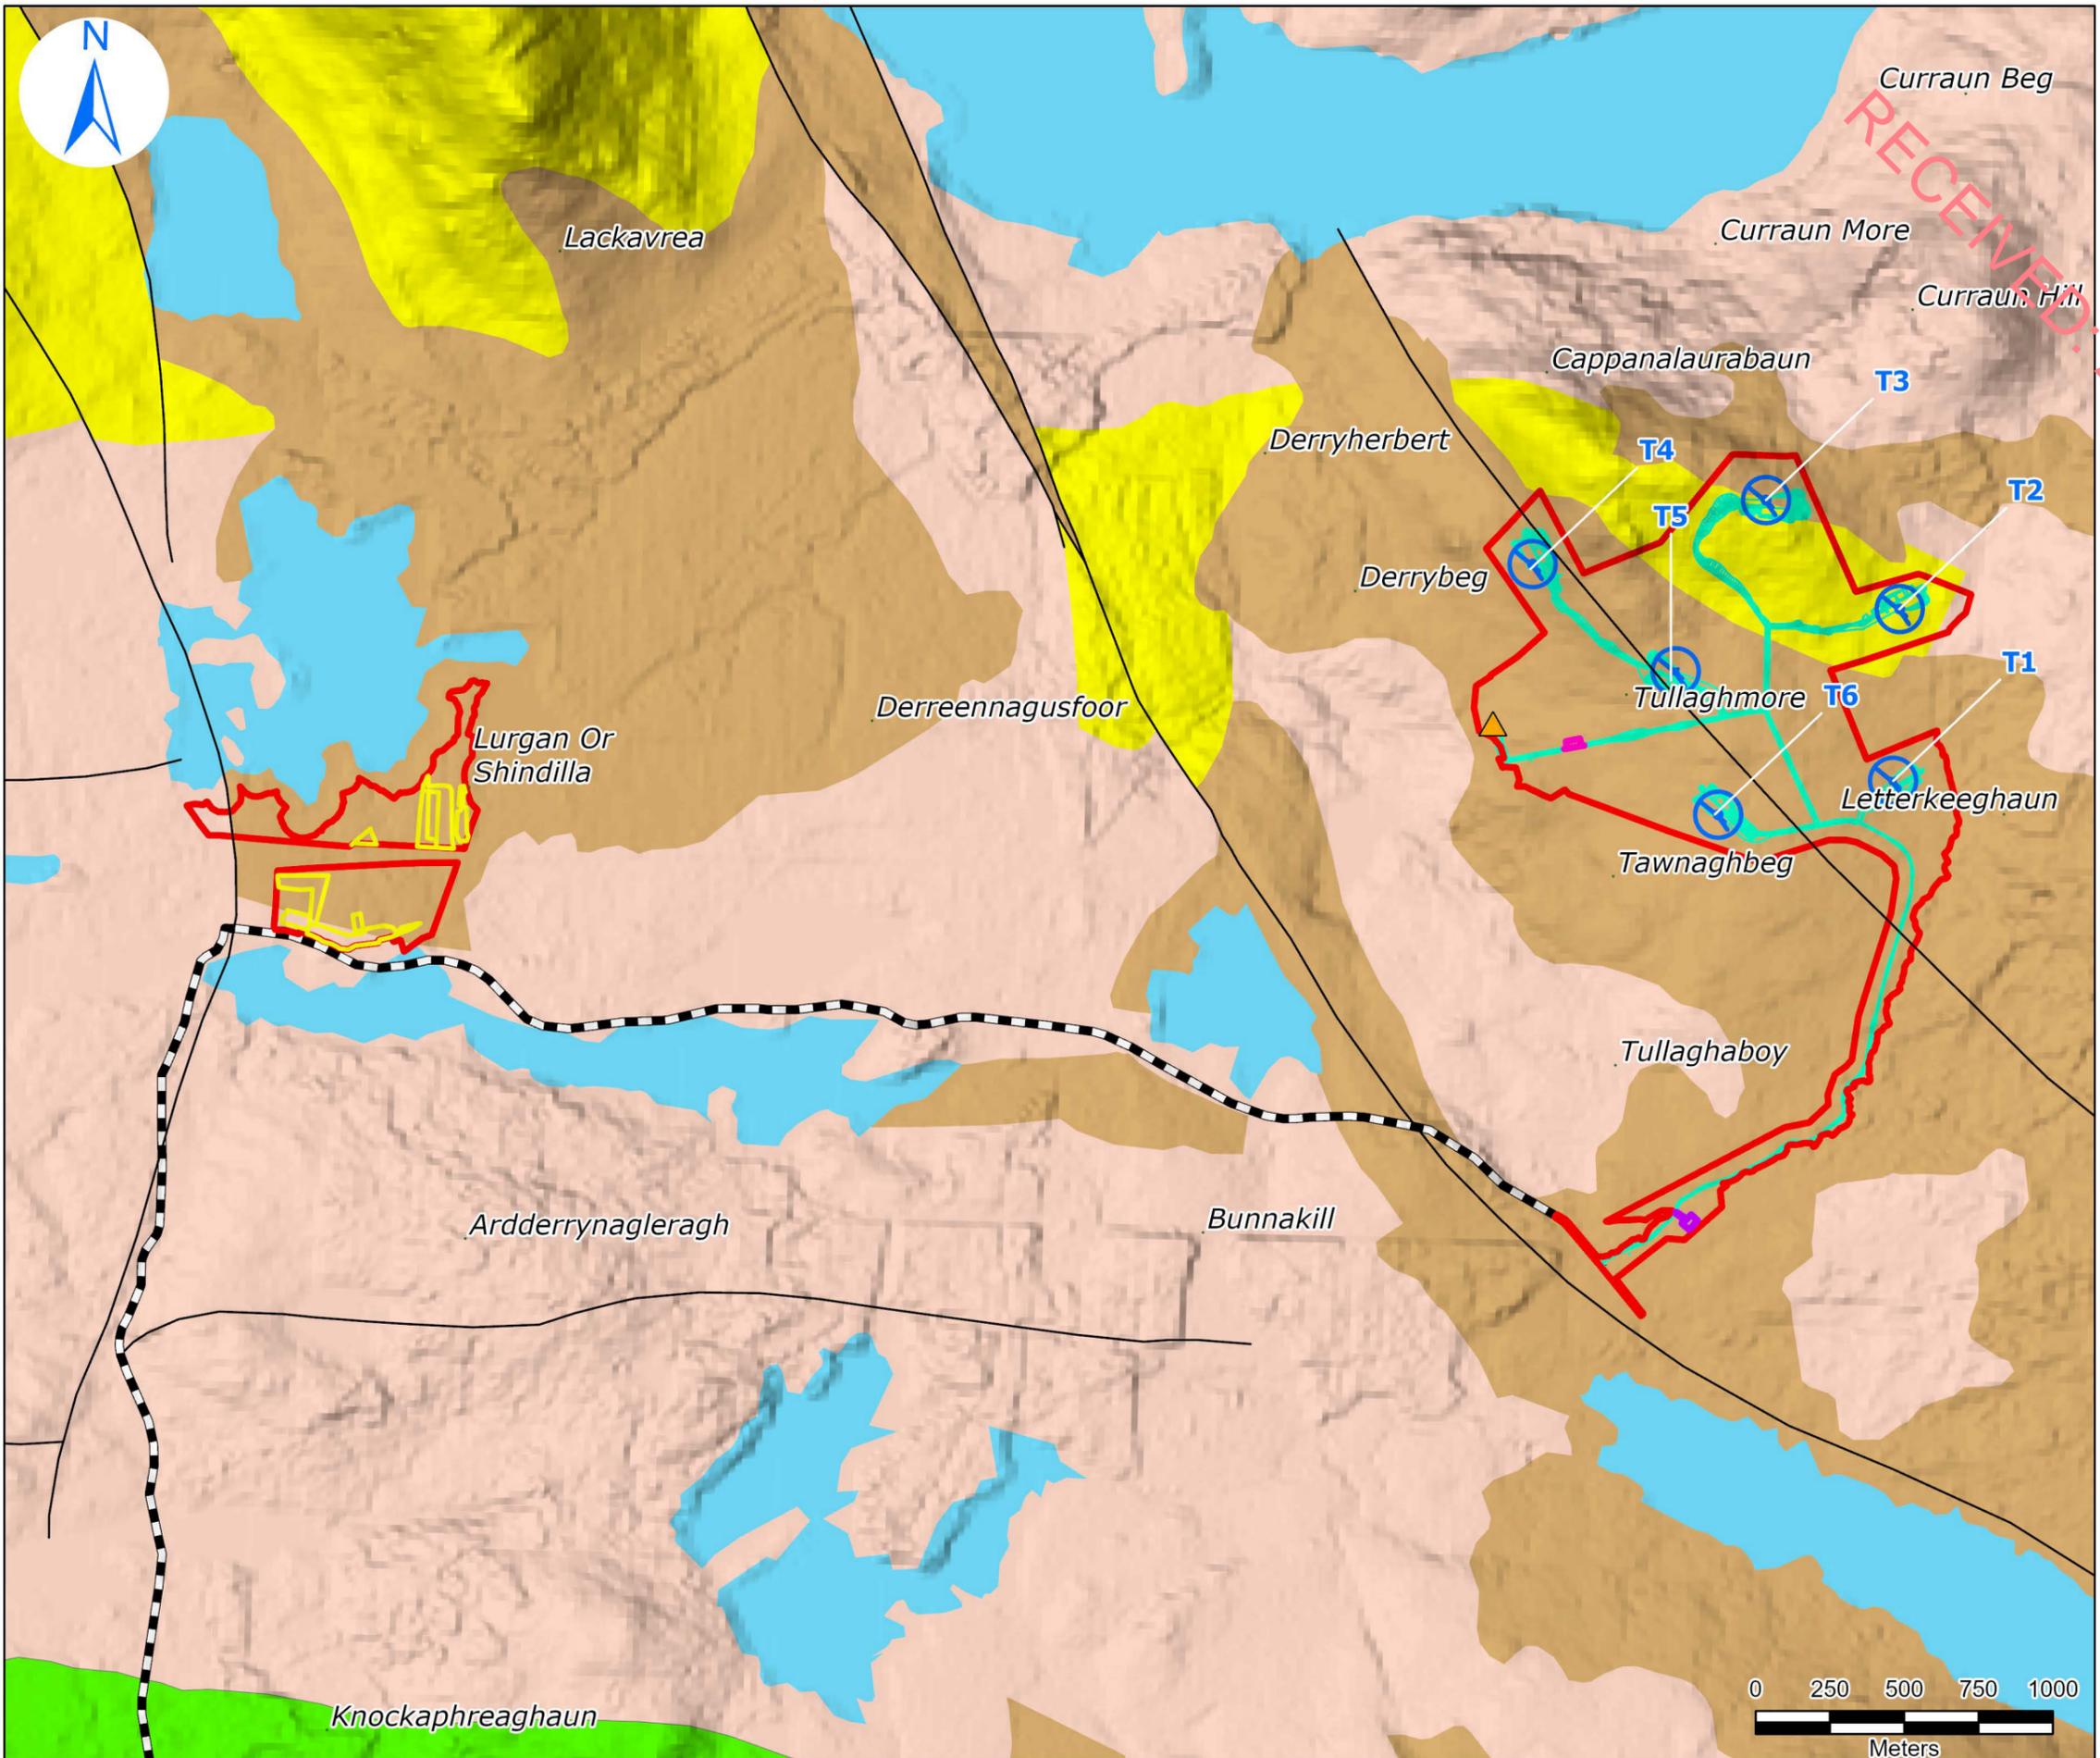
The GSI maps and website for this area shows that the majority of the site is underlain by Ordovician age igneous and metamorphic rocks as shown in Figure 1. It should be noted that some outcrops of bedrock are present throughout the site, particularly within the upland (northern) parts of the site.

The majority of the main site is underlain by the Oughterard Granite formation which consists of two main bodies, the Oughterard mass in the east and the Tullaghmore mass in the west, which are linked by a narrow granite strip. The granite is non-porphyrific and medium to coarse grained, with pink or white K-feldspar but also includes areas of granodiorite, tonalite and dacite. The northern part of the main site (between T2 and T3) is mainly underlain by the Bennabeola Quartzite Formation which comprises Proterozoic age pale quartzite (Argyl Group). A small part of the northeast corner of the site is underlain by Proterozoic age Streamstown Schist Formation which comprises psammitic pelitic and semi-pelitic schists (Argyl Group).

Structurally, the Site is crossed by a northwest-southeast trending fault which runs close to the proposed locations of turbines T4 and T5. This fault is not however expected to impact on any infrastructure locations. An anticlinal fold axis trends east-west across the northern part of the Site which is also not considered significant. Due to the tectonic history of Ireland, these features are common throughout the country and particularly along the west coast.

An overview of the bedrock geology for the main site is shown in Figure 1. An overview of the quaternary geology for the main site is shown in Figure 2.

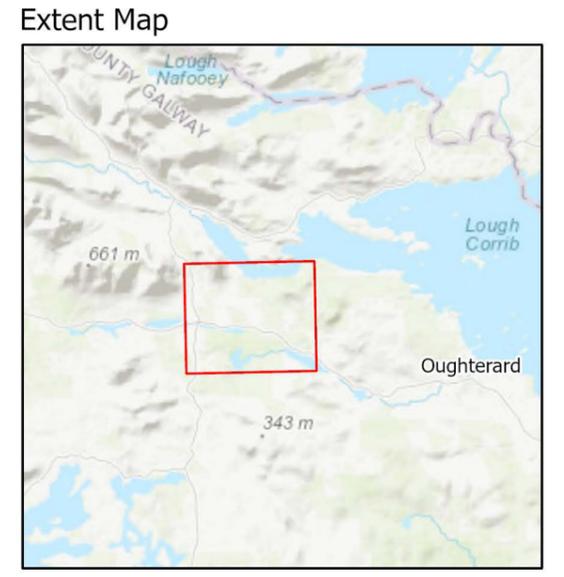
Bedrock Geology

- Argyll Group; Quartzite
- Argyll Group; Psammitic & pelitic schist, marble, amphibolite, diamictite
- Orthogneiss suite, mainly quartz diorite (Connemara)
- Granodiorite, tonalite, dacite, granite

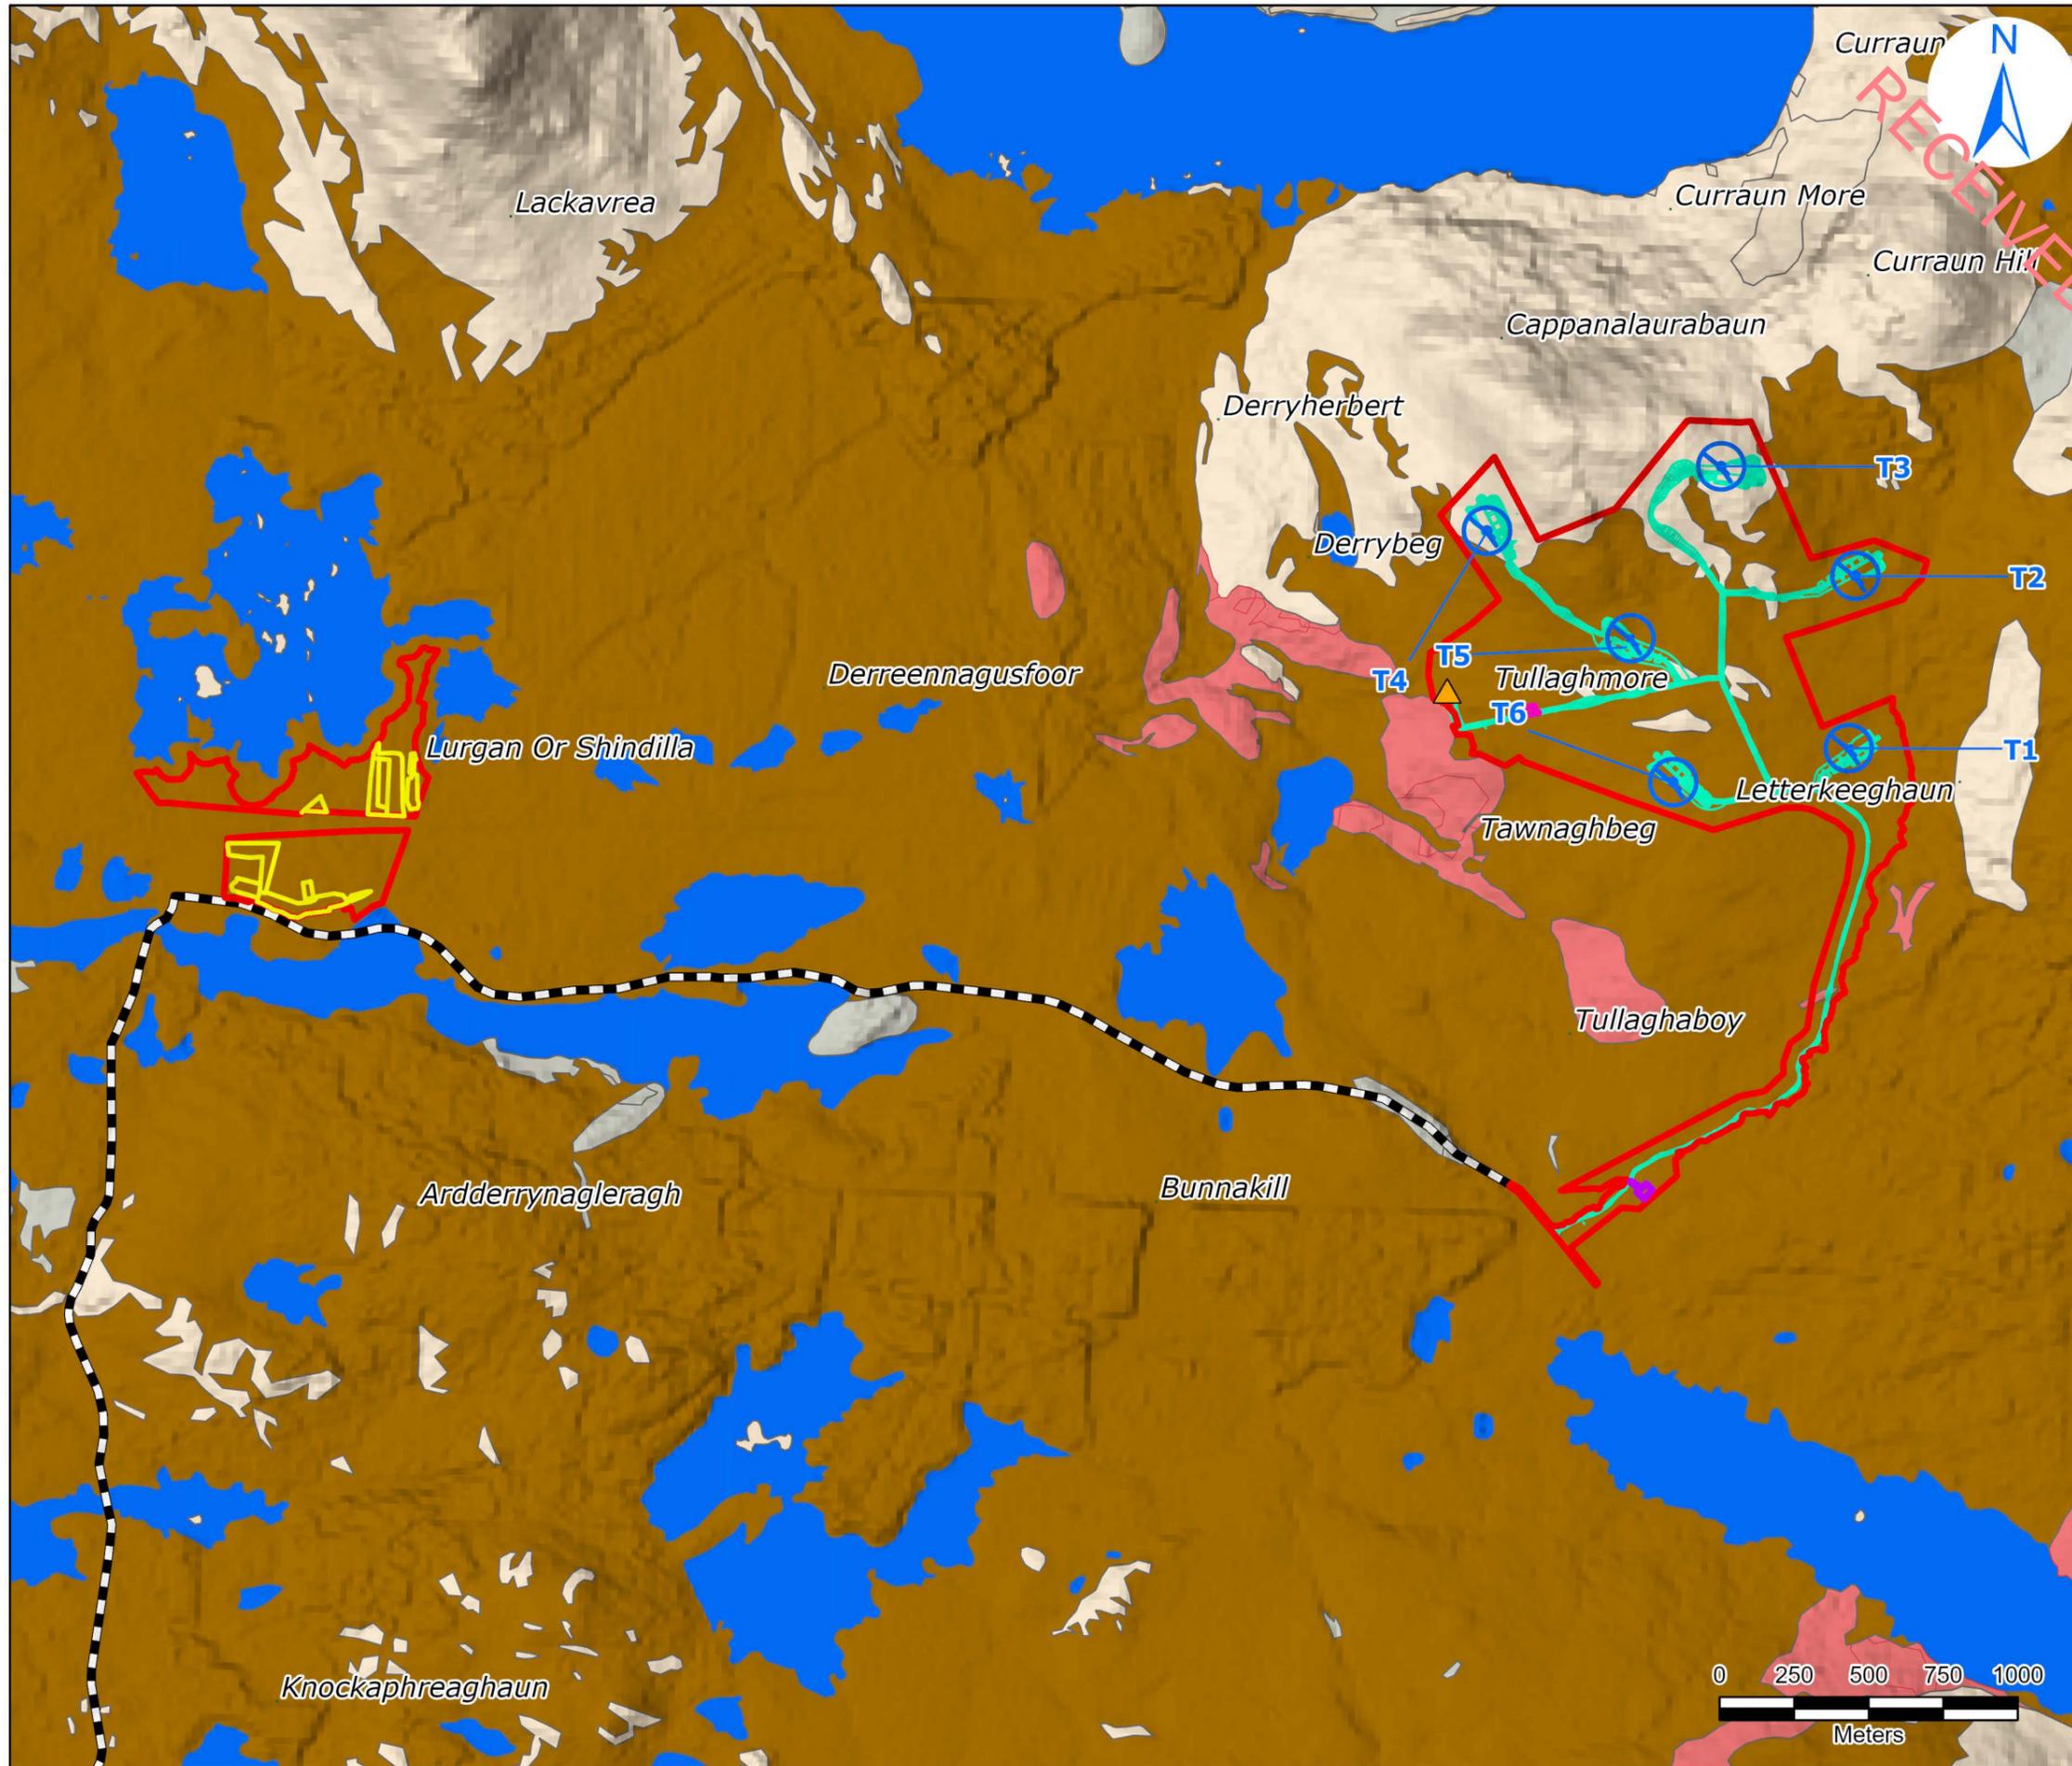
- Blanket peat covers the majority of the site to variable depths (based on the GSI Quaternary and Groundwater Vulnerability mapping). The peat is absent from some of the upland (northern) areas of the site and parts of the lowland (southern) parts of the site in addition to parts of the grid connection route to Screebe.
- Glacial till derived from the underlying granite bedrock and covering approximately 5% or less of the main site area and minor parts of the grid connection route.
- Approximately 20% or less of the main site and less than 5% of the grid connection route has shallow/exposed bedrock and hence has no superficial geology cover.

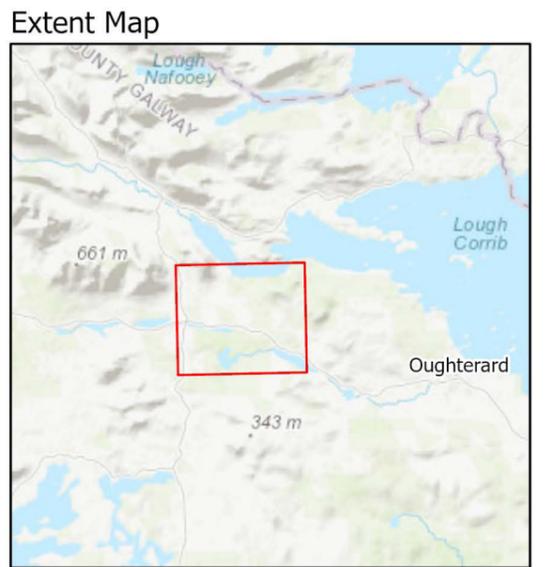
Subsoil Susceptibility

- Blanket peat
- Bedrock at or near surface-Non calcareous
- Granite till
- Metamorphic till
- Lakes

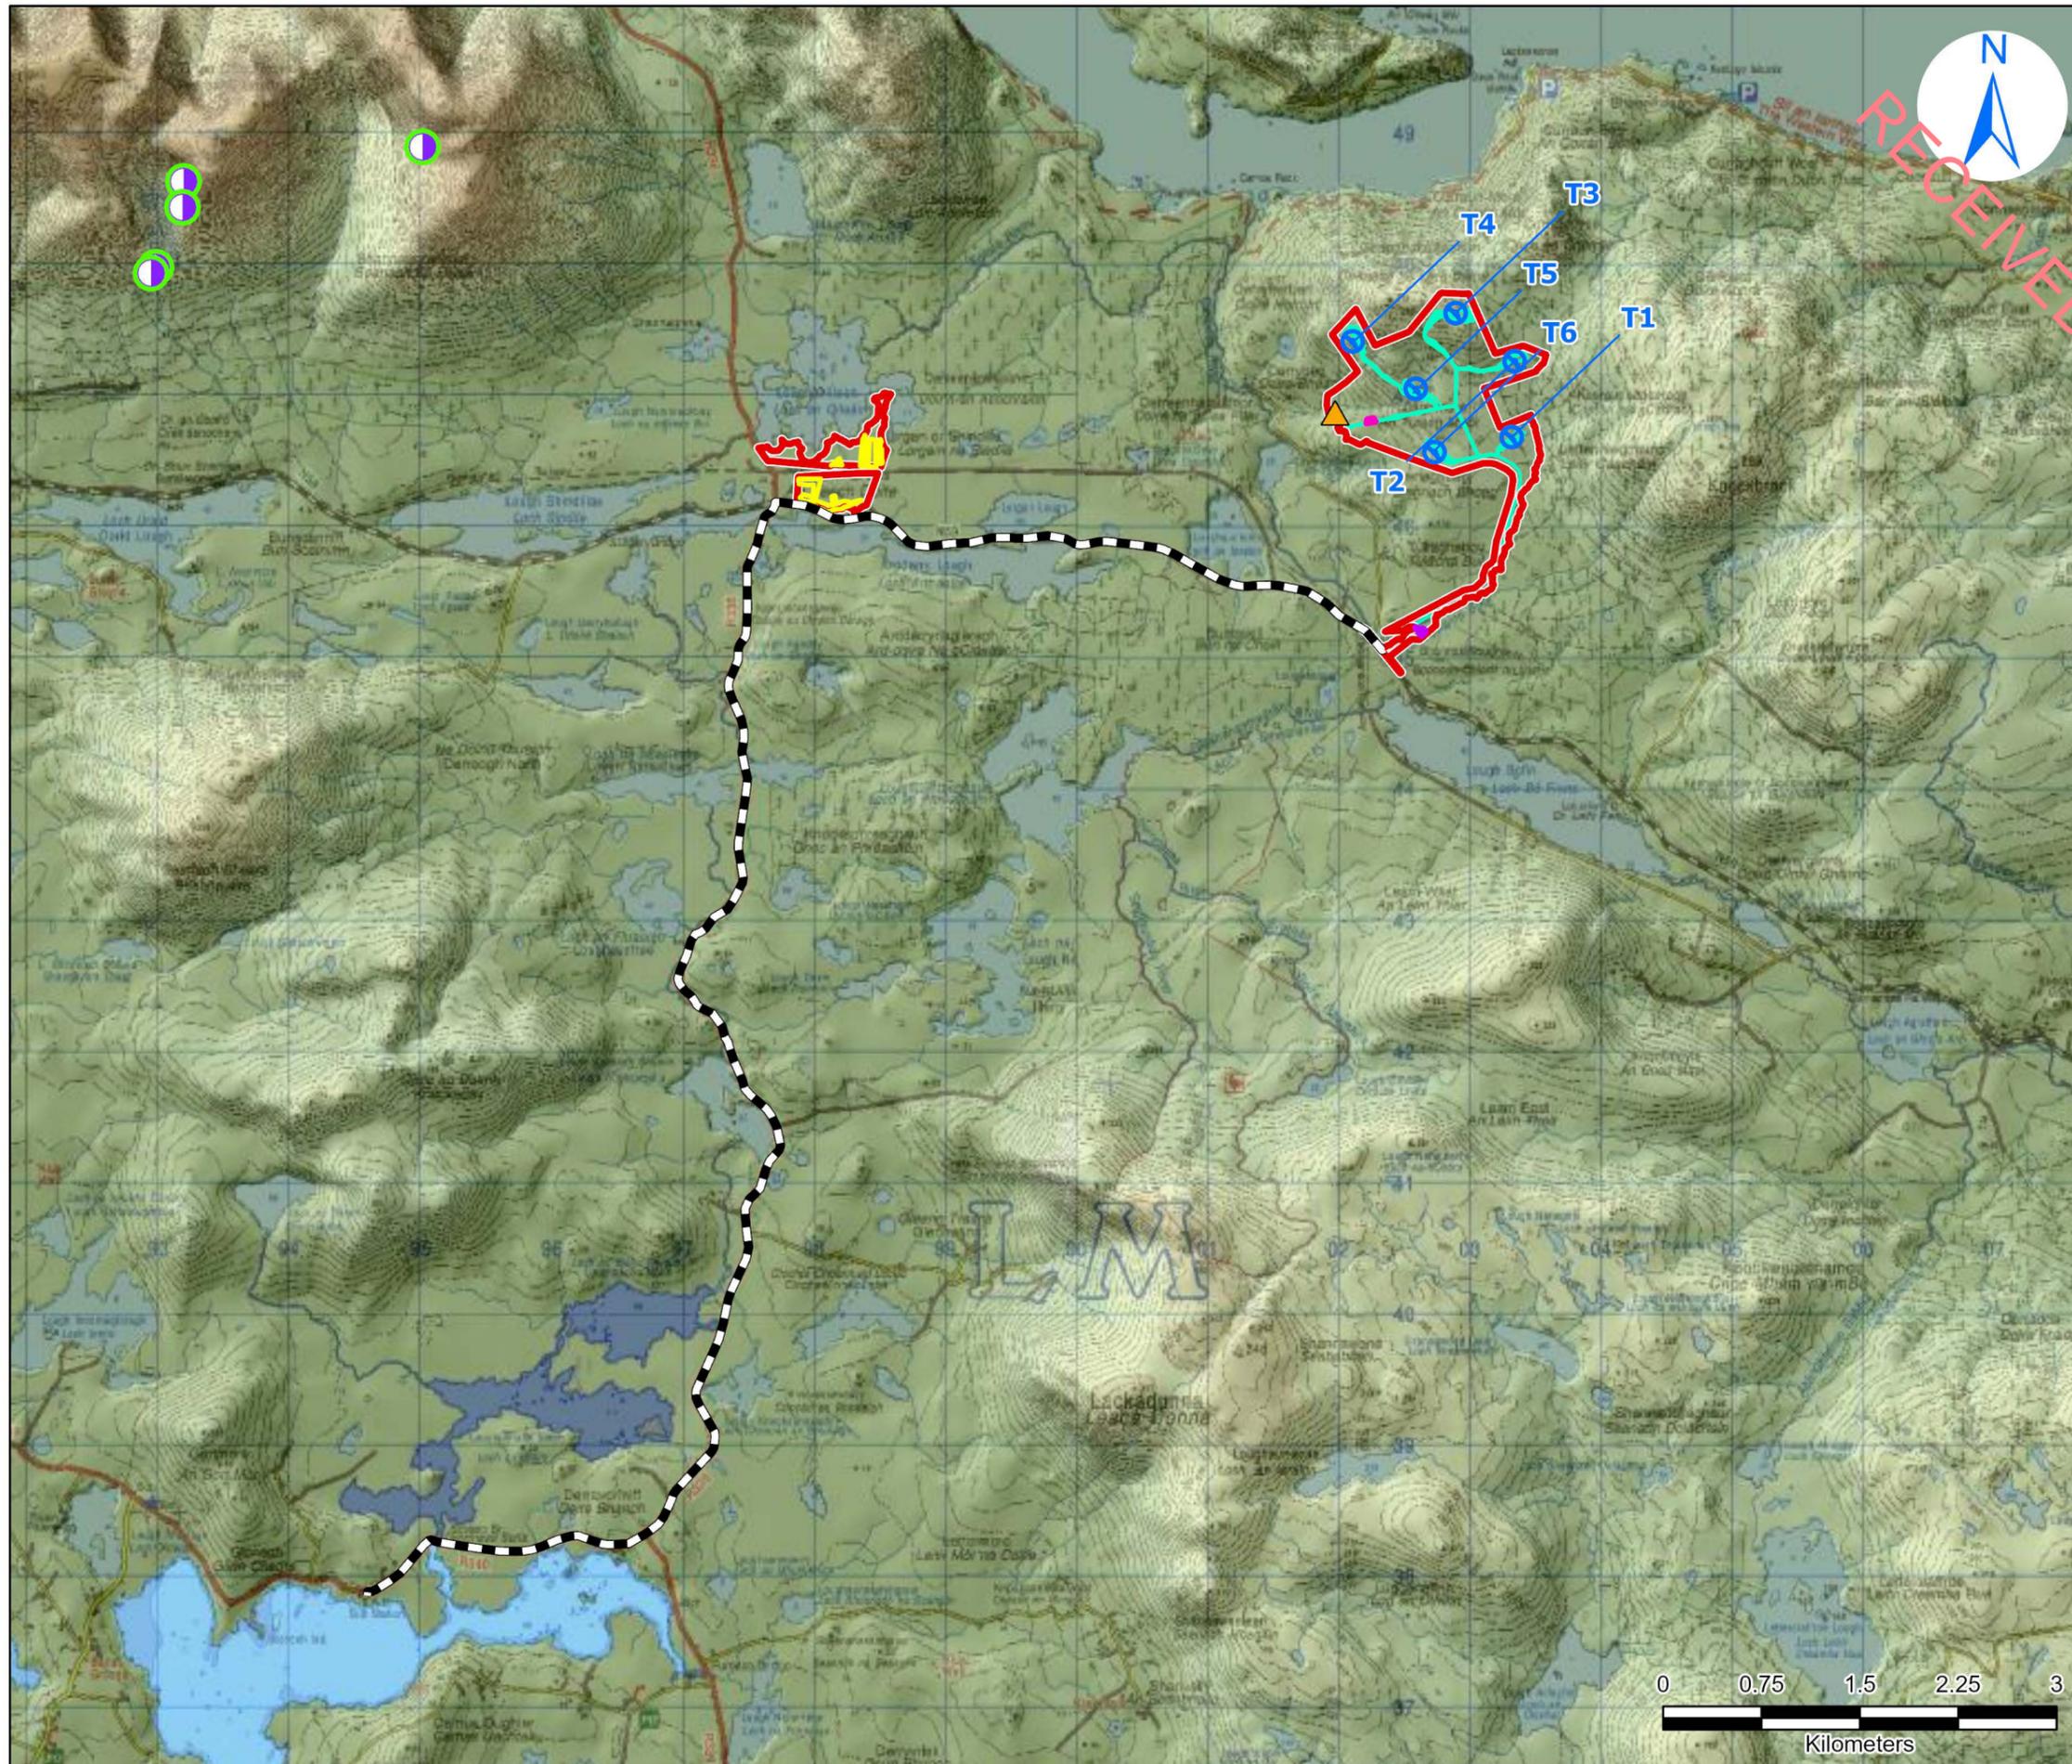
The Geological Survey of Ireland (GSI) maintains a database of known landslides in Ireland. The database records no landslides on or adjacent to the site. The nearest recorded landslides are shown approximately 7km west of the site where five landslides are recorded to the northwest of Maam Cross as shown in Figure 3. The landslides are of unknown type but are recorded as having bedrock within 1m of the surface.

An initial step in the assessment of pre-existing landslide risk is the determination of landslide history in the area. The GSI Irish landslides database as consulted on 2nd November 2021. The GSI online database shows no recorded landslides within or near the site. The nearest recorded landslides are shown approximately 7km west of the main site where five landslides are recorded 4 to 5km northwest of Maam Cross as shown in Figure 3. The landslides are of unknown type but are recorded as having bedrock within 1m of the surface. Aerial photographs of the site and surrounding area also show no evidence of historic landslides.

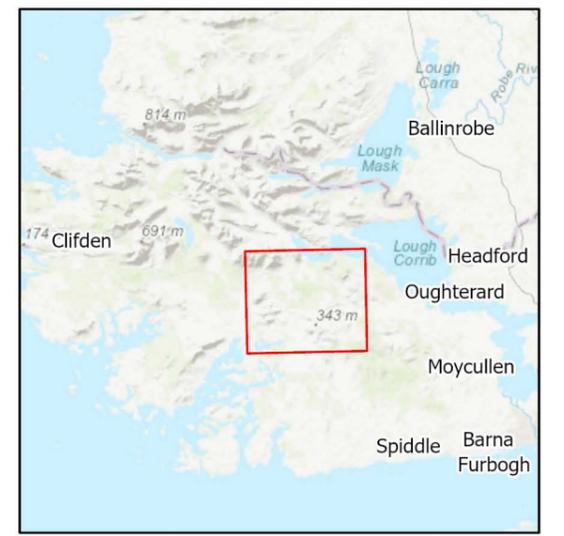
- Previously Recorded Landslide Events
- Met Mast
- Turbine Locations
- Temporary Construction Compound
- Sub Station Location
- Spoil Storage Areas
- Redline Boundaries
- Hardstand and Roads
- Grid Connection Route

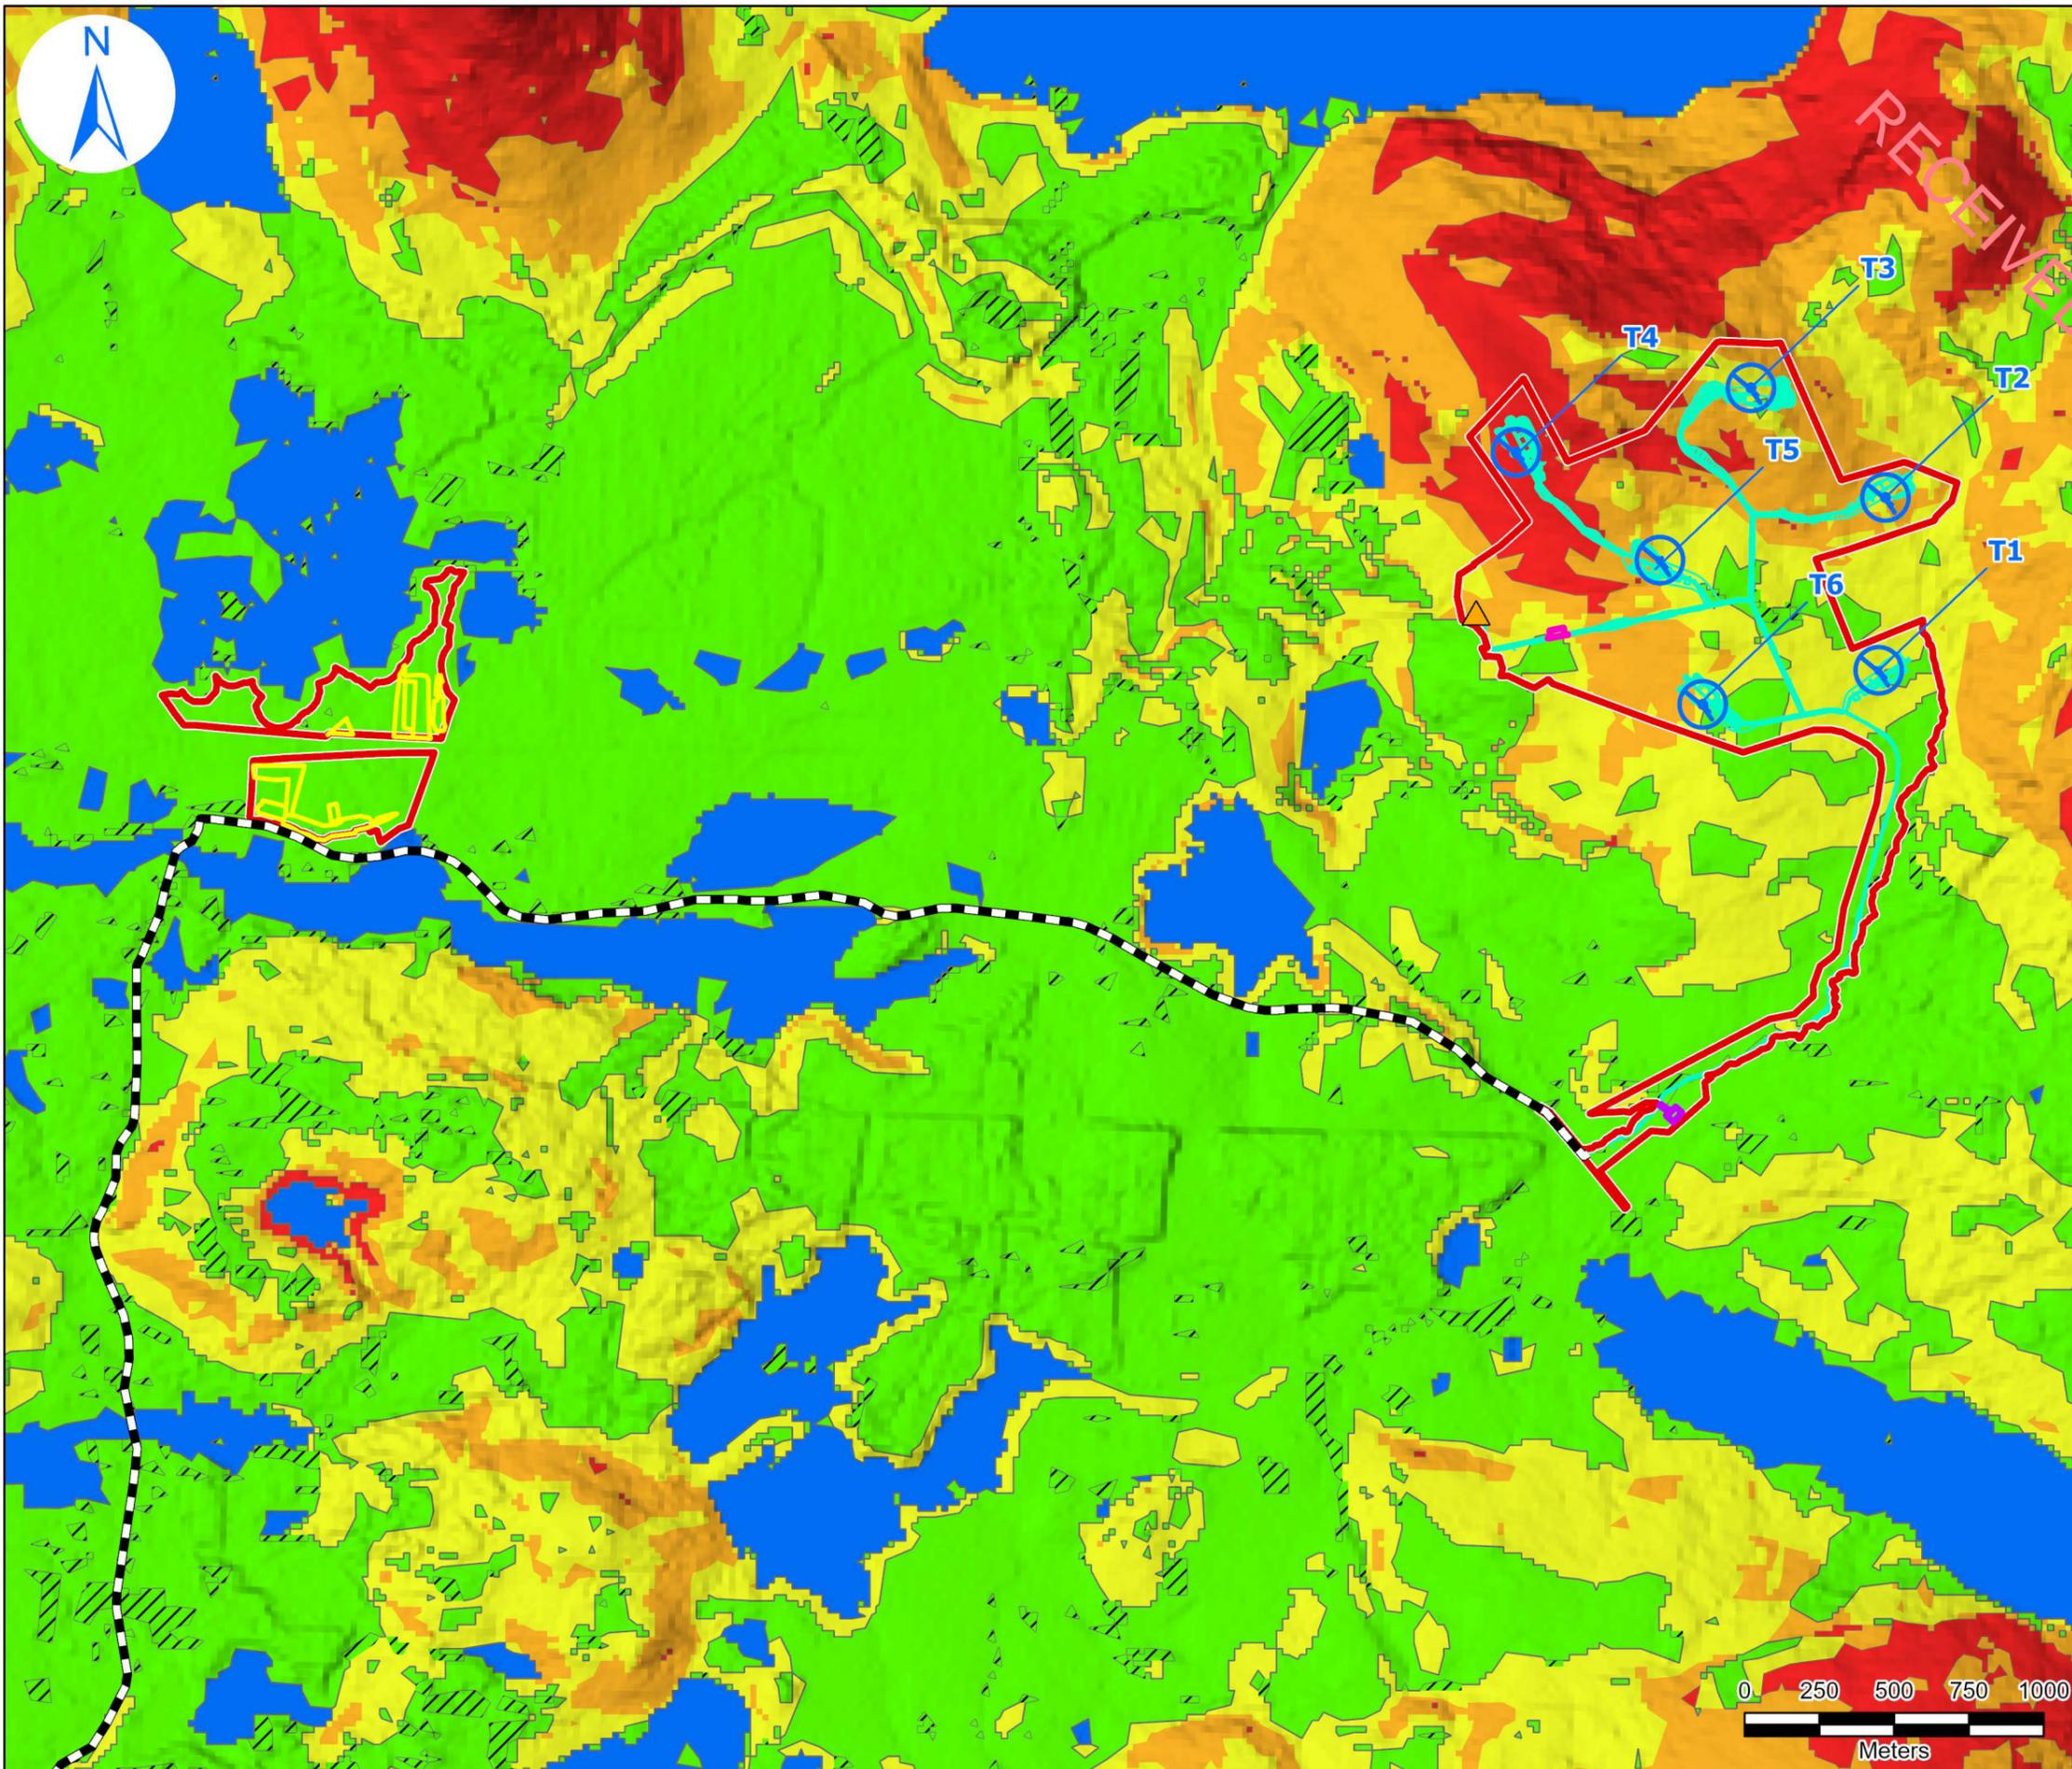
The GSI also maintains a Landslide Susceptibility Map for Ireland. Although some statistical approaches were also explored, the literature research and the requirement for a methodology that could be applied to Ireland as a whole coupled with the uncertainty as to how many additional landslides would be found by extending the inventory lead to a methodology known as the Unique Condition Unit (UCU) approach. As the name suggests, UCUs are parcels of terrain where a set of attributes are combined in a unique way. In the context of landslide susceptibility mapping, the attributes being considered are slope, soil type and an index which is a measure of overland flow concentration from intense rainfall events. The latter parameter has been called the Topographic Flow Index (TFI). As shown in Figure 4, the landslide susceptibility for the site has been categorised by the GSI as Low to High.

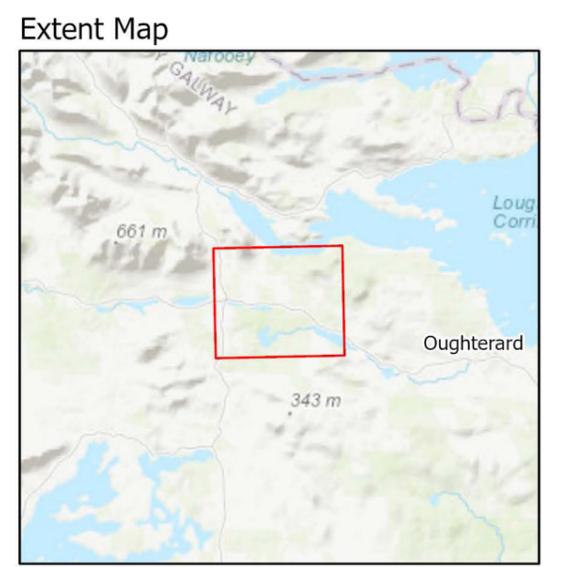
Landslide Susceptibility Classification

- High
- Low
- ▨ Low (inferred)
- Moderately high
- Moderately Low
- Water
