Appendix A12.2
Aquatic Baseline
Report

Aquatic baseline report for the BusConnects project, Dublin City

Prepared by Triturus Environmental Ltd. for Scott Cawley

December 2020

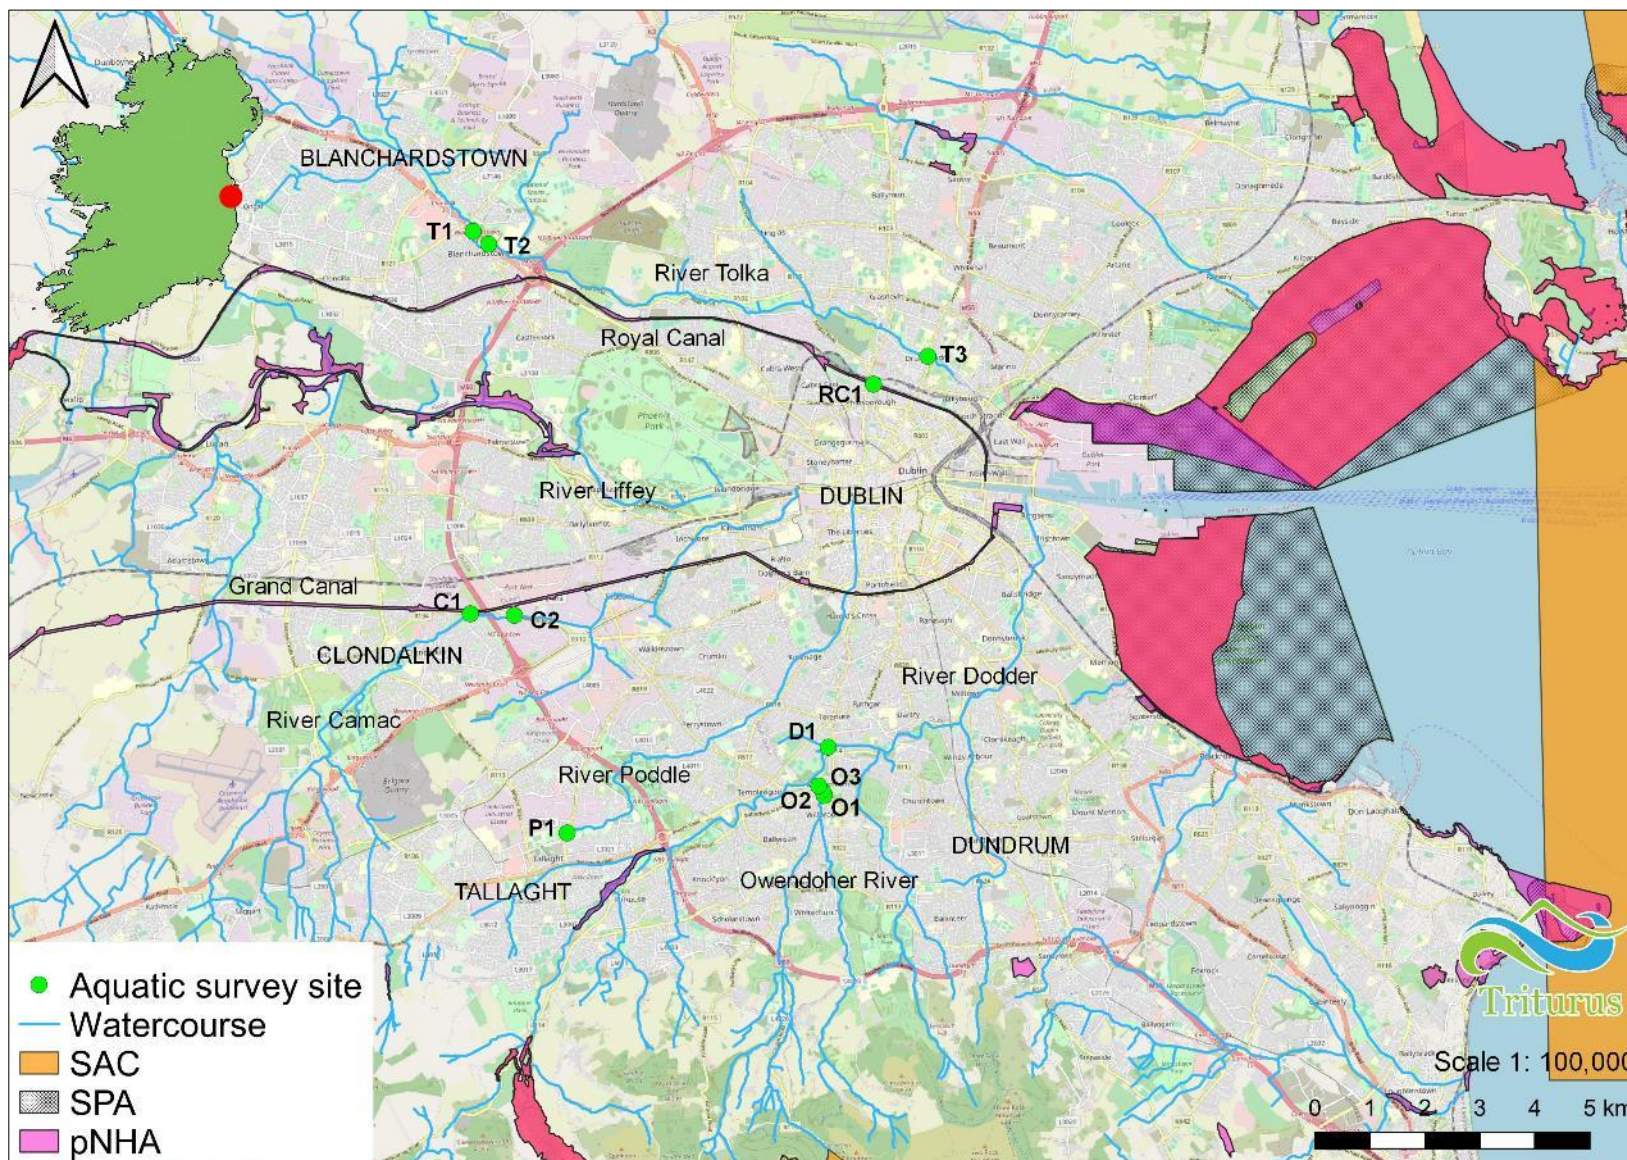
Figure 2.1 Location of aquatic sites surveyed to inform the Bus Connects project, Dublin City.

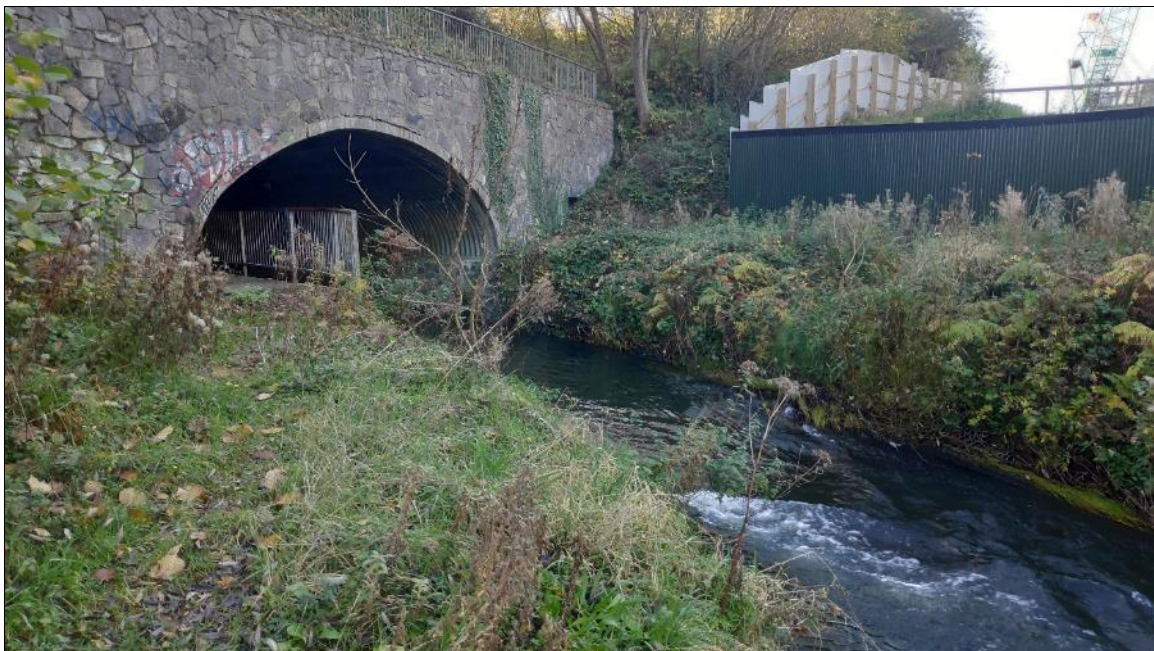
The River Tolka at site T2 was a semi-natural lowland depositing watercourse (FW2) with a swift flow and a well-defined thalweg downstream of the bridge crossing and associated culvert. Located approx. 0.5km downstream of site T1, the river profile was dominated by glide (50%) and riffle (40% area) with more localised pool 10%. The channel width was variable between 6m and 14m wide. The depth was also variable and recorded between 0.4m and 1.0m deep. The good semi-natural character for an urban river, however, was diminished by riverine substrata that were in poor condition due to siltation pressures. Furthermore, hydro-morphologically the river had been altered at the N3 crossing with the channel bed comprising of rendered concrete with little gravel or cobble deposition under the road crossing. Downstream of the culvert, the bed comprised bedrock, boulder and cobble with very localised pockets of medium and fine gravels. The substrata were very however, heavily bedded and covered by filamentous green algae (20% surface area cover, indicating enrichment). While the bed suffered from heavily siltation, the swift flows reduced the visible deposition levels on the visible instream substrata (as with other areas on the River Tolka). The macrophyte community comprised locally frequent watercress (*Rorippa nasturtium-aquaticum* agg.) and lesser water parsnip (*Berula erecta*) in the margins. The coarse substrata on the bed also supported *Cinclidotus fontinaloides* and *Platyhipnidium riparoides* locally. The riparian habitats supported mainly scrub habitat and rank grassy areas with frequent winter heliotrope, nettle, bramble (*Rubus fruticosus* agg.), bracken (*Pteridium aquilinum*), buddleja (*Buddleja davidii*), hemp agrimony (*Eupatorium cannabinum*), spear thistle (*Cirsium vulgare*) and hogweed (*Heracleum sphondylium*). The banks supported a few scattered mature crack willow (*Salix fragilis*), with a more mature treeline downstream of the survey area. The river upstream of the culvert was narrower, very fast flowing and heavily overgrown with scrub. Historical bank works were evident with gabion baskets present.

The river was considered a moderate brown trout nursery, with some localised deeper pools providing good holding habitat. Spawning habitat for both salmonids and lamprey was poor given substrata compaction and bedding. Swift flows largely precluded sediment deposition but some superficial silts were present marginally which provided some limited suitability for *Lampetra* sp. ammocoetes. European eel habitat was moderate overall albeit compaction of the bed and swift flows provided for less optimal refugia. White-clawed crayfish are not present in the River Tolka (no known records) and were not recorded during the survey. Regular otter spraint sites were recorded on the concrete path on the downstream side (ITM 708122, 738814) and upstream side of the culvert (ITM 708095, 738790).

The site T2 was found to be of moderate salmonid and European eel quality, with observable utilisation by otter.

Plate 3.2 Representative image of site T2 on the River Tolka (facing upstream towards culvert)

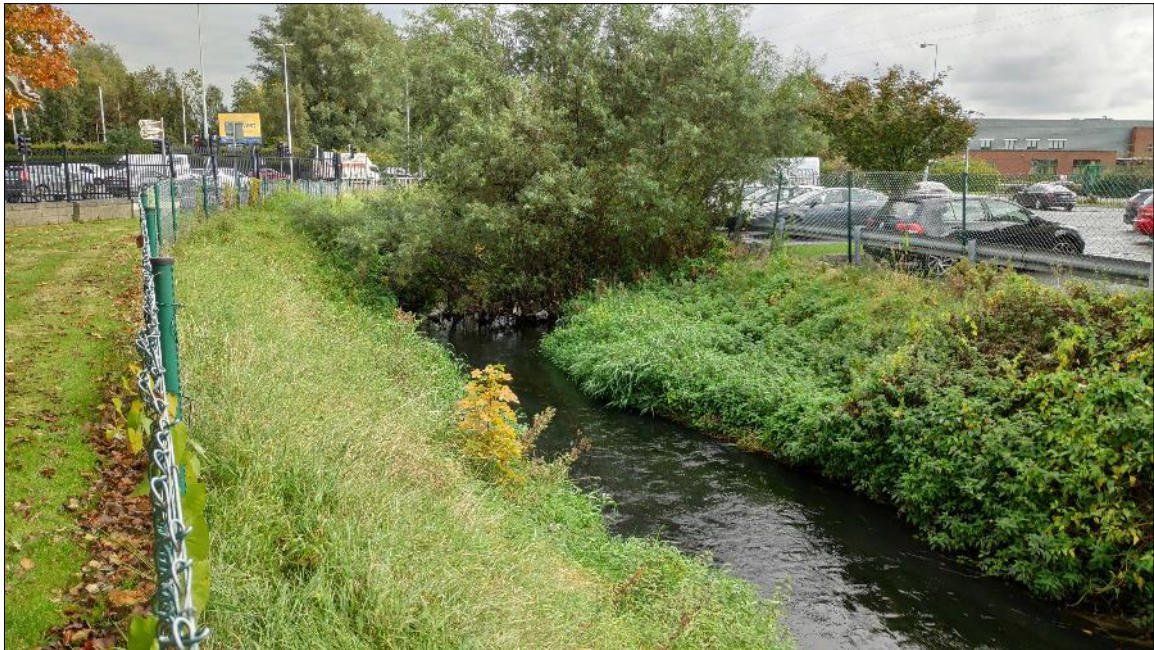
Site C2 offered some very good salmonid habitat (brown trout only). Upstream of the culvert provided excellent quality spawning and nursery habitat (among the best on the entire river) with very good holding habitat for abundant adult trout in undercut banks/under overhanging reed canary grass. A single mature crack willow immediately upstream of the culvert also provided an excellent deep holding pool for adult salmonids. Downstream, whilst spawning and nursery value was somewhat reduced, adult holding habitat was very good given undercut banks and prominent submerged tree roots (willow and sycamore). These also offered excellent refugia for white-clawed crayfish, which were recorded at 'moderate' densities (≥ 1 to < 3 per 10 refugia; Peay, 2003). A total of $n=8$ crayfish were recorded via sweep netting, with males, females and juveniles present, ranging from 19-41mm carapace length. Lamprey ammocoete habitat was present both upstream and downstream of the culvert, usually in association with instream macrophyte beds. European eel habitat was good throughout but better upstream. Despite known utilisation of the river and abundant prey resource, no otter signs were recorded during the site visit (few suitable marking sites present).

The presence of a healthy Annex II white-clawed crayfish population, in addition to excellent brown trout habitat and good lamprey habitat summarizes the key habitats found at this site.

Plate 3.10 Representative image of site C2 on the River Camac (upstream of the culvert)
