Appendix A14.1
Scheme Walkover
Summary

The following is a summary of the observations by the Land, Soils, Geology and Hydrogeology Environmental Impact Assessment Team following a physical walkover of the scheme. The walkover occurred on the 21 January 2020, 7 July 2021 and 16 January 2023. The drawings used to determine the type and extent of proposed works and in turn to inform the site walkovers were the General Arrangement drawings which are contained in Volume 3 of the EIAR.

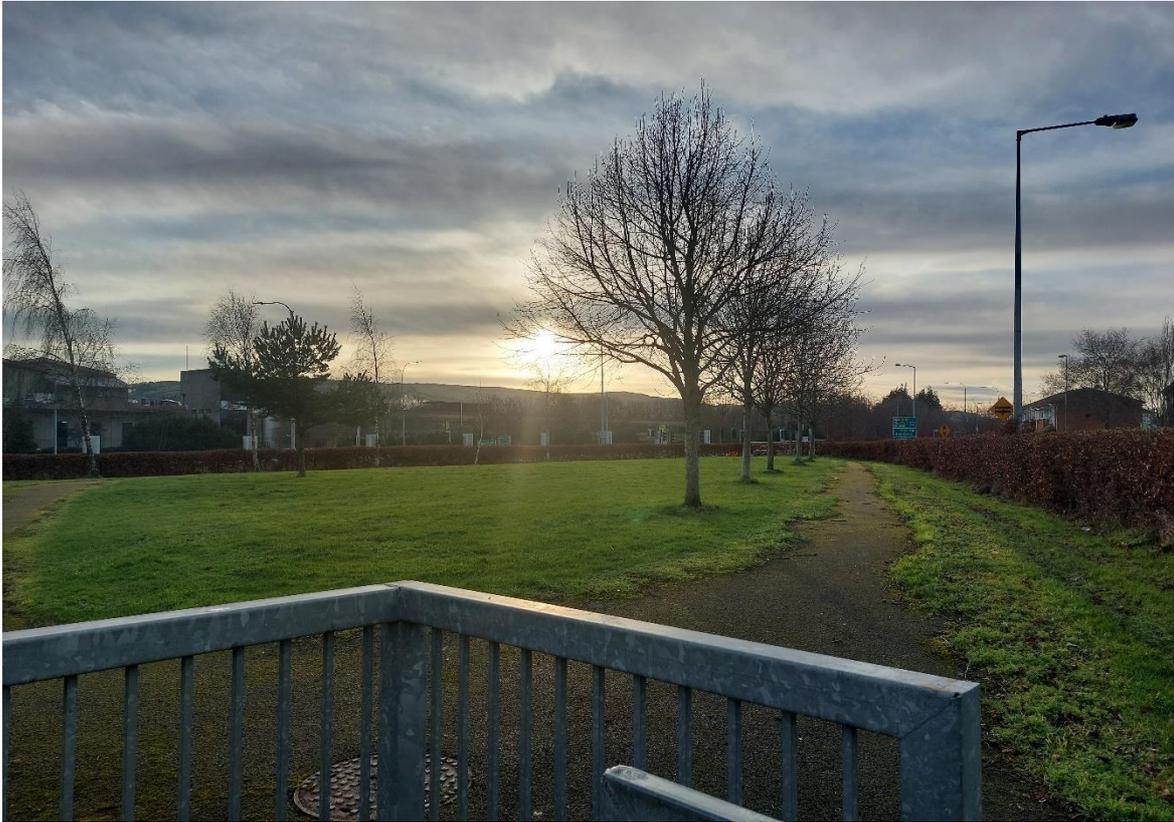
Photo ID	Caption	Date Taken	Coordinates
Tallaght / Clondalkin Image 01	A potential temporary Construction Compound is to be located at the western end of Old Blessington Road, adjacent to the junction with the N81 Tallaght bypass.	16/01/2023	708101 727280 (ITM)

Observation	General Arrangement Drawing Sheet Number *	Description	Possible Impact	Photo Number
Potential temporary Construction Compound	Sheet 1	A potential Construction Compound is to be located at the western end of Old Blessington Road, adjacent to the junction with the N81 Tallaght bypass. It is likely that the topsoil will be stripped, and level changes will be required at this location to accommodate the Construction Compound.	This may pose an issue for the earthworks balance and waste assessment.	Tallaght / Clondalkin Image 01
Potential temporary Construction Compound	Sheet 6	A potential Construction Compound is to be located at R819 Greenhills Road, immediately south of the junction of Bancroft Park and R819 Greenhills Road. It is likely that the topsoil will be stripped, and level changes will be required at this location to accommodate the Construction Compound.	This may pose an issue for the earthworks balance and waste assessment.	Tallaght / Clondalkin Image 02

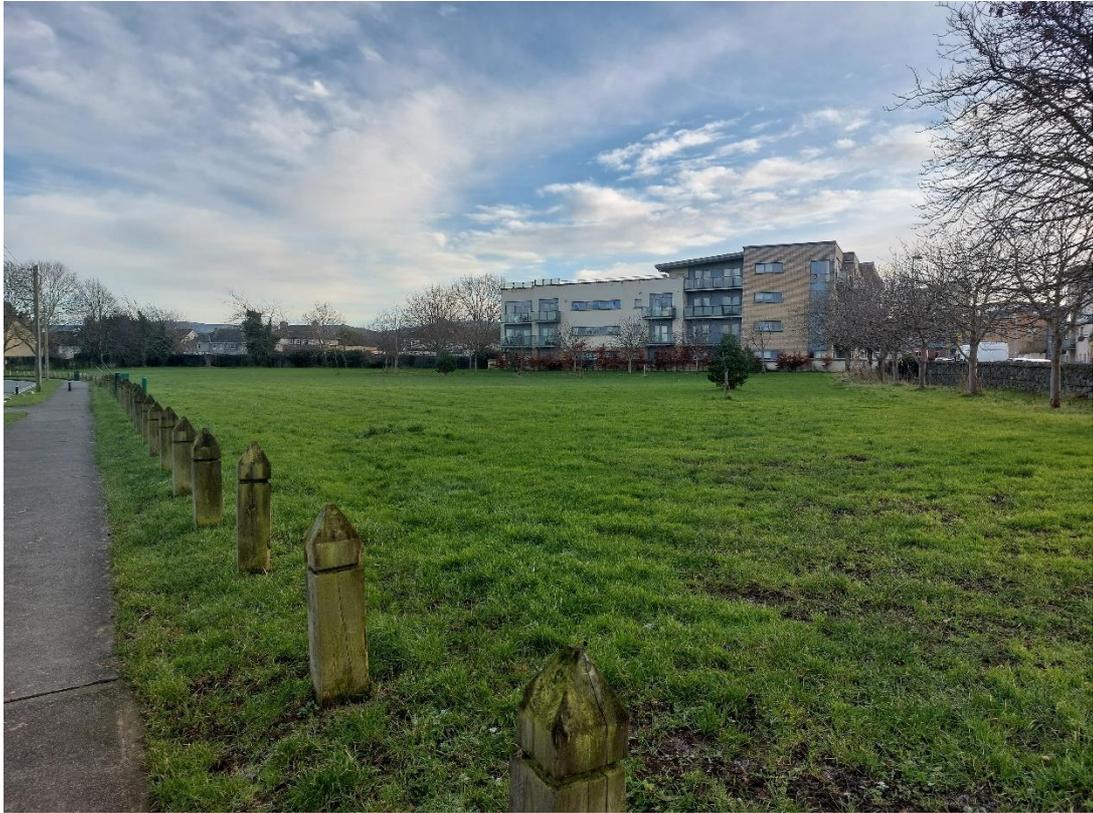
Photo ID	Caption	Date Taken	Coordinates
Tallaght / Clondalkin Image 02	A potential temporary Construction Compound is to be located at R819 Greenhills Road, immediately south of the junction of Bancroft Park and R819 Greenhills Road	16/01/2023	709499, 727862 (ITM)

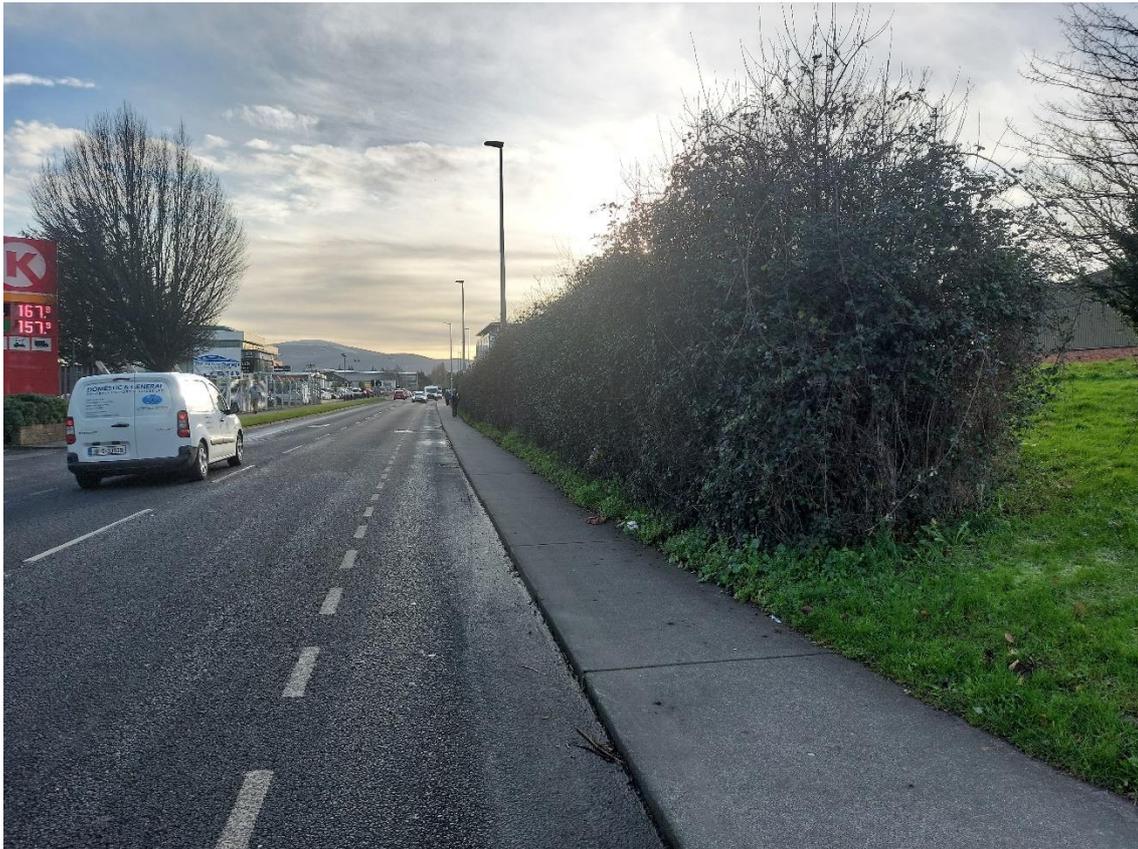
Photo ID	Caption	Date Taken	Coordinates
Tallaght / Clondalkin Image 03	Potential land acquisition for road widening at this location	16/01/2023	709684, 728557 (ITM)

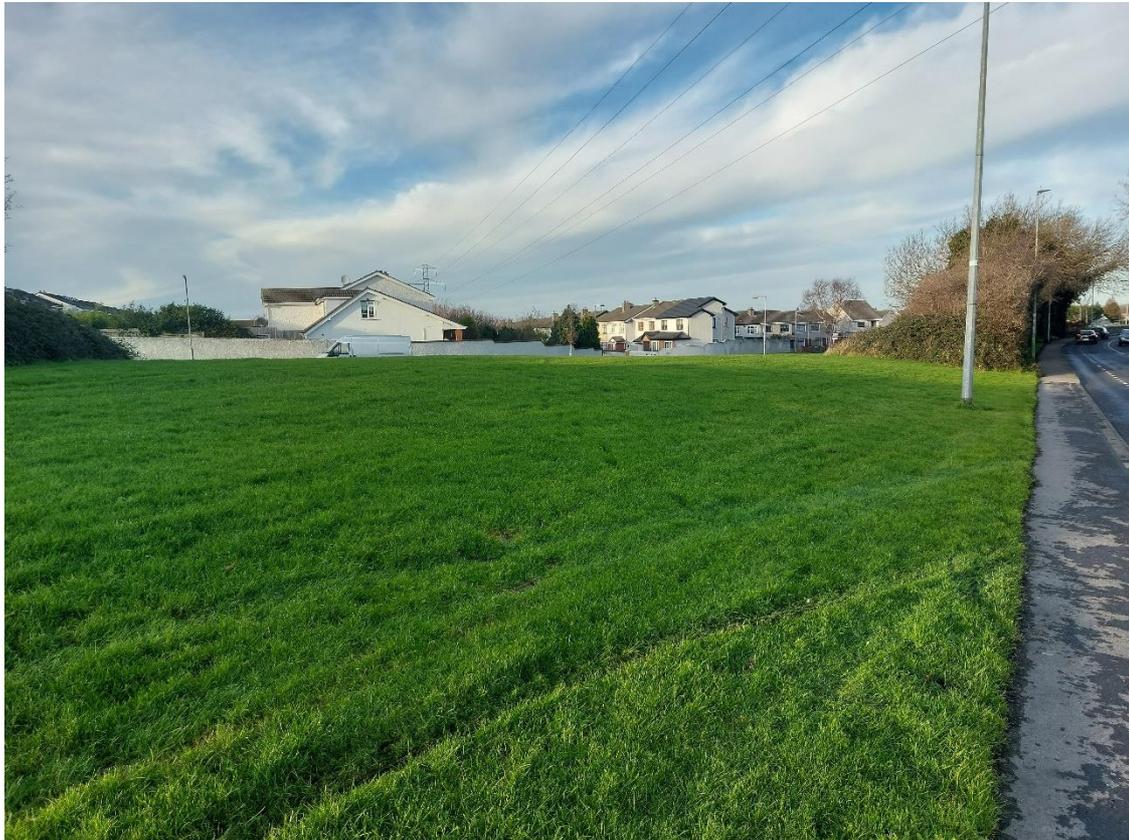
Photo ID	Caption	Date Taken	Coordinates
Tallaght / Clondalkin Image 04	A potential temporary Construction Compound is to be located at R819 Greenhills Road, between Birchview Avenue and R819 Greenhills Road.	16/01/2023	709738, 729048 (ITM)

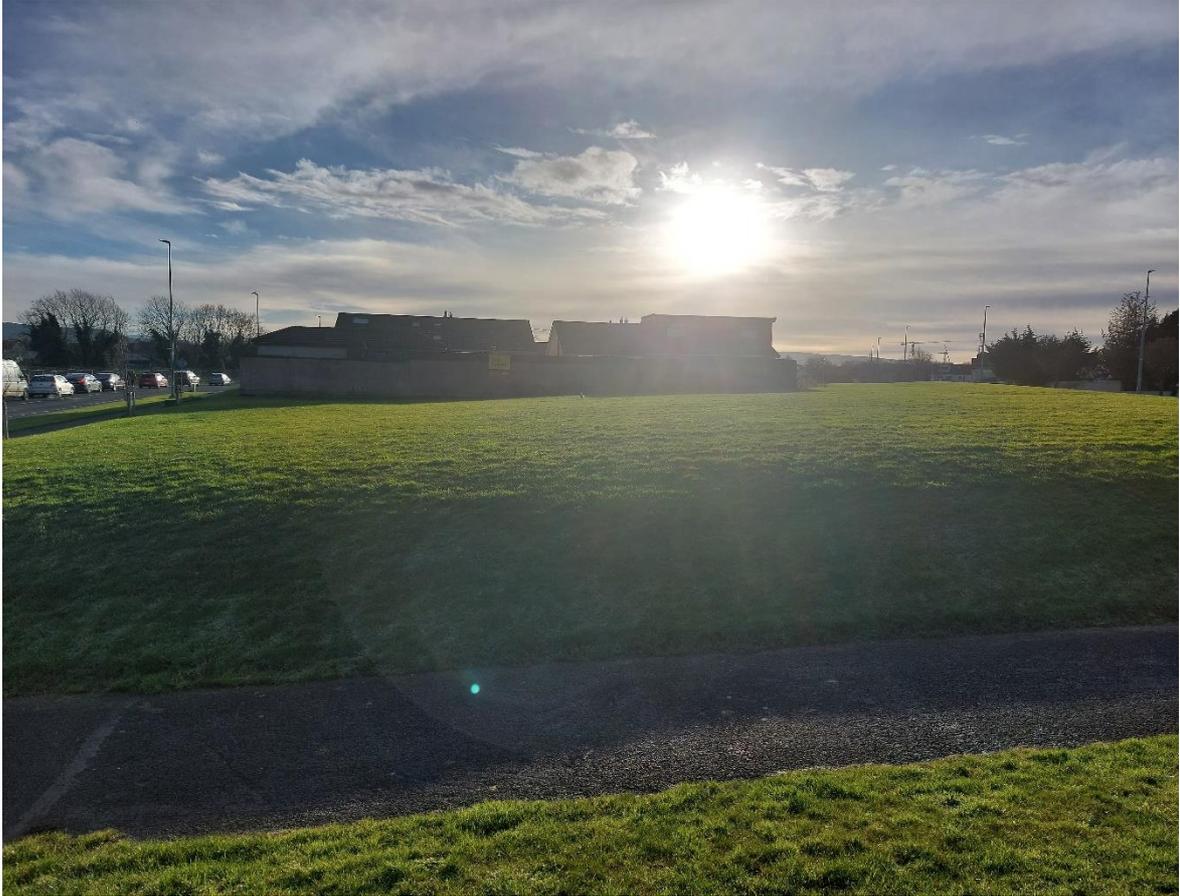
Photo ID	Caption	Date Taken	Coordinates
Tallaght / Clondalkin Image 05	A potential temporary Construction Compound is to be located at R819 Greenhills Road, between Treepark Road and R819 Greenhills Road.	16/01/2023	709851, 729353 (ITM)

Potential retaining wall	Sheet 9	Potential land acquisition for road widening at this location and the construction of a new retaining wall. It is likely that the topsoil will be stripped, and level changes will be required at this location.	This may pose an issue for the earthworks balance and waste assessment.	Tallaght / Clondalkin Image 03
Potential temporary Construction Compound	Sheet 10	A potential Construction Compound is to be located at R819 Greenhills Road, between Birchview Avenue and R819 Greenhills Road. It is likely that the topsoil will be stripped, and level changes will be required at this location to accommodate the Construction Compound.	This may pose an issue for the earthworks balance and waste assessment.	Tallaght / Clondalkin Image 04
Potential temporary Construction Compound	Sheet 11	A potential Construction Compound is to be located at R819 Greenhills Road, between Treepark Road and R819 Greenhills Road. It is likely that the topsoil will be stripped, and level changes will be required at this location to accommodate the Construction Compound.	This may pose an issue for the earthworks balance and waste assessment.	Tallaght / Clondalkin Image 05

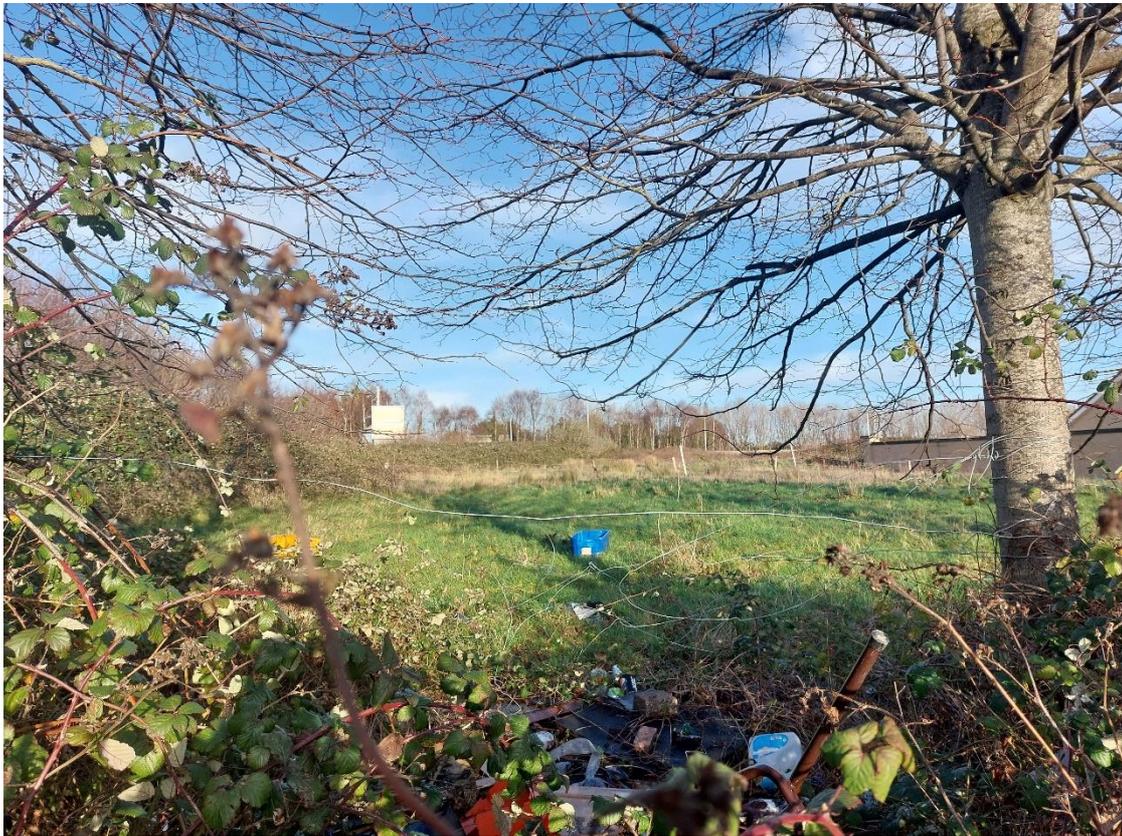
Photo ID	Caption	Date Taken	Coordinates
Tallaght / Clondalkin Image 06	A potential temporary Construction Compound is to be located at R819 Greenhills Road, to the north of Tymon Lane, south-east of the M50 Motorway.	16/01/2023	709937, 729453 (ITM)

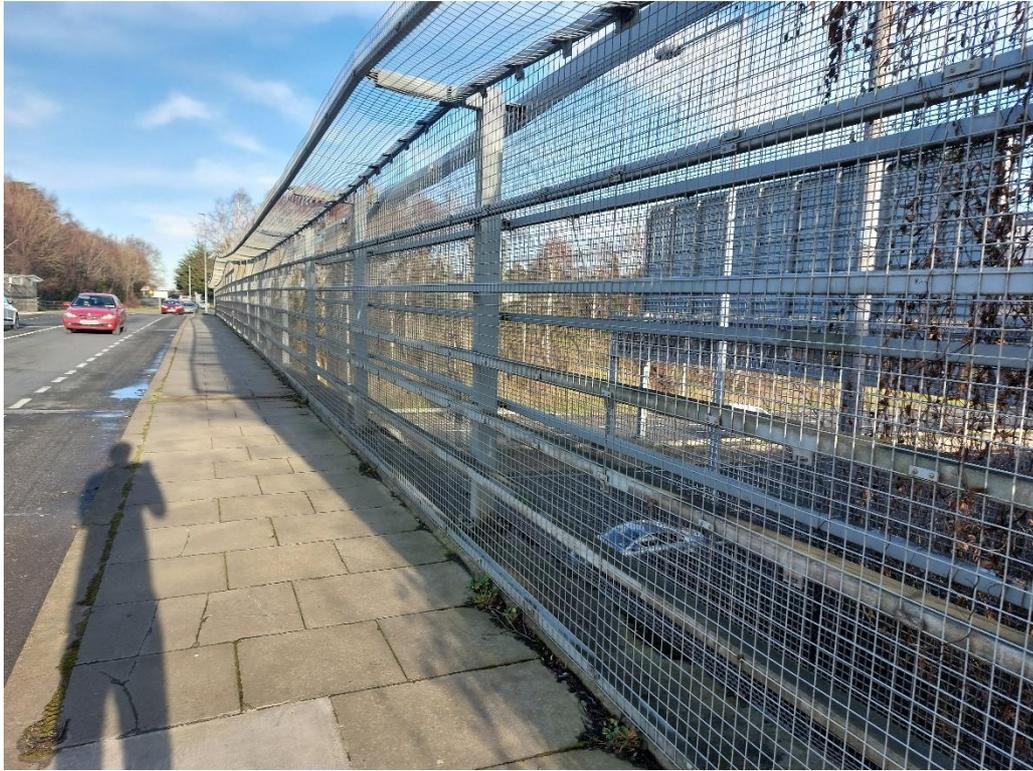
Photo ID	Caption	Date Taken	Coordinates
Tallaght / Clondalkin Image 07	Potential Pedestrian and cycle bridges	16/01/2023	709960, 729528 (ITM)

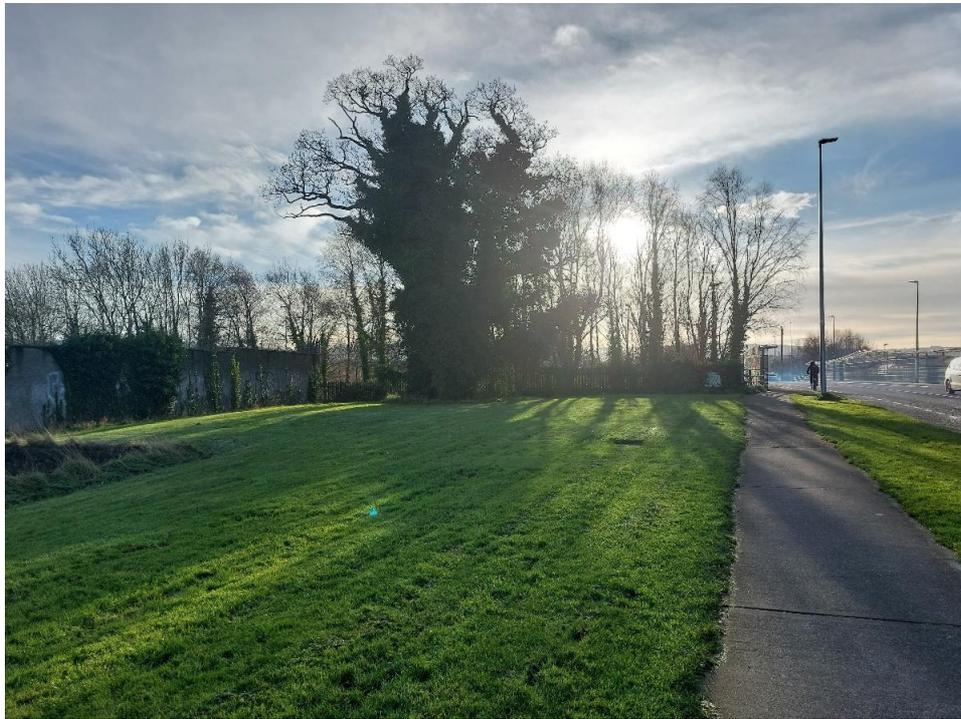
Photo ID	Caption	Date Taken	Coordinates
Tallaght / Clondalkin Image 08	A potential temporary Construction Compound is to be located at R819 Greenhills Road, outside Tallaght Truck Dismantlers, north-east of the M50 Motorway.	16/01/2023	710025, 729601 (ITM)

Potential temporary Construction Compound	Sheet 11	A potential Construction Compound is to be located at R819 Greenhills Road, to the north of Tymon Lane, south-east of the M50 Motorway. It is likely that the topsoil will be stripped, and level changes will be required at this location to accommodate the Construction Compound.	This may pose an issue for the earthworks balance and waste assessment.	Tallaght / Clondalkin Image 06
Potential Pedestrian and cycle bridges	Sheet 12	Significant earthworks are expected for the proposed new pedestrian and cycle bridges.	This may pose an issue for the earthworks balance and waste assessment	Tallaght / Clondalkin Image 07
Potential temporary Construction Compound	Sheets 12	A potential Construction Compound is to be located at R819 Greenhills Road, outside Tallaght Truck Dismantlers, north-east of the M50 Motorway. It is likely that the topsoil will be stripped, and level changes will be required at this location to accommodate the Construction Compound.	An earthwork retaining structure or cut / fill balance may be required to facilitate the works.	Tallaght / Clondalkin Image 08

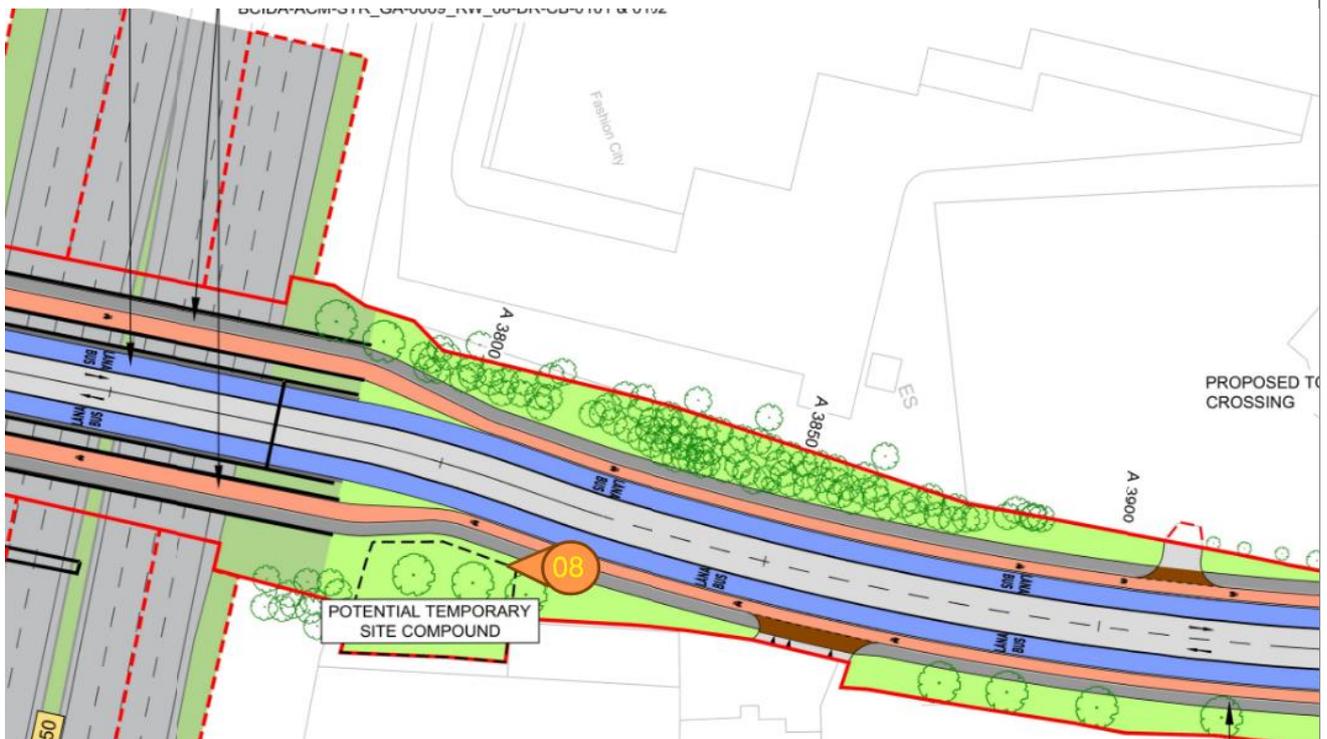
Photo ID	Caption	Date Taken	Coordinates
Tallaght / Clondalkin Image 09	A potential temporary Construction Compound is to be located at R819 Greenhills Road, between Ballymount Avenue and R819 Greenhills Road.	16/01/2023	710148, 729898 (ITM)

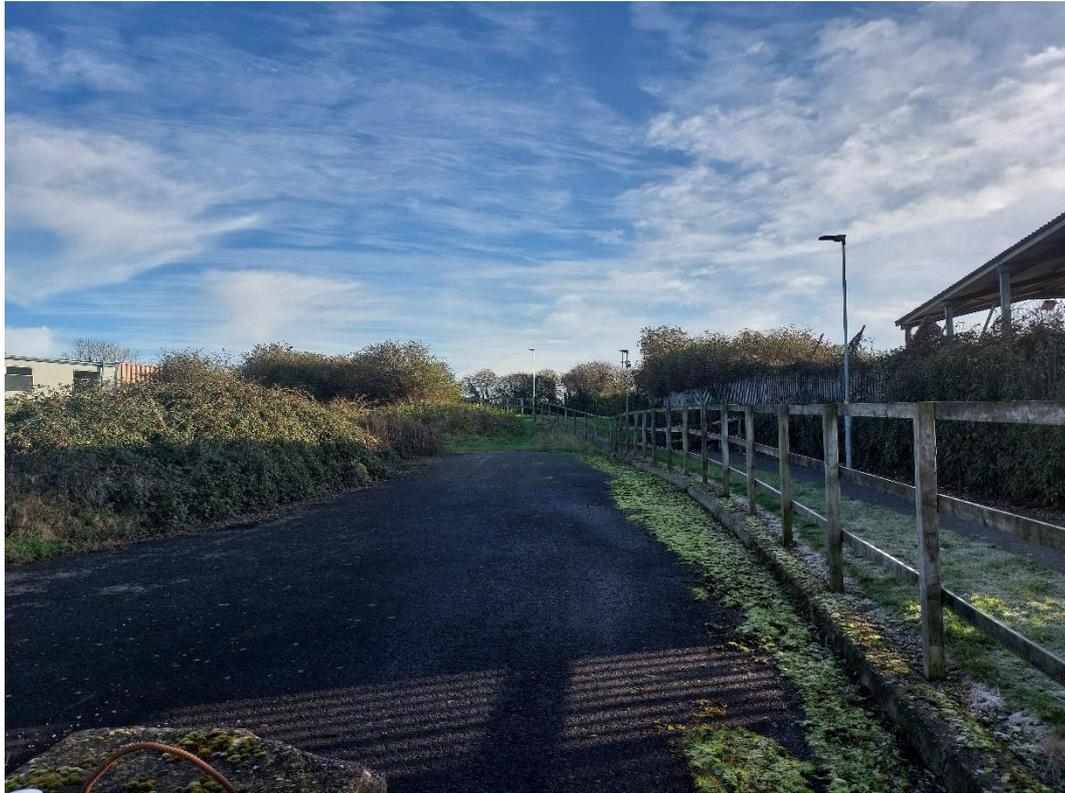
Photo ID	Caption	Date Taken	Coordinates
Tallaght / Clondalkin Image 10	Proposed new link road with retaining walls along Greenhills Road	16/01/2023	710347, 730321 (ITM)

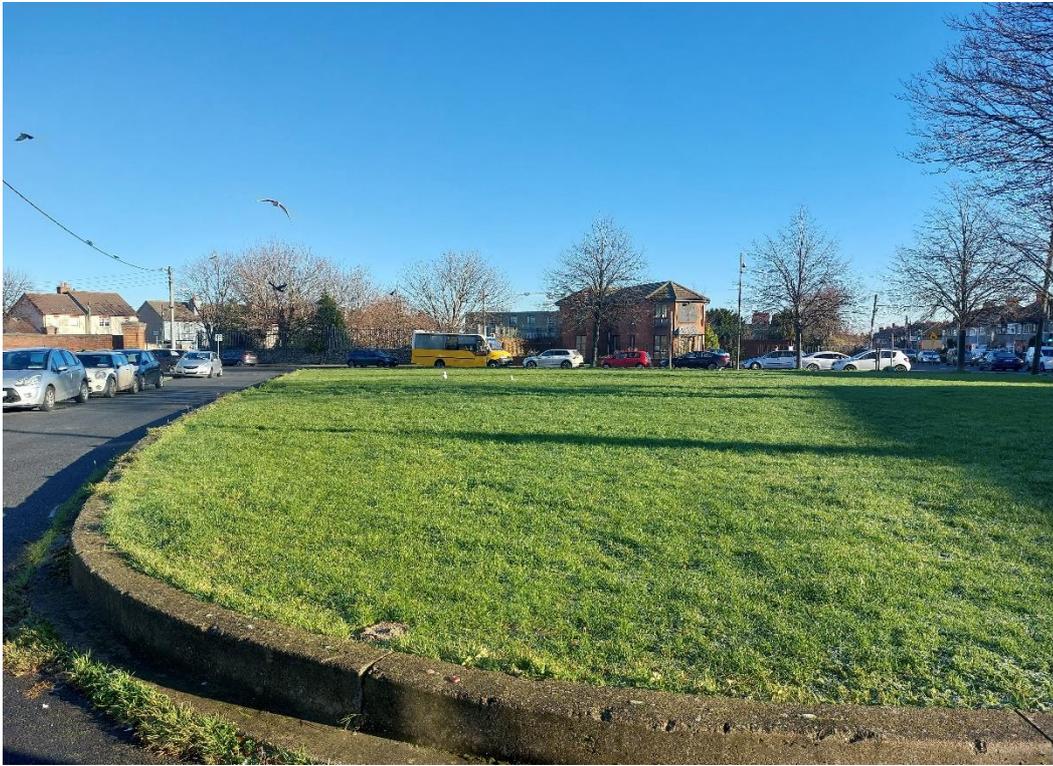
Photo ID	Caption	Date Taken	Coordinates
Tallaght / Clondalkin Image 13	A potential temporary Construction Compound is to be located at R110 Crumlin Road, immediately west of the junction of Rafter's Road and the R110 Crumlin Road.	16/01/2023	712273, 732033 (ITM)

Observation	General Arrangement Drawing Sheet Number *	Description	Possible Impact	Photo Number
		wells. Minor earthworks and level changes will be required to facilitate the works.		
Proposed retaining wall	Sheet 22	Potential new retaining wall along the Long Mile Road near Slievebloom Road. Minor earthworks and level changes will be required to facilitate the works	This may pose an issue for the earthworks balance and waste assessment.	Tallaght / Clondalkin Image 12
Potential temporary Construction Compound	Sheet 24	A potential Construction Compound is to be located at R110 Crumlin Road, immediately west of the junction of Rafter's Road and the R110 Crumlin Road. It is likely that the topsoil will be stripped, and level changes will be required at this location to accommodate the Construction Compound.	This may pose an issue for the earthworks balance and waste assessment.	Tallaght / Clondalkin Image 13

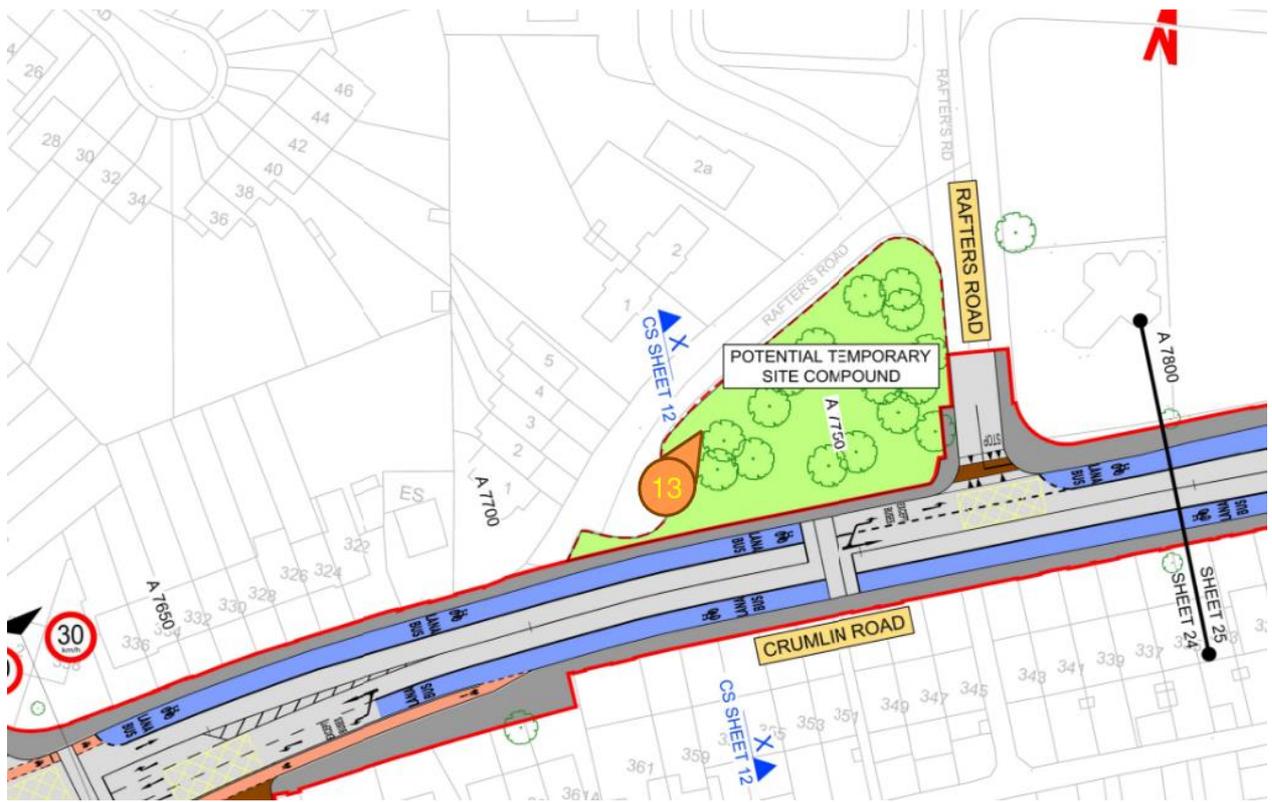
Photo ID	Caption	Date Taken	Coordinates
Tallaght / Clondalkin Image 14	A potential temporary Construction Compound is to be located at R110 Crumlin Road, immediately east of the junction of Rutland Avenue and the R110 Crumlin Road.	16/01/2023	713665, 732631 (ITM)

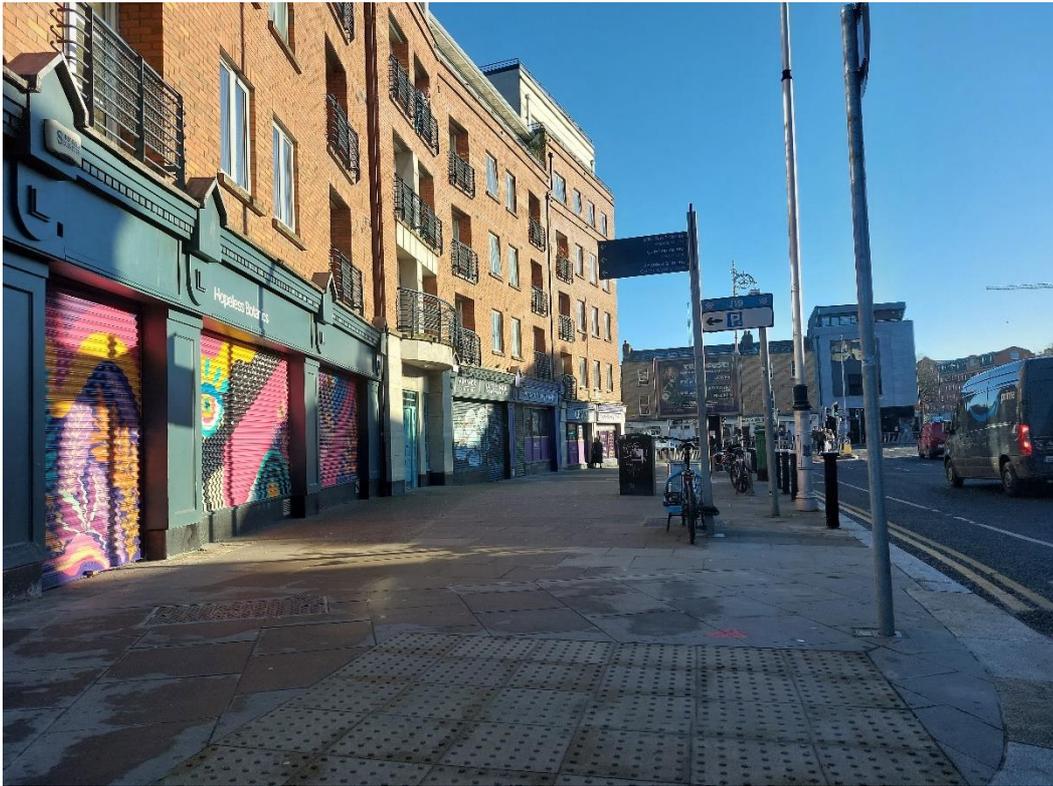
Photo ID	Caption	Date Taken	Coordinates
Tallaght / Clondalkin Image 15	A potential temporary Construction Compound Dean Street / R137 Patrick Street.	16/01/2023	714982, 733503 (ITM)

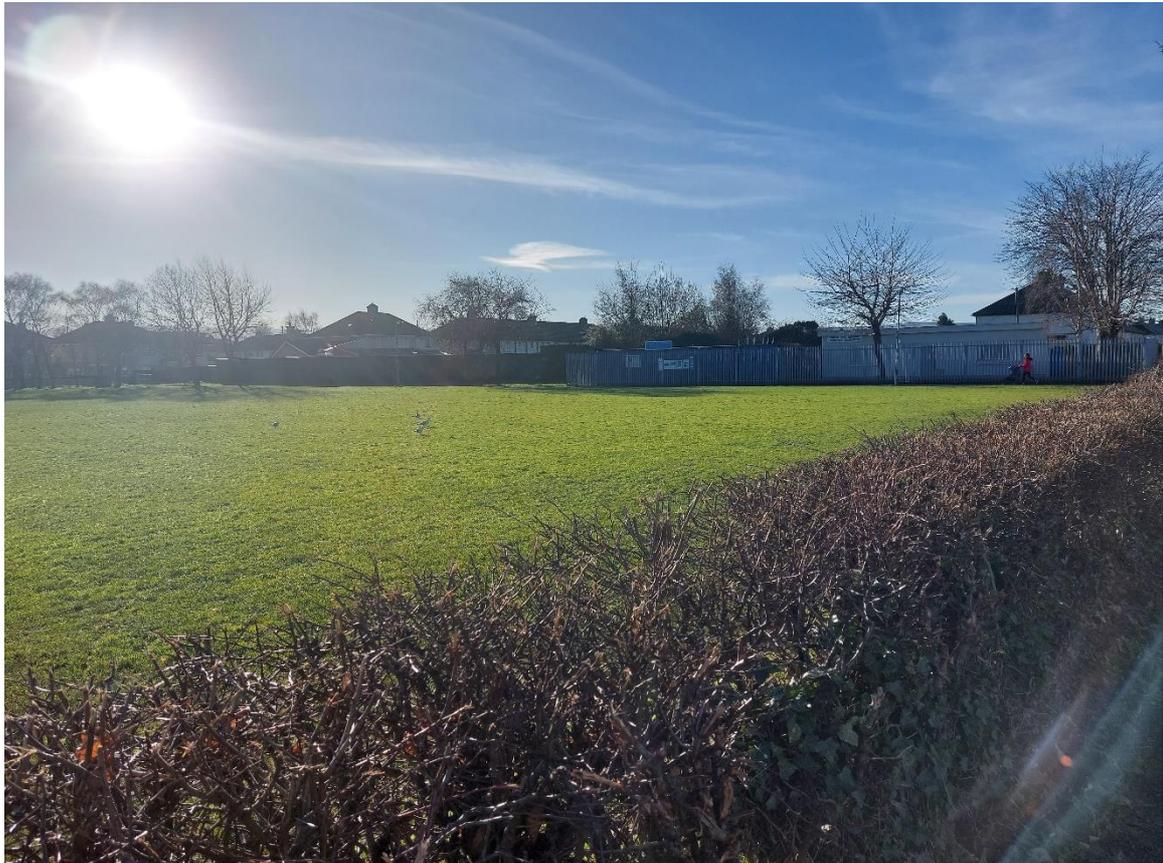
Photo ID	Caption	Date Taken	Coordinates
Tallaght / Clondalkin Image 16	A potential temporary Construction Compound at Bunting Park, along Bunting Road.	16/01/2023	711611, 731356 (ITM)

Potential temporary Construction Compound	Sheet 28	A potential Construction Compound is to be located at R110 Crumlin Road, immediately east of the junction of Rutland Avenue and the R110 Crumlin Road. It is likely that the topsoil will be stripped, and level changes will be required at this location to accommodate the Construction Compound.	This may pose an issue as the river could be a pathway for contamination to the underlying aquifer.	Tallaght / Clondalkin Image 14
Potential temporary Construction Compound	Sheets 33	A potential Construction Compound is to be located at Dean Street / R137 Patrick Street.	It may require an earthworks cut/fill balance if it interacts with this feature.	Tallaght / Clondalkin Image 15
Potential temporary Construction Compound	Sheet 36	A potential Construction Compound is to be located at Bunting Park, along Bunting Road. It is likely that the topsoil will be stripped, and level changes will be required at this location to accommodate the Construction Compound.	This may pose an issue for the earthworks balance and waste assessment	Tallaght / Clondalkin Image 16

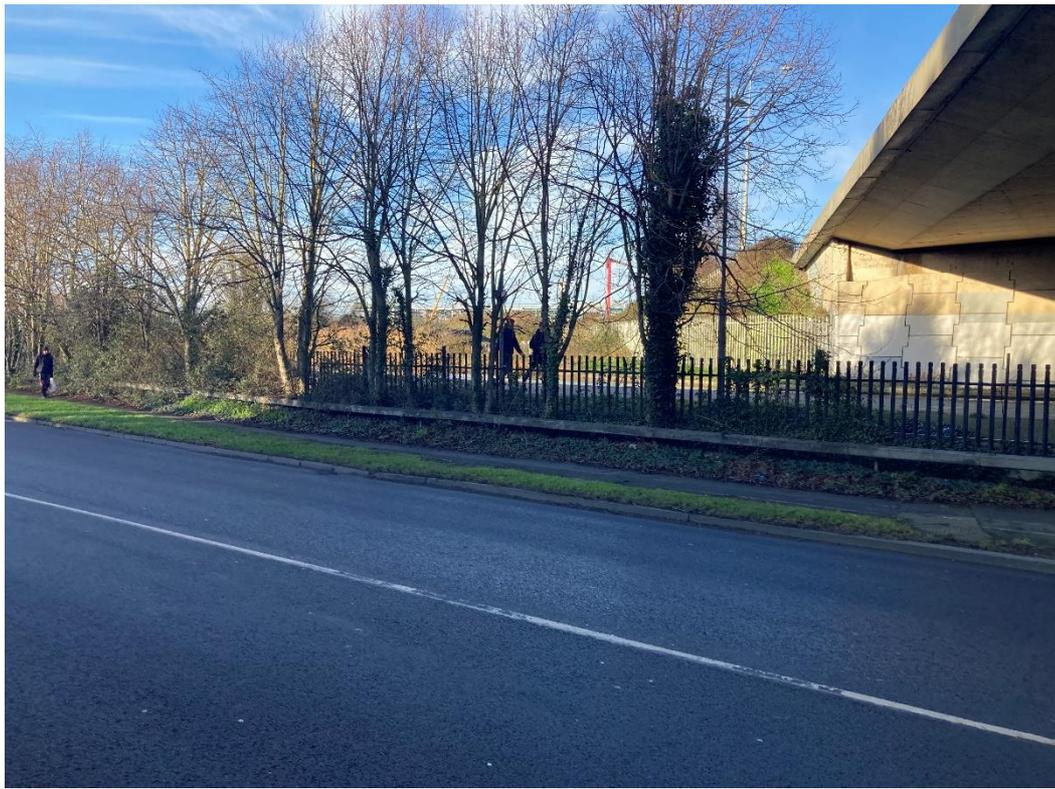
Photo ID	Caption	Date Taken	Coordinates
Tallaght / Clondalkin Image 17	Potential connection to Grand Canal Greenway	16/01/2023	708047, 732104 (ITM)

Proposed connection to Grand Canal Greenway	Sheet 46	Potential removal of a grass verge and trees to connect with the Grand Canal Greenway. Minor earthworks and level changes are expected to accommodate the works.	This may pose an issue for the earthworks balance and waste assessment	Tallaght / Clondalkin Image 17
Potential interaction with Cammock River	Sheet 48	Land acquisition is noted at this location. Minor earthworks and level changes may be required.	This may pose an issue as the river could be a pathway for contamination to the underlying aquifer.	Tallaght / Clondalkin Image 18
Potential Road Widening	Sheet 48	Potential land acquisition along the New Nangor Road. Minor earthworks and level changes will be required to facilitate the works.	This may pose an issue for the earthworks balance and waste assessment	Tallaght / Clondalkin Image 19
Potential temporary Construction Compound	Sheet 50	A potential Construction Compound is to be located between R134 New Nangor Road and Killeen Road. Potential retaining wall also at this location. Minor earthworks and topsoil stripped are expected to accommodate the works.	This may pose an issue for the earthworks balance and waste assessment	Tallaght / Clondalkin Image 20

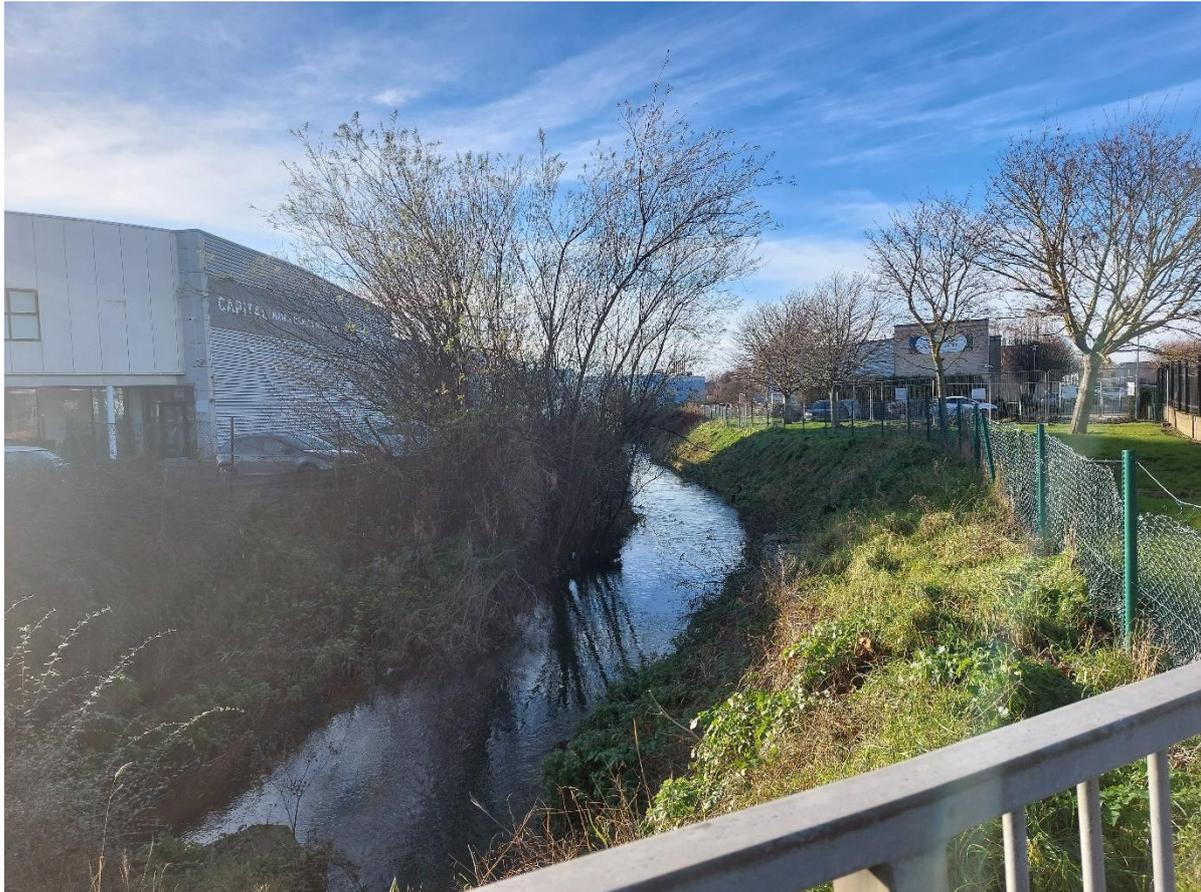
Photo ID	Caption	Date Taken	Coordinates
Tallaght / Clondalkin Image 18	Potential interaction with Cammock River	16/01/2023	708561, 732049 (ITM)

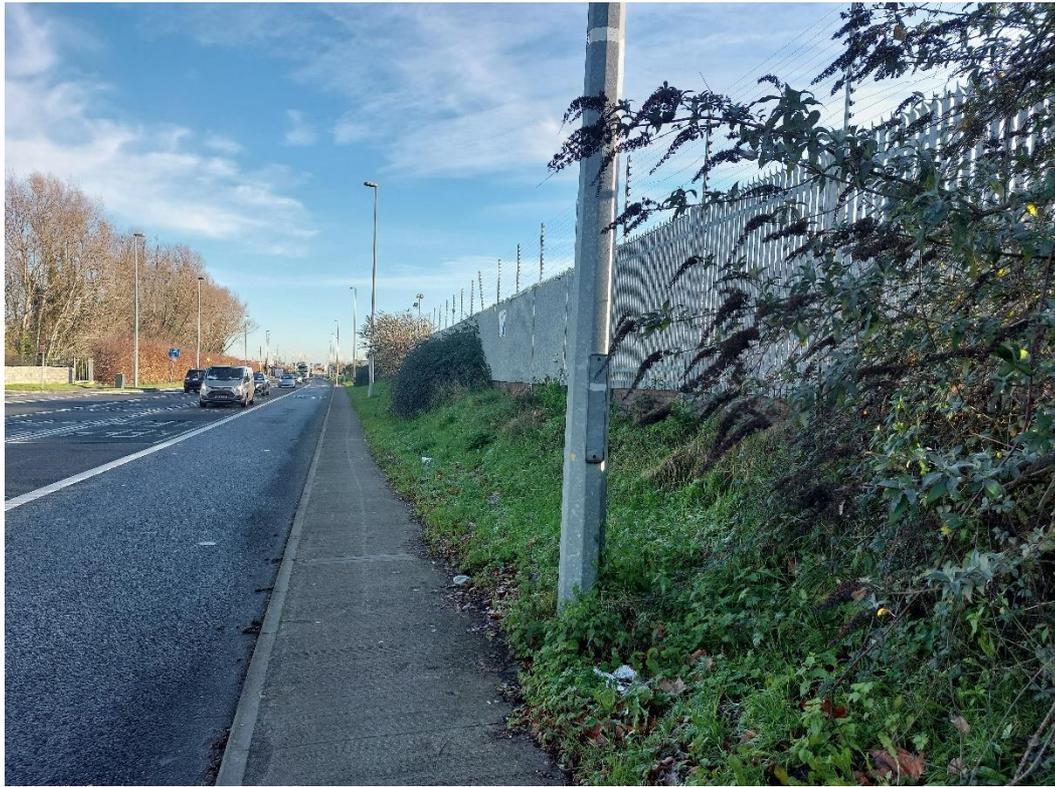
Photo ID	Caption	Date Taken	Coordinates
Tallaght / Clondalkin Image 19	Potential road widening New Nangor Road	16/01/2023	709049, 731955 (ITM)

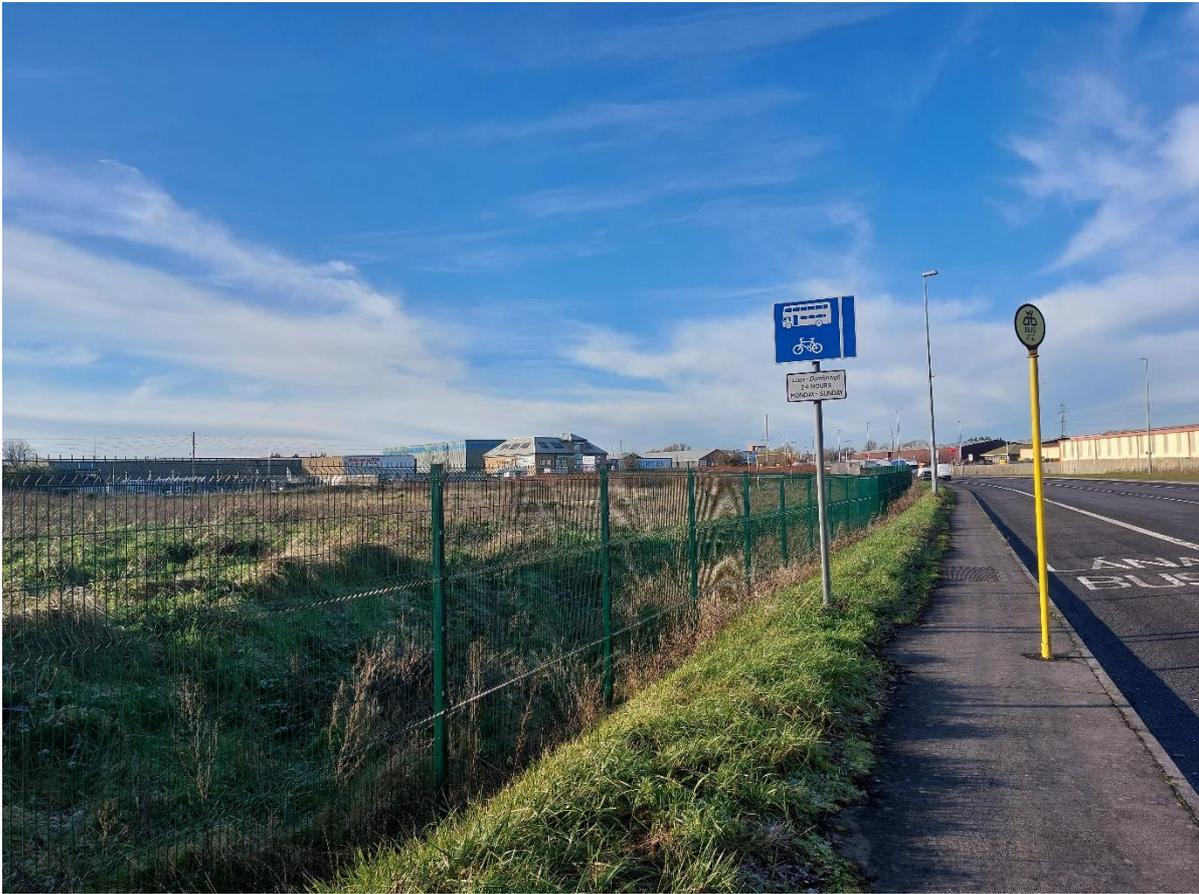
Photo ID	Caption	Date Taken	Coordinates
Tallaght / Clondalkin Image 20	Potential temporary Construction Compound Between R134 New Nangor Road and Killeen Road.	16/01/2023	709567, 731762 (ITM)

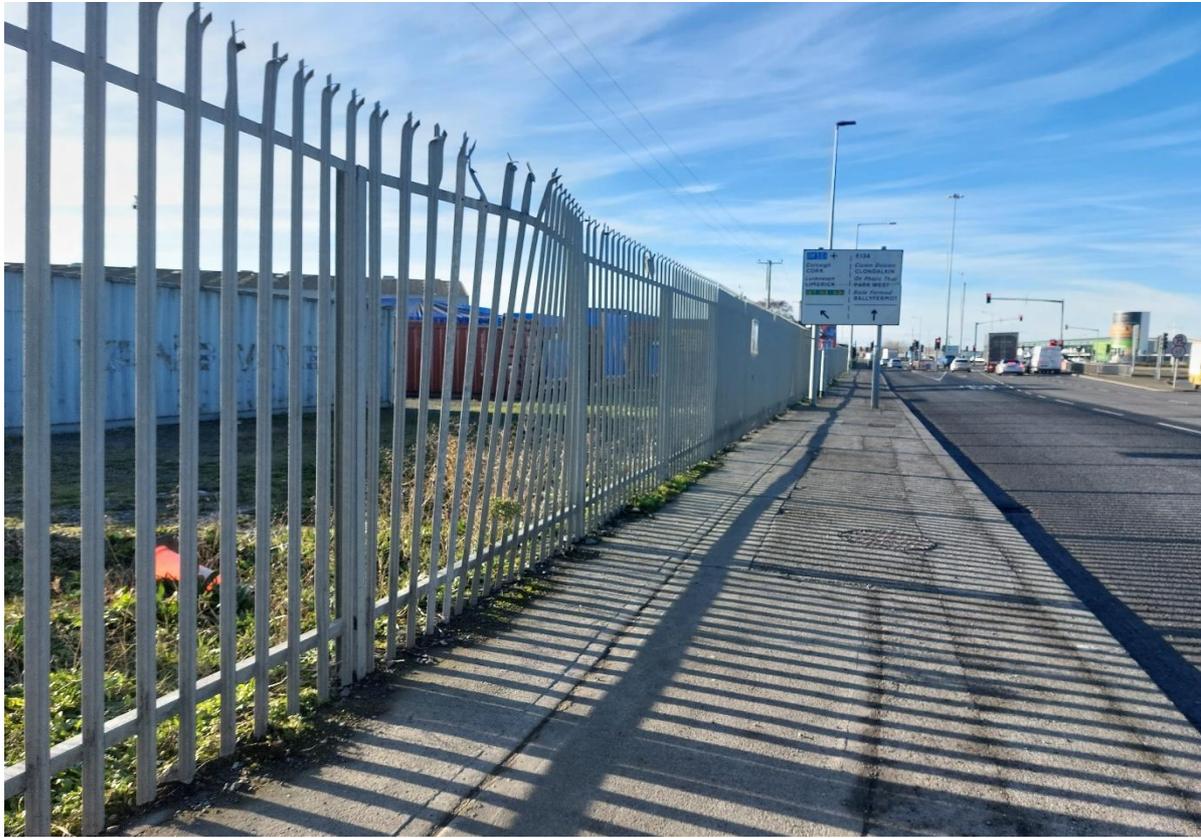
Photo ID	Caption	Date Taken	Coordinates
Tallaght / Clondalkin Image 22	Potential temporary Construction Compound on R110 Long Mile Road, south of the New Nangor Road / Naas Road / Long Mile Road junction.	16/01/2023	709889, 731607 (ITM)
