**Appendix A15.1**  
Previous Archaeological  
Investigations in the  
Vicinity of the Proposed  
Scheme

## **Appendix A15.1: Previous Archaeological Investigations in the Vicinity of the Proposed Scheme**

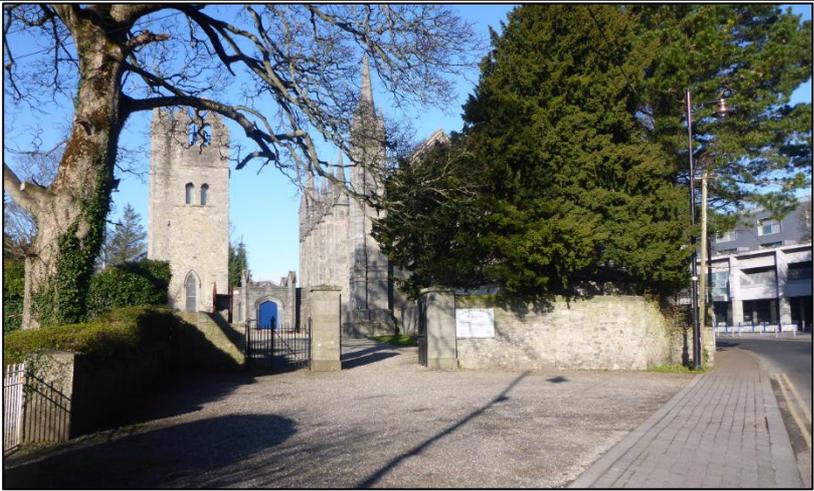
St. Maelruain's Church, facing north-west

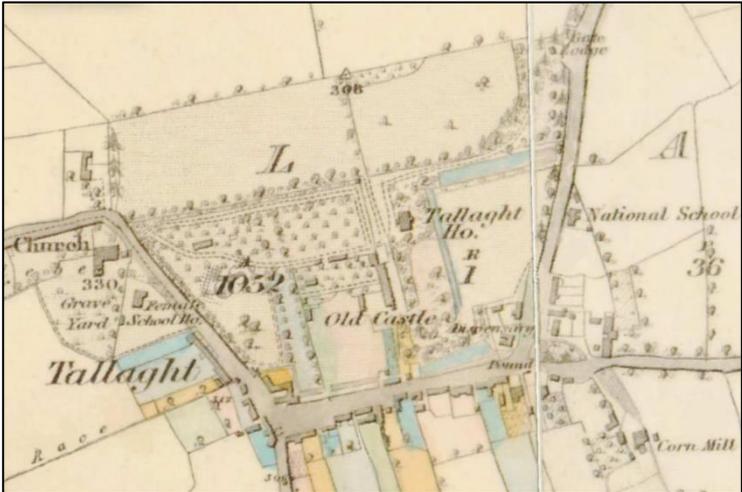
<p>First edition OS map, 1843, showing Tallaght village (OSI 2020)</p>
<p><b>Impact of scheme</b></p>	<p>No impact</p>
<p><b>Proposed mitigation</b></p>	<p>None required</p>
<p><b>Approx. distance</b></p>	<p>0m</p>
<p><b>Photography</b></p>

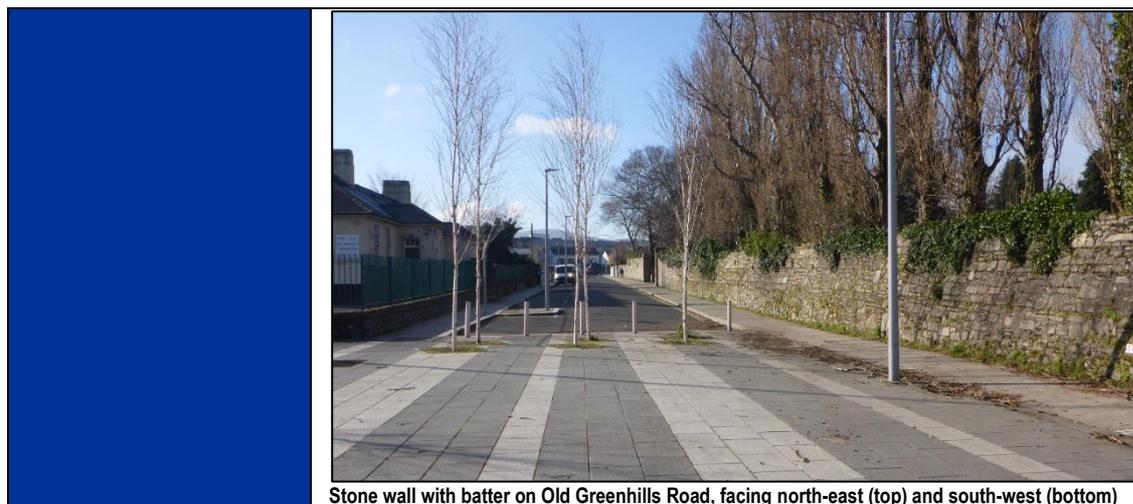
Stone wall with batter on Old Greenhills Road, facing north-east (top) and south-west (bottom)

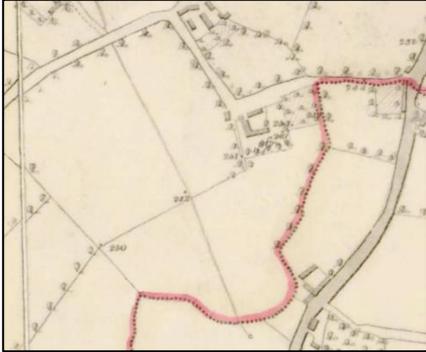
<p>First edition OS six-inch map (1843; OSI 2020) showing line of ecclesiastical enclosure (DU022-005005) and possible annexe following the townland boundary (in red; east to south-west) and field boundary (north-east)</p>

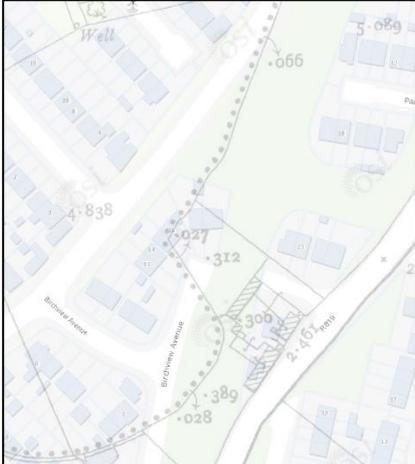
<p>Revised edition OS 25-inch map (1906-09) overlaid onto modern OS (OSI 2020), showing line of ecclesiastical enclosure (DU022-005005) and possible annexe running through greenfield area proposed for Greenhills Road realignment</p>

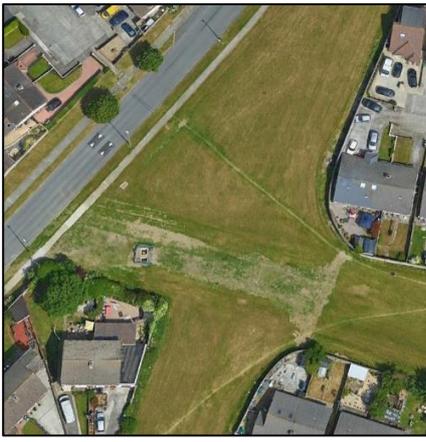
<p>There is some evidence for recent disturbance in this area (Google Earth imagery 29/5/2018); Treepark Road is on the top-left in the image</p>
<p><b>Impact of scheme</b></p>	<p>Negative, Slight, Permanent</p>	
<p><b>Proposed mitigation</b></p>	<p>The monitoring of topsoil-stripping across this whole area will be carried out as an archaeological exercise.</p>

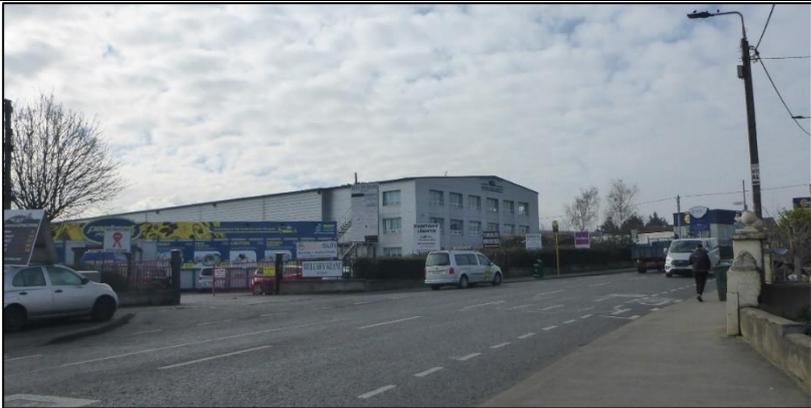
**View towards site of flat cemetery in Greenhills Industrial Estate, facing south / south-west**

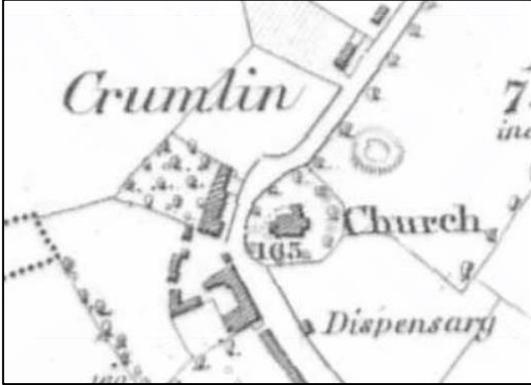
<p>OS six-inch map, first edition 1843, showing houses opposite St Mary's Church (OSI 2020)</p>

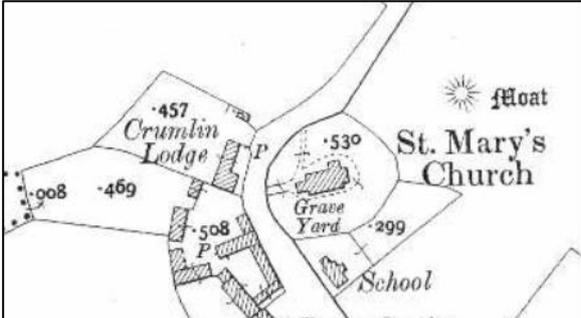
<p>OS 25-inch map, revised edition 1908, showing Crumlin Lodge (OSI 2020)</p>

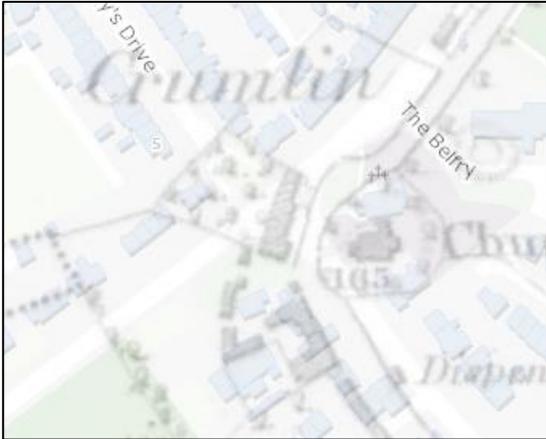
<p>OS six-inch map, first edition 1843, overlaid onto modern aerial imagery (OSI 2020)</p>
<b>Impact of scheme</b>	Negative, Slight, Permanent
<b>Proposed mitigation</b>	Archaeological monitoring
<b>Approx. distance</b>	0m

<b>Identification No.</b>	CBC0809AH002
<b>Legal Status</b>	None
<b>Townland / Street Address</b>	Bunting Road
<b>Site Type</b>	18 <sup>th</sup> / 19 <sup>th</sup> century house (site of)
<b>ITM</b>	711925, 731604
<b>Description</b>	House depicted on the first edition OS six-inch map (1843; OSI 2020) on the outskirts of Crumlin village on the west / north-west side of the road curving around St Mary's Church (at the junction of Bunting Road and St Mary's Road). Named as Crumlin Lodge on the 25-inch OS map of 1908 and OS revised edition six-inch map of 1940. Destroyed during the construction of Bunting Road and the new housing along it in the mid-20 <sup>th</sup> century. It is possible that remains of the house foundations may survive below-ground, despite the disturbances during the during the construction of Bunting Road. Ground-breaking works at this location will impact on any remains that survive below ground. The house site has a low sensitivity value and the magnitude of impact is medium, resulting in a slight impact.

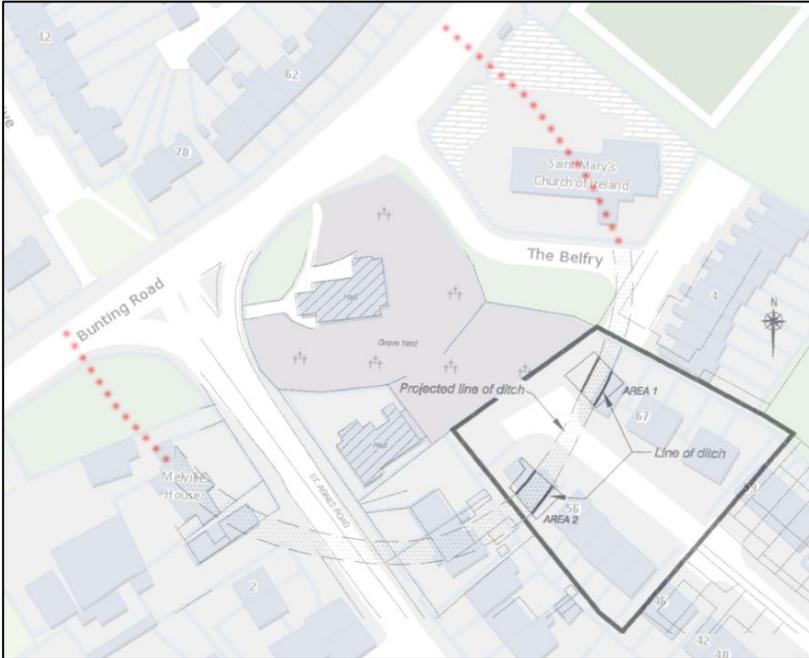
<p><b>Figure 3 in Murphy 2000 showing projected line of enclosing ditch, overlaid onto modern OS with the line projected further to its possible intersection with Bunting Road (OSI 2020)</b></p>
<b>Impact of scheme</b>	Negative, Significant, Permanent
<b>Proposed mitigation</b>	Archaeological monitoring

<b>Approx. distance</b>	Adjacent wall of graveyard – potential that the ditch of the outer enclosure survives beneath the existing road
<b>Photography</b>

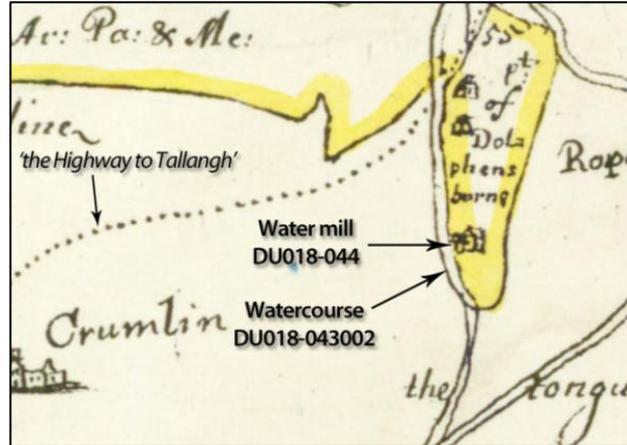
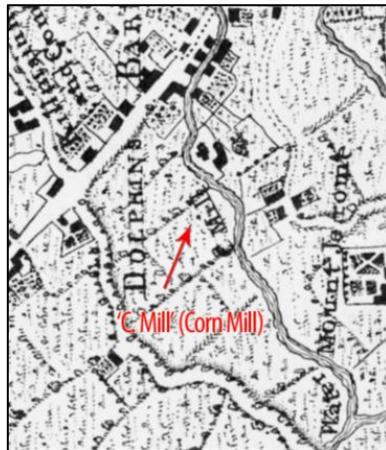
Recorded water mill and watercourse on the Down Survey map c. 1656 (top) (TCD 2013) and Rocque's map of County Dublin 1760 (bottom) (Ferguson 1998)

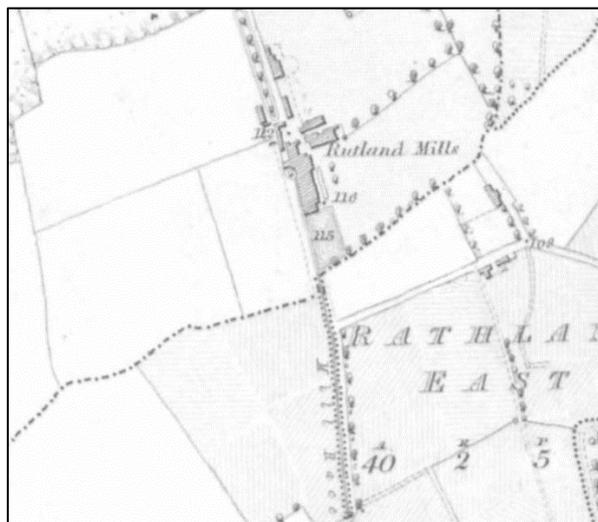
First edition OS six-inch map (1843) (OSI 2020), showing Rutland Mills and mill race

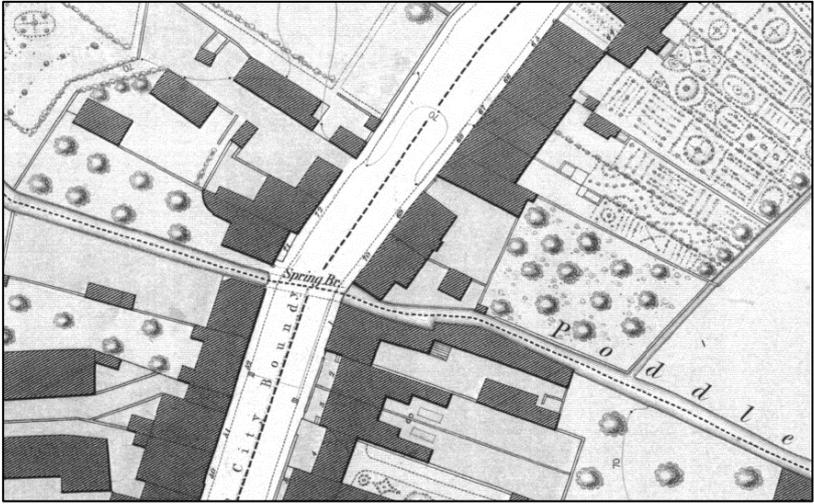
<b>OS five foot plan, 1847, showing Spring Bridge (UCD 2020)</b>
<b>Impact of scheme</b>	Excavated site
<b>Proposed mitigation</b>	No impact
<b>Approx. distance</b>	Within Proposed Scheme
<b>Photography</b>	n/a

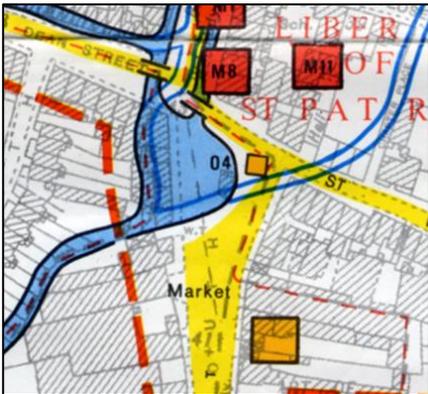
<p>FMD map (Clarke 1978), showing mill pond at junction of New Street South and Patrick Street</p>
<b>Impact of scheme</b>	Negative, Moderate, Permanent
<b>Proposed mitigation</b>	Archaeological monitoring
<b>Approx. distance</b>	Within Proposed Scheme
<b>Photography</b>	n/a

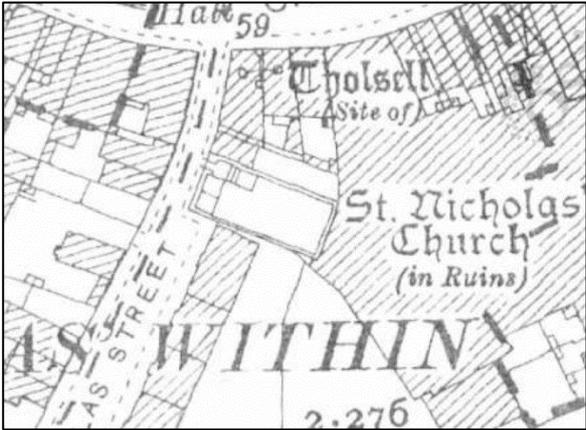
<p>OS 25-inch map (1907 to 09) showing widening of street to south (OSI 2020)</p>

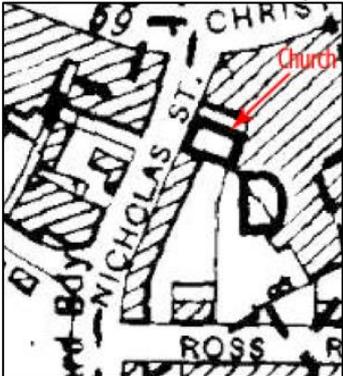
<p>OS six-inch map (1935 to 38) showing widening of north end of Nicholas Street and part-removal of church building (OSI 2020)</p>
<p><b>Impact of scheme</b></p>	<p>Negative, Moderate, Permanent</p>
<p><b>Proposed mitigation</b></p>	<p>Archaeological monitoring</p>
<p><b>Approx. distance</b></p>	<p>0m</p>

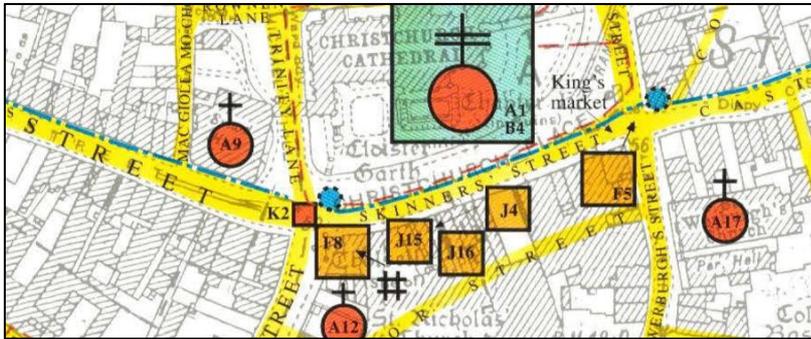
<p><b>FMD map (Clarke 2002), showing watercourse (dashed blue line)</b></p>
<b>Impact</b>	Negative, Moderate, Permanent
<b>Proposed mitigation</b>	Archaeological monitoring

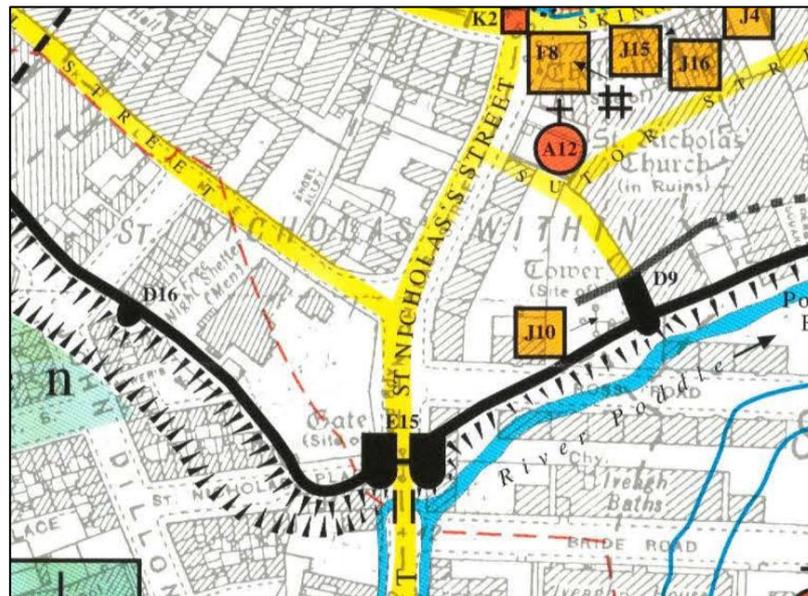
FMD map (Clarke 1978), showing the city wall (solid black line) and gateway (St Nicholas' Gate) at Nicholas Street and Town Ditch outside the wall

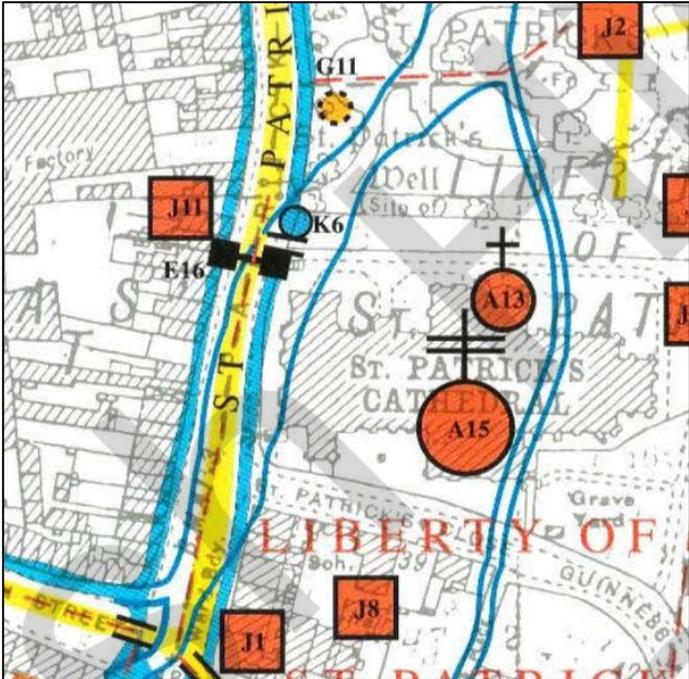
<p>FMD map (Clarke 1978), showing the city wall (solid black line) and gateway (St Patrick's Gate, E16)</p>

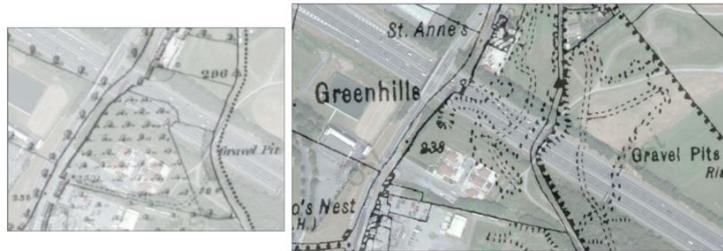
<p>First Edition OS Six-Inch Map of 1843 (Left) and Revised Edition OS Six-Inch Map of 1935-38 (Right) Overlaid on to Modern Aerial Imagery (OSI 2020), showing gravel pits at Construction Compound TC5</p>
<b>Impact</b>	Negative, Slight, Permanent
<b>Proposed mitigation</b>	Archaeological monitoring
<b>Approx. distance</b>	Within Proposed Scheme
<b>Photography</b>	n/a

<b>Identification No.</b>	Compound TC5
<b>Legal Status</b>	N/A
<b>Townland / Street Address</b>	Greenhills Road
<b>Site Type</b>	N/A
<b>ITM</b>	710000 729467
<b>Description</b>	A Construction Compound is proposed on the east side of R819 Greenhills Road, north of Tymon Lane and The Cuckoo's Nest public house. This is a small greenfield site, part of a former arable field that is now partly occupied by houses built in the early 2000s. A review of historic OS mapping revealed that the field was under tree plantation at the time of the first edition OS six-inch map (1843), with gravel pits depicted in the northern half on the revised edition OS six-inch map of 1935-38. Whether or not the quarrying subsequently extended further into the field is not known. Although no specific potential was identified, and as the extent of previous disturbance is uncertain, it is possible that previously unknown archaeological features or deposits may be present below ground. There is a potential that ground-breaking works will uncover previously unknown archaeological features or deposits. The site has a low sensitivity value and the magnitude of impact is medium, therefore the predicted impact is Negative, Slight and Permanent.

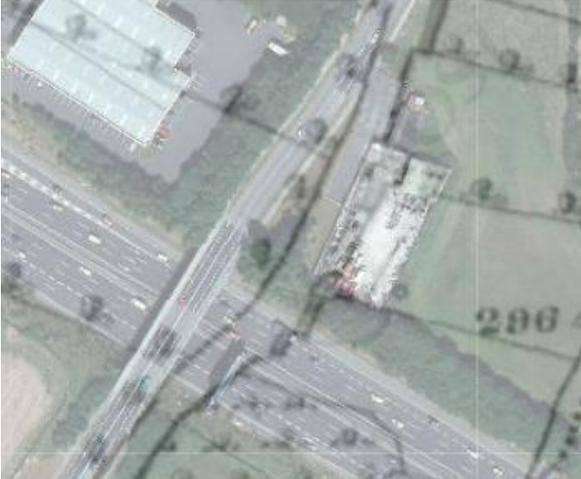
<p><b>First Edition OS Six-Inch Map of 1843 Overlaid on to Modern Aerial Imagery (OSI 2020), showing old Greenhills Road at Construction Compound TC6</b></p>
<b>Impact</b>	Negative, Slight, Permanent
<b>Proposed mitigation</b>	Archaeological monitoring
<b>Approx. distance</b>	Within Proposed Scheme
<b>Photography</b>	n/a

<b>Identification No.</b>	Compound TC6
<b>Legal Status</b>	N/A
<b>Townland / Street Address</b>	Greenhills Road
<b>Site Type</b>	N/A
<b>ITM</b>	710020 729573
<b>Description</b>	A Construction Compound is proposed at a green space along R819 Greenhills Road, outside Tallaght Truck Dismantlers, north-east of the M50 Motorway. A review of historic OS mapping revealed that western edge of the old Greenhills Road once ran through part of this site, as evident on the first edition OS six-inch map (1843). No other features of interest are depicted within the proposed compound site. Previously unknown archaeological features or deposits may survive below the present surface and may be uncovered by ground-breaking works. The site has a low sensitivity value and the magnitude of impact is medium, therefore the predicted impact is Negative, Slight and Permanent.
<b>Sources</b>	OSI 2020. Google Earth Pro 2001 to 2018.

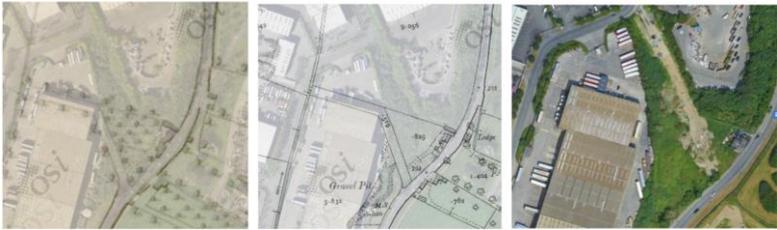
<p><b>First Edition OS Six-Inch Map of 1843 (Left) and OS 25-Inch Map of 1905-07 (Centre) Overlaid on to Modern Aerial Imagery (OSI 2020), and Aerial Imagery 2018 (Right), showing farmstead at Construction Compound TC7</b></p>
<b>Impact</b>	Negative, Slight, Permanent

<b>Identification No.</b>	Compound TC7 (CBC0809AH005)
<b>Legal Status</b>	N/A
<b>Townland / Street Address</b>	New Ballymount Avenue / Greenhills Road
<b>Site Type</b>	18th / 19th century structures (site of)
<b>ITM</b>	710200 729964
<b>Description</b>	<p>A Construction Compound is proposed on the R819 Greenhills Road, between Ballymount Avenue and R819 Greenhills Road. Although currently under grass and scrub, this site was at least partly disturbed during advance construction works for the New Ballymount Avenue road, an extension connecting Ballymount Avenue with Greenhills Road that is as yet unfinished. A review of historic OS mapping revealed that the southern half of the site was part of a small orchard associated with a farm property located at the roadside. The property contained two building ranges at the time of the first edition OS six-inch map of 1843, comprising a house (possibly with attached outbuildings) to the south and separate outbuilding to the north. The southernmost building range had been replaced by a smaller house by the time of the 25-inch map of 1905-07 and a single-storey house survives today at the same location, though the northern outbuilding is no longer present (both lie outside the compound site to the north). The now demolished building to the south of the existing house is located within the area previously disturbed, however, whether the disturbance extended beyond a topsoil strip is unknown and it is possible that subsurface remains survive (CBC0809AH005). It is also possible that previously unknown archaeological features or deposits may be present below ground. There is a potential that ground-breaking works will uncover previously unknown archaeological features or deposits. The site has a low sensitivity value and the magnitude of impact is medium, therefore the predicted impact is Negative, Slight and Permanent.</p>

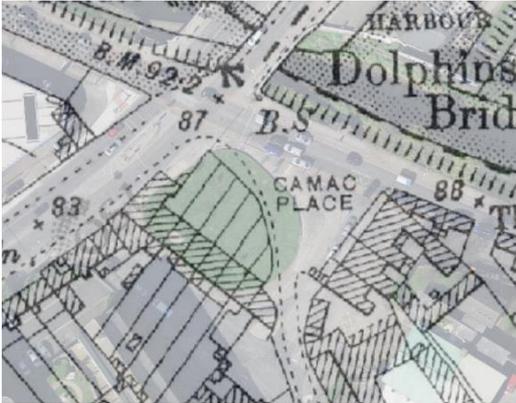
<p>OS 25-Inch Map of 1905-07 Overlaid on to Modern Aerial Imagery (OSI 2020), showing houses at Camac Place</p>
<b>Impact</b>	Negative, Slight, Permanent
<b>Proposed mitigation</b>	Archaeological monitoring
<b>Approx. distance</b>	Within Proposed Scheme
<b>Photography</b>	n/a

<b>Identification No.</b>	Compound TC10 (CBC0809AH007)
<b>Legal Status</b>	N/A
<b>Townland / Street Address</b>	Parnell Road / Rutland Avenue
<b>Site Type</b>	18 <sup>th</sup> / 19 <sup>th</sup> century structure (site of)
<b>ITM</b>	713686 732622
<b>Description</b>	<p>A Construction Compound is proposed on R110 Crumlin Road, immediately east of the junction of Rutland Avenue and the R110 Crumlin Road, in a hard surface area adjacent a small green space. A review of historic OS mapping indicates that a row of terraced houses with gardens to the rear occupied the present green area, at what was then called Camac Place, extending slightly into the proposed compound location. The houses, which first appear on the 25-inch OS map of 1905-07, had been cleared by the time of the revised edition OS six-inch map of 1935-38. Aerial imagery shows no subsequent changes to the site. It is likely that the 19th century house building – one of which lies within the compound site – and the construction of the 18th century canal to the north, would have resulted in considerable ground disturbance within the site, which would have reduced the general archaeological potential here. Nonetheless, it is possible that foundations of the house may survive subsurface. There is also a potential that ground-breaking works will uncover previously unknown archaeological features or deposits. The site has a low sensitivity value and the magnitude of impact is medium, therefore the predicted impact is Negative, Slight and Permanent.</p>

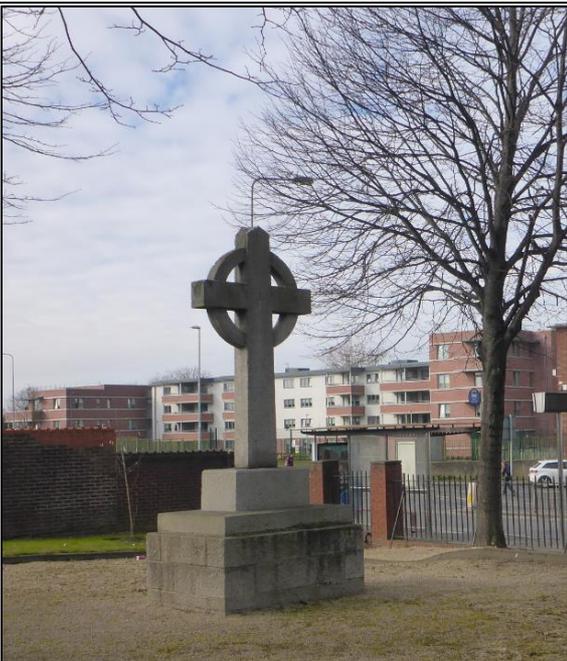
<p>Stone cross, facing east towards Dolphin's Barn Street</p>

<p>OS five-foot plan (1864) (left) and OS five-foot plan (1847) (right)</p>
<b>Impact of scheme</b>	Negative, Slight, Temporary
<b>Proposed mitigation</b>	The cross will be protected from any adverse impacts during construction works and if necessary for its protection, it will be removed under archaeological supervision. This will be undertaken in accordance with a method statement agreed with the statutory authorities. It will be returned to its current setting and as close as possible to its current location following completion of the works.
<b>Approx. distance</b>	0m
<b>Photography</b>

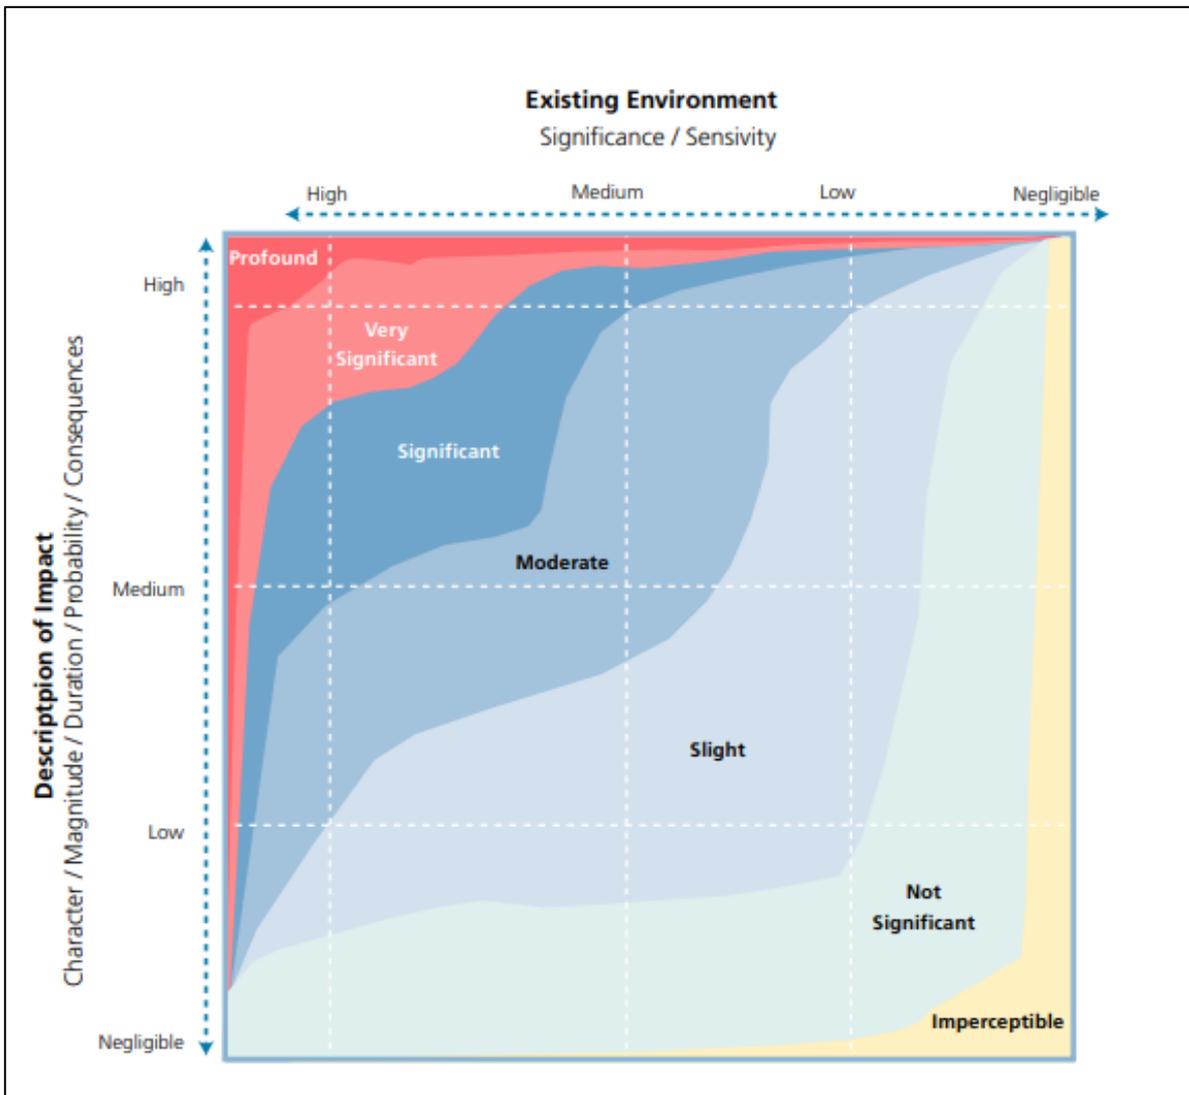
**Image 1: Chart Showing Typical Classifications of the Significance of Effects, from the EPA Guidelines on Information to be Contained in Environmental Impact Assessment Reports (EPA 2022).**
