Appendix 7-6 – Peat Stability Risk Assessment

Drehid Waste Management Facility – Further Development Planning Stage Peat Stability Risk Assessment

DOCUMENT P22009_RP001

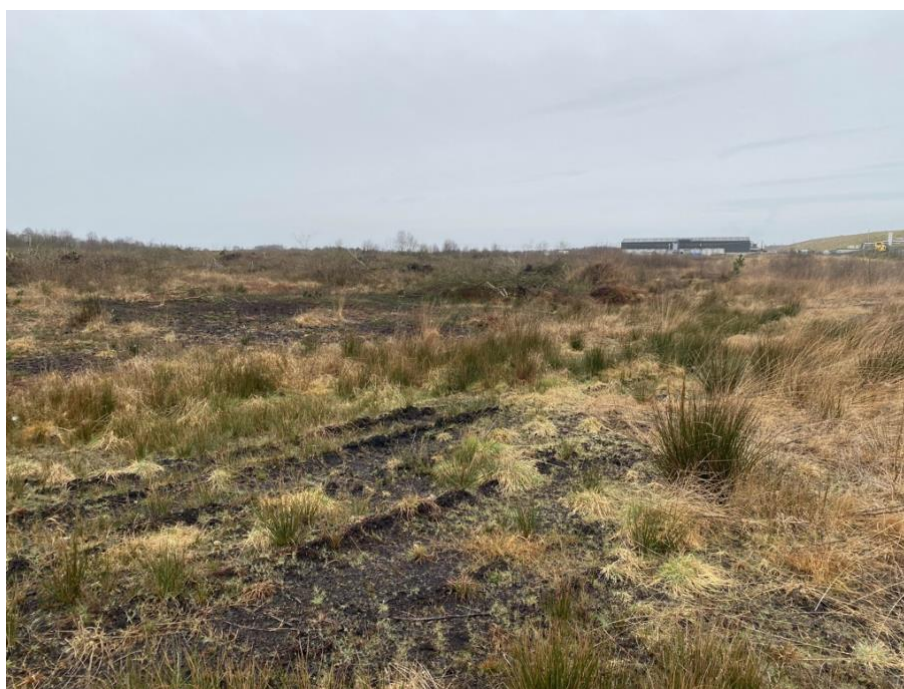
Figure 1 - Typical view of proposed site (existing Composting Facility building appears in right background)

The proposed site covers a total area of 85 hectares and ranges in elevation between approximately 81.5 and 88.1 mOD. The topography of the proposed site is in general flat. A typical view of the proposed site is shown in Figure 1. Figure 1 - Typical view of proposed site (existing Composting Facility building appears in right background)

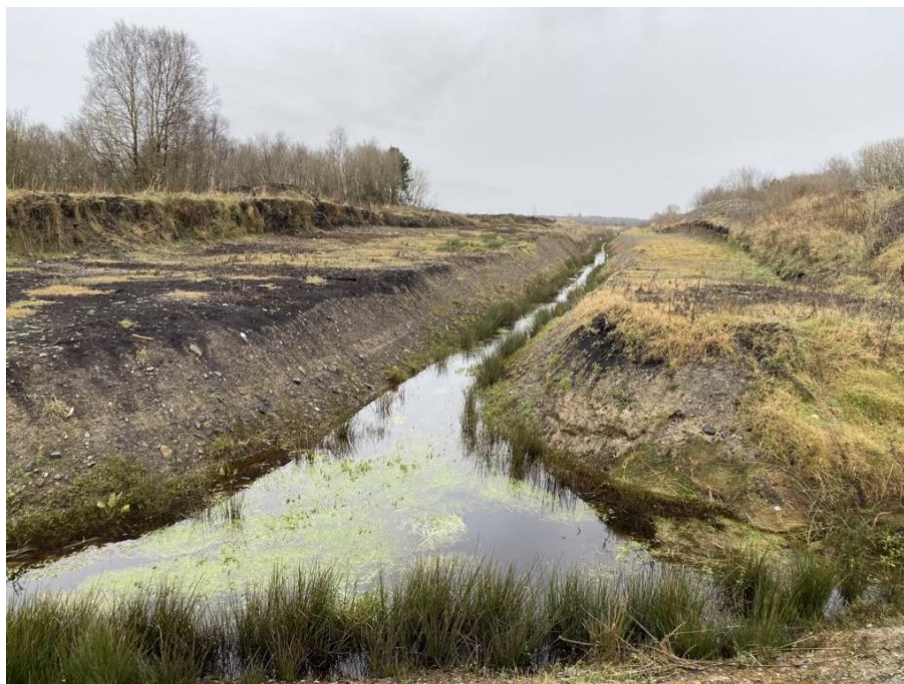
Several man-made drains cut through the site, draining typically to the southwest. An example of one such drain is shown in Figure 2.

Figure 2 - Drain through proposed site.

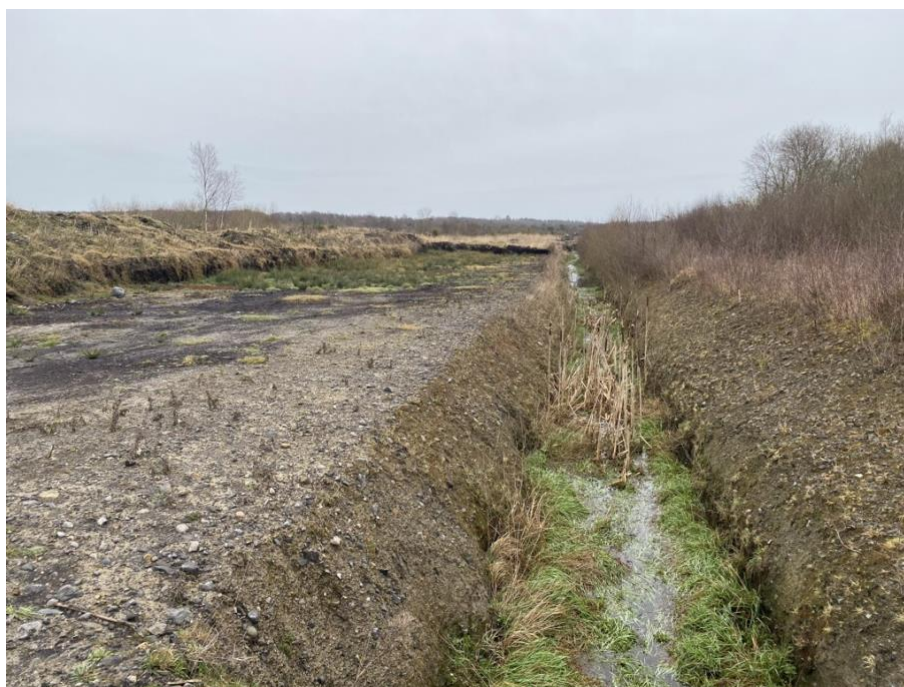
In places, the peat has been stripped back entirely and the underlying glacial till is exposed. A typical example is shown in Figure 4.

Figure 4 - Exposed glacial till at drain location

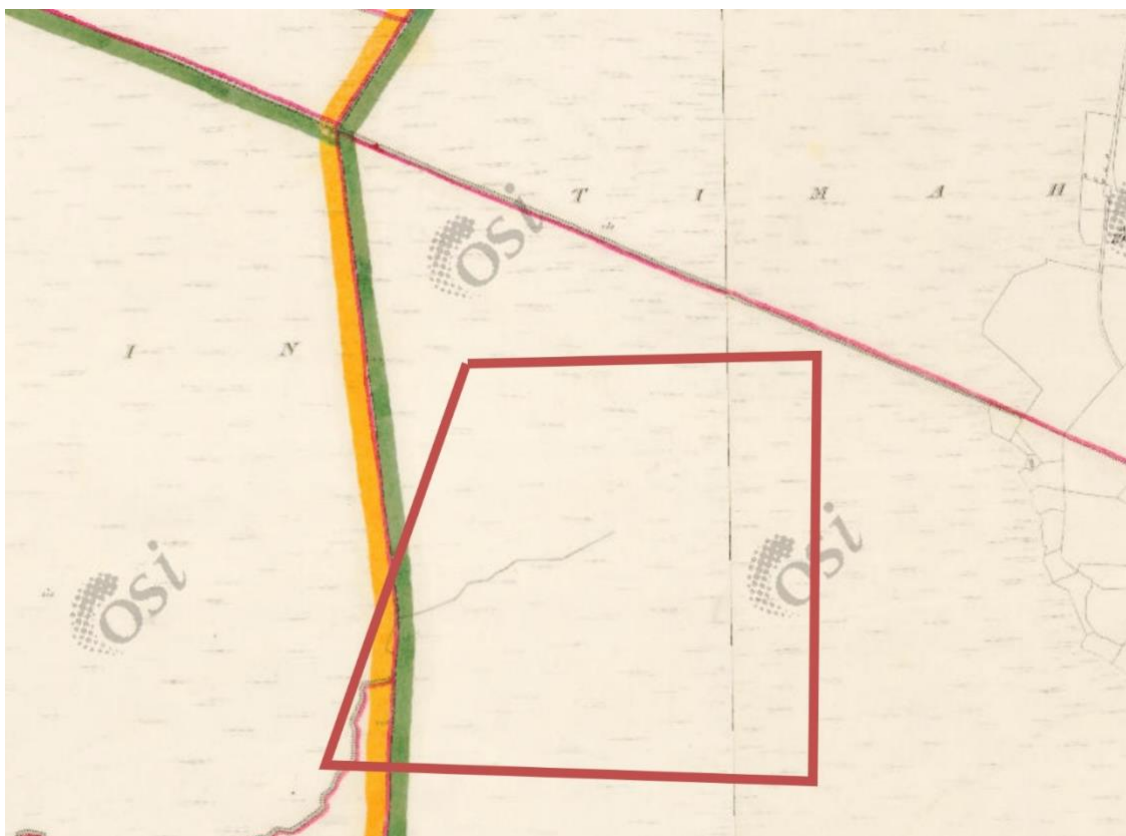
Figure 5 - Ordnance Survey 6" first edition mapping showing drainage feature with similar alignment to present-day Cushaling River draining the proposed site (outlined in red) to the southwest.

Mapping, aerial photography, and satellite imagery available via the Geohive (2023) services were consulted. Ordnance Survey 6-inch and 25 inch (Geohive, 2023) shows the area as peatland with a drainage feature, on a similar alignment to the present day Cushaling River, draining the site to the southwest. The 6-inch first edition mapping is reproduced as Figure 5.

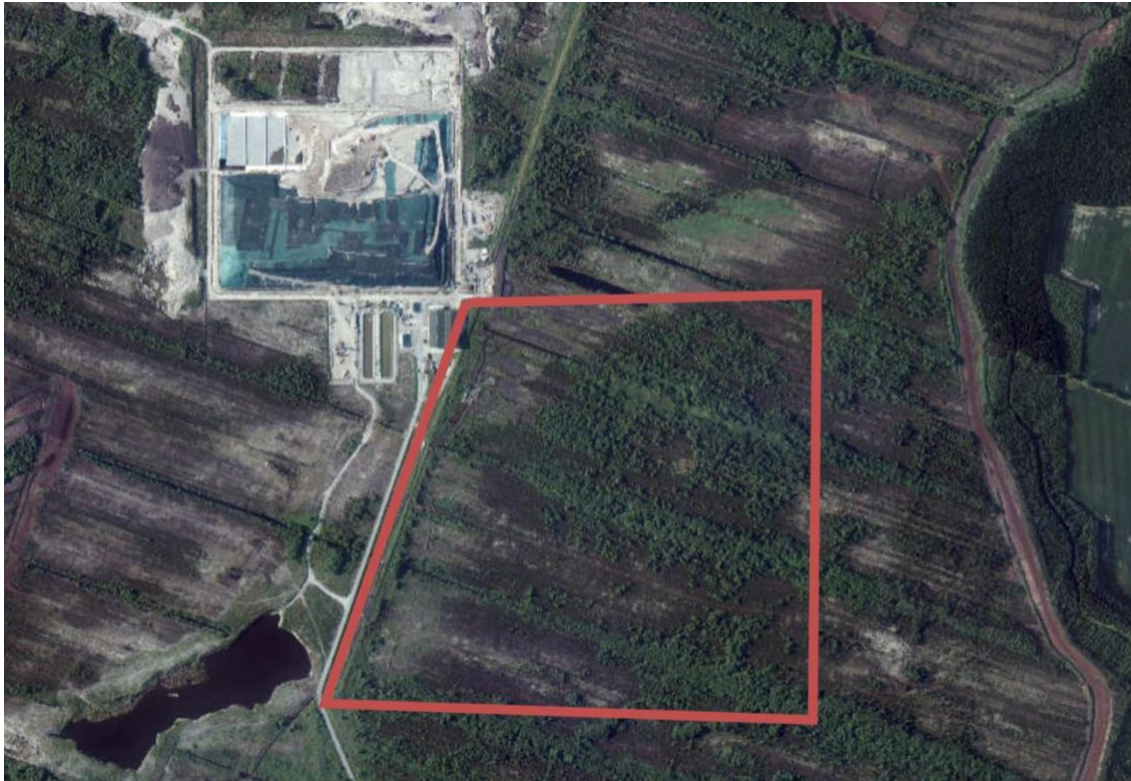
Figure 6 - Aerial image from MapGenie Digital Globe (Geohive, 2023) showing proposed site outlined in red and existing Phases 1 to 8 under construction.

The site is crossed by a network of artificial drains which in the past served to facilitate BnM's peat extraction activity. The drains can be up to 4 m deep and 4 m wide, extending through both peat and subsoils. Typical examples of these drains are shown in Figure 2 and Figure 4. The landfill expansion area currently forms a drained mosaic of young birch and scrub woodland with dry heath, as shown in Figure 1. We understand peat extraction from the site ceased in the early to mid 1980s. Aerial photography from 1995, 1999-2003, 2004-2006, and 2005-2012 shows the site lying idle with most of the described artificial ditches in place. More recent (2013 to present) aerial photography and satellite imagery shows the site largely as configured today, with the Drehid WMF in place, as shown in Figure 6 and Figure 7.

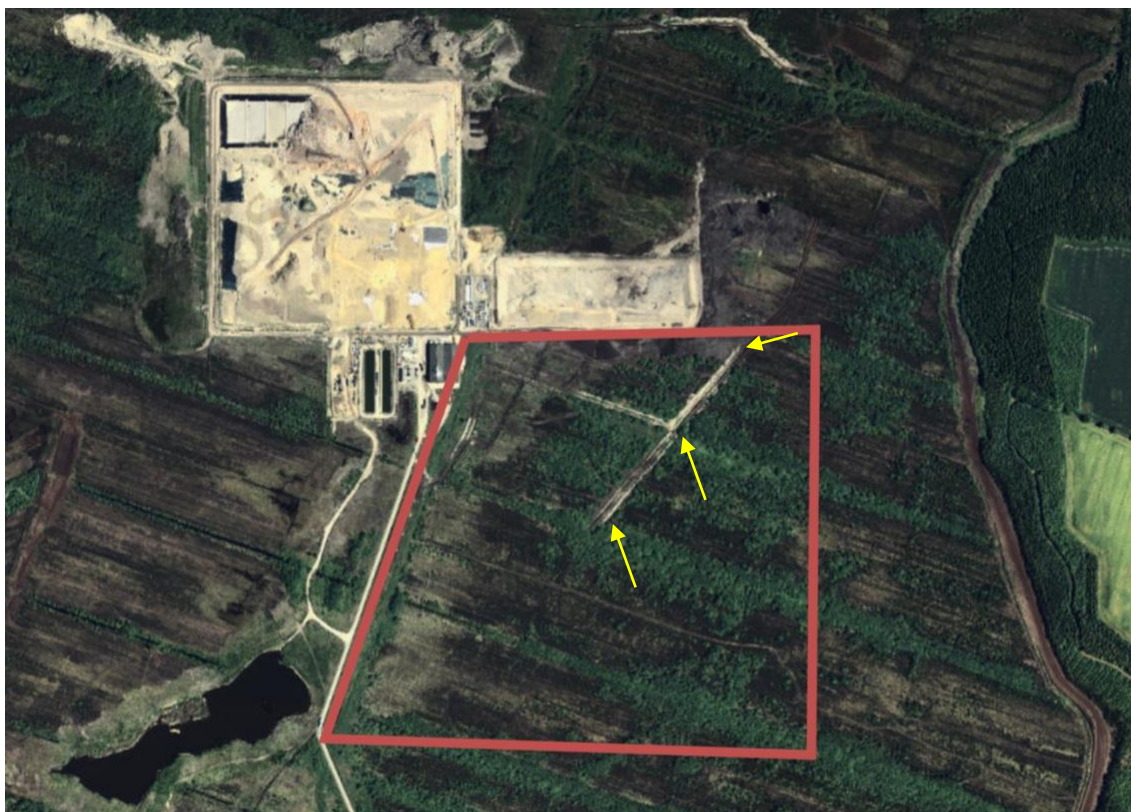
Figure 7 shows a more recent diversion drain feature (highlighted by yellow arrows) constructed to divert existing flows around Phase 9 and 10. A new north-south oriented drain to the east of the expanded landfill footprint will be constructed to lead bog drainage water around the landfill expansion area and maintain the hydrology of the site. This is shown in Figure 7-31 of the Soils, Geology and Hydrogeology chapter of the main EIAR.

Figure 7 - MapGenie (2013- 2018) satellite image (Geohive, 2023) showing proposed site outlined in red and existing Phases 1 to 8 undergoing filling and capping and Phases 9 and 10 under construction. Diversion drain shown by yellow arrows.
