GEOTECHNICAL & PEAT STABILITY REPORT

PROPOSED SUBSTATION, UNDERGROUND CABLING & ACCESS ROADS TO
KNOCKNAMORK RENEWABLE ENERGY DEVELOPMENT

Date: July 2022

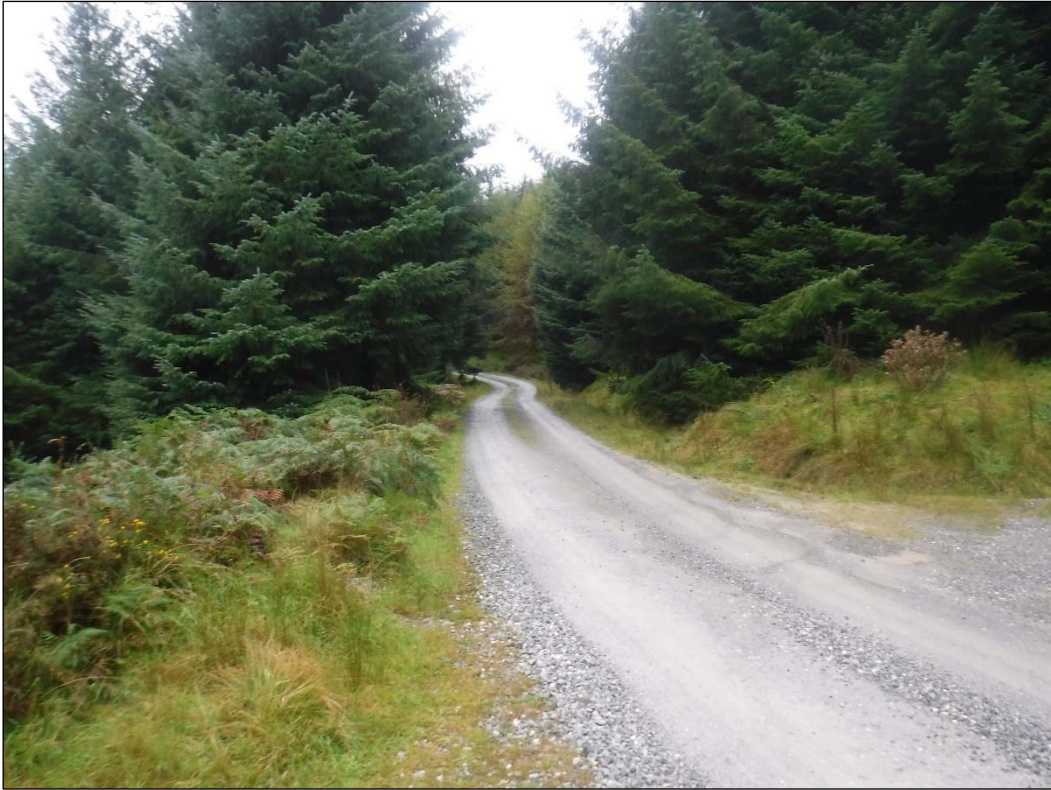
Photo 1: Existing access track on TDR

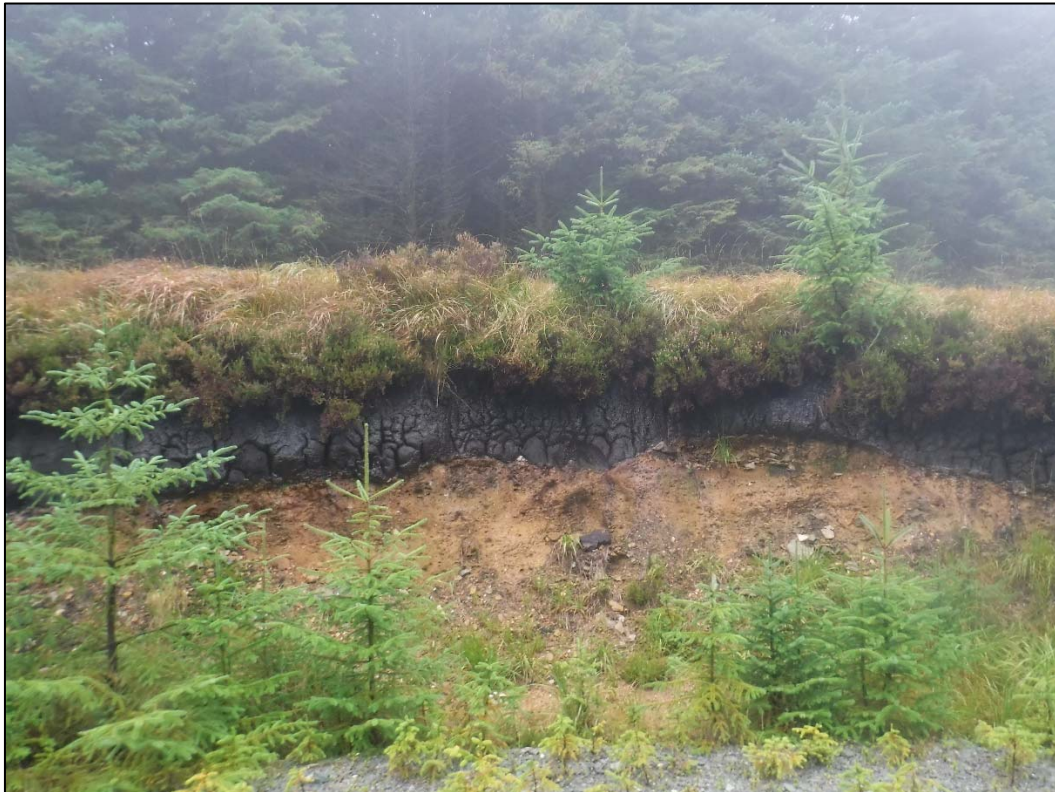
Photo 2: Peat exposed alongside existing track on TDR

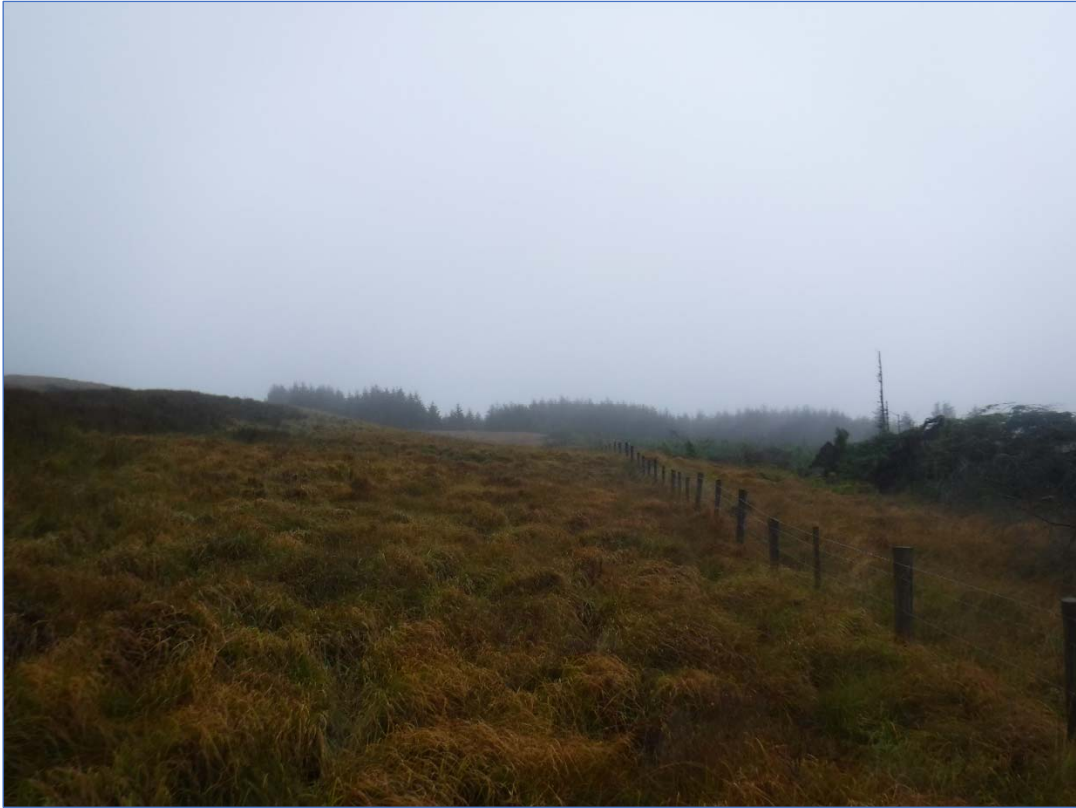
Photo 3: Typical ground conditions along 33kV underground cabling route

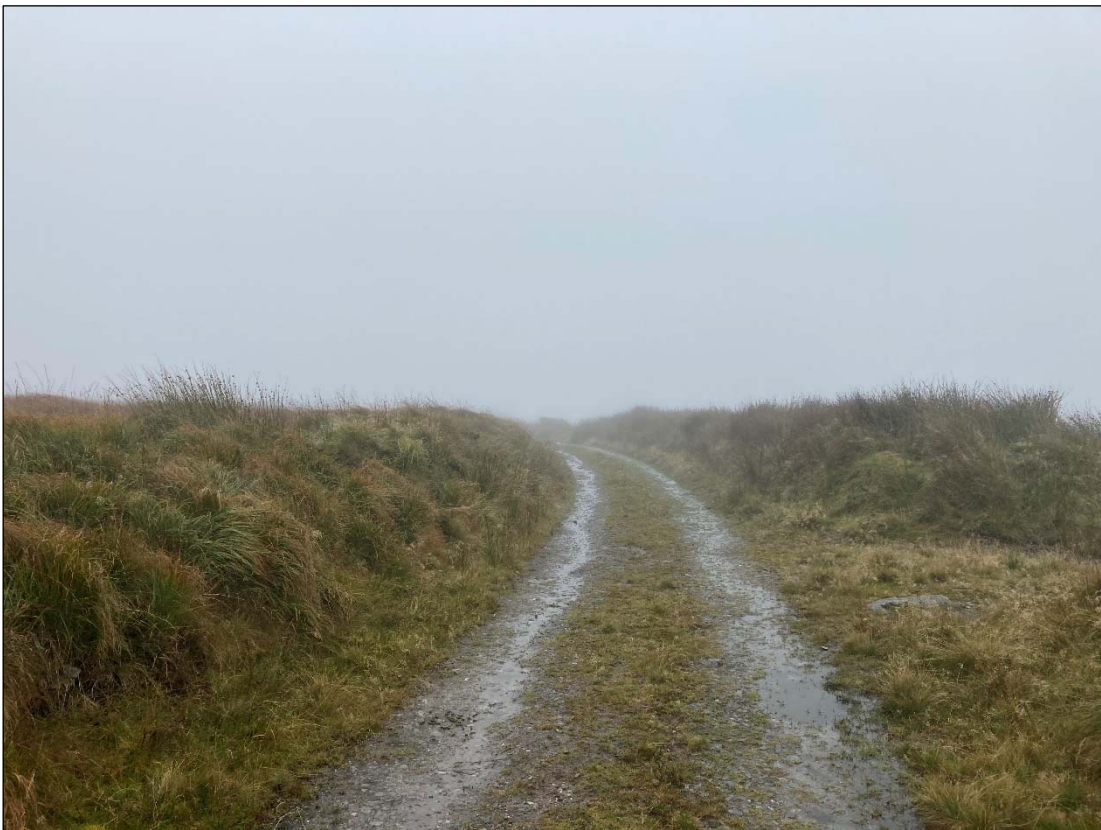
Photo 4: Existing track along section of 110kV underground cabling route

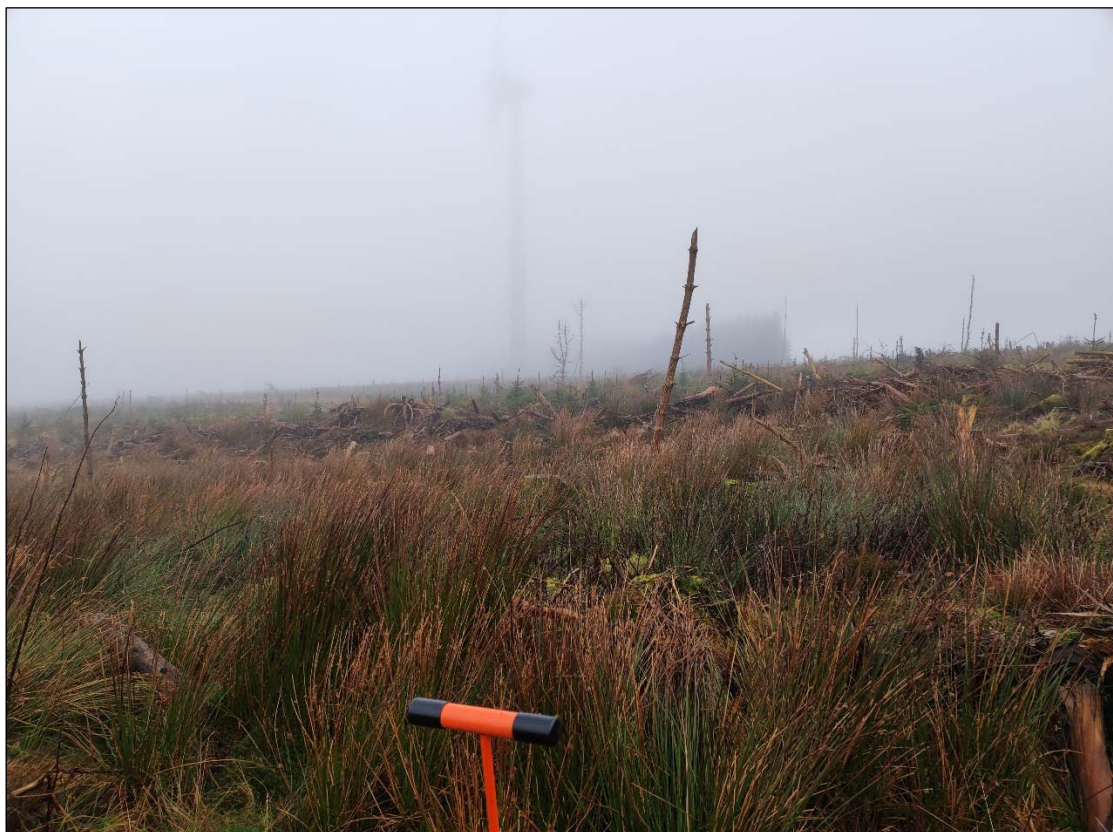
Photo 6: Proposed substation location
