Intended for  
**Vantage Data Centers DUB13 Limited**

Date  
**March 2023**

# **VANTAGE DUBLIN DATA CENTER**

## **VOLUME 2A: LANDSCAPE, VISUAL AND BUILT HERITAGE IMPACT ASSESSMENT**

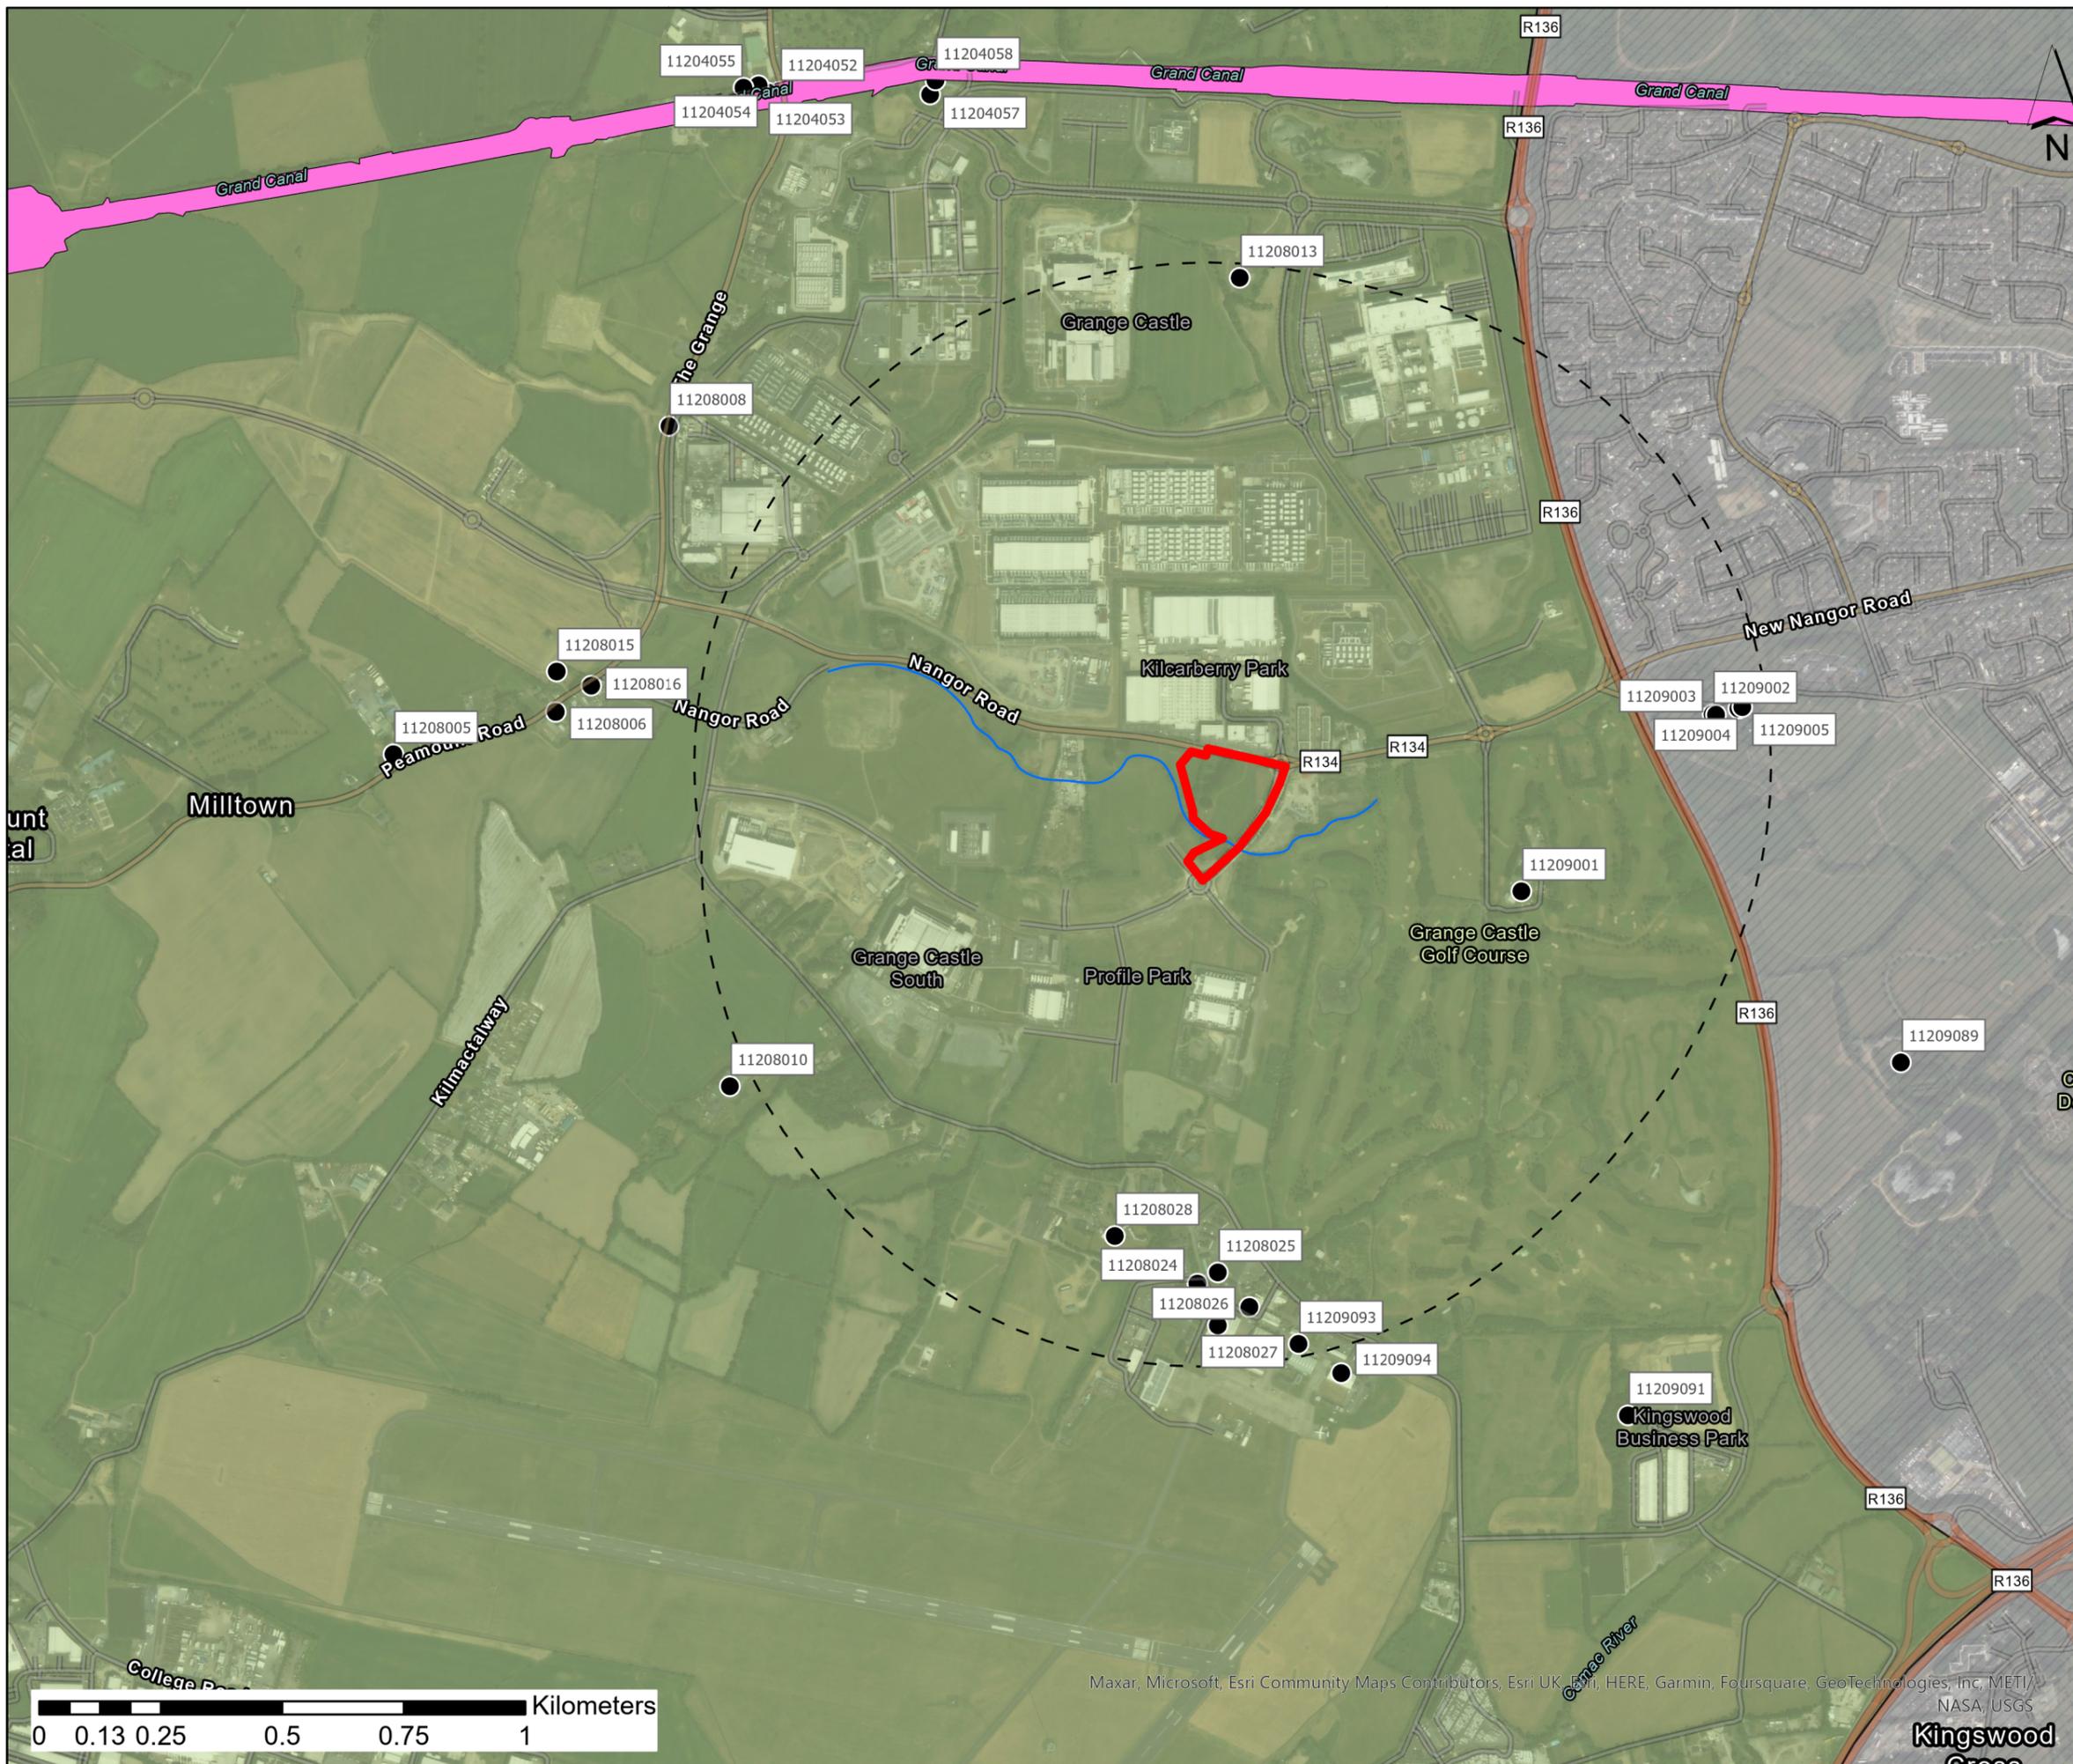
Figure 1: Location, study area and landscape features

- DUB-13 Site Boundary
- Baldonnel Stream
- 1km study area
- Grand Canal pNHA
- NIAH sites with reference number
- Newcastle Lowlands
- Urban South Dublin

- 1.3 The chapter is supported by the following technical appendices in EIAR Volume 2:
  - Appendix 1.1:
    - Figure 1: Location Plan and Study Area;
    - Figure 2: Site Landscape Elements and Features;

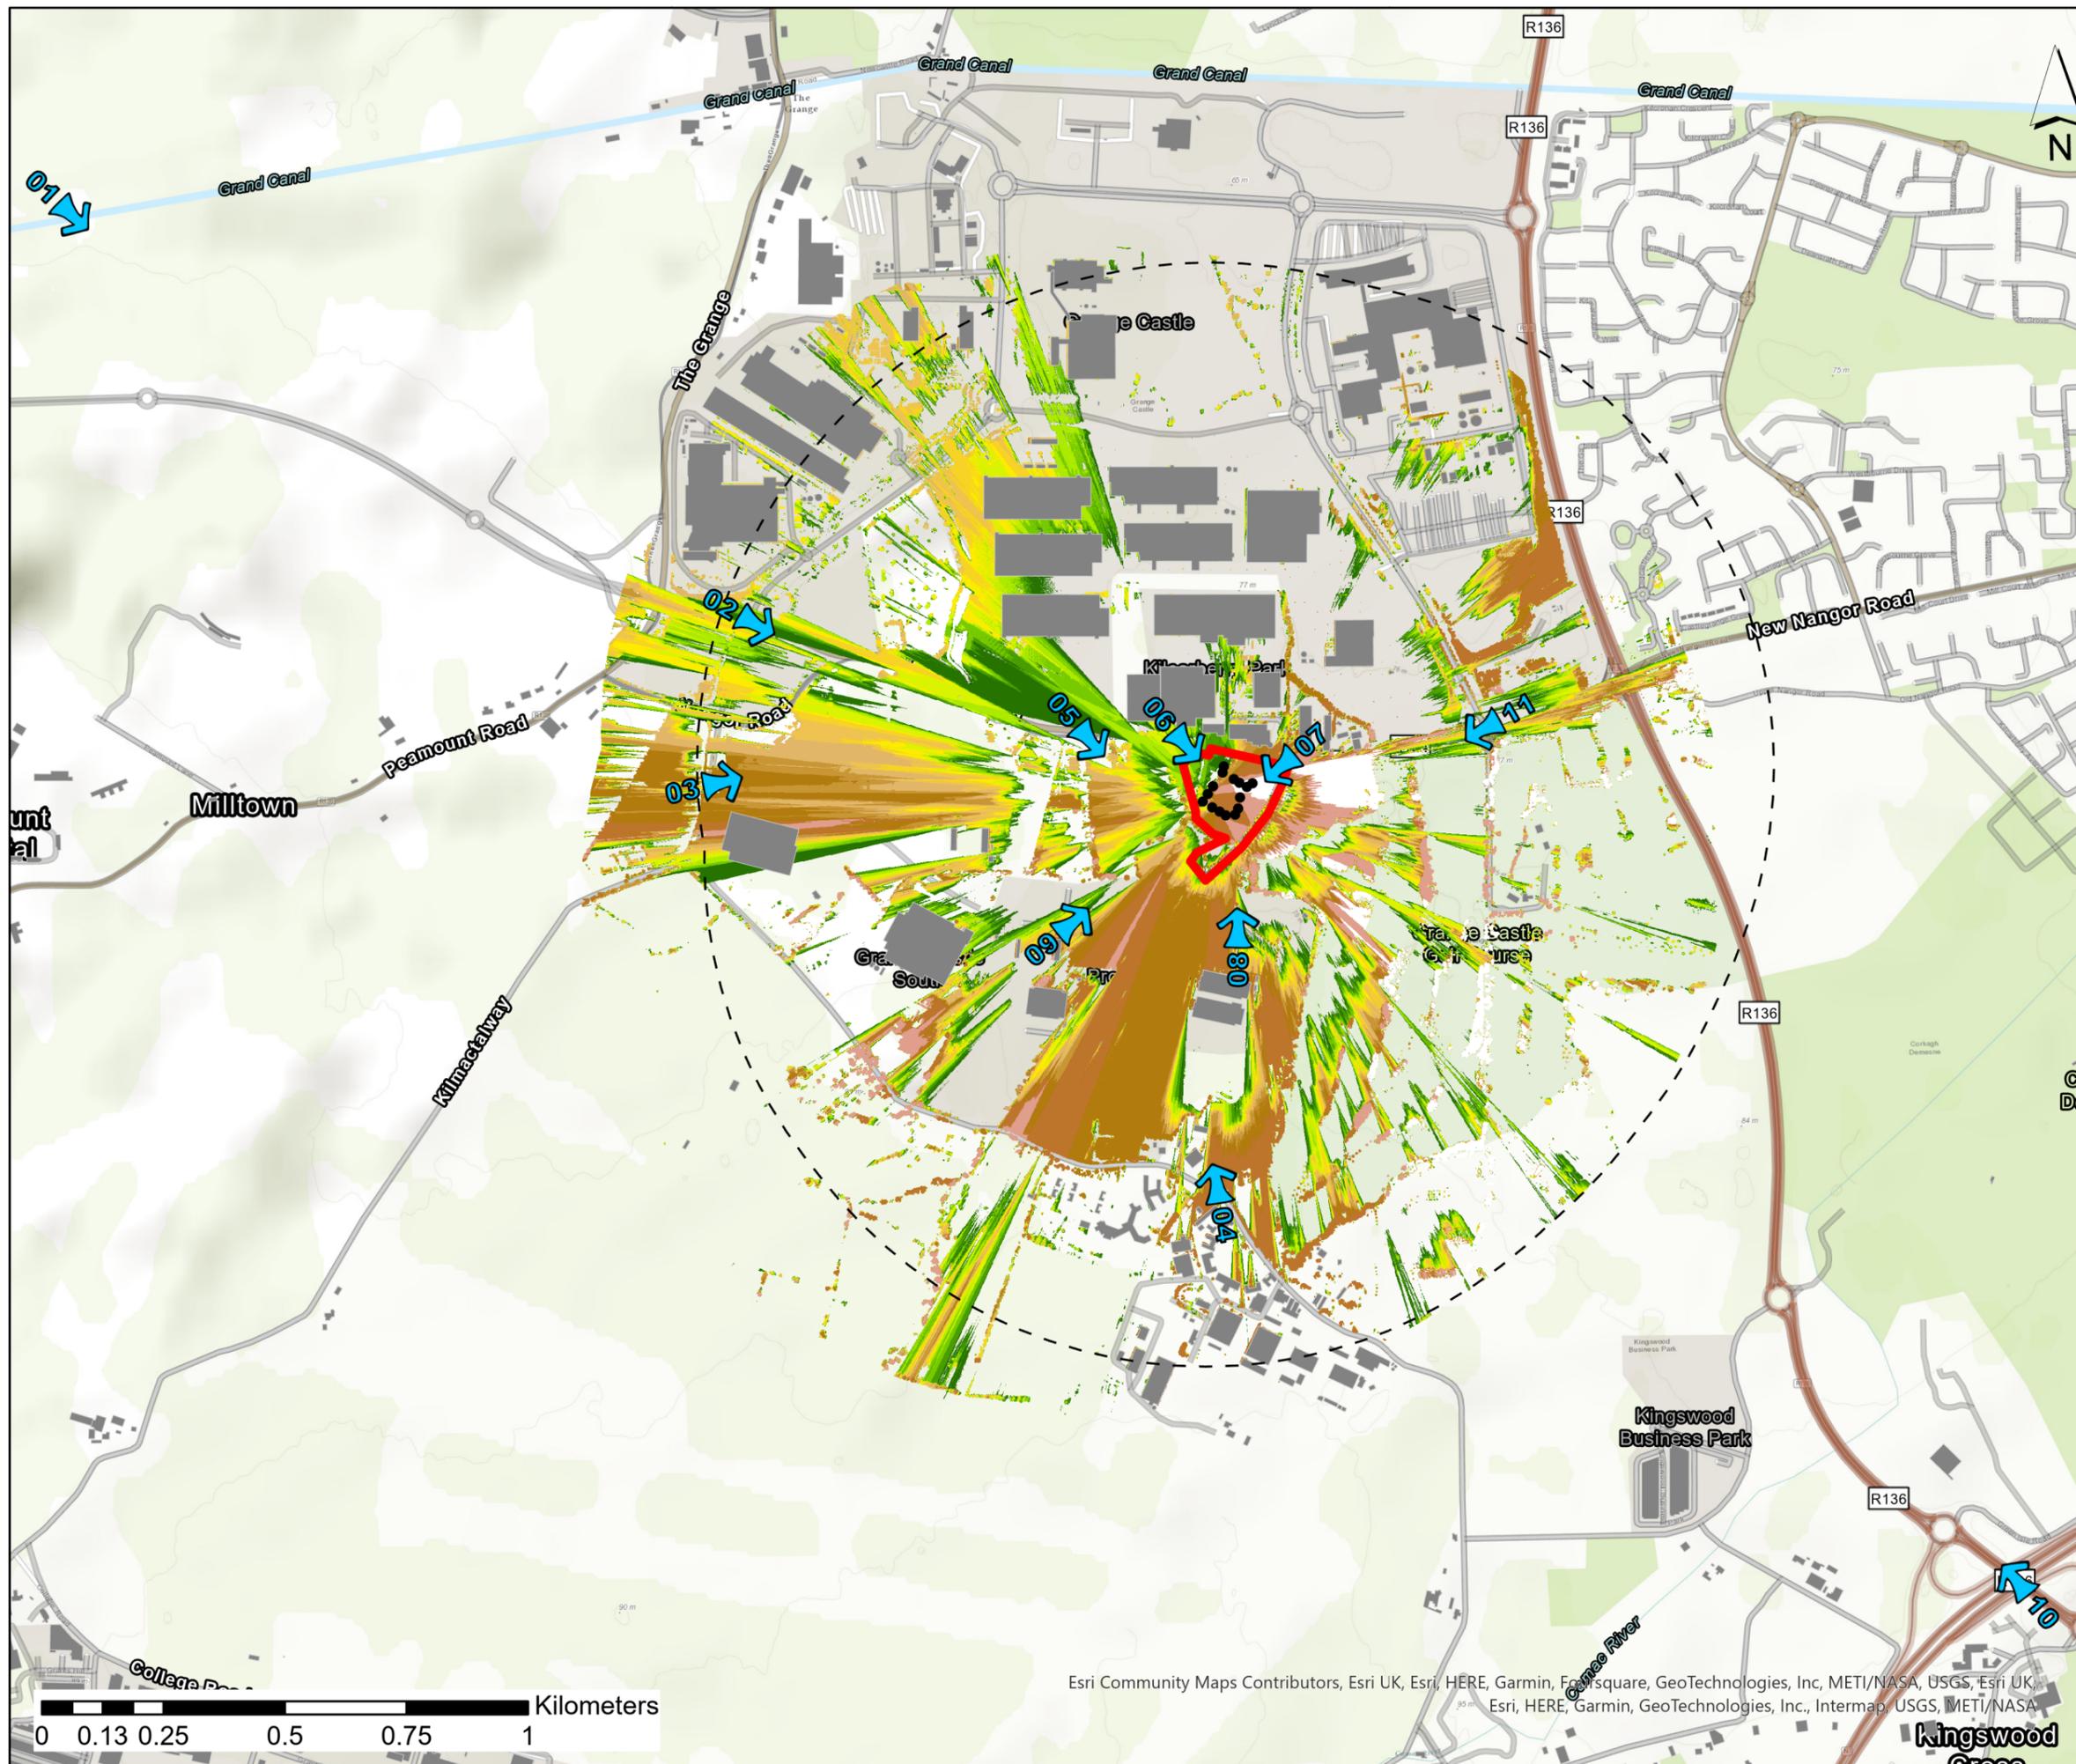
Figure 3: Zone of Theoretical Visibility and Viewpoint Locations

- DUB-13 Site Boundary
  - ↑ Viewpoint
  - Building height points
  - 1km study area
  - Existing Buildings
- Visibility**
- Value
- High
  - Low

- 1.75 To assess the potential effect of the proposed development on landscape and visual amenity generally, a series of representative viewpoints have been selected. The effects on specific landscape and visual receptors and these locations are assessed. Baseline conditions at these locations are described in Table 1.6 below and the location of the viewpoints are shown in **Figure 3, Appendix 1.1**.

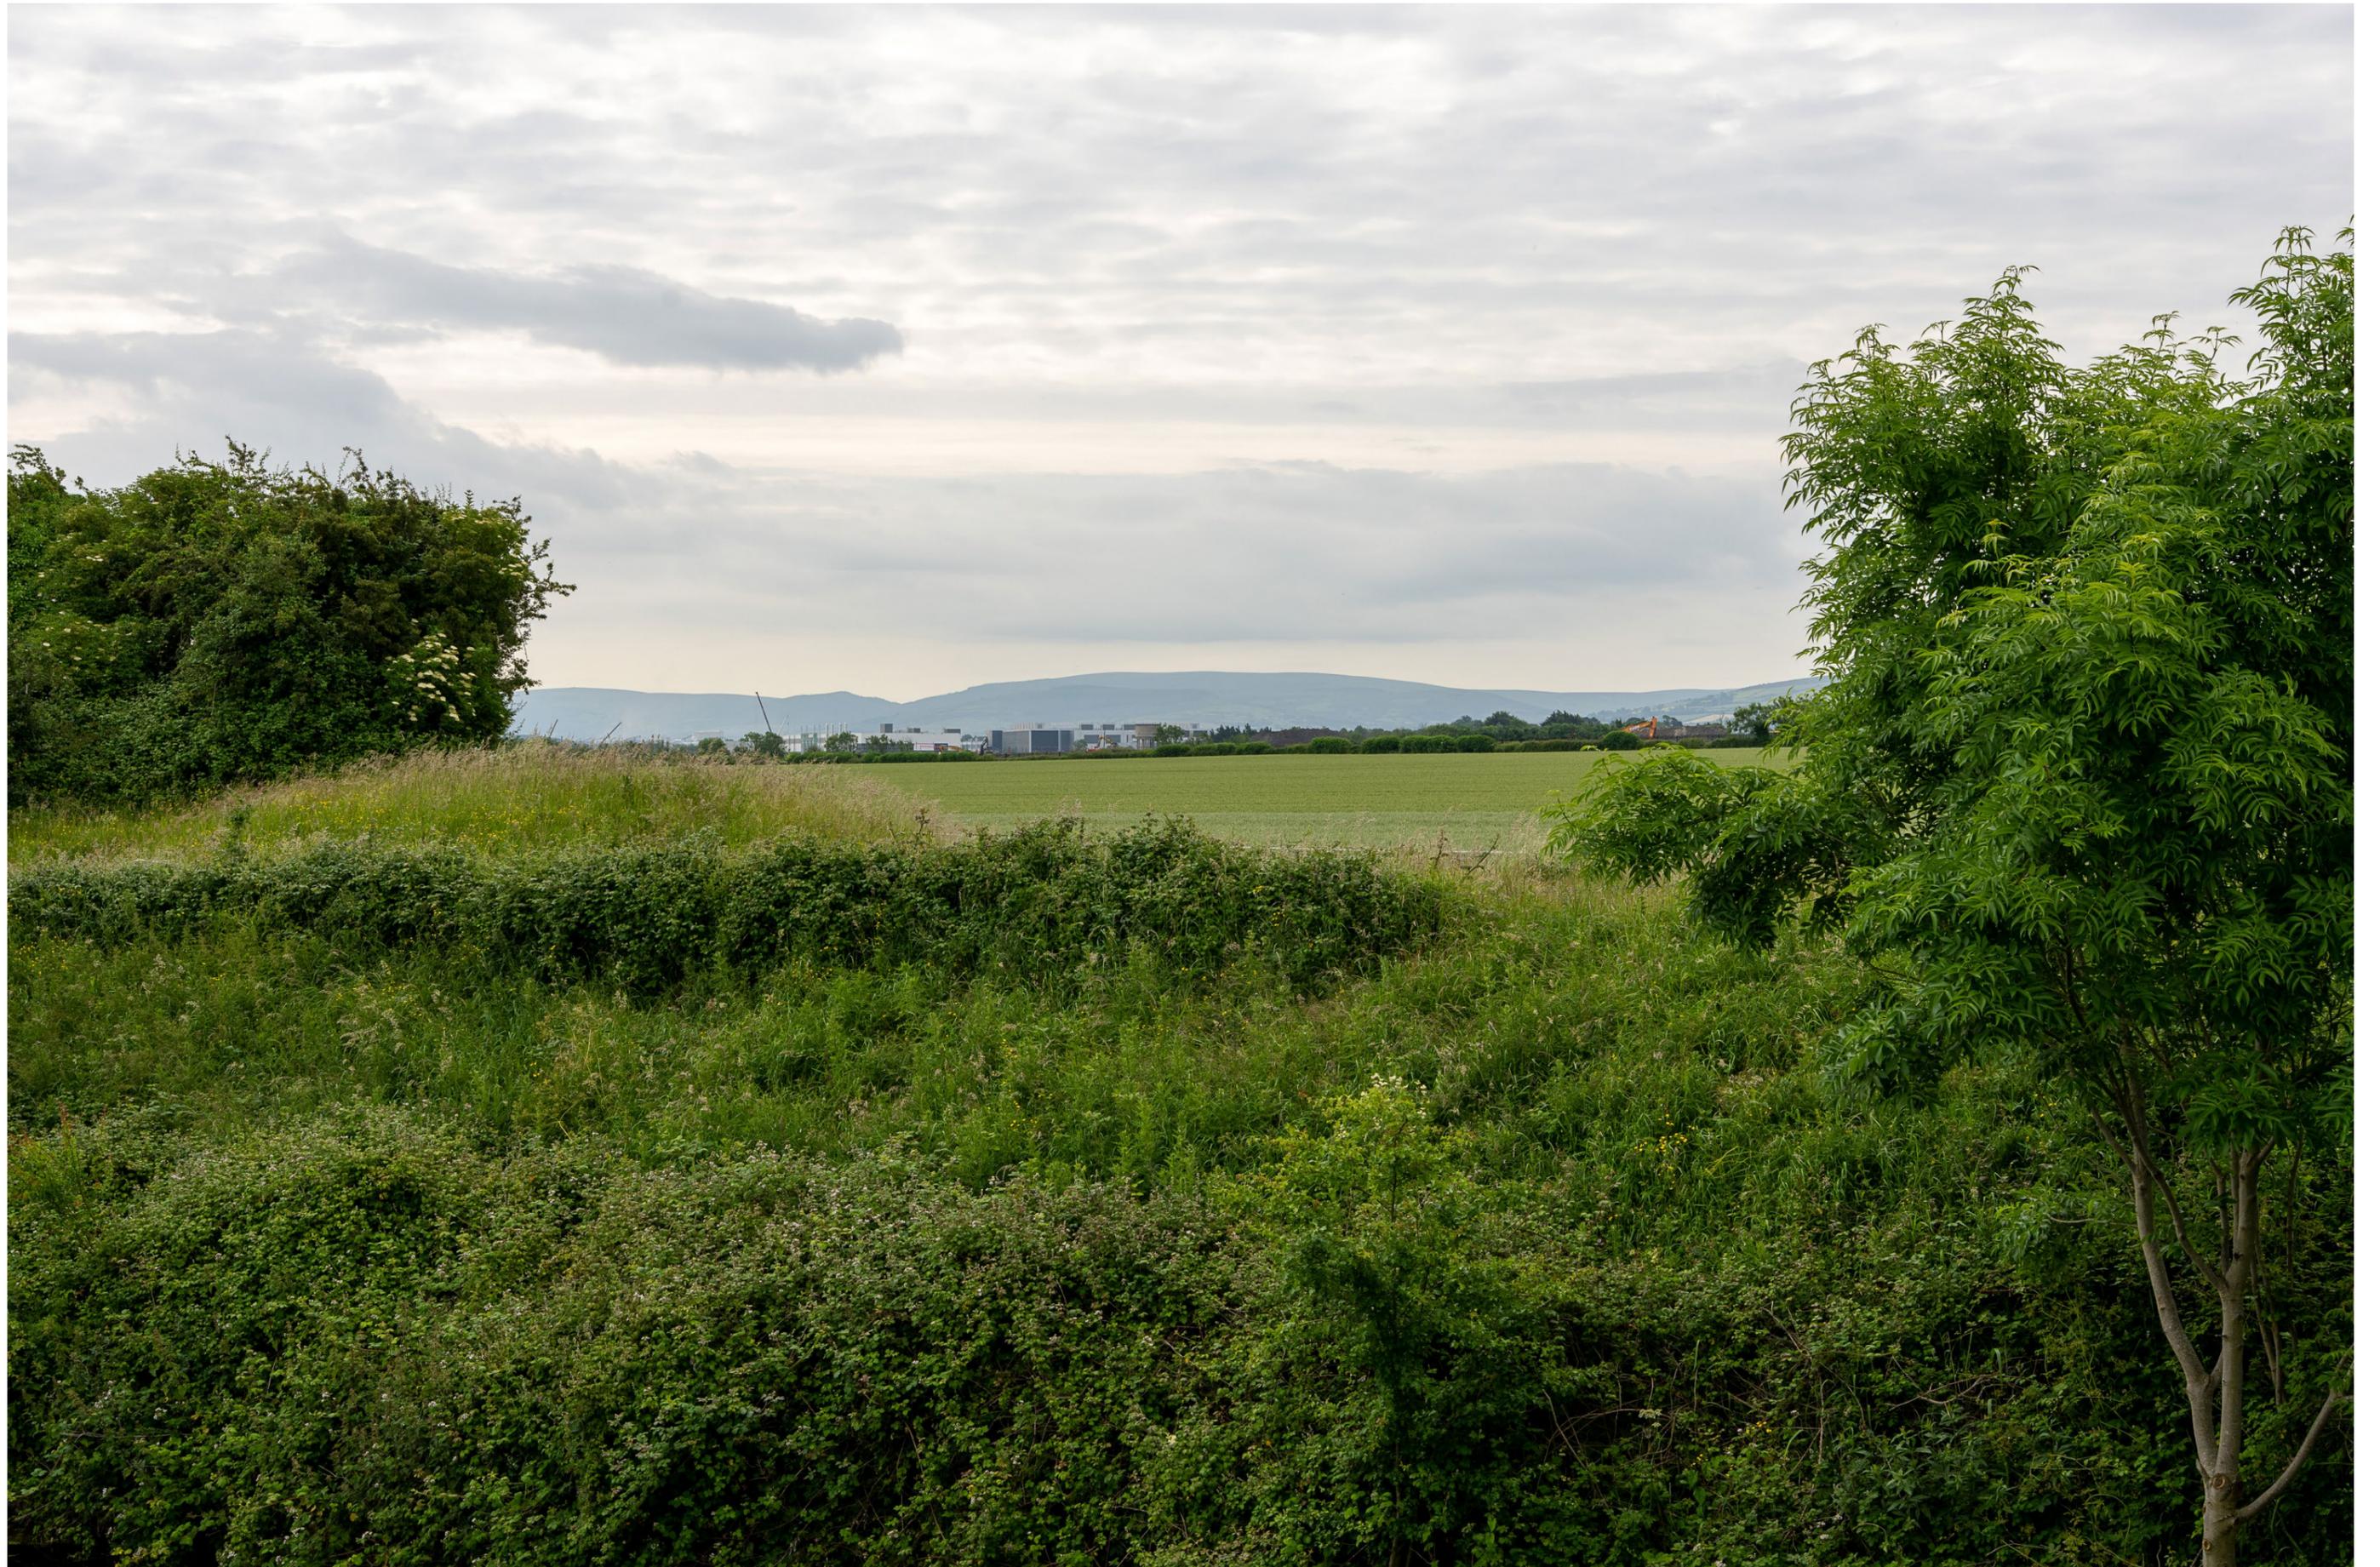
Viewpoint 1: The Grand Canal | Viewing distance at A3: 542mm | Horizontal field of view: 39.6° | Direction of view: 134°  
Camera: Sony ILCE-1| Lens: Sony 50mm | Camera height: 1.5m AGL | Date taken: 28 June 2021 | Aperture: f/11 | ISO speed: 100 | Shutter: 1/160 sec

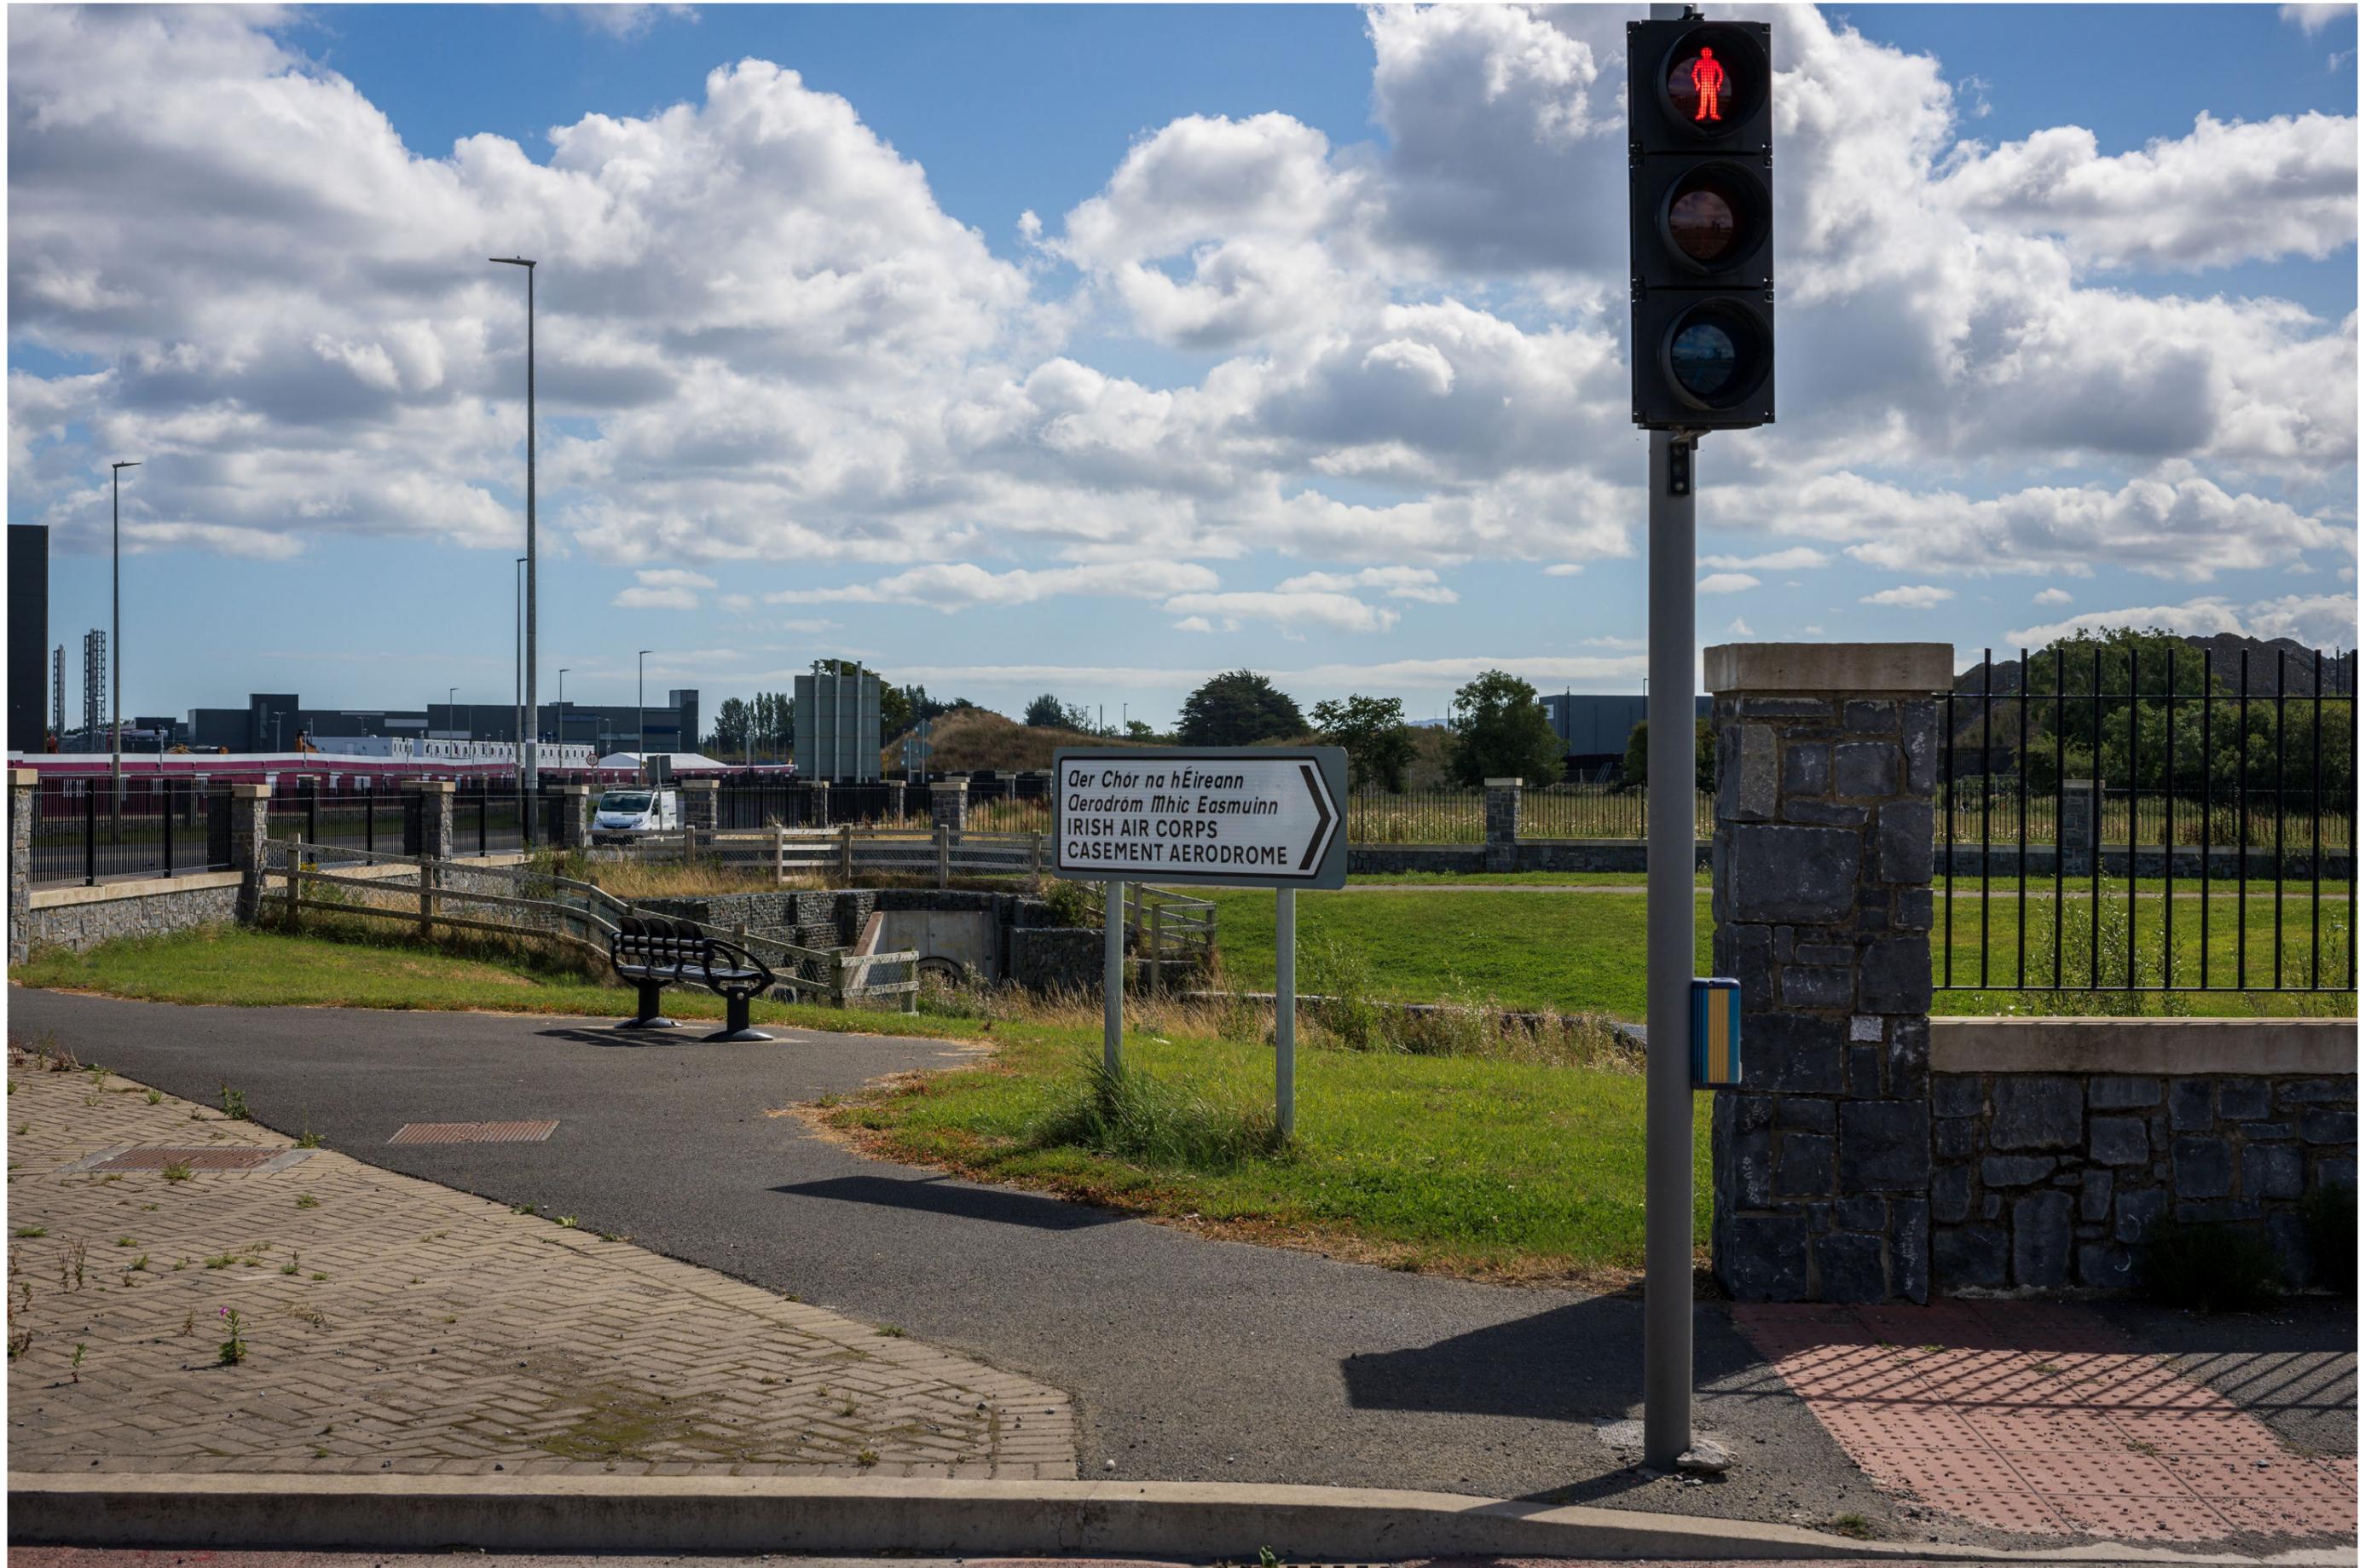
Viewpoint 2: Corner of R134 New Nangor Road and Baldonnell Road Junction | Viewing distance at A3: 542mm | Horizontal field of view: 39.6° | Direction of view: 114°  
Camera: Sony ILCE-1 | Lens: Sony 50mm | Camera height: 1.5m AGL | Date taken: 25 August 2022 | Aperture: f/8 | ISO speed: 100 | Shutter: 1/500 sec

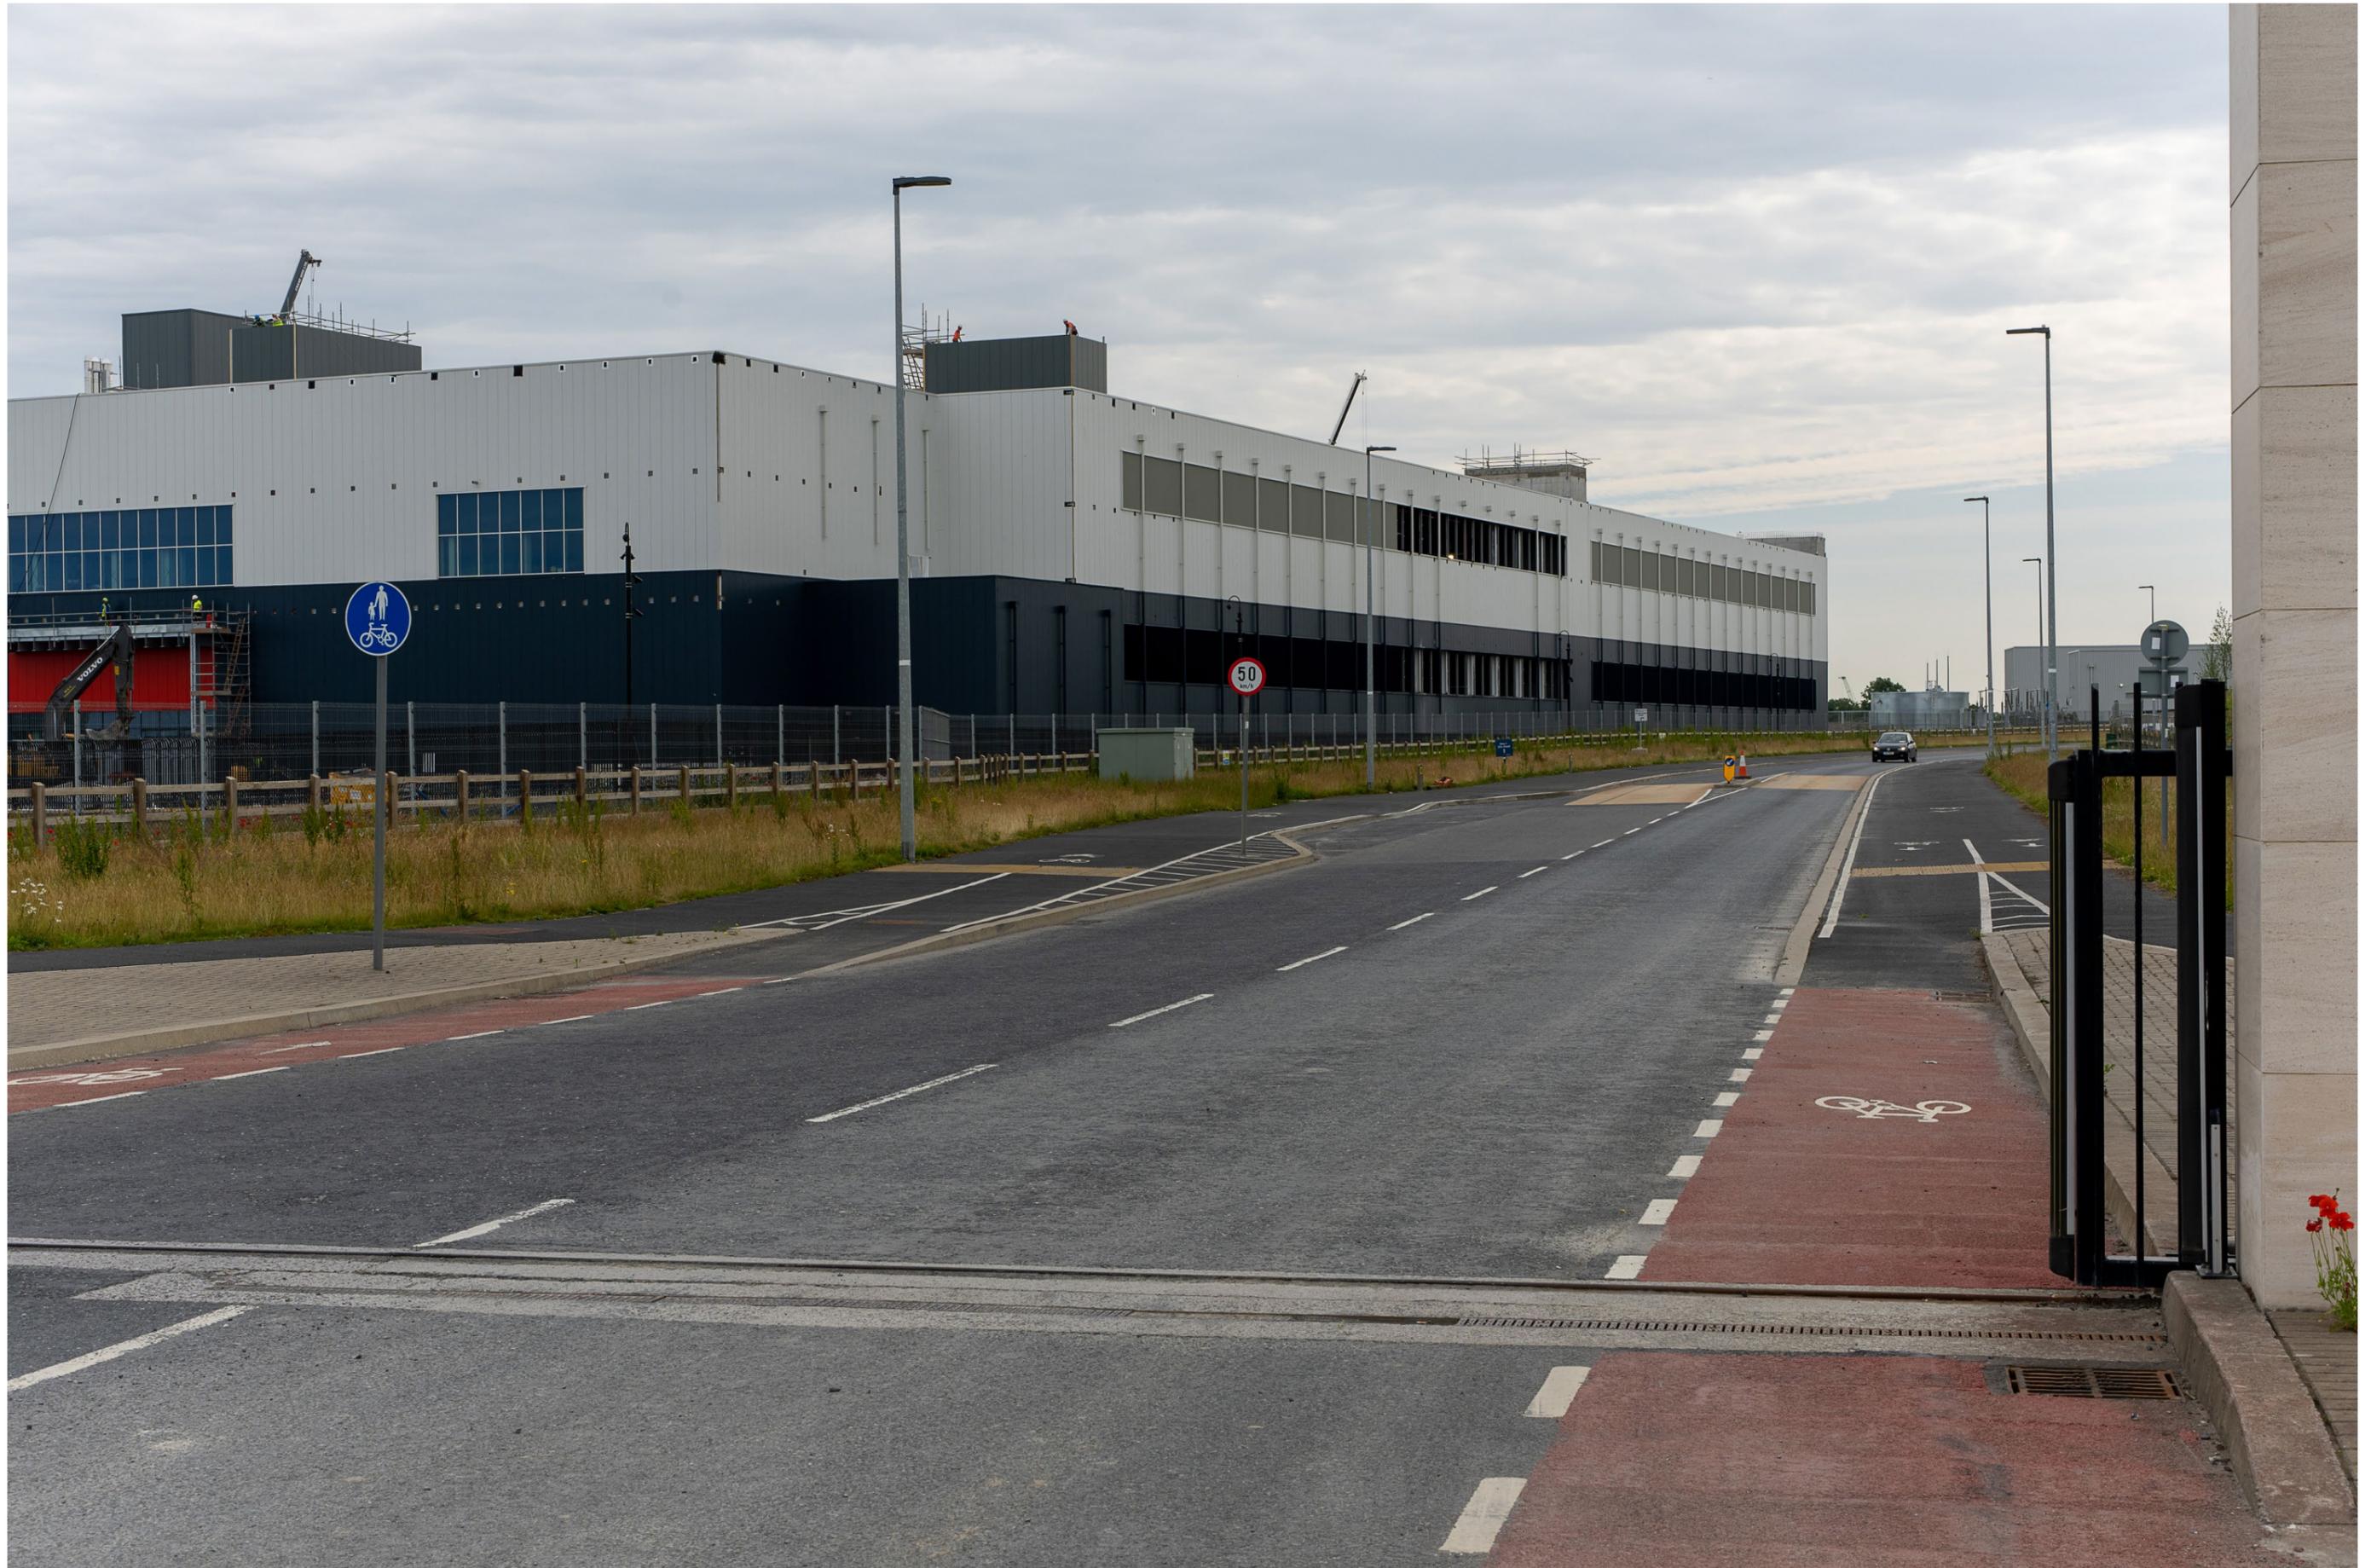
Viewpoint 3: Baldonnell Road at Falcon Avenue junction | Viewing distance at A3: 542mm | Horizontal field of view: 39.6° | Direction of view: 63°  
Camera: Sony ILCE-1| Lens: Sony 50mm | Camera height: 1.5m AGL | Date taken: 28 June 2021 | Aperture: f/11 | ISO speed: 100 | Shutter: 1/160 sec

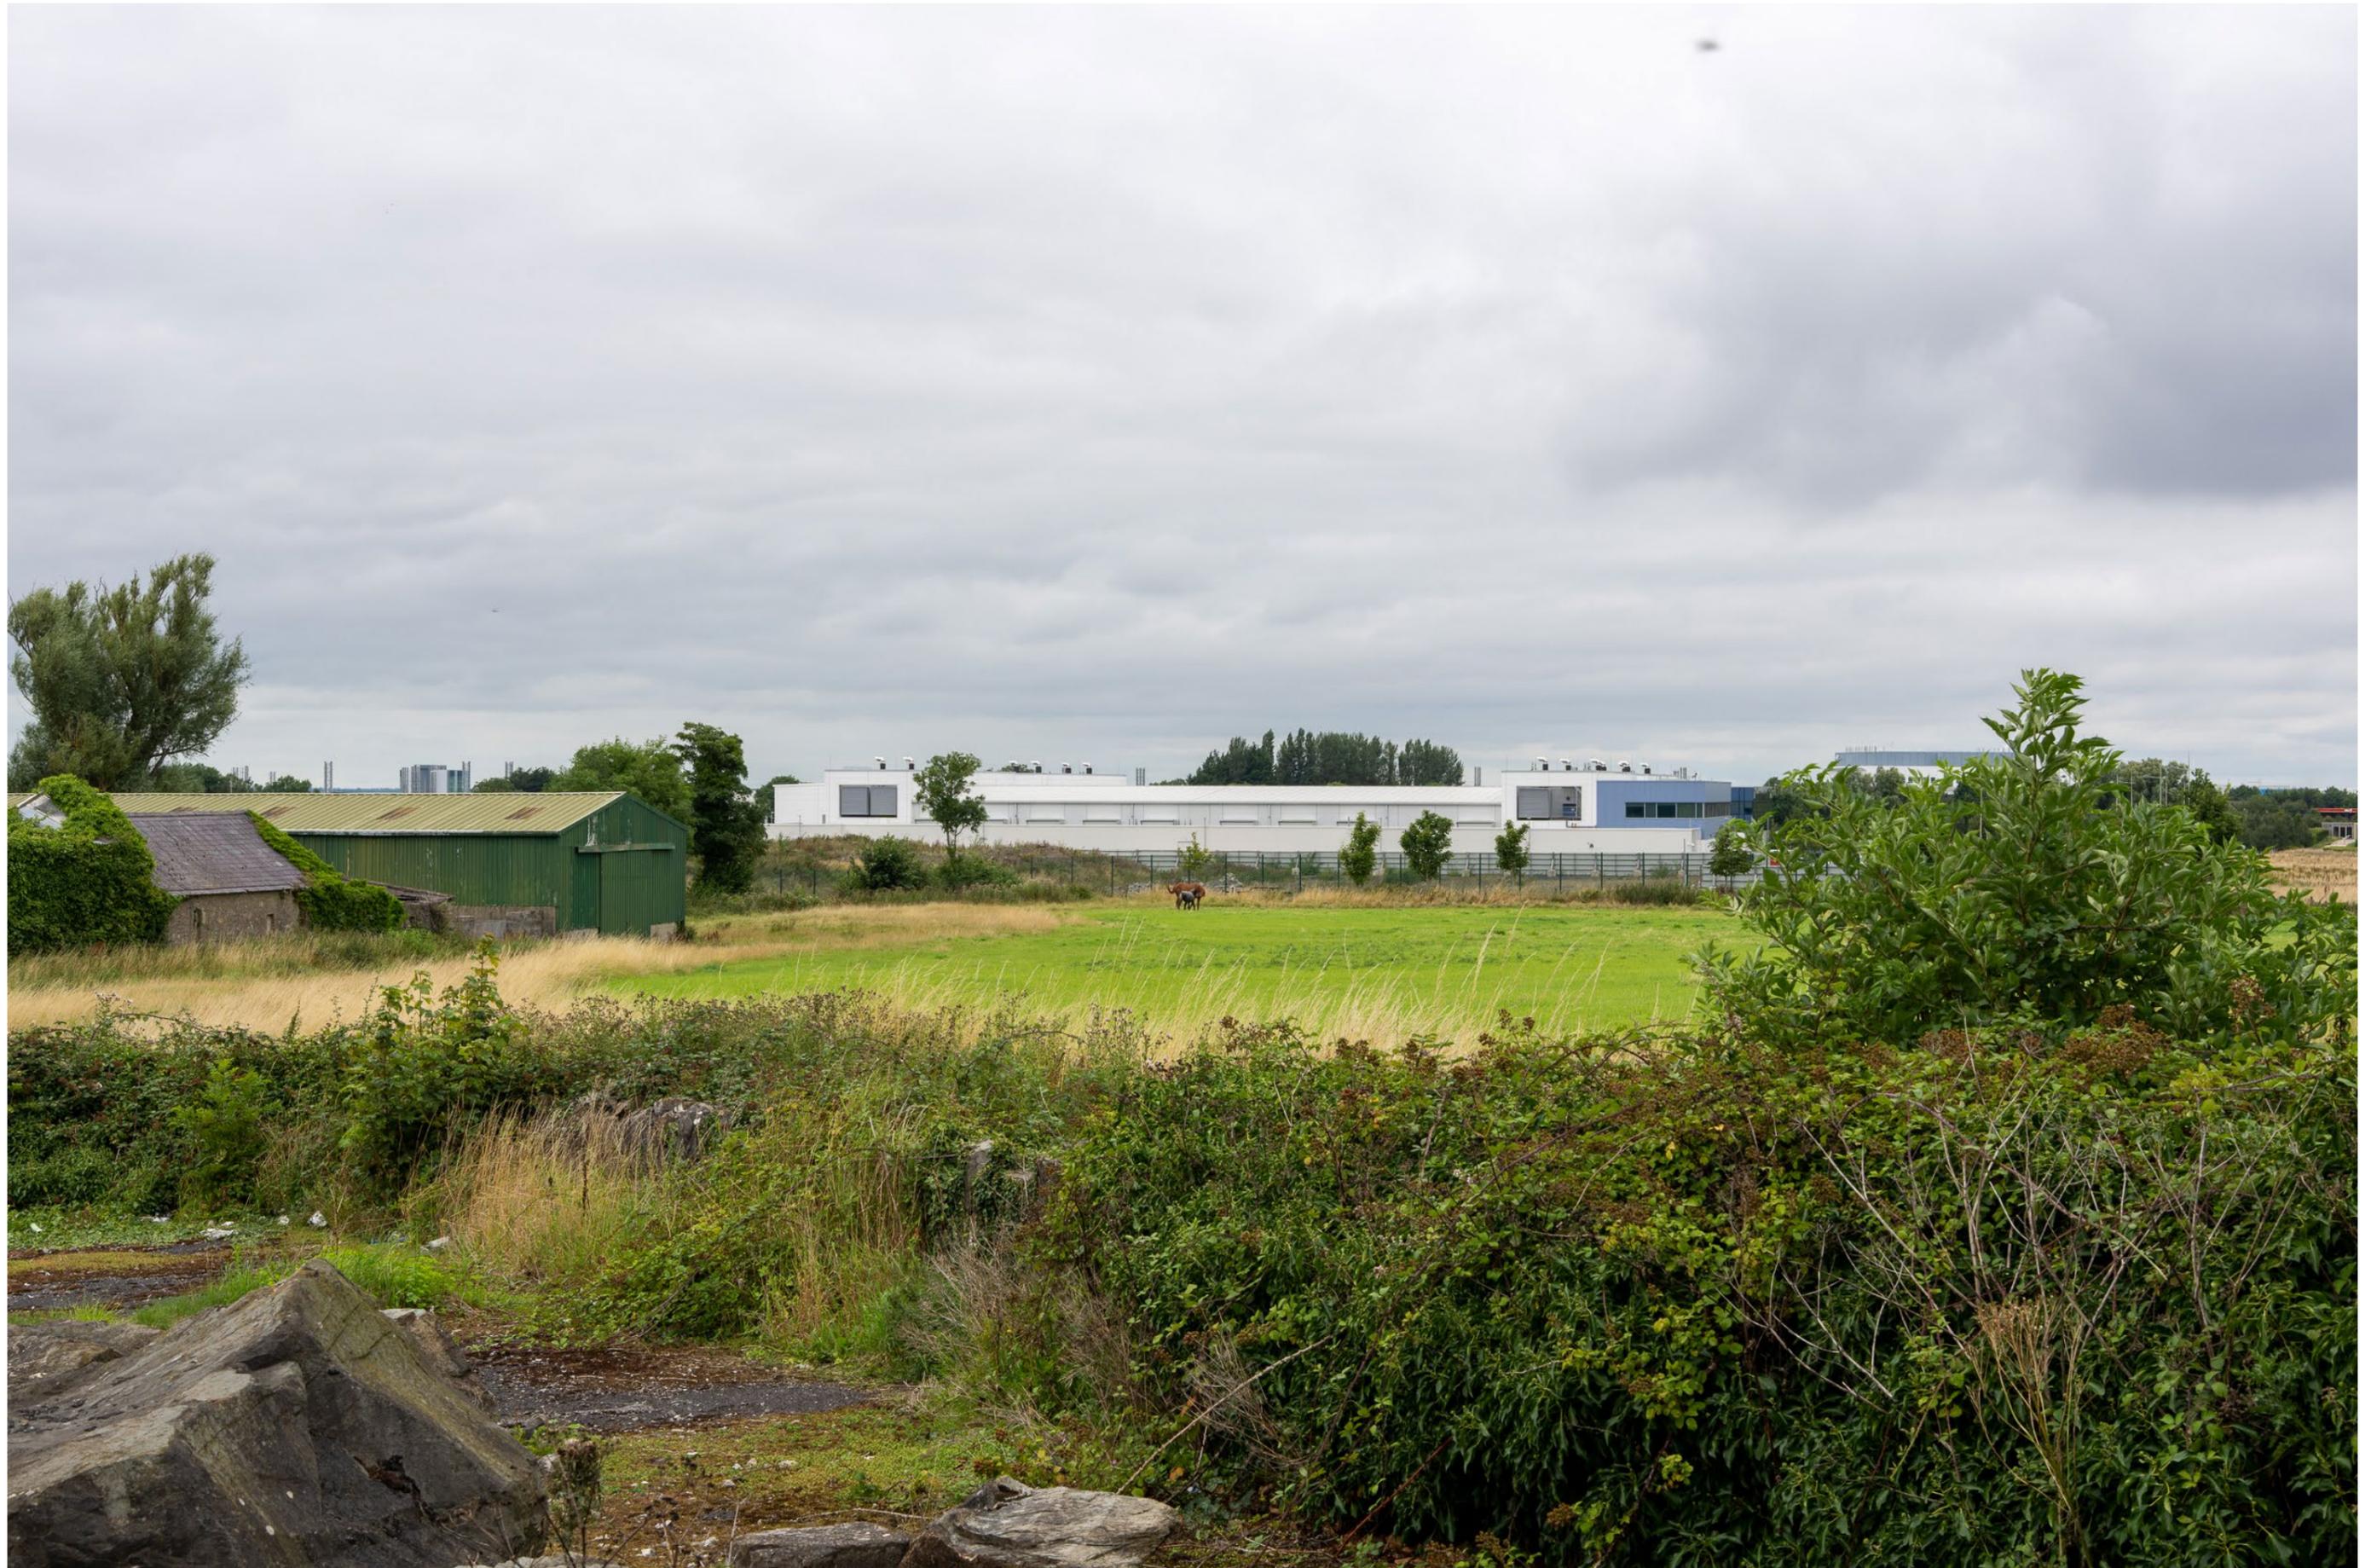
Viewpoint 4: Baldonnell Road layby near the entrance to the Casement Aerodrome | Viewing distance at A3: 542mm | Horizontal field of view: 39.6° | Direction of view: 360°  
Camera: Sony ILCE-1 | Lens: Sony 50mm | Camera height: 1.5m AGL | Date taken: 18 August 2021 | Aperture: f/11 | ISO speed: 100 | Shutter: 1/50 sec
