Intended for  
**Vantage Data Centers DUB13 Limited**

Date  
**March 2023**

# **VANTAGE DUBLIN DATA CENTER**

## **VOLUME 2A: LANDSCAPE, VISUAL AND BUILT HERITAGE IMPACT ASSESSMENT**

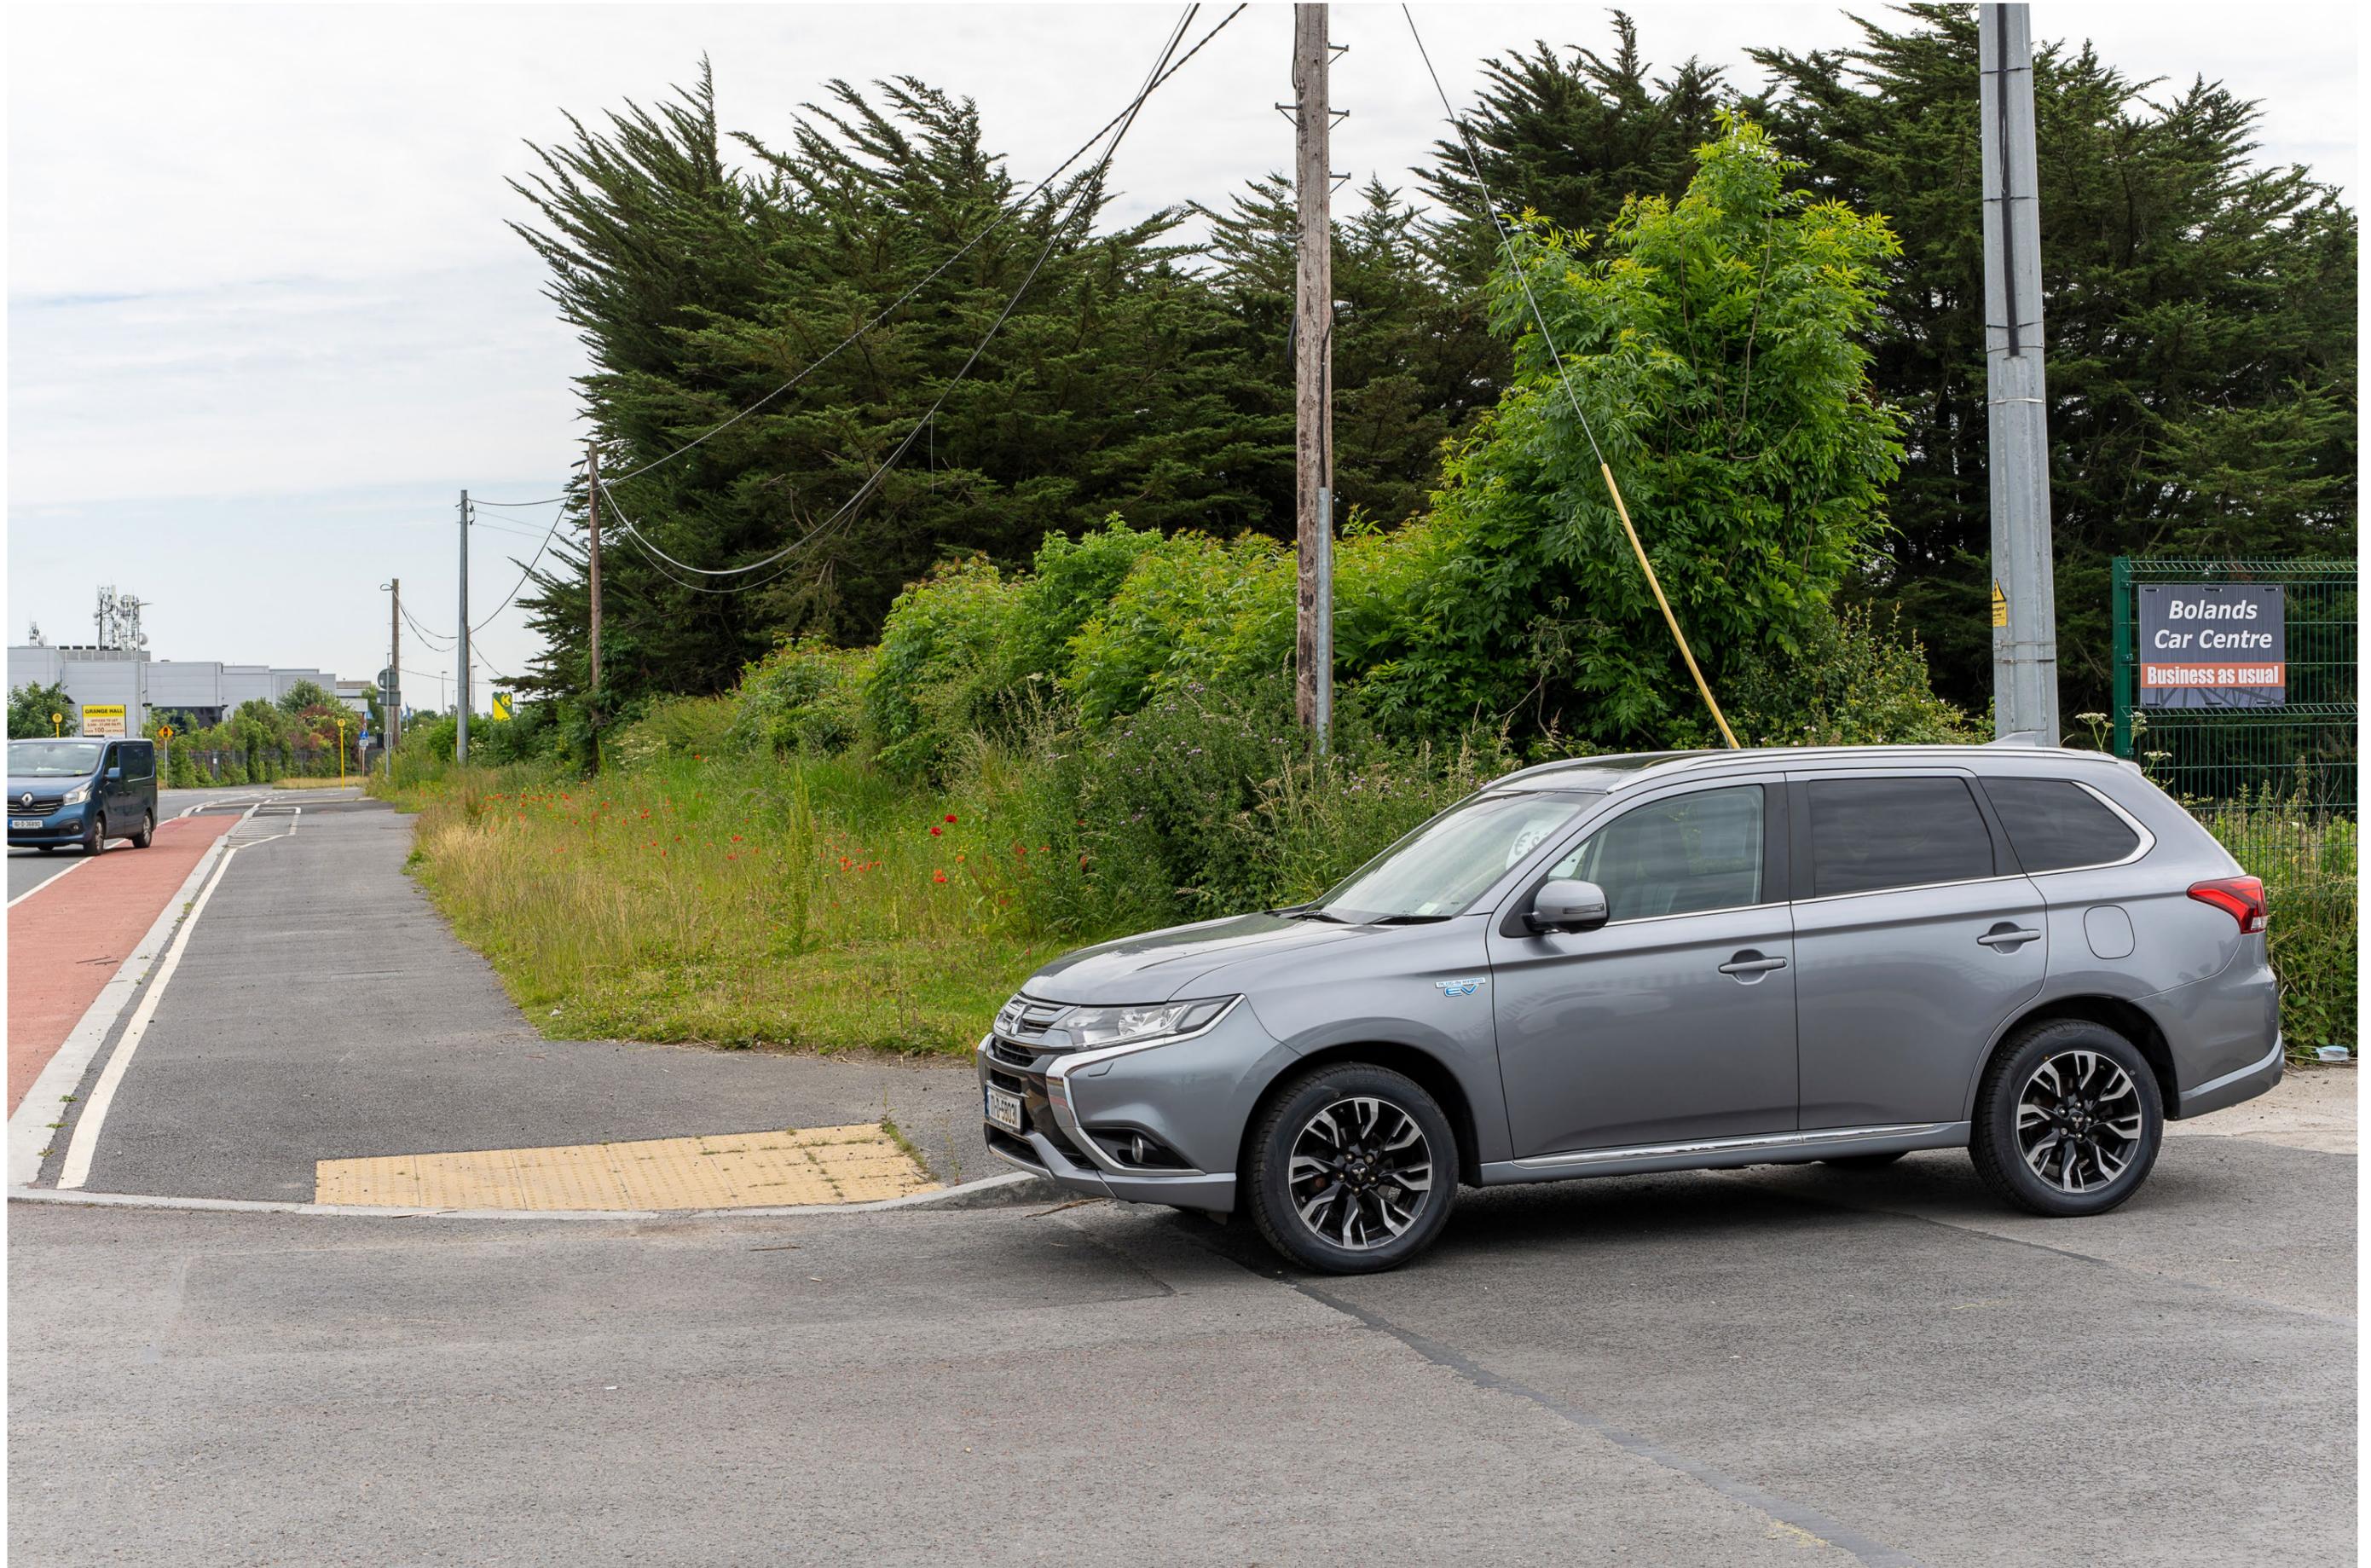
Viewpoint 5: R134 New Nangor Road at Bolands Car Centre | Viewing distance at A3: 542mm | Horizontal field of view: 39.6° | Direction of view: 109°  
Camera: Sony ILCE-1| Lens: Sony 50mm | Camera height: 1.5m AGL | Date taken: 28 June 2021 | Aperture: f/11 | ISO speed: 100 | Shutter: 1/80 sec

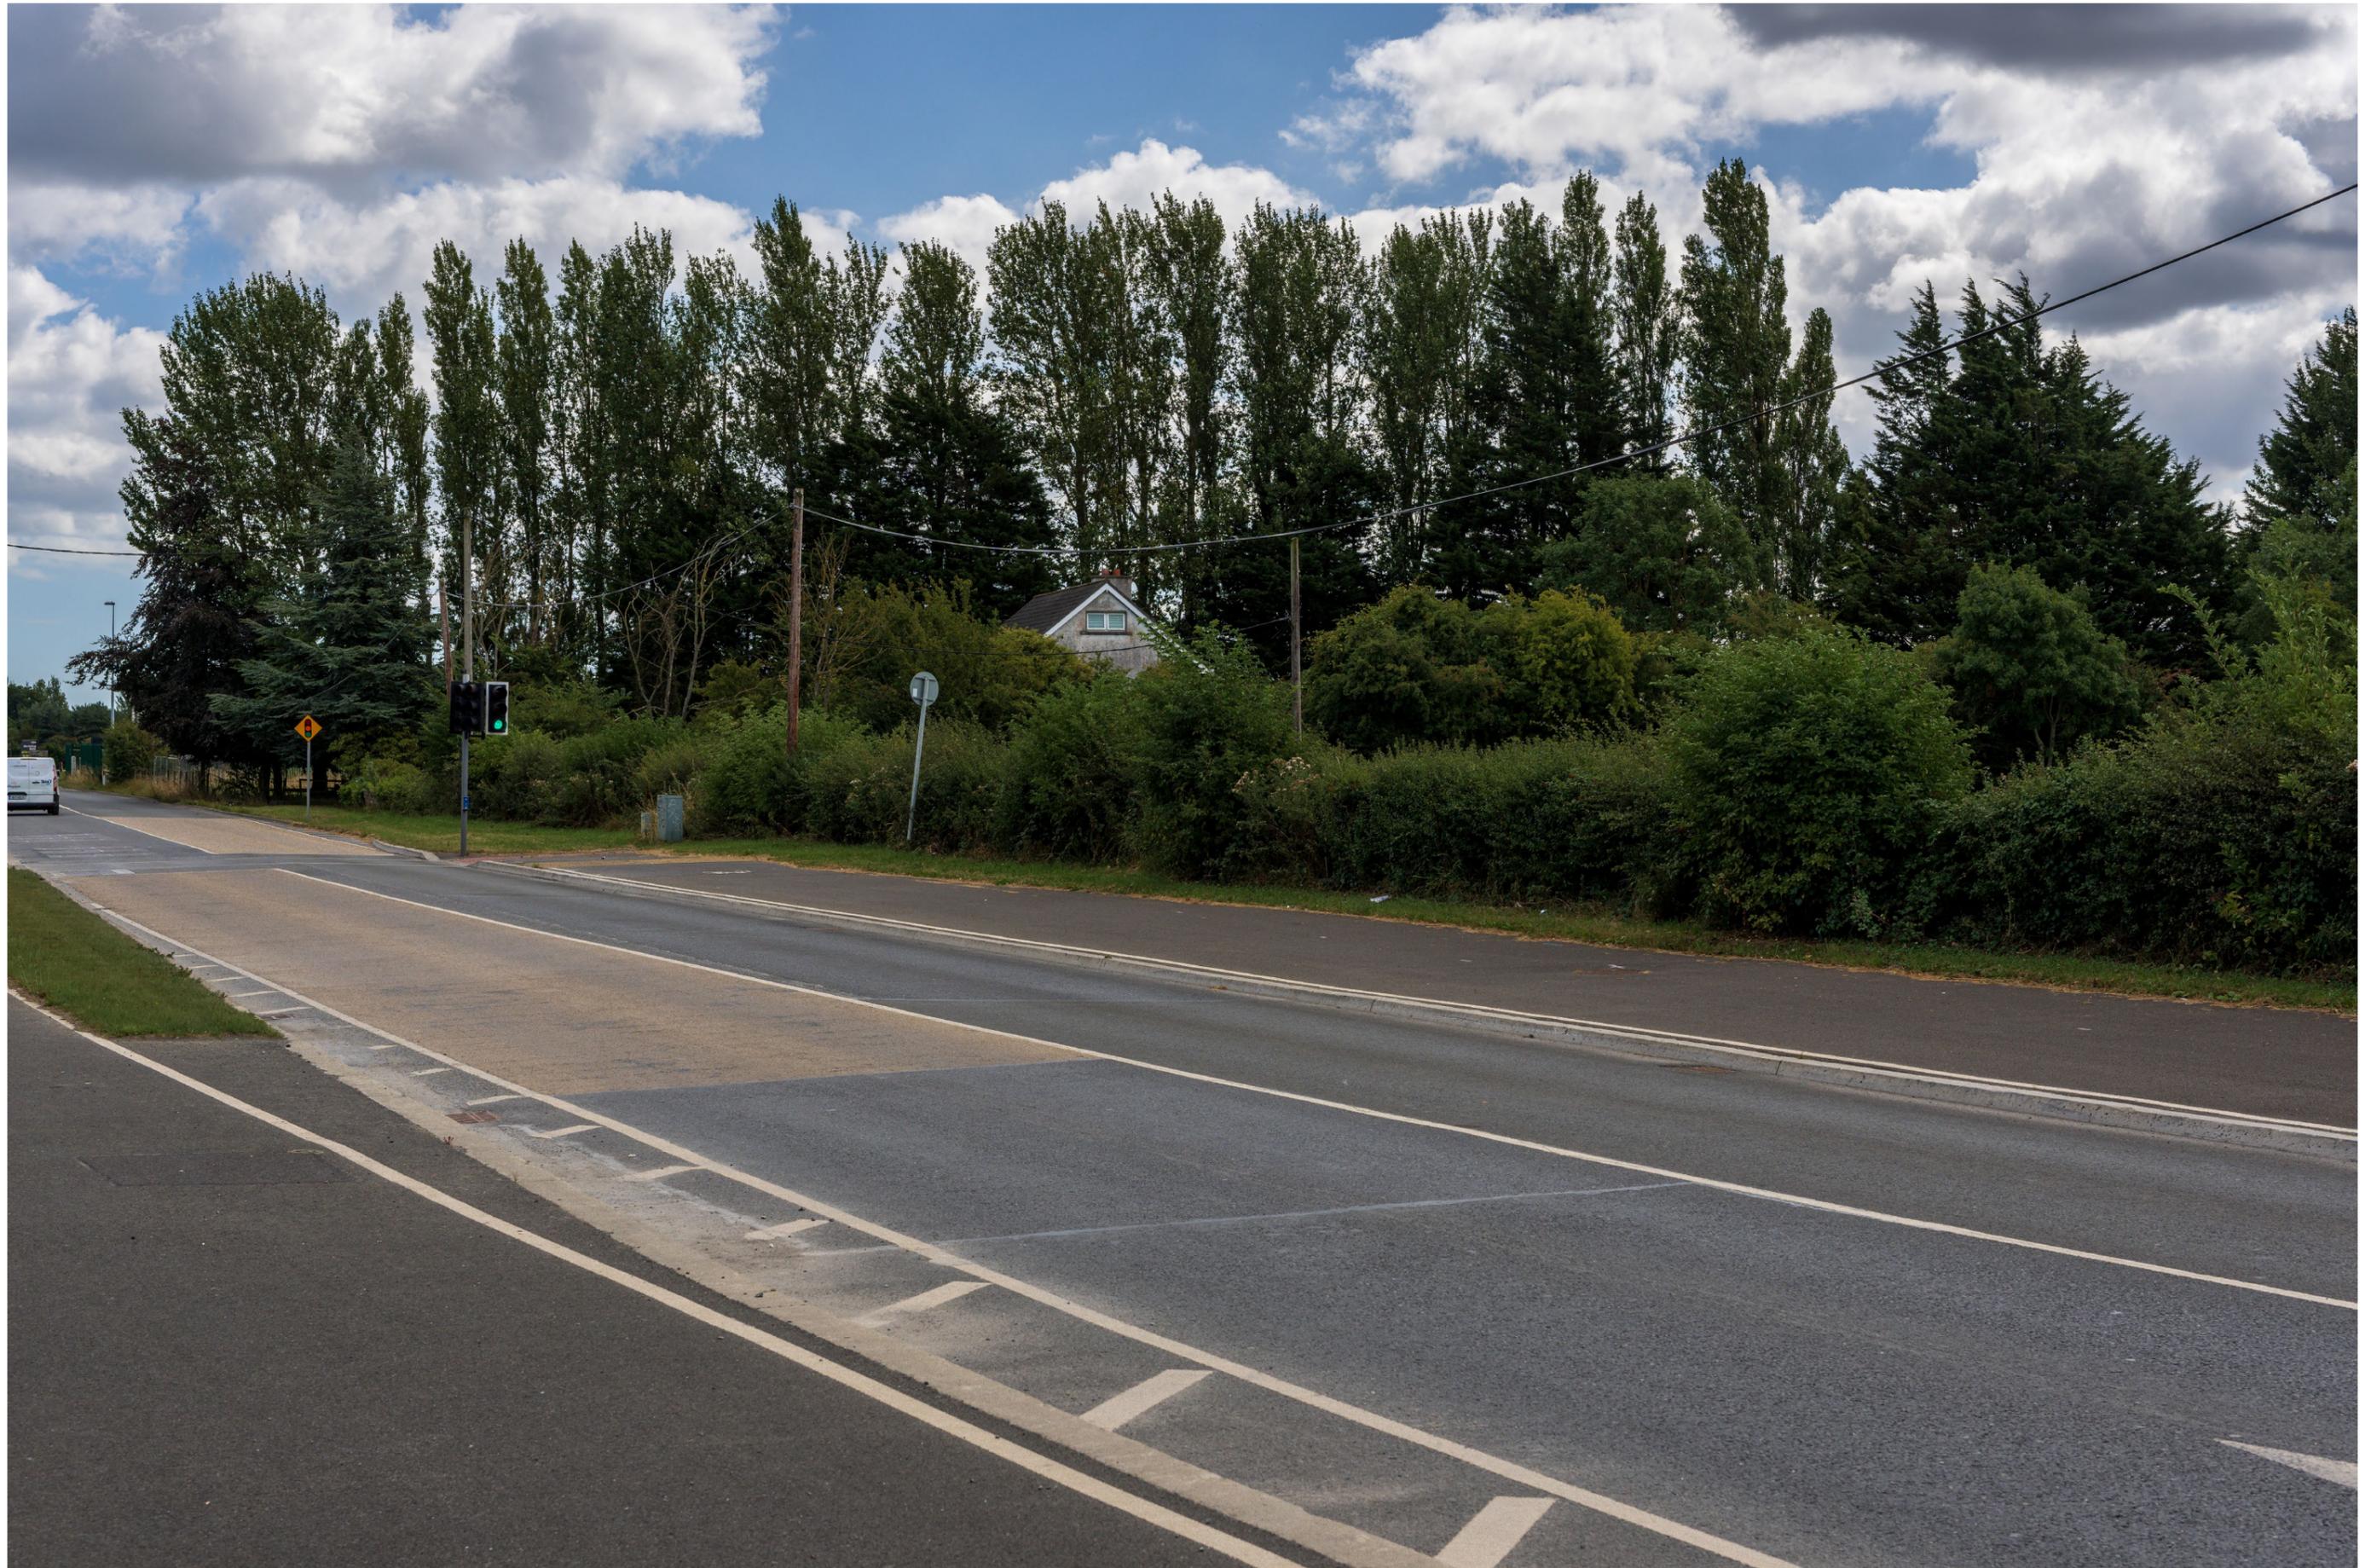
Viewpoint 6: R134 New Nangor Road at the north west corner of the Site | Viewing distance at A3: 542mm | Horizontal field of view: 39.6° | Direction of view: 178°  
Camera: Sony ILCE-1 | Lens: Sony 50mm | Camera height: 1.5m AGL | Date taken: 25 August 2022 | Aperture: f/8 | ISO speed: 100 | Shutter: 1/500 sec

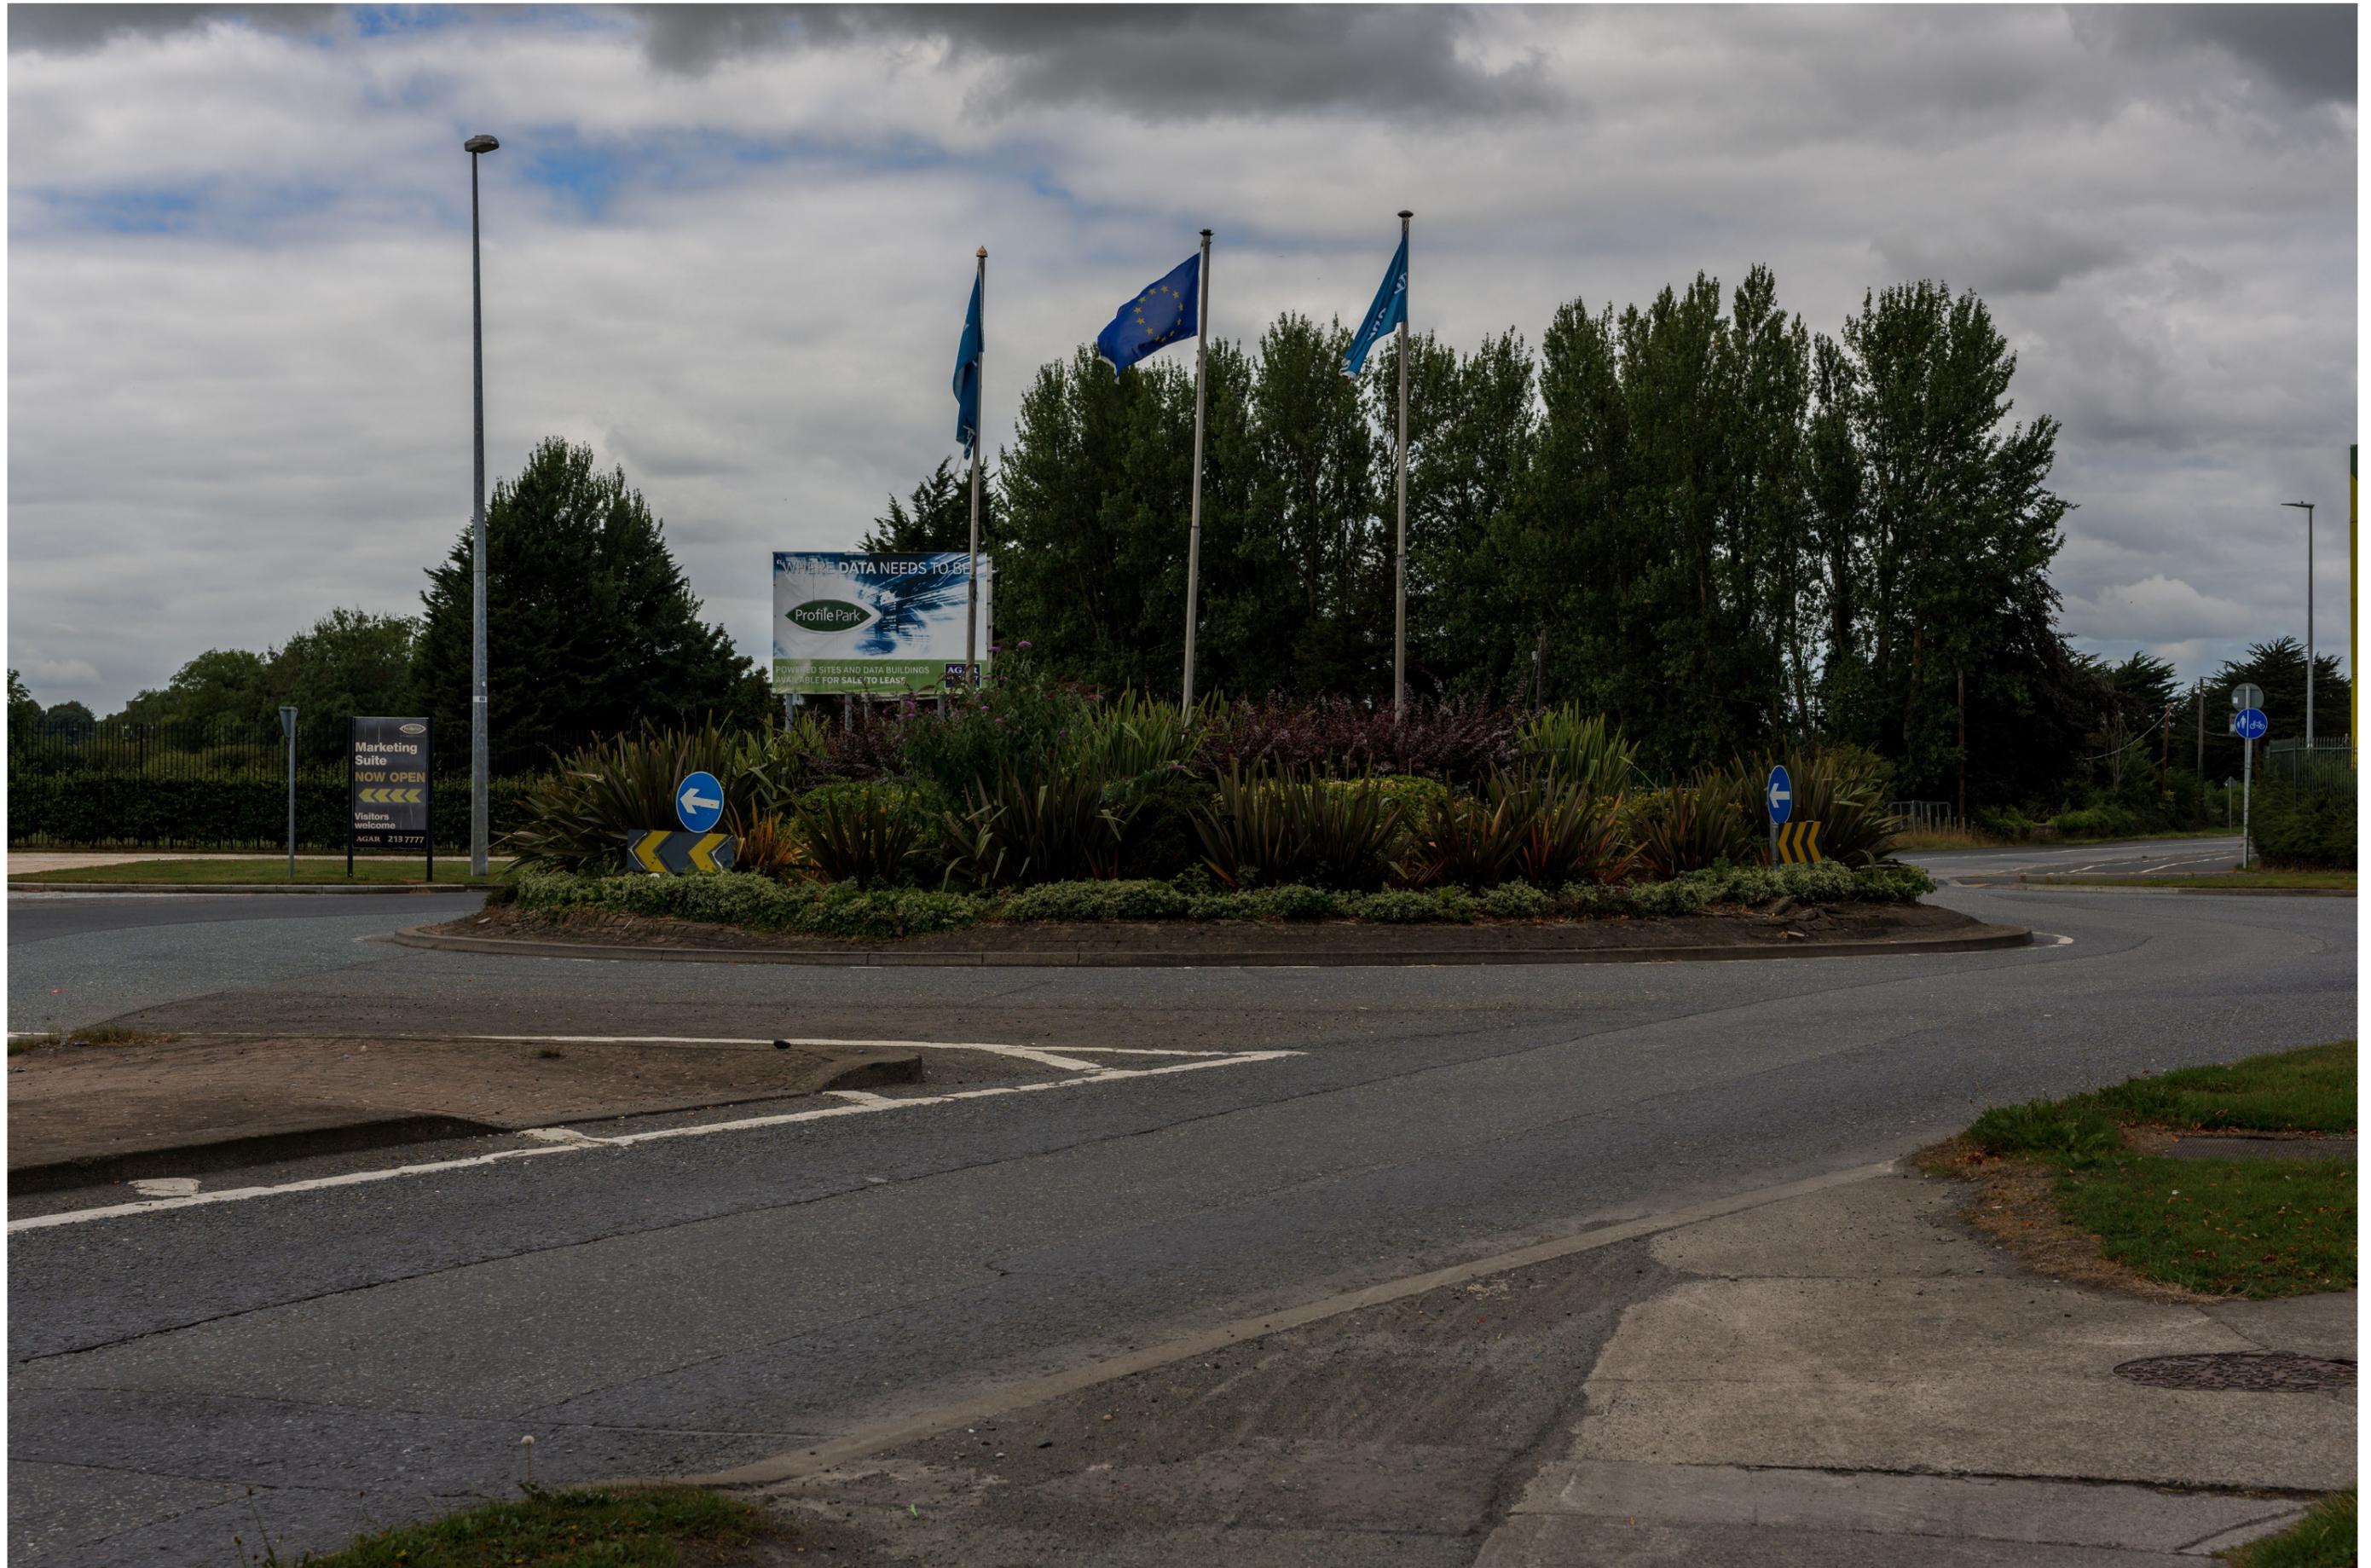
Viewpoint 7: R134 New Nangor Road at Profile Park entrance | Viewing distance at A3: 542mm | Horizontal field of view: 39.6° | Direction of view: 252°  
Camera: Sony ILCE-1| Lens: Sony 50mm | Camera height: 1.5m AGL | Date taken: 25 August 2022 | Aperture: f/8 | ISO speed: 100 | Shutter: 1/320 sec

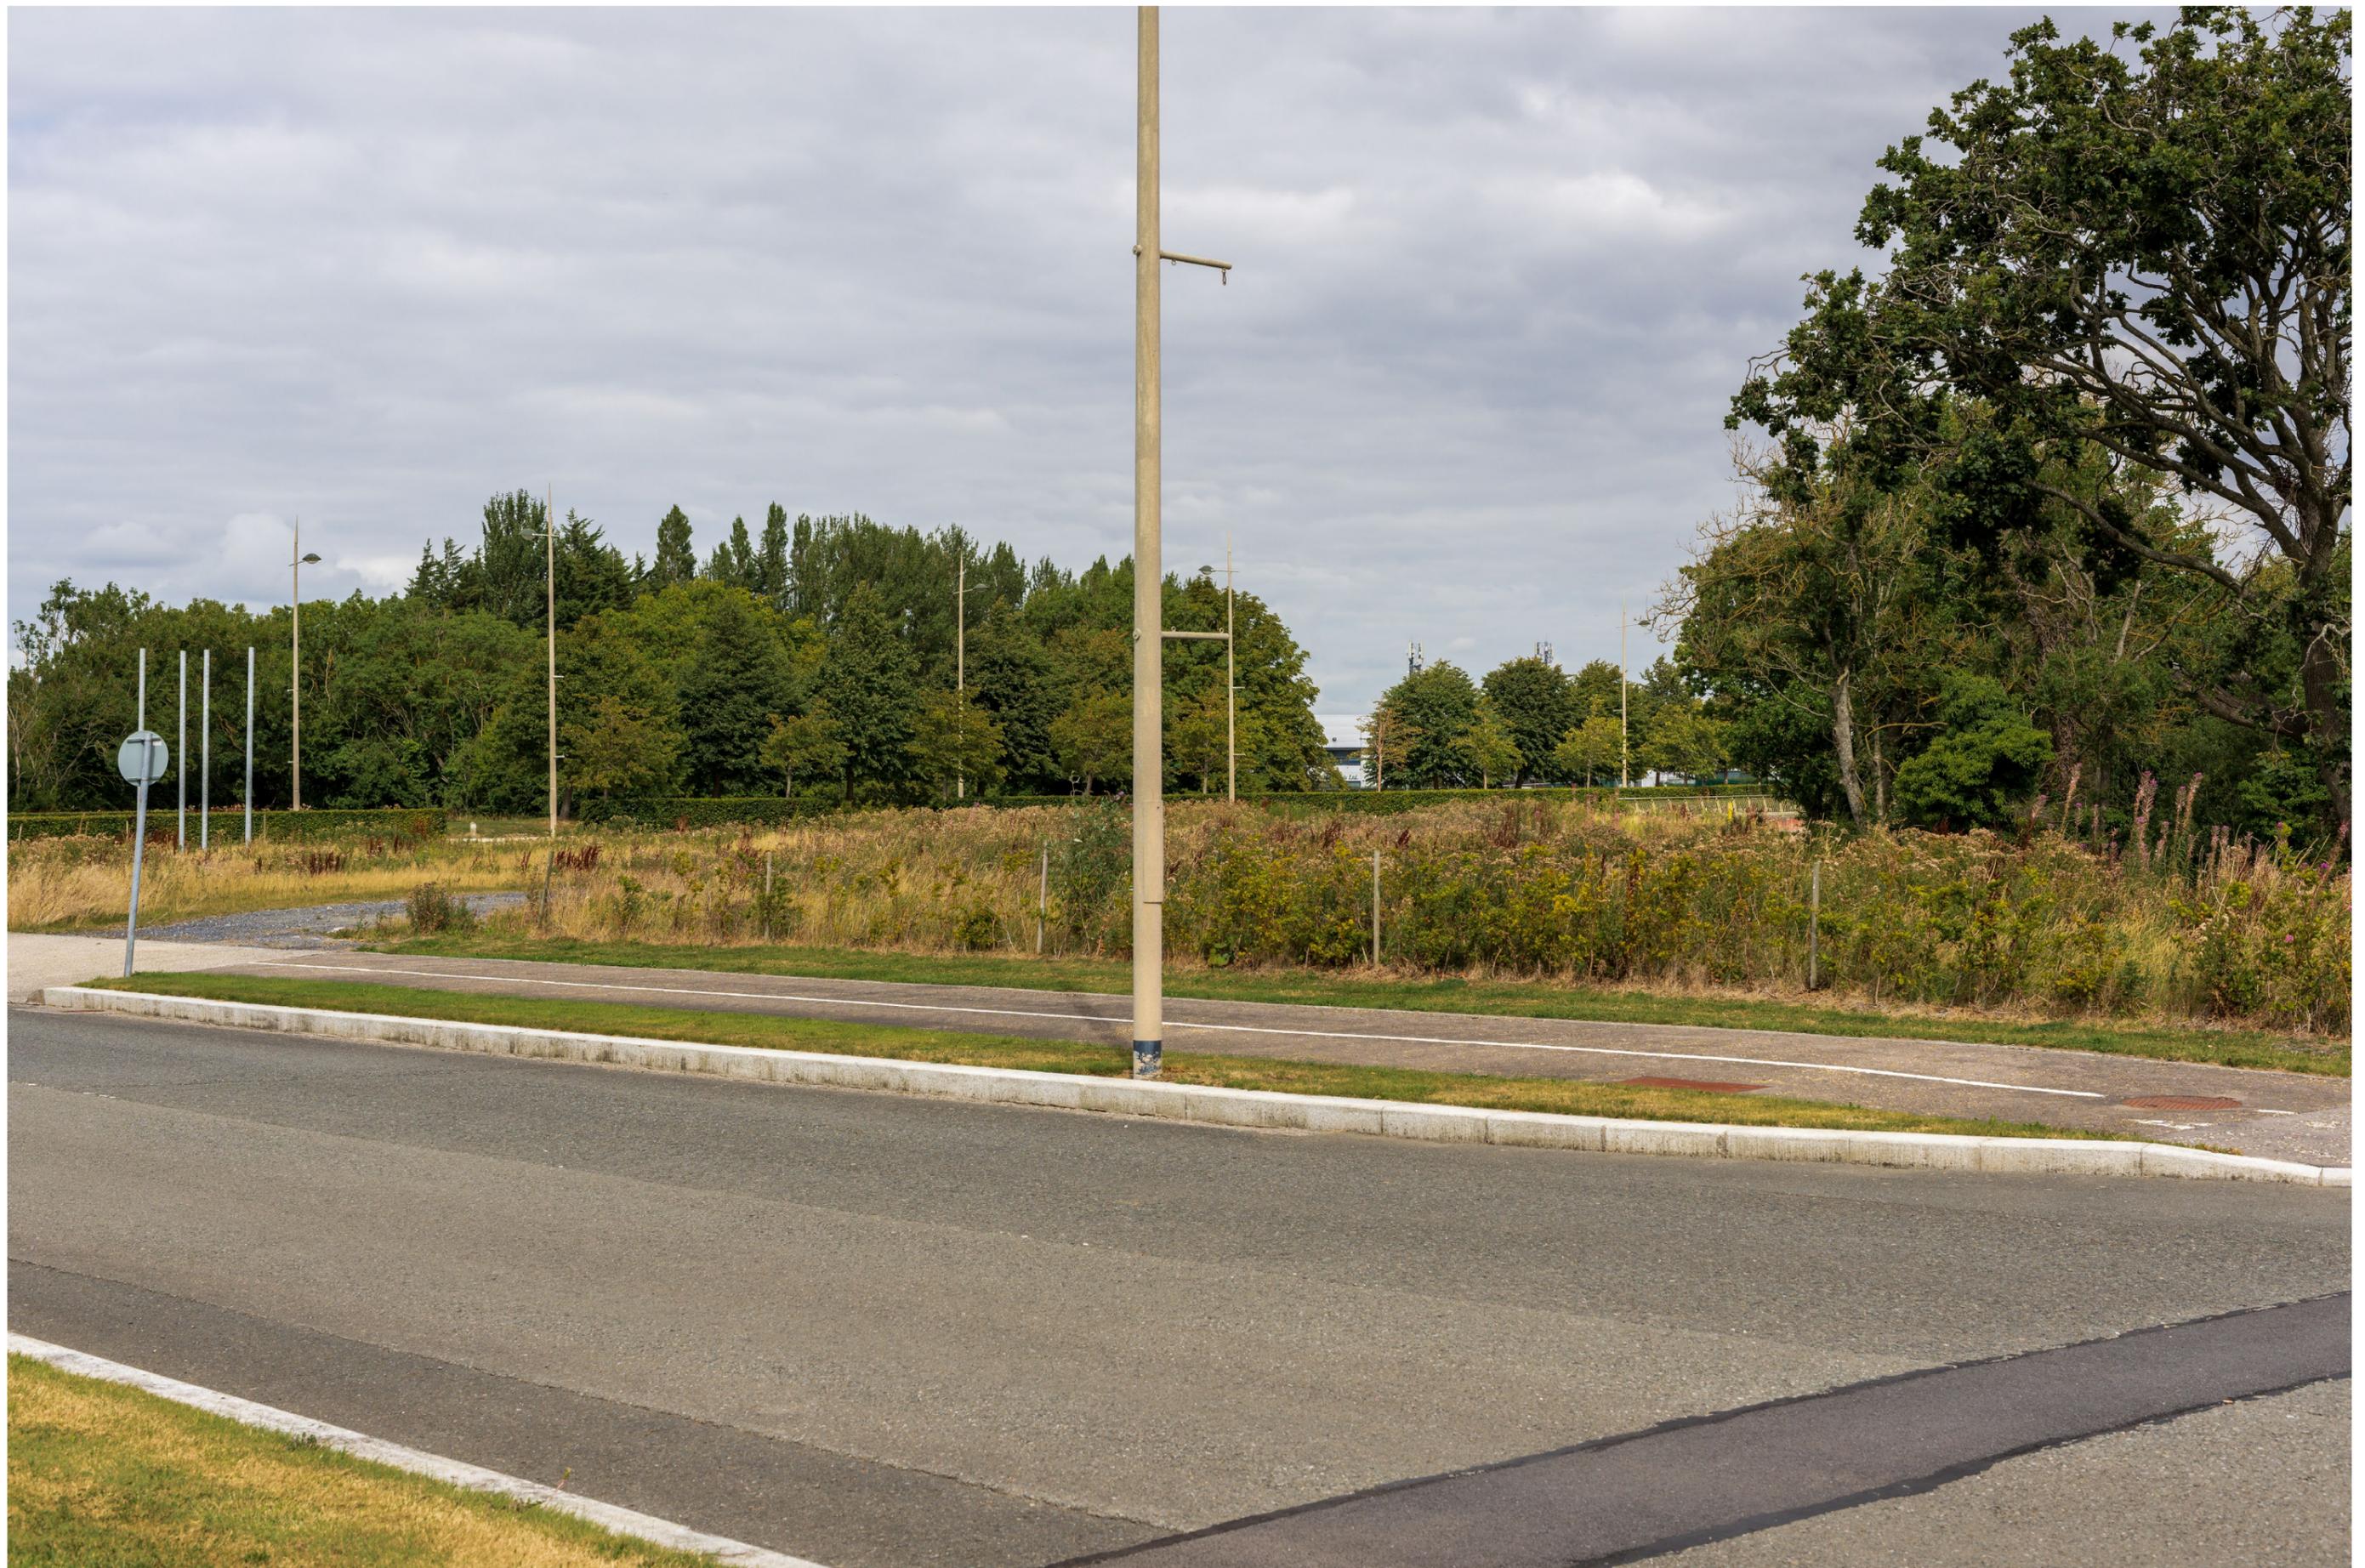
Viewpoint 8: Profile Park Access Road | Viewing distance at A3: 542mm | Horizontal field of view: 39.6° | Direction of view: 354°  
Camera: Sony ILCE-1 | Lens: Sony 50mm | Camera height: 1.5m AGL | Date taken: 25 August 2022 | Aperture: f/8 | ISO speed: 100 | Shutter: 1/320sec

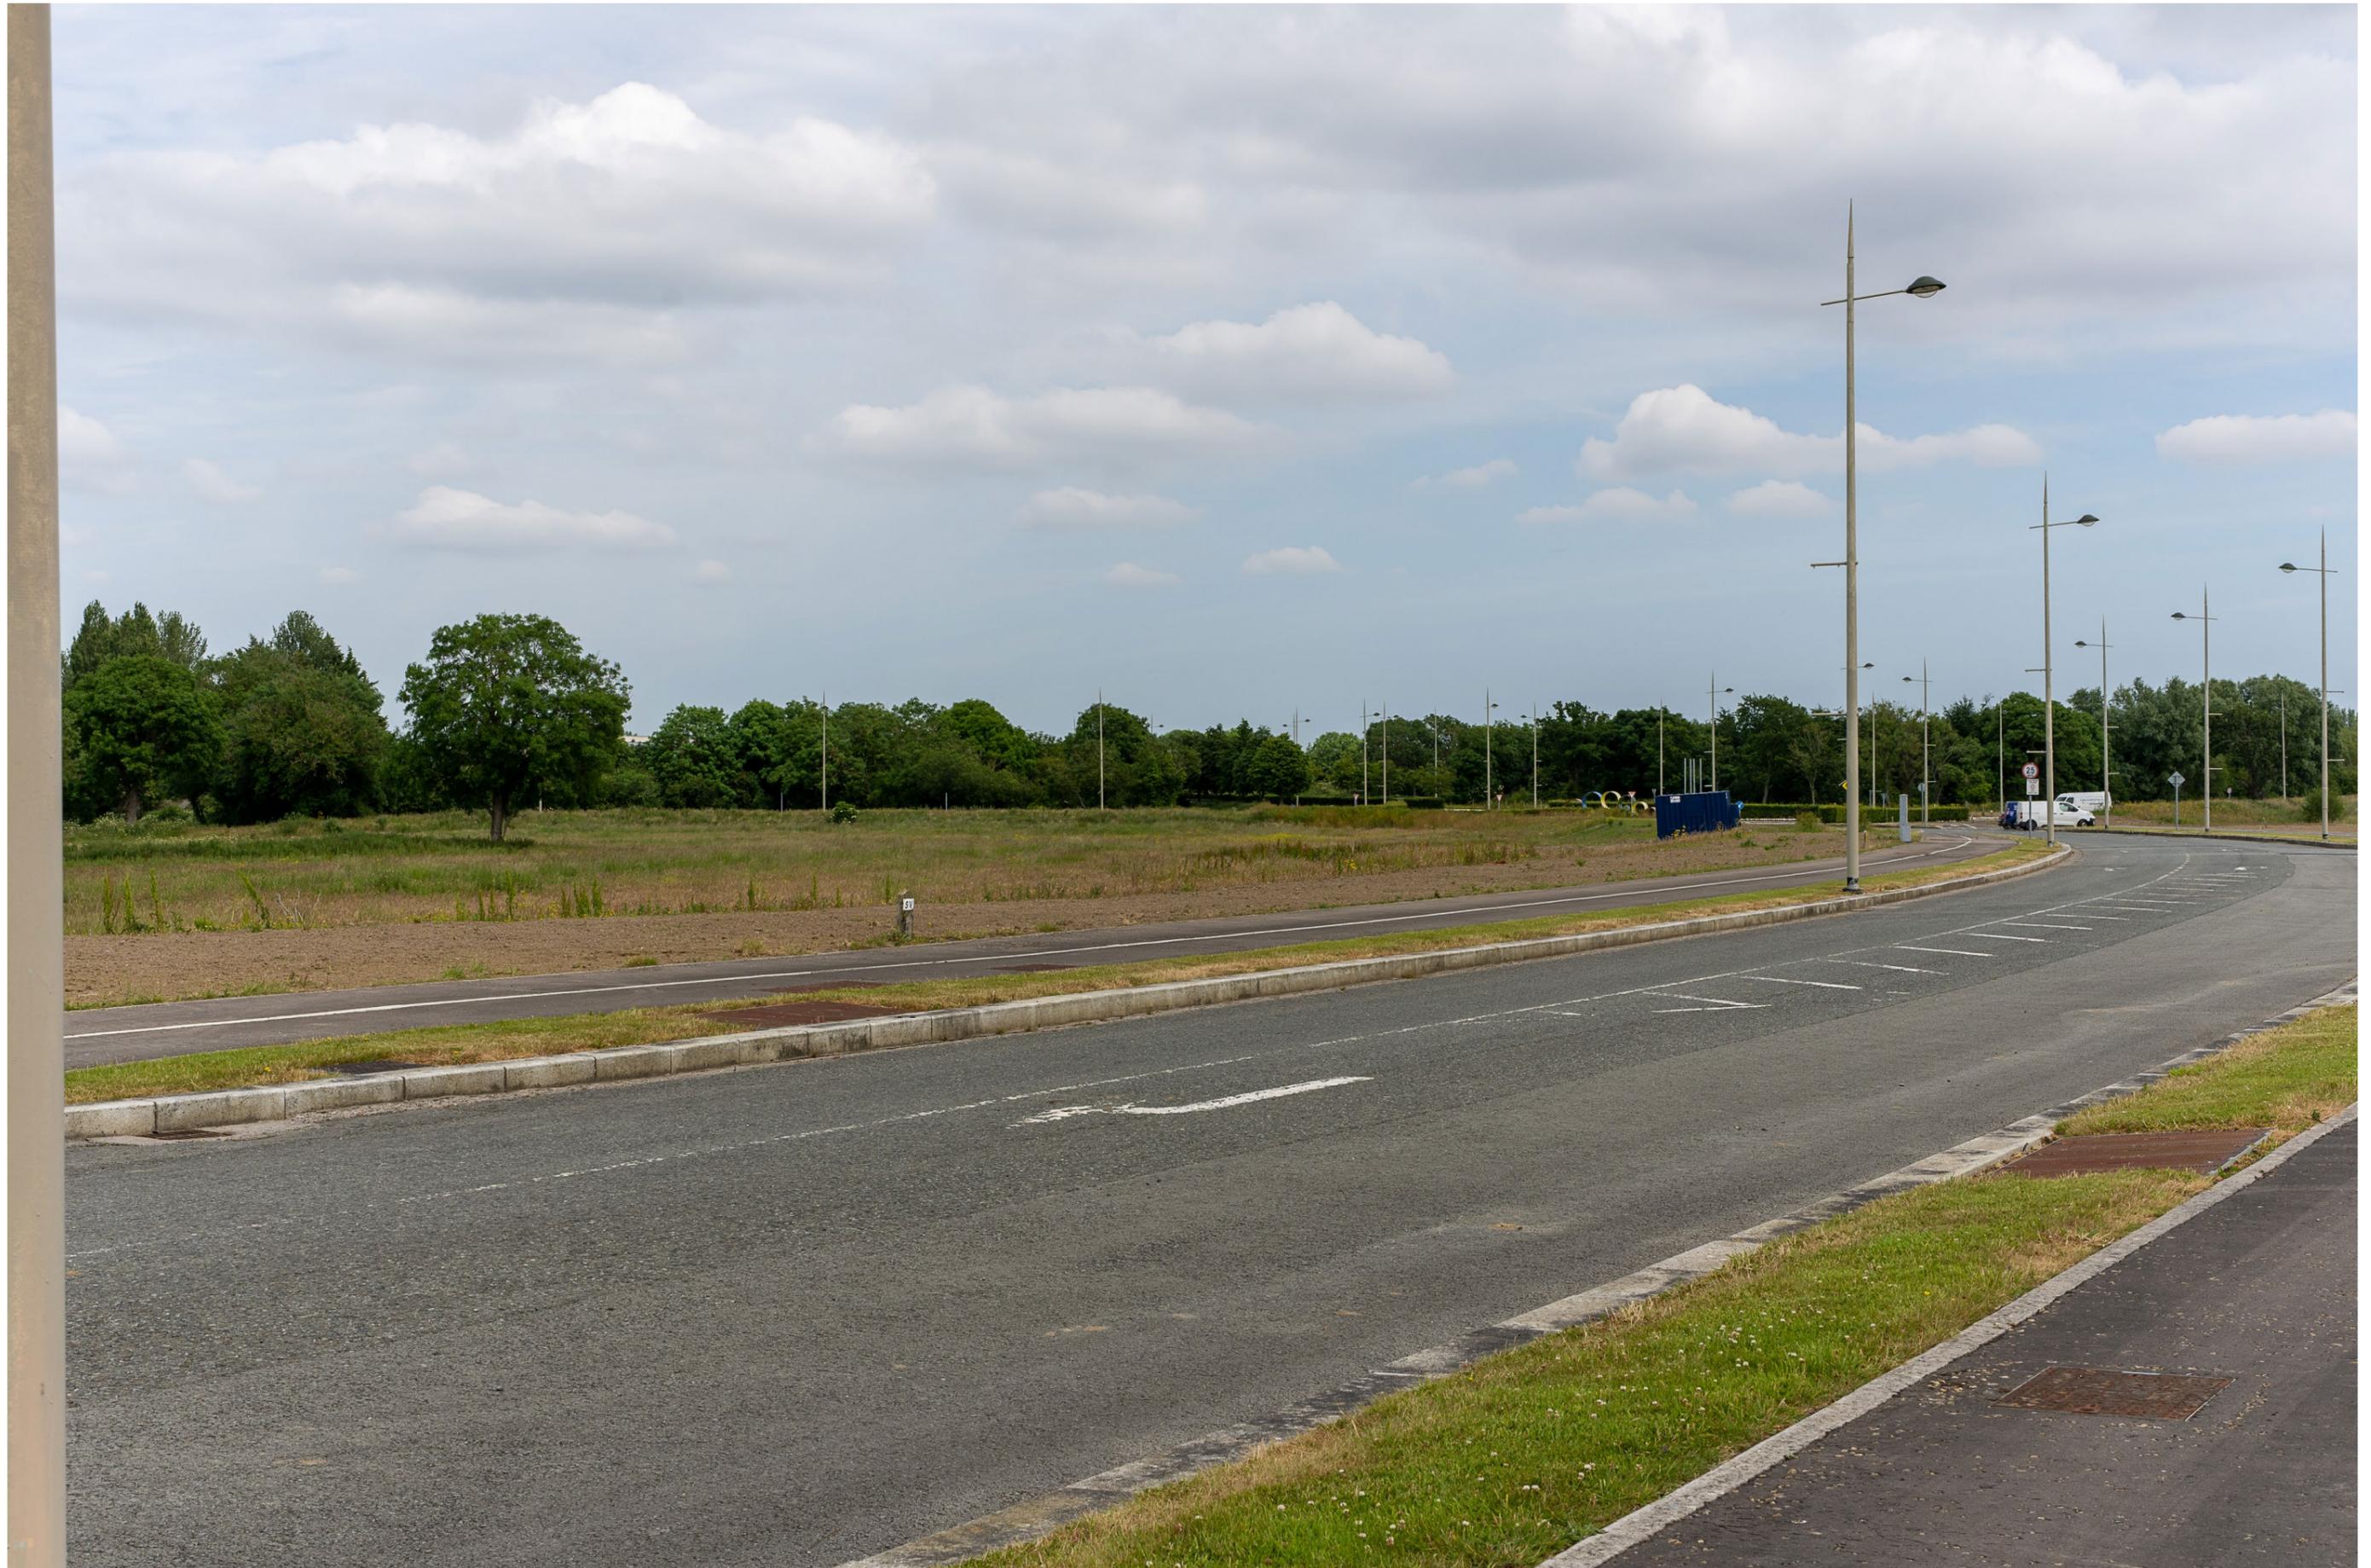
Viewpoint 9: Profile Park Access Road | Viewing distance at A3: 542mm | Horizontal field of view: 39.6° | Direction of view: 335°  
Camera: Sony ILCE-1 | Lens: Sony 50mm | Camera height: 1.5m AGL | Date taken: 28 June 2021 | Aperture: f/11 | ISO speed: 100 | Shutter: 1/160 sec

- 2.7.29 The site is not part of an area of intact historic landscape and there are no on-site standing structures of heritage interest. The portion of the townland boundaries representing pre-17th century land divisions between Ballybane and Kilbride noted above survives as a line of vegetation along the stream on the south edge of the site (see viewpoint photographs 9 and 10, Volume 2, Chapter 1: Landscape and Visual Impact Assessment (LVIA)).

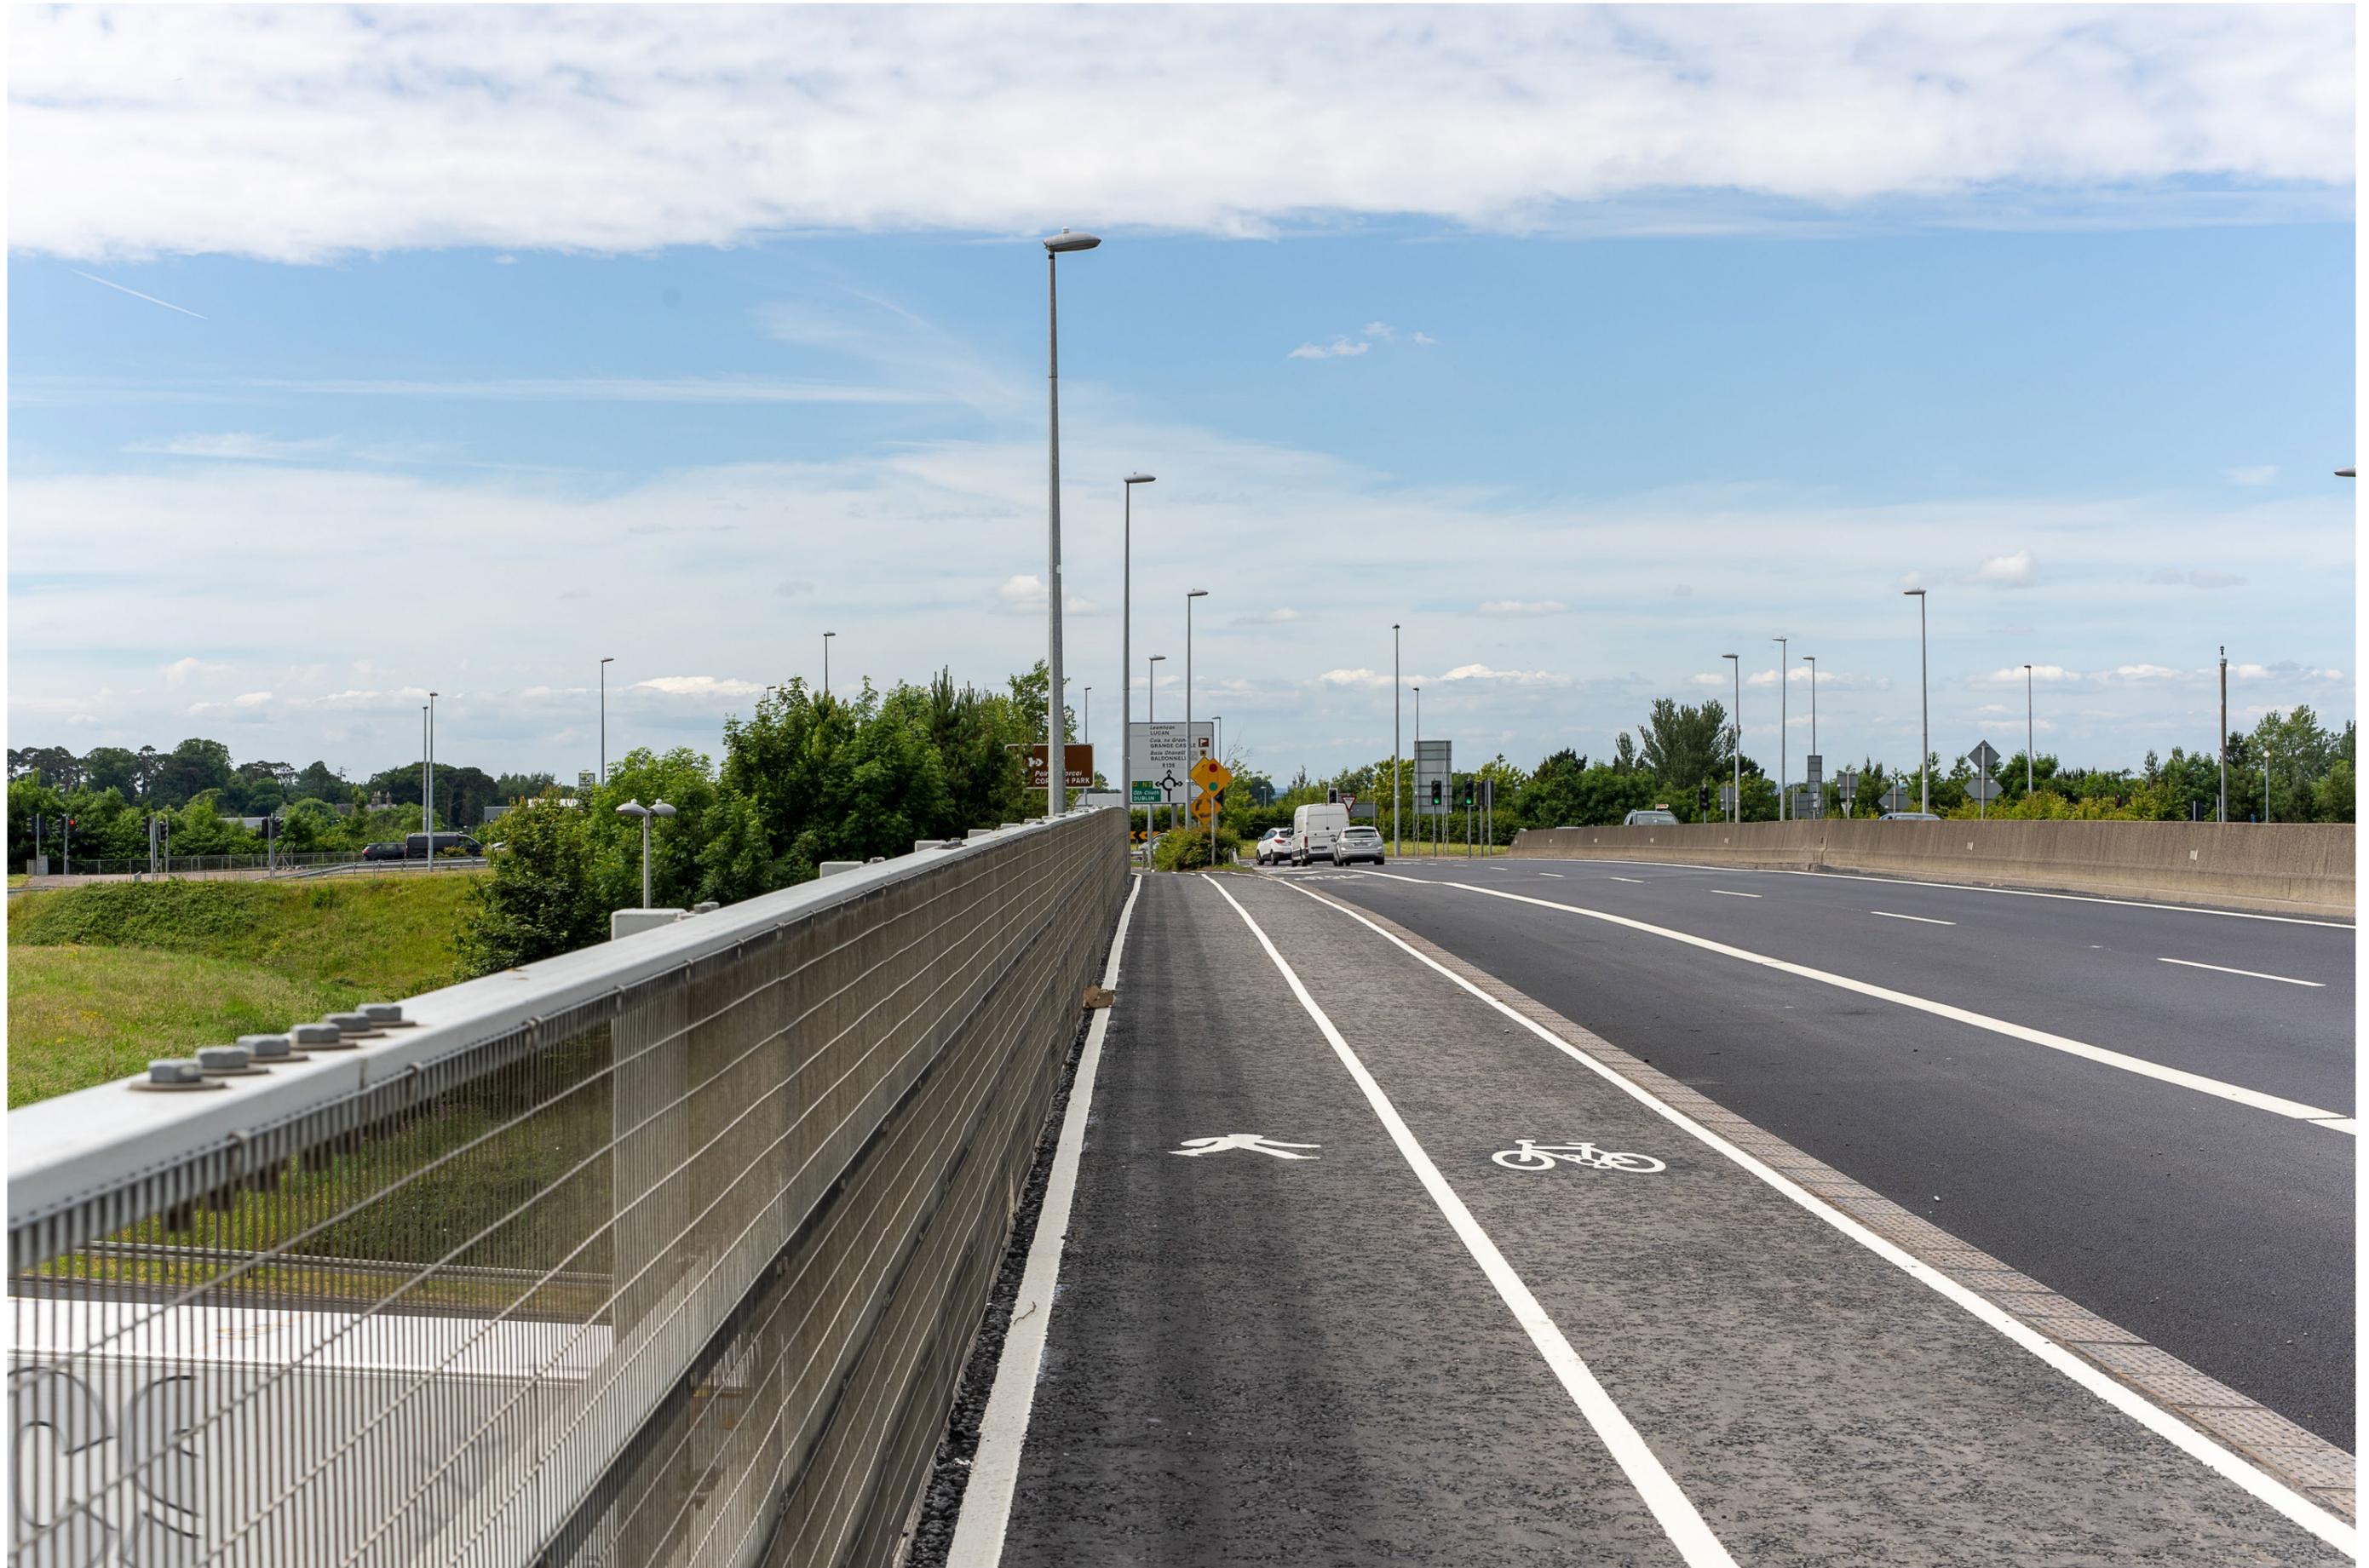
Viewpoint 10: N7 and R136 Junction | Viewing distance at A3: 542mm | Horizontal field of view: 39.6° | Direction of view: 310°  
Camera: Sony ILCE-1 | Lens: Sony 50mm | Camera height: 1.5m AGL | Date taken: 28 June 2021 | Aperture: f/11 | ISO speed: 100 | Shutter: 1/160 sec
