Intended for  
**Vantage Data Centers DUB13 Limited**

Date  
**March 2023**

# **VANTAGE DUBLIN DATA CENTER**

## **VOLUME 2A: LANDSCAPE, VISUAL AND BUILT HERITAGE IMPACT ASSESSMENT**

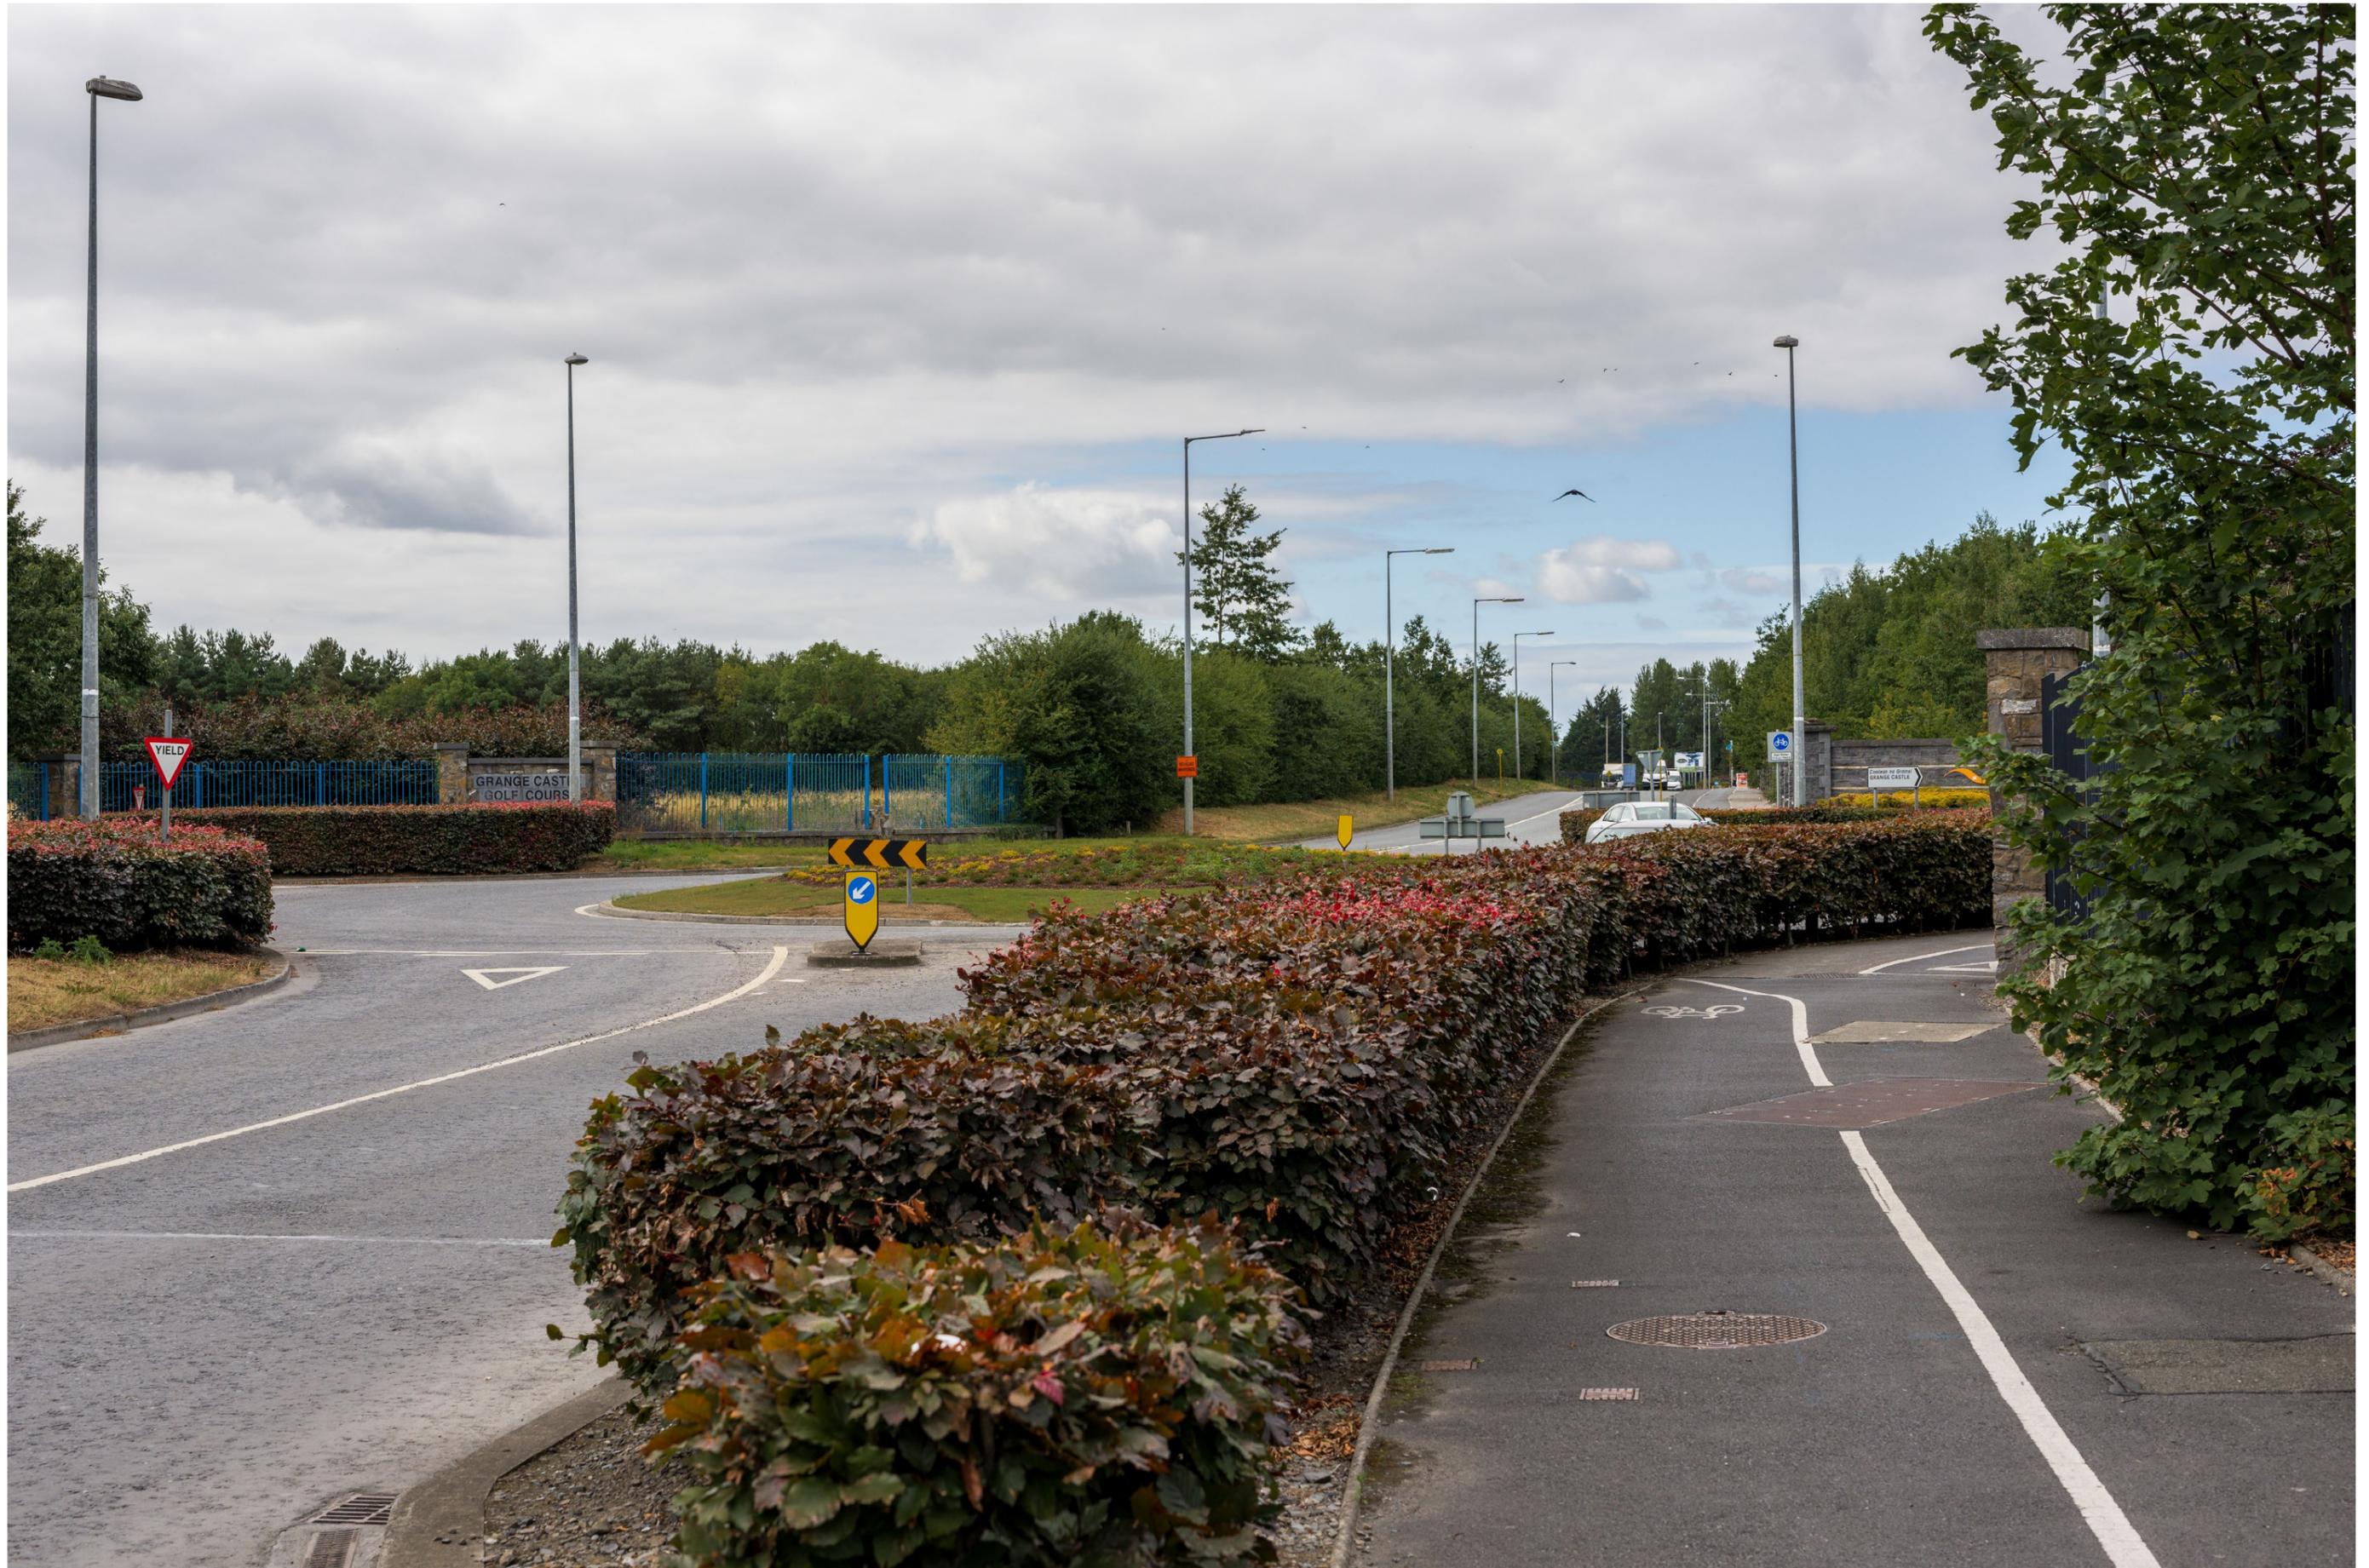
Viewpoint 11: R134 at entrance to Grange Castle Golf Course | Viewing distance at A3: 542mm | Horizontal field of view: 39.6° | Direction of view: 264°  
Camera: Sony ILCE-1 | Lens: Sony 50mm | Camera height: 1.5m AGL | Date taken: 25 August 2022 | Aperture: f/8 | ISO speed: 100 | Shutter: 1/320sec

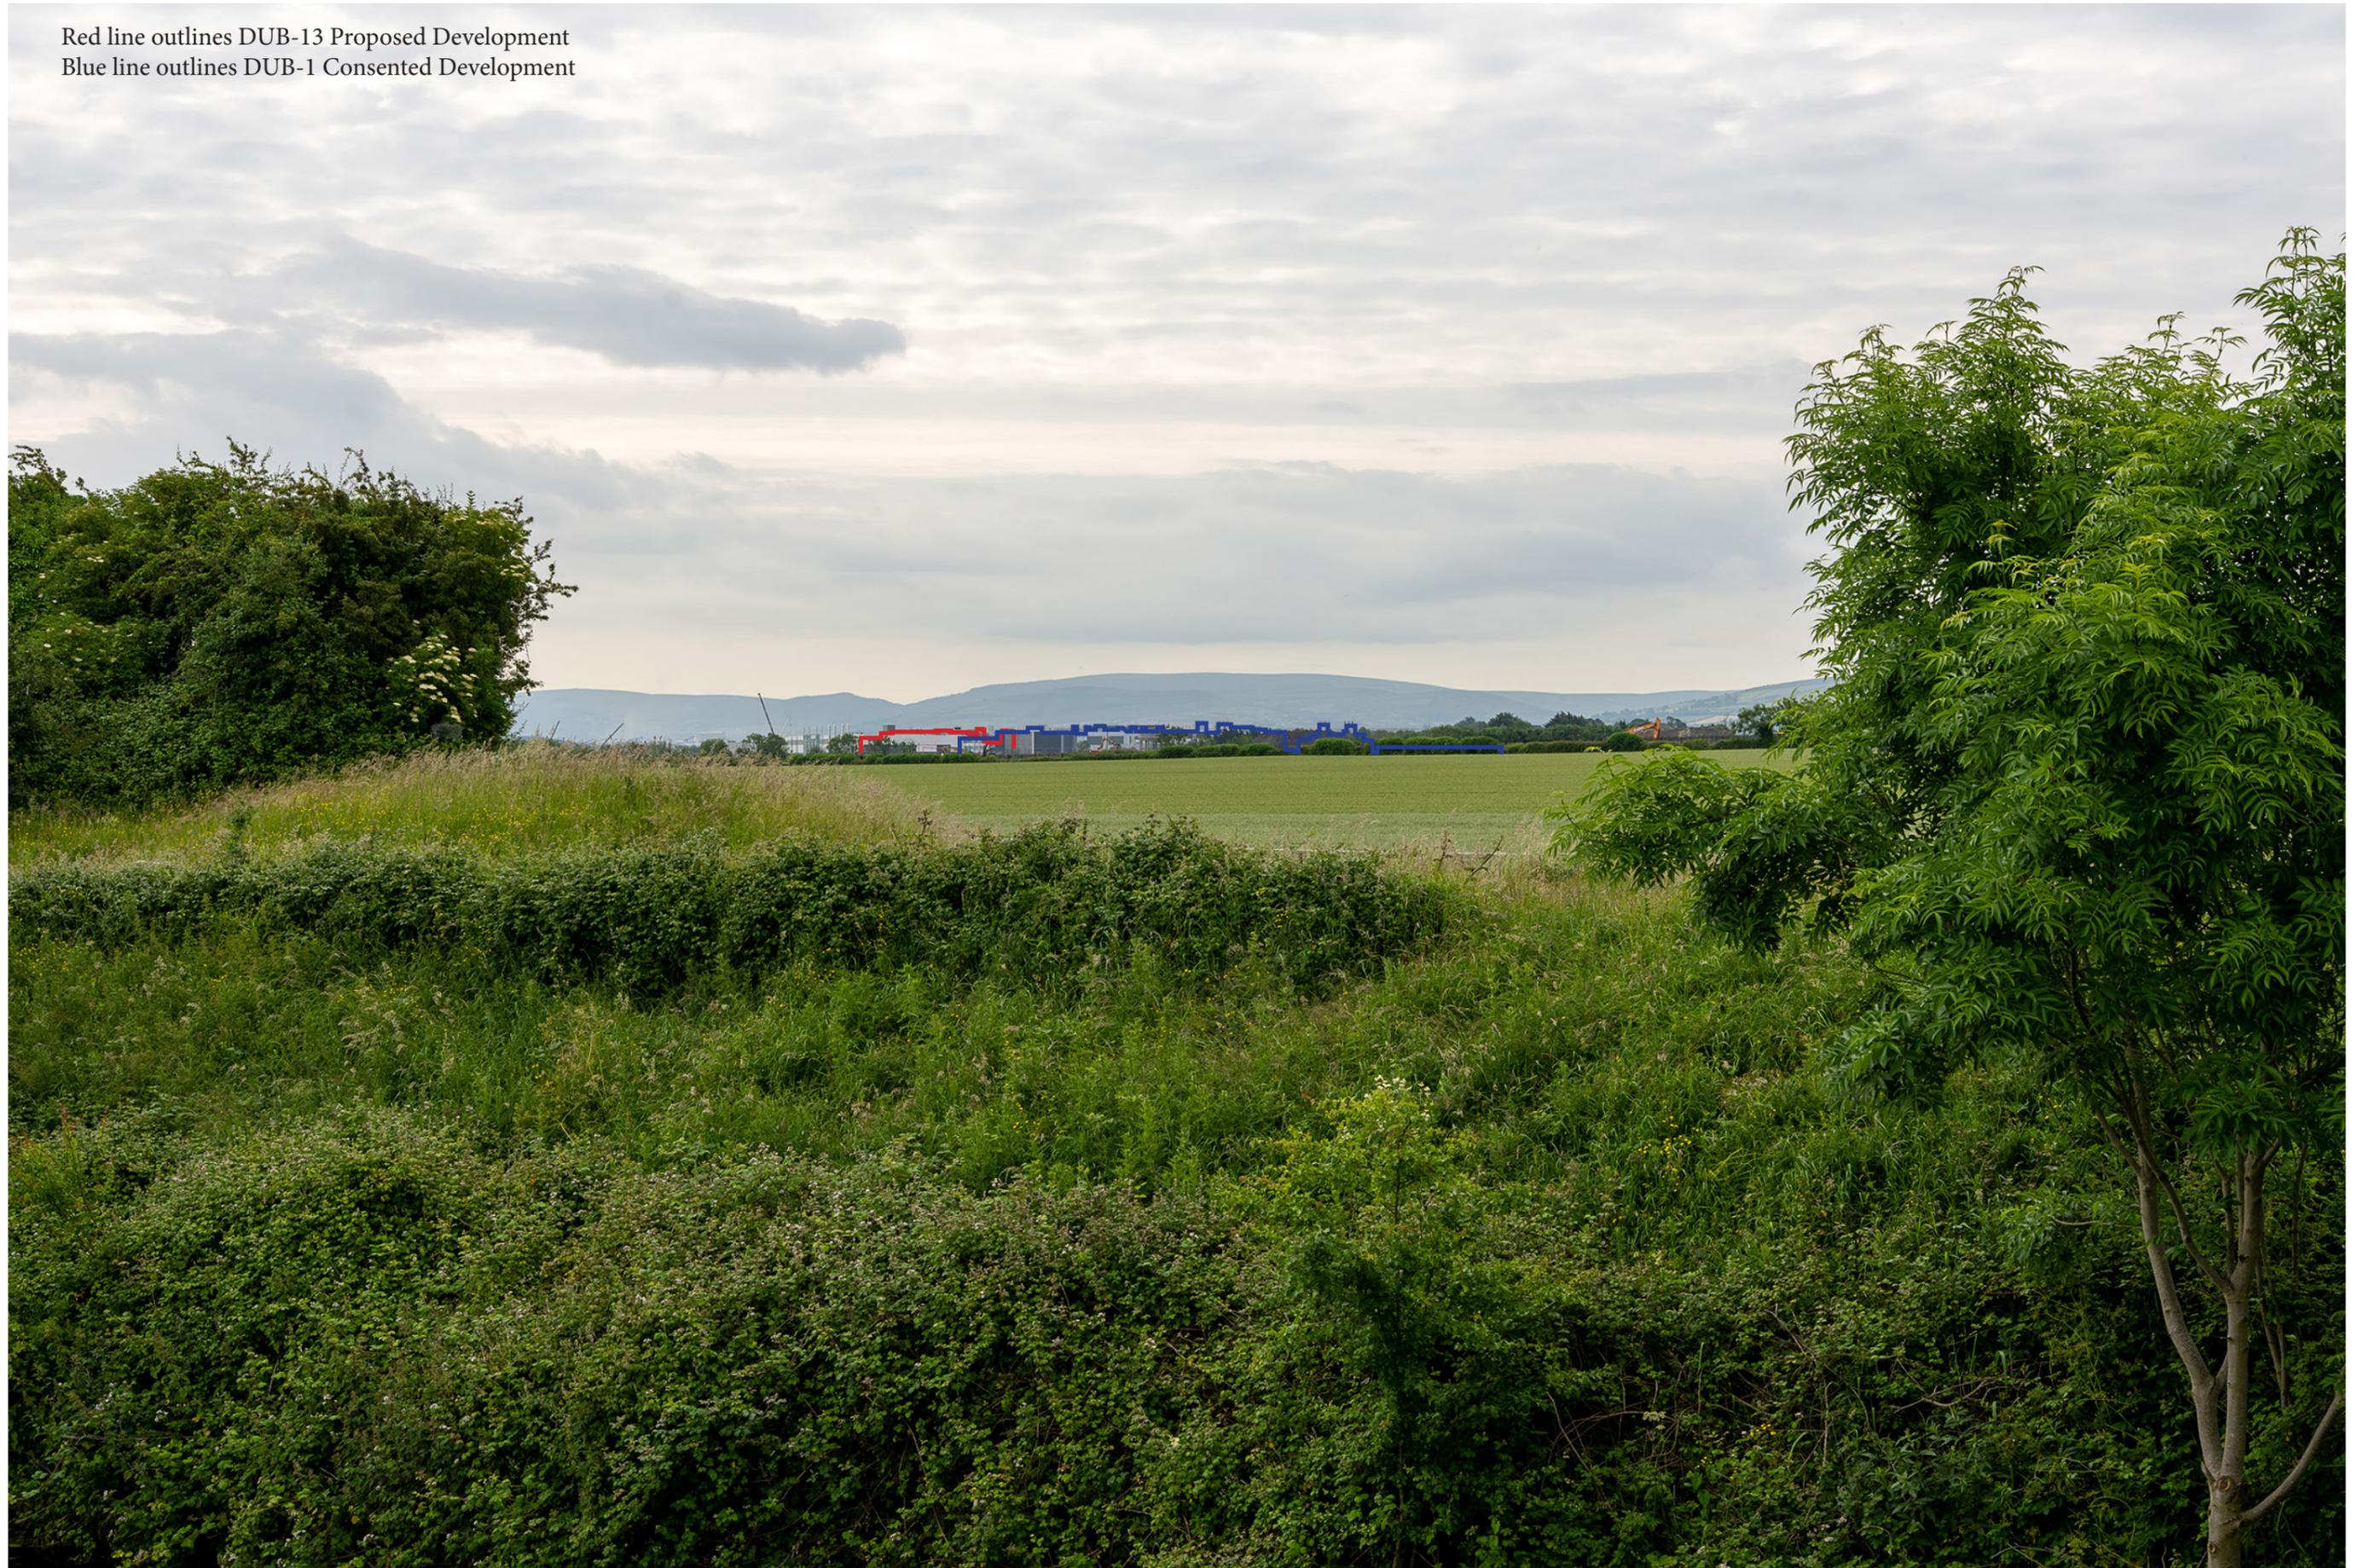
Viewpoint 1: Photomontage of Day 1 view from the Grand Canal | Viewing distance at A3: 542mm | Horizontal field of view: 39.6° | Direction of view: 134°  
Camera: Sony ILCE-1| Lens: Sony 50mm | Camera height: 1.5m AGL | Date taken: 28 June 2021 | Aperture: f/11 | ISO speed: 100 | Shutter: 1/160 sec

Red line indicates location of DUB-13 where screened.  
Blue line indicates DUB-1 Consented Development where screened.

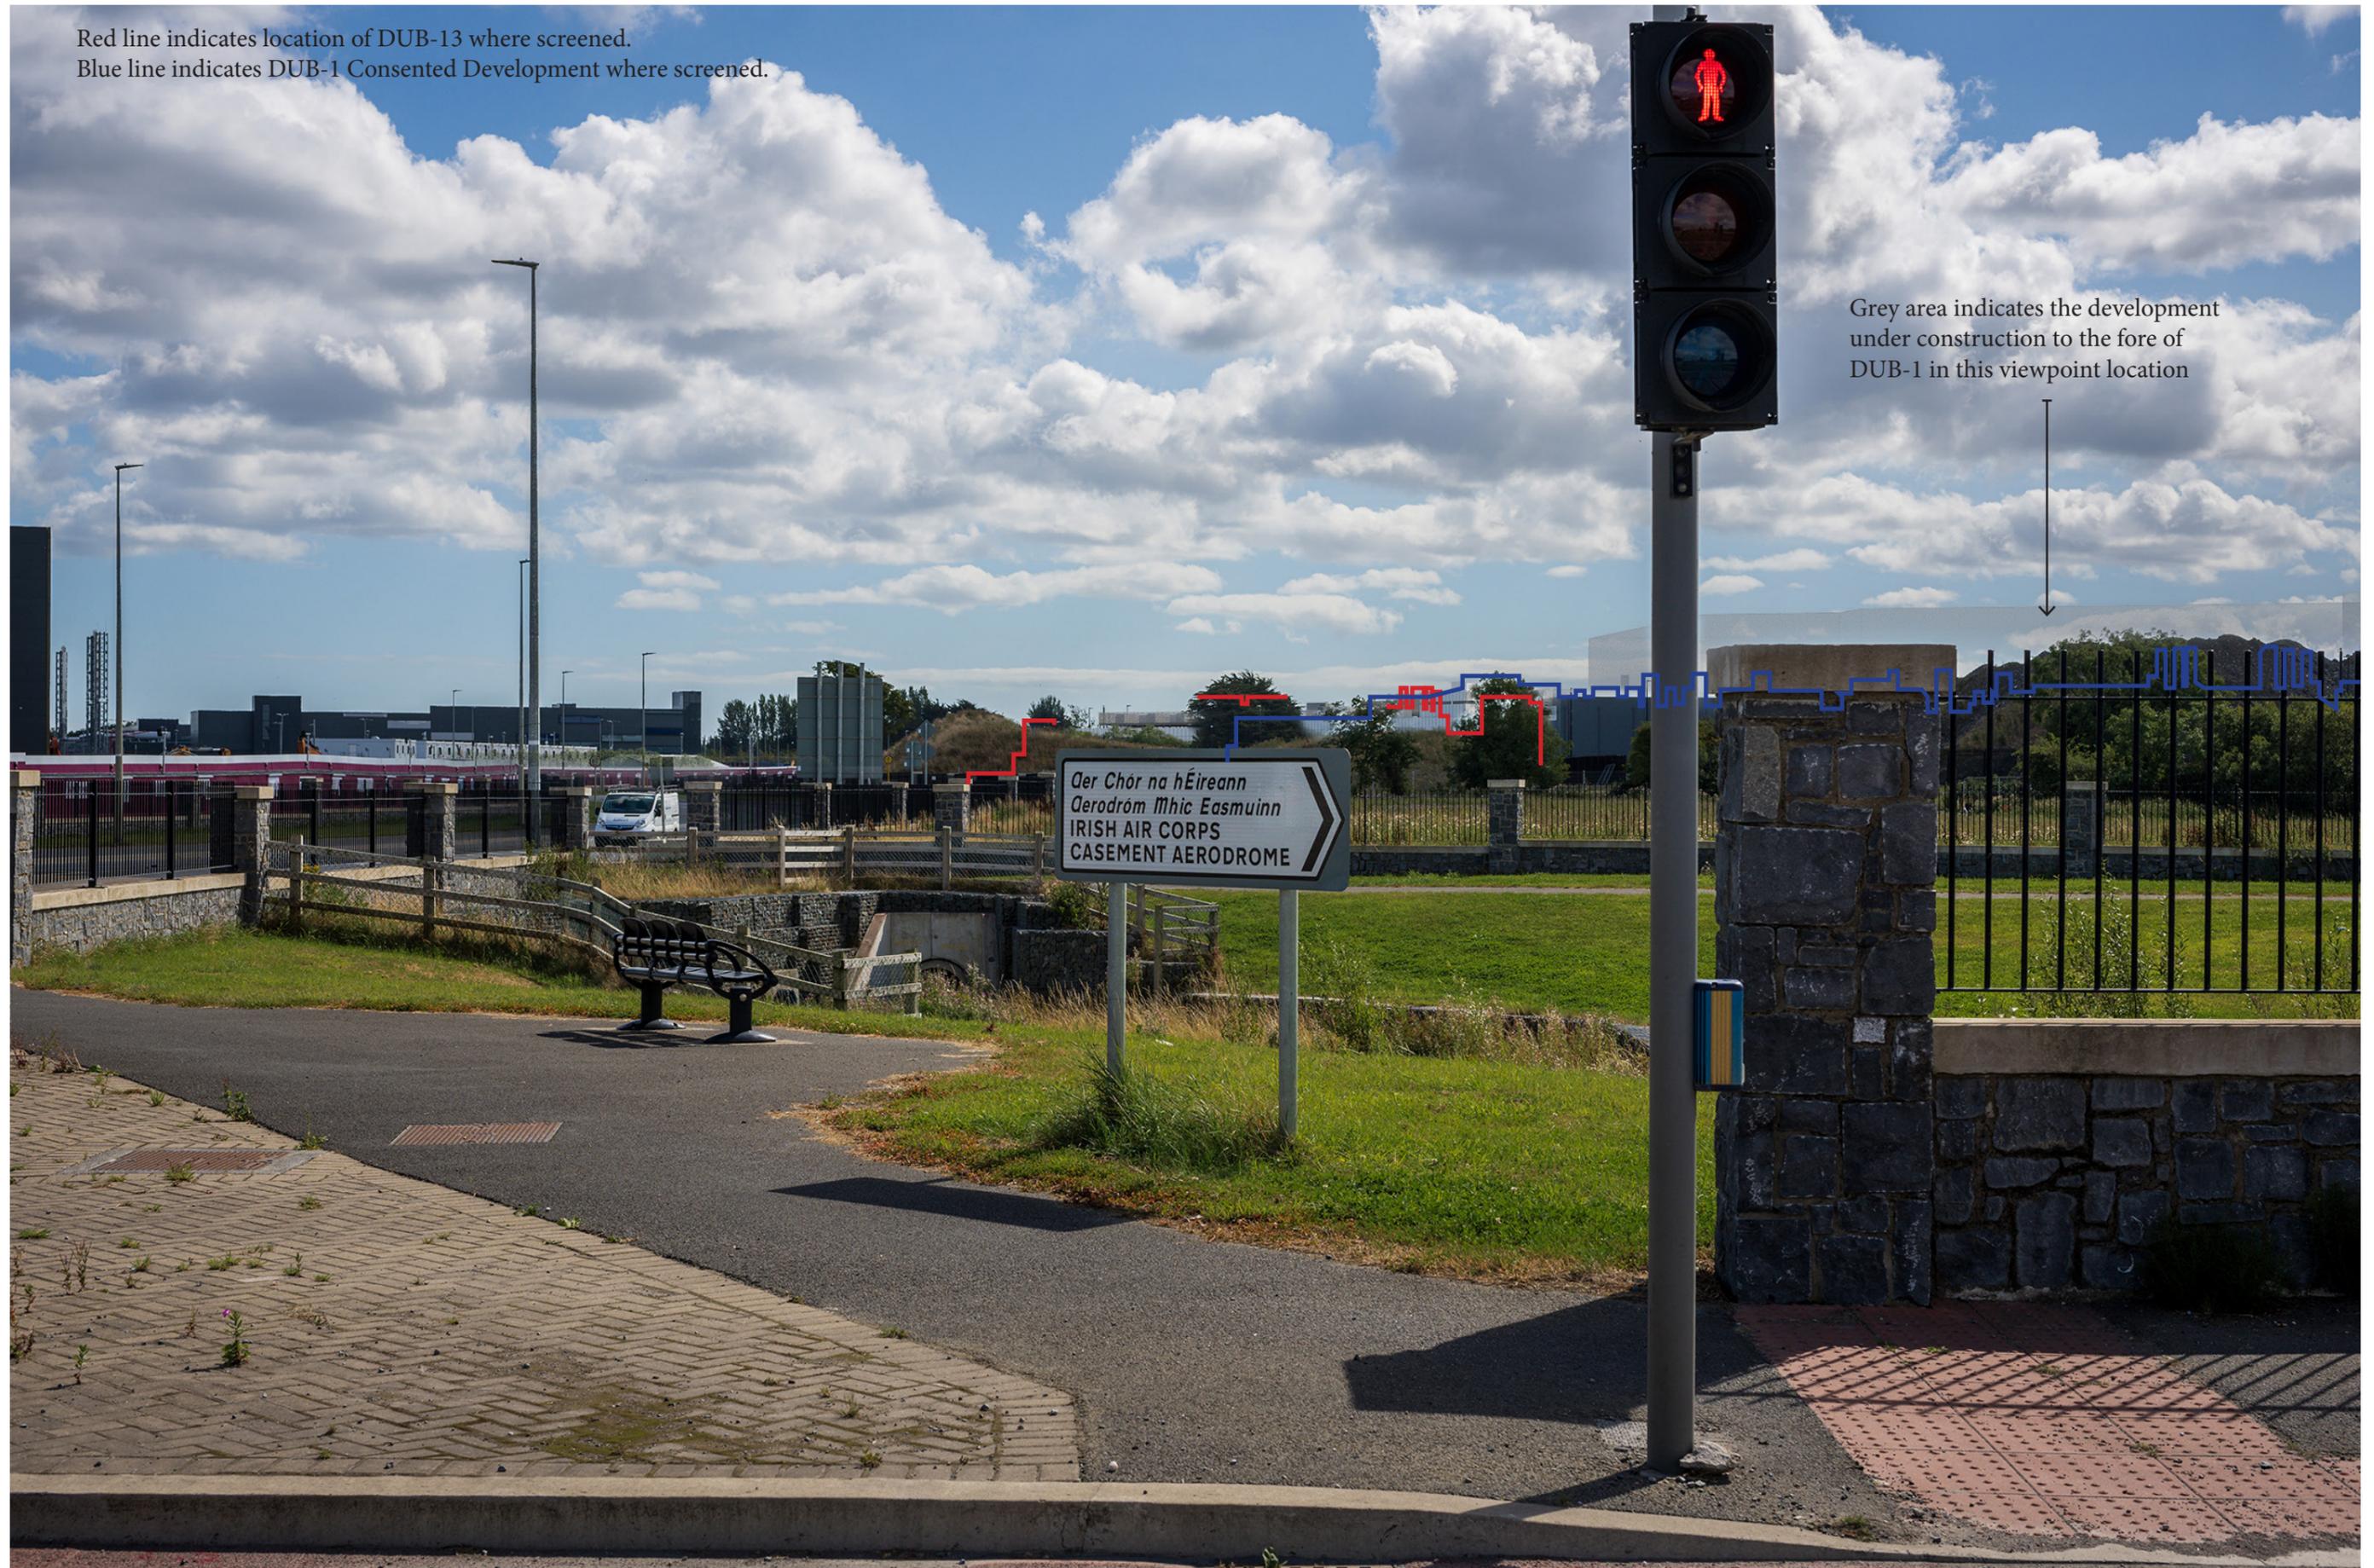
Grey area indicates the development under construction to the fore of DUB-1 in this viewpoint location

Viewpoint 2: Photomontage of Day 1 view from corner of R134 New Nangor Road at the junction with Baldonnel Road | Viewing distance at A3: 542mm | Horizontal field of view: 39.6° | Direction of view: 114°  
Camera: Sony ILCE-1 | Lens: Sony 50mm | Camera height: 1.5m AGL | Date taken: 25 August 2022 | Aperture: f/8 | ISO speed: 100 | Shutter: 1/500 sec

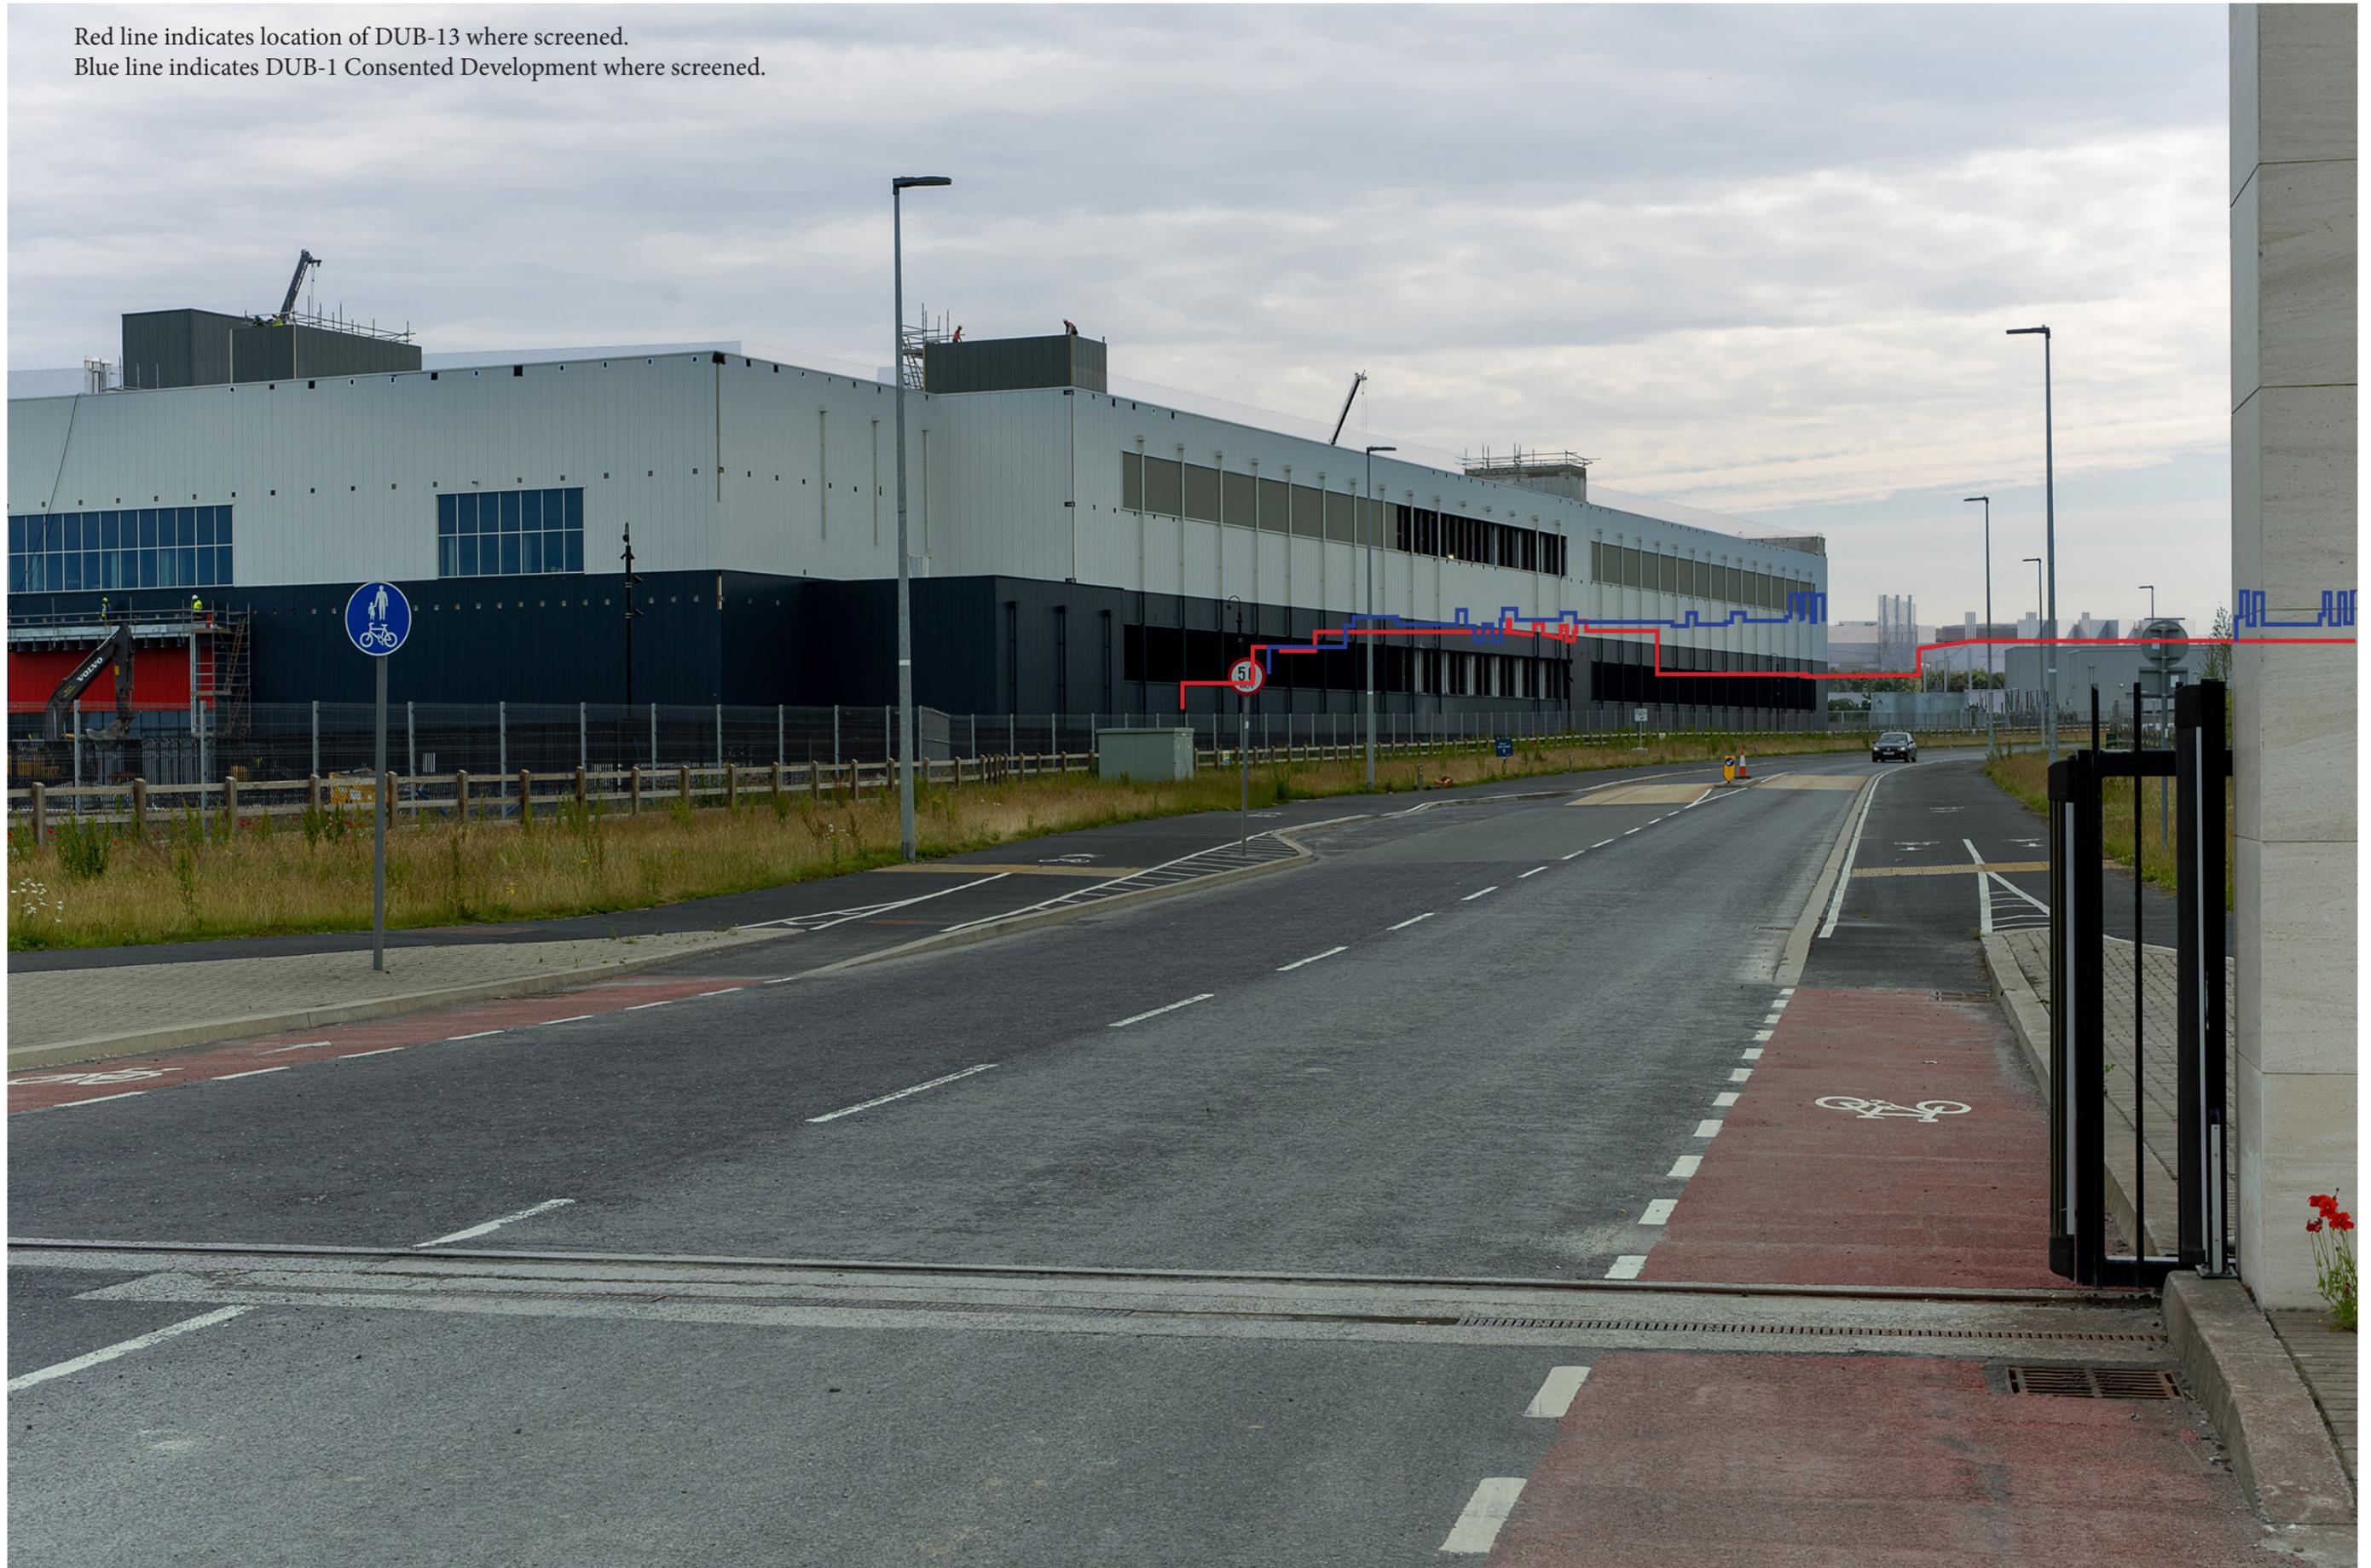
Viewpoint 3: Photomontage of Day 1 view from Baldonnell Road at junction with Falcon Avenue | Viewing distance at A3: 542mm | Horizontal field of view: 39.6° | Direction of view: 63°  
Camera: Sony ILCE-1| Lens: Sony 50mm | Camera height: 1.5m AGL | Date taken: 28 June 2021 | Aperture: f/11 | ISO speed: 100 | Shutter: 1/160 sec

Blue line indicates where DUB-1 Consented Development is screened.

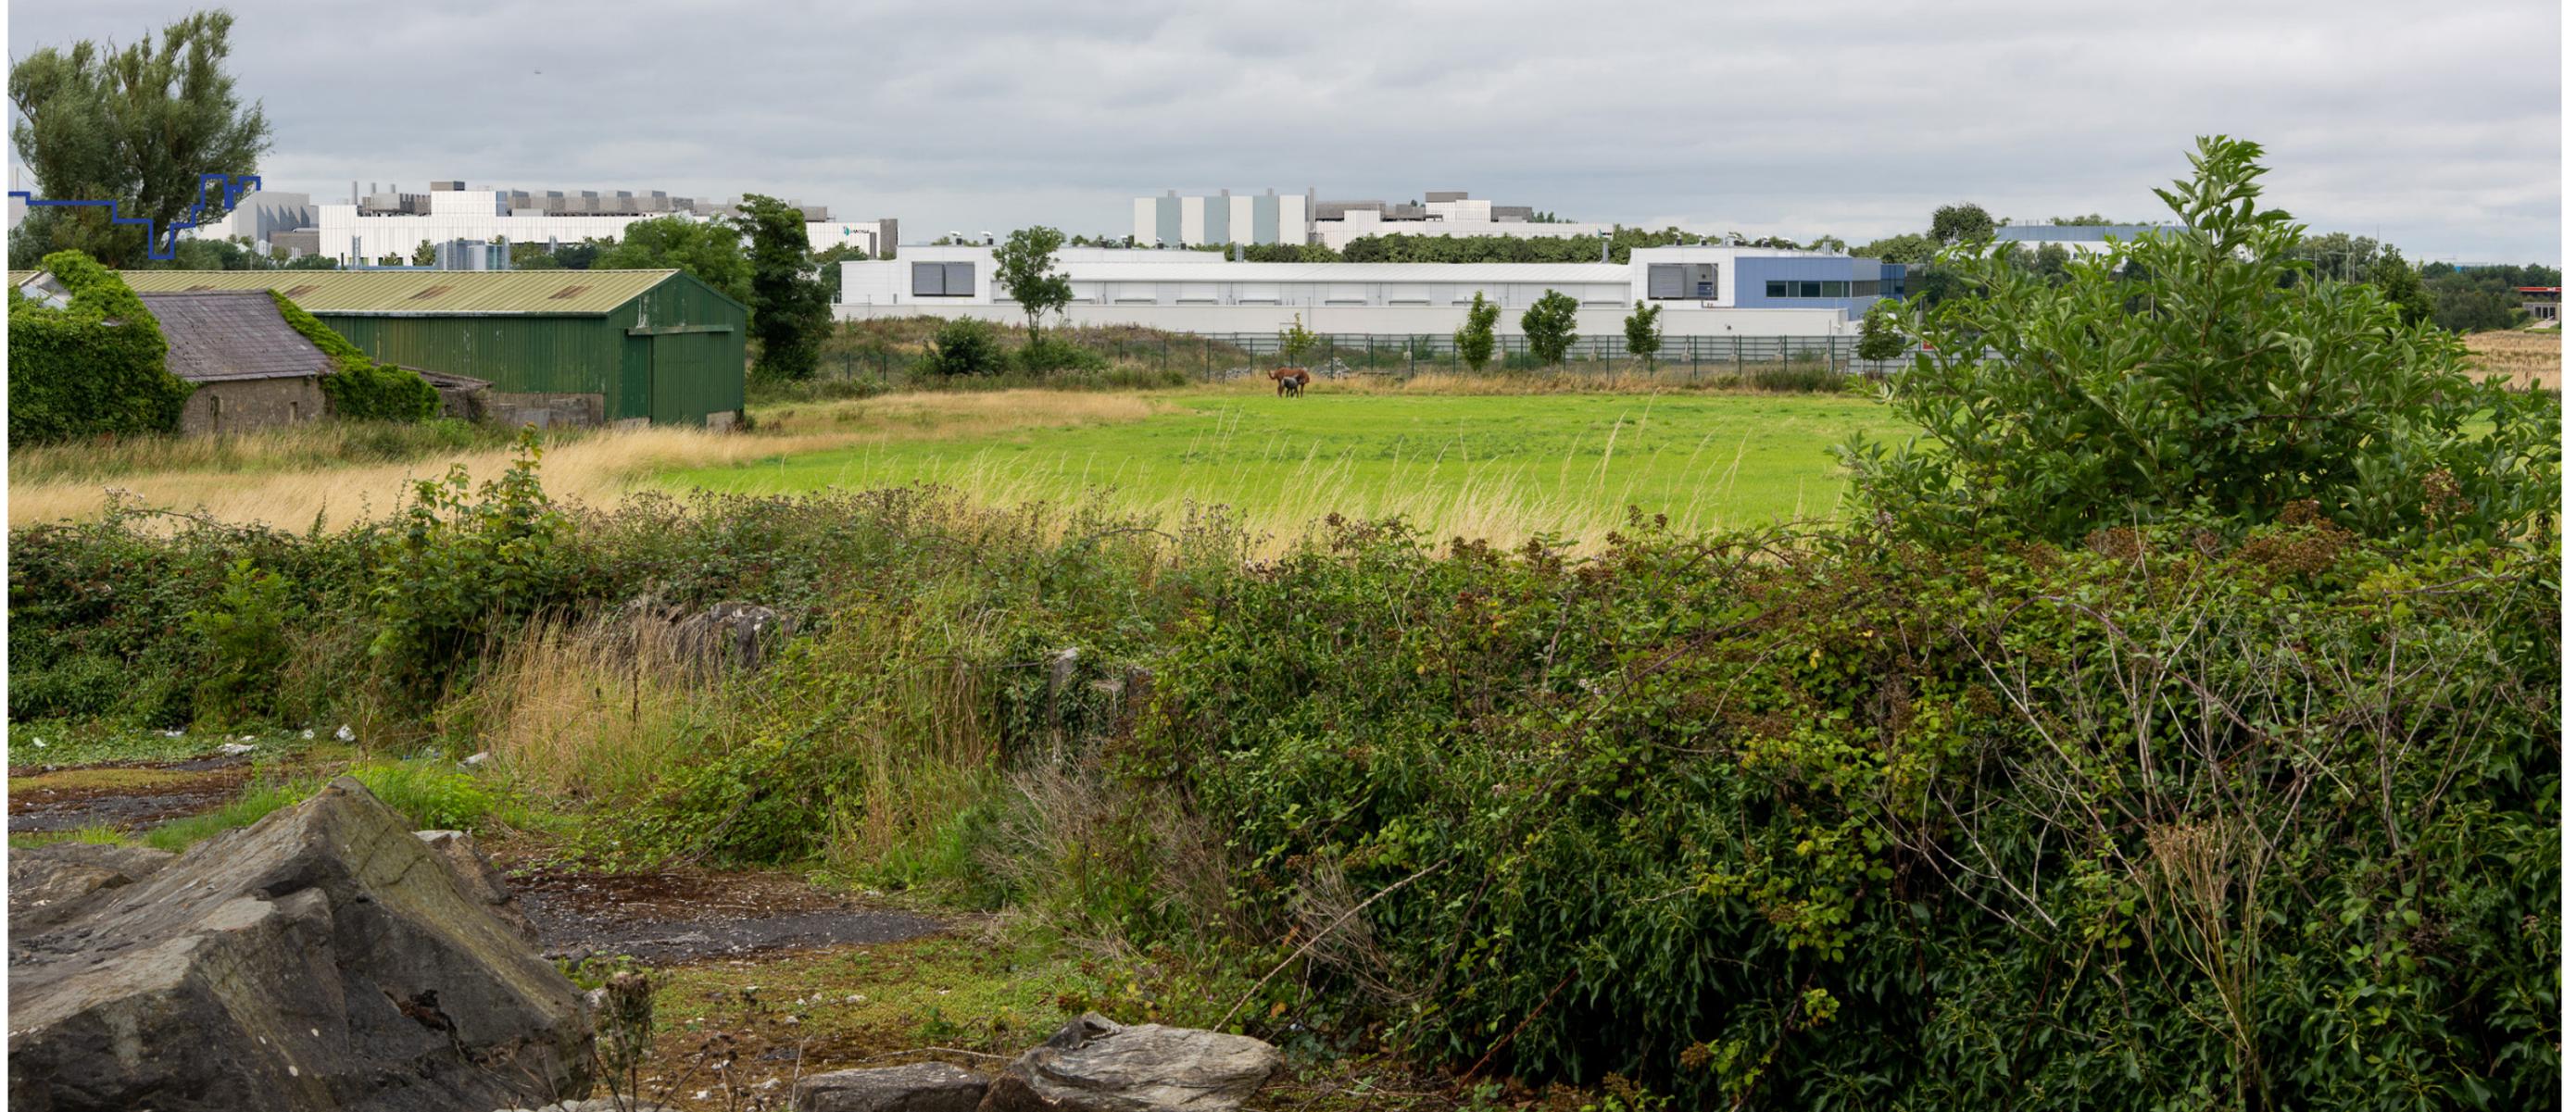
Viewpoint 4: Photomontage of Day 1 view from layby on Baldonnell Road near the entrance to Casement Aerodrome | Viewing distance at A3: 542mm | Horizontal field of view: 39.6° | Direction of view: 360°  
Camera: Sony ILCE-1| Lens: Sony 50mm | Camera height: 1.5m AGL | Date taken: 18 August 2021 | Aperture: f/11 | ISO speed: 100 | Shutter: 1/50 sec

Red line indicates location of DUB-13 where screened.  
Blue line indicates location of DUB-1 Consented Development where screened.

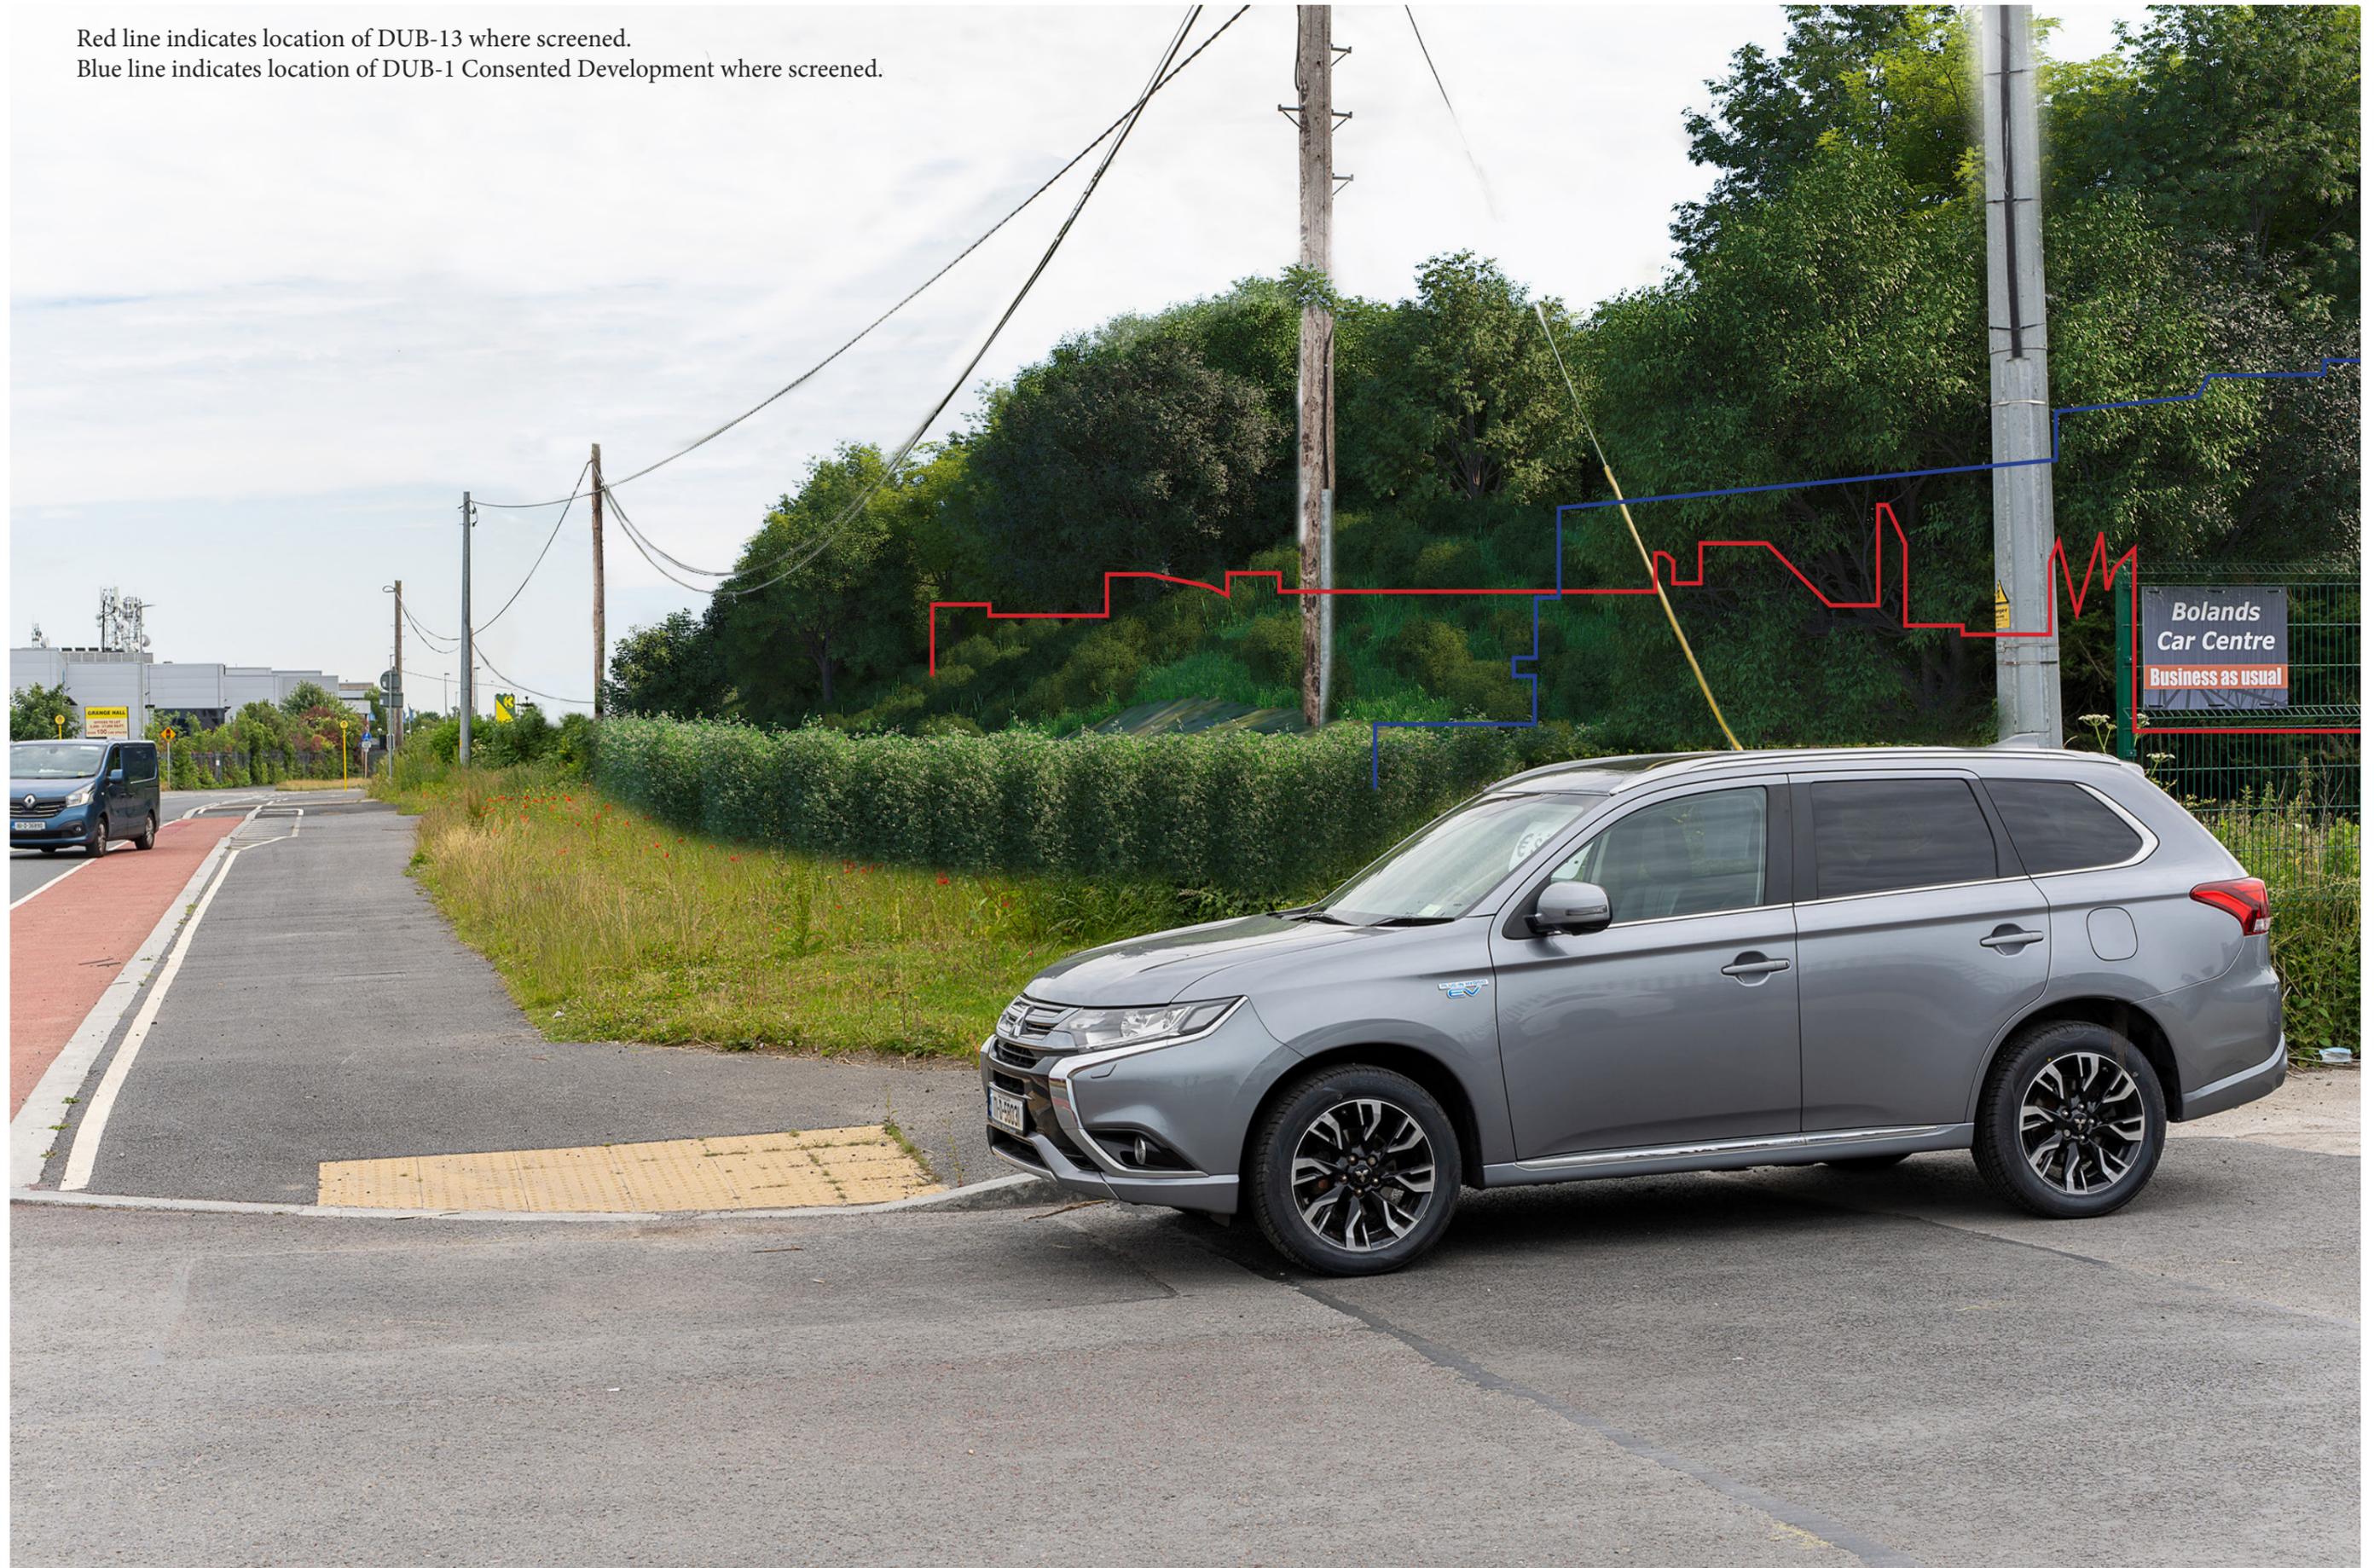
Viewpoint 5: Photomontage of view from R134 New Nangor Road at Bolands Car Centre | Viewing distance at A3: 542mm | Horizontal field of view: 39.6° | Direction of view: 109°  
Camera: Sony ILCE-1| Lens: Sony 50mm | Camera height: 1.5m AGL | Date taken: 28 June 2021 | Aperture: f/11 | ISO speed: 100 | Shutter: 1/80 sec
