Intended for  
**Vantage Data Centers DUB13 Limited**

Date  
**March 2023**

# **VANTAGE DUBLIN DATA CENTER**

## **VOLUME 2A: LANDSCAPE, VISUAL AND BUILT HERITAGE IMPACT ASSESSMENT**

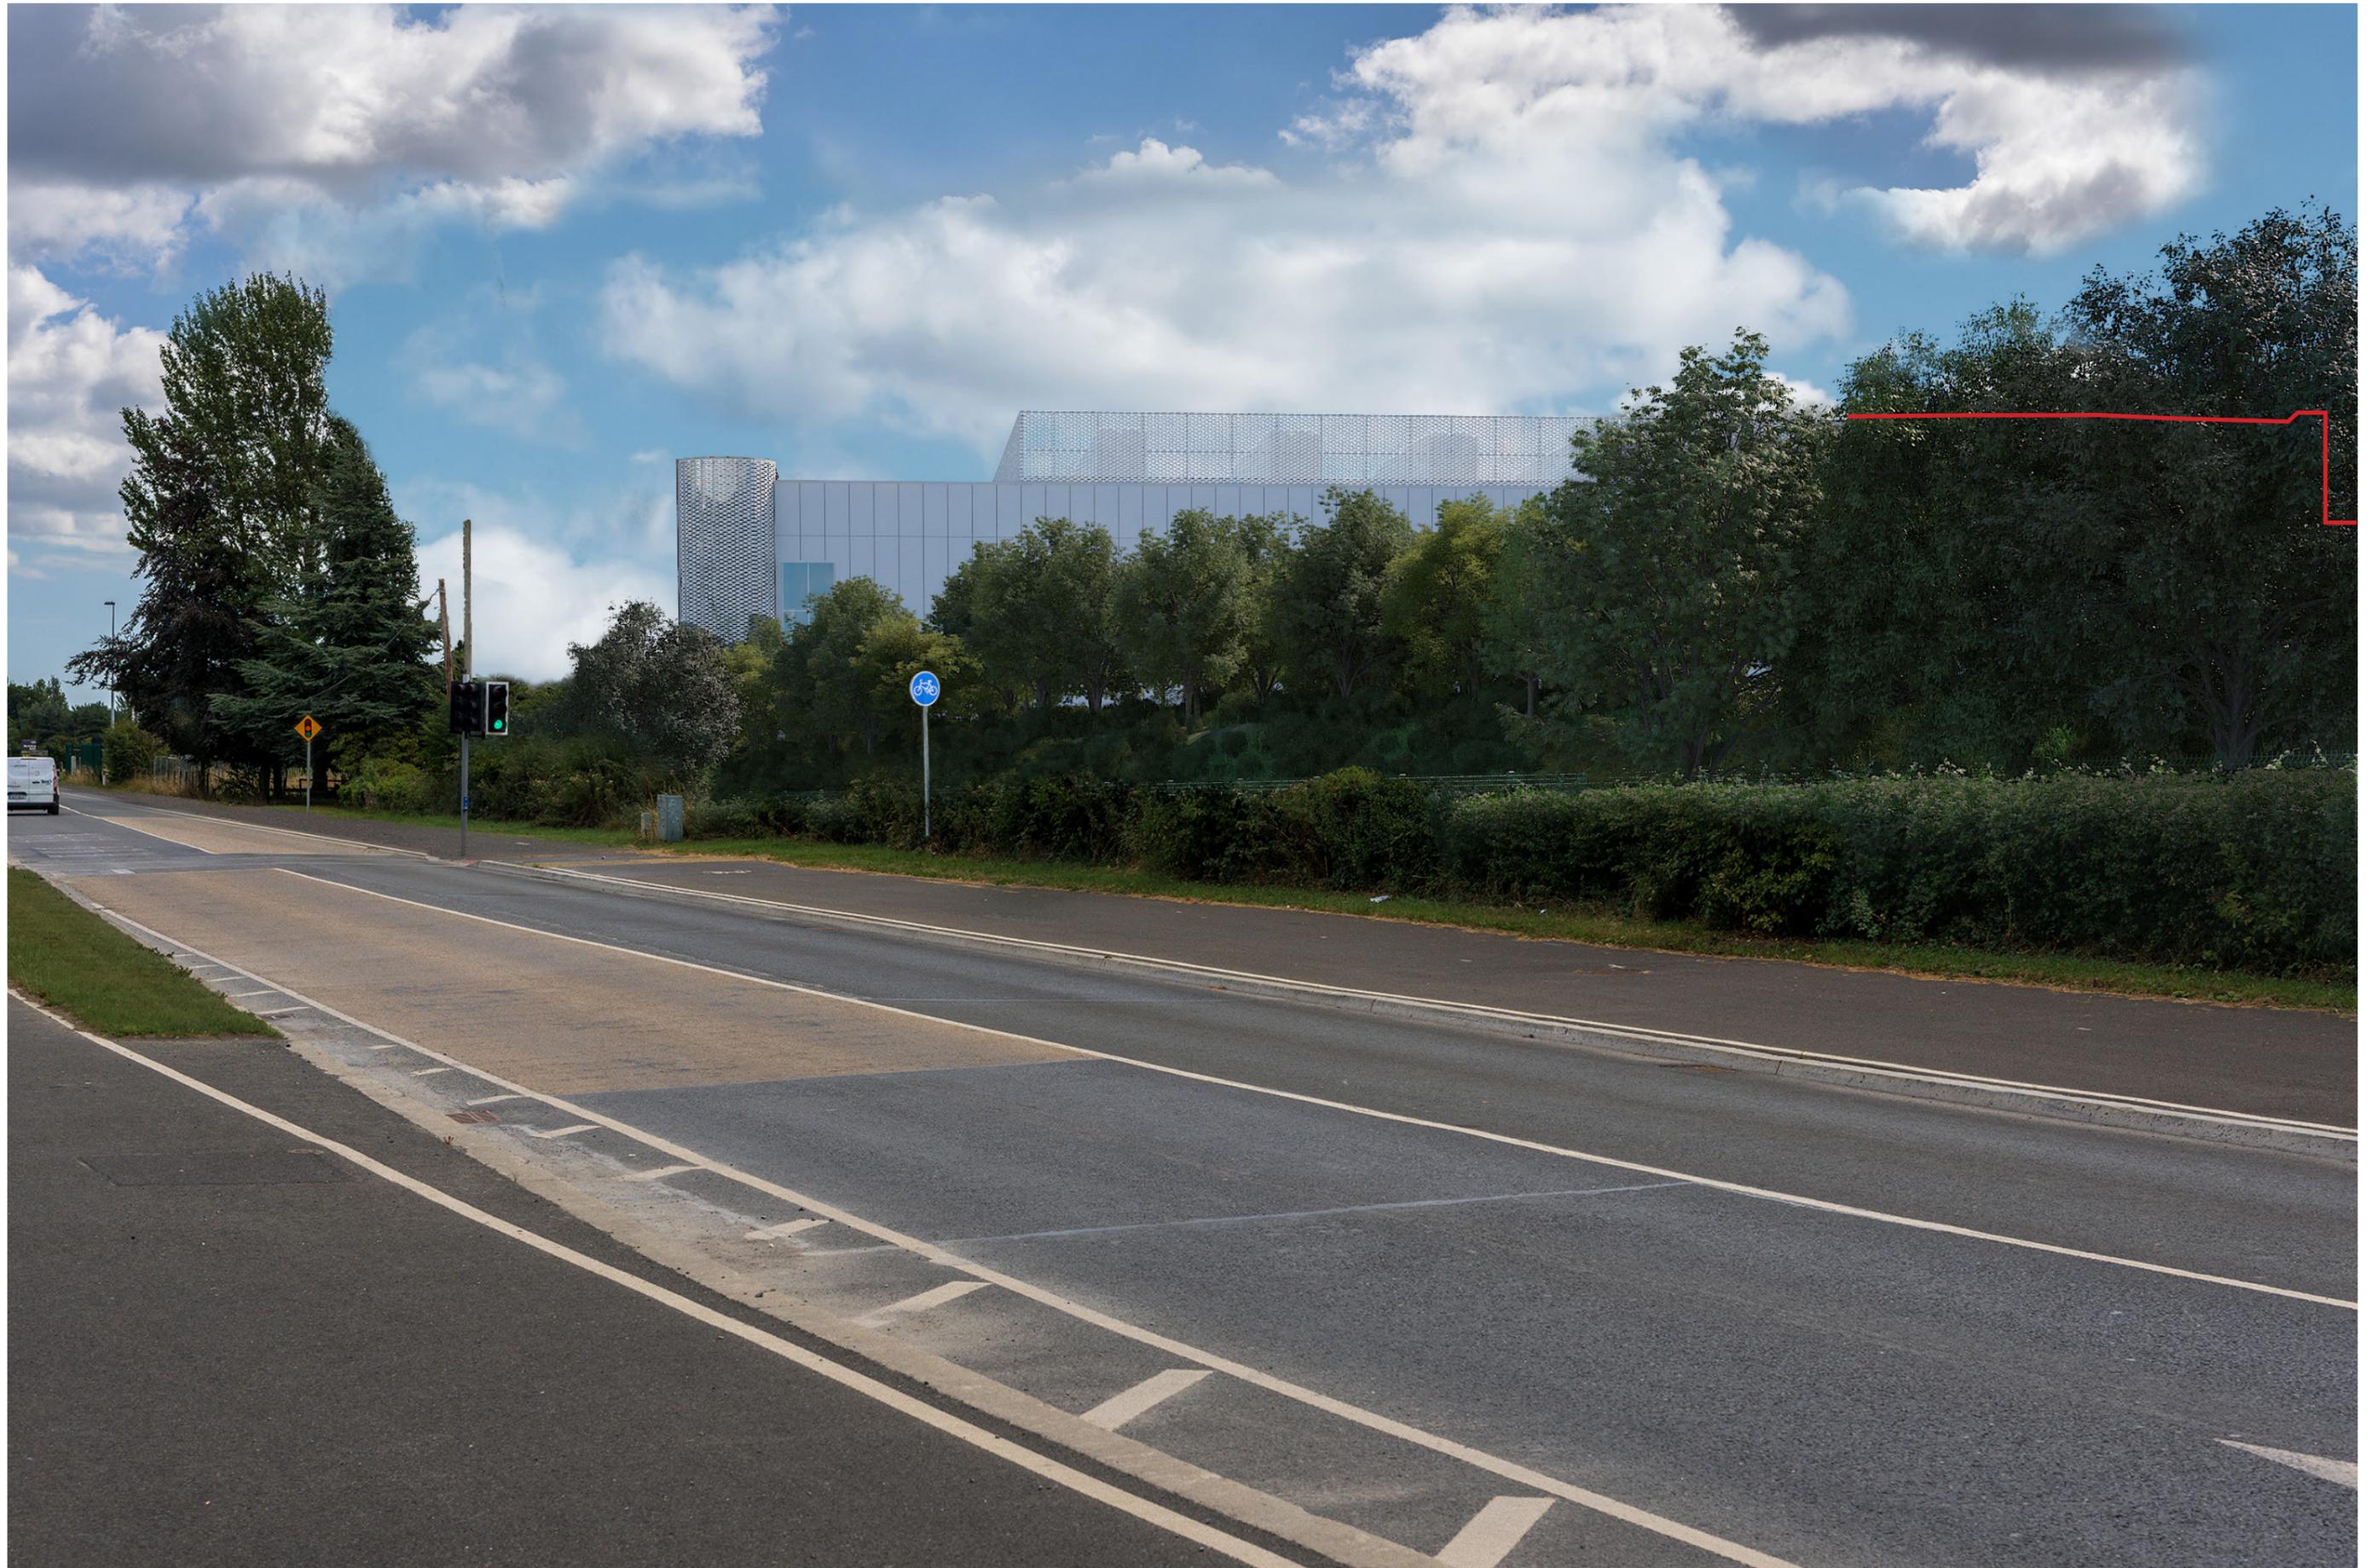
Viewpoint 6: Photomontage of Day 1 view from R134 New Nangor Road at the north west corner of the Site | Viewing distance at A3: 542mm | Horizontal field of view: 39.6° | Direction of view: 178°  
Camera: Sony ILCE-1| Lens: Sony 50mm | Camera height: 1.5m AGL | Date taken: 25 August 2022 | Aperture: f/8 | ISO speed: 100 | Shutter: 1/500 sec

Blue line indicates location of DUB-1 Consented Development where screened.

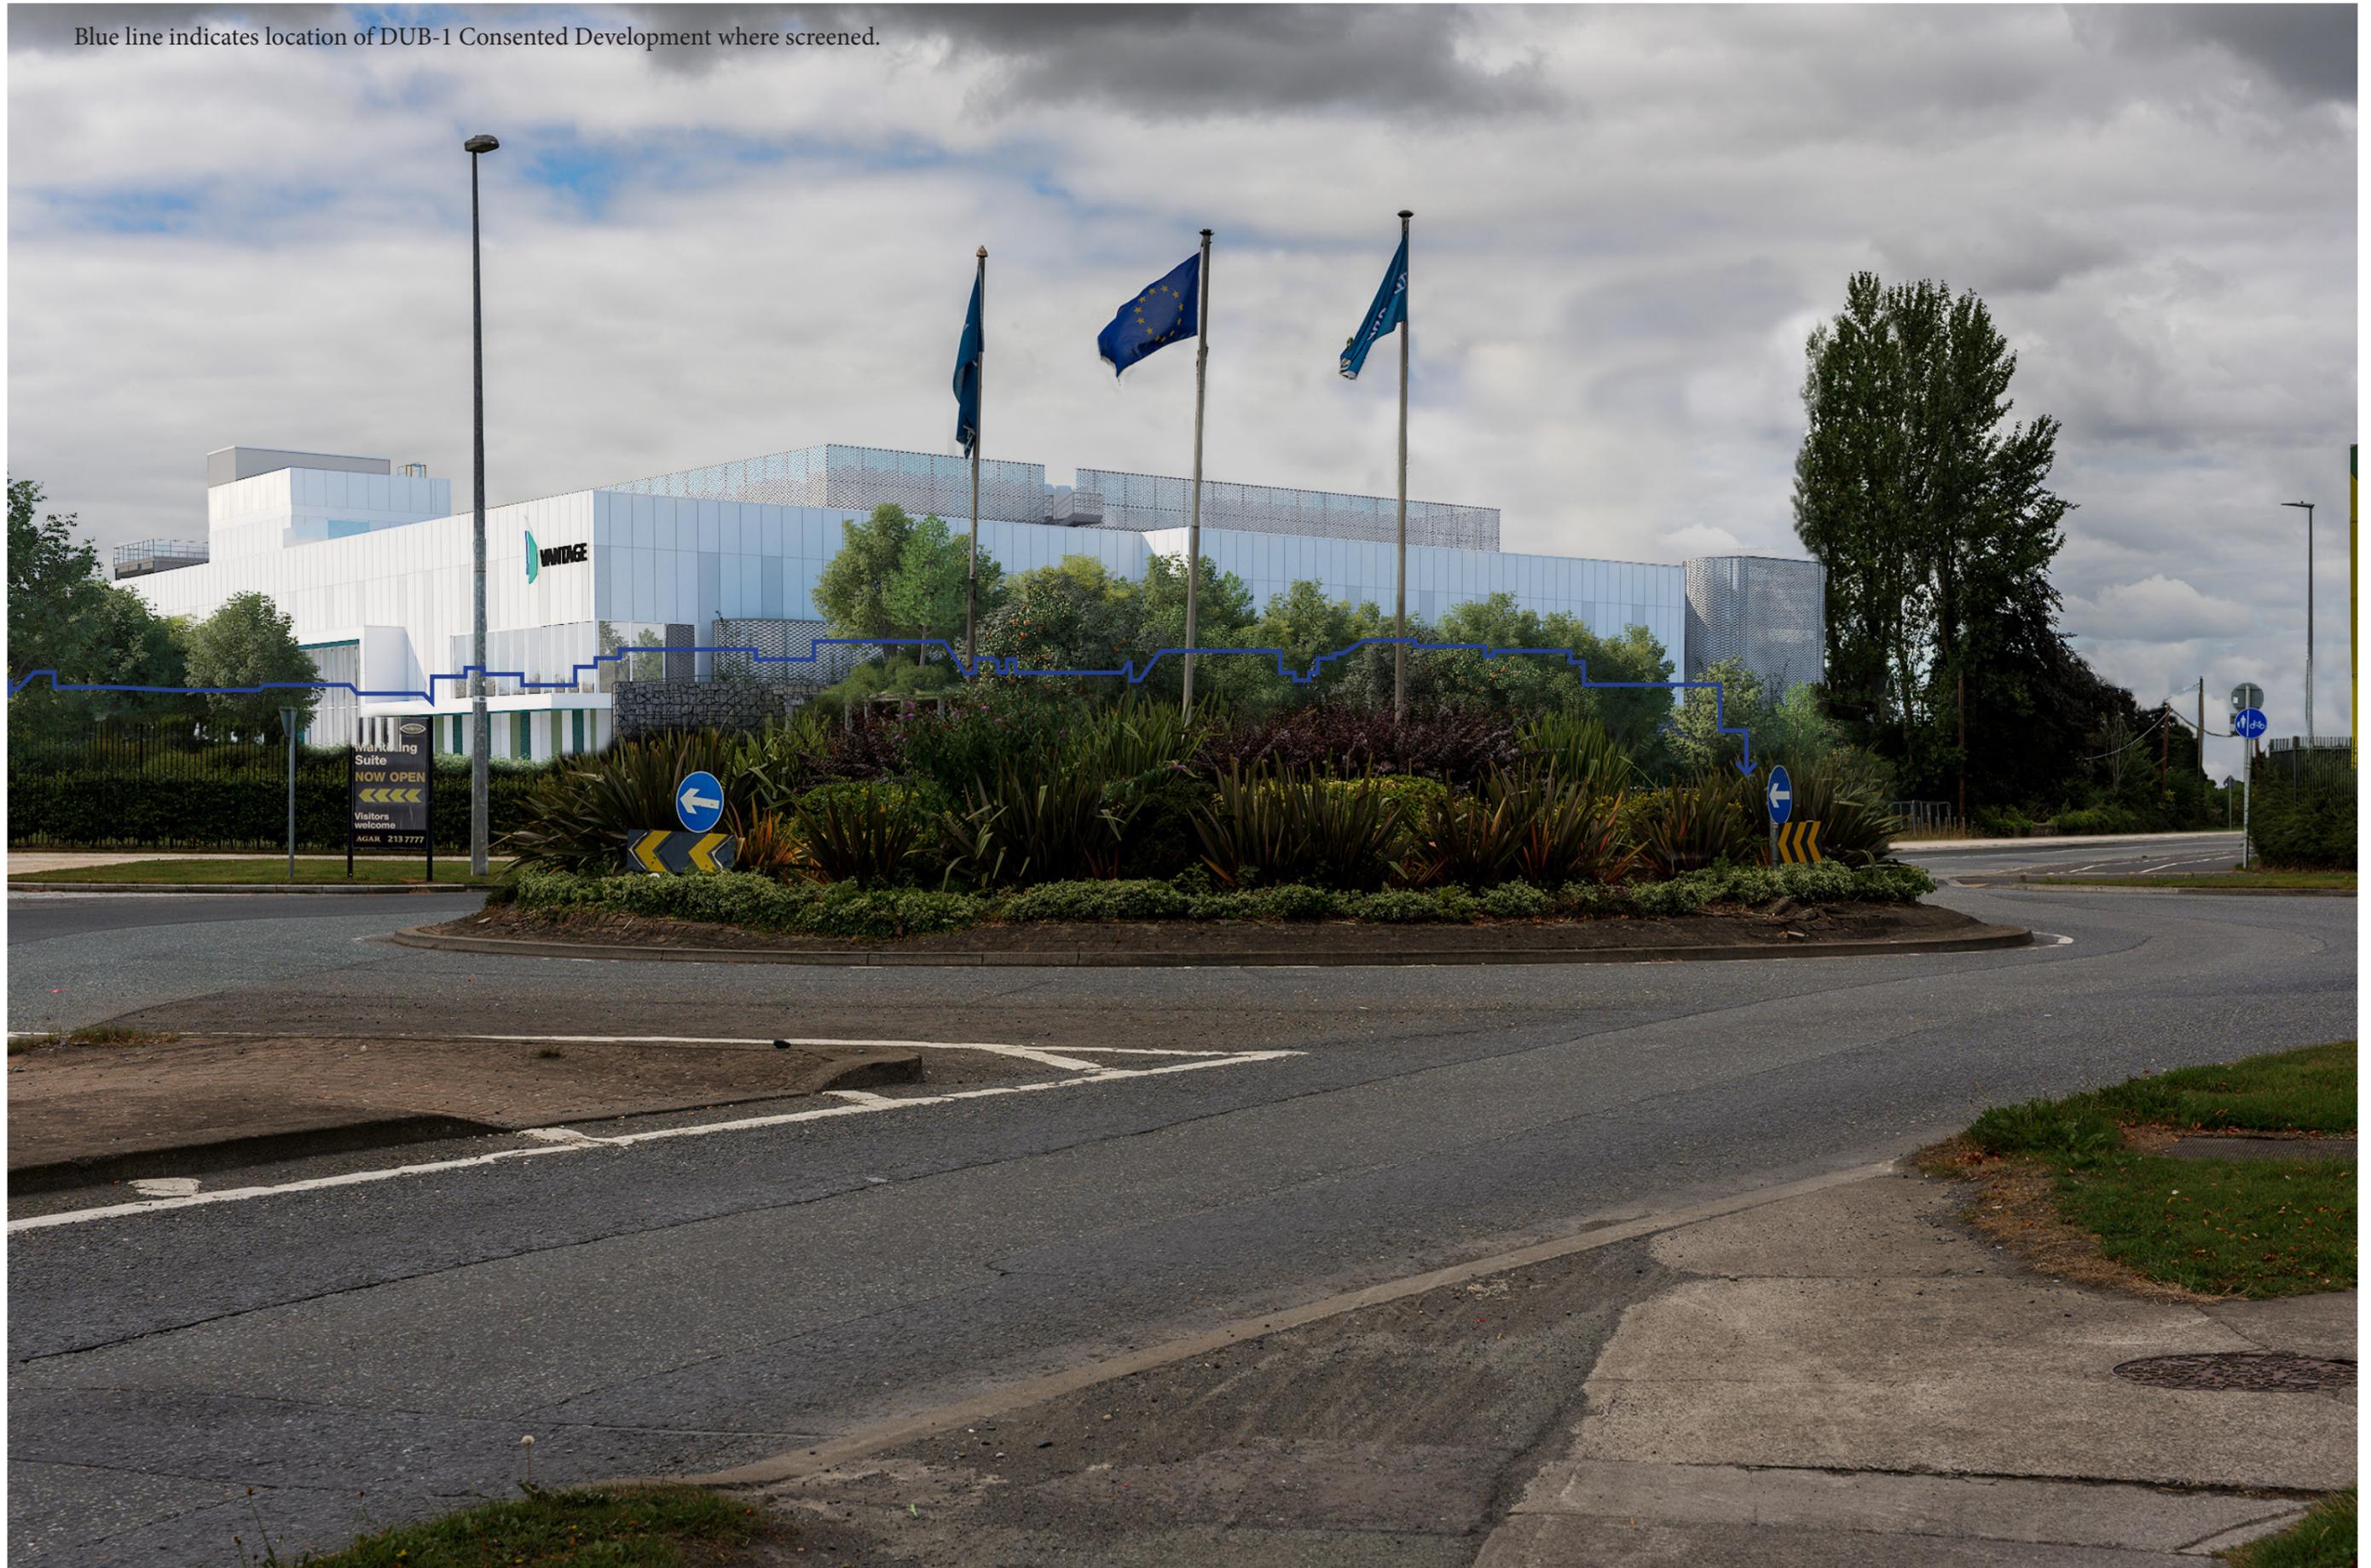
Viewpoint 7: Photomontage of Day 1 view from R134 New Nangor Road at the entrance to Profile Park | Viewing distance at A3: 542mm | Horizontal field of view: 39.6° | Direction of view: 252°  
Camera: Sony ILCE-1| Lens: Sony 50mm | Camera height: 1.5m AGL | Date taken: 25 August 2022 | Aperture: f/8 | ISO speed: 100 | Shutter: 1/320 sec

Red line indicates location of DUB-13 Development where screened.

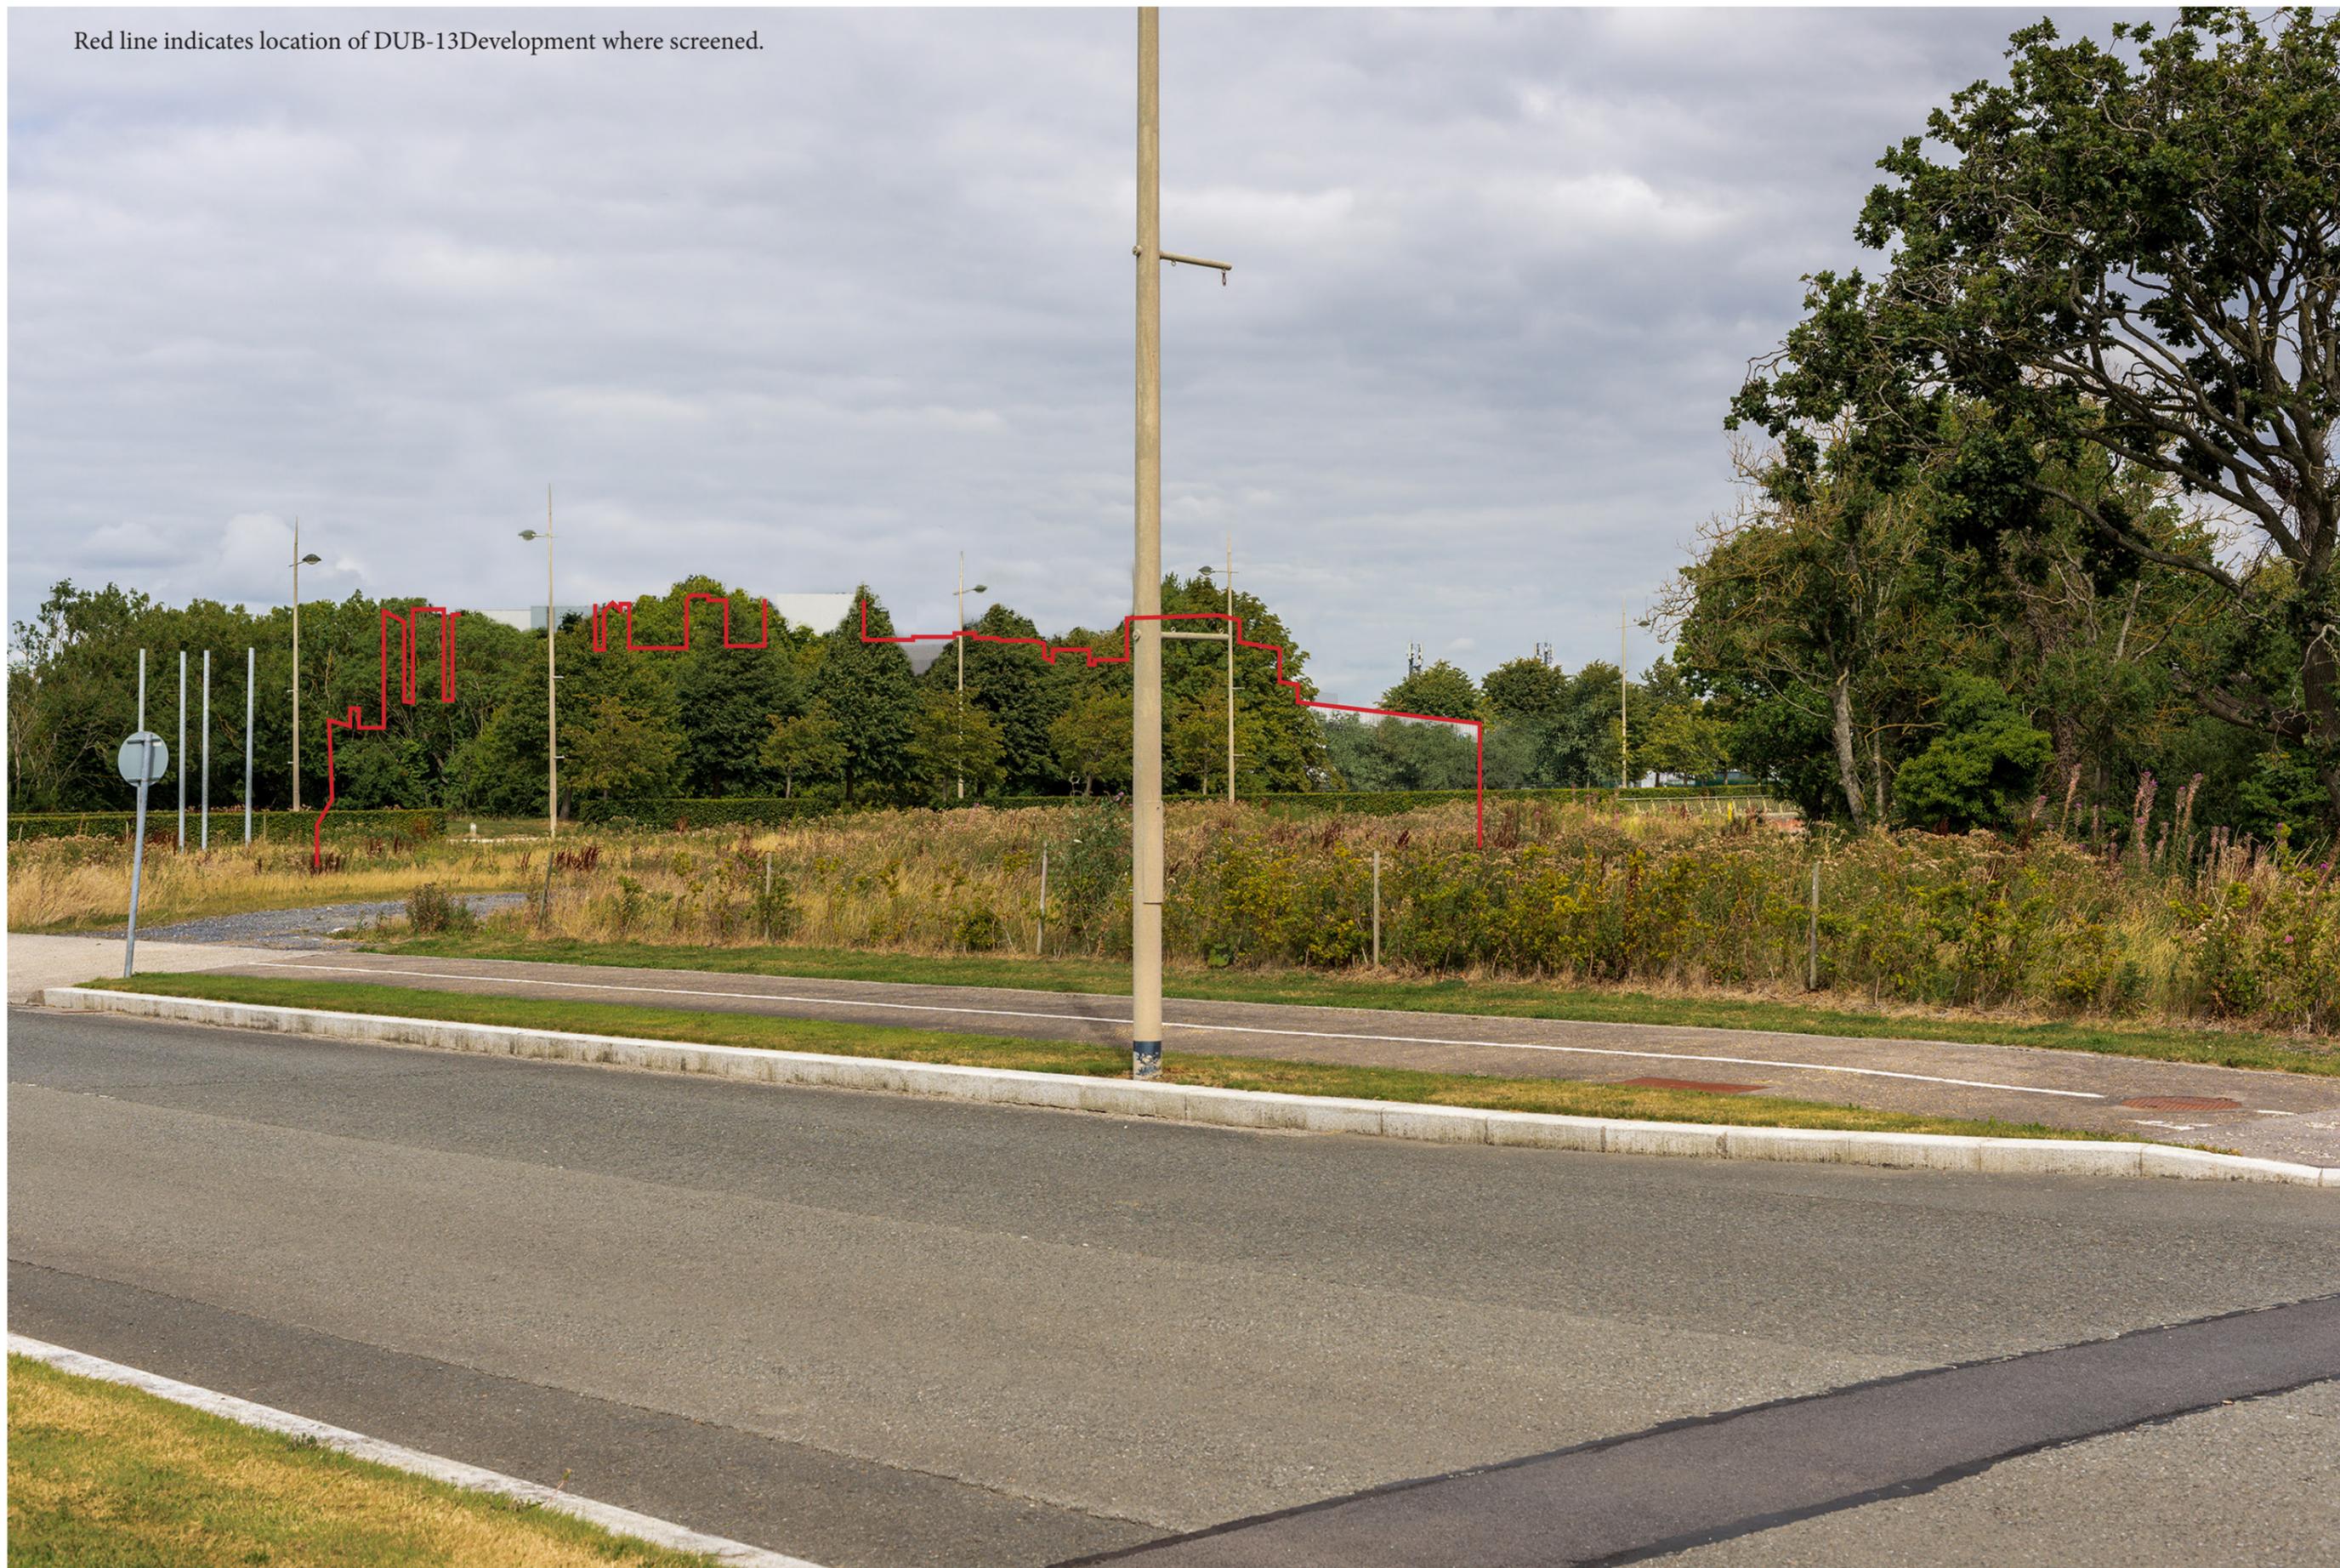
Viewpoint 8: Photomontage of Day 1 view from Profile Park Access Road | Viewing distance at A3: 542mm | Horizontal field of view: 39.6° | Direction of view: 354°  
Camera: Sony ILCE-1| Lens: Sony 50mm | Camera height: 1.5m AGL | Date taken: 25 August 2022 | Aperture: f/8 | ISO speed: 100 | Shutter: 1/320sec

Red line indicates location of DUB-13 where screened.  
Blue line indicates location of DUB-1 Consented Development where screened.

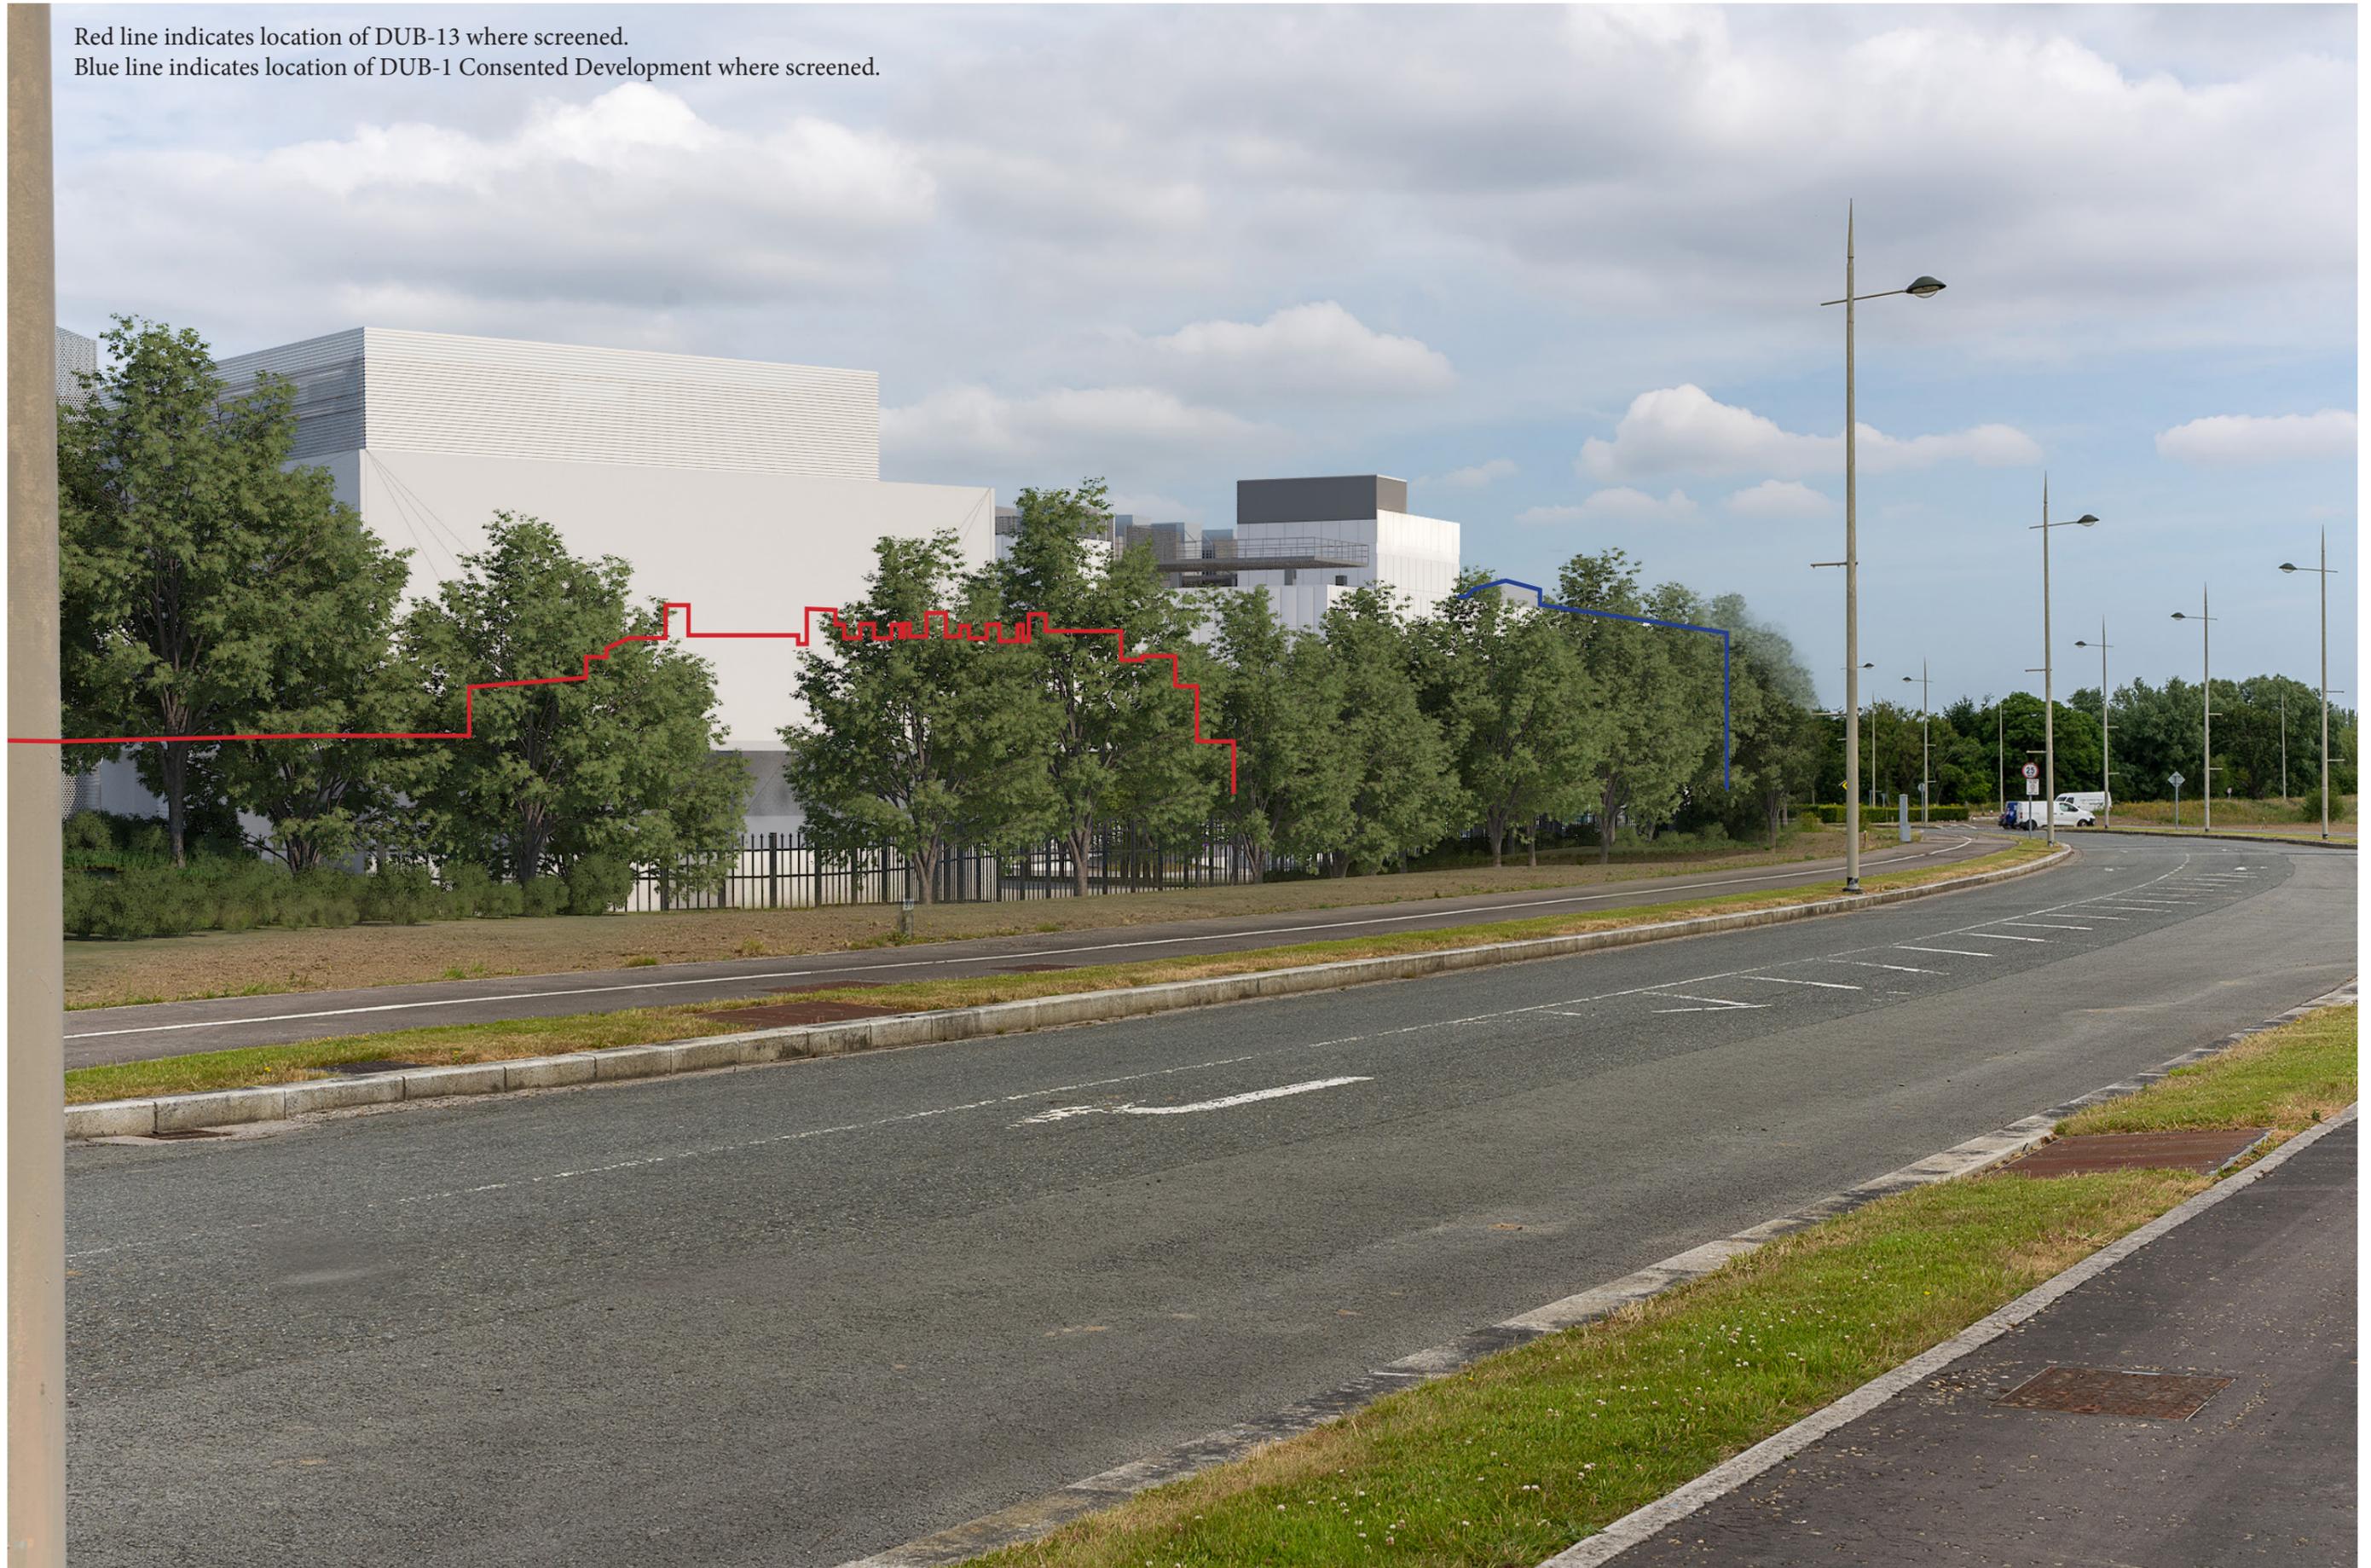
Viewpoint 9: Photomontage of Day 1 view from Faclon Avenue | Viewing distance at A3: 542mm | Horizontal field of view: 39.6° | Direction of view: 335°  
Camera: Sony ILCE-1| Lens: Sony 50mm | Camera height: 1.5m AGL | Date taken: 28 June 2021 | Aperture: f/11 | ISO speed: 100 | Shutter: 1/160 sec

Red line indicates location of DUB-13 where screened.  
Blue line indicates location of DUB-1 Consented Development where screened.

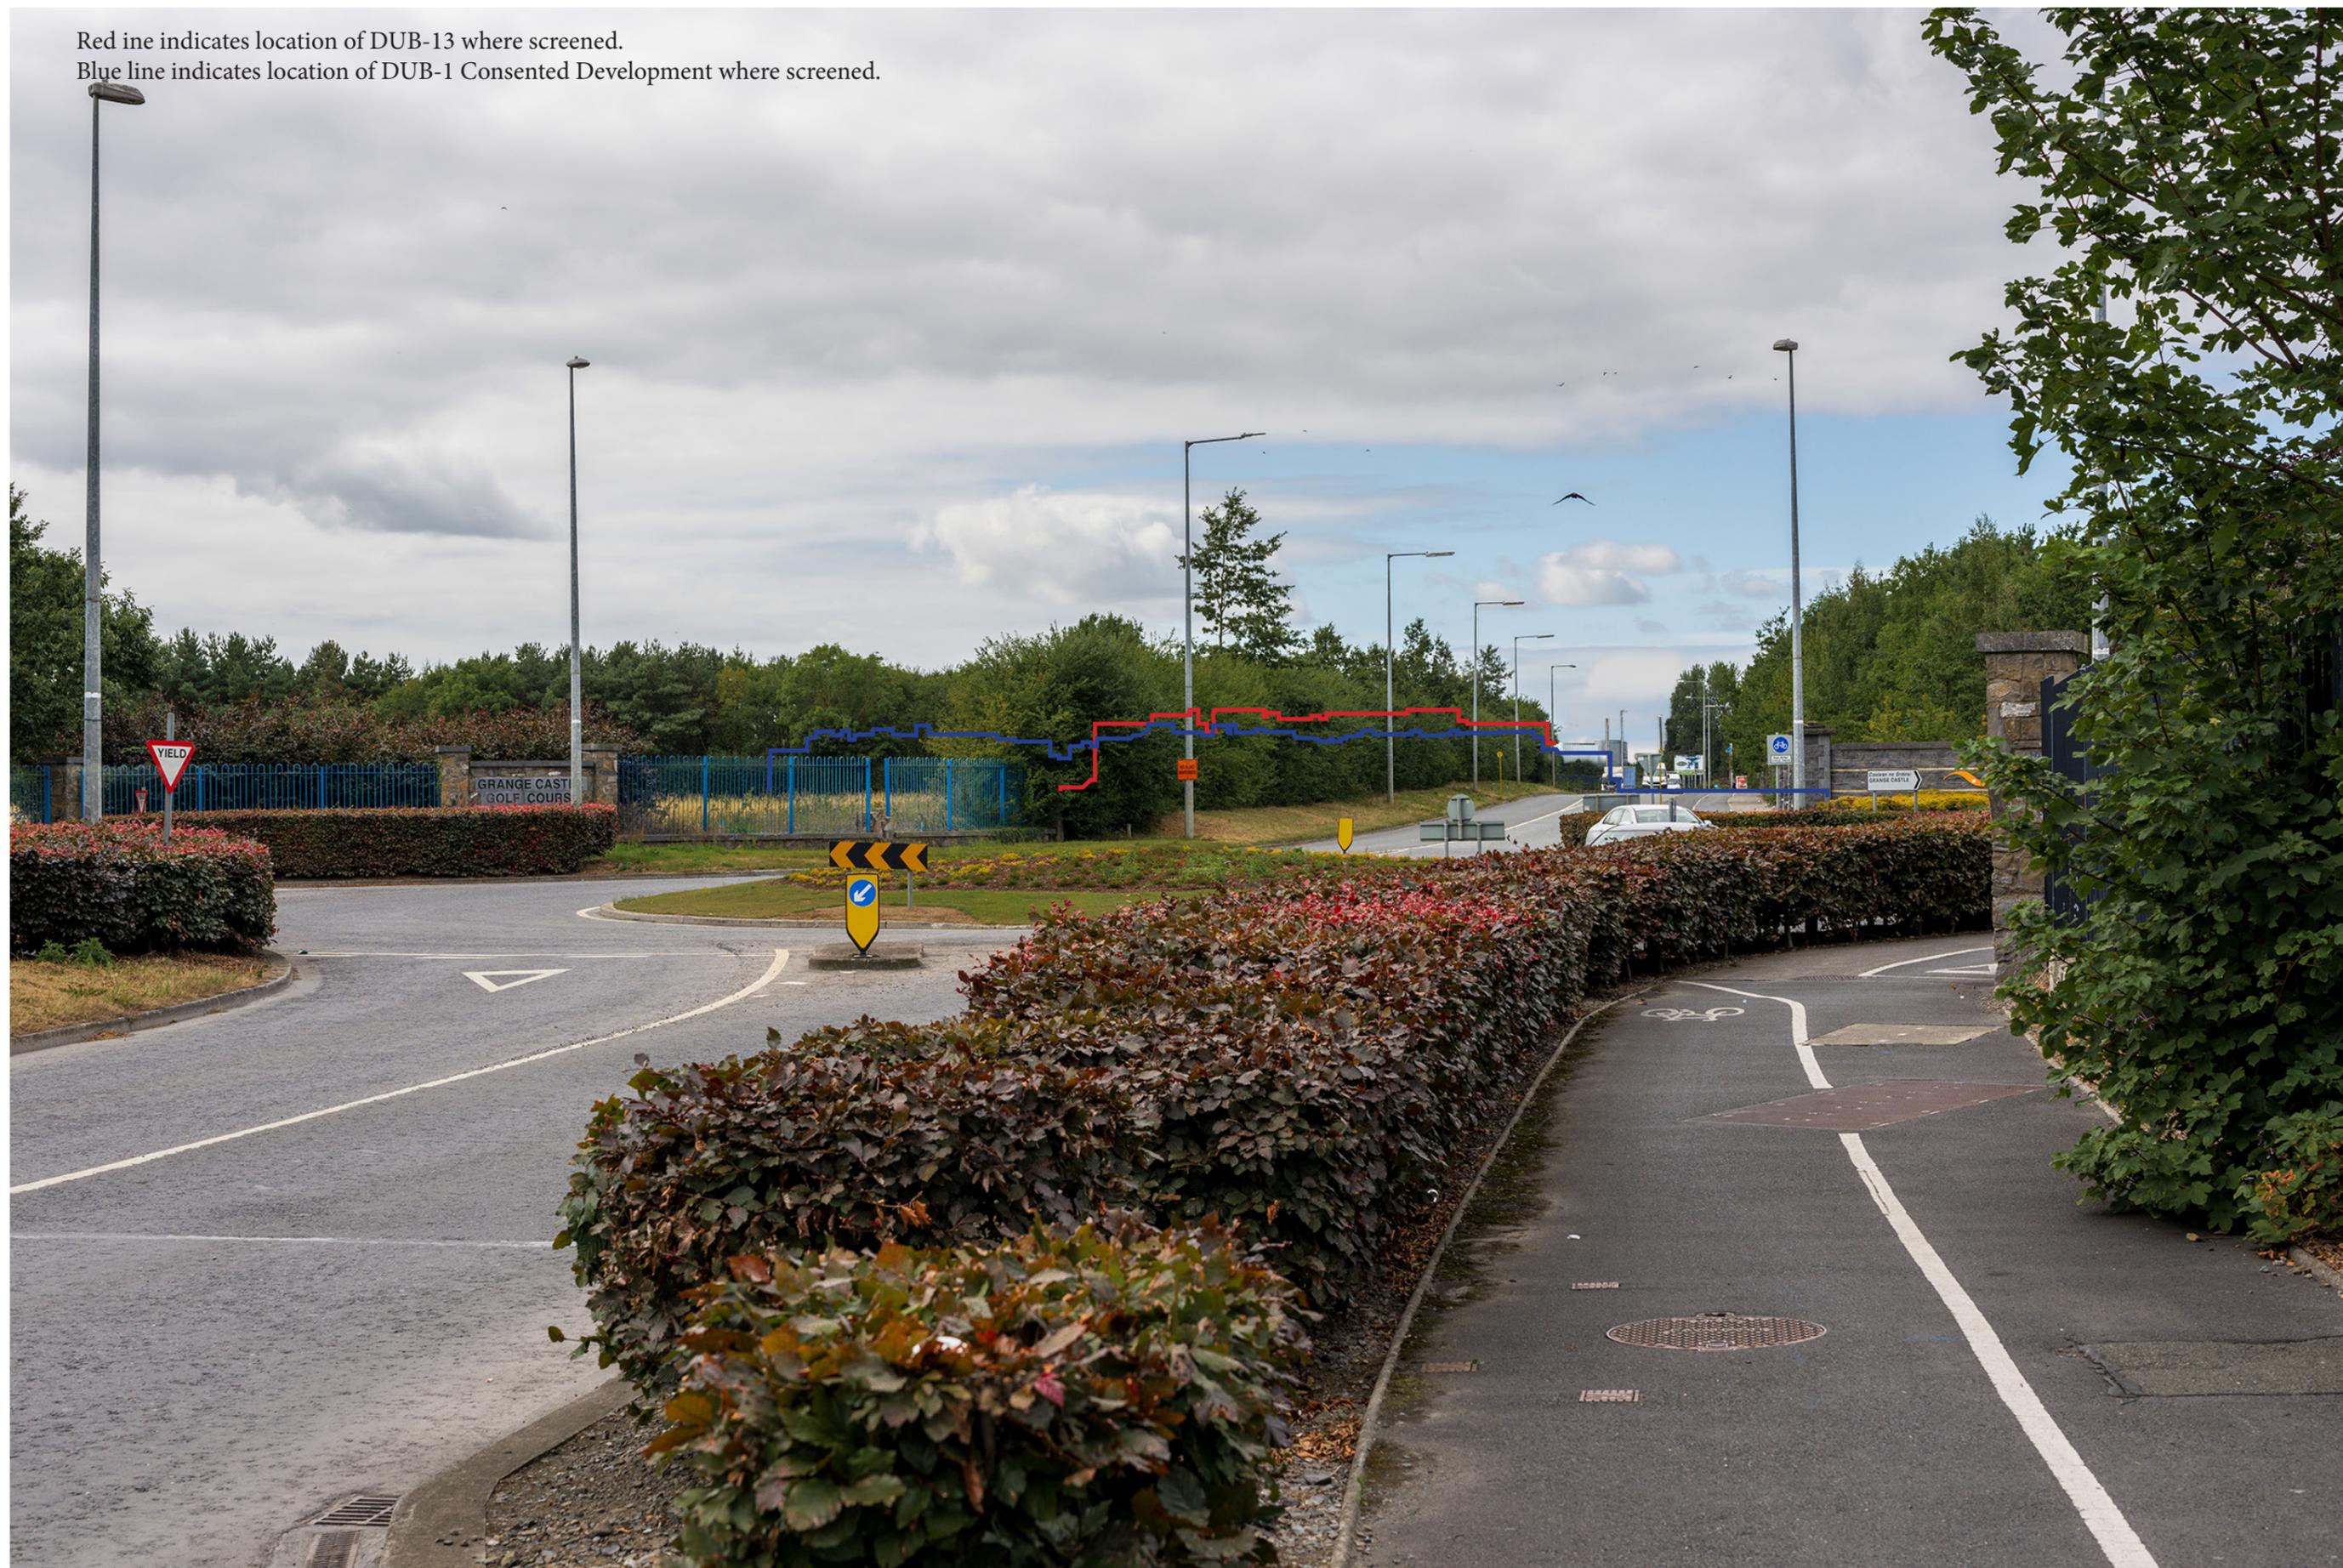
Viewpoint 11: Photomontage of Day 1 view from R134 at entrance to Grange Castle Golf Course | Viewing distance at A3: 542mm | Horizontal field of view: 39.6° | Direction of view: 264°  
Camera: Sony ILCE-1 | Lens: Sony 50mm | Camera height: 1.5m AGL | Date taken: 25 August 2022 | Aperture: f/8 | ISO speed: 100 | Shutter: 1/320sec

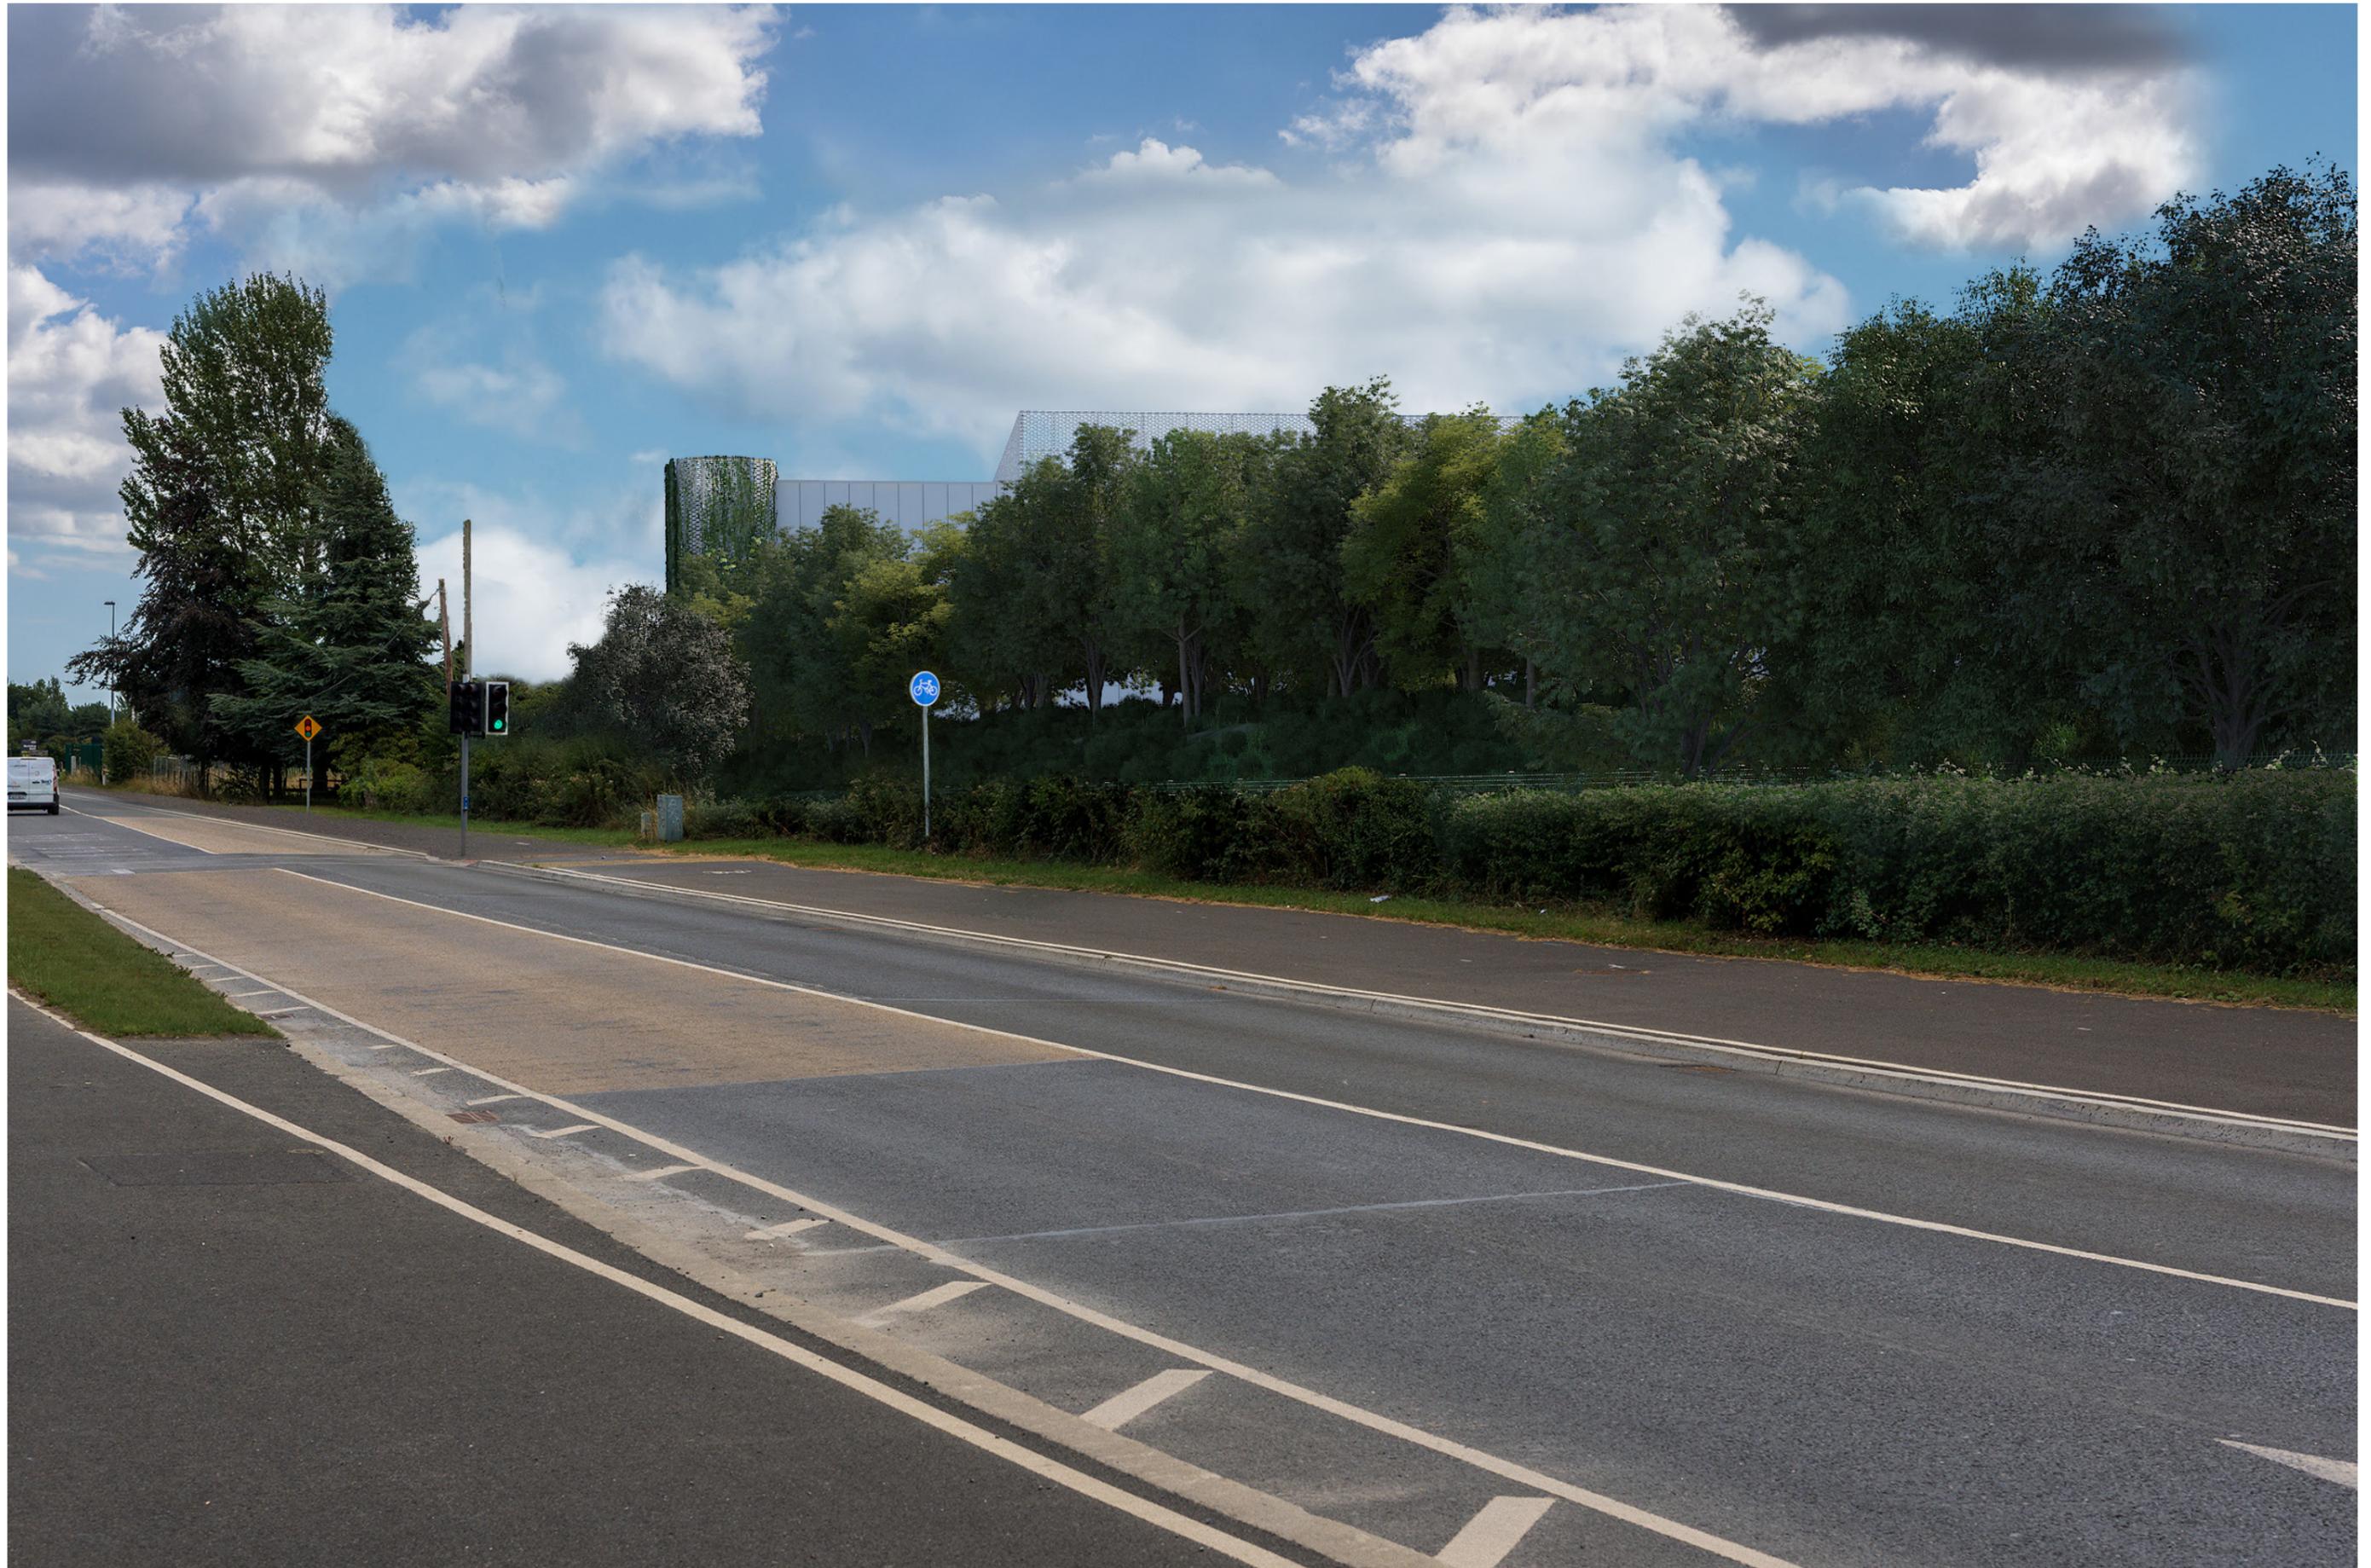
Viewpoint 6: Photomontage of Year 5 view from R134 New Nangor Road at the north west corner of the Site | Viewing distance at A3: 542mm | Horizontal field of view: 39.6° | Direction of view: 178°  
Camera: Sony ILCE-1| Lens: Sony 50mm | Camera height: 1.5m AGL | Date taken: 25 August 2022 | Aperture: f/8 | ISO speed: 100 | Shutter: 1/500 sec
