Intended for  
**Vantage Data Centers DUB13 Limited**

Date  
**March 2023**

# **VANTAGE DUBLIN DATA CENTER**

## **VOLUME 2A: LANDSCAPE, VISUAL AND BUILT HERITAGE IMPACT ASSESSMENT**

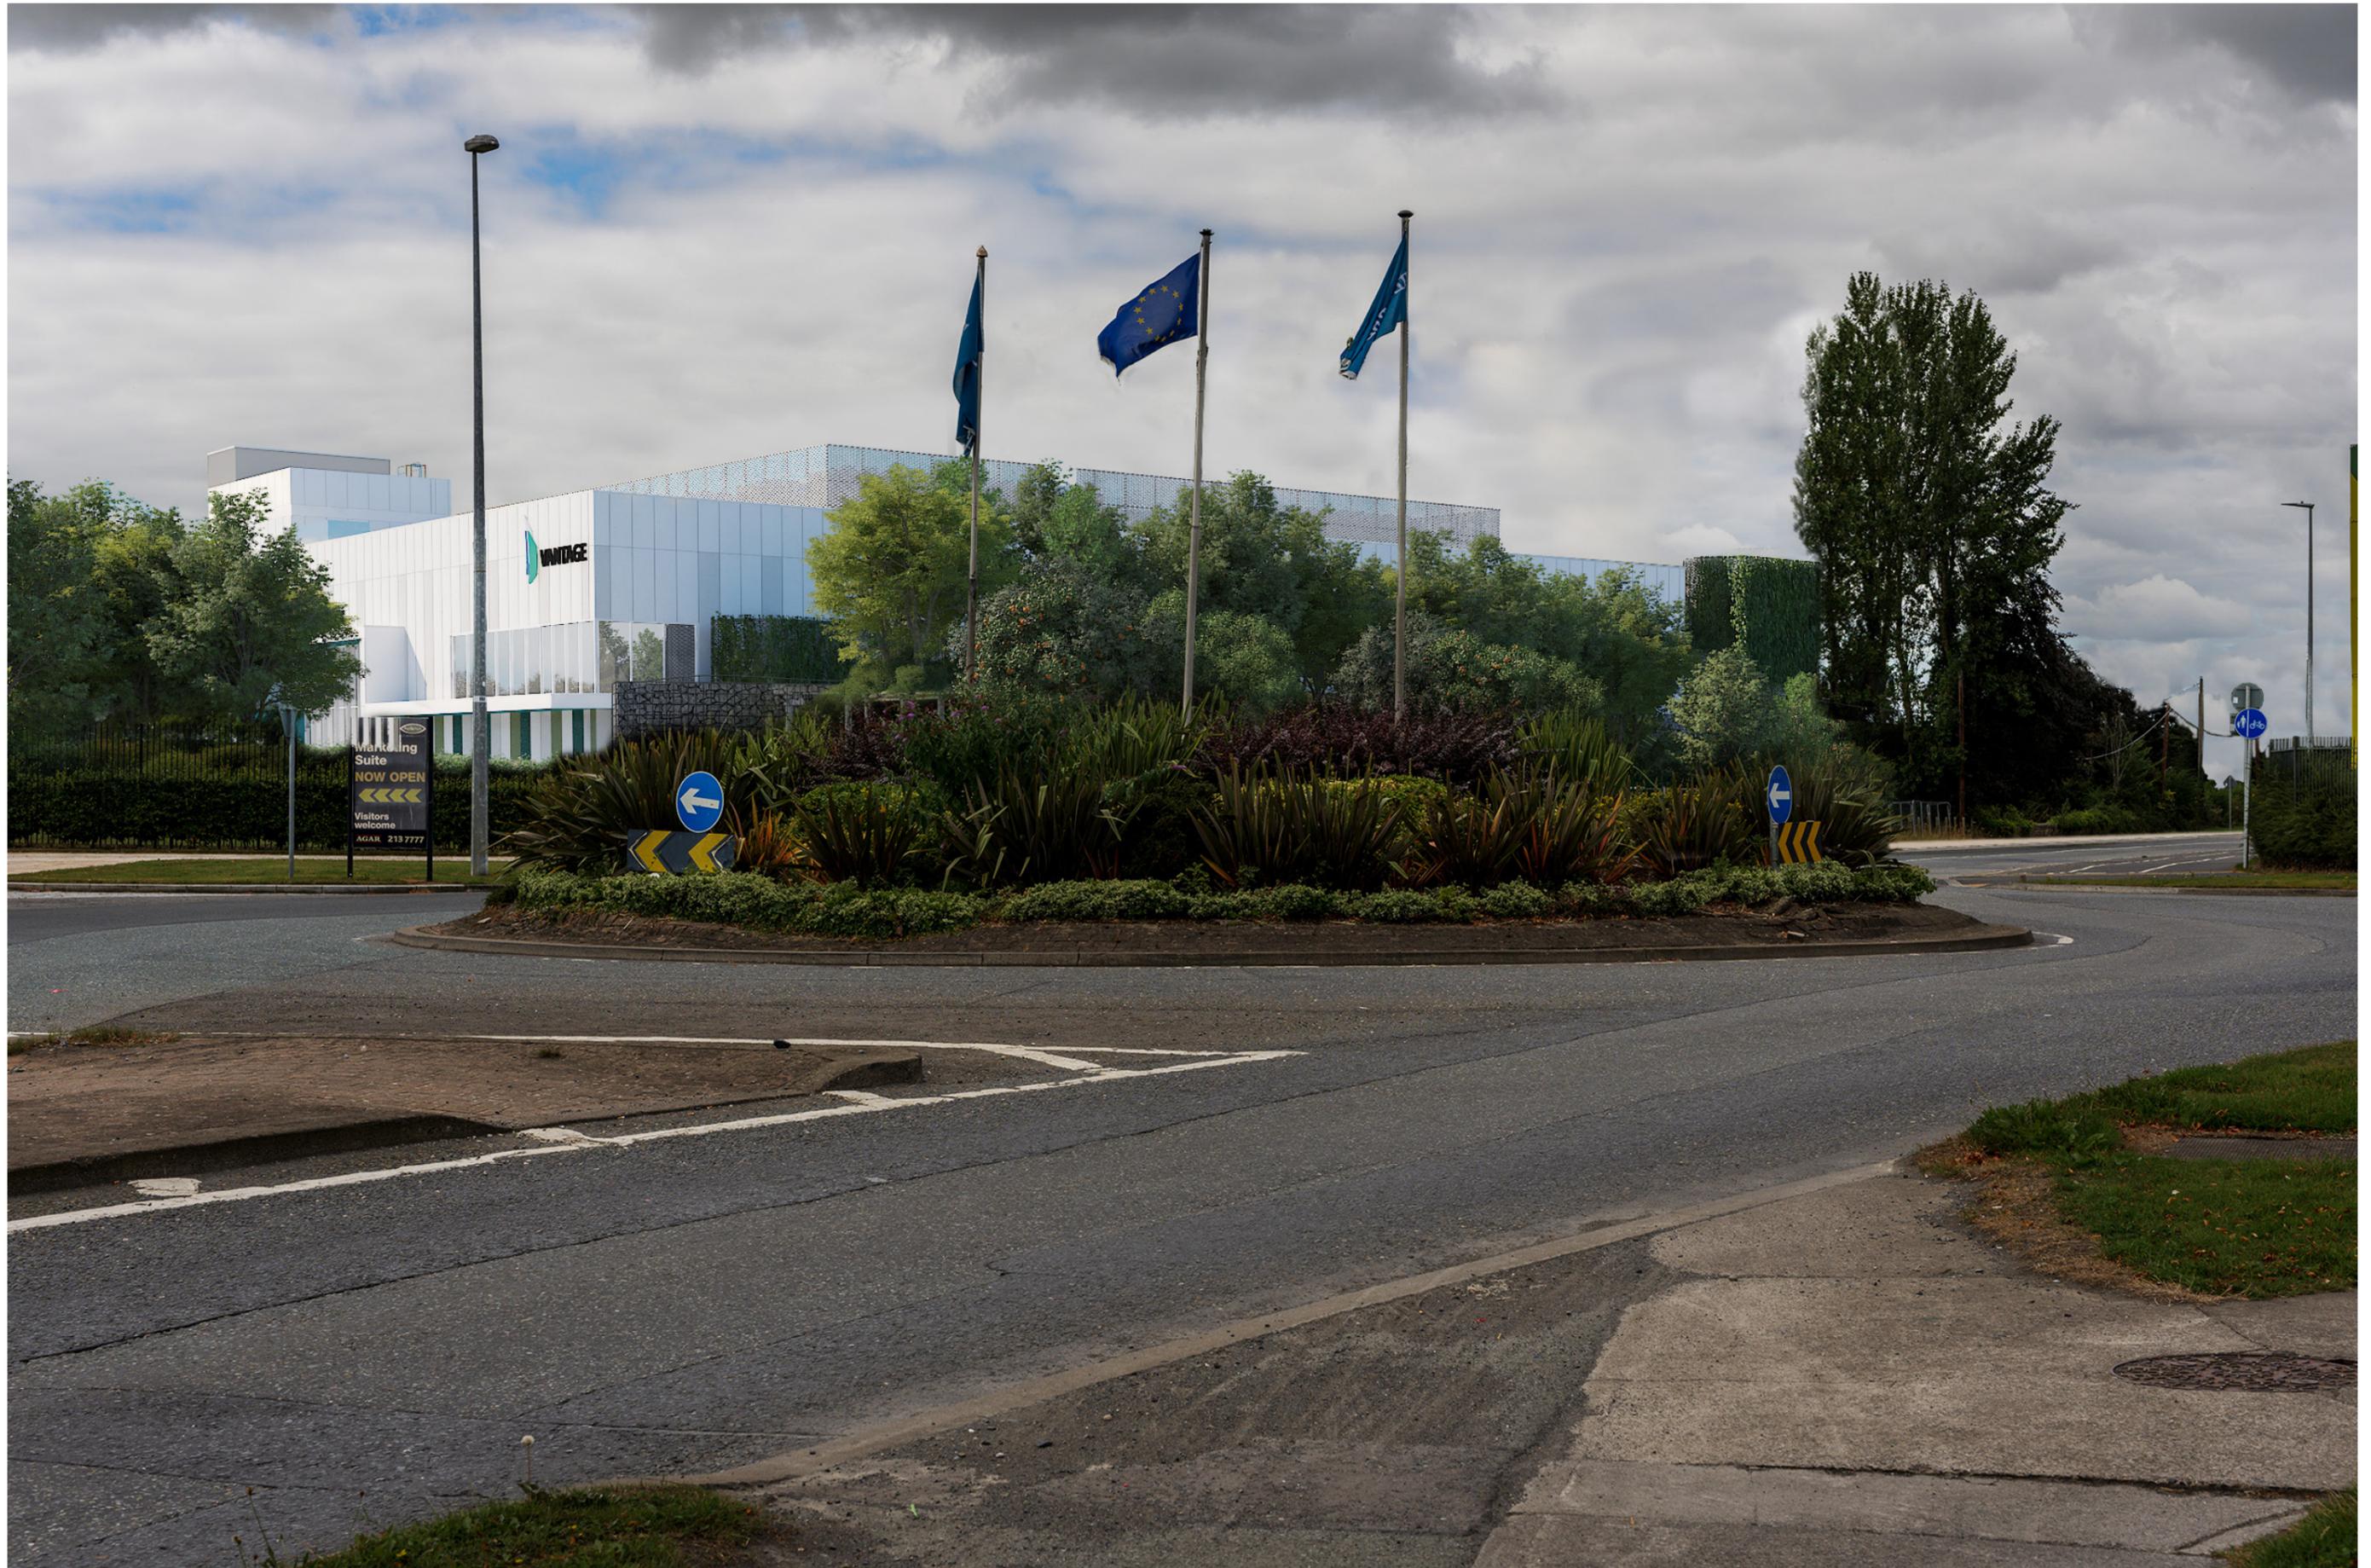
Viewpoint 7: Photomontage of Year 5 view from R134 New Nangor Road at the entrance to Profile Park | Viewing distance at A3: 542mm | Horizontal field of view: 39.6° | Direction of view: 252°  
Camera: Sony ILCE-1 | Lens: Sony 50mm | Camera height: 1.5m AGL | Date taken: 25 August 2022 | Aperture: f/8 | ISO speed: 100 | Shutter: 1/320 sec

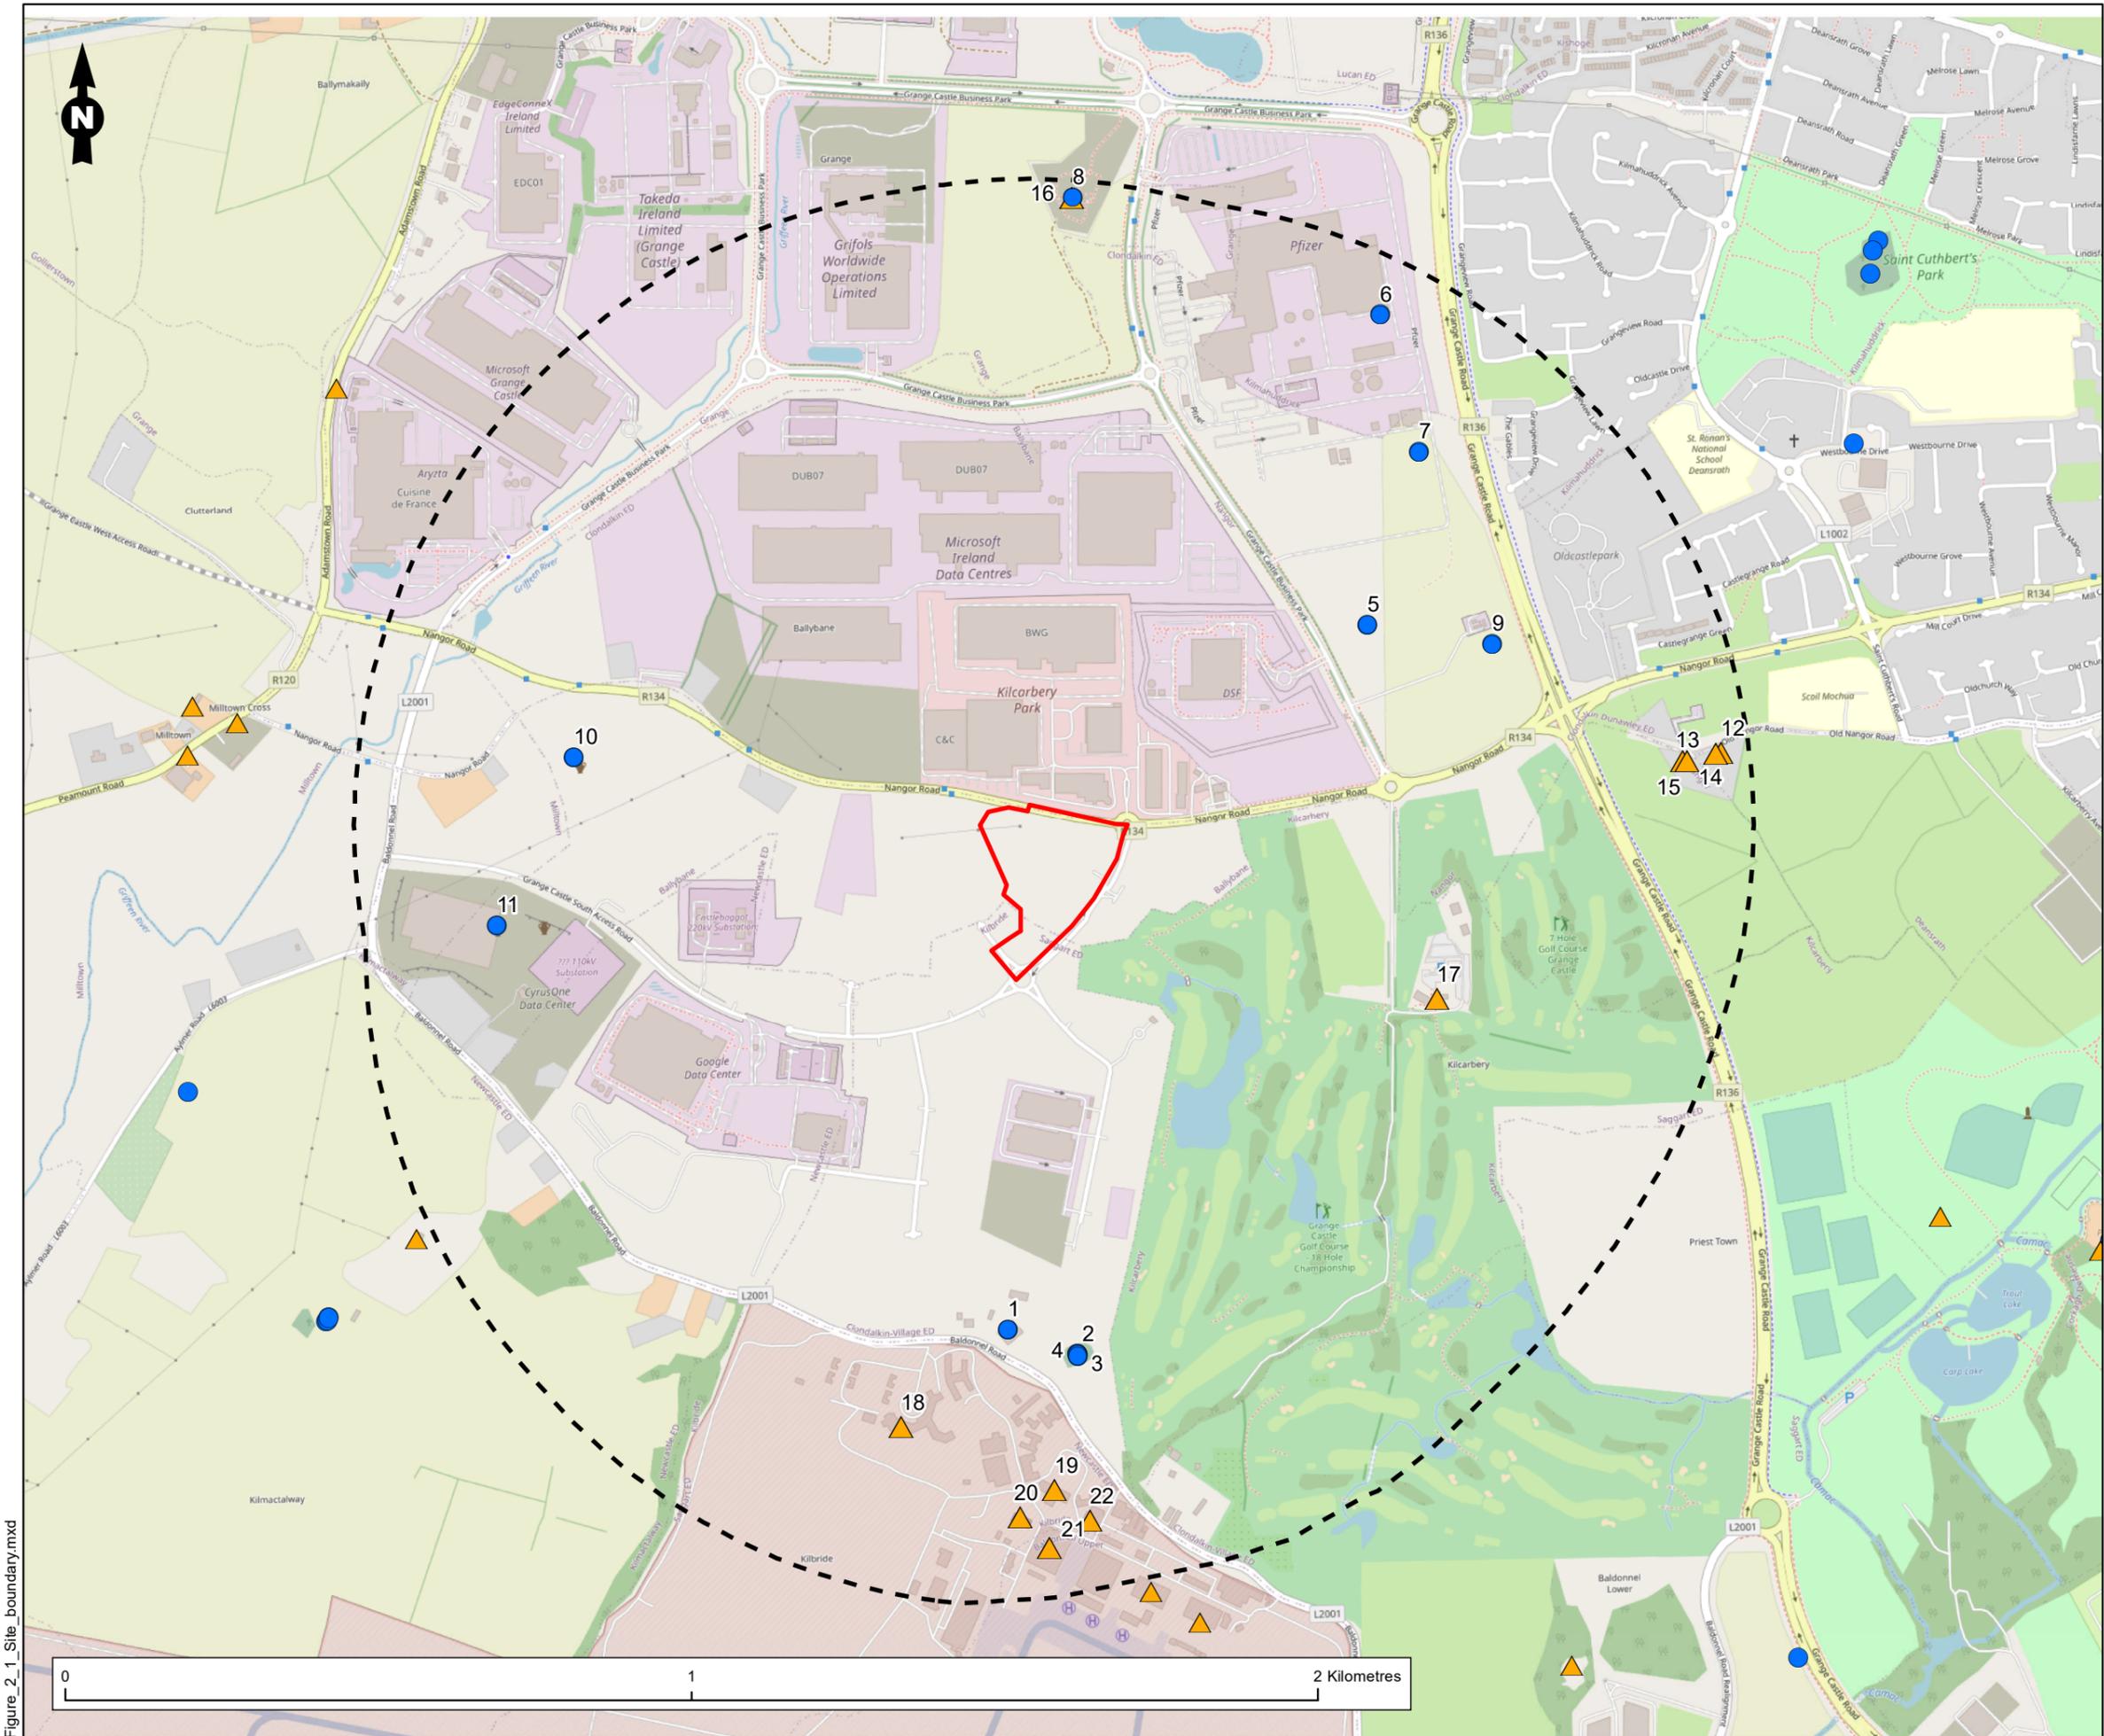
Site boundary  
 1km study area  
● National Monuments  
▲ NIAH sites

Figure Title	
Heritage assets in the 1km study area	
Project Name	
DUB 13 Profile Park	
Project Number	Figure No.
198409	2.1
Date	Prepared By
October 2022	JC
Scale	Issue
1:10,000 @A3	1
Client	
Vantage Data Centers

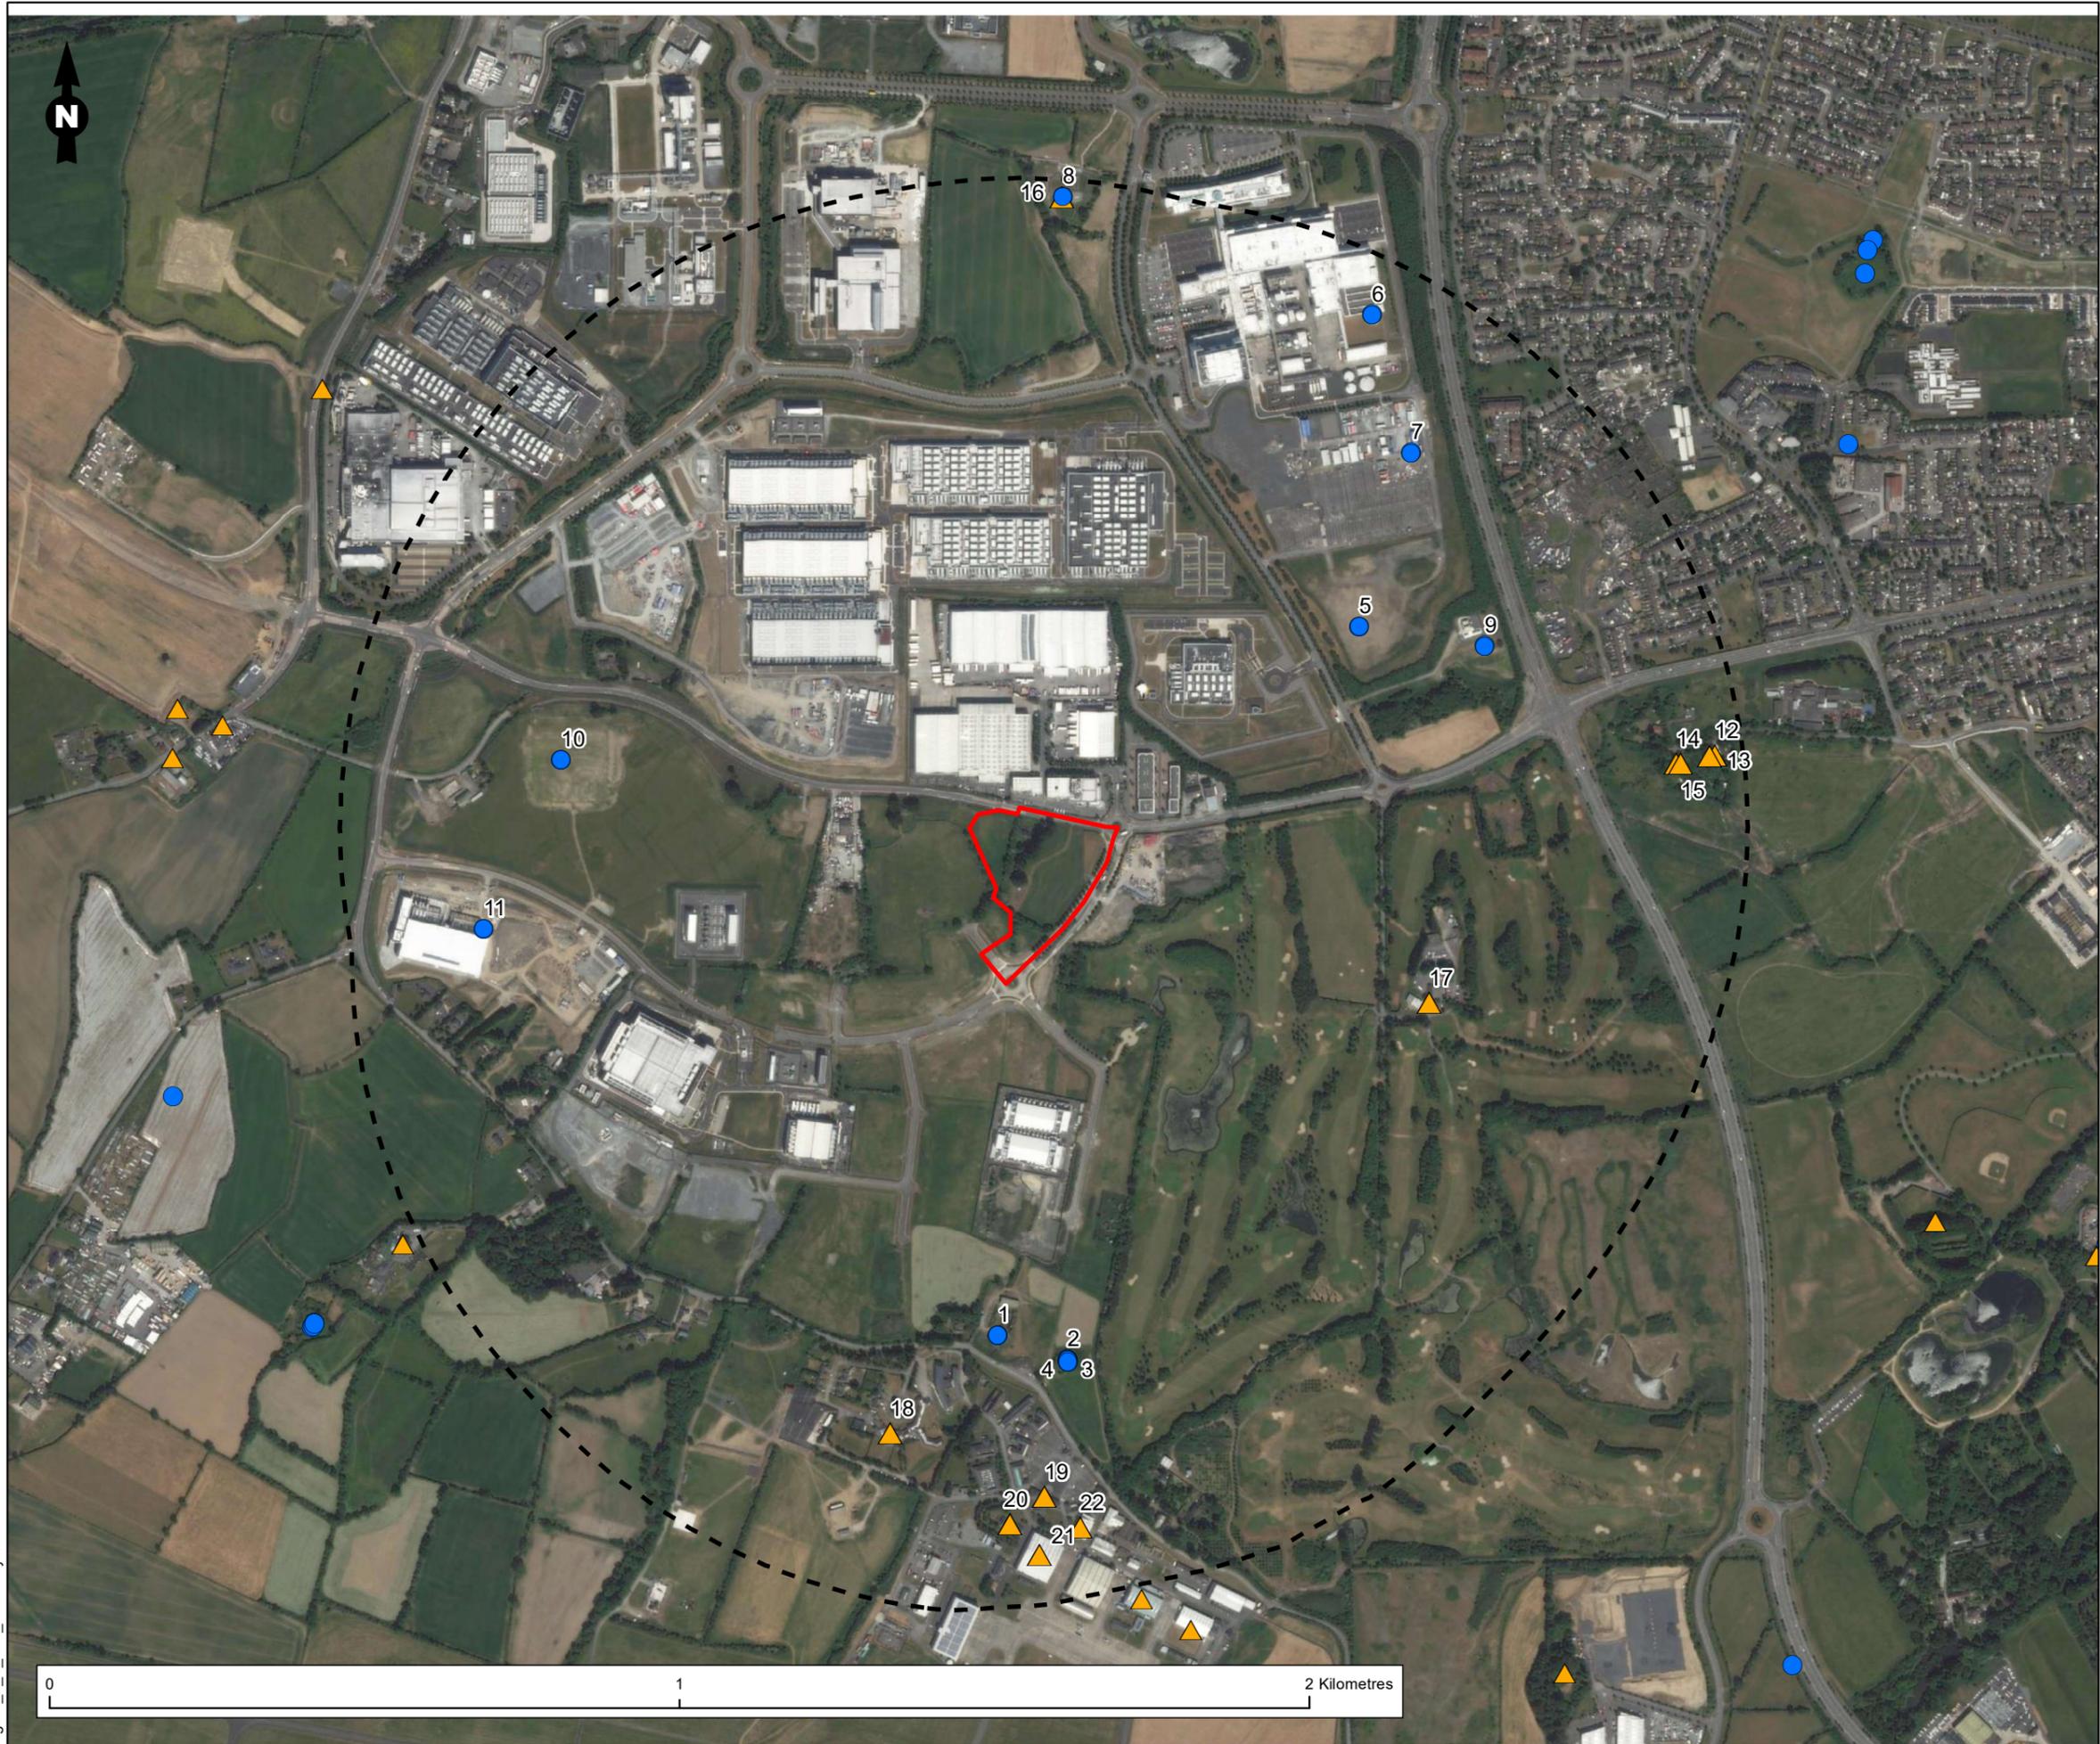
- Site boundary
- 1km study area
- National Monuments
- ▲ NIAH sites

Figure Title	
Heritage assets in the 1km study area	
Project Name	
DUB 13 Profile Park	
Project Number	Figure No.
198409	2.2
Date	Prepared By
October 2022	JC
Scale	Issue
1:10,000 @A3	1
Client	
Vantage Data Centers

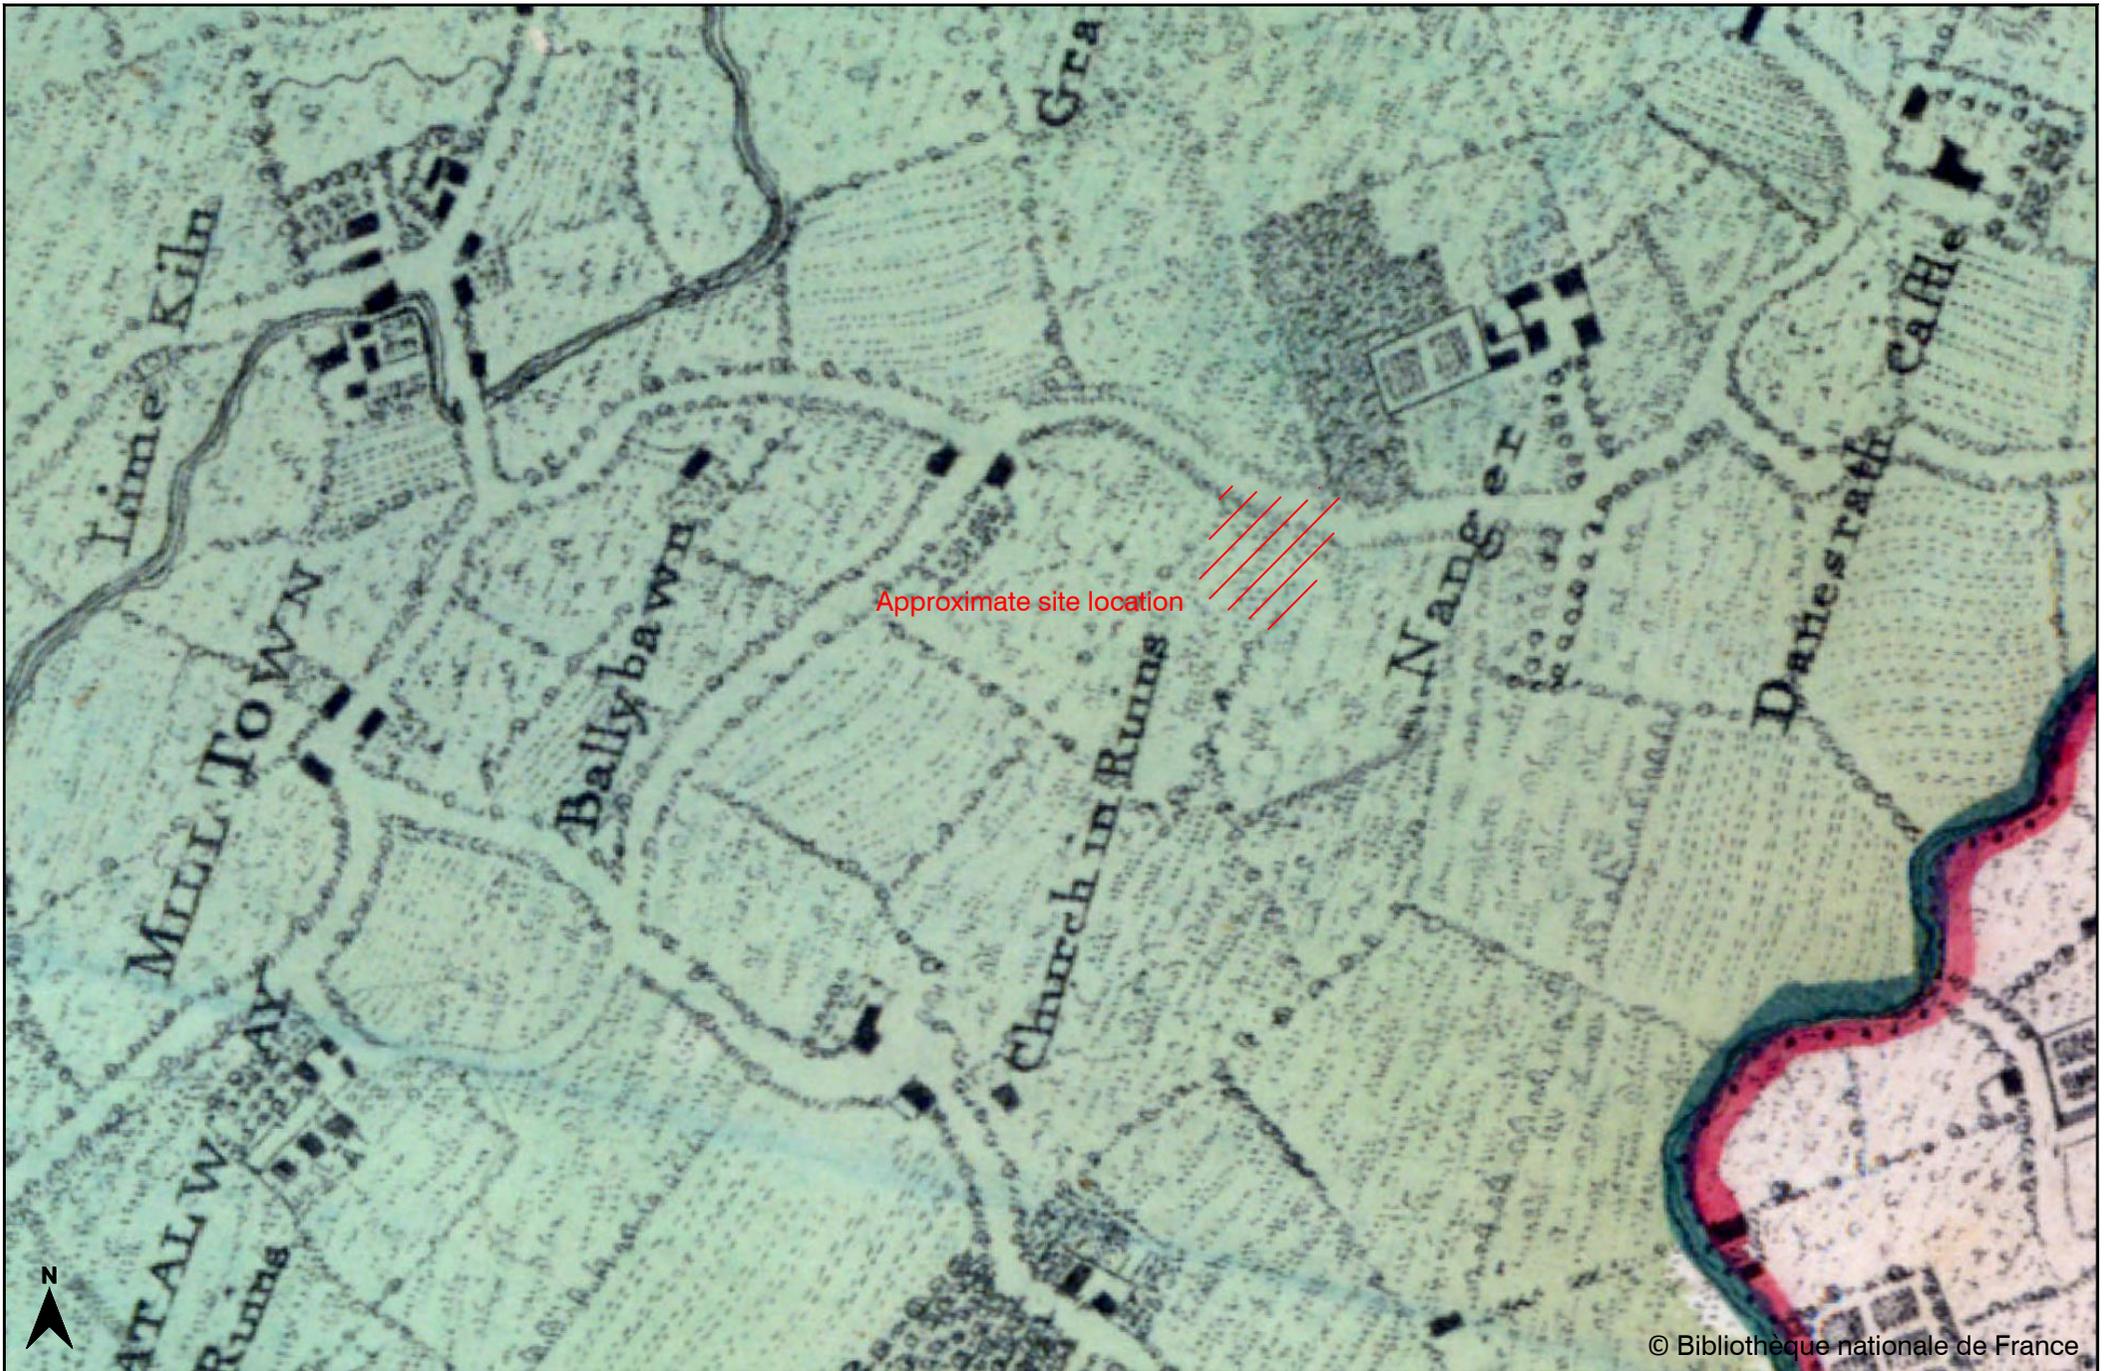
<b>Figure 3</b> Extract from An actual survey of the county of Dublin by John Rocque - southeast sheet (1760) , showing approximate location of site		<b>Scale</b> Not to scale

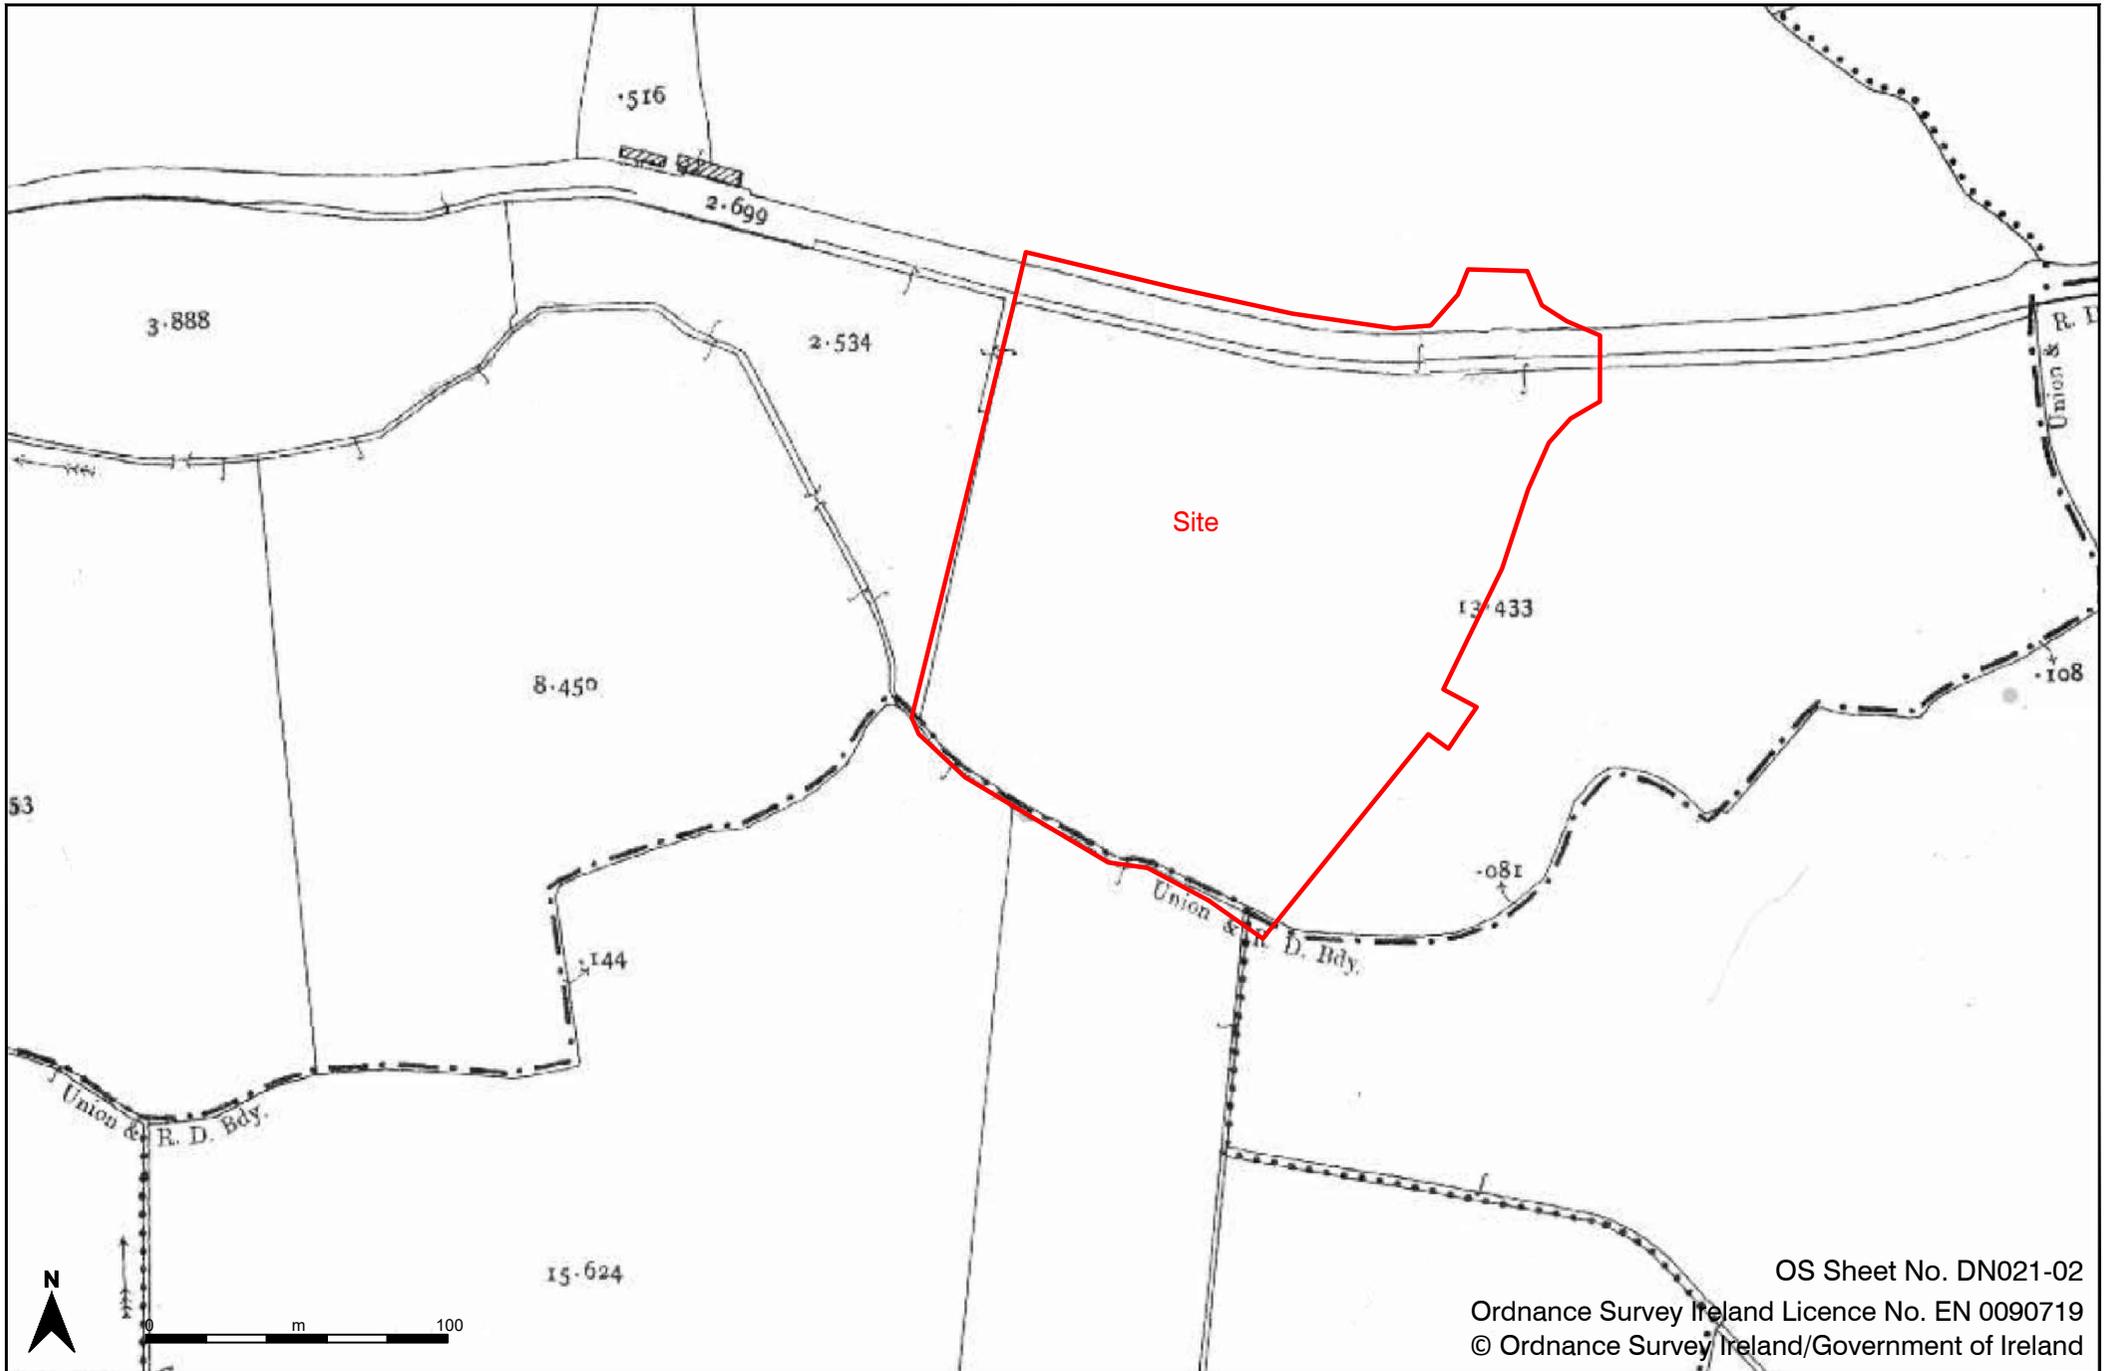
**Figure 5** Extract from 3rd edition Ordnance Survey (OS) 25-inch map (surveyed 1908 - published 1910), showing location of site

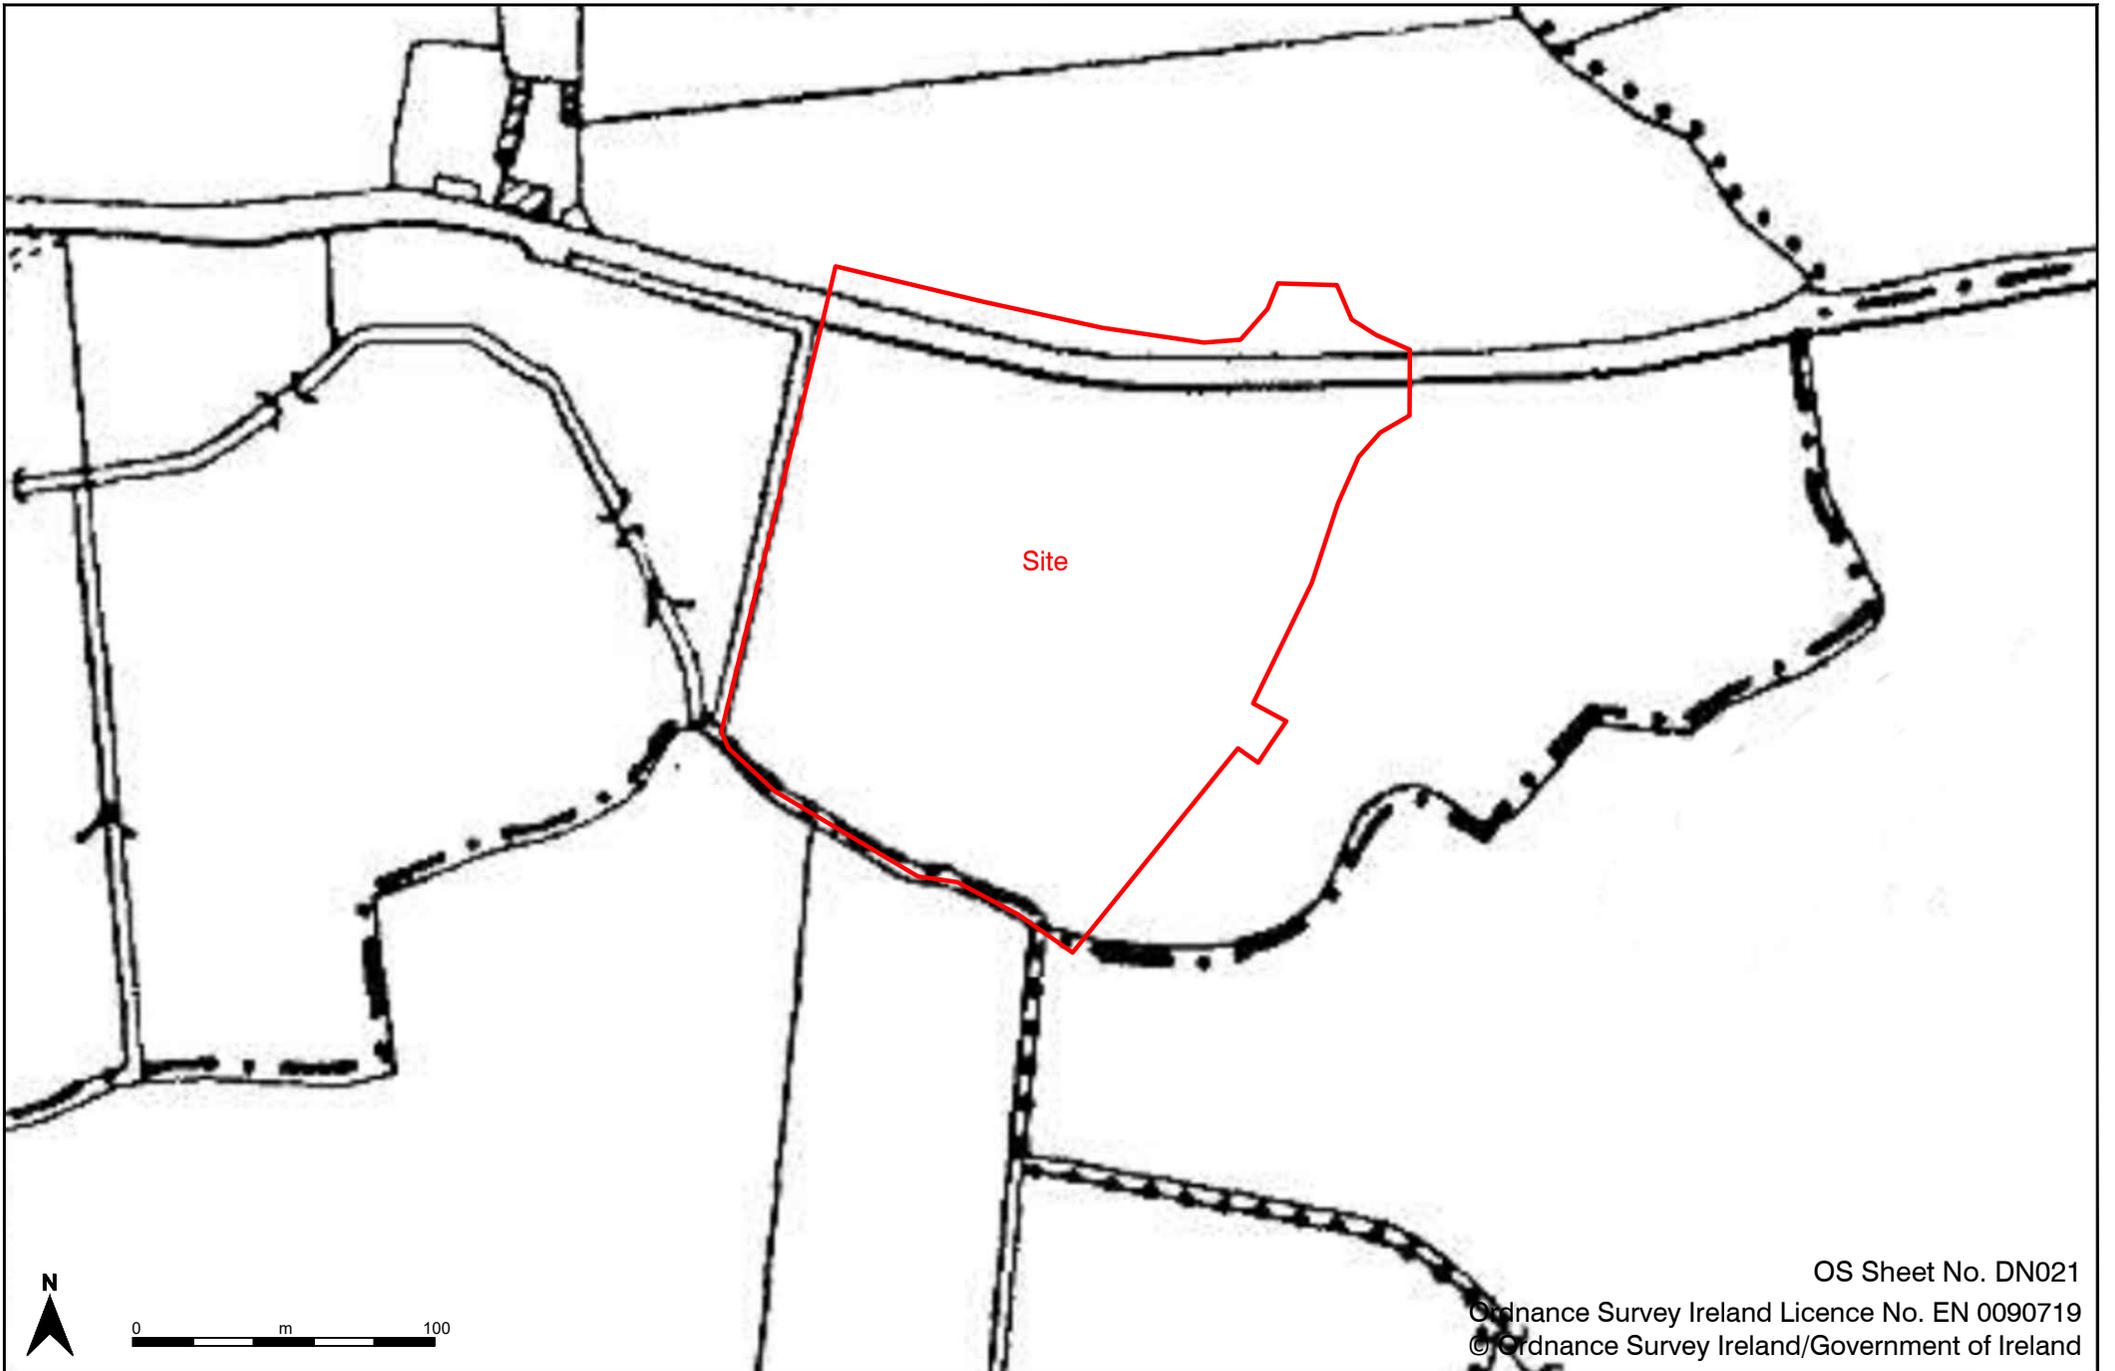
**Figure 6** Extract from Cassini edition Ordnance Survey (OS) 6-inch map (1935-38), showing location of site

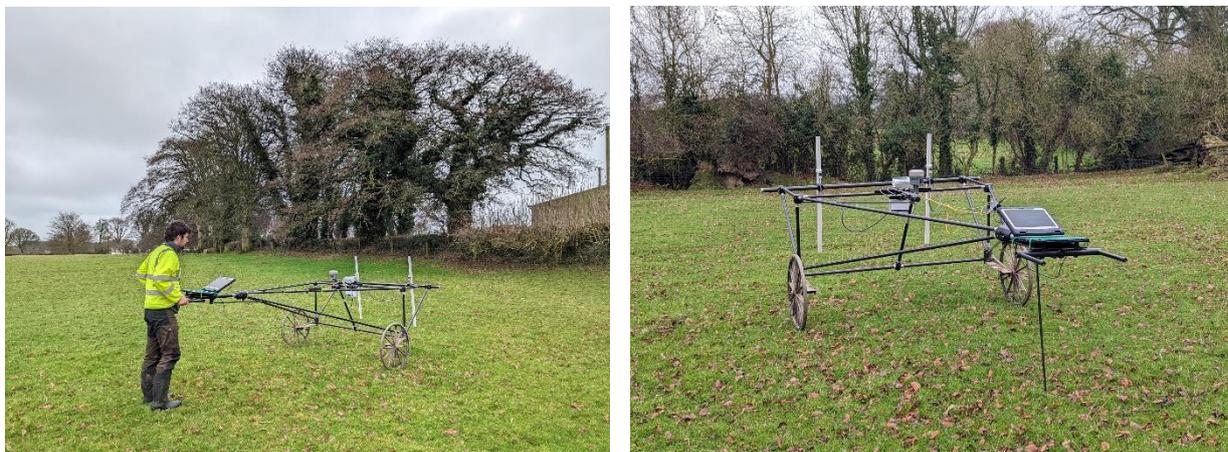
The instrument can be employed in both commercial and research-based investigations allowing for the completion of projects within short timescales. Regular grid sample densities from standard 1600 readings to 12800 readings per 20m by 20m grid are permitted. A constant high quality of data is assured by experienced field staff operating in accordance with English Heritage guidelines *Geophysical Survey In Archaeological Field Evaluation* (2008) and *EAC Guidelines for the use of Geophysics in Archaeology* (Schmidt et al. 2016).

Bartington Grad 601-2 mounted on Bartington Cart system

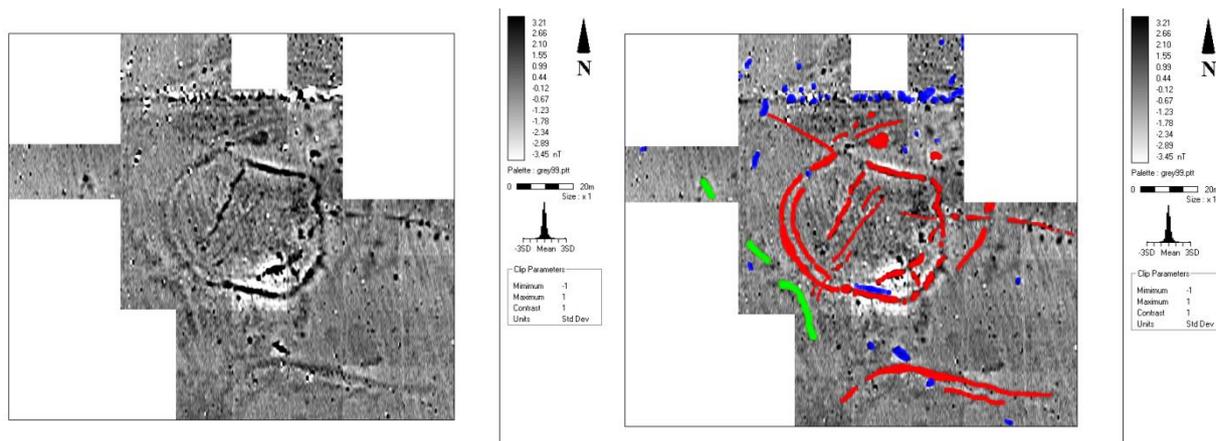
**Greyscale:** The greyscale format assigns a cell to each datum according to its location on the grid. The display of each data point is conducted at very fine increments, allowing the full range of values to be displayed within the given data set. This display method also enables the identification of discrete responses that may be at the limits of instrument detection.

Early medieval enclosure greyscale
