Intended for  
**Vantage Data Centers DUB13 Limited**

Date  
**March 2023**

# **VANTAGE DUBLIN DATA CENTER**

## **VOLUME 2A: LANDSCAPE, VISUAL AND BUILT HERITAGE IMPACT ASSESSMENT**

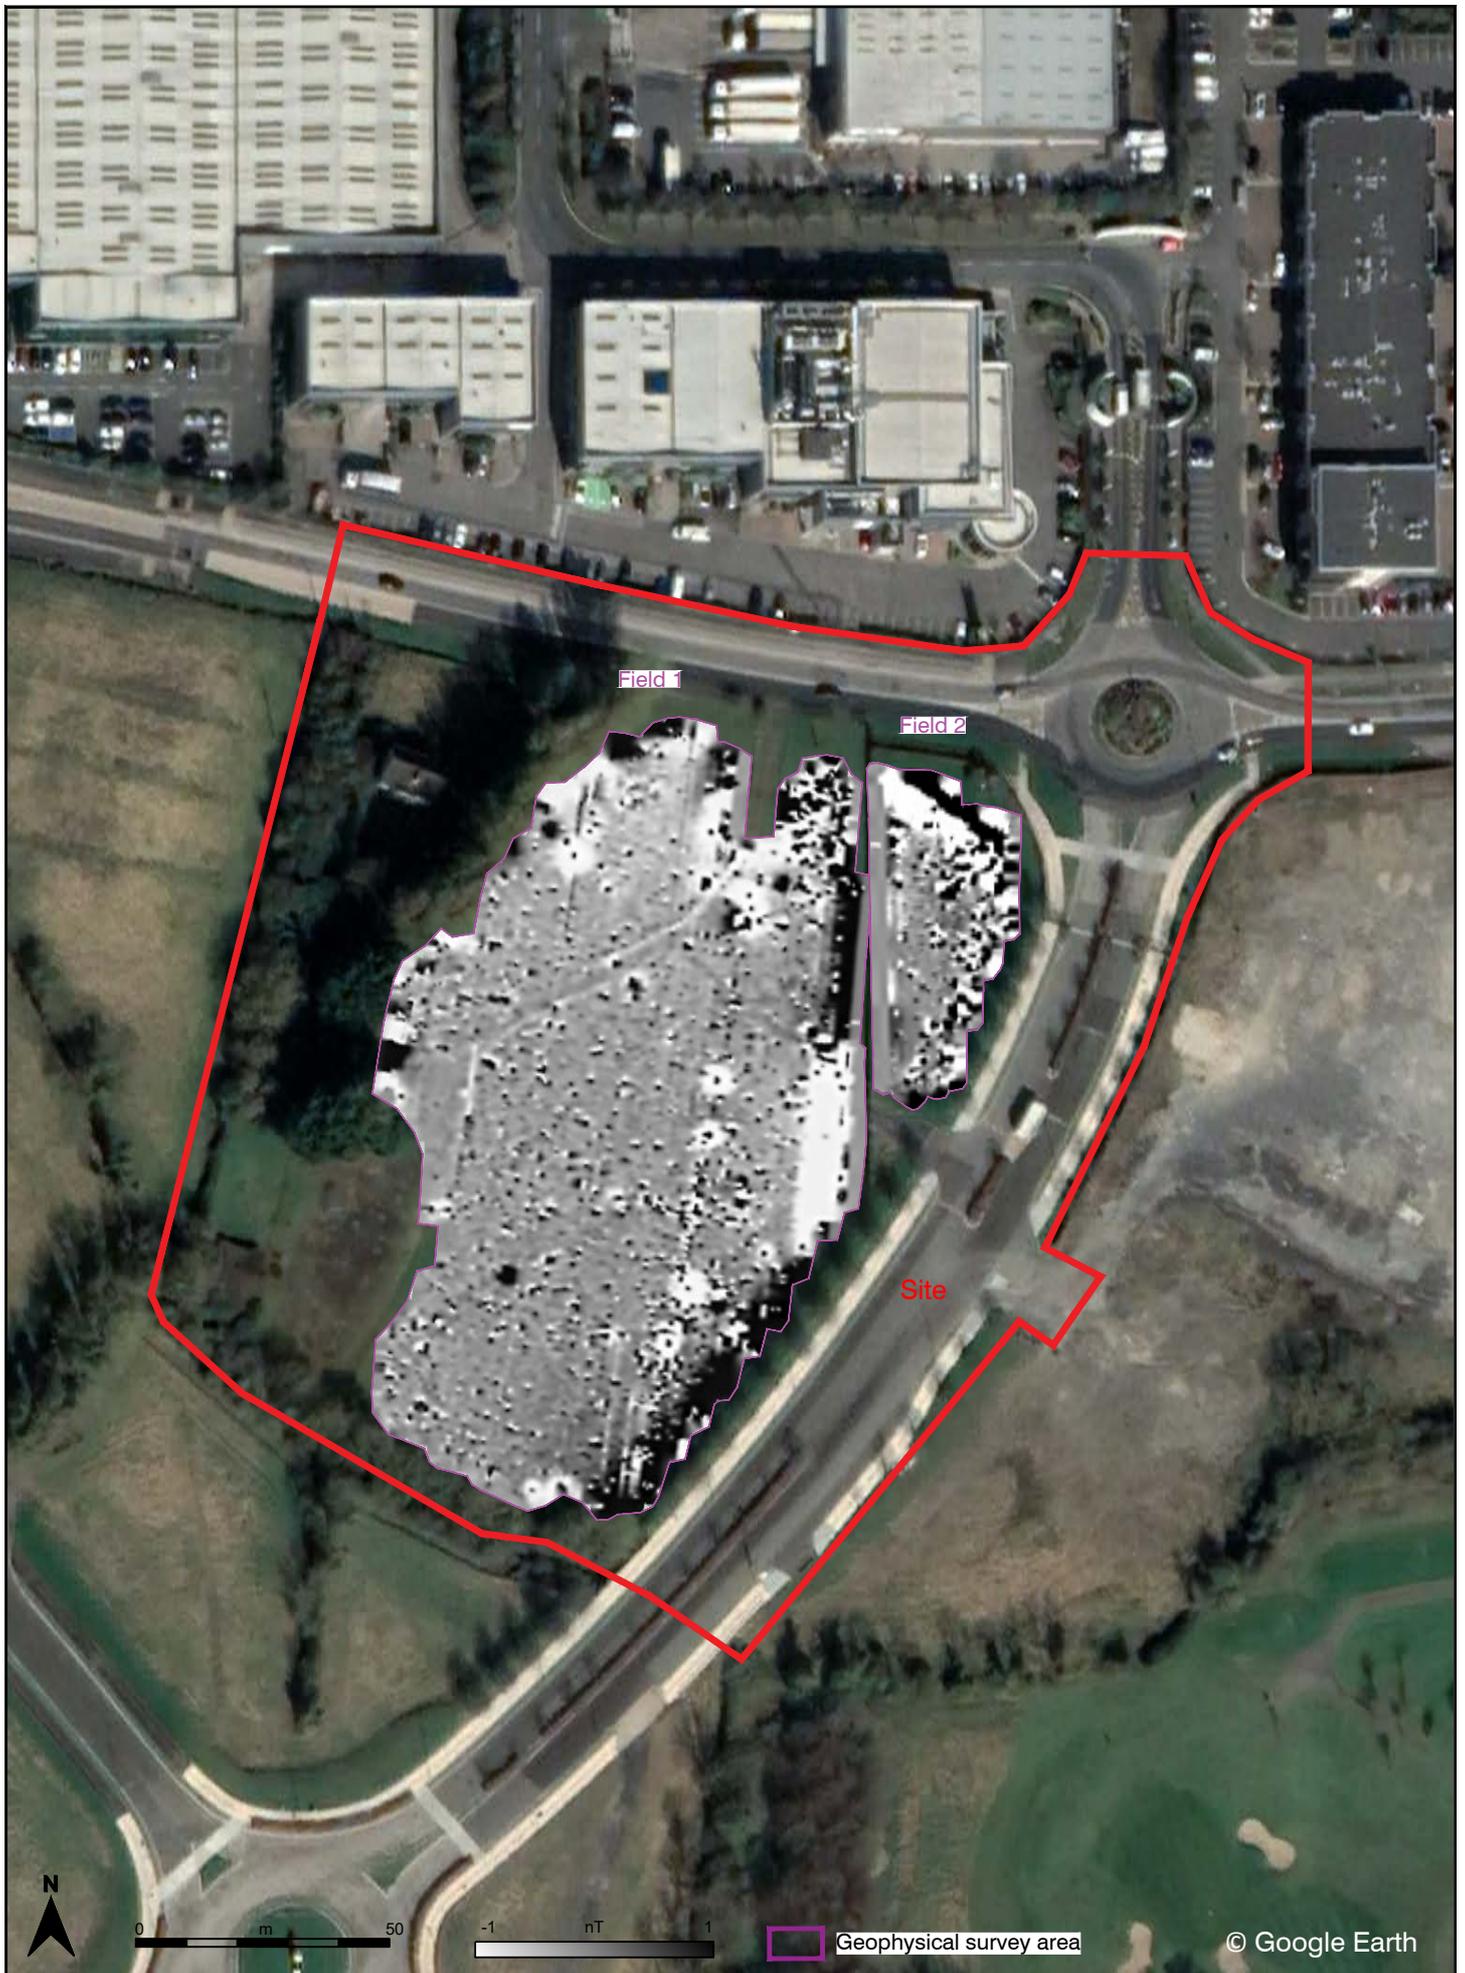
Figure 7 Aerial view of site, showing geophysical survey results (greyscale image)

A total of 11 test trenches were excavated within the site, targeting the trends identified in the geophysical survey (Figure 7). Each trench measured 1.8m in width, and in total 597m of linear trenches were excavated. In general, the sod and topsoil measured 0.34–0.50m in thickness and lay above a mid-grey natural clay and stone (Table 3; Plates 1–12). Only one potential archaeological feature was identified, within Trenches 5, 6 and 11. This feature corresponded with a geophysical trend (Anomaly 1a). It consisted of a linear feature or ditch (C3), aligned northwest–southeast and measuring c.25.0m in length, 1.7m in width and 0.32m in depth. It was filled with a mid-brown silty clay containing occasional inclusions of decayed stone and a few small fragments of animal bone (C4; Plate 12).

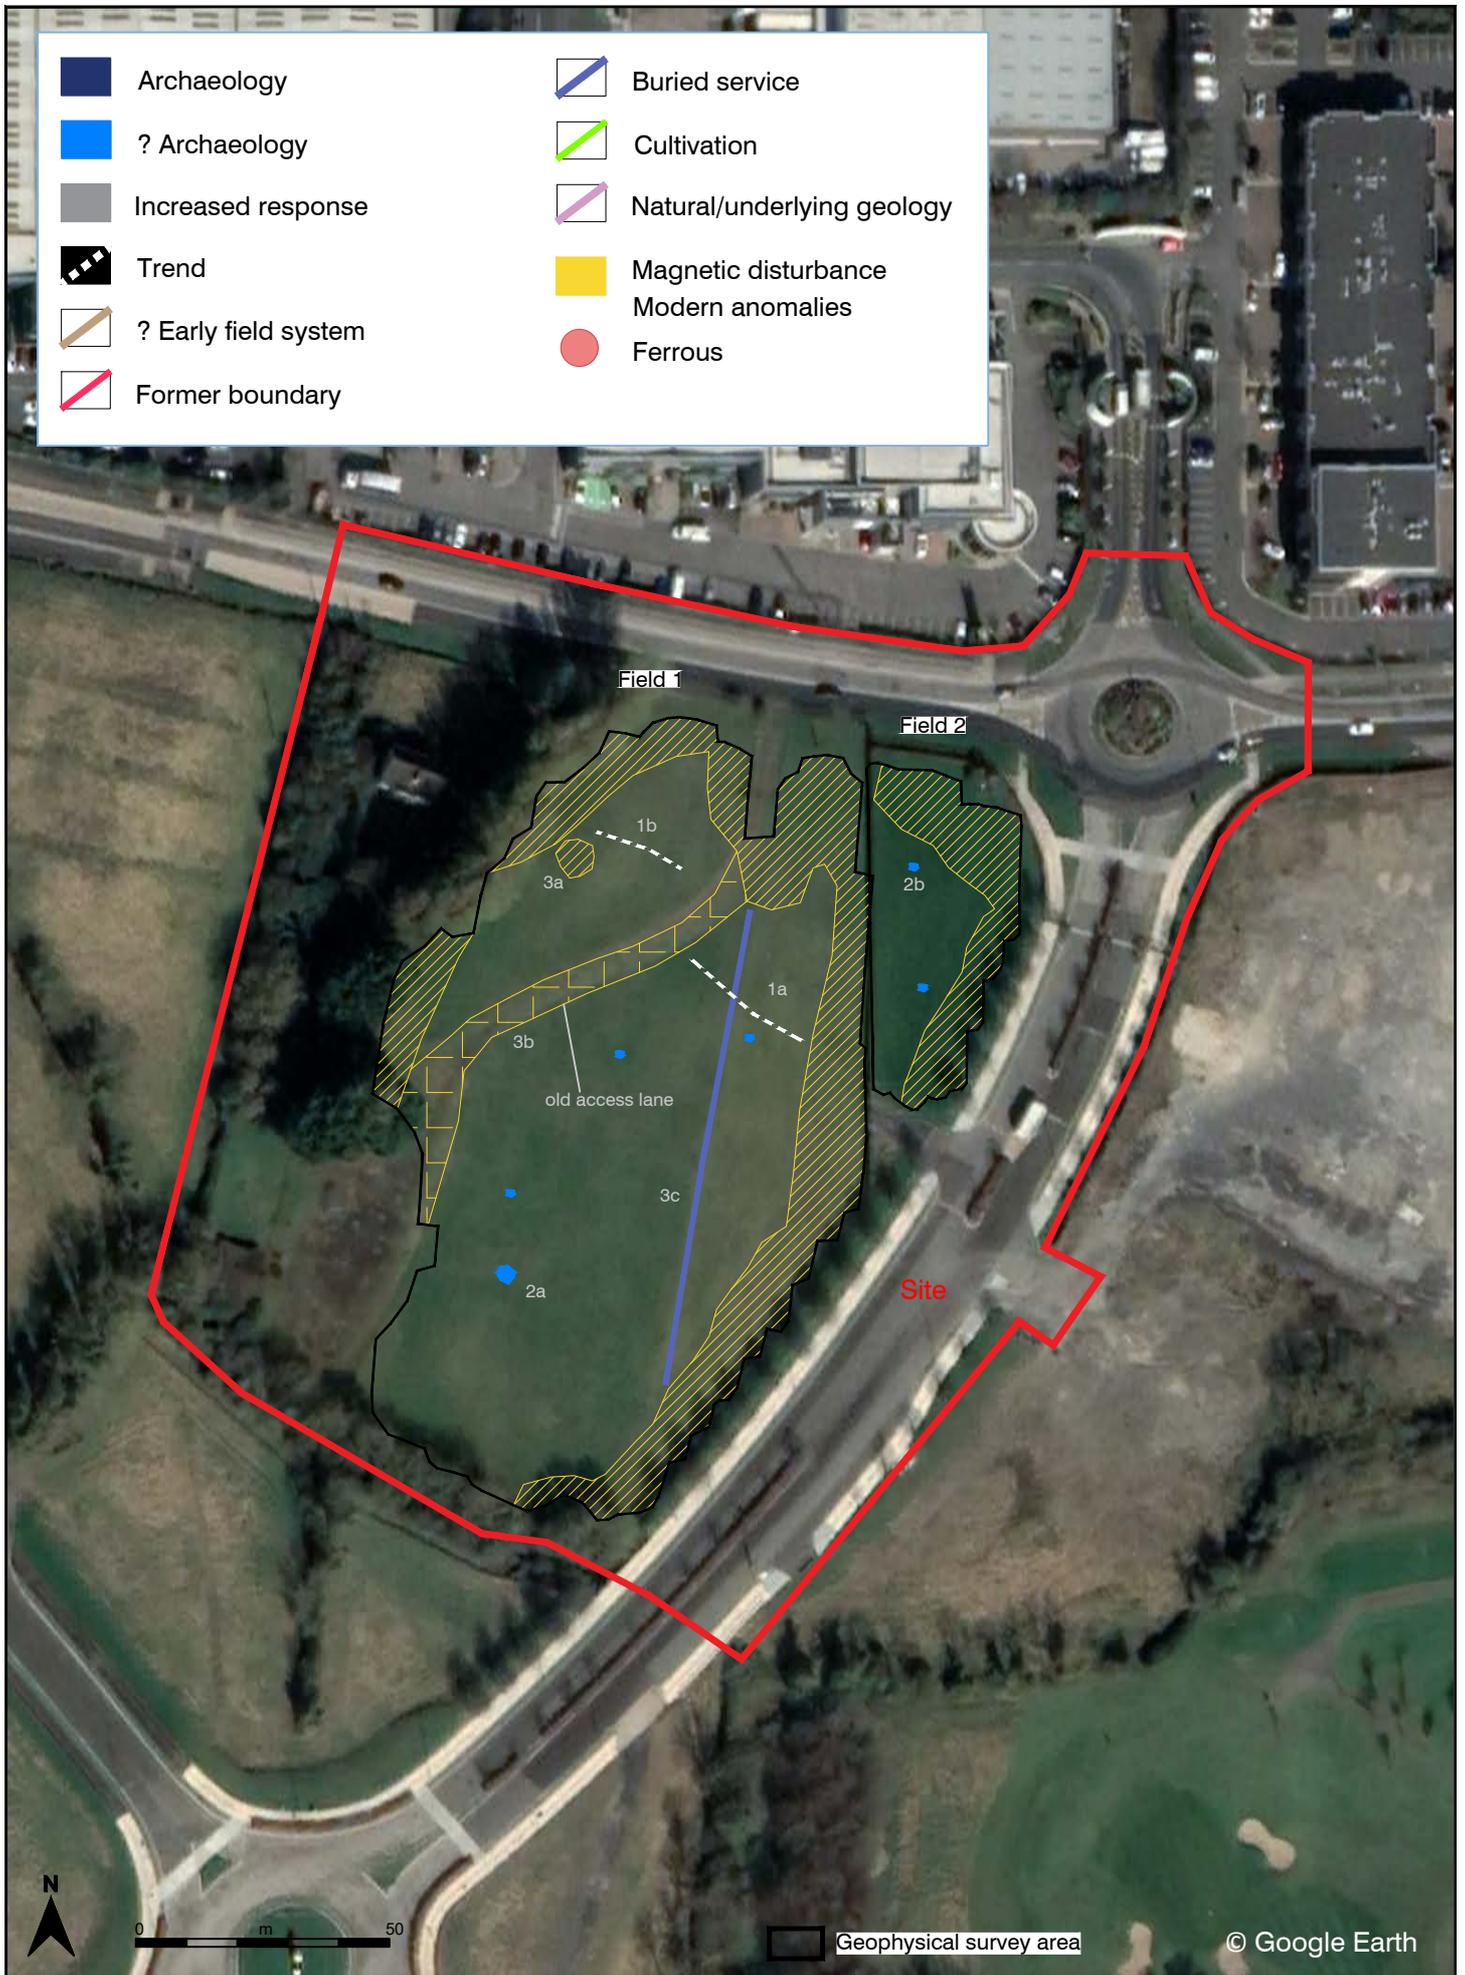
Figure 8 Aerial view of site, showing geophysical survey interpretation

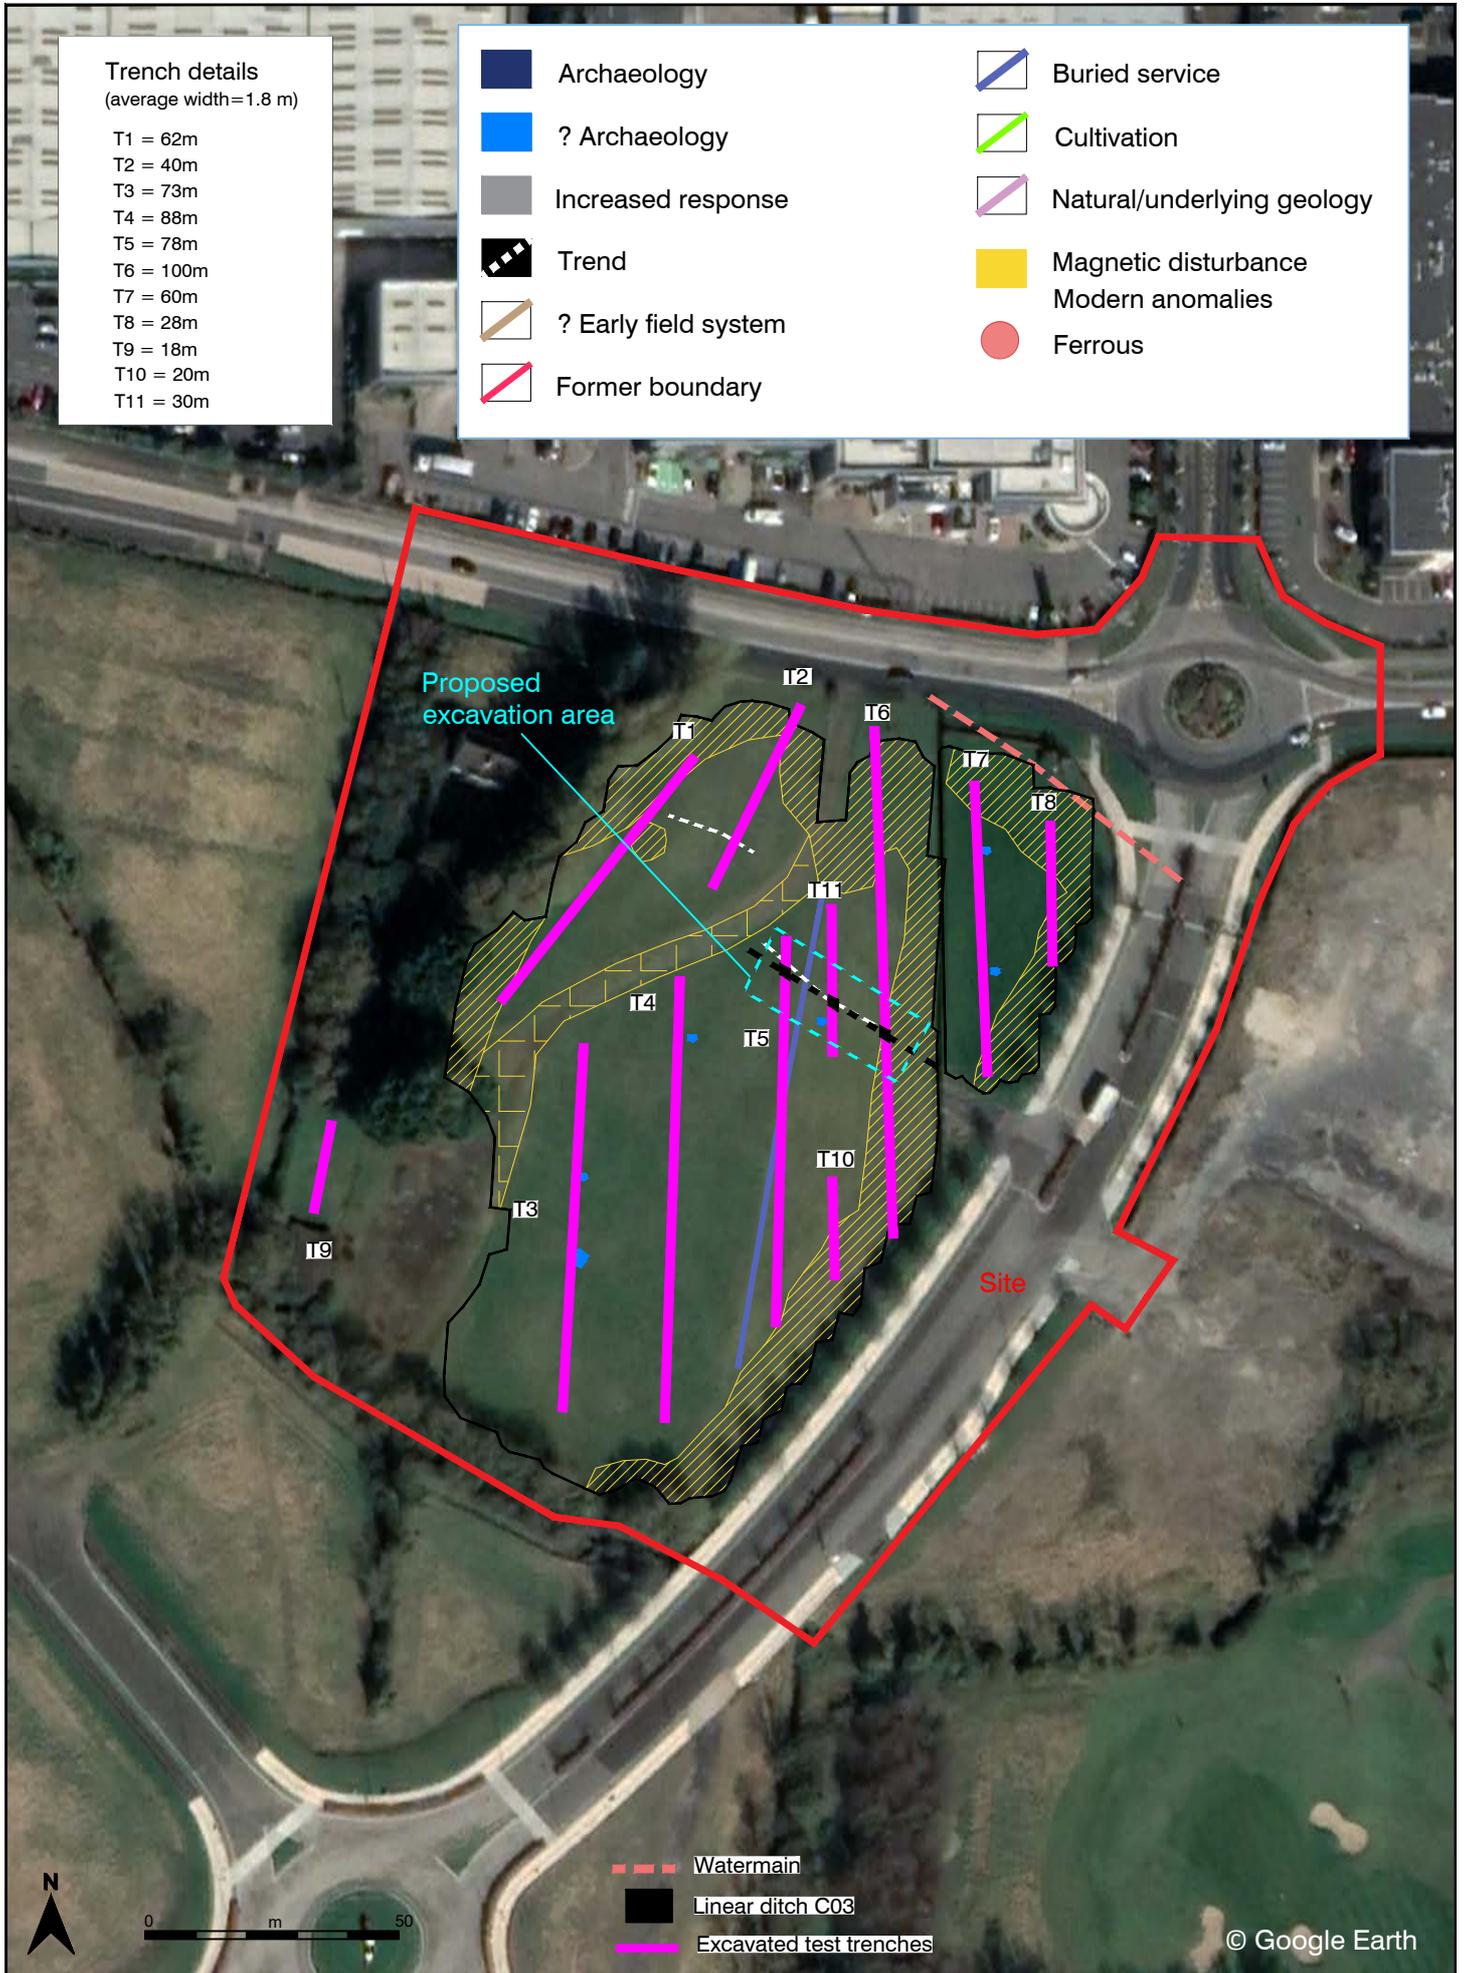
- Watermain
- Linear ditch C03
- Excavated test trenches

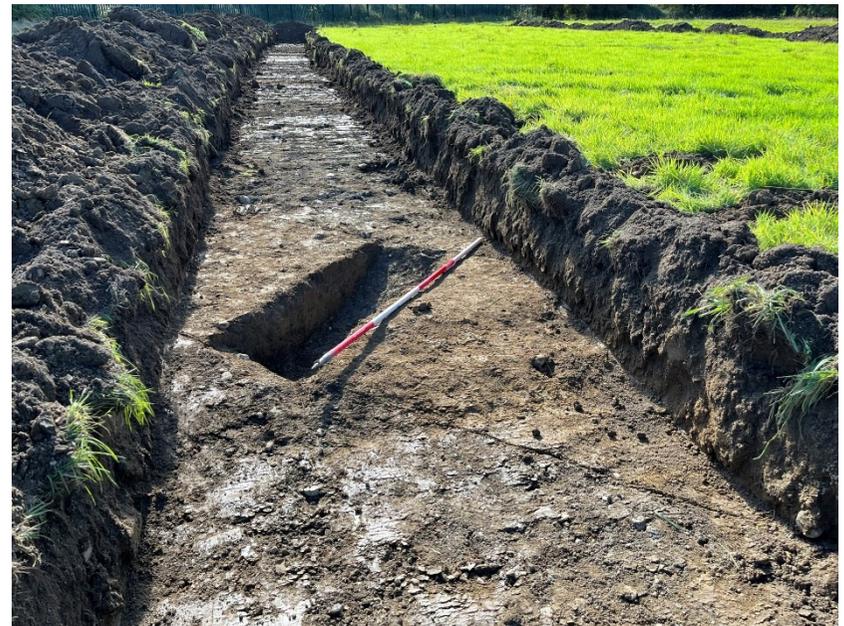
Plate 12: Trench 11, ditch C03 looking south.

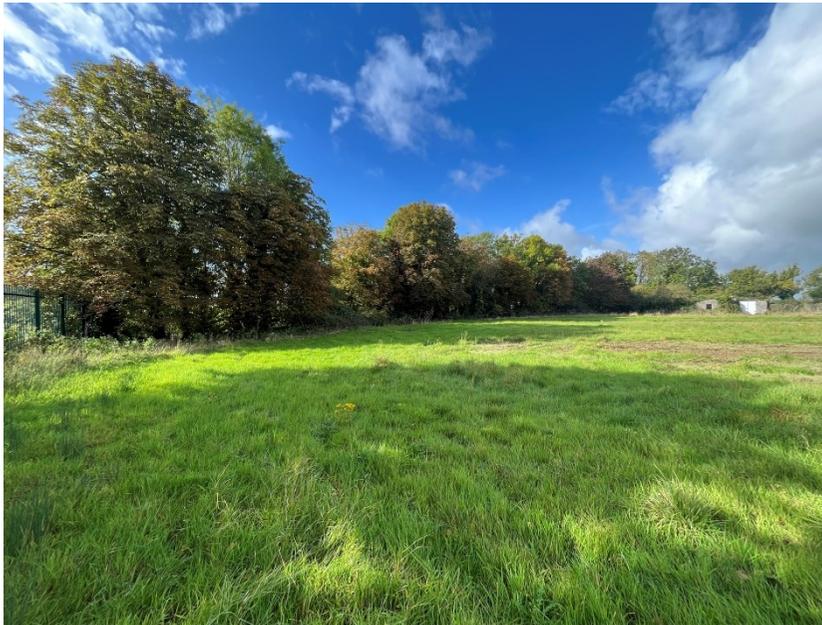
Plate 13: General view of townland boundary looking southwest.

The townland boundary between Ballybane and Kilbride, forming the south boundary of the site, consists of a mature hedgerow and tree line on either side of an extant ditch/stream (Plates 13–16). The stream is V-shaped in profile and measures 1.8m wide at the base rising to c.4.35m at the top and is 2.24m in depth. The trees and hedgerow are more prevalent on the northern side, with less trees present on the southern side of the boundary. No banks were visible on either side of the stream.

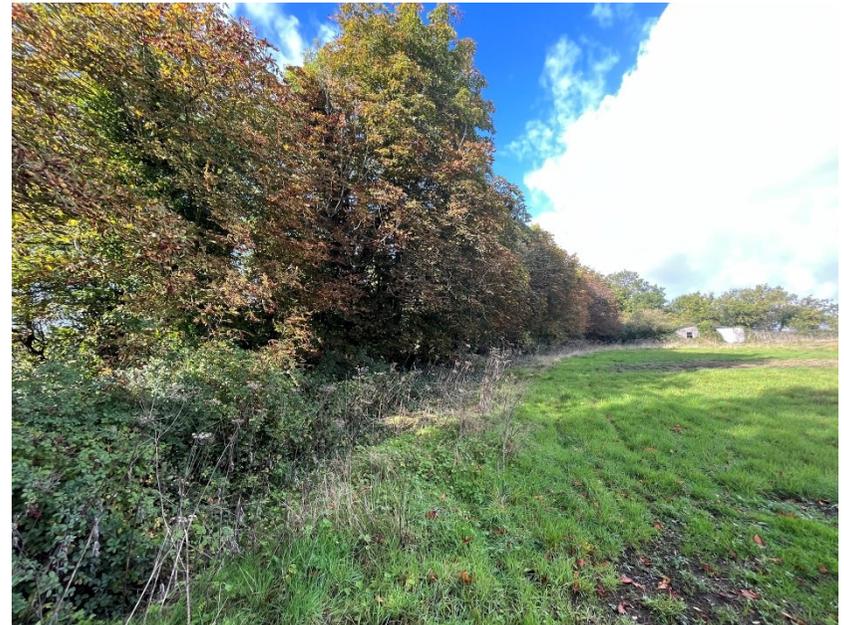
Plate 14: Detail of townland boundary looking southwest.

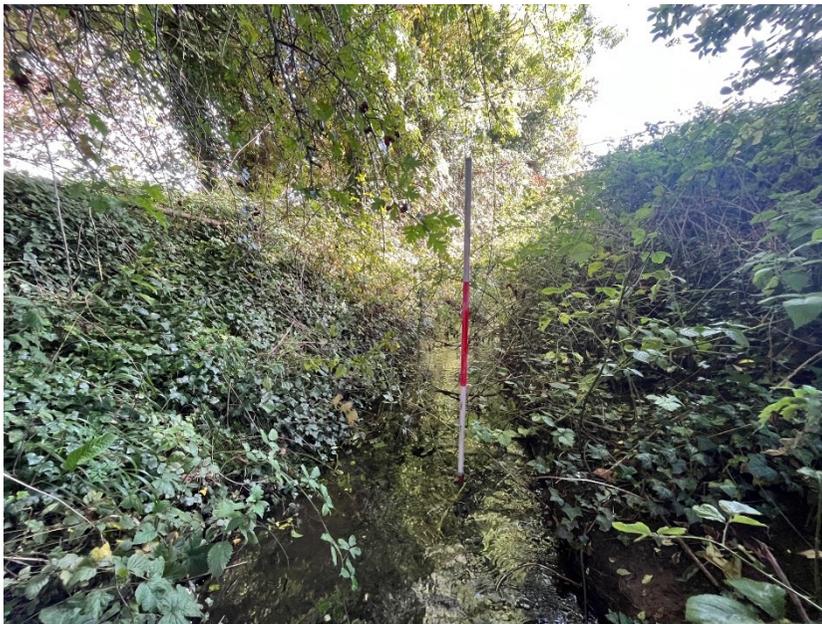
Plate 15: Detail of banks and stream within townland boundary looking east.

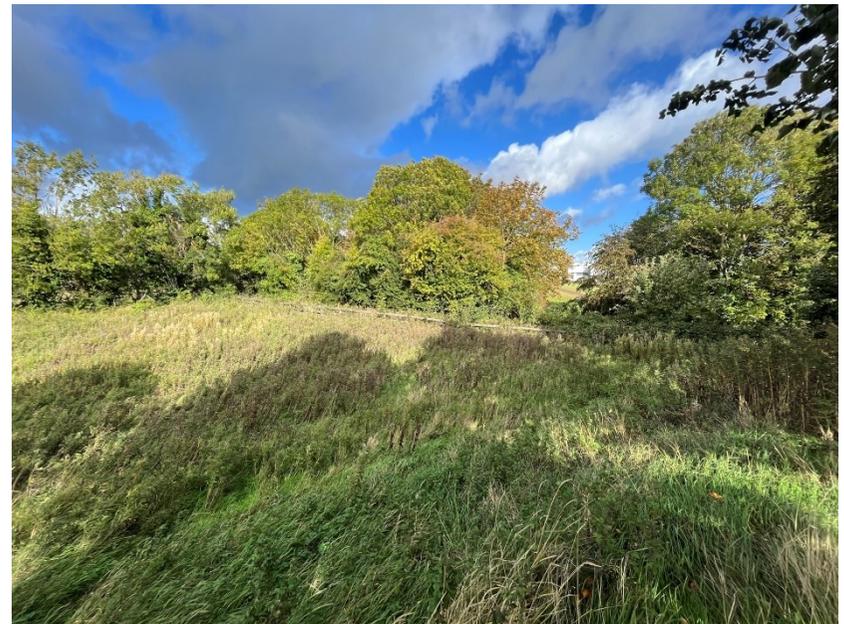
Plate 16: General view of townland boundary looking northwest.
