Intended for
Vantage Data Centers DUB13 Limited

Date
March 2023

VANTAGE DUBLIN DATA CENTER

VOLUME 2A: LANDSCAPE, VISUAL AND BUILT HERITAGE IMPACT ASSESSMENT

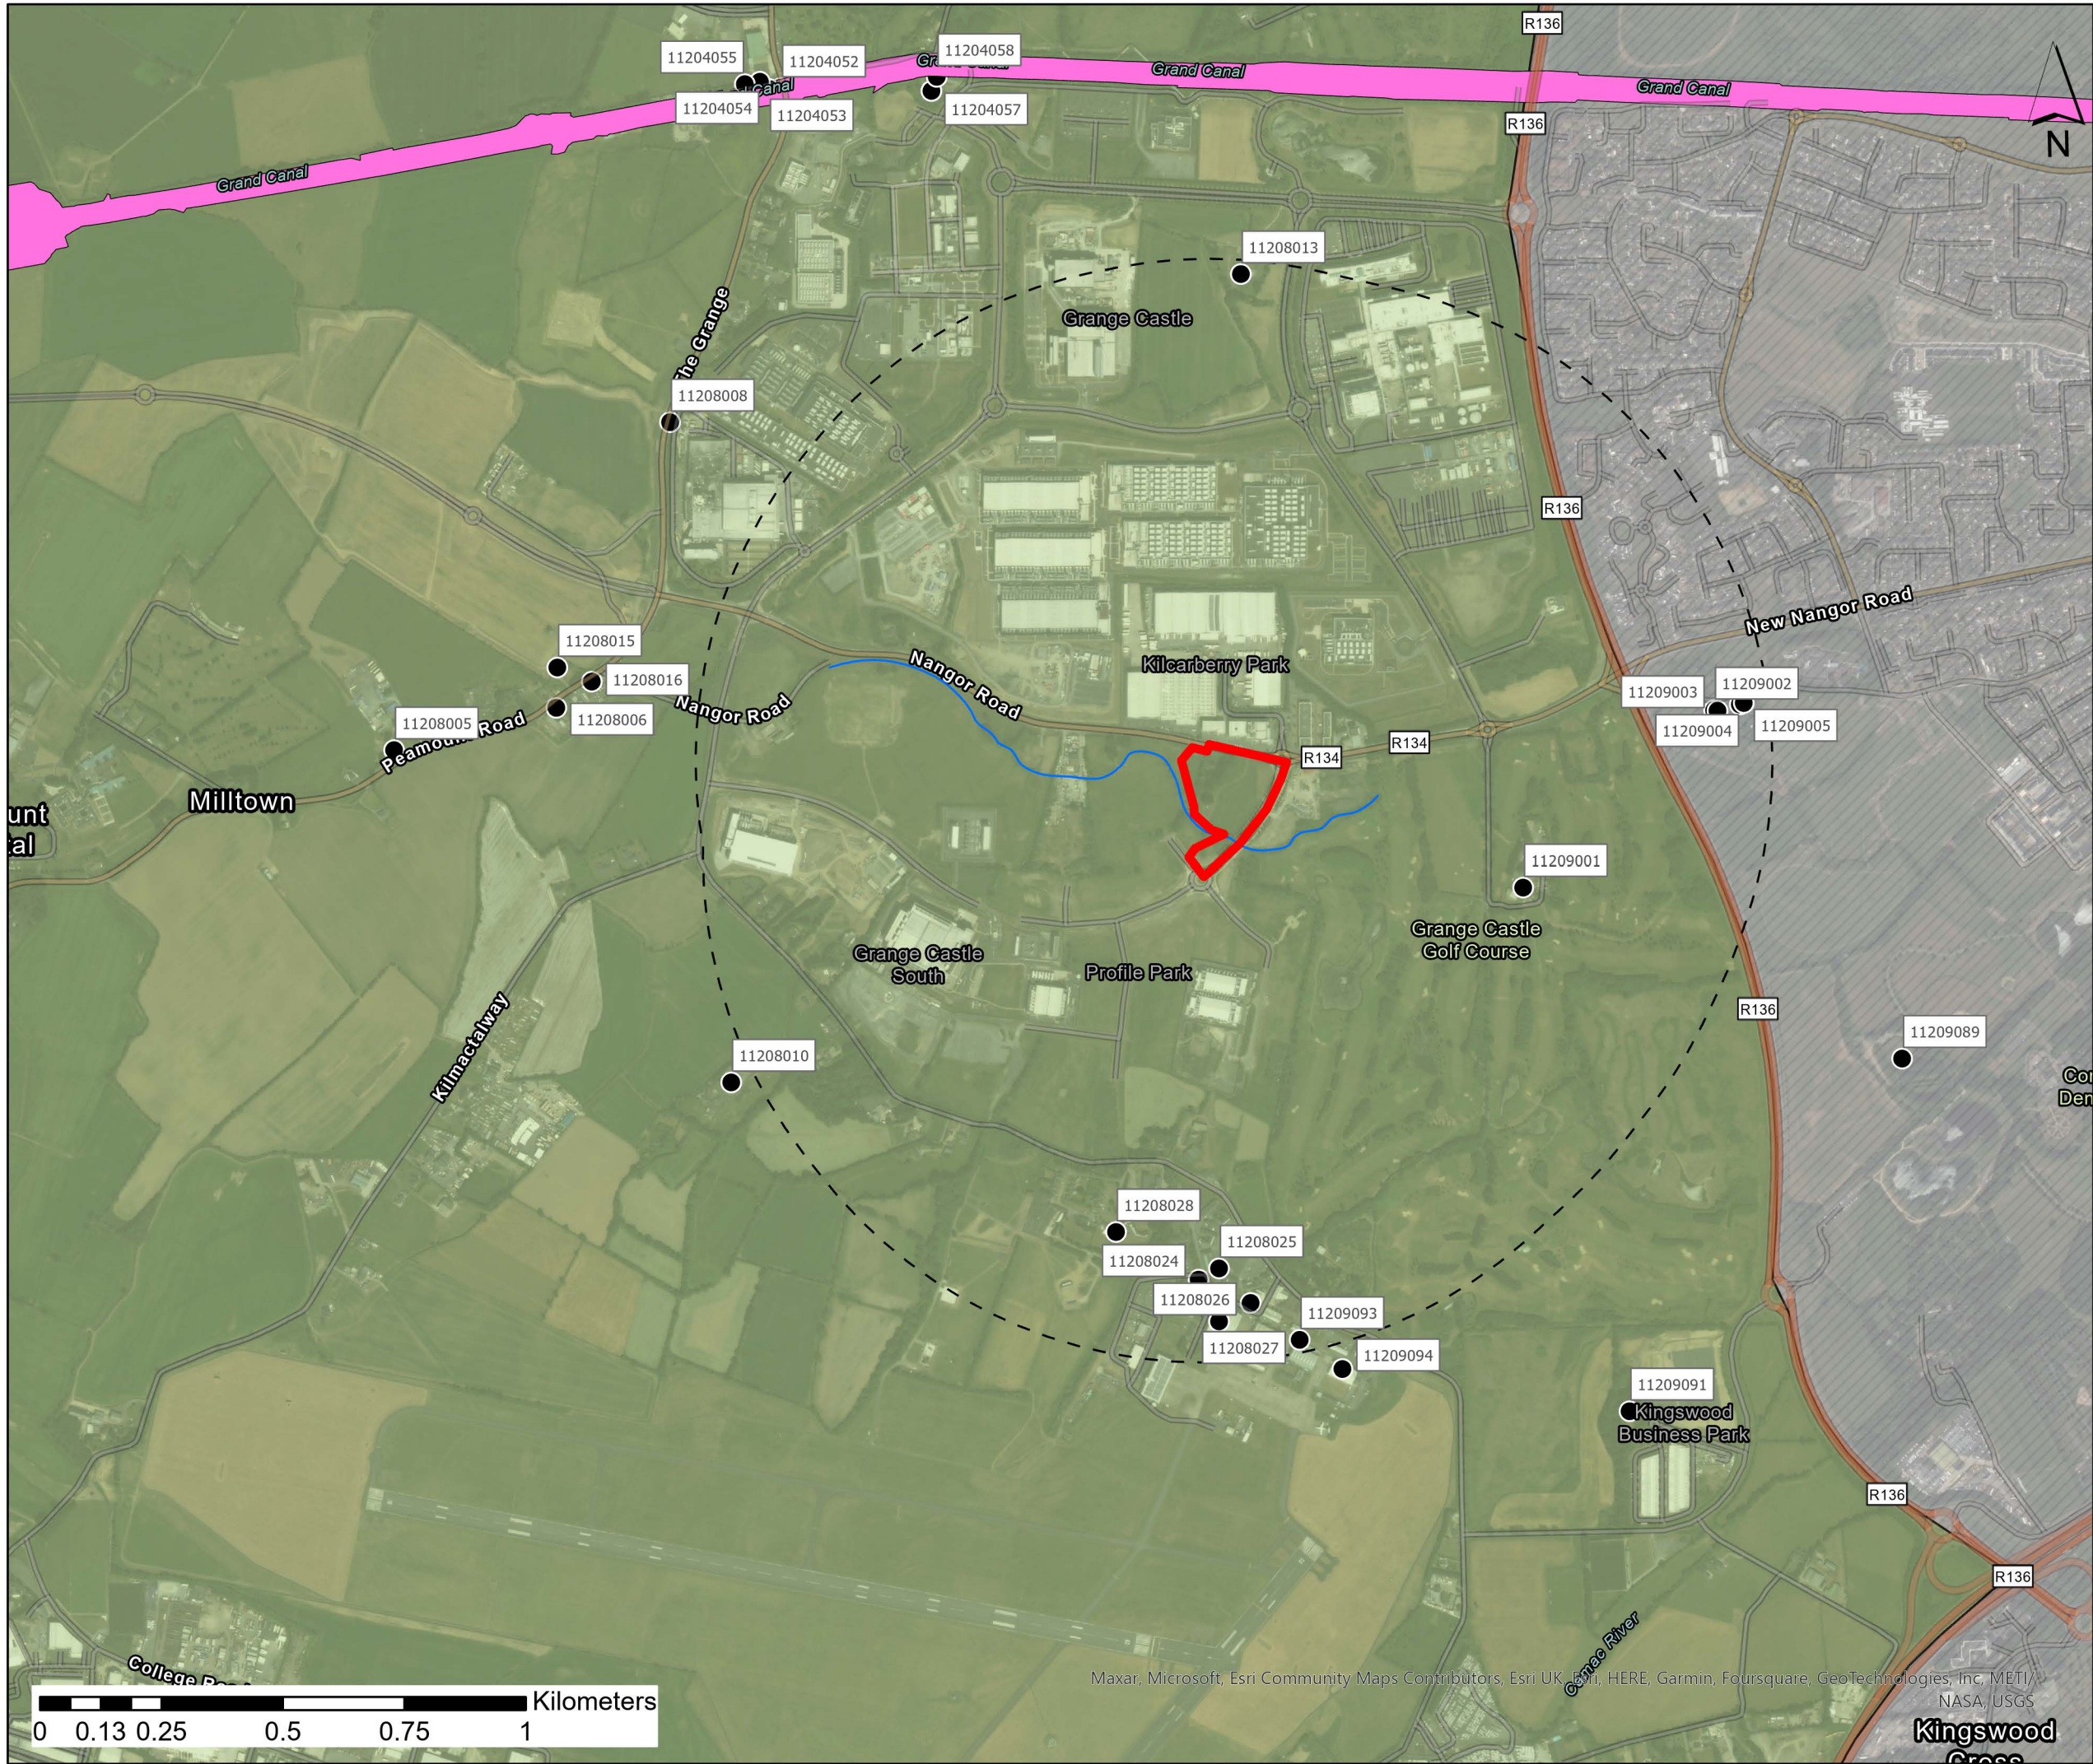
Figure 1: Location, study area and landscape features

- DUB-13 Site Boundary
- Baldonnell Stream
- 1km study area
- Grand Canal pNHA
- NIAH sites with reference number
- Newcastle Lowlands
- Urban South Dublin

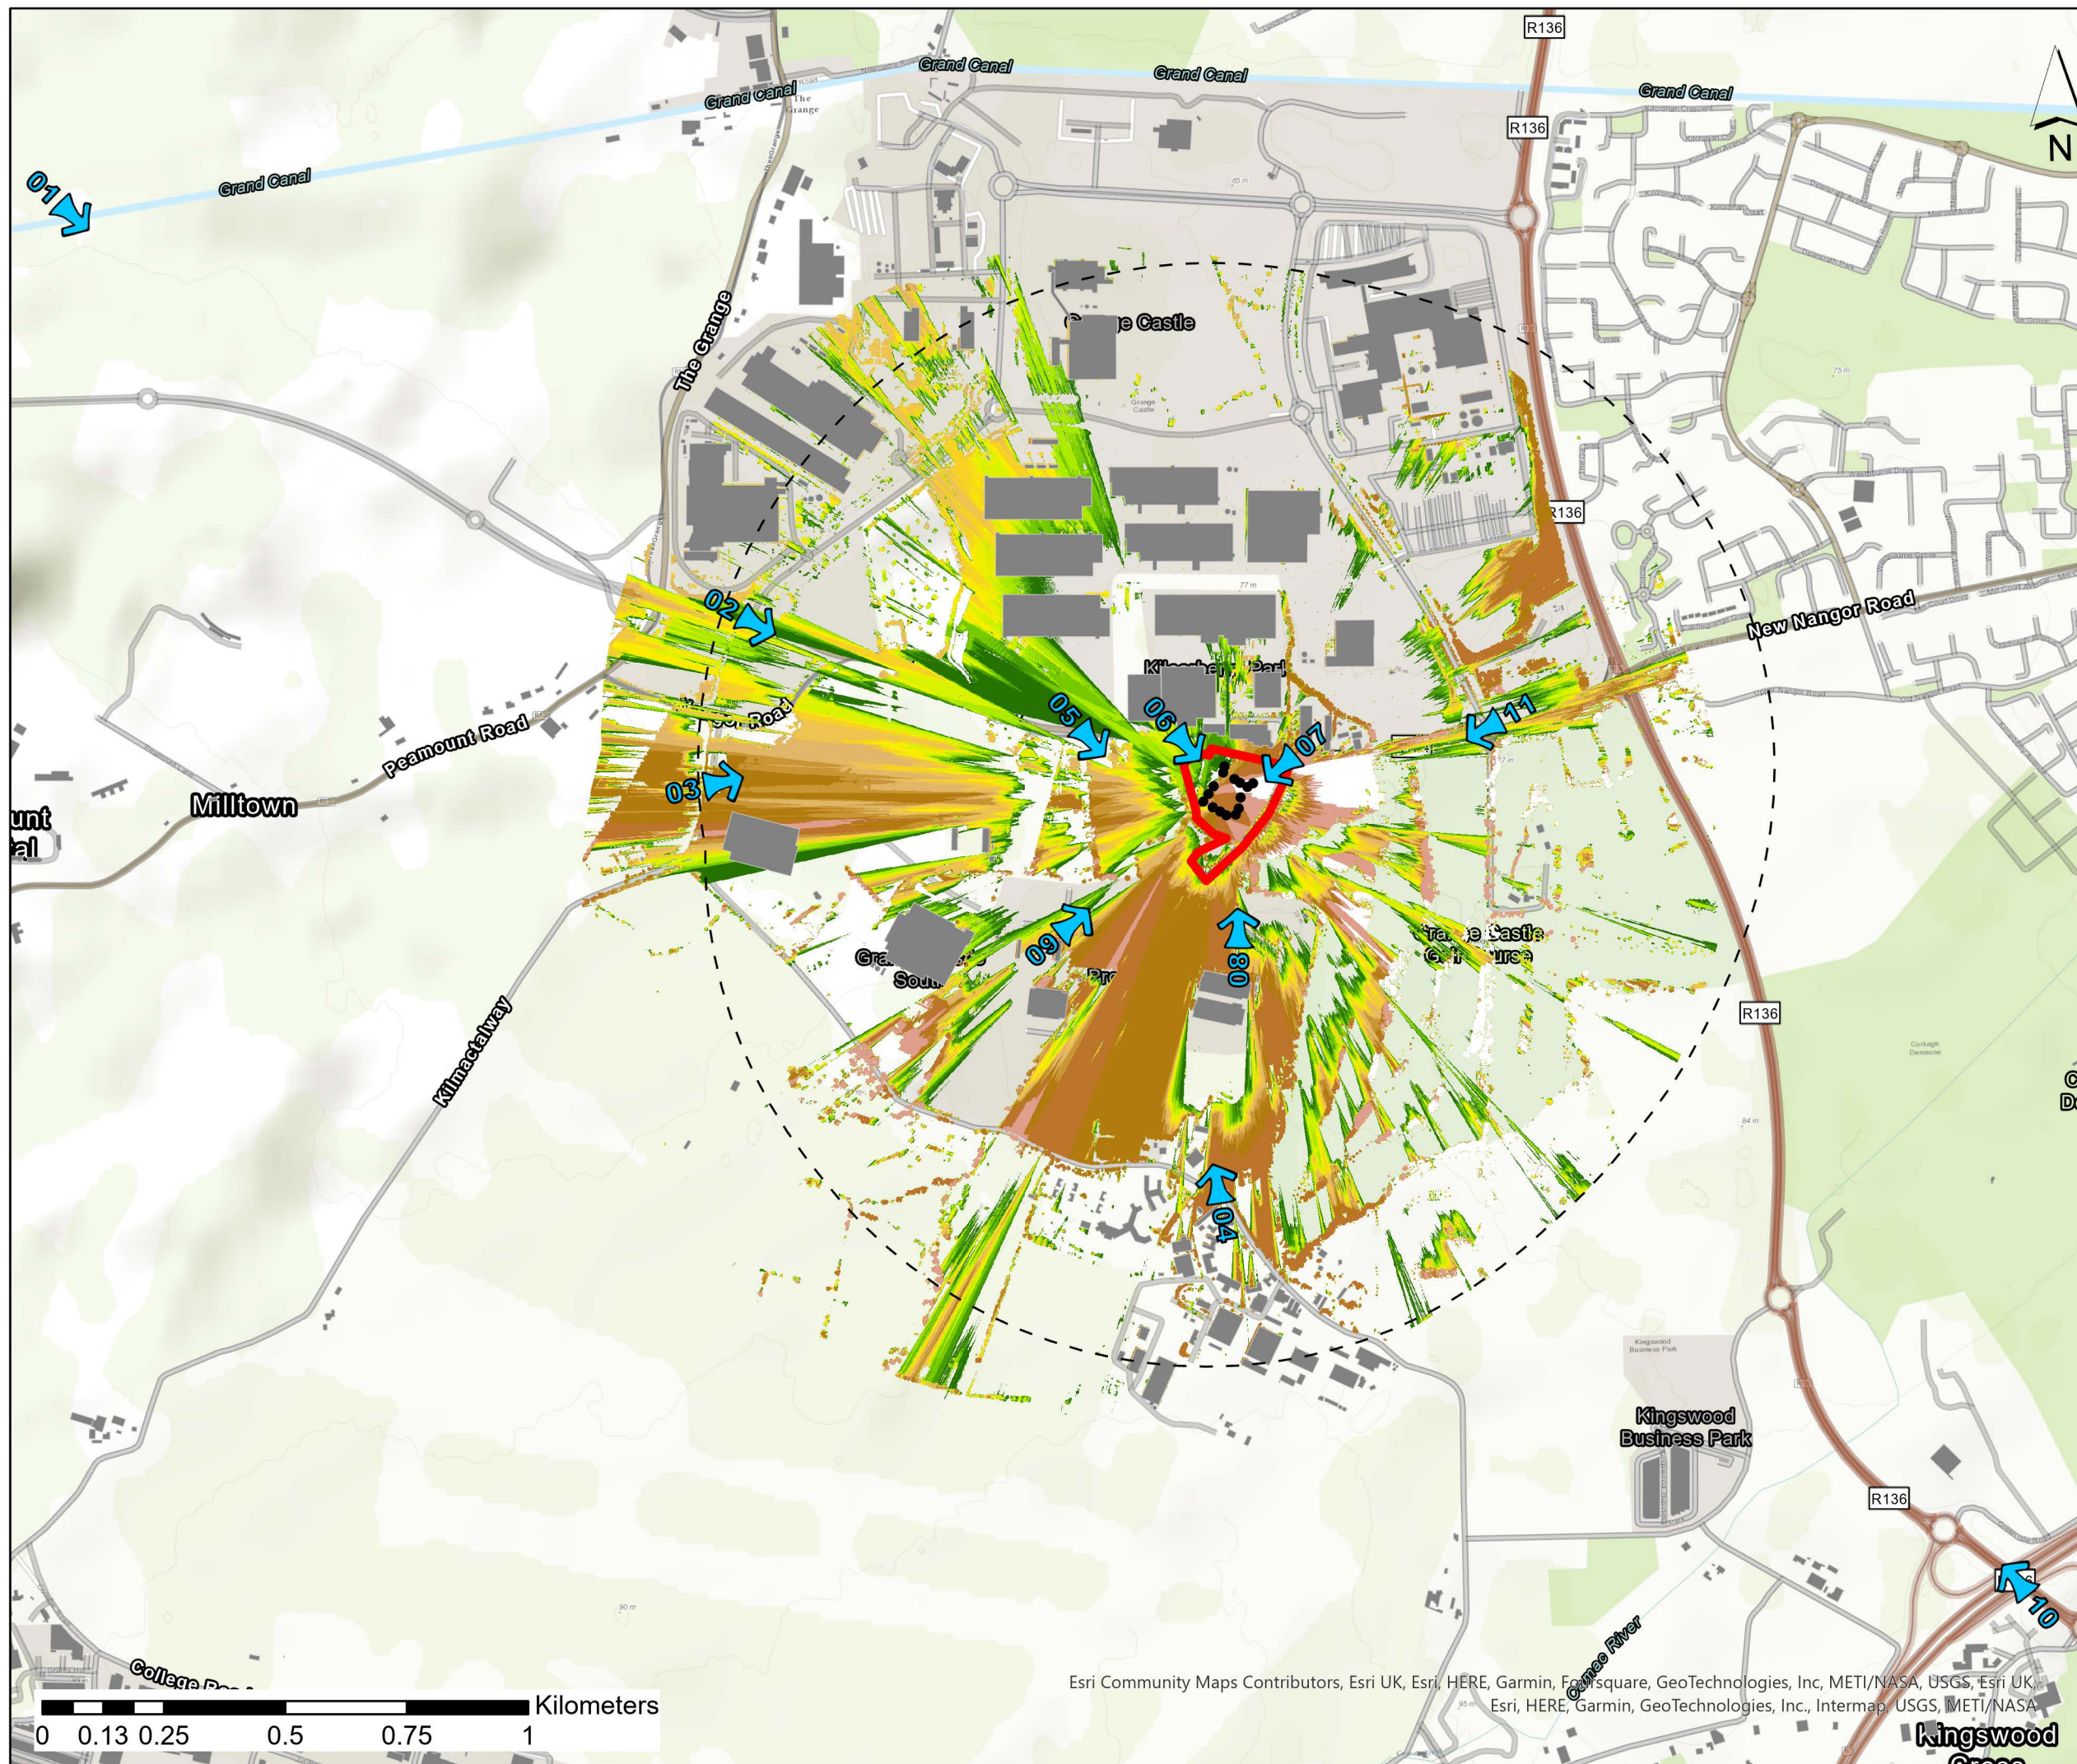
Figure 3: Zone of Theoretical Visibility and Viewpoint Locations

■ DUB-13 Site Boundary

➔ Viewpoint

- 1.75To assess the potential effect of the proposed development on landscape and visual amenity generally, a series of representative viewpoints have been selected. The effects on specific landscape and visual receptors and these locations are assessed. Baseline conditions at these locations are described in Table 1.6 below and the location of the viewpoints are shown in **Figure 3, Appendix 1.1**.

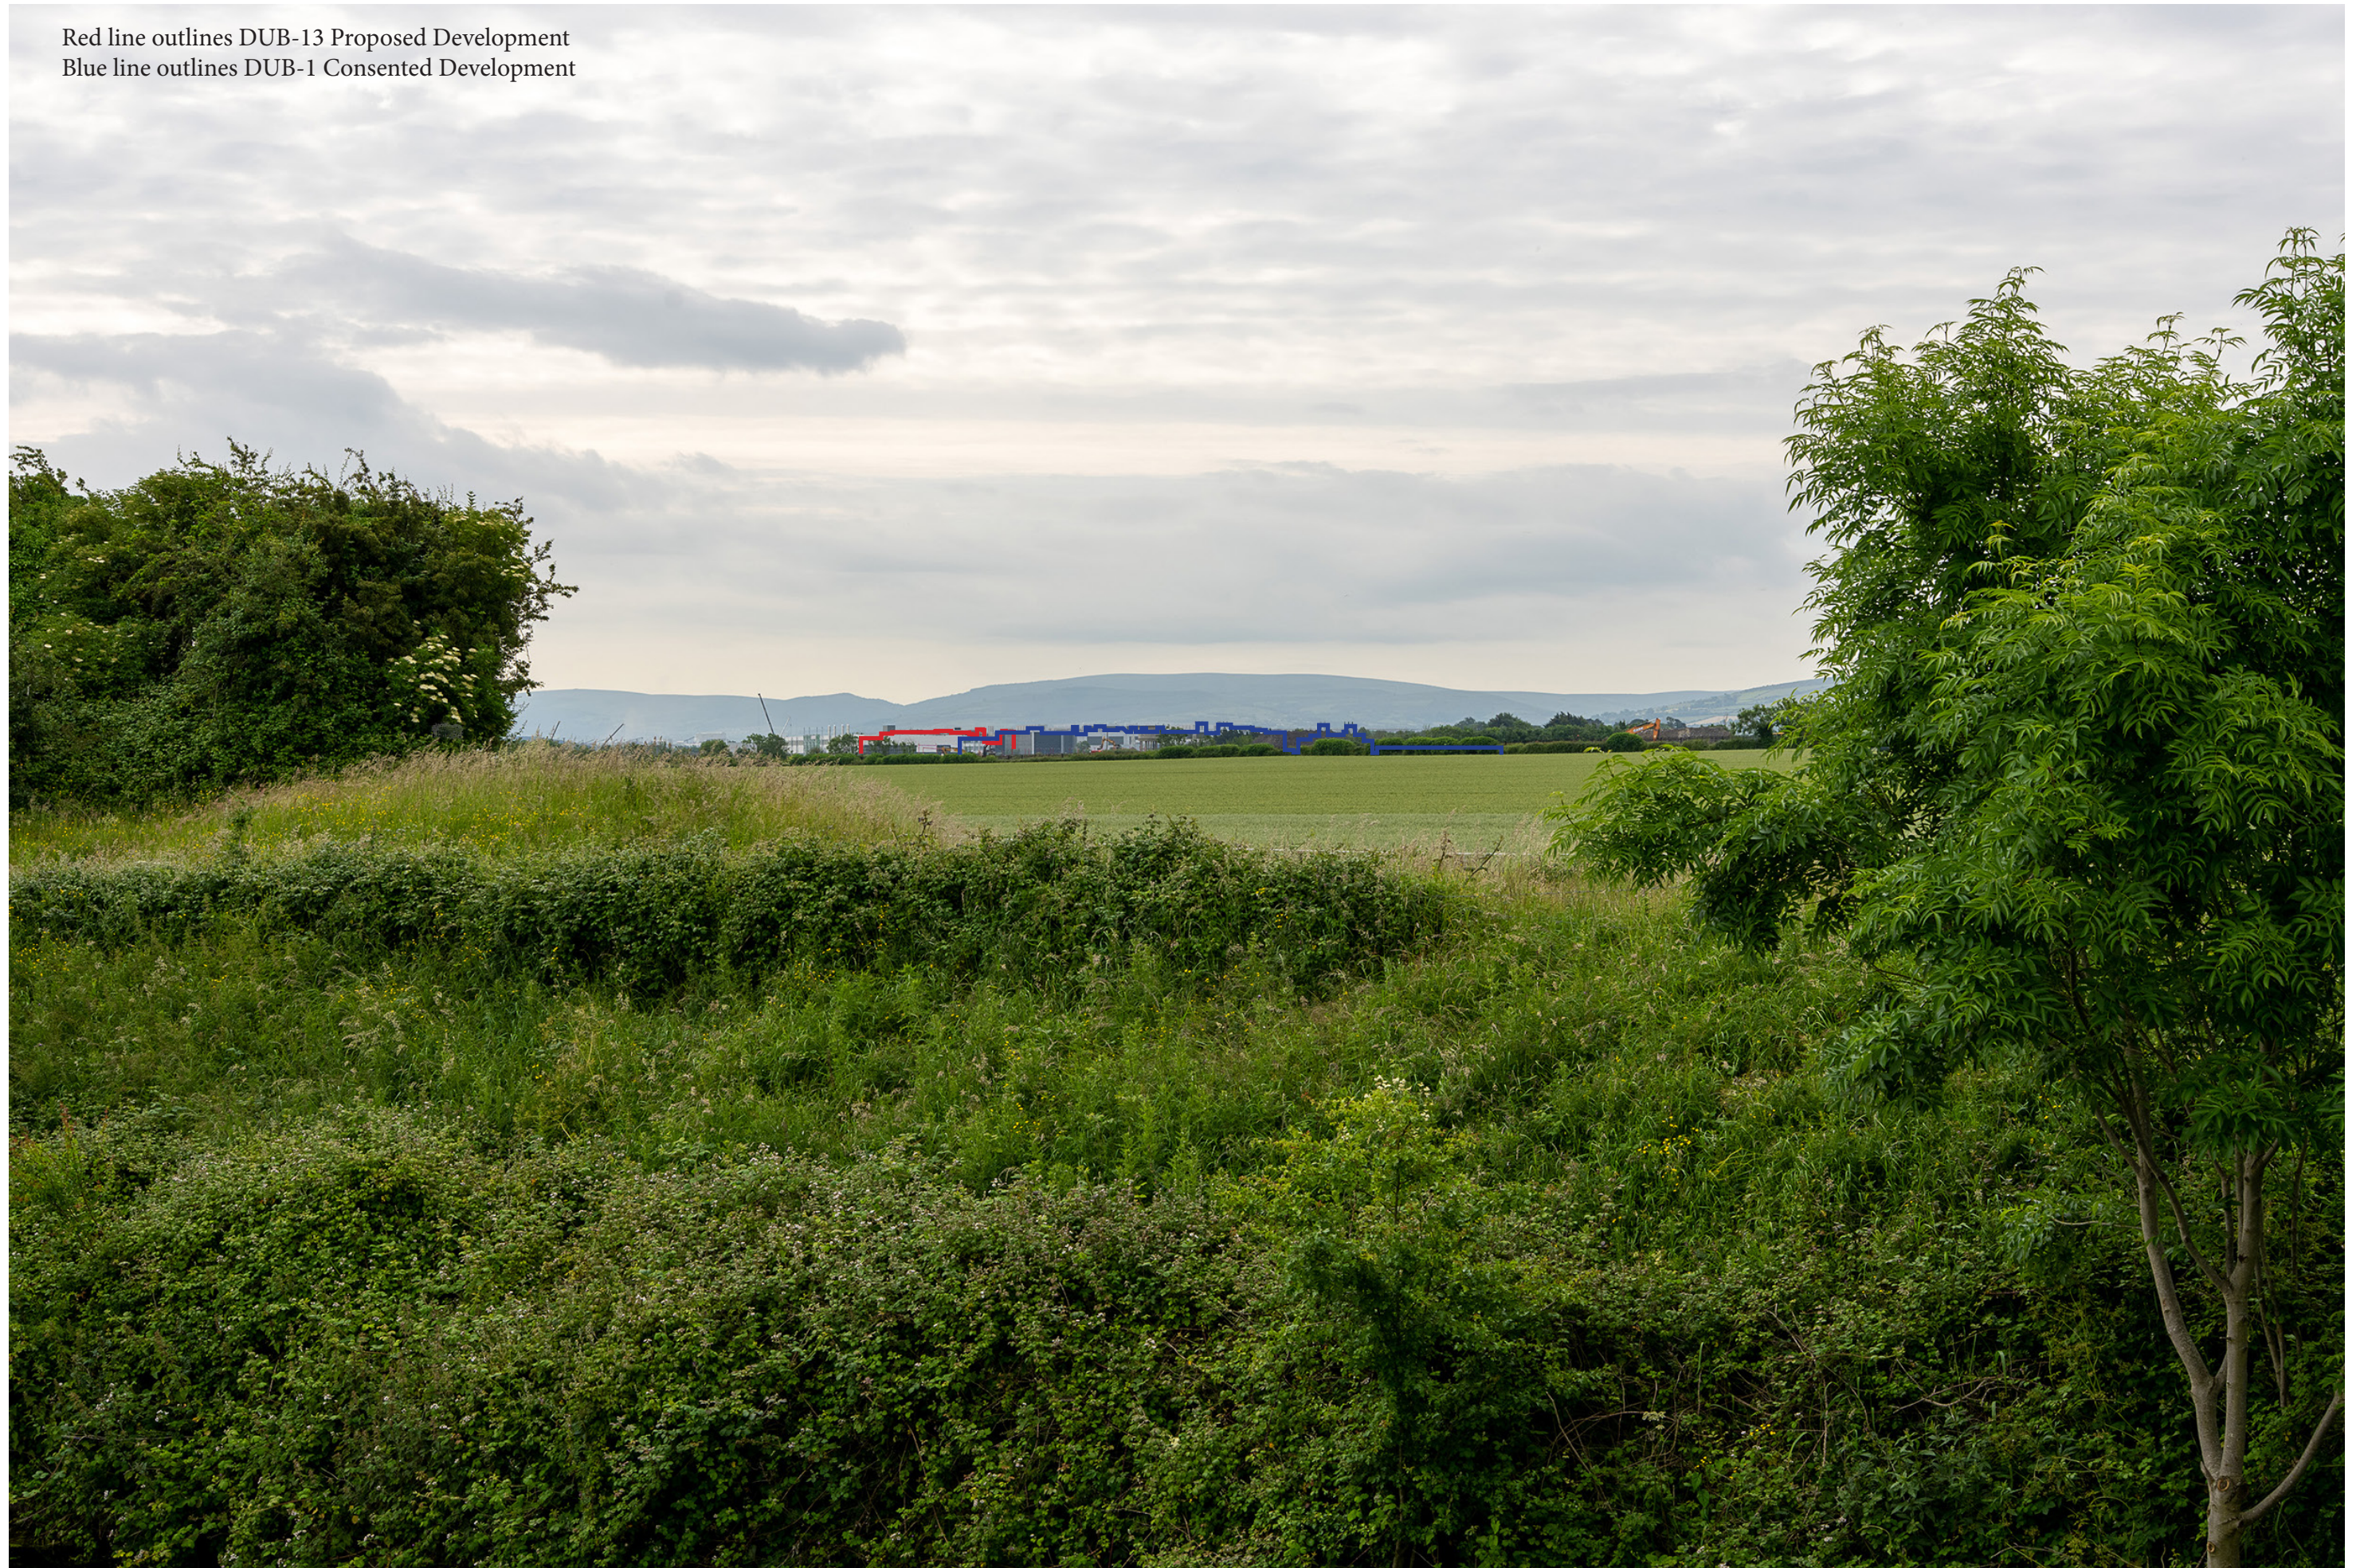
Red line outlines DUB-13 Proposed Development
Blue line outlines DUB-1 Consented Development

Viewpoint 1: Photomontage of Day 1 view from the Grand Canal | Viewing distance at A3: 542mm | Horizontal field of view: 39.6° | Direction of view: 134°
Camera: Sony ILCE-1| Lens: Sony 50mm | Camera height: 1.5m AGL | Date taken: 28 June 2021 | Aperture: f/11 | ISO speed: 100 | Shutter: 1/160 sec

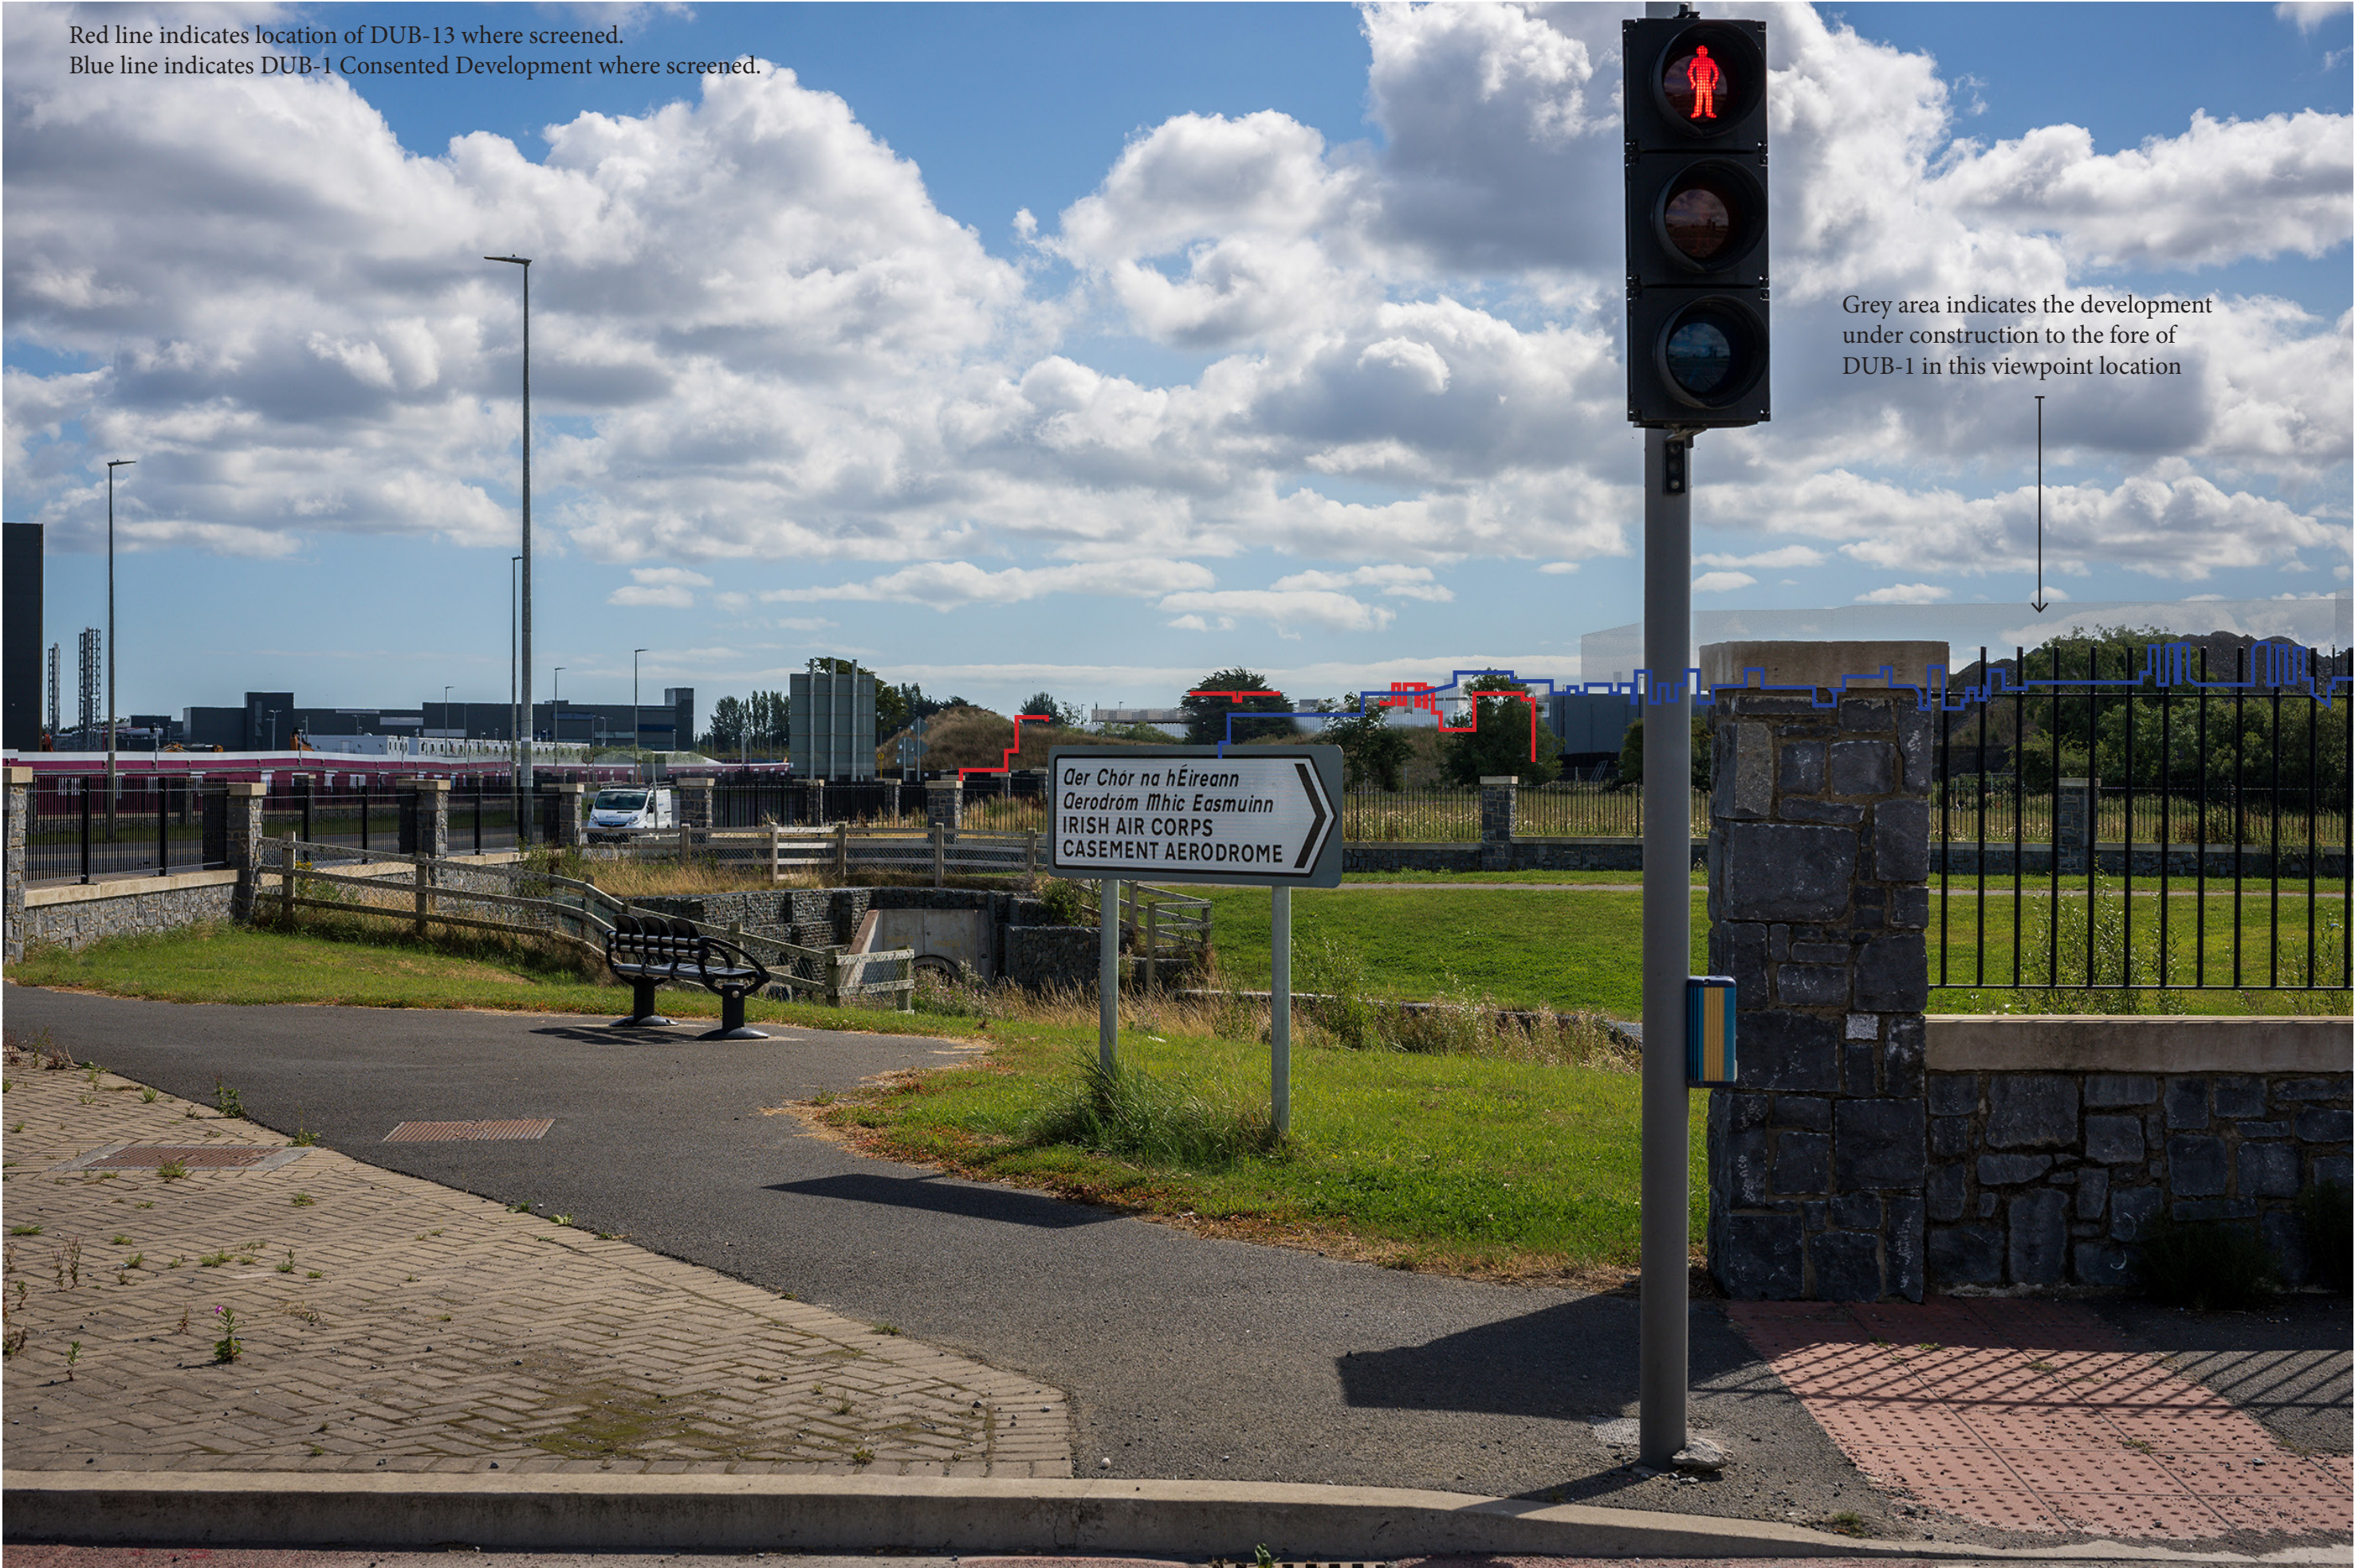
Viewpoint 2: Photomontage of Day 1 view from corner of R134 New Nangor Road at the junction with Baldonnel Road | Viewing distance at A3: 542mm | Horizontal field of view: 39.6° | Direction of view: 114°
Camera: Sony ILCE-1| Lens: Sony 50mm | Camera height: 1.5m AGL | Date taken: 25 August 2022 | Aperture: f/8 | ISO speed: 100 | Shutter: 1/500 sec

Red line indicates location of DUB-13 where screened.
Blue line indicates DUB-1 Consented Development where screened.

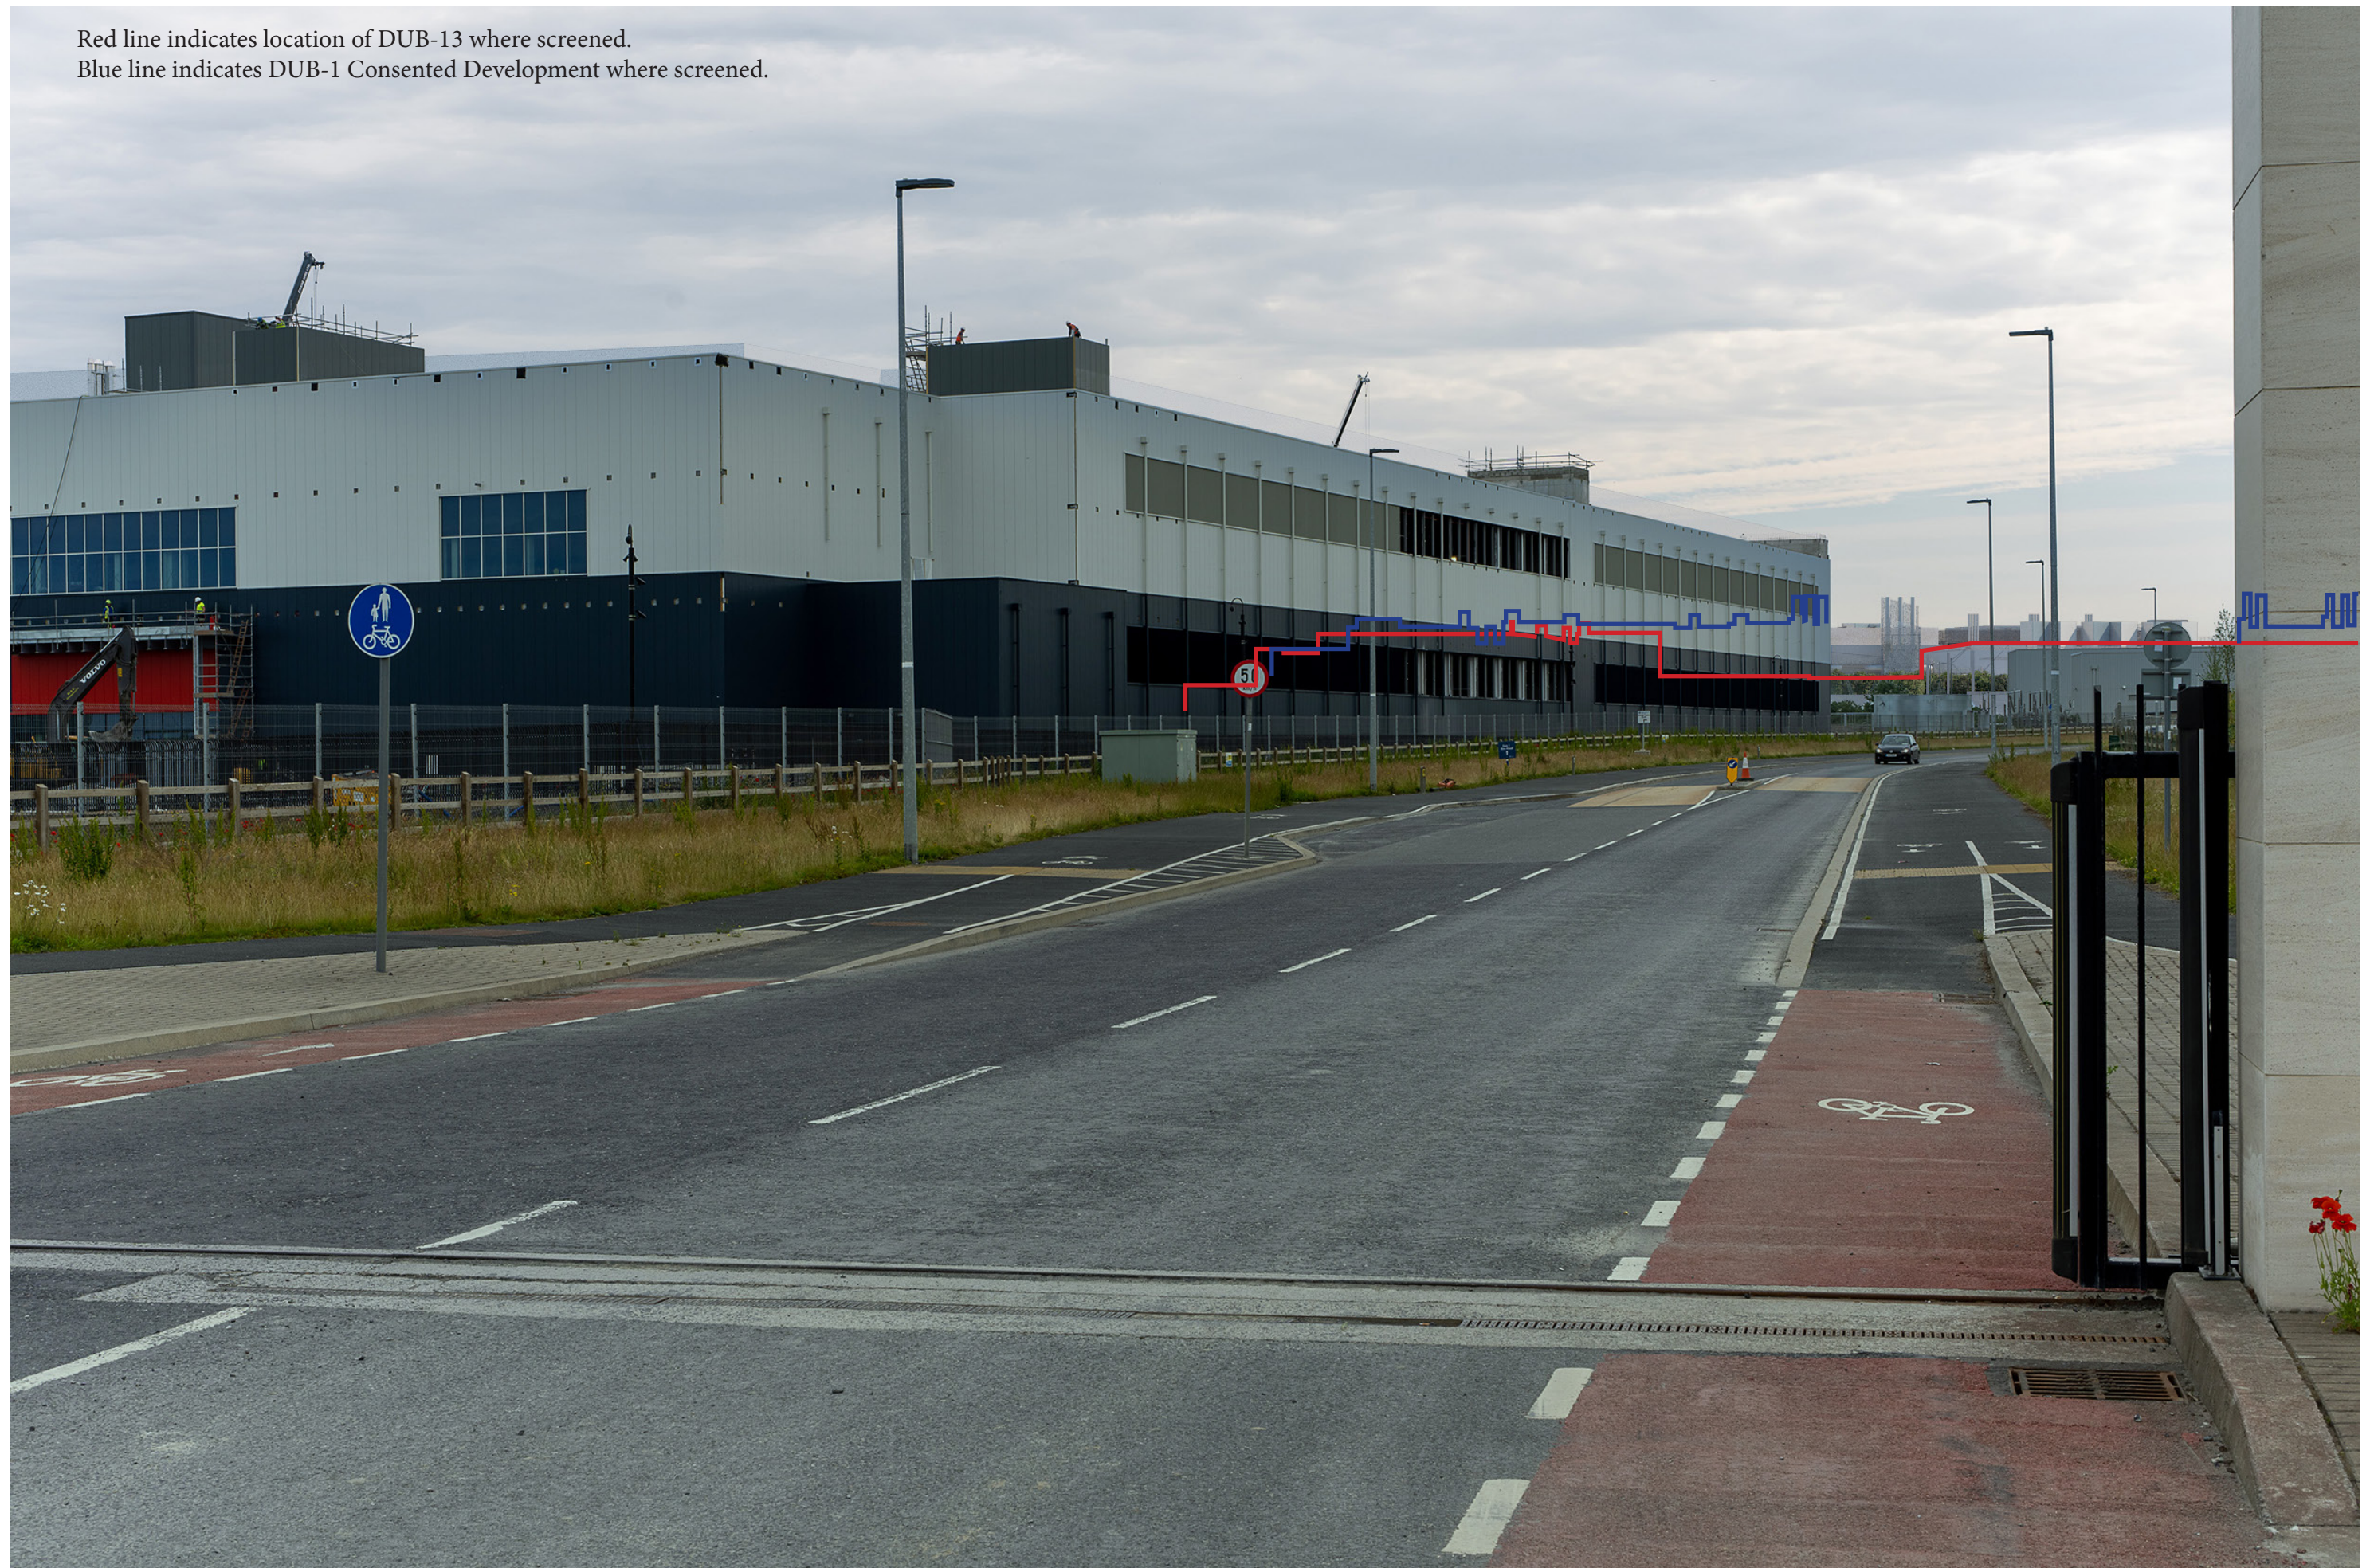
Viewpoint 3: Photomontage of Day 1 view from Baldonnell Road at junction with Falcon Avenue | Viewing distance at A3: 542mm | Horizontal field of view: 39.6° | Direction of view: 63°
Camera: Sony ILCE-1 | Lens: Sony 50mm | Camera height: 1.5m AGL | Date taken: 28 June 2021 | Aperture: f/11 | ISO speed: 100 | Shutter: 1/160 sec

Blue line indicates where DUB-1 Consented Development is screened.

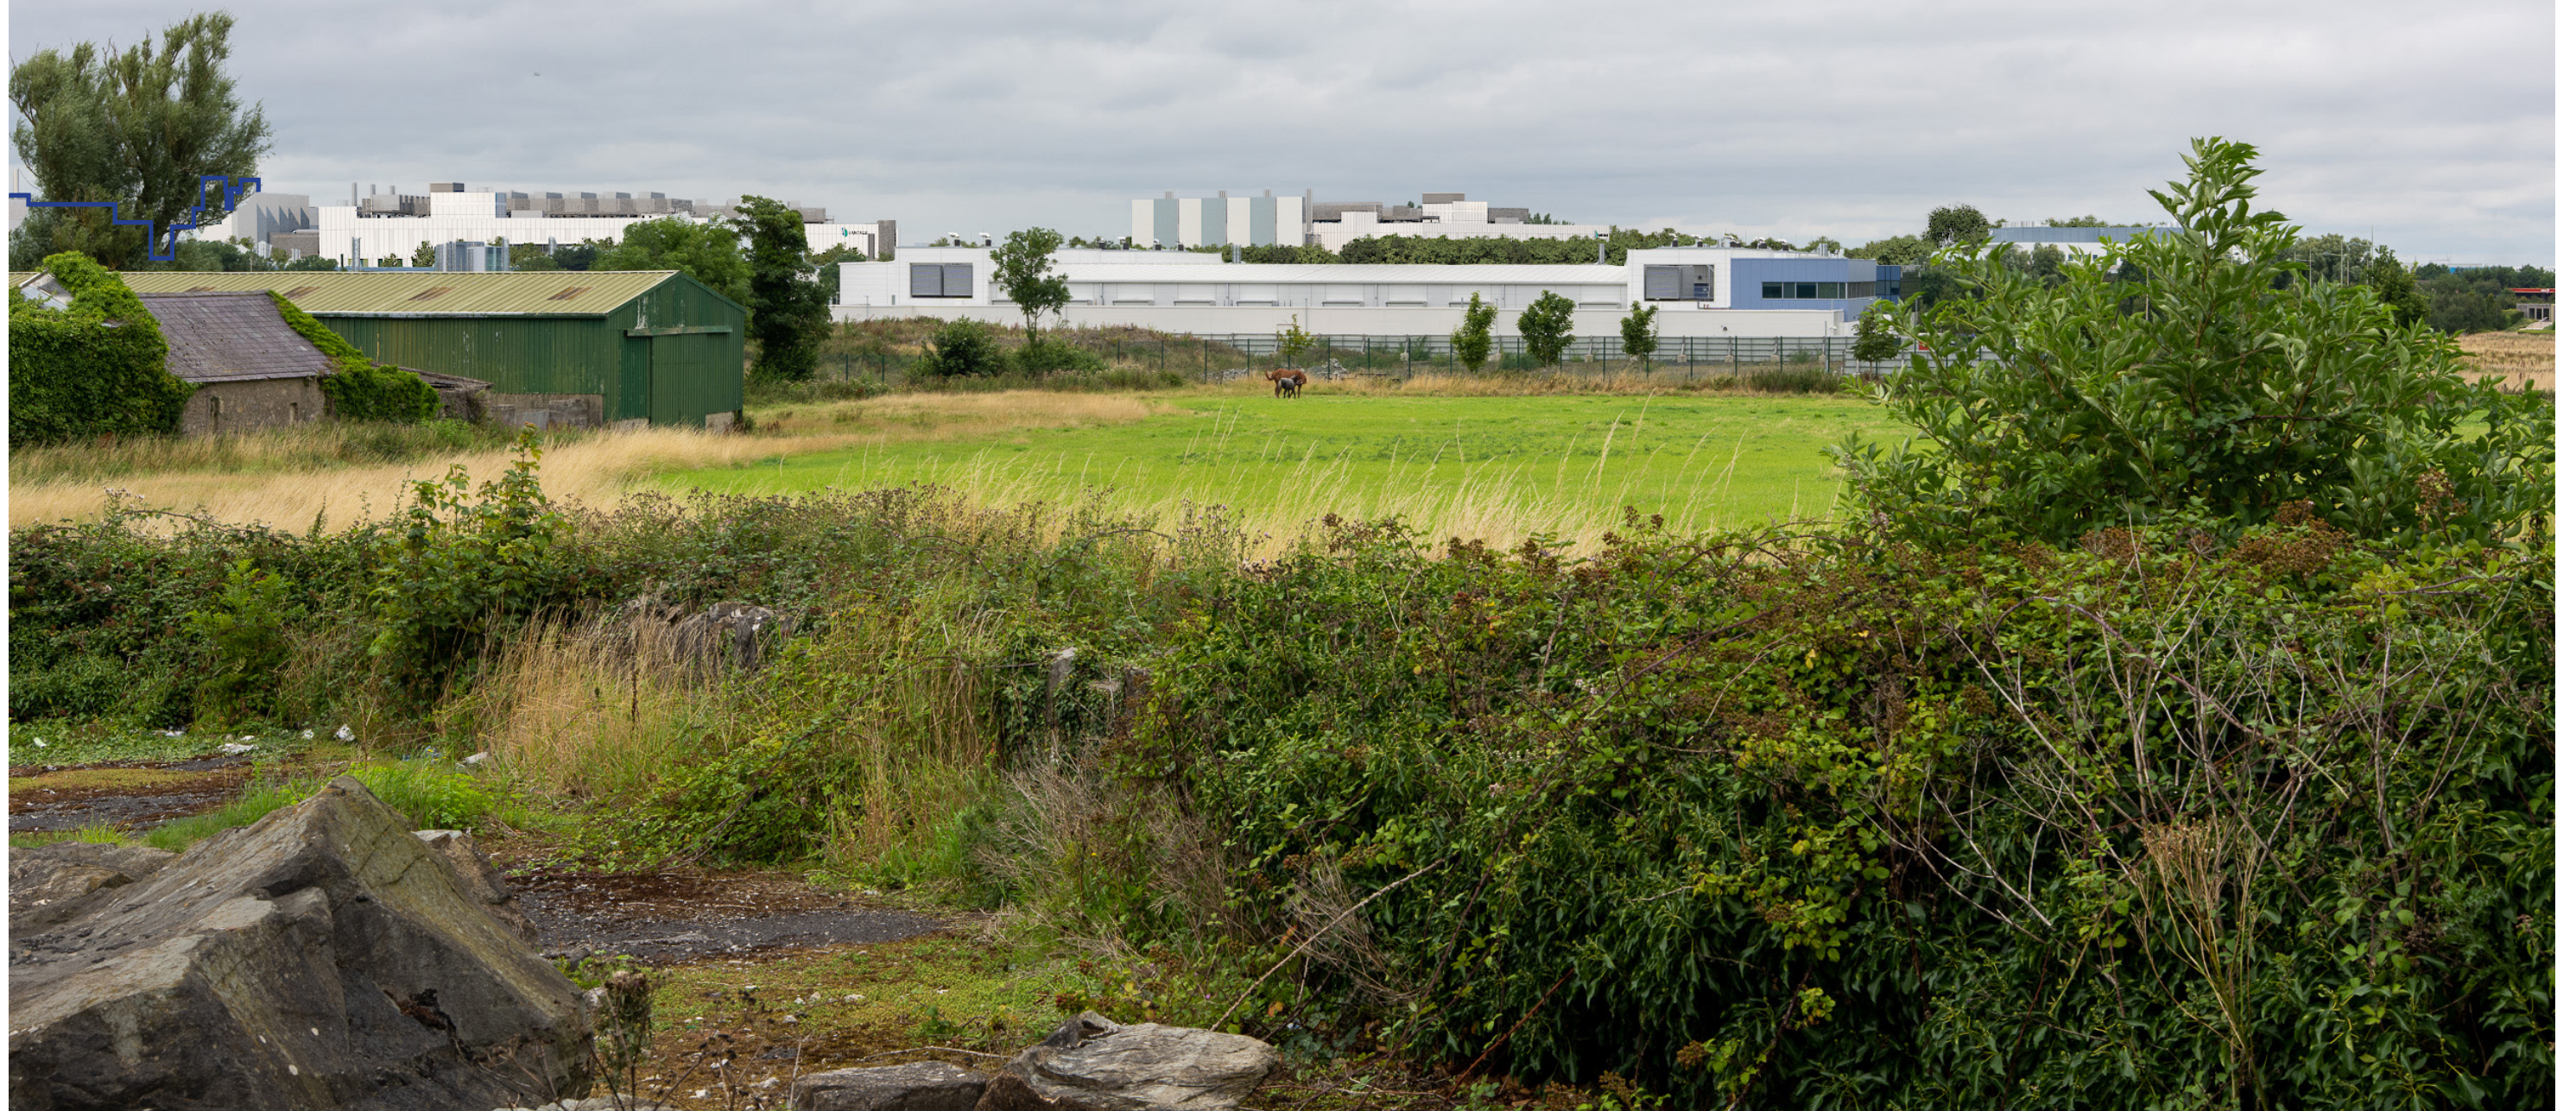
Viewpoint 4: Photomontage of Day 1 view from layby on Baldonnell Road near the entrance to Casement Aerodrome | Viewing distance at A3: 542mm | Horizontal field of view: 39.6° | Direction of view: 360°
Camera: Sony ILCE-1 | Lens: Sony 50mm | Camera height: 1.5m AGL | Date taken: 18 August 2021 | Aperture: f/11 | ISO speed: 100 | Shutter: 1/50 sec

Red line indicates location of DUB-13 where screened.
Blue line indicates location of DUB-1 Consented Development where screened.
