Intended for
Vantage Data Centers DUB13 Limited

Date
March 2023

VANTAGE DUBLIN DATA CENTER

VOLUME 2A: LANDSCAPE, VISUAL AND BUILT HERITAGE IMPACT ASSESSMENT

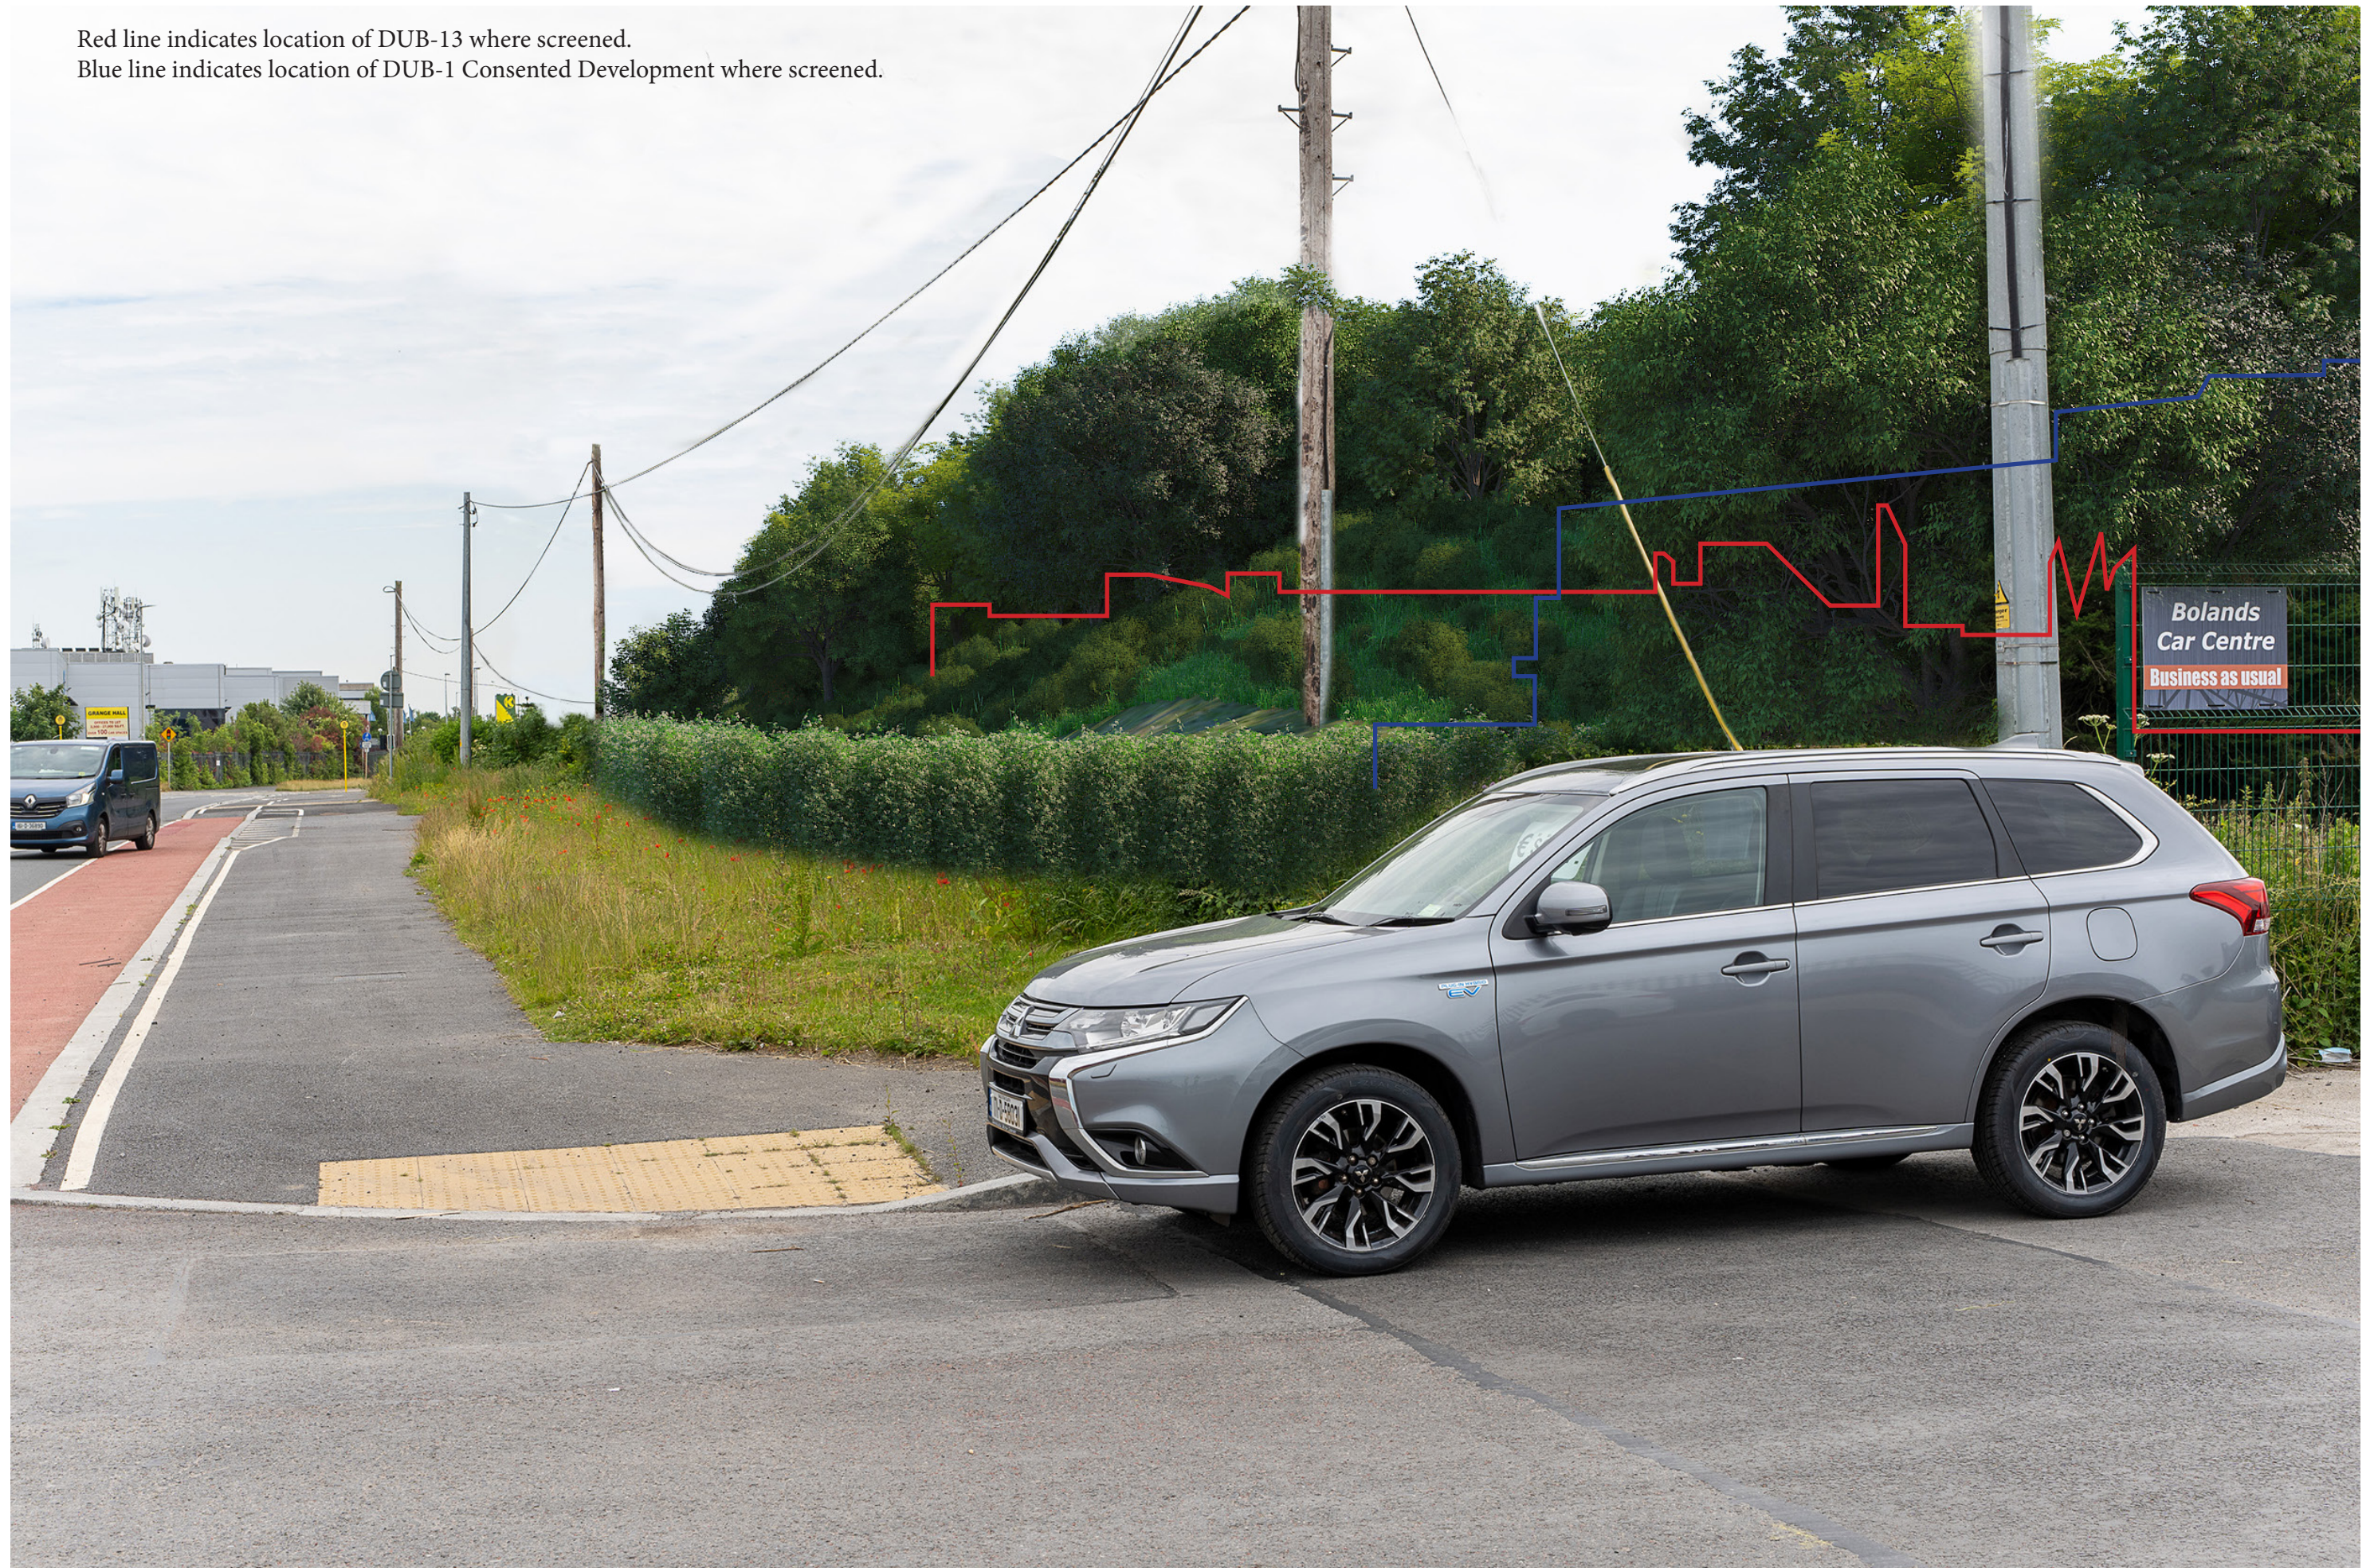
Viewpoint 5: Photomontage of view from R134 New Nangor Road at Bolands Car Centre | Viewing distance at A3: 542mm | Horizontal field of view: 39.6° | Direction of view: 109°
Camera: Sony ILCE-1 | Lens: Sony 50mm | Camera height: 1.5m AGL | Date taken: 28 June 2021 | Aperture: f/11 | ISO speed: 100 | Shutter: 1/80 sec

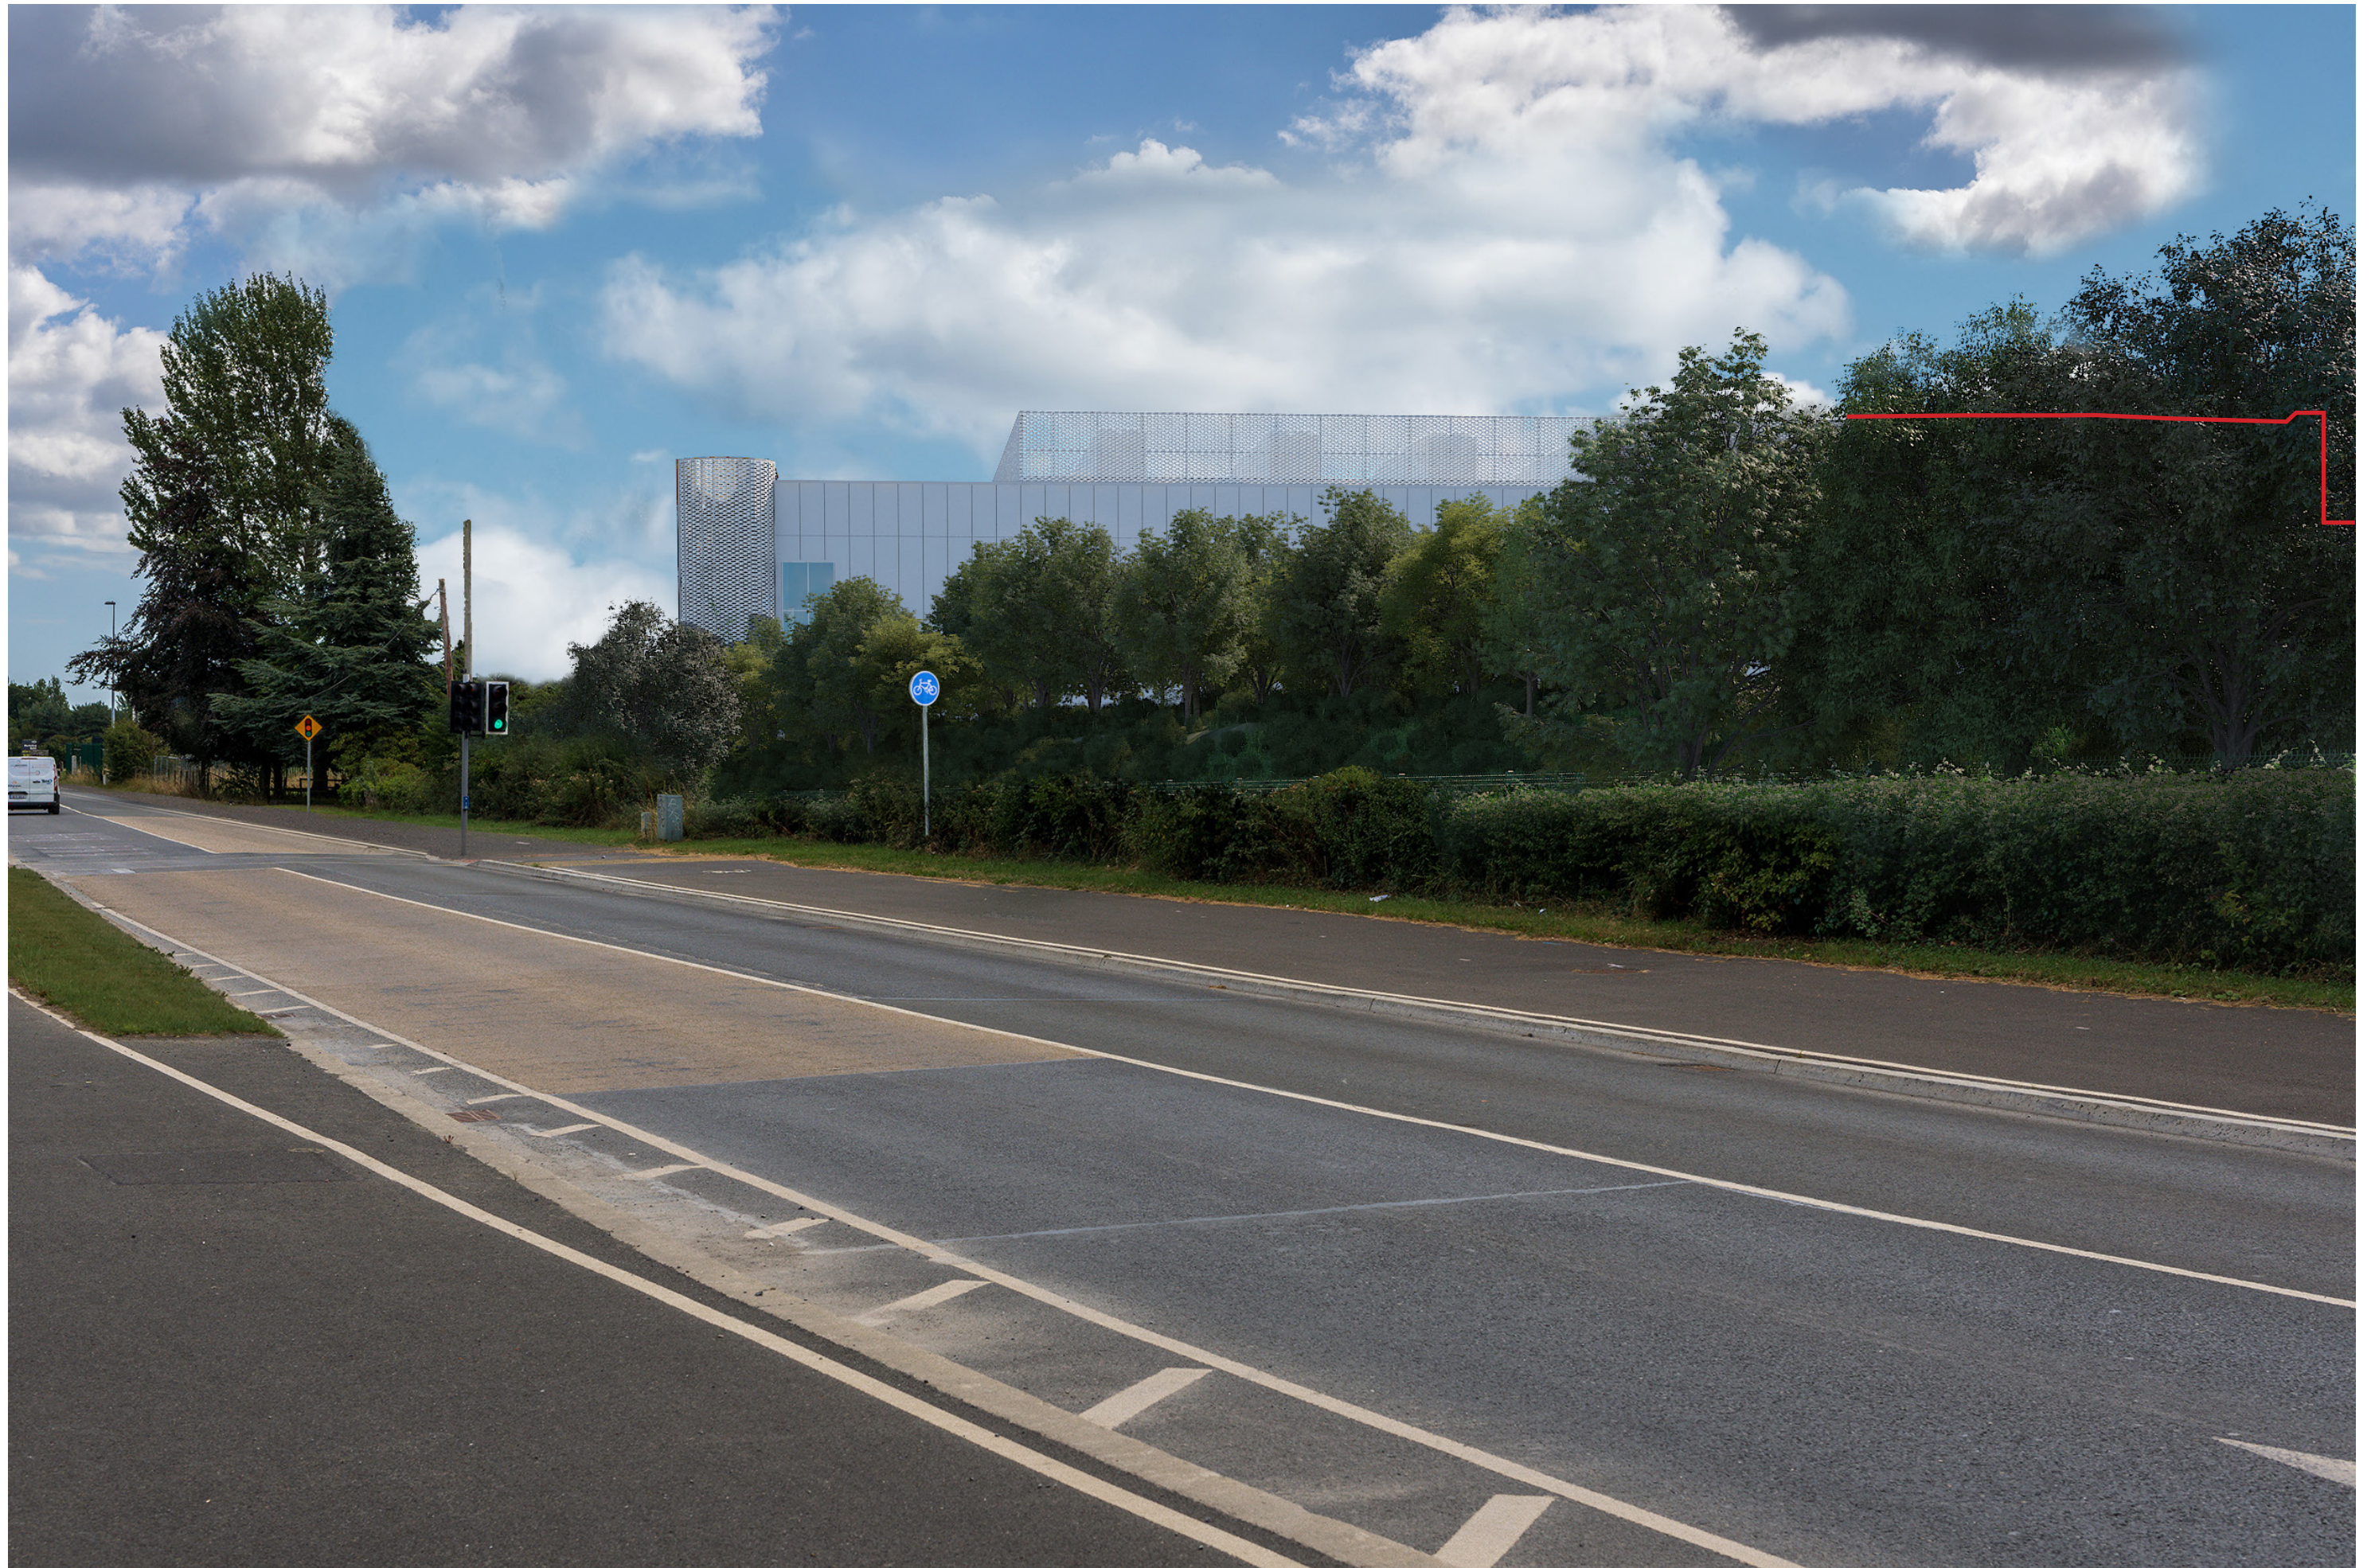
Viewpoint 6: Photomontage of Day 1 view from R134 New Nangor Road at the north west corner of the Site | Viewing distance at A3: 542mm | Horizontal field of view: 39.6° | Direction of view: 178°
Camera: Sony ILCE-1 | Lens: Sony 50mm | Camera height: 1.5m AGL | Date taken: 25 August 2022 | Aperture: f/8 | ISO speed: 100 | Shutter: 1/500 sec

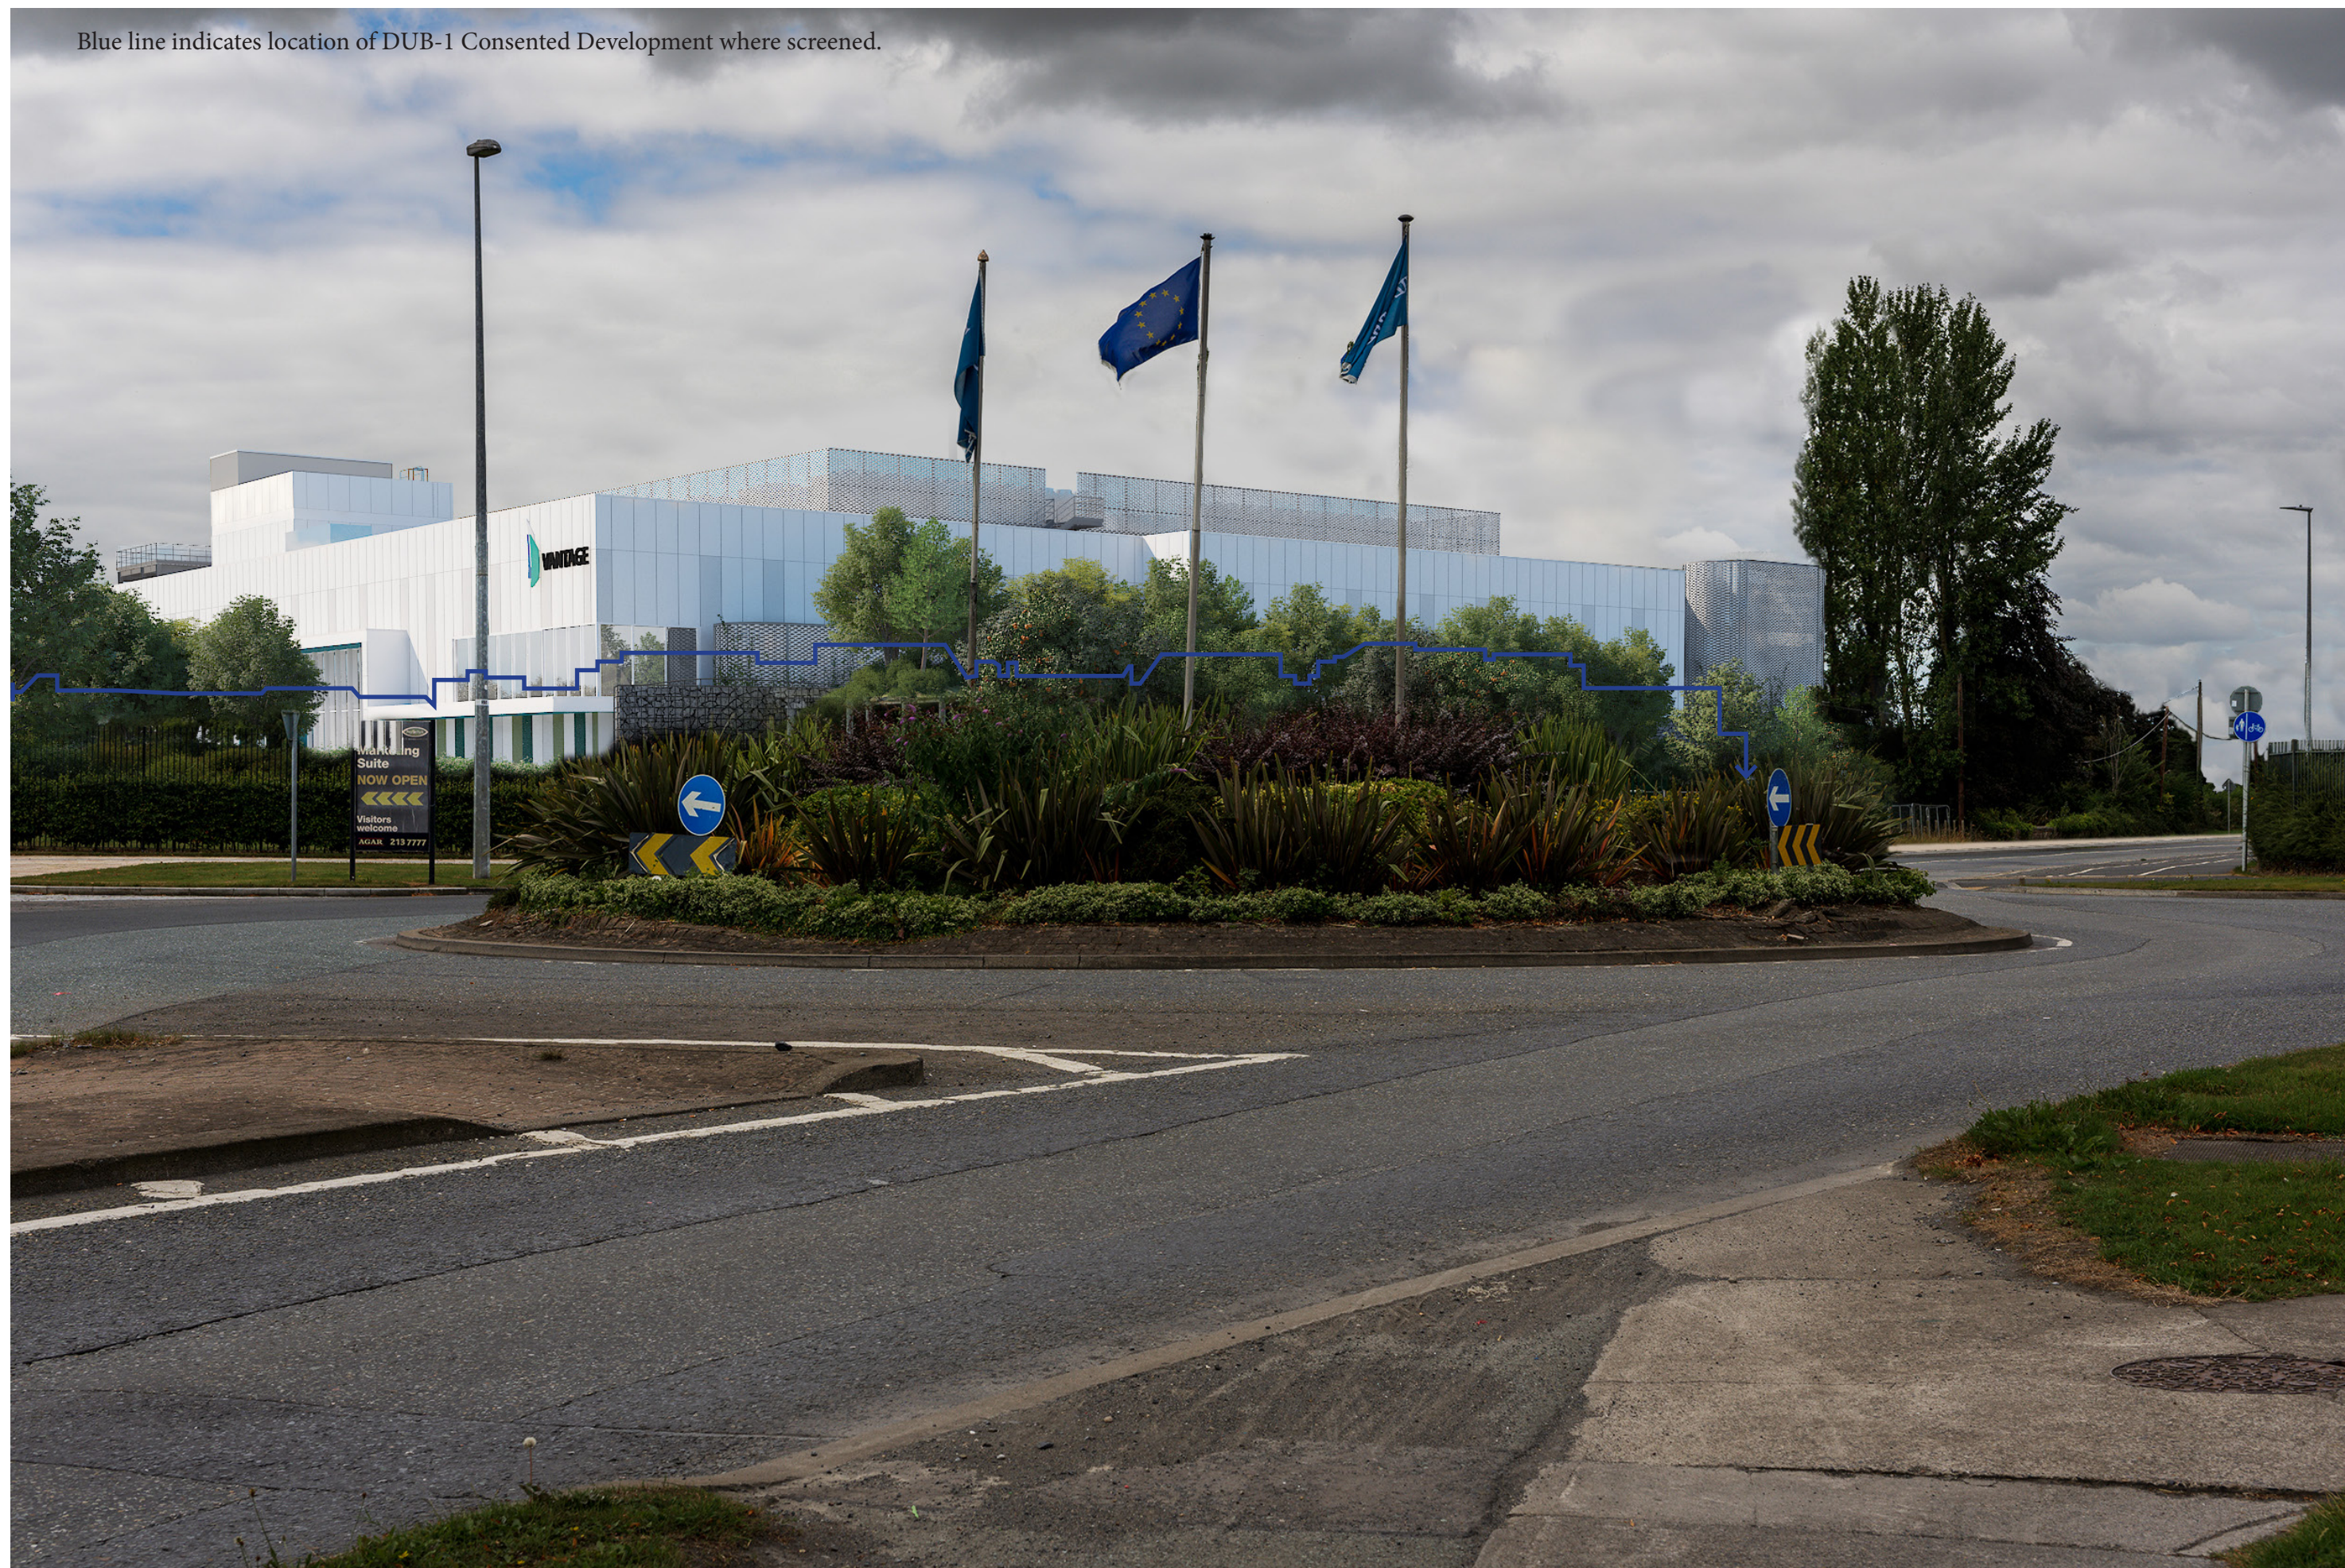
Viewpoint 7: Photomontage of Day 1 view from R134 New Nangor Road at the entrance to Profile Park | Viewing distance at A3: 542mm | Horizontal field of view: 39.6° | Direction of view: 252°
Camera: Sony ILCE-1 | Lens: Sony 50mm | Camera height: 1.5m AGL | Date taken: 25 August 2022 | Aperture: f/8 | ISO speed: 100 | Shutter: 1/320 sec

Red line indicates location of DUB-13Development where screened.

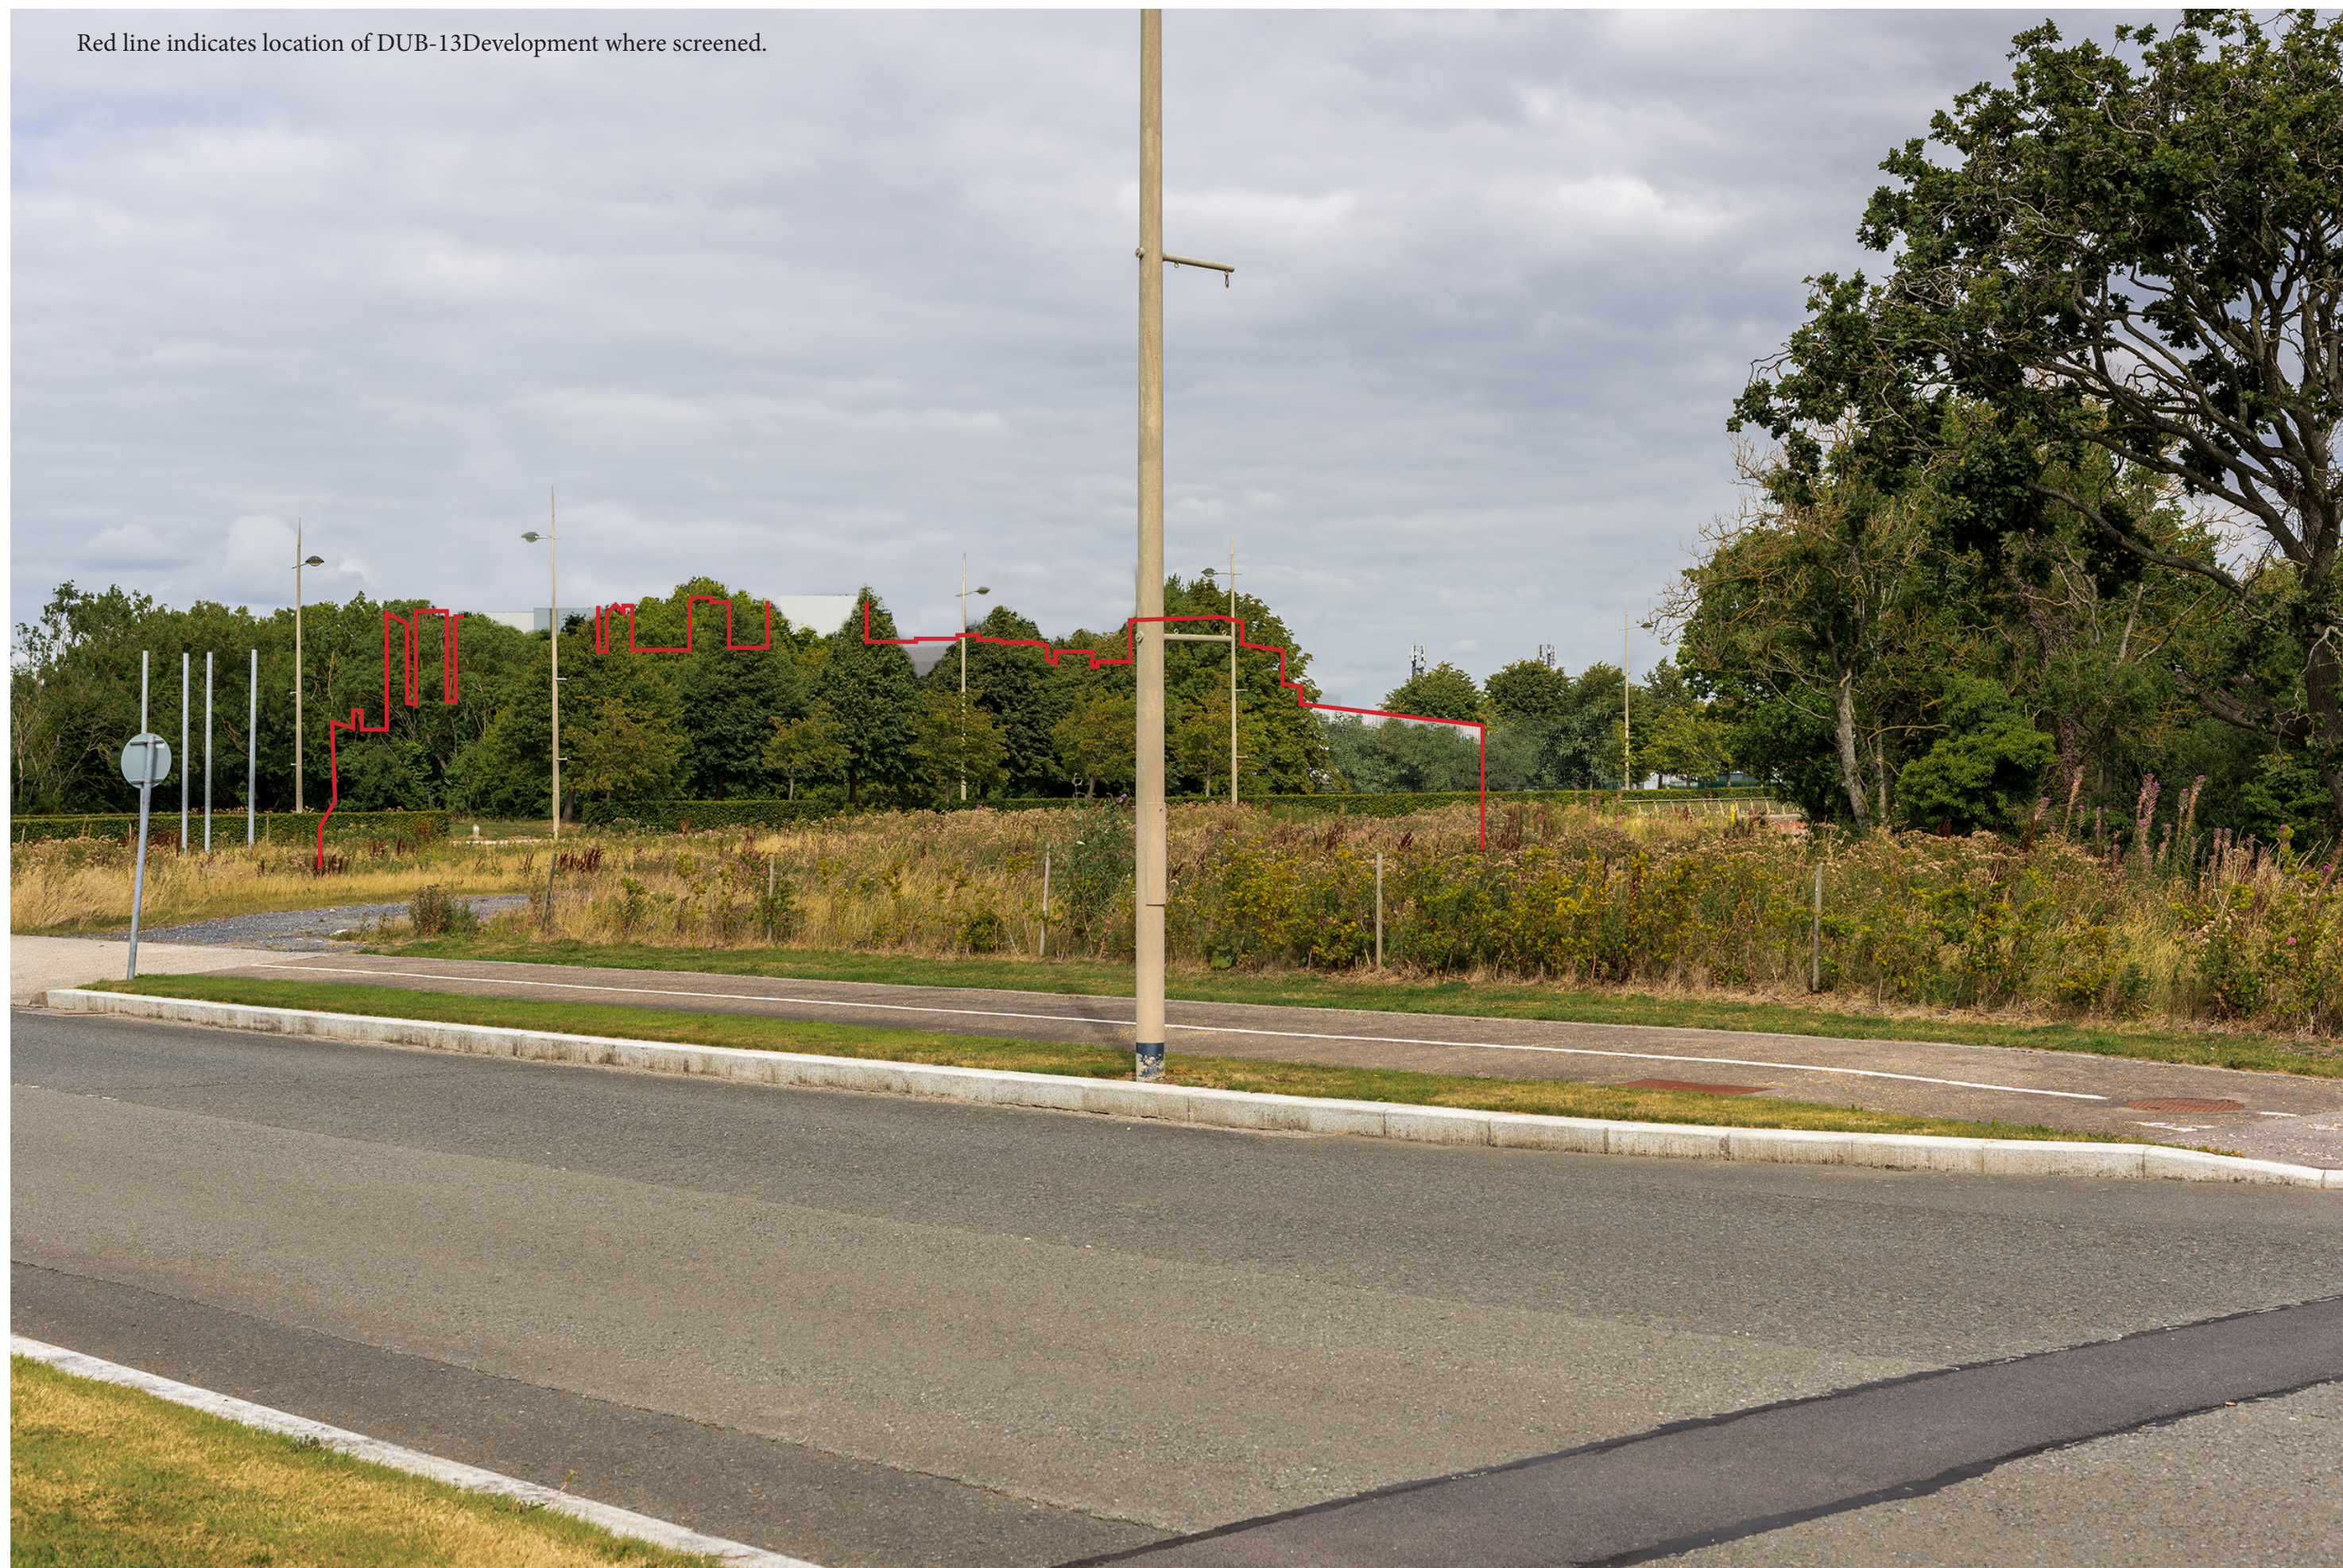
Viewpoint 8: Photomontage of Day 1 view from Profile Park Access Road | Viewing distance at A3: 542mm | Horizontal field of view: 39.6° | Direction of view: 354°
Camera: Sony ILCE-1| Lens: Sony 50mm | Camera height: 1.5m AGL | Date taken: 25 August 2022 | Aperture: f/8 | ISO speed: 100 | Shutter: 1/320sec

Red line indicates location of DUB-13 where screened.
Blue line indicates location of DUB-1 Consented Development where screened.

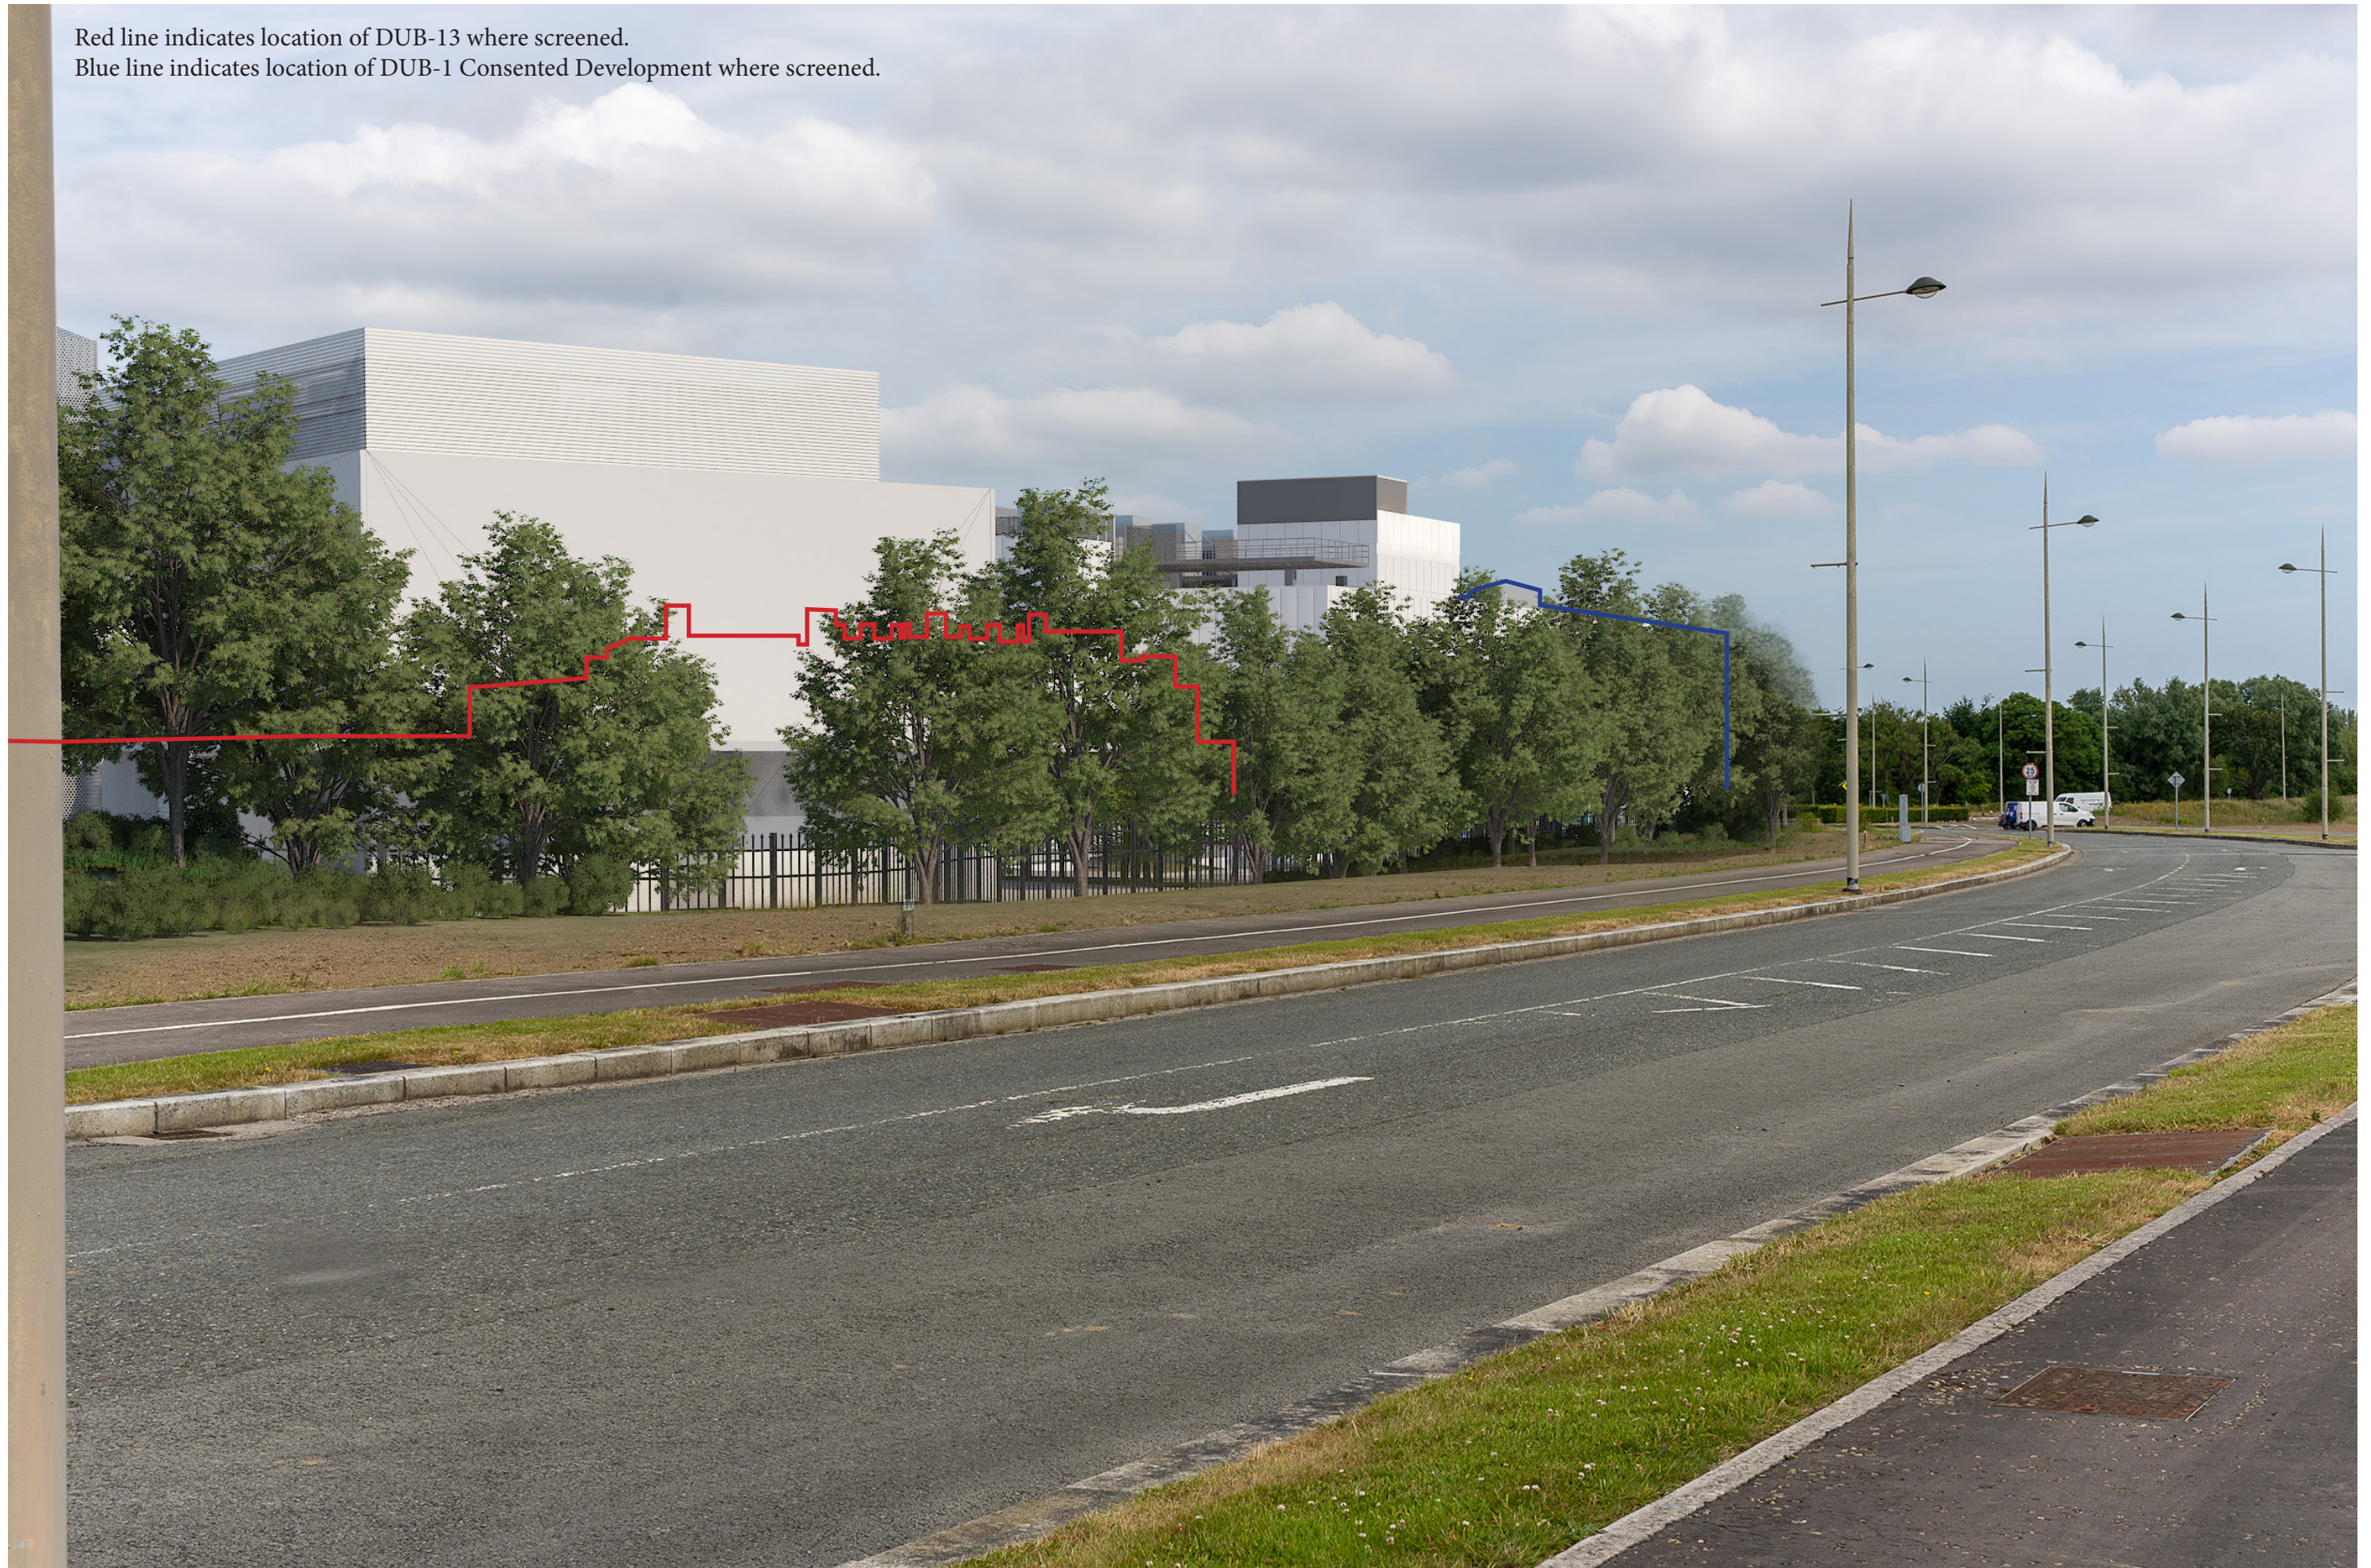
Viewpoint 9: Photomontage of Day 1 view from Faclon Avenue | Viewing distance at A3: 542mm | Horizontal field of view: 39.6° | Direction of view: 335°
Camera: Sony ILCE-1 | Lens: Sony 50mm | Camera height: 1.5m AGL | Date taken: 28 June 2021 | Aperture: f/11 | ISO speed: 100 | Shutter: 1/160 sec

Red line indicates location of DUB-13 where screened.
Blue line indicates location of DUB-1 Consented Development where screened.

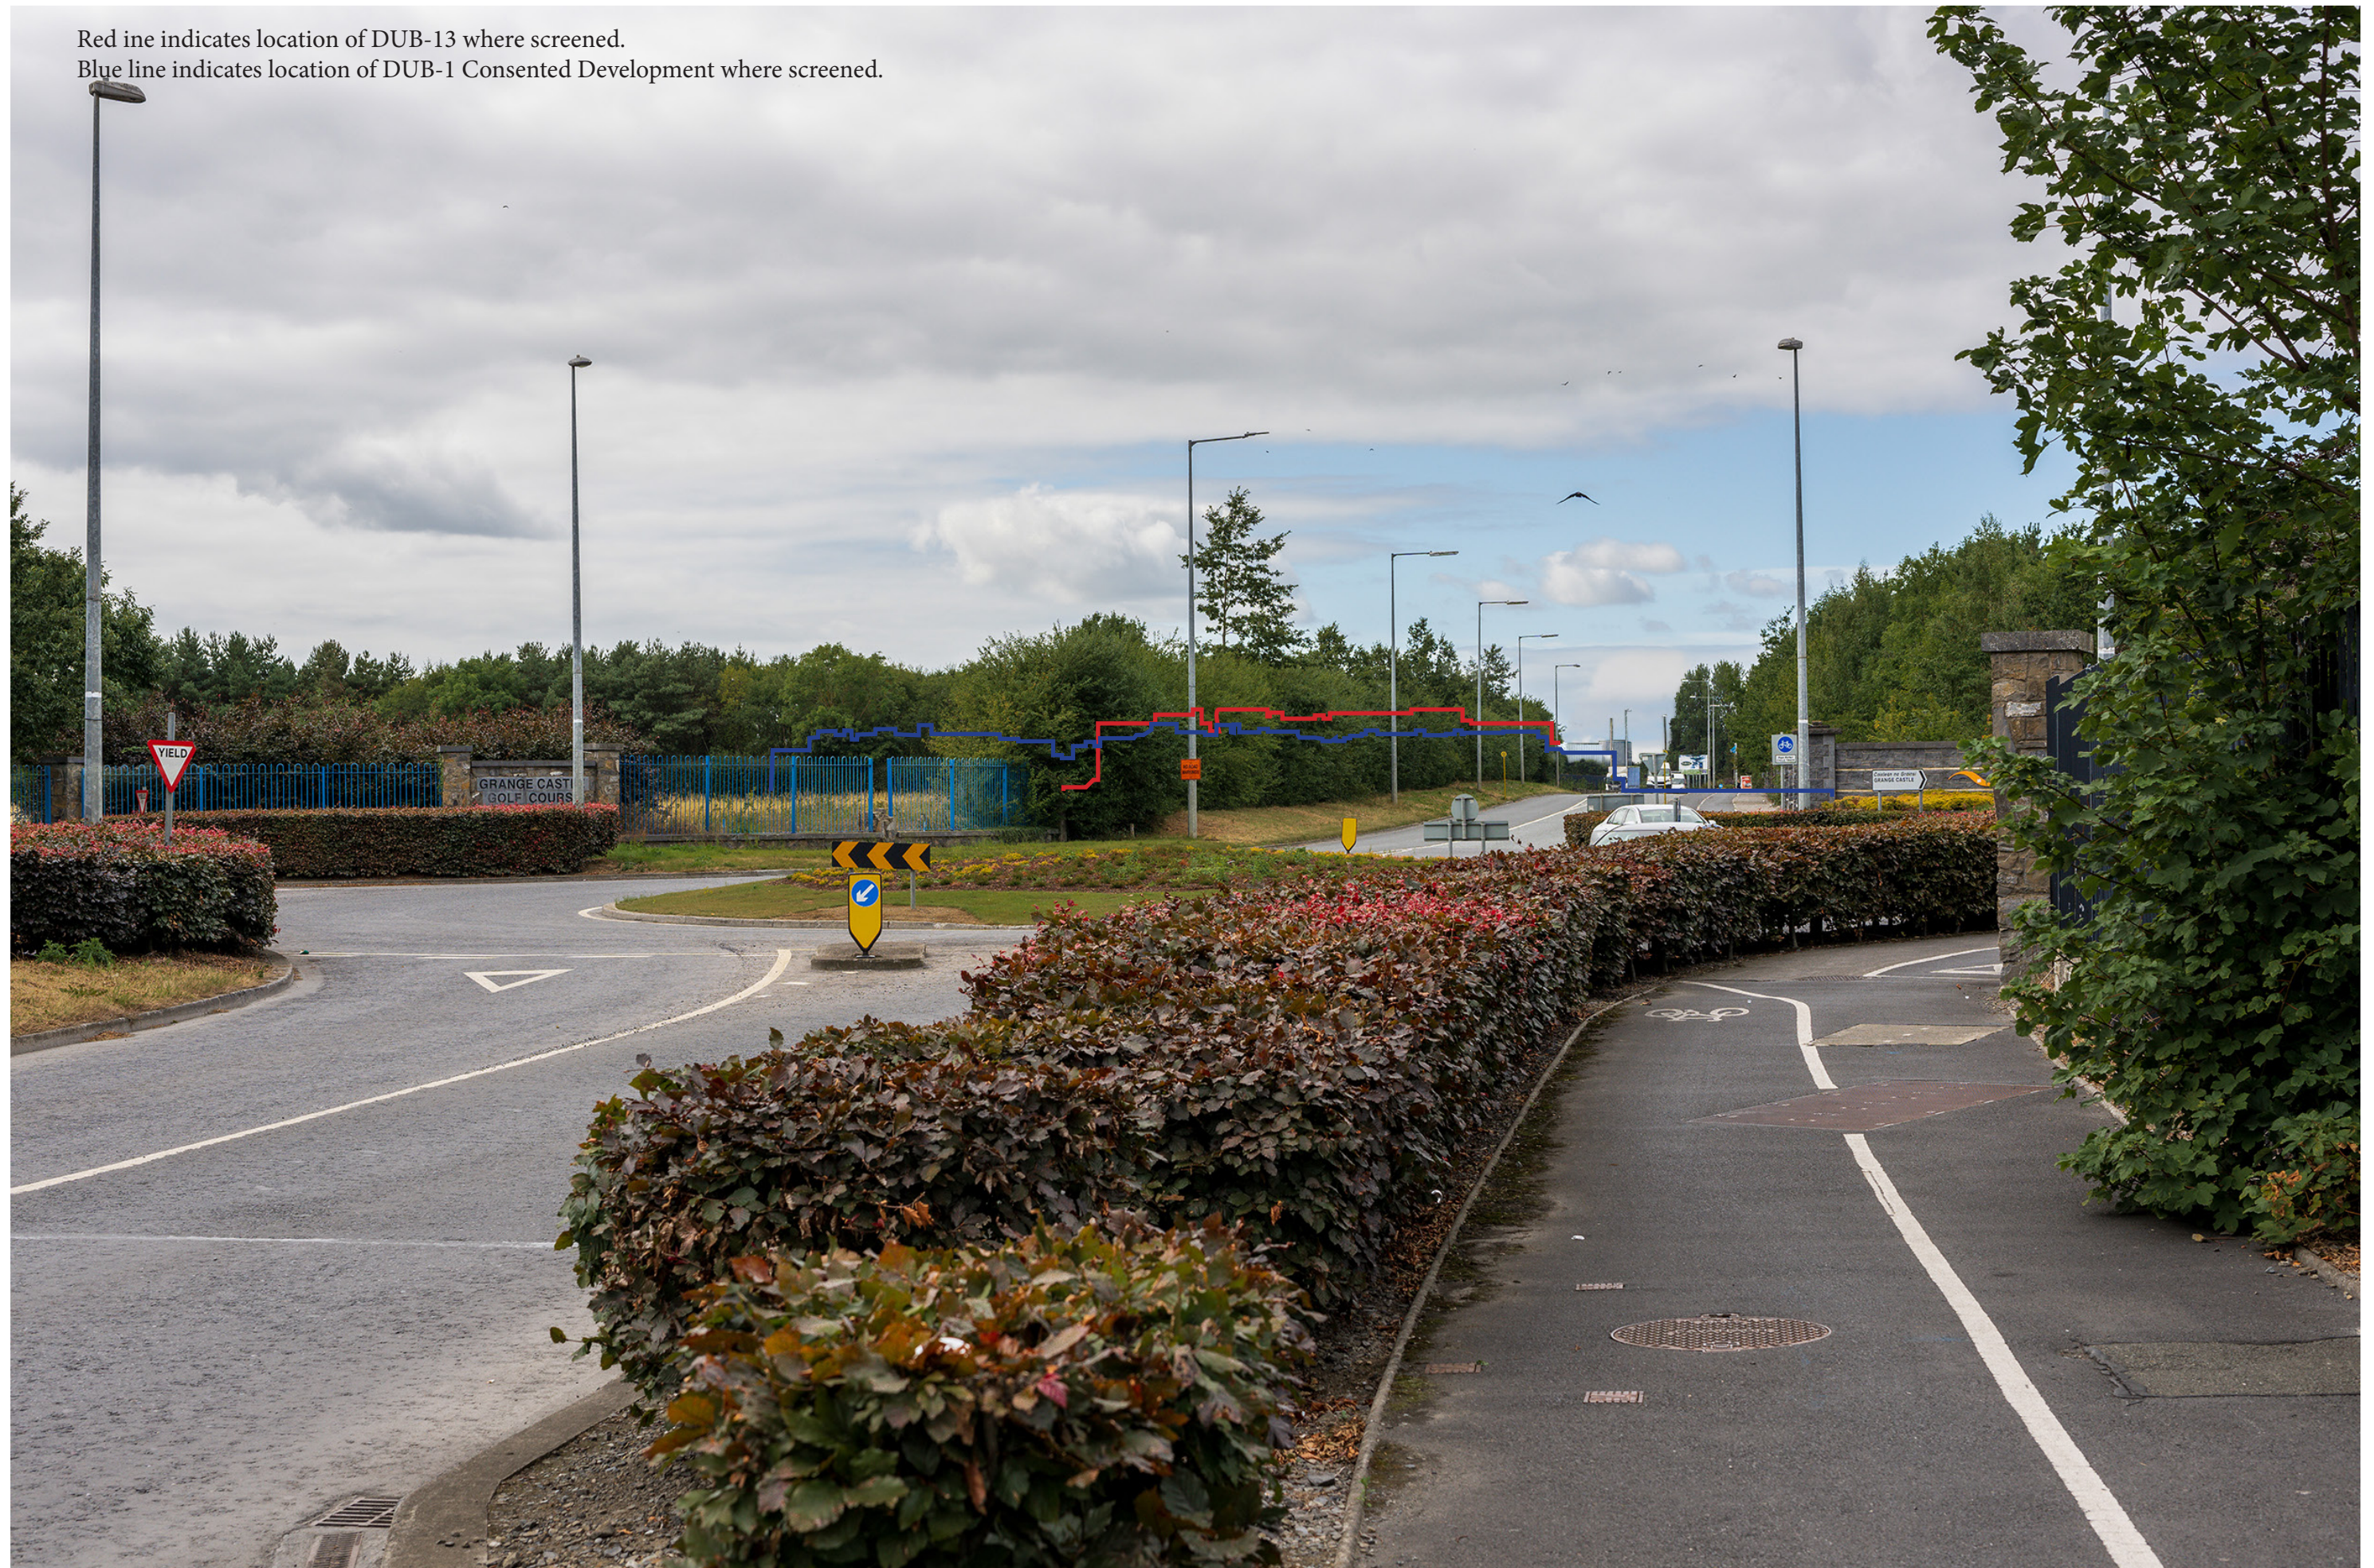
Viewpoint 11: Photomontage of Day 1 view from R134 at entrance to Grange Castle Golf Course | Viewing distance at A3: 542mm | Horizontal field of view: 39.6° | Direction of view: 264°
Camera: Sony ILCE-1 | Lens: Sony 50mm | Camera height: 1.5m AGL | Date taken: 25 August 2022 | Aperture: f/8 | ISO speed: 100 | Shutter: 1/320sec
