Intended for
Vantage Data Centers DUB13 Limited

Date
March 2023

VANTAGE DUBLIN DATA CENTER

VOLUME 2A: LANDSCAPE, VISUAL AND BUILT HERITAGE IMPACT ASSESSMENT

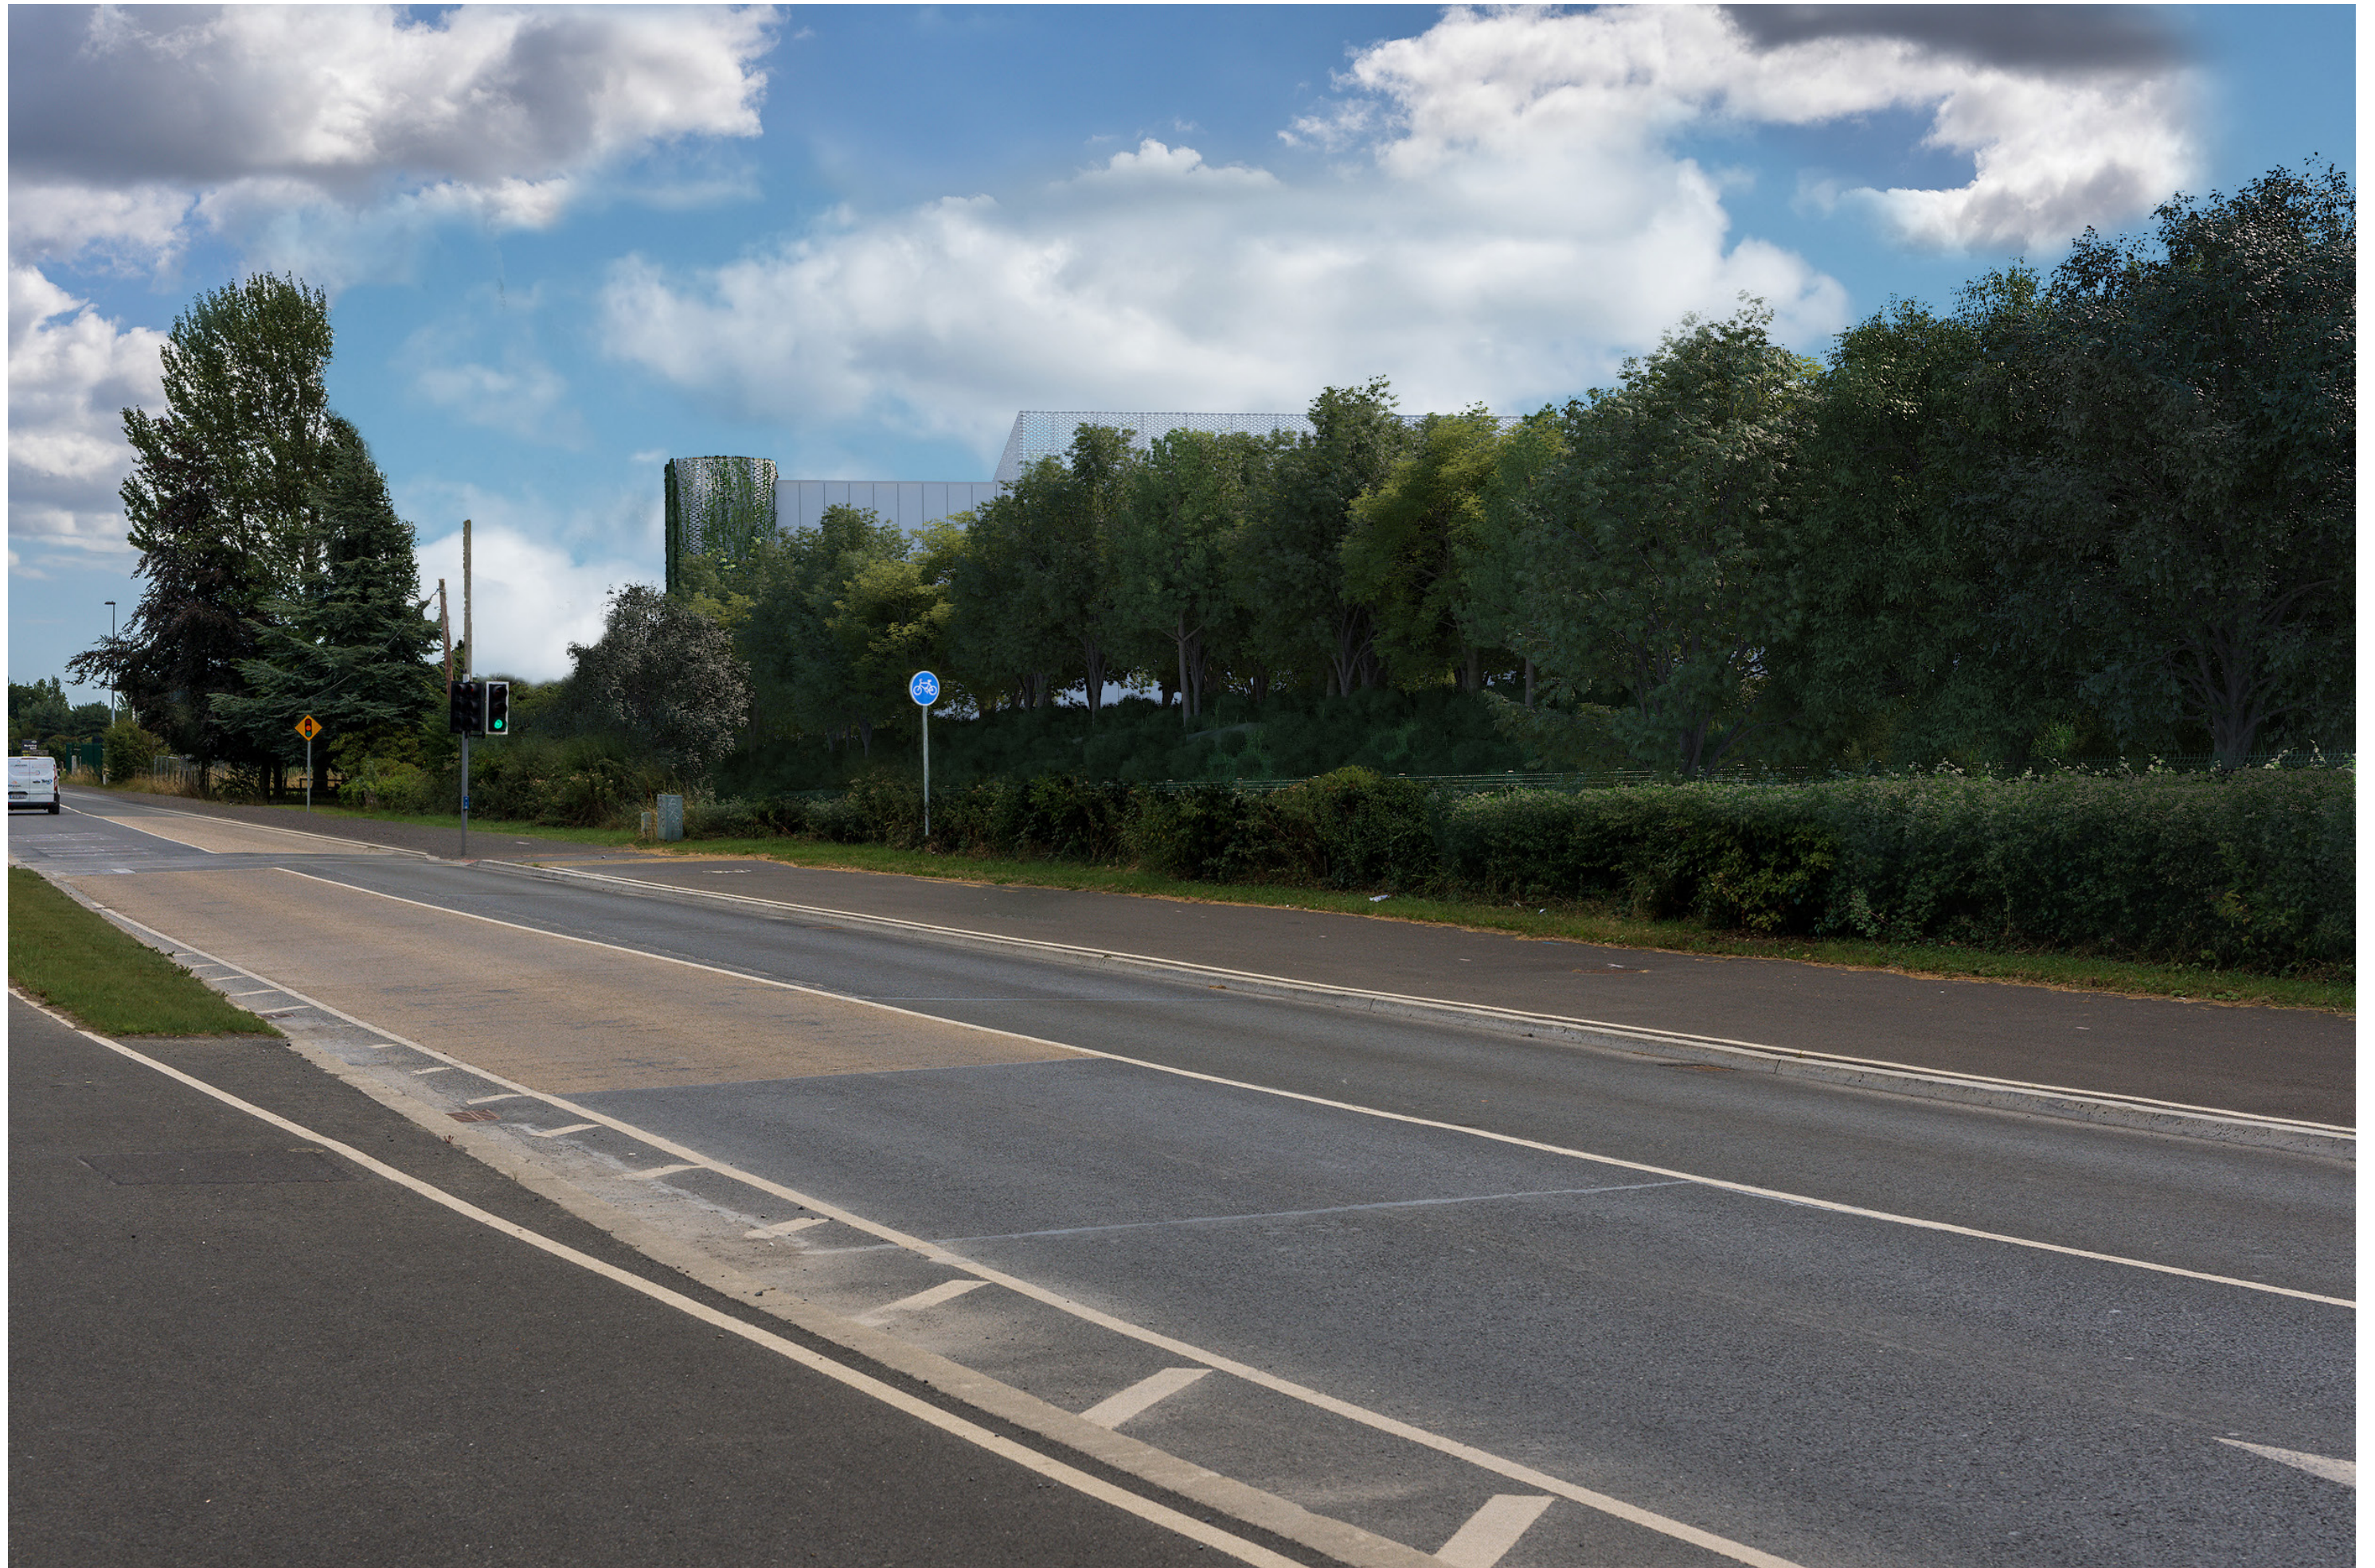
Viewpoint 6: Photomontage of Year 5 view from R134 New Nangor Road at the north west corner of the Site | Viewing distance at A3: 542mm | Horizontal field of view: 39.6° | Direction of view: 178°
Camera: Sony ILCE-1 | Lens: Sony 50mm | Camera height: 1.5m AGL | Date taken: 25 August 2022 | Aperture: f/8 | ISO speed: 100 | Shutter: 1/500 sec

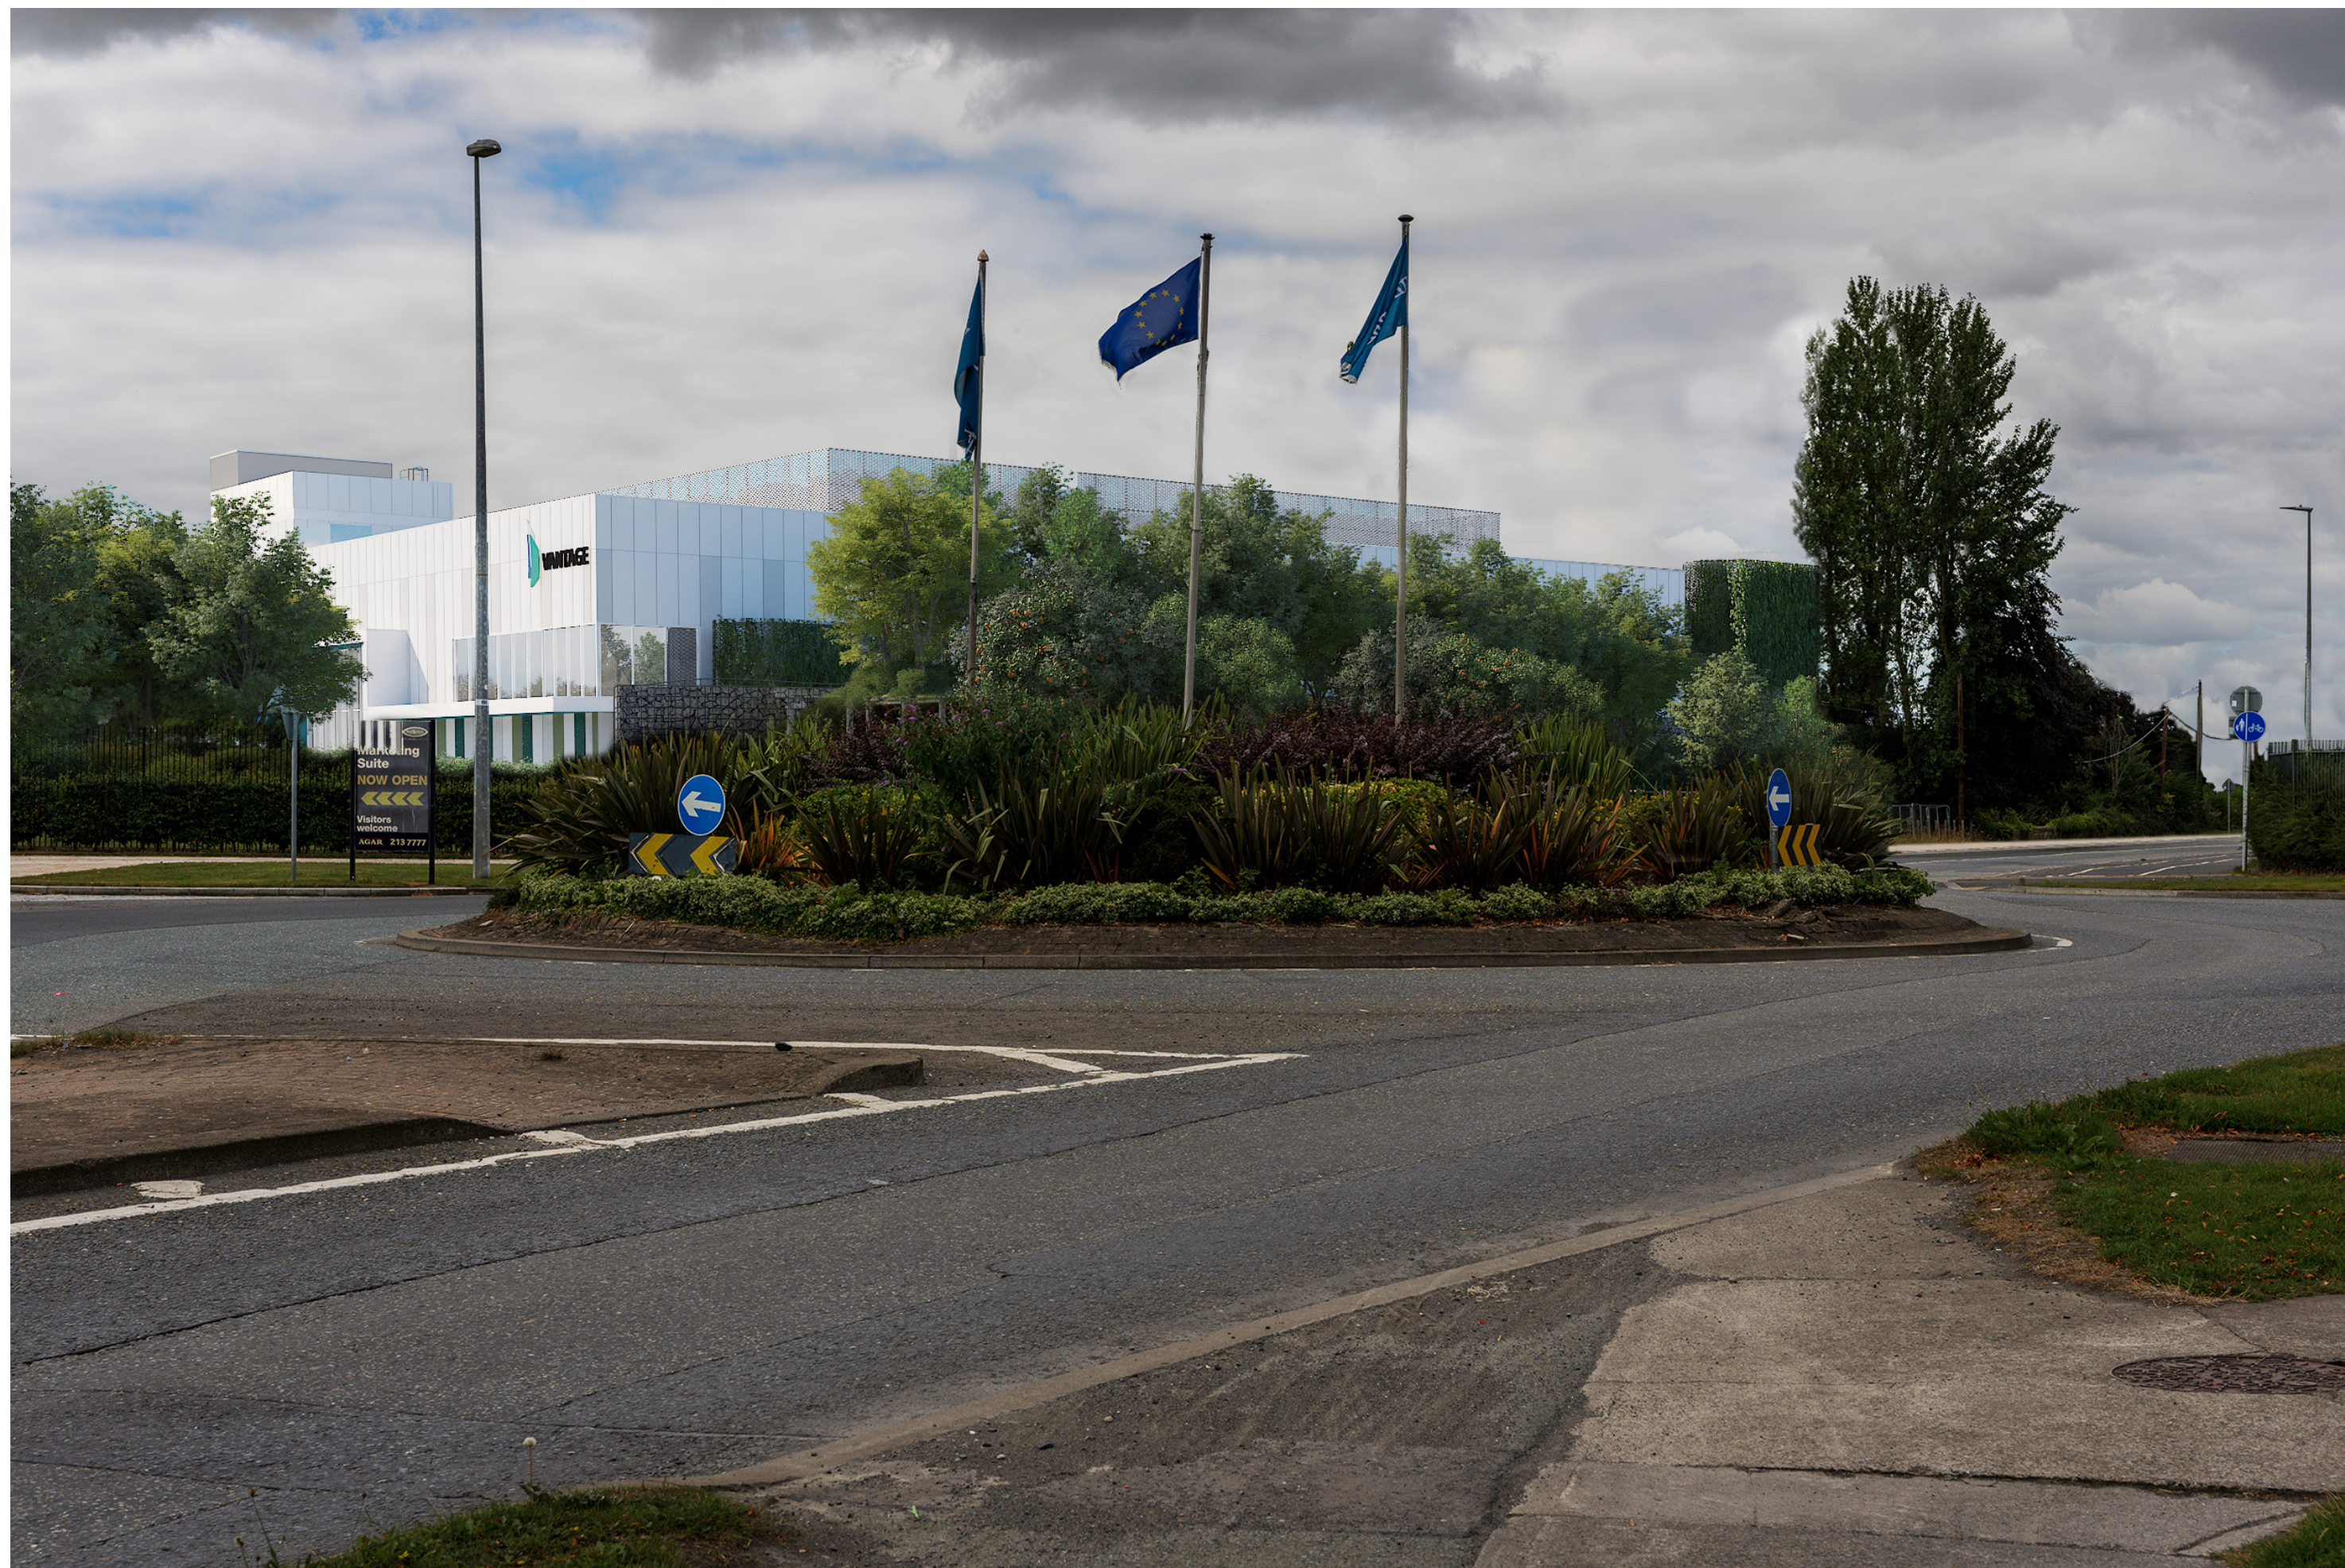
Viewpoint 7: Photomontage of Year 5 view from R134 New Nangor Road at the entrance to Profile Park | Viewing distance at A3: 542mm | Horizontal field of view: 39.6° | Direction of view: 252°
Camera: Sony ILCE-1 | Lens: Sony 50mm | Camera height: 1.5m AGL | Date taken: 25 August 2022 | Aperture: f/8 | ISO speed: 100 | Shutter: 1/320 sec

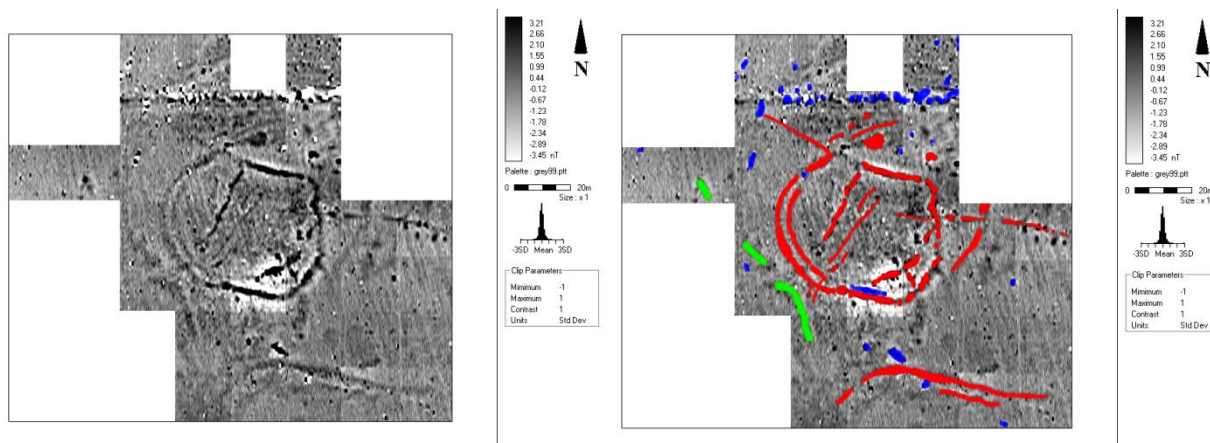
Greyscale: The greyscale format assigns a cell to each datum according to its location on the grid. The display of each data point is conducted at very fine increments, allowing the full range of values to be displayed within the given data set. This display method also enables the identification of discrete responses that may be at the limits of instrument detection.

Early medieval enclosure greyscale

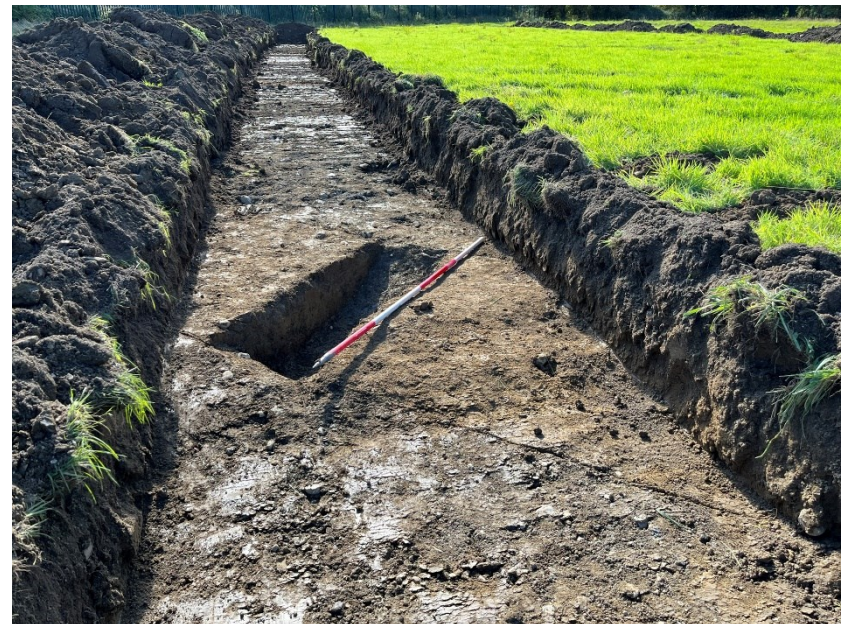
Plate 12: Trench 11, ditch C03 looking south.

- 2.7.26
- The site investigations identified the alignment of a ditch of possible prehistoric or early historic date.
- 2.7.27
- The geophysical survey undertaken for the July 2022 DUB-1 permitted development by ACSU in 2020 failed to reveal any clear probable or possible archaeological anomalies pertaining to previous activity. The subsequent test trenching exercise to evaluate the archaeological resource and determine its likely significance, failed to reveal any archaeological finds, features or deposits.
