APPENDIX 15.2: CULTURAL HERITAGE INVENTORIES

APPENDIX 15.3: FIGURES

CHAPTER SIXTEEN THE LANDSCAPE

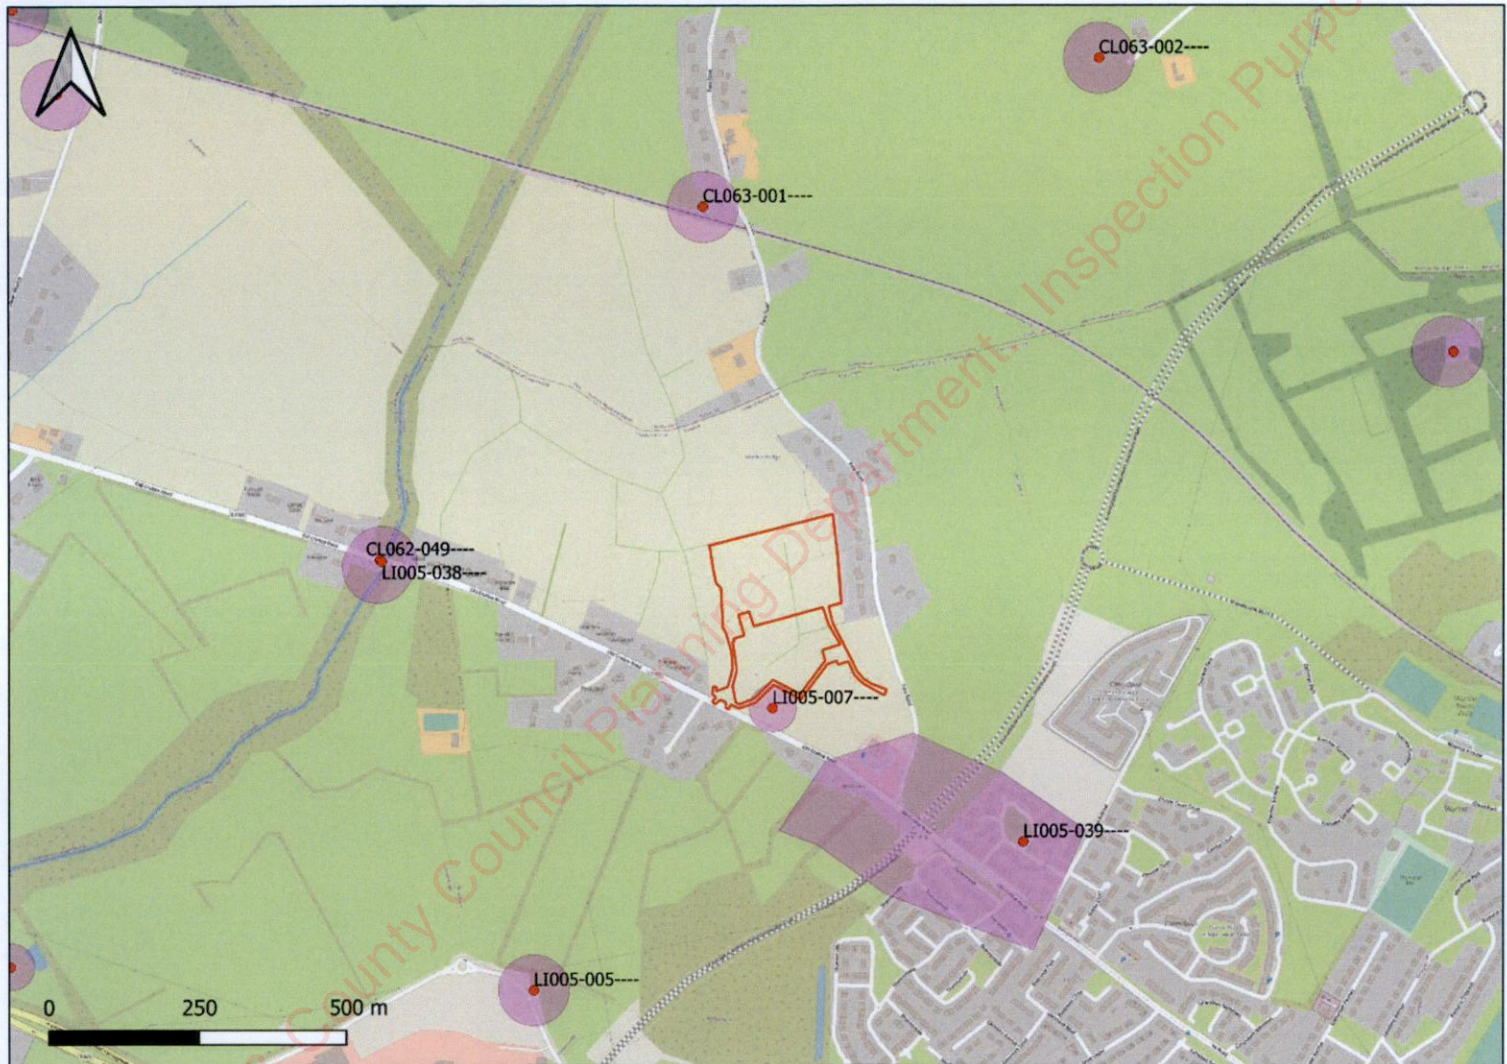
Figure 15.6 Recorded archaeological sites (red dots) and their ZoNs (shaded purple) located within approximately 1km of the Phase 3 area

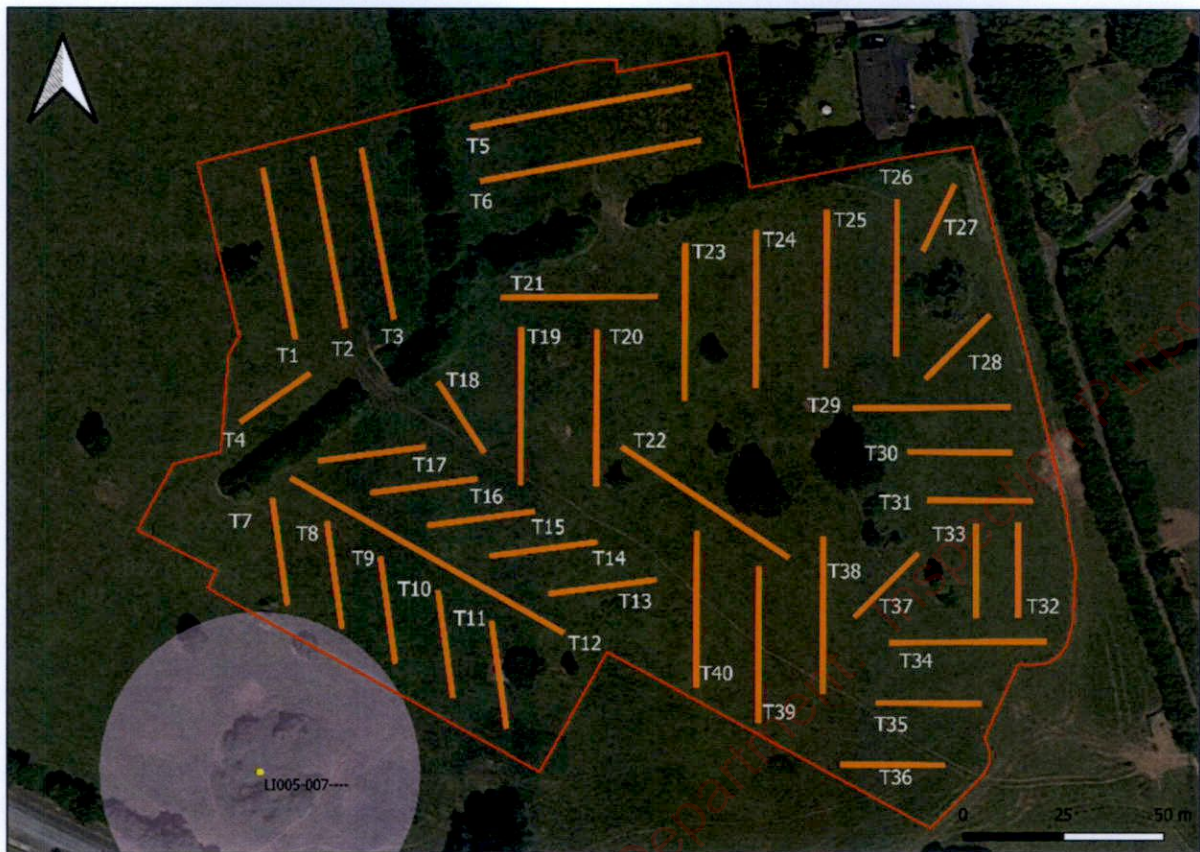
Figure 15.15 Location of test trenches excavated across the Phase 1 area

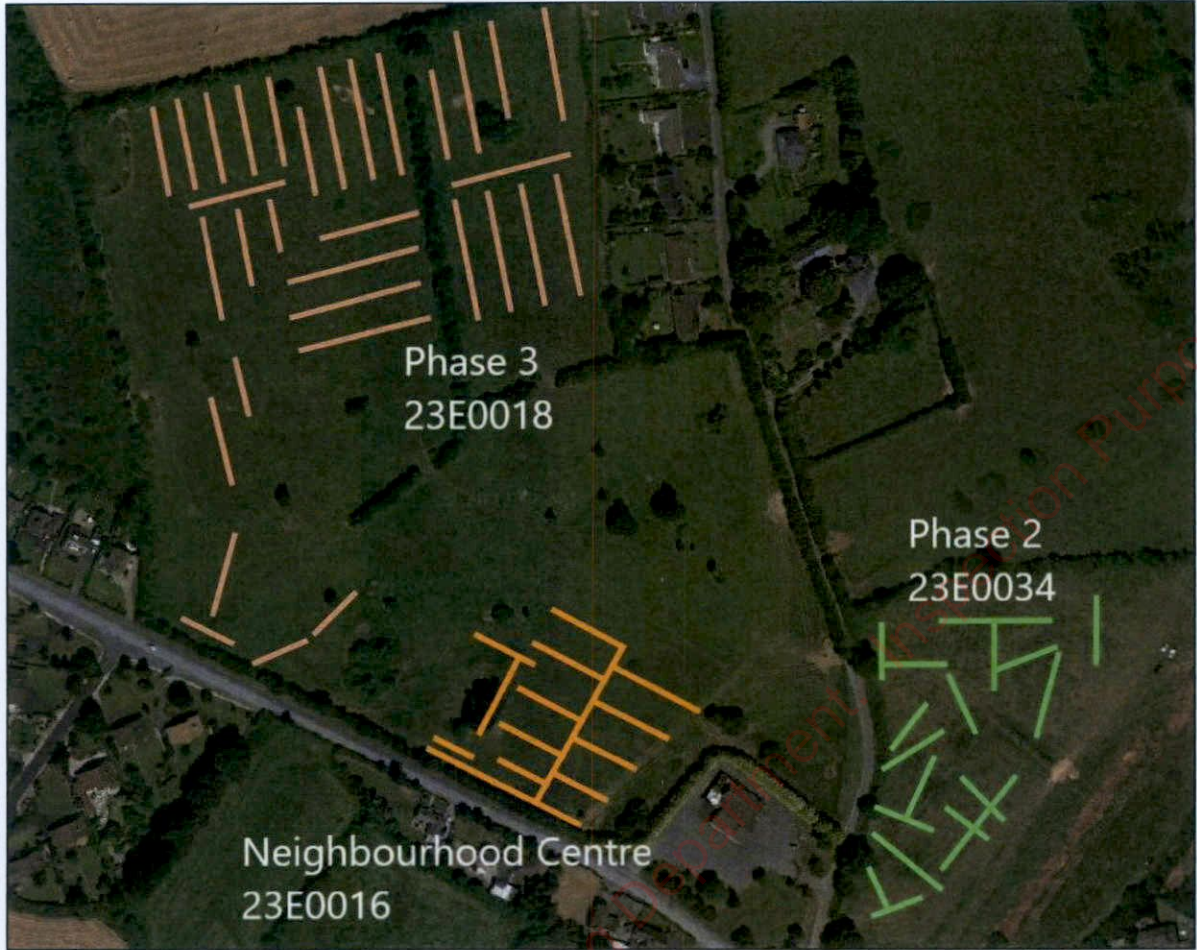
Figure 15.16 Location of test trenches excavated across the Phase 2, Phase 3 and Neighbourhood Centre areas

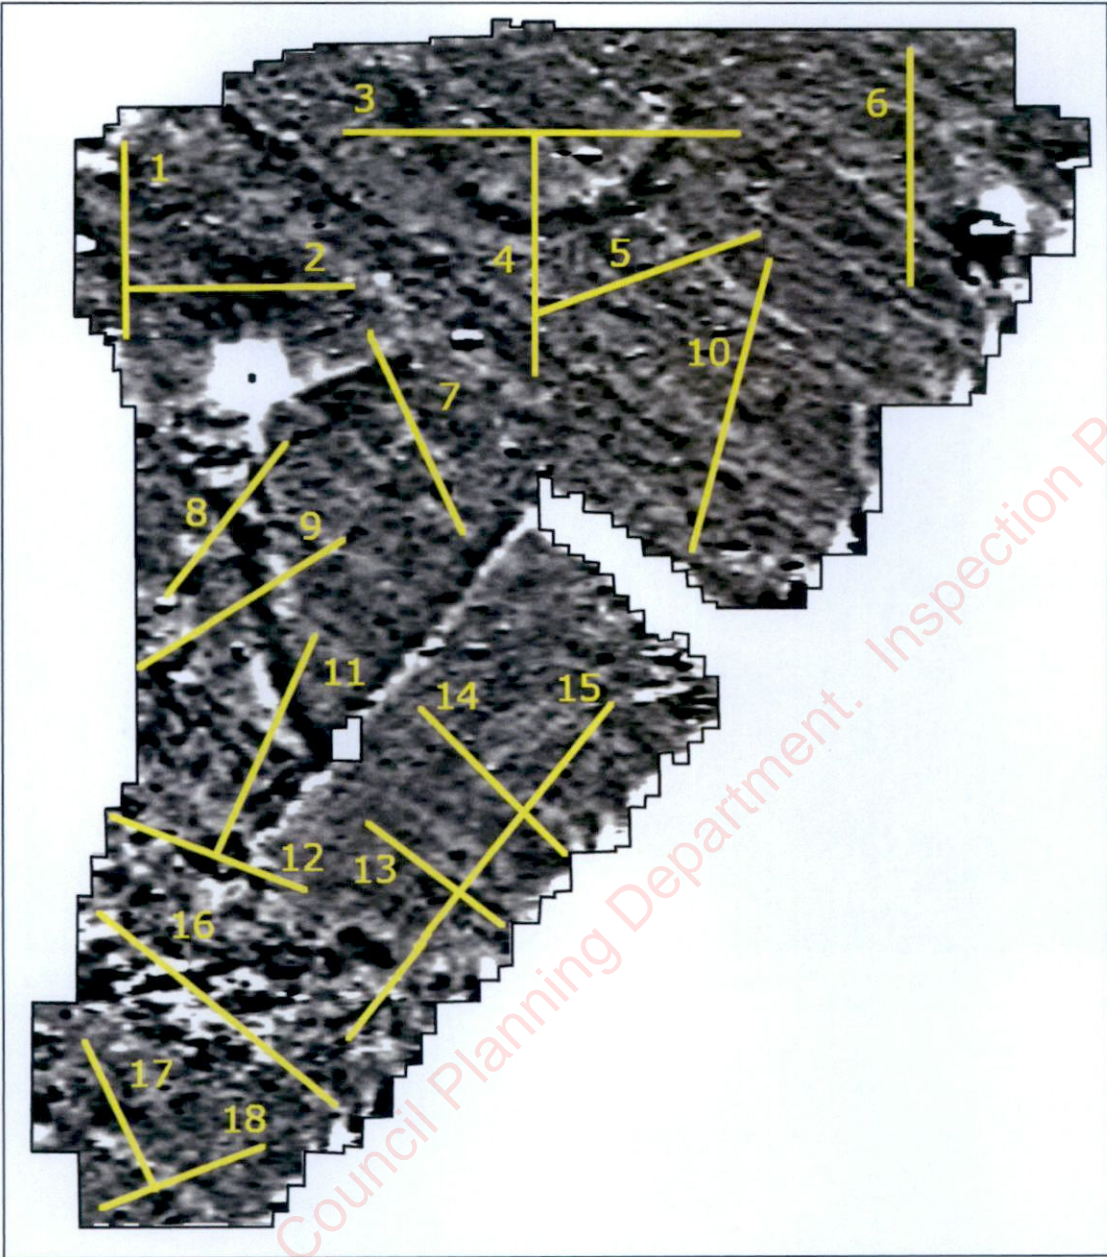
Figure 15.17 Test trench layout for Phase 2, over greyscale image from geophysical survey

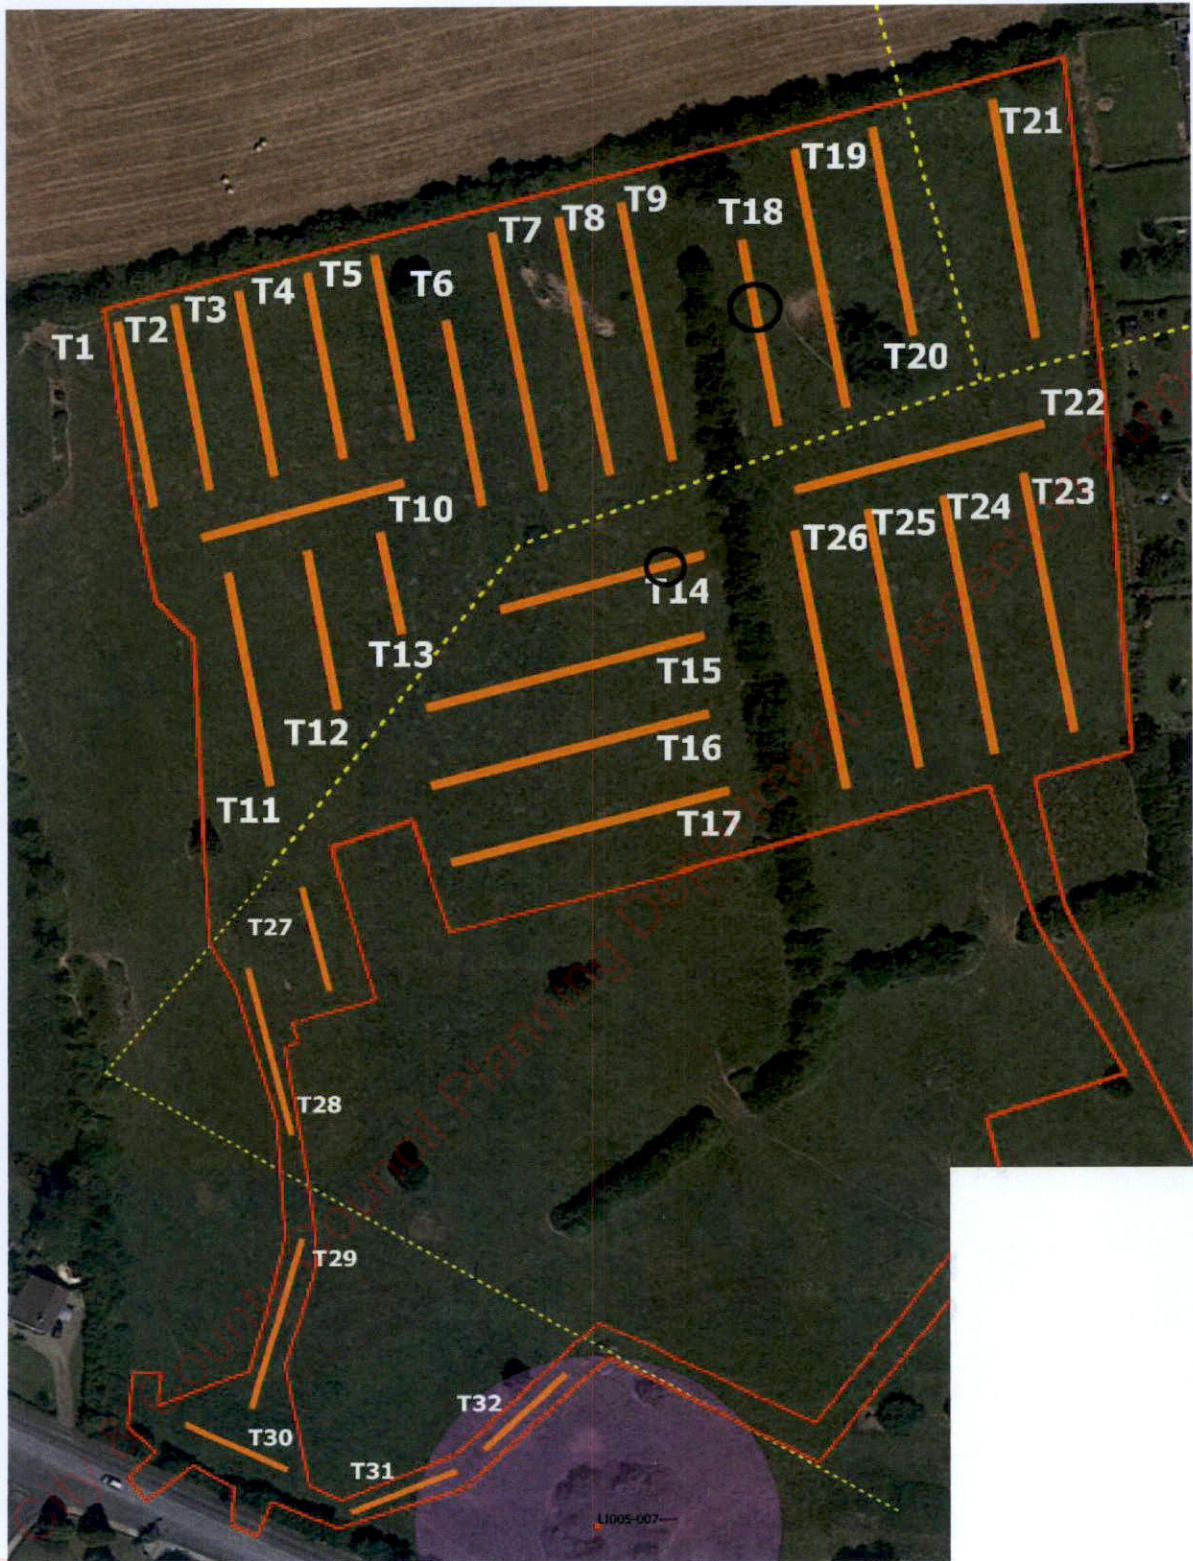
Figure 15.18 Location of test trenches excavated across the Phase 3 area with potential archaeological features circled in black

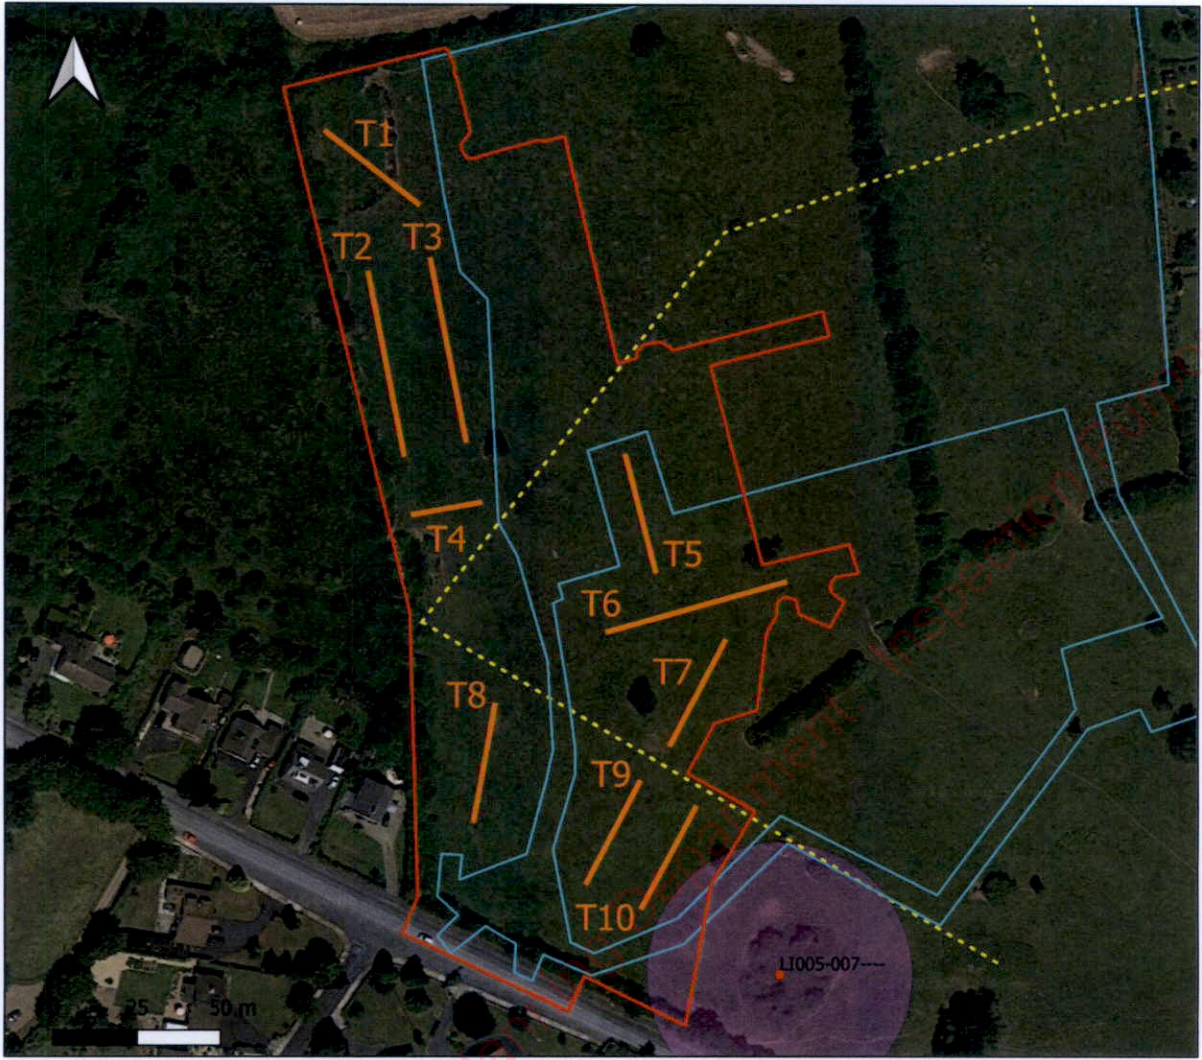
Figure 15.19 Location of test trenches excavated across the Phase 4 area

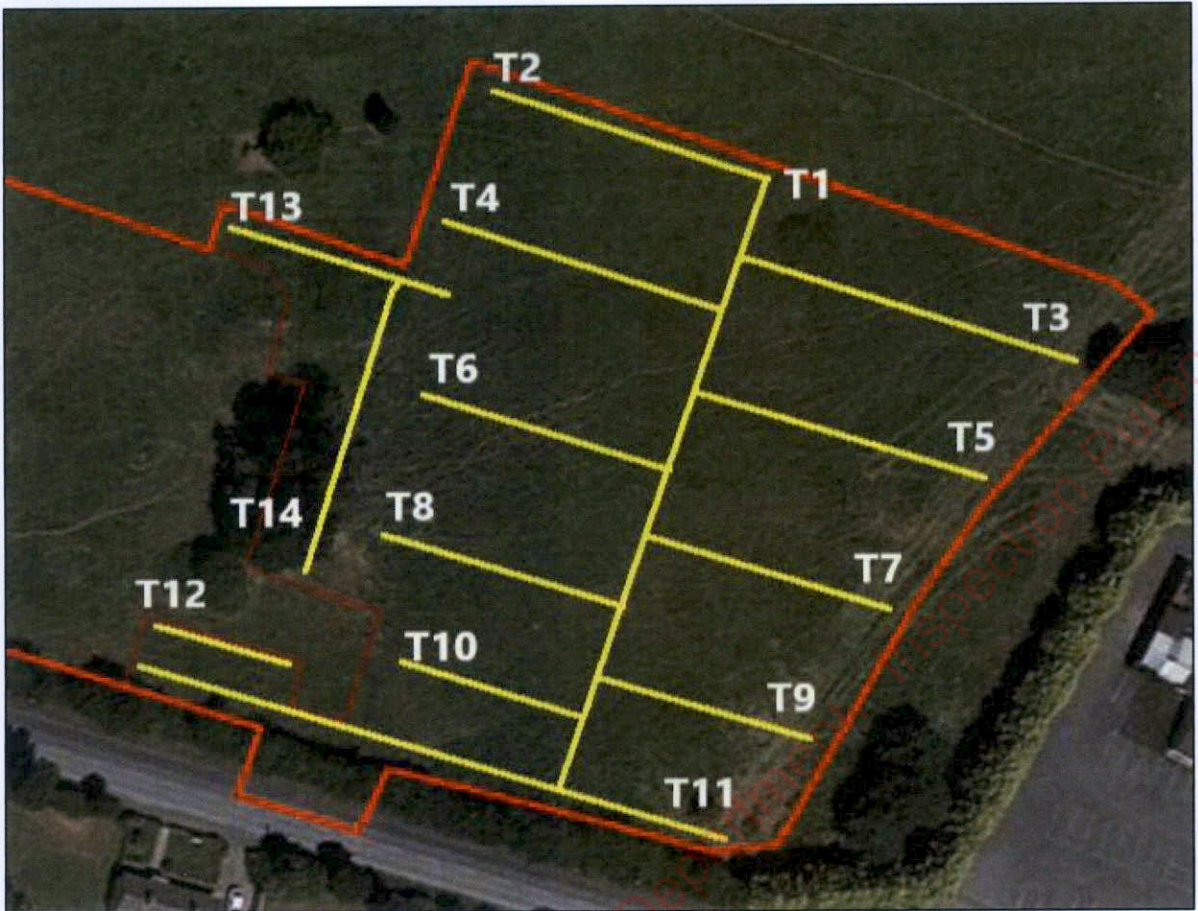
Figure 15.20 Location of test trenches excavated across the Neighbourhood Centre area

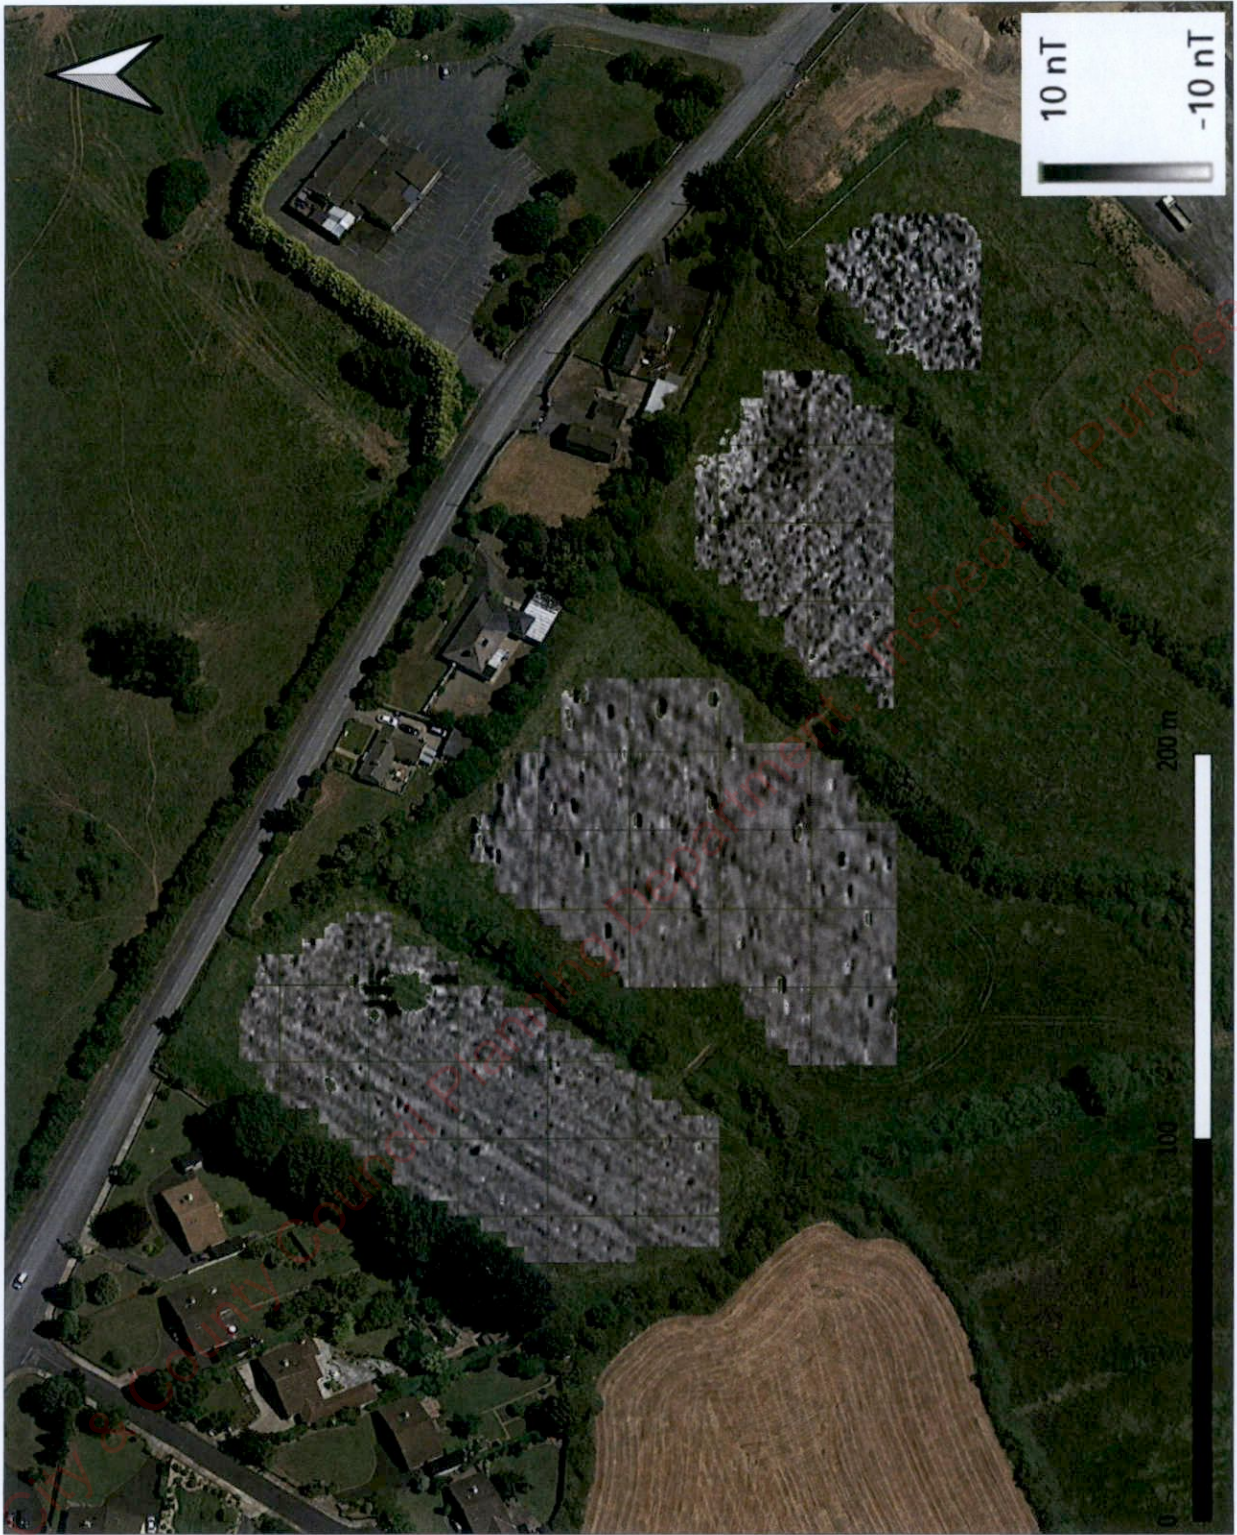
Figure 15.22 Greyscale image from geophysical survey of the Phase 5 area

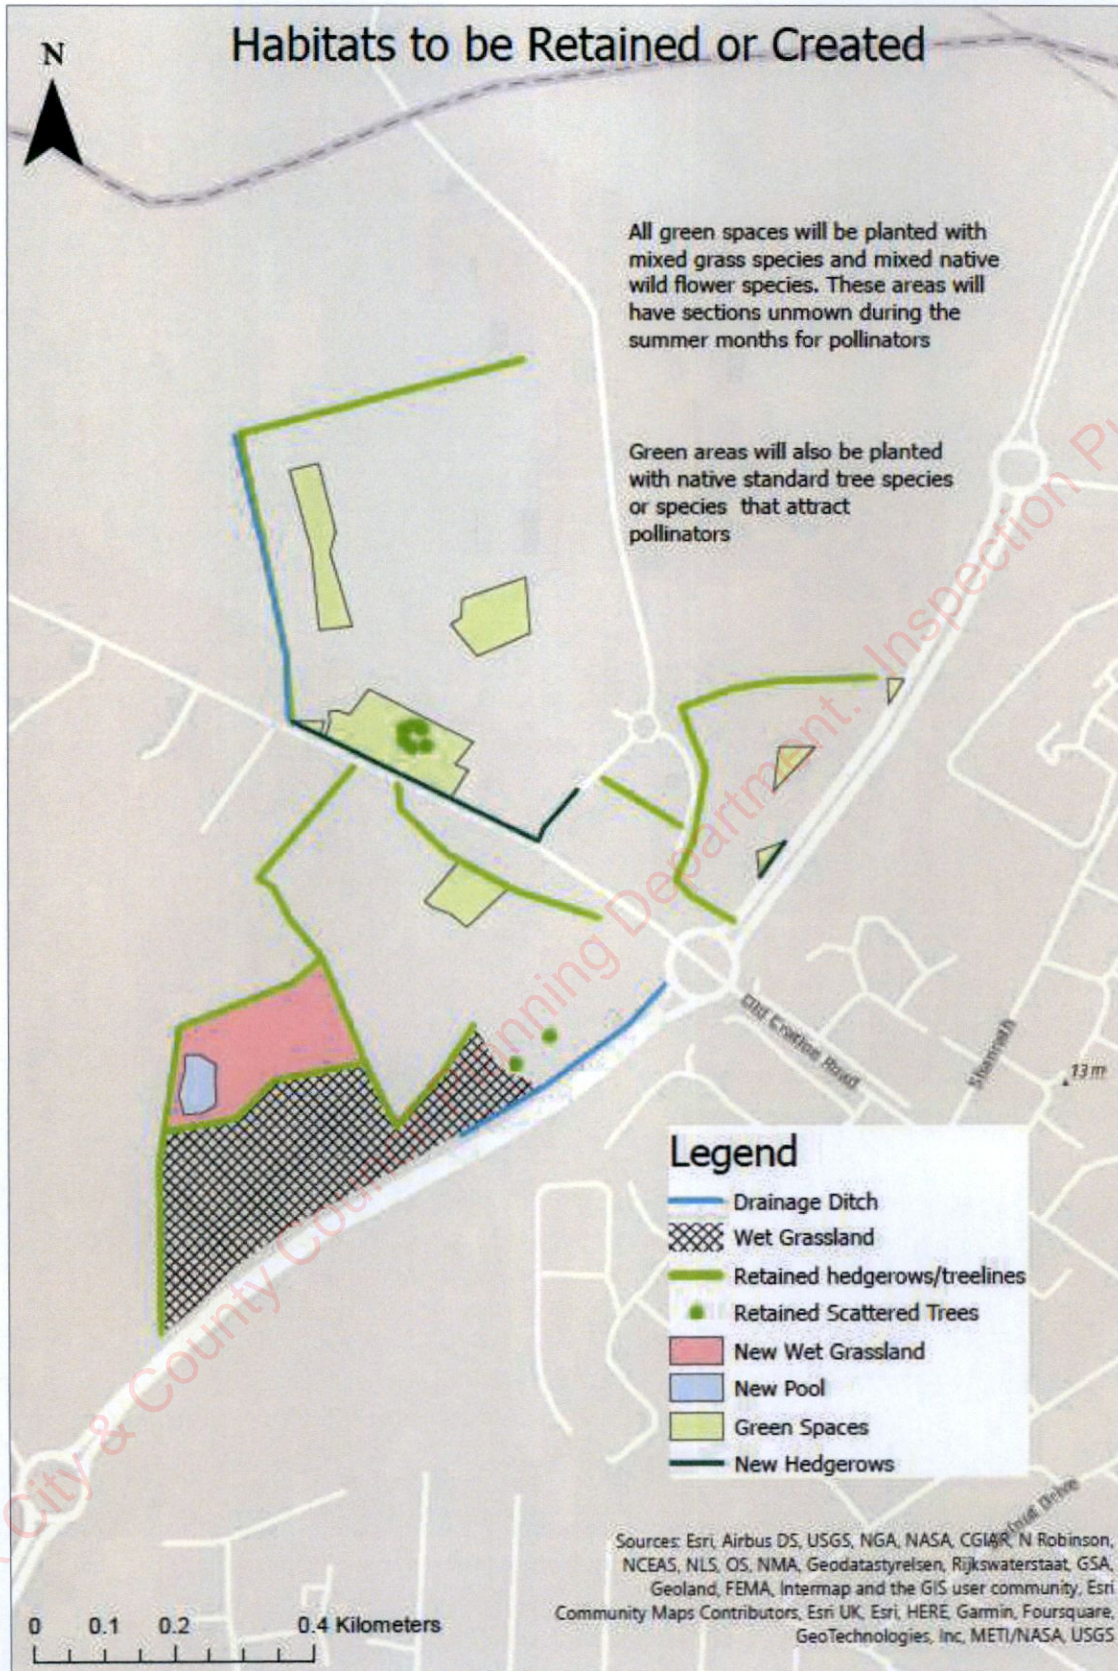
Figure 15.23 Habitats to be retained or created, including a proposed new wet grassland and pond in the Phase 5 area

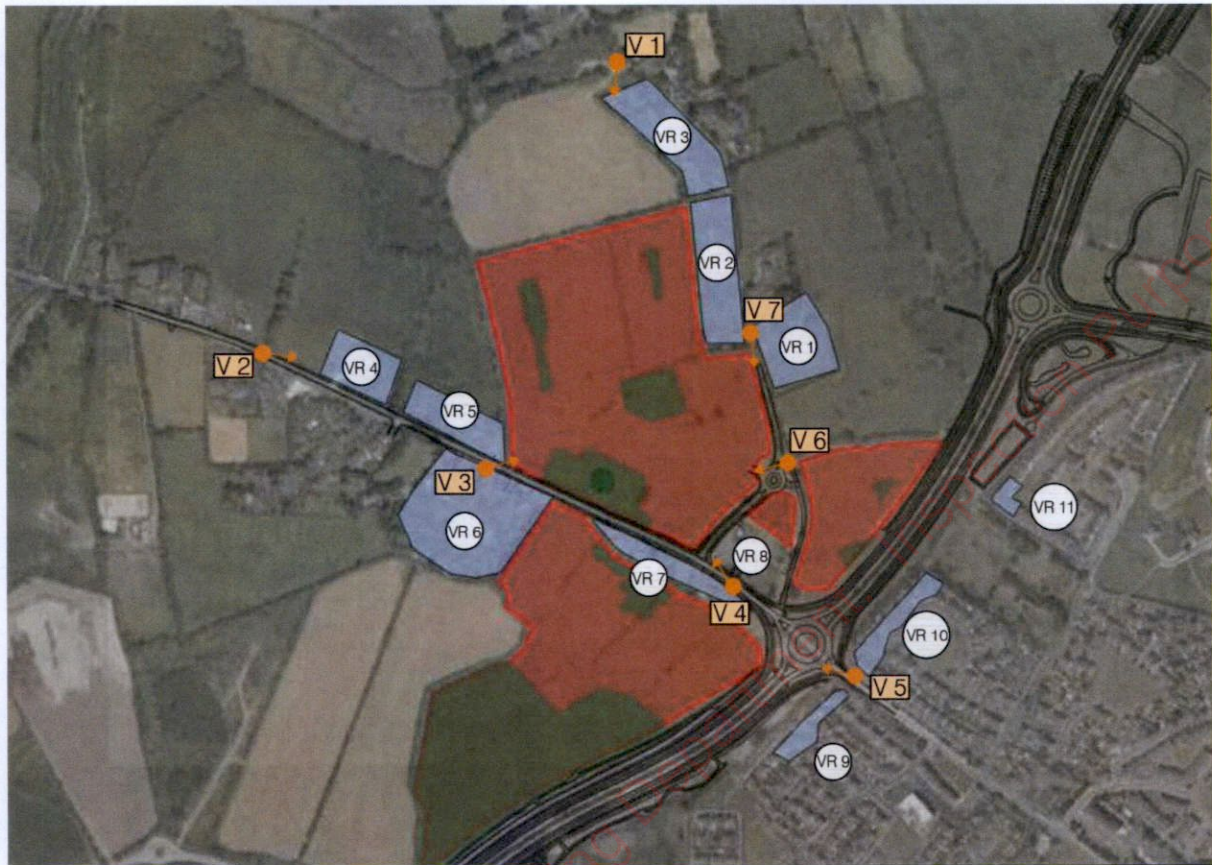
Figure 16.6 Location of Viewpoints in relation to subject lands and the Sensitive Visual Receptors as listed in Table 16.3.

View 01	190m from edge of masterplan lands
Existing View :	
A medium-range view taken on the Pass road to the north of the proposed development. The viewpoint is located on Pass road in the vicinity of the group of residences listed as VR 3 in this study. The foreground of the view is mostly taken up by the roadside hedgerow and back garden hedges and trees of the houses. Beyond this, some of the trees on the site are visible where they form a small part of the background of the view. .	
Proposed View Year 5 :	
Due to the distance between the viewpoint and the proposed development and intervening features in the local landscape, the proposed development is mostly hidden from view. The roofs of the most northern units are visible, however they are mostly screened by vegetation and do not abstract any part of the view. The View is a small glimpsed view through a section break in the roadside hedgerow reducing the impact further

View 03		38m from edge of masterplan lands
Existing View : A short-range view taken to the west of the proposed masterplan lands. The viewpoint is located on Old Cratloe Road in the vicinity of the group of residences listed as VR 5 and 6 in this study. The subject lands are visible in the centre of the view with the trees and scrub at Crag Graveyard visible on the right side of the view. The scattered trees and some of the hedgerows are also visible. The roadside hedgerow has recently been removed and replaced with a timber fence making this view more expansive than previously.		
Proposed View Year 5 : The proposed masterplan development will result in a notable change to this view. The housing along the western perimeter will be prominent and change the character of the existing view. Crag Graveyard and the trees in the 'Open Space' lands will be visible and unchanged in the view. Due to the removal of the roadside hedgerow during the recent road works this view is quite expansive and residences and public realm users in this area would be impacted.

View 06	15m from edge of masterplan lands
Existing View :	
A short-range view taken from the public road at the junction of the new public road and the upgraded section of Pass road. The viewpoint is located on the edge of the masterplan lands with the new road infrastructure and fencing dominant in the foreground. The subject lands are visible in the centre of the view with the scattered trees of the old golf course quite prominent. The roadside hedgerow has recently been removed and replaced with a timber fence making this view more expansive than previously.	
Proposed View Year 5 :	
The housing in the permitted phase of the masterplan lands are prominent in this view. The development would be consistent in scale and typology to the existing development directly to the east. The impact of the development on this view is reduced due to the significant alterations to this area by the building of the new road infrastructure and removal of vegetation.

View 07	15m from edge of masterplan lands
Existing View : A short-range view taken from the public road at the junction of the new public road and the upgraded section of Pass road. The viewpoint is located on the edge of the masterplan lands with the new road infrastructure and fencing dominant in the foreground. The subject lands are visible in the centre of the view with the scattered trees of the old golf course quite prominent. The roadside hedgerow has recently been removed and replaced with a timber fence making this view more expansive than previously.	
Proposed View Year 5 : The housing in the permitted phase of the masterplan lands is prominent in this view. The development would be consistent in scale and typology to the existing development directly to the east. The housing will read visually as a continuation of the built environment between the existing housing on Pass road and Old Cratloe Road. The impact of the development on this view is reduced due to the significant alterations to this area by the building of the new road infrastructure and removal of vegetation.

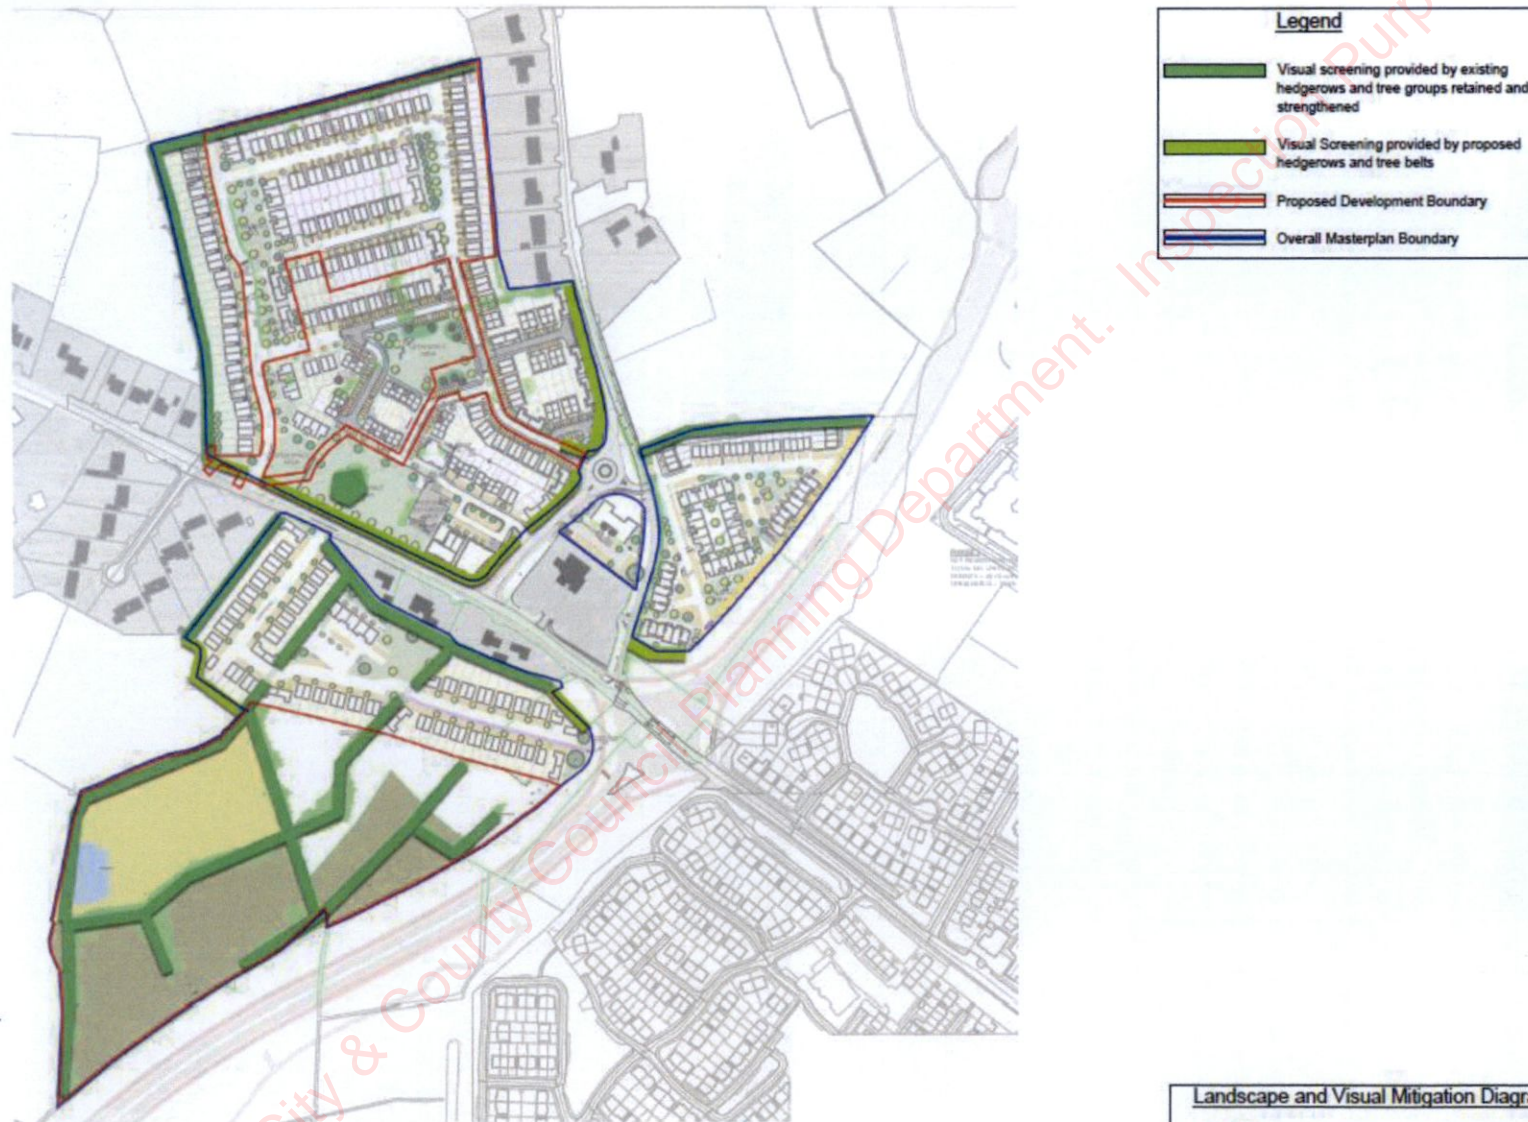
Figure 16.7 Landscape and Visual Mitigation Diagram
