**Appendix A14.1**  
Scheme Walkover  
Summary

## **Appendix A14.1: Scheme Walkover Summary**

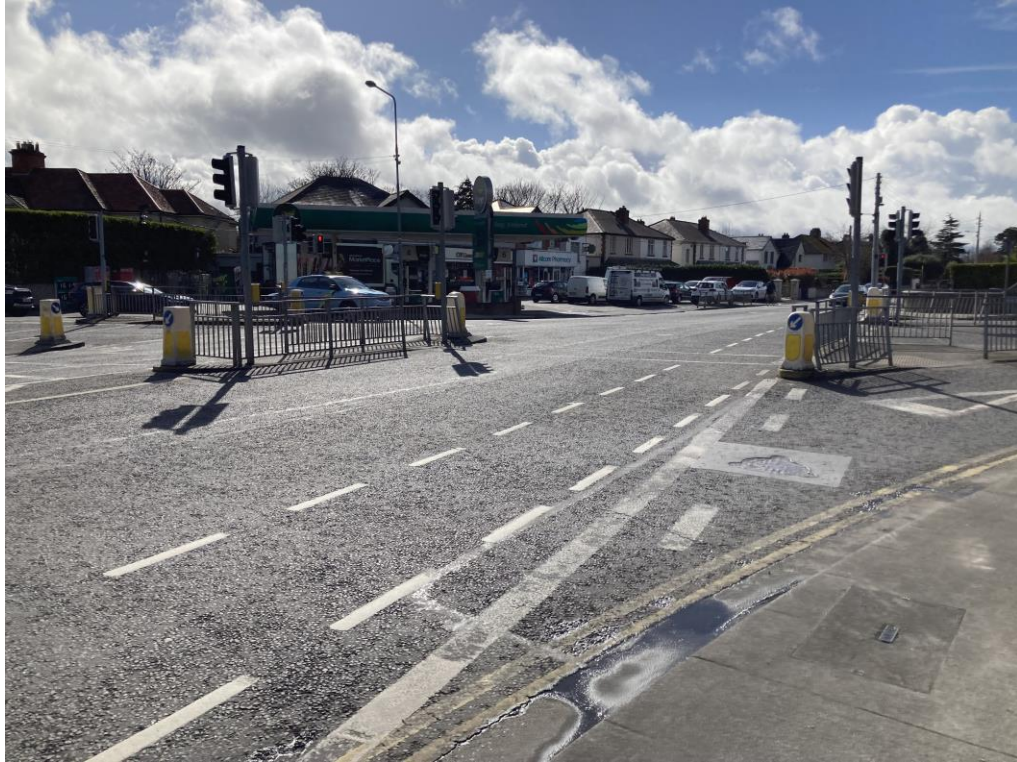
Photo ID	Caption	Date Taken	Coordinates
Kimmage_Image01	Potential interaction with service station at junction	13/03/2023	713310, 730457 (ITM)

Observation	Consultation Drawing Sheet Number	Description	Possible Impact	Photo
Petrol Station	Sheets01	Historic activities at petrol stations may have resulted in oil leaks into the surrounding soils and groundwater in the past.	This may pose an issue for the earthworks balance and waste assessment	Kimage_Image01
Urban Green Area and existing walls	Sheet 01	There is a level change noted in the green area.	This may pose an issue for the earthworks balance and waste assessment	Kimage_Image02
Petrol Station	Sheet 02	Historic activities at petrol stations may have resulted in oil leaks into the surrounding soils and groundwater in the past.	This may pose an issue for the earthworks balance and waste assessment	Kimage_Image03
Possible interaction with the River Dodder	Sheet 03	There is a potential for the Proposed Scheme to interact with the local waterbody during the development of the Stoneboat Boardwalk for the Poddle cycleway.	This may pose an issue if a localized contamination source is identified.	Kimage_Image04 & 05

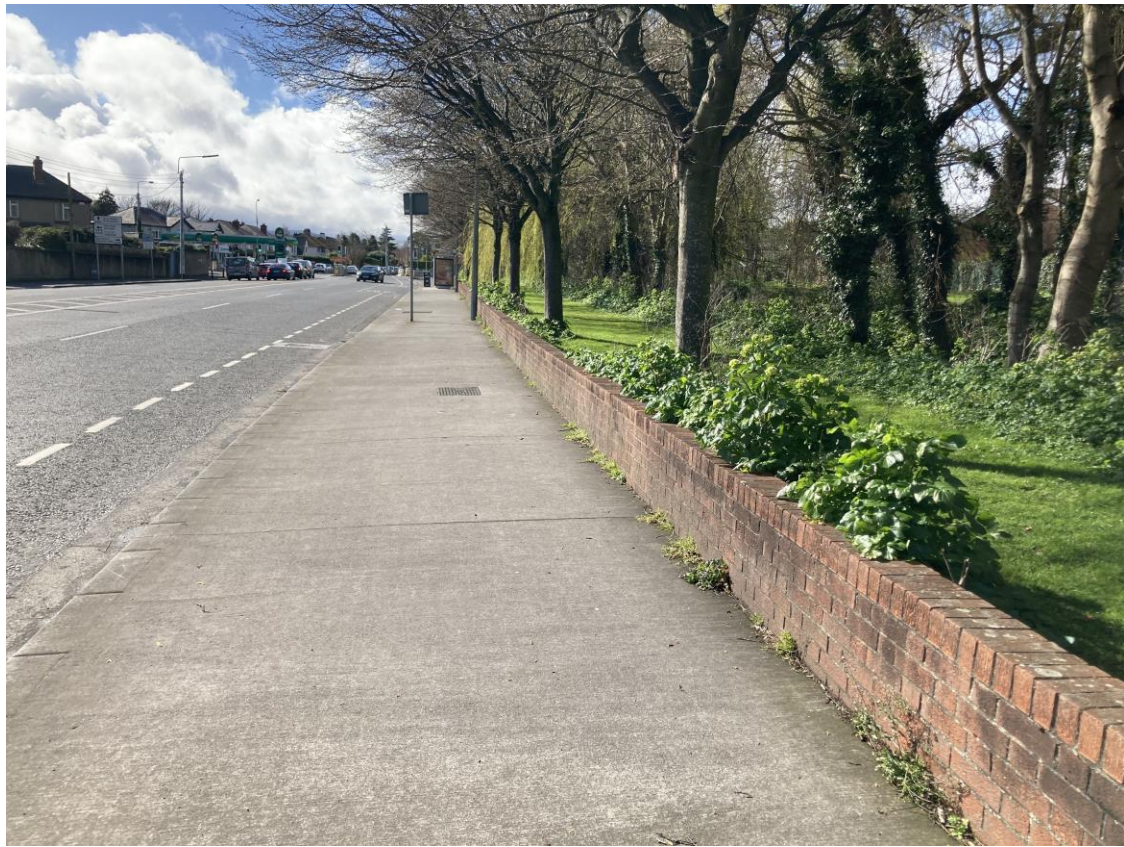
Photo ID	Caption	Date Taken	Coordinates
Kimmage_Image02	Potential level change	13/03/2023	713415, 730585 (ITM)

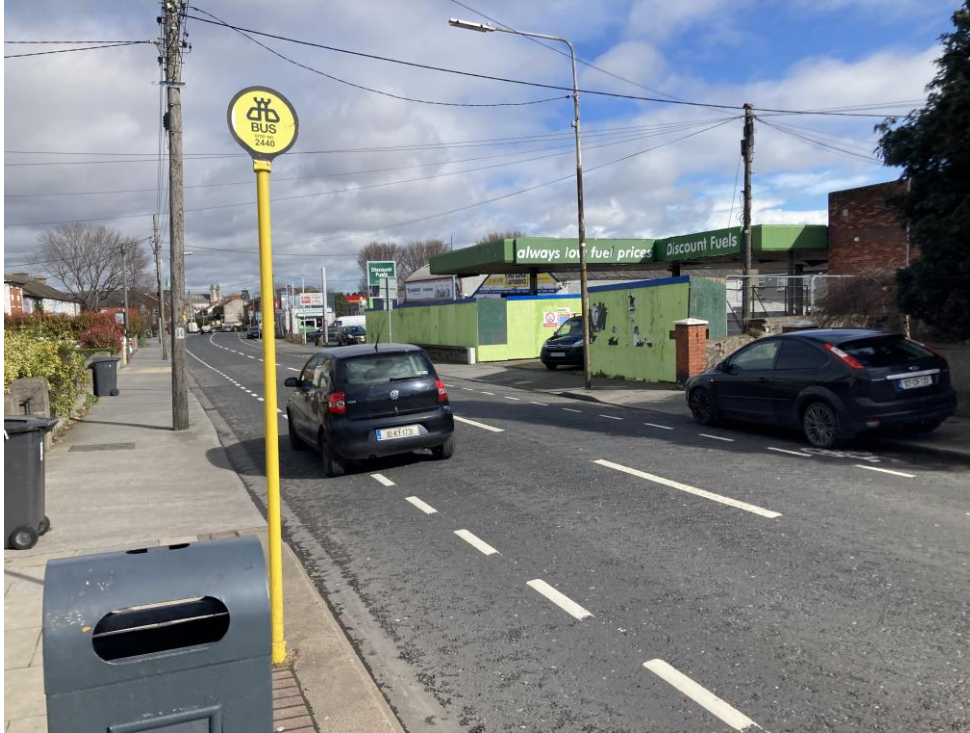
Photo ID	Caption	Date Taken	Coordinates
Kimmage_Image3	Potential interactions with service station along Kimmage Road Lower	13/03/2023	713655, 730932 (ITM)

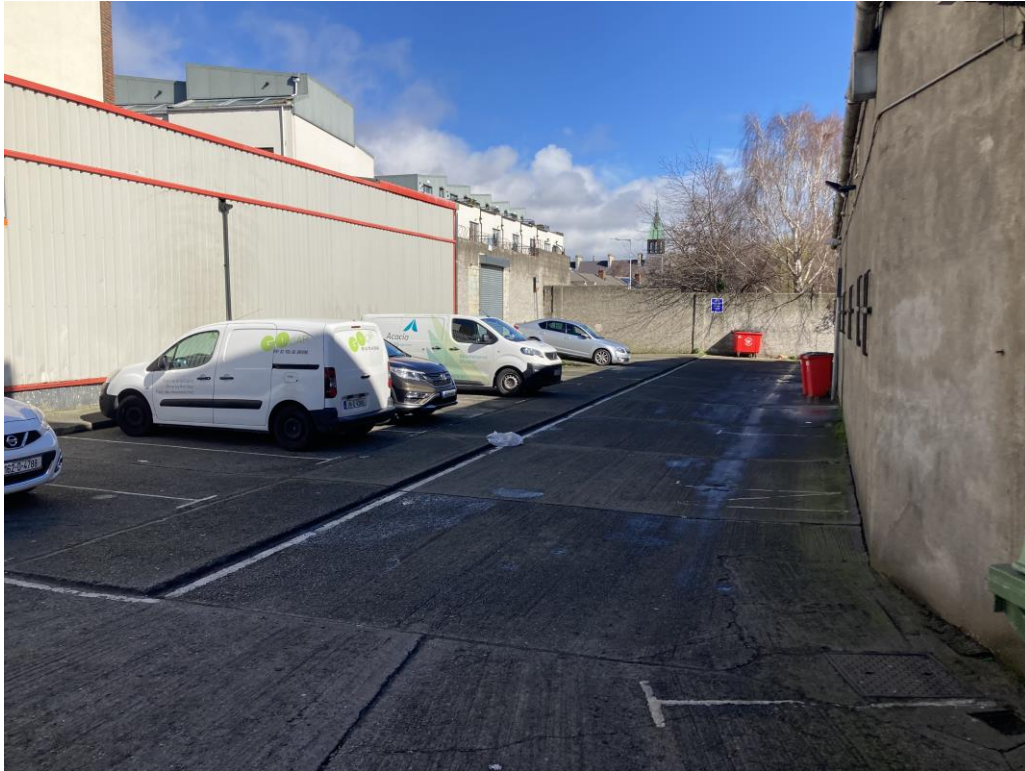
Photo ID	Caption	Date Taken	Coordinates
Kimmage_Image04	Potential location for the Poddle cycle way	13/02/20 20	713842, 731338 (ITM)

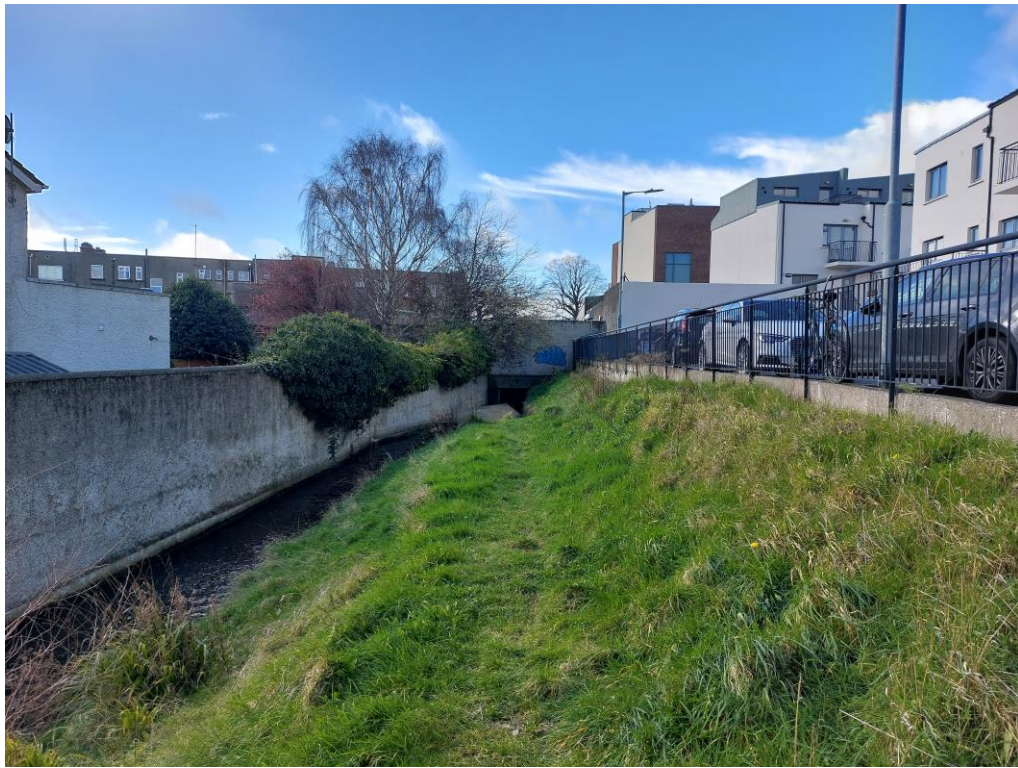
Photo ID	Caption	Date Taken	Coordinates
Kimmage_Image05	Potential location of proposed stone boat boardwalk	13/03/2023	713903, 731378 (ITM)

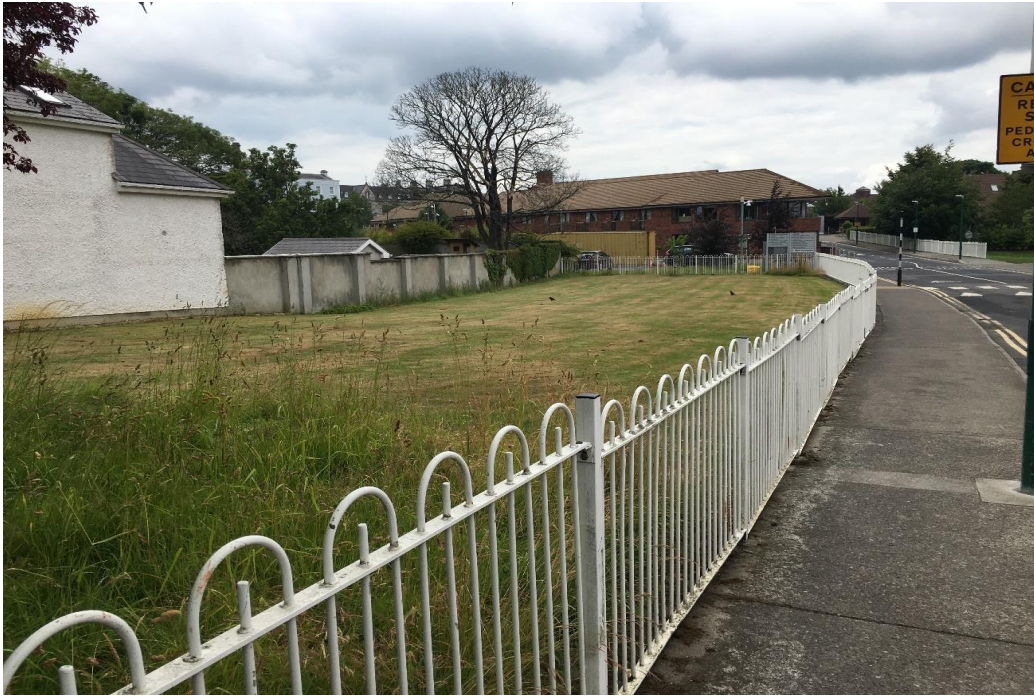
Photo ID	Caption	Date Taken	Coordinates
Kimmage_Image_06	Proposed location for a construction compound at Our Lady's Hospice – Harold's Cross Road	07/07/2021	714708, 732129 (ITM)

Potential Construction Compound	Sheet 07	Proposed location for a construction compound at Our Lady's Hospice – Harold's Cross Road. It is likely that the topsoil will be stripped, and level changes will be required at this location to accommodate the construction compound.	This may pose an issue for the earthworks balance and waste assessment	Kimage_Image06
Proposed land acquisition	Sheet 07	Proposed land acquisition along Harolds Cross Road on both sides of the carriageway. Minor level changes noted in the area	This may pose an issue for the earthworks balance and waste assessment	Kimage_Image07
Proposed new pedestrian and cycle bridge over Grand Canal	Sheet 08	There is an existing retaining wall which separates the carpark from the existing road level. There is proposed road widening in this area. There is a potential for the Proposed Scheme to interact with the local waterbody.	This may pose an issue for the earthworks balance and waste assessment and may pose an issue if a localized contamination source is identified.	Kimage_Image08 & 09

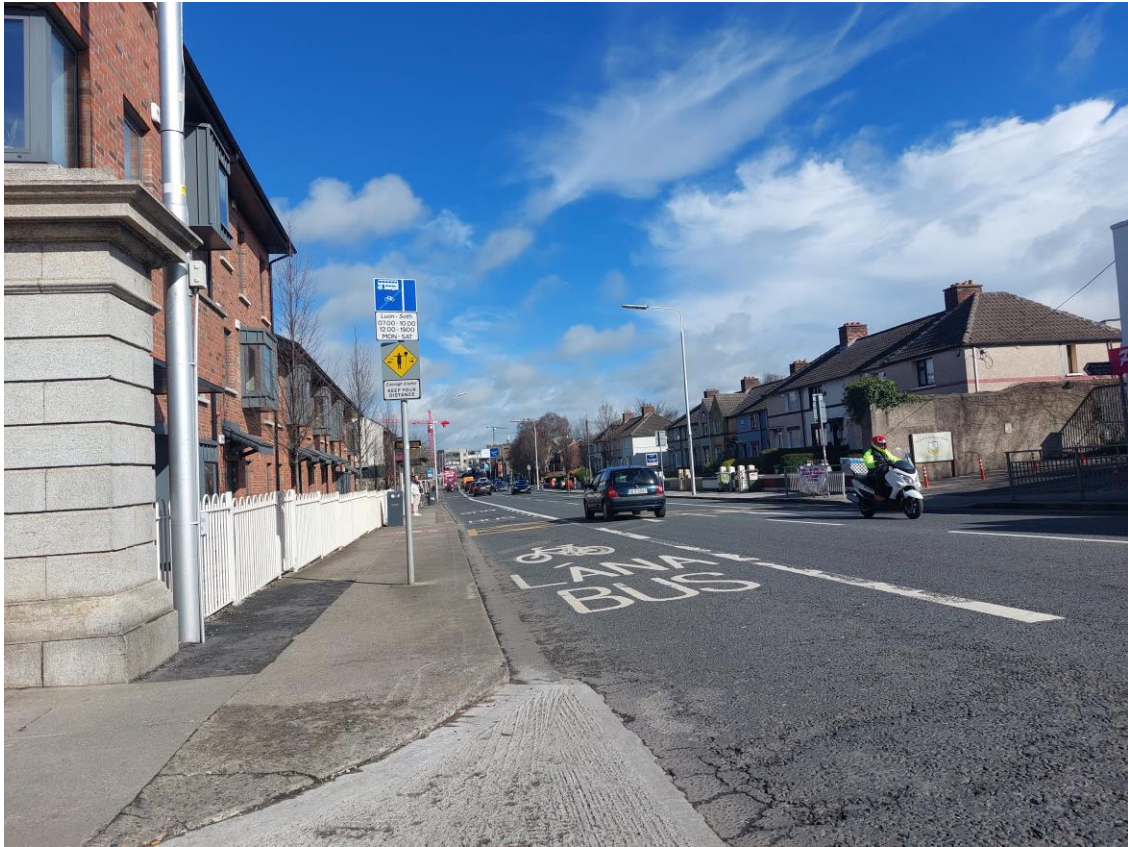
Photo ID	Caption	Date Taken	Coordinates
Kimmage_Image_07	Proposed land acquisition along Harolds Cross Road	13/03/2023	714726, 732134 (ITM)

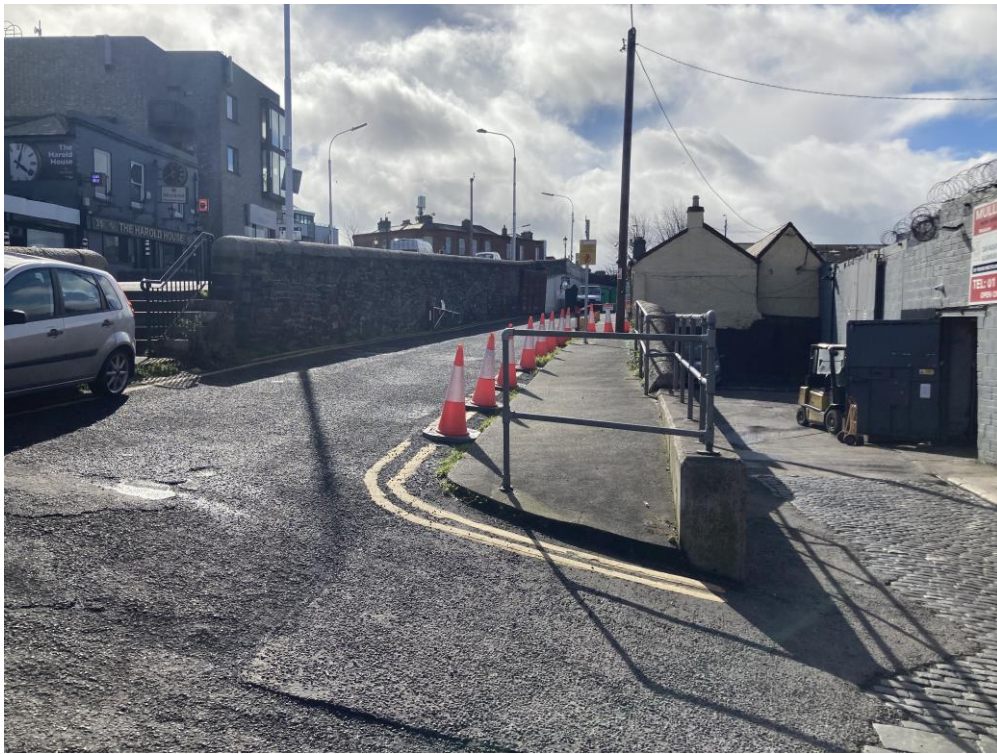
Photo ID	Caption	Date Taken	Coordinates
Kimmage_Image_09	Proposed new pedestrian and cycle bridge	13/03/2023	714867, 732512 (ITM)

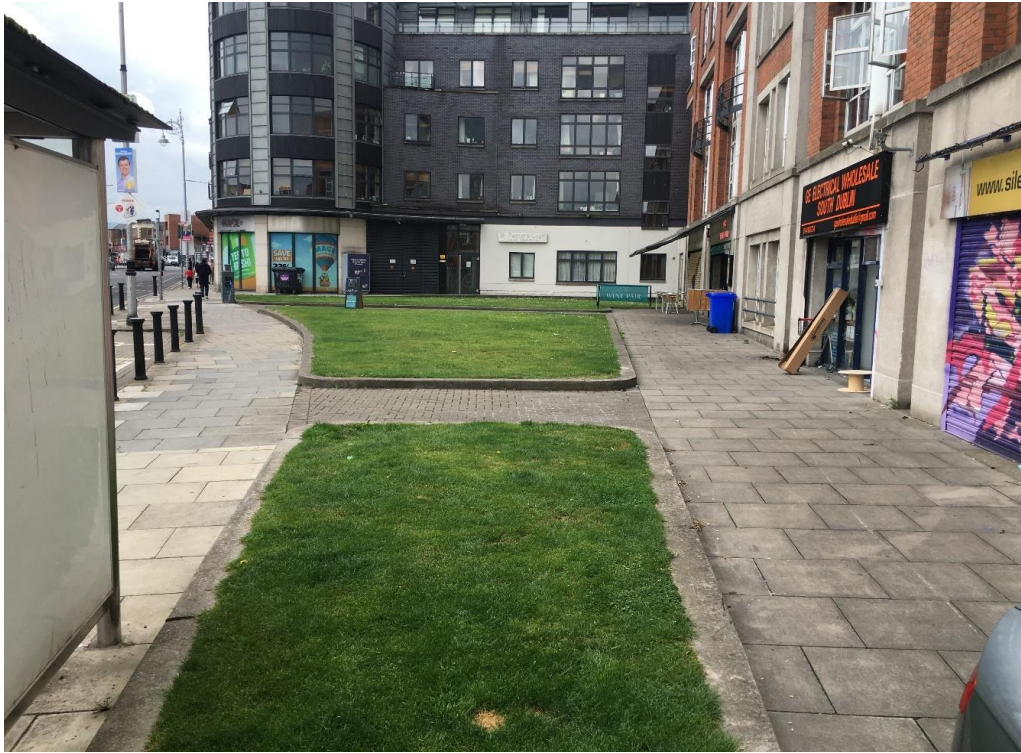
Photo ID	Caption	Date Taken	Coordinates
Kimmage_Image_10	Possible location of a construction compound at St Patrick's Court – Clanbrassil Street Lower.	07/07/2021	714888, 732937 (ITM)

Construction Compounds	Sheet 09	Possible location for a construction compound at St Patrick's Court – Clanbrassil Street Lower.Road. It is likely that the topsoil will be stripped, and level changes will be required at this location to accommodate the construction compound.	This may pose an issue for the earthworks balance and waste assessment.	Kimage_Image_10
