**Appendix A14.1**  
Scheme Walkover  
Summary

## Appendix A14.1: Scheme Walkover Summary

### 1.1 Introduction

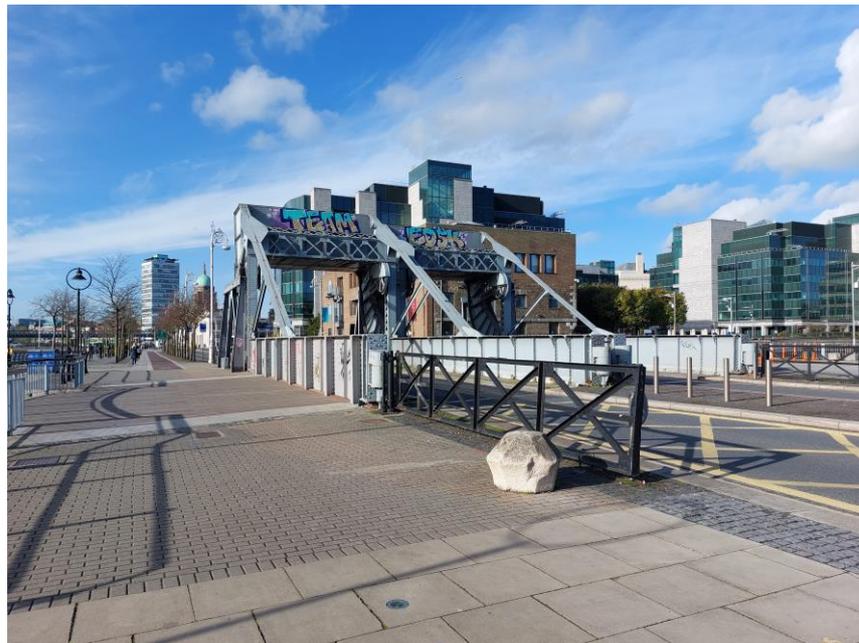
Photo ID	Caption	Date Taken	Coordinates
Ringsend_Image01	Scherzer Bridges to be relocated near George's Dock	03/11//2022	716609,734516 (ITM)

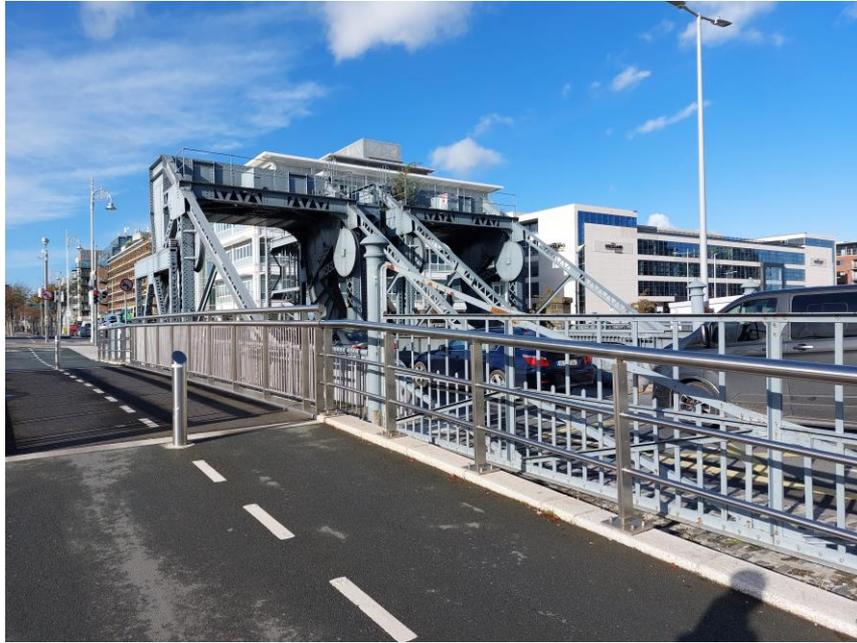
Photo ID	Caption	Date Taken	Coordinates
Ringsend_Image02	Scherzer Bridges to be relocated near the Convention Centre	03/11/2022	717154,734473 (ITM)

Observation	General Arrangement Drawing Sheet Number	Description	Possible Impact	Photo Number
Existing Scherzer Bridges to be relocated near George's Dock	Sheet 01	This will require a large level of earthworks. The map indicates the existing Scherzer Bridges are to be relocated and new carriageway bridges to be constructed. This will likely require land take, there is also a possible presence of made ground. The areas build up is uncertain and may be overlying potentially contaminated soil, mitigation measures may be needed to be put in place. GI will be required to confirm the ground conditions.	This may pose an issue for the earthworks balance, waste assessment and mobilising contaminants into the groundwater.	Ringsend_Image01
Scherzer Bridge to be relocated near the Convention Centre	Sheet 03	This will require a large level of earthworks. The map indicates the existing Scherzer Bridges are to be relocated and new carriageway bridges to be constructed. This will likely require land take, there is also a possible presence of made ground. The areas build up is uncertain and may be overlying potentially contaminated soil, mitigation measures may be needed to be put in place. GI will be required to confirm the ground conditions.	This may pose an issue for the earthworks balance, waste assessment and mobilising contaminants into the groundwater.	Ringsend_Image02

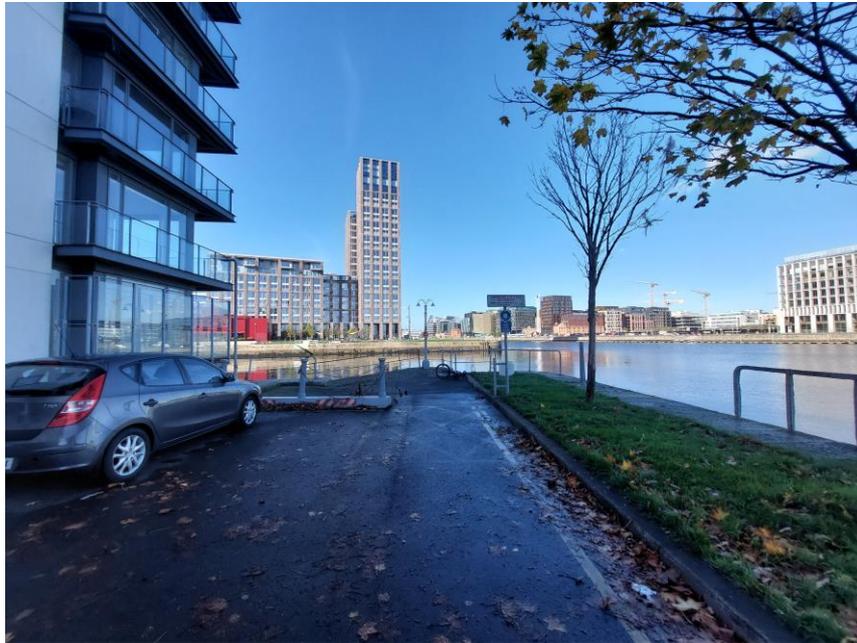
Photo ID	Caption	Date Taken	Coordinates
Ringsend_Image03	DPTOB	03/11//2022	717941,734196 (ITM)

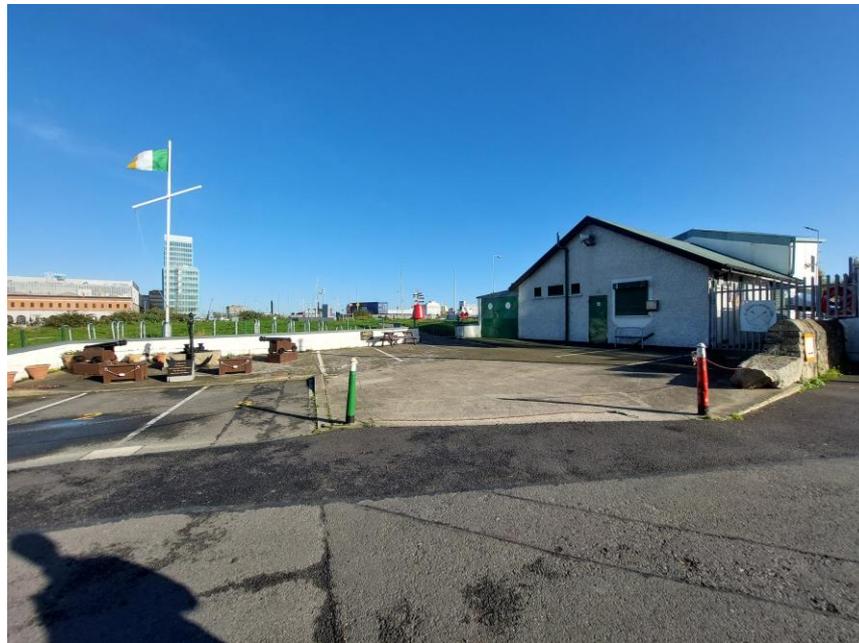
Photo ID	Caption	Date Taken	Coordinates
Ringsend_Image04	SPRC	03/11/2022	717976,734181 (ITM)

Dodder Public Transport Opening Bridge (DPTOB)	Sheet 04/05	This will require a large level of earthworks. This will likely require land take, there is also a possible presence of made ground. The areas build up is uncertain and may be overlying potentially contaminated soil, mitigation measures may be needed to be put in place.	This may pose an issue for the earthworks balance, waste assessment and mobilising contaminants into the groundwater.	Ringsend_Image03
St Patrick's Rowing Club (SPRC)	Sheet 04/05	The map indicates the proposed demolition of the existing clubhouse and construction of a new clubhouse at this location. Minor level changes were noted at this location. It will likely result in the removal of local walls, kerbs and trees. Due to the close proximity to the River Liffey, mitigation measures will need to be implemented to prevent any local contamination entering the water system from the ongoing works.	This may pose an issue for the earthworks balance, waste assessment and mobilising contaminants into the groundwater.	Ringsend_Image04

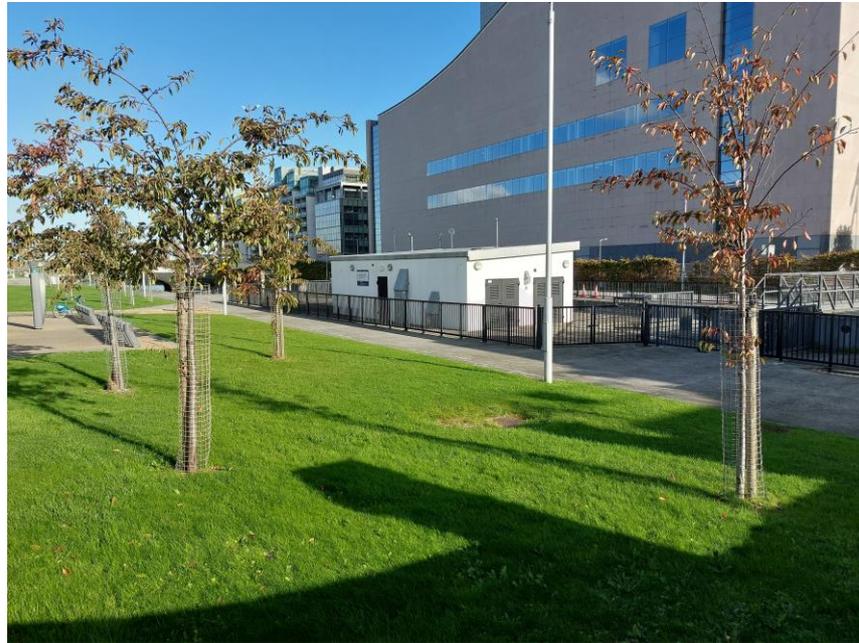
Photo ID	Caption	Date Taken	Coordinates
Ringsend_Image05	Construction Compound	03/11/2022	717115,734501 (ITM)

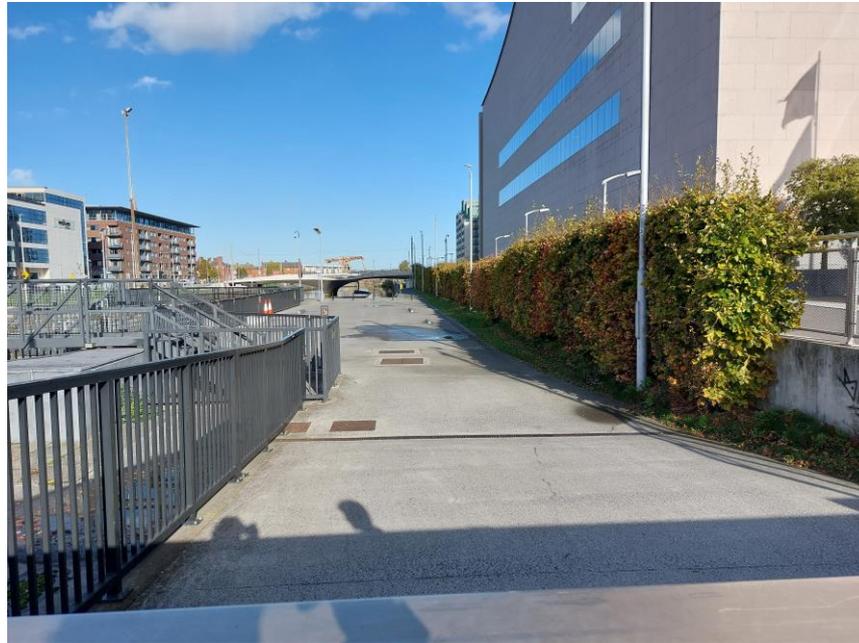
Photo ID	Caption	Date Taken	Coordinates
Ringsend_Image06	Construction Compound	03/11/2022	717163, 734491 (ITM)

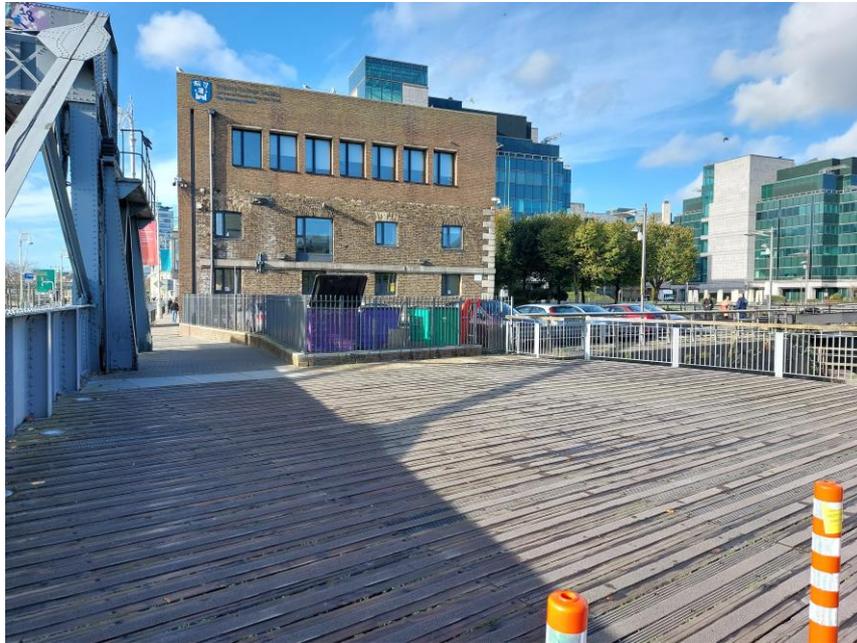
Photo ID	Caption	Date Taken	Coordinates
Ringsend_Image08	Construction Compound	03/11/2022	716588, 734540 (ITM)

Construction Compound	Sheet 01	A potential construction compound is to be located within this area which is located to the north of the Scherzer Rolling Bridges.	This may pose an issue for the earthworks balance and waste assessment if a localised contamination source or spill is identified.	Ringsend_Image08
Construction Compound	Sheet 04	A potential construction compound is to be located within this area at Sir John Rogerson's Quay which is adjacent to the River Liffey.	This may pose an issue for the earthworks balance and waste assessment if a localised contamination source or spill is identified.	Ringsend_Image09
Construction Compound	Sheet 06	A potential construction compound is to be located within this grass area to the north of the existing St. Patrick's Rowing Club. Trees were noted at this location. It is likely that the topsoil will be stripped, and minor earthworks are likely to be required to accommodate the works.	This may pose an issue for the earthworks balance and waste assessment if a localised contamination source or spill is identified.	Ringsend_Image10

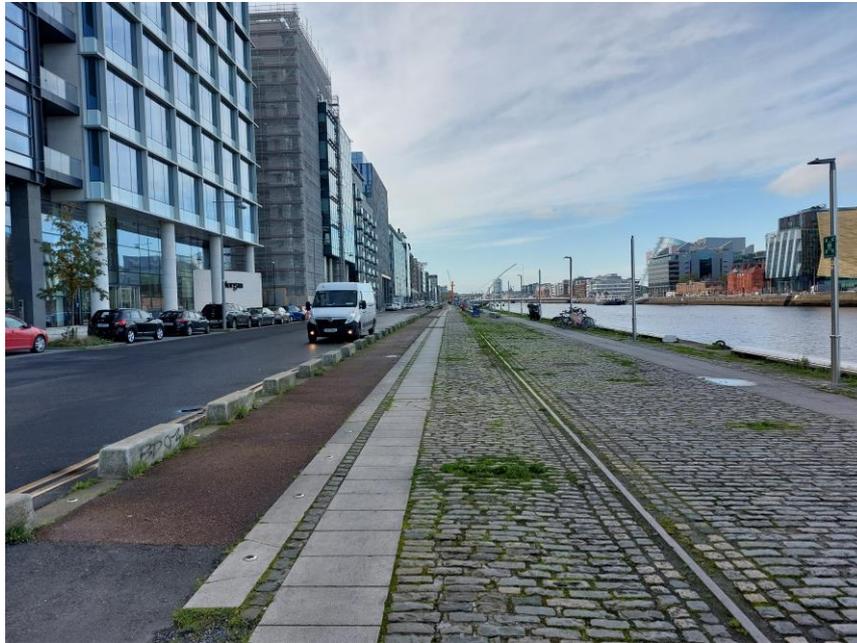
Photo ID	Caption	Date Taken	Coordinates
Ringsend_Image09	Construction Compound	03/11/2022	717742, 734272 (ITM)

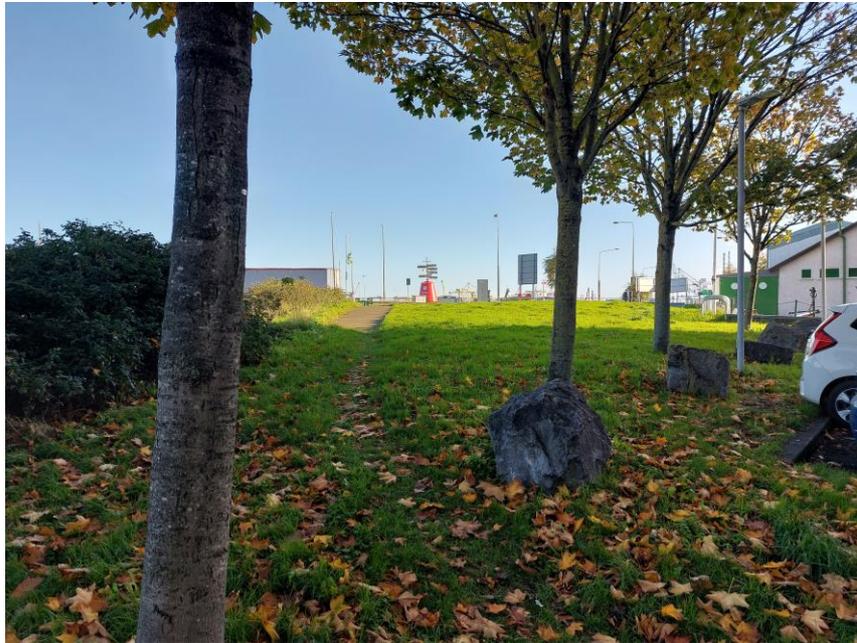
Photo ID	Caption	Date Taken	Coordinates
Ringsend_Image10	Construction Compound	03/11/2022	717972, 734198 (ITM)
