**Appendix A14.2**  
Ground Investigation  
Report

## **Bus Connects Route 13 Bray to City Centre – Ground Investigation**

Report No.: 20-0399E

Date: December 2020

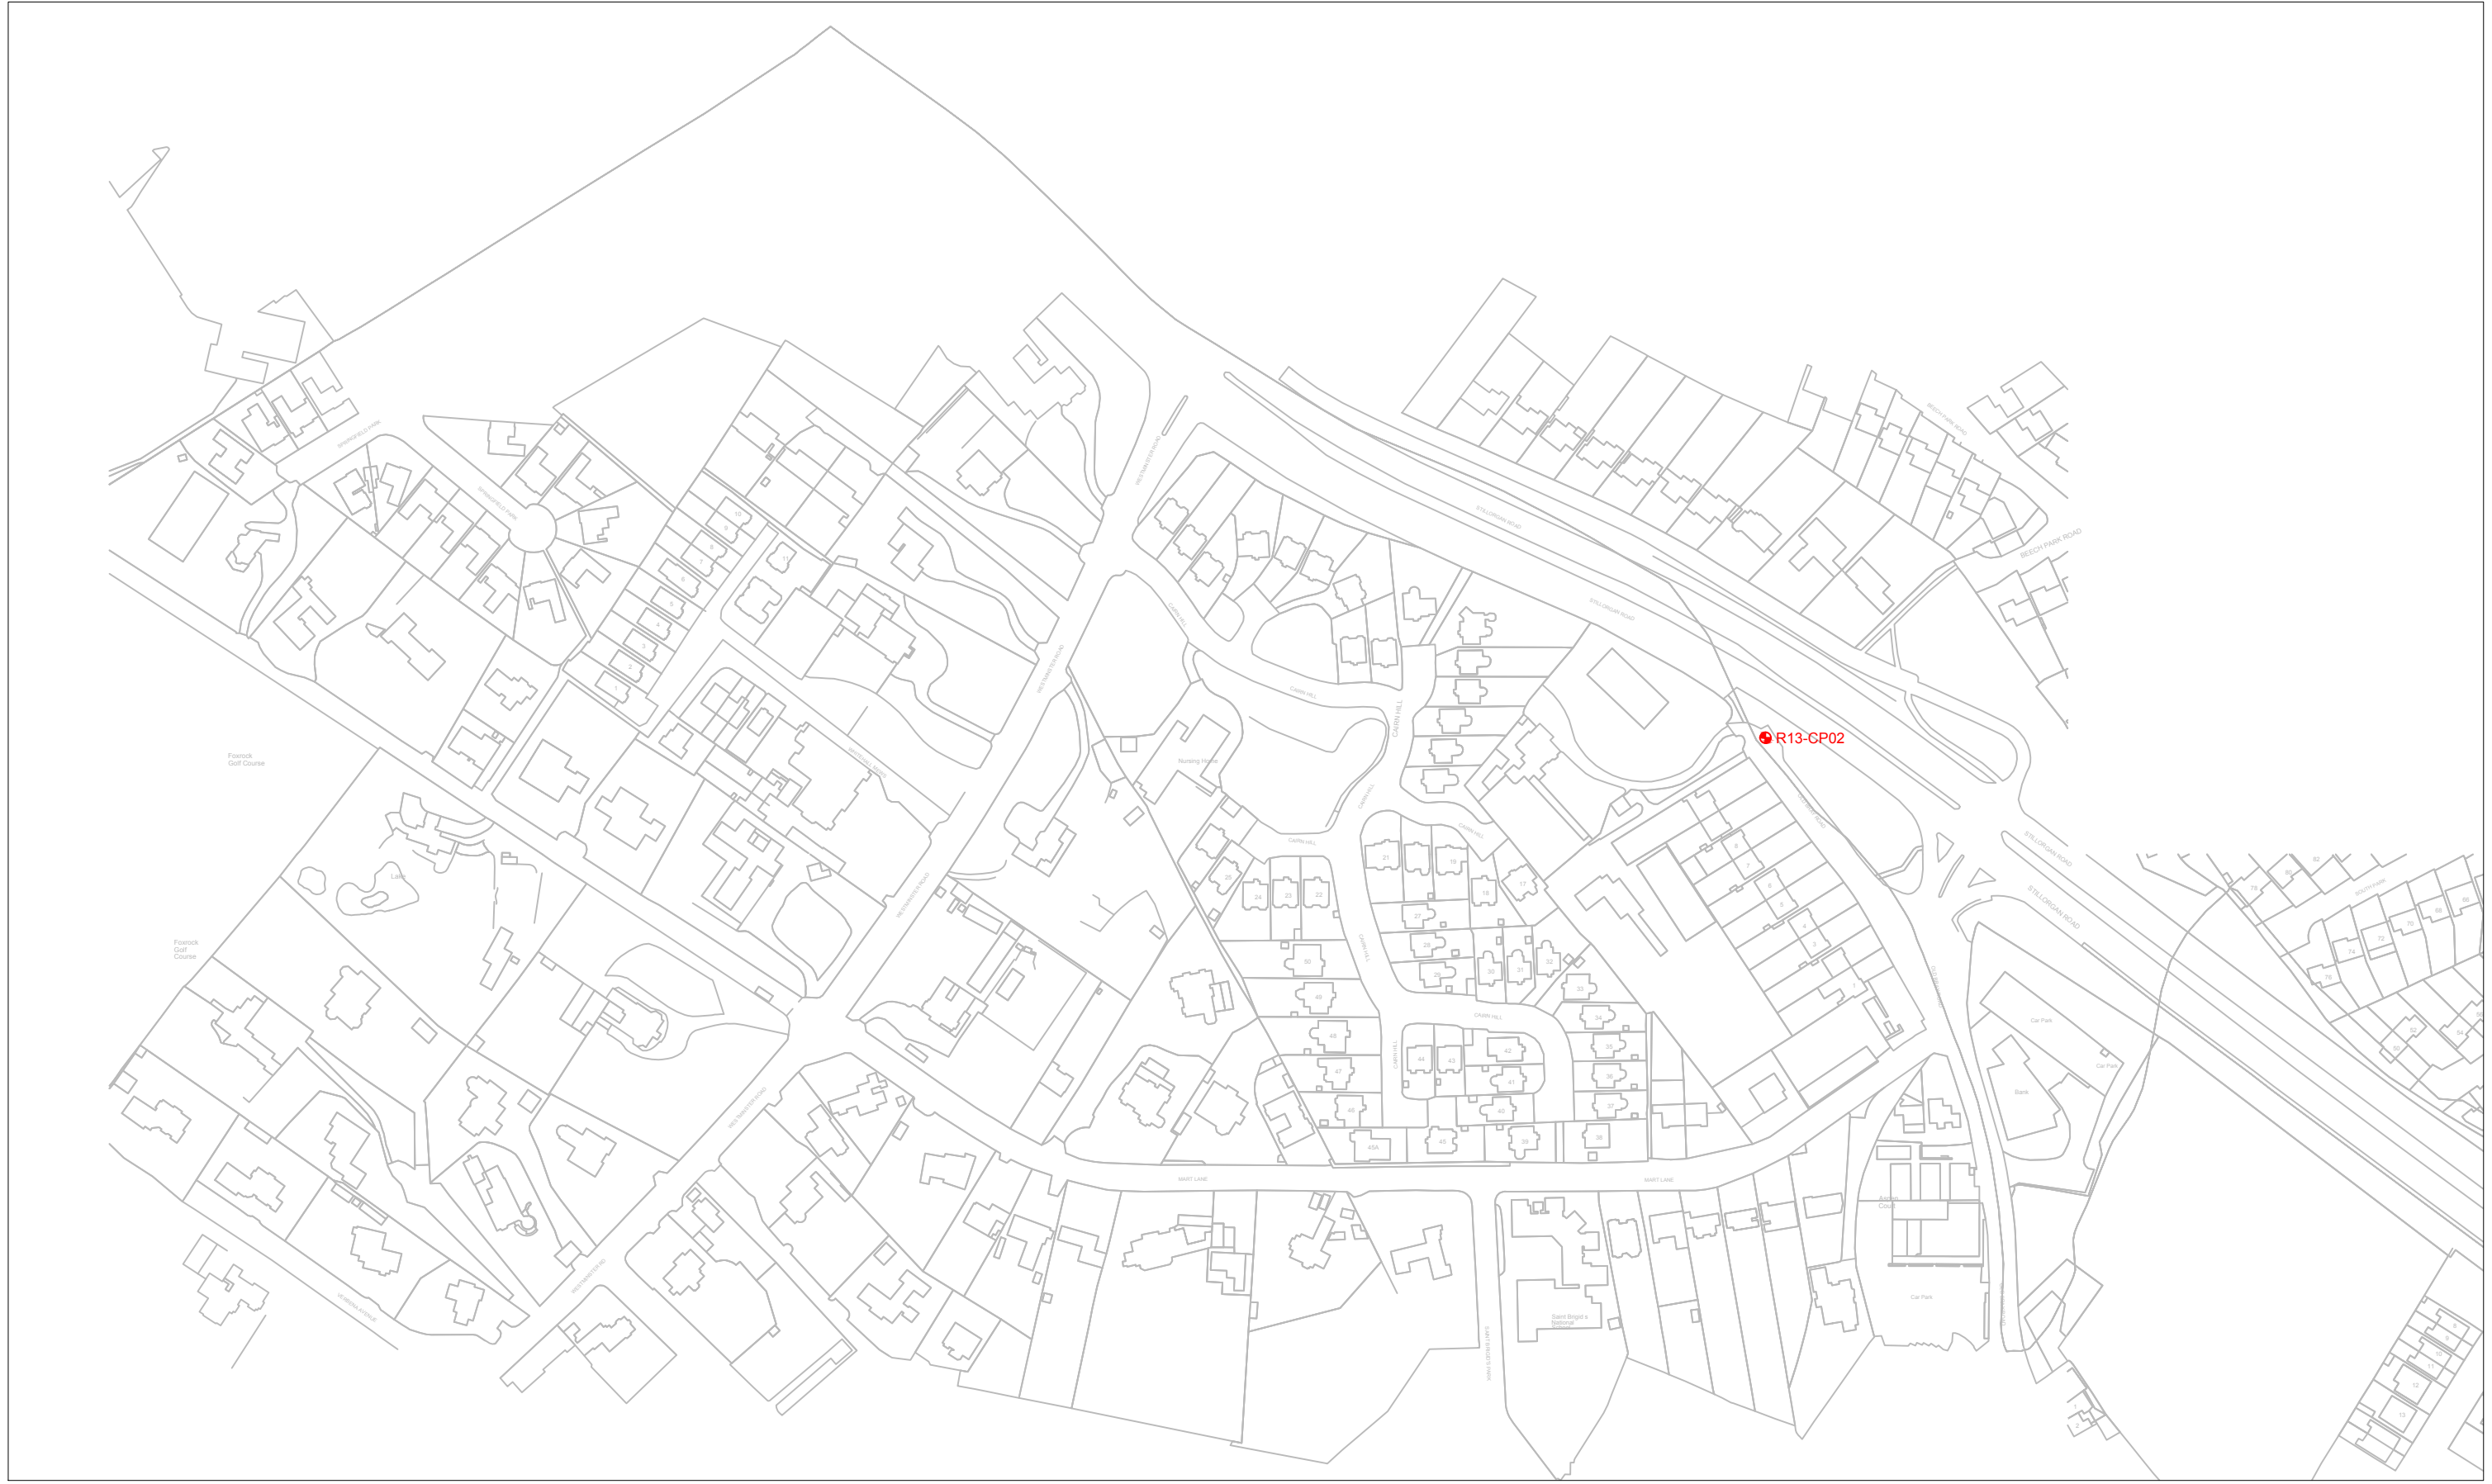
DWG No: 20-0399E-EHL-003

TITLE: Exploratory hole location plan

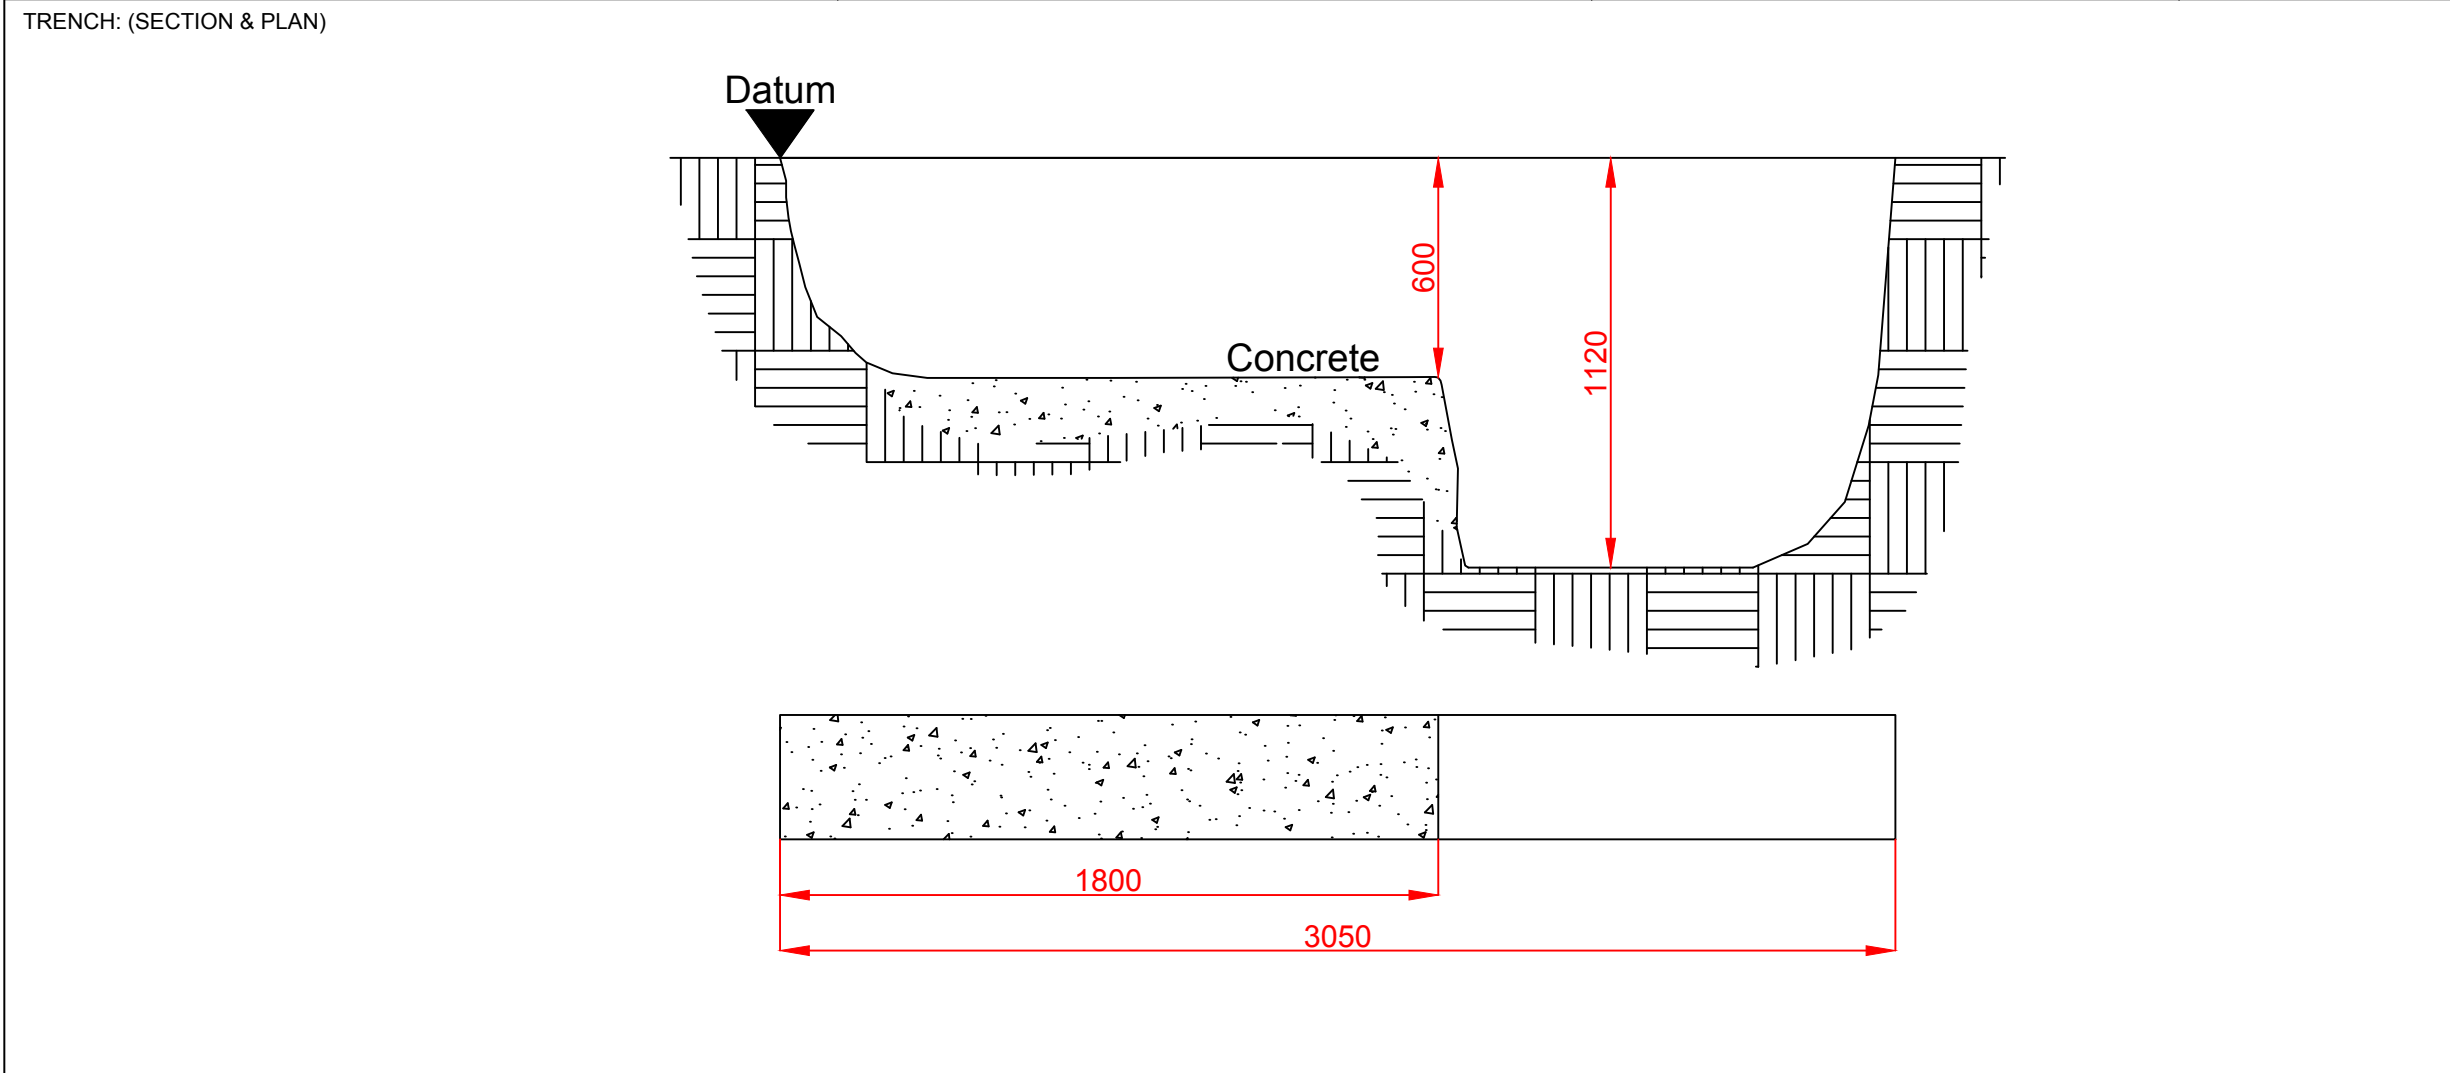
JOB NUMBER: 20-0399E      JOB NAME: Route 13 Bray to City Centre      LOCATION: R13 - SLT01

No:	Type of Service:	Diameter (in mm)	Depth to Top of Service (m)	Distance to Centre of Service (m)	Details/Comments
01	Possible ESB	Unknown	0.60	0.90 (assumed)	Lean mix covering ESB
02					
03					
04					
05					
06					
07					
08					
09					
10					
11					
12					
13					
14					
15

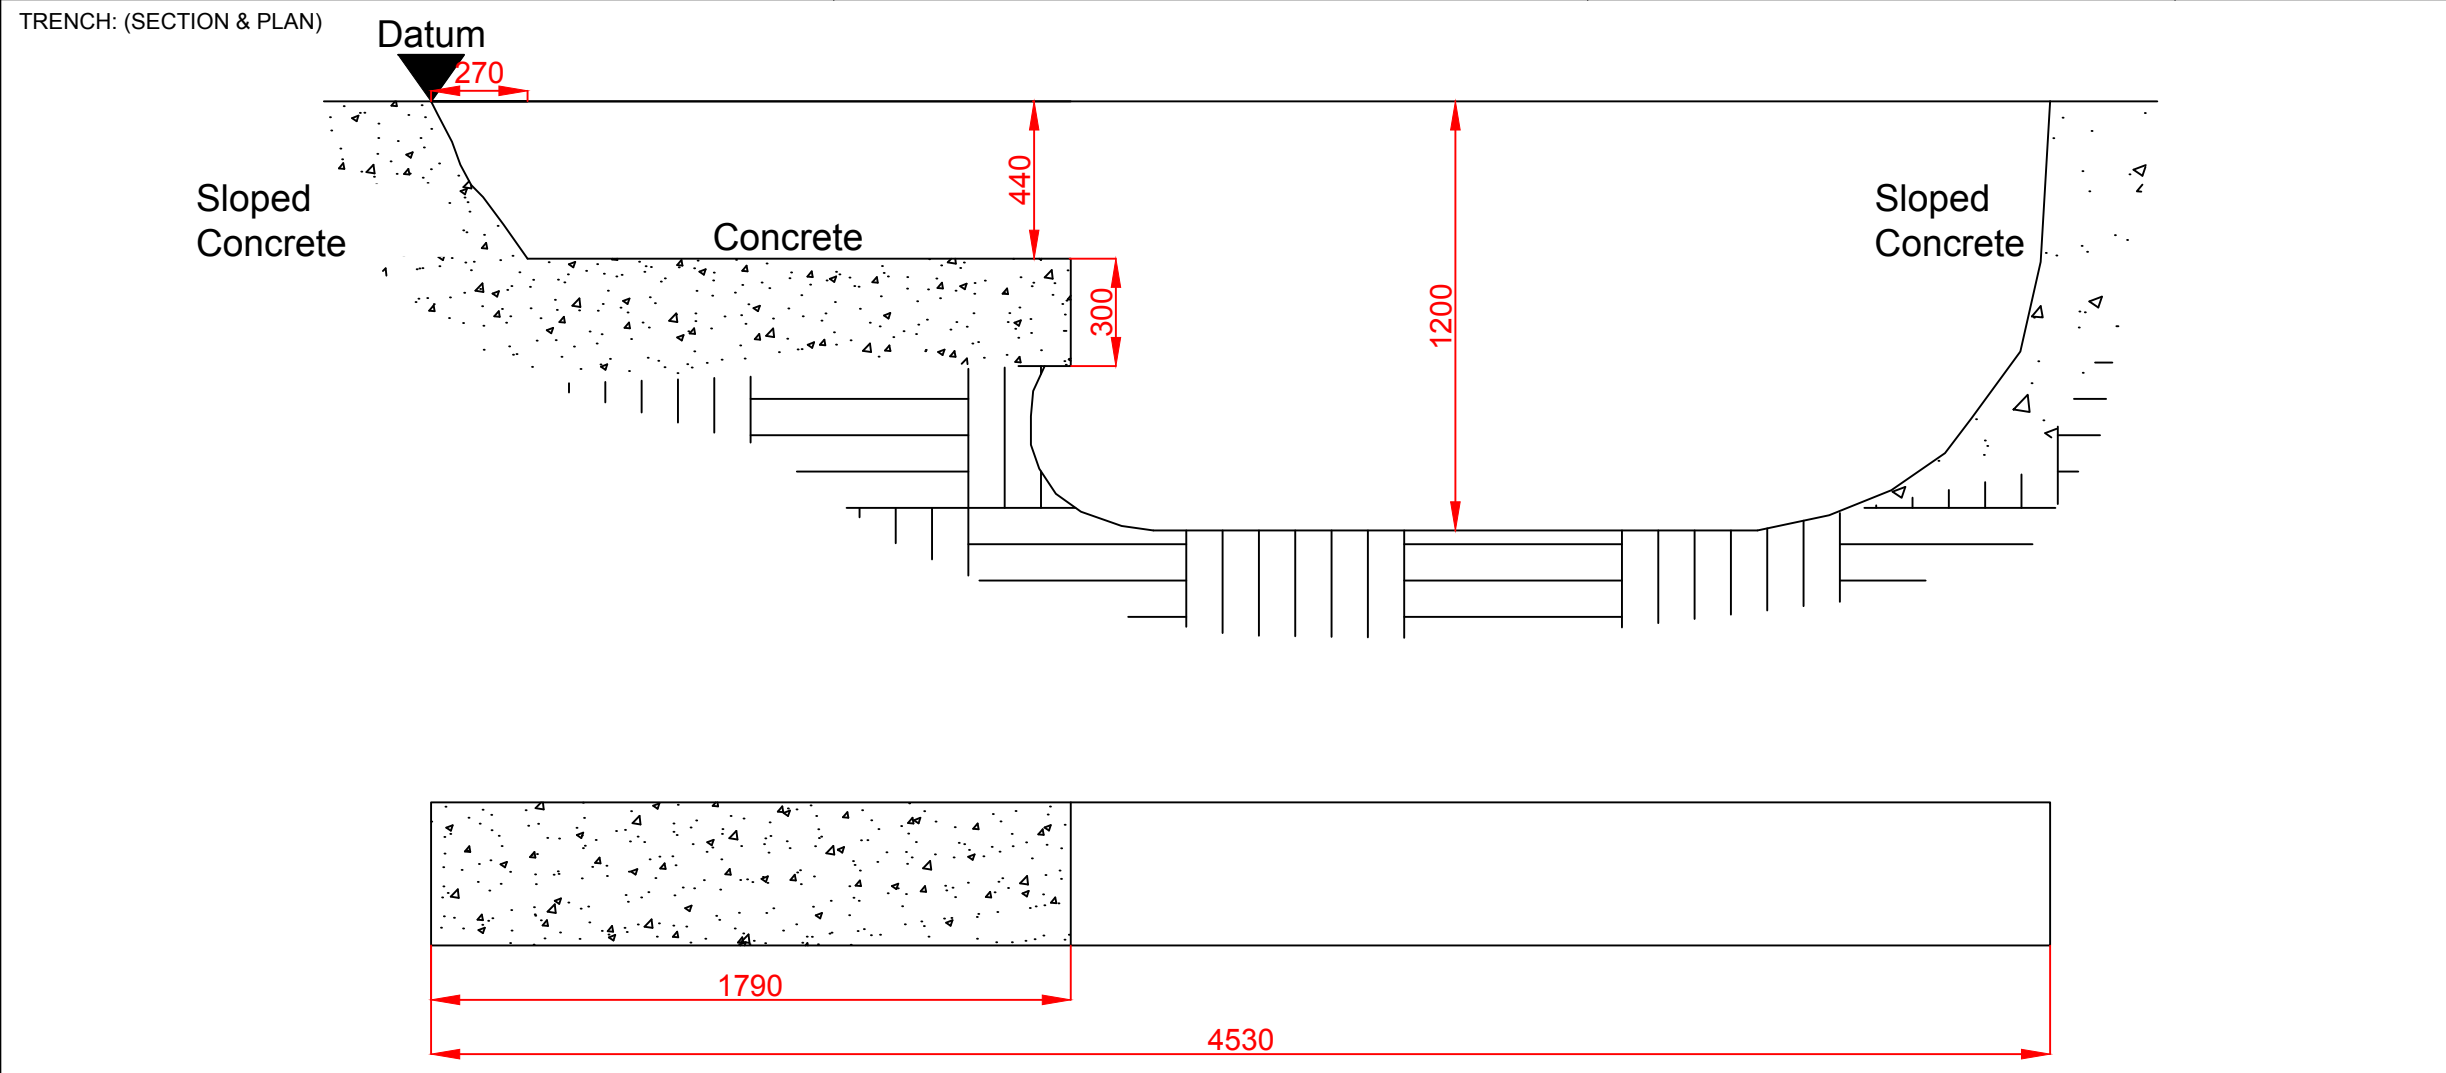
JOB NUMBER: 20-0399E      JOB NAME: Route 13 Bray to City Centre      LOCATION: R13 - SLT02

No:	Type of Service:	Diameter (in mm)	Depth to Top of Service (m)	Distance to Centre of Service (m)	Details/Comments
01	Possible ESB	Unknown	0.44	Unknown	Lean mix covering ESB
02					
03					
04					
05					
06					
07					
08					
09					
10					
11					
12					
13					
14					
15

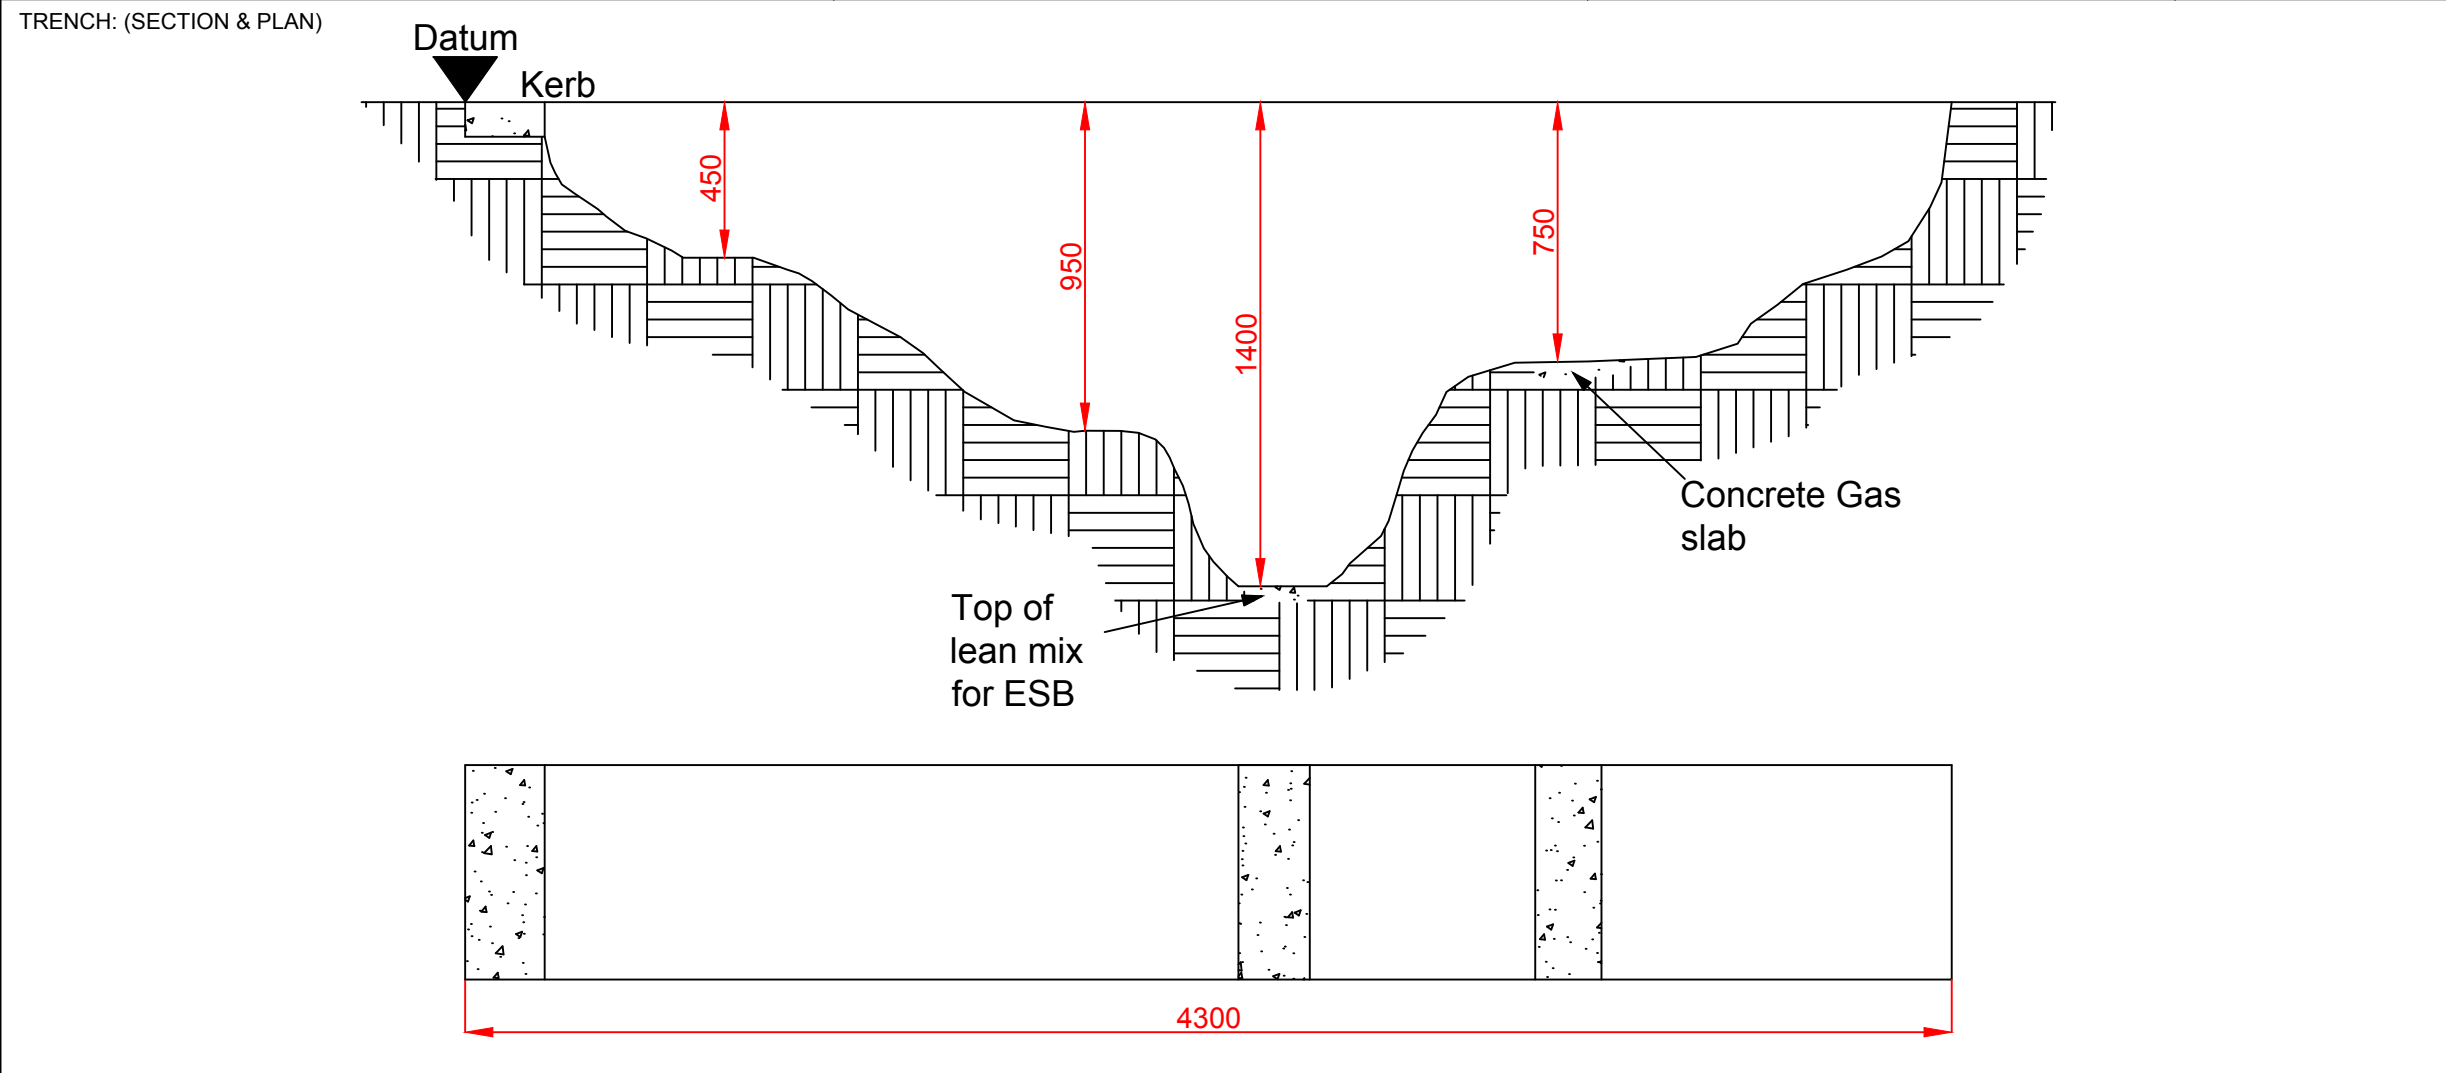
JOB NUMBER: 20-0399E      JOB NAME: Route 13 Bray to City Centre      LOCATION: R13 - SLT04

No:	Type of Service:	Diameter (in mm)	Depth to Top of Service (m)	Distance to Centre of Service (m)	Details/Comments
01	ESB	Unknown	1.40	2.30	Lean mix covering ESB
02	Gas	160	0.75	3.00	Lean mix covering Gas
03					
04					
05					
06					
07					
08					
09					
10					
11					
12					
13					
14					
15

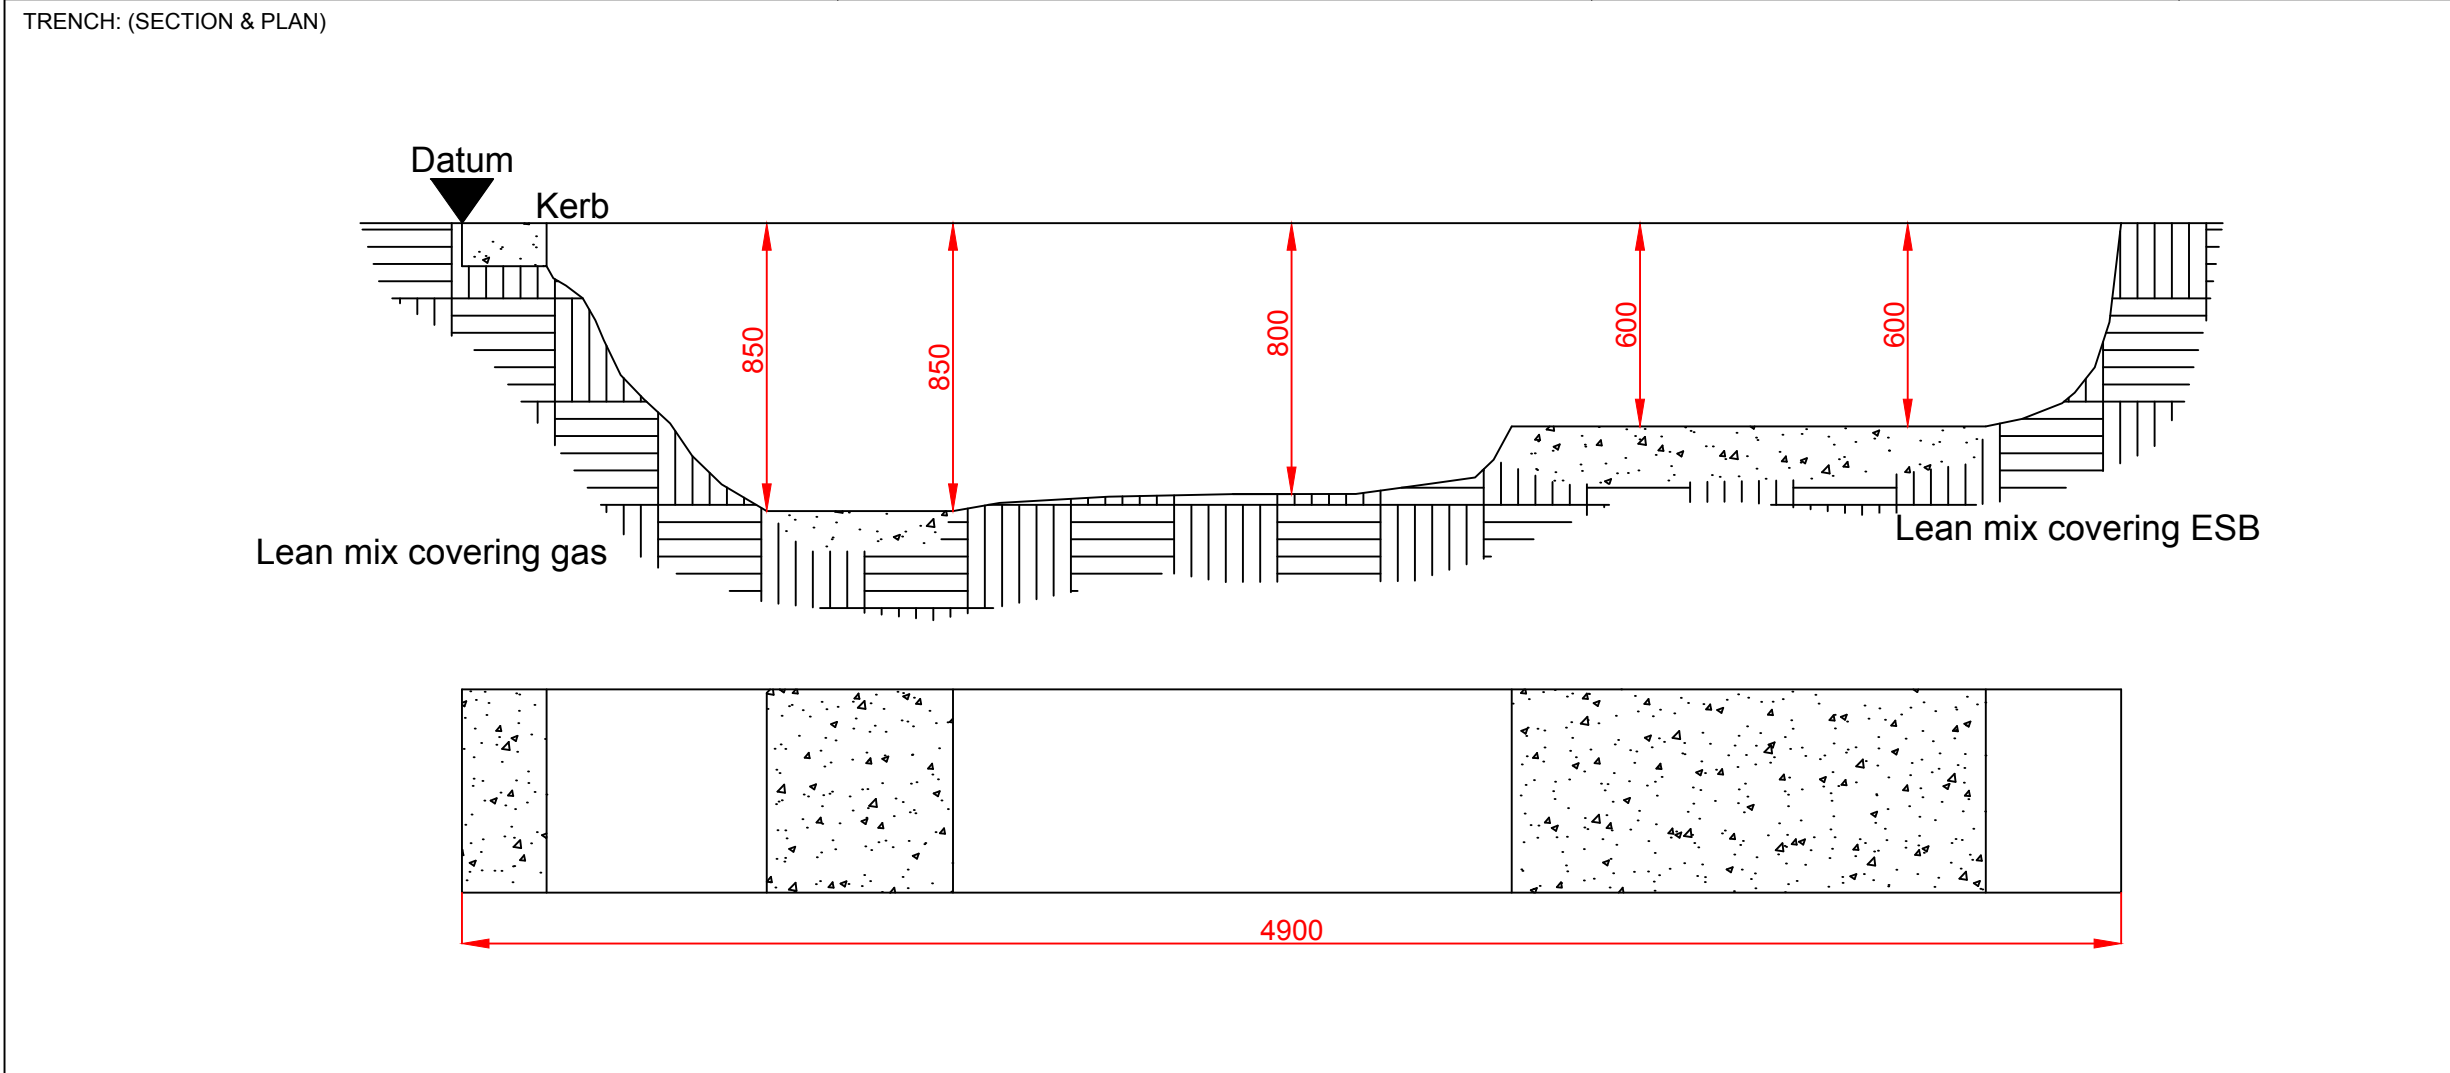
JOB NUMBER: 20-0399E      JOB NAME: Route 13 Bray to City Centre      LOCATION: R13 - SLT05

TRENCH ORIENTATED : 275° FROM NORTH
