ROAD SAFETY AUDIT

Title: STAGE 1 ROAD SAFETY AUDIT

Primary Care Centre & Nursing Home, Moygaddy, Co. Meath.

Report reference: 1388R02

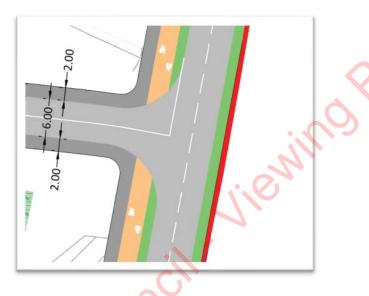
Drawing S665- OCSC-1B-MH-DR-C-0111 S2 P01 Sheet 2 of 3, cycle track across side road.

The proposed two way cycle track crosses the mouth of the proposed side road. There is a risk that drivers exiting the side road may not expect two way cyclists as they approach the stop line.

It is recommended that a 'bend out crossing' be provided.

3.2	Y	N	It is proposed to provide a shared space and tactile for crossing before the cyclist and pedestrian approach the junction. A raised crossing will be provided to indicate priority for pedestrians and cyclists.	Yes

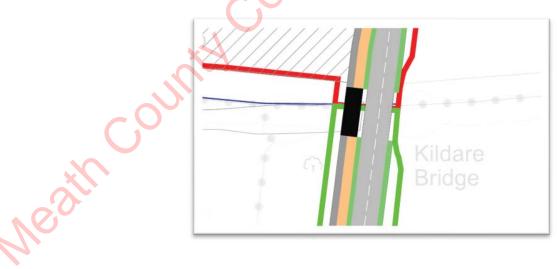
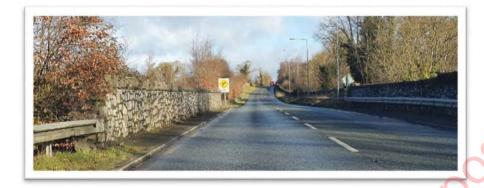
Drawing S665- OCSC-1B-MH-DR-C-0112 S2 P01 Sheet 3 of 3, Kildare Bridge Cross Section.

It is unclear if there is sufficient width at Kildare Bridge to accommodate a consistent cross section including the cycle track and footpath and the vehicle restraint systems (with correct setback to the front and working width to the rear). This could lead to a pinch point in the facilities for vulnerable road users which may result in cyclists opting to travel on the R157 carriageway where they would be at grater risk of being struck by passing vehicles.

It is recommended that the effective width of the cycle and pedestrian facilities be consistent all along the R157.

3.4	Y	C _N	The width of the cycle way and footway will stay consistent. A new pedestrian and cyclist bridge section will be constructed adjacent to the existing bridge to accommodate these modes.	Yes

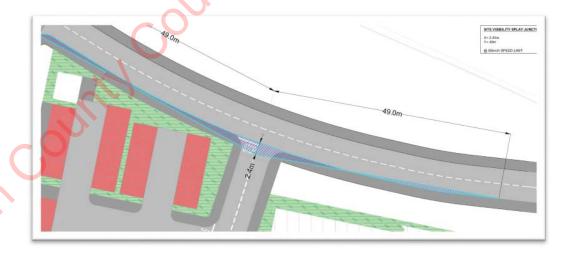
Drawing S665- OCSC-1B-MH-DR-C-0115 S2 P01 Visibility Splay at side road junction with the proposed units.

The visibility splay is shown for a 50km/hr urban design speed. It is unknown what the planned speed limit and design speed will be. The speed limit on the R157 is currently 80km/hr. There may be insufficient visibility to oncoming vehicles leading to side-impact or rear-end collisions.

It is recommended that visibility splays be provided to match the design speed of the side road.

3.5	N	N	The visibility splay is achieved for 50kmph.The new speed limit will be 50kmph once the new distributor road and development is completed.	Yes

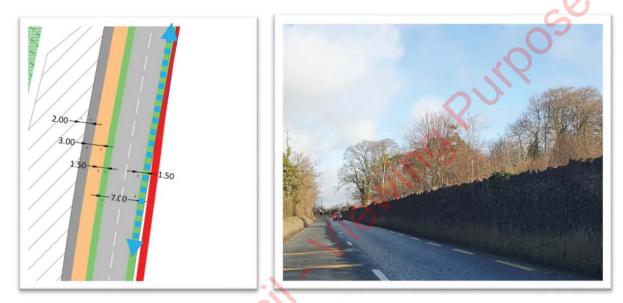
Drawing S665- OCSC-1B-MH-DR-C-0112 S2 P01 Sheet 3 of 3, Carton Estate boundary wall.

It is proposed to provide a 1.5m verge between the R157 and the Carton Estate boundary wall. The wall may be hazard if struck by an errant vehicle.

It is recommended that a suitable Clear Zone be provided between the boundary wall and the R157 carriageway.

3.7	N	N	The proposed 1.5 m verge separation is an improvement to the existing condition, and the section of road is straight and the speed limit on the road will be reduced	Yes
